✓  
DOT/FAA/CT-88/03

# Study of Benefits of Passenger Protective Breathing Equipment From Analysis of Past Accidents

Louise Speitel  
Richard G. Hill

Final Report

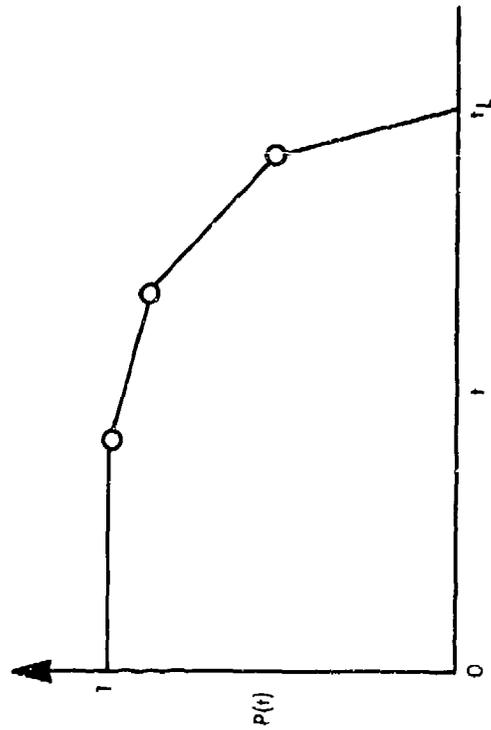
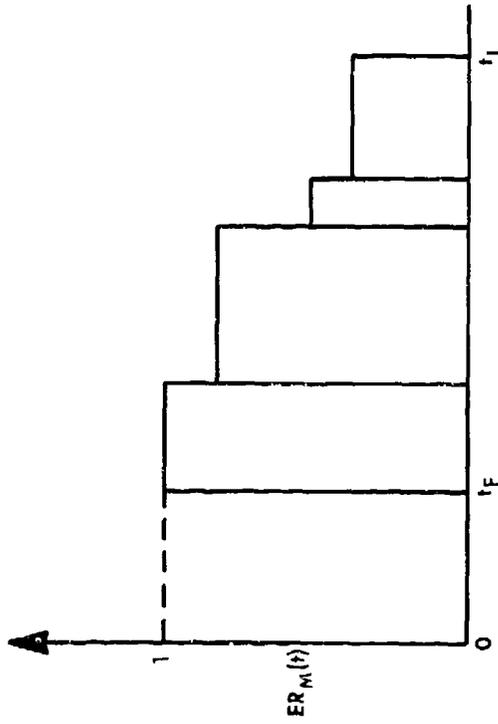
FIGURE 1. METHOD OF APPROACH

THERMAL AND TOXIC HAZARD PROFILE

$t_1$  = TIME AFTER AIRCRAFT STOPPED (SECONDS)  
 $P(t)$  = THERMAL AND TOXIC HAZARDS  
 $t_L$  = TIME OF EVACUATION BY LAST SURVIVOR

MOBILITY RATE PROFILE

$ER_M(t)$  = MOBILITY RATE  
 $A$  =  $ER_A(t)$  WHEN  $P(t) \cdot ER_M(t) = 1$   
 $t_F$  = TIME OF EVACUATION BY FIRST SURVIVOR

$$\text{EVACUATION RATE} = ER_A(t) = \dots P(t) \cdot ER_M(t)$$

- SOLVE FOR A FROM NUMBER OF SURVIVORS
- COMPARE A WITH EVACUATION DEMONSTRATION DATA
- MODIFY ASSUMPTIONS, IF NECESSARY, TO MAKE A CONSISTENT WITH EVACUATION DATA
- A FIRE SAFETY IMPROVEMENT WILL CHANGE THE PROFILES, BUT NOT A
- CALCULATE THE NUMBER OF SURVIVORS FOR EACH IMPROVEMENT

A simple model was developed to predict the number of survivors in an aircraft fire scenario, based on mobility and fire hazard profiles. The model is one-dimensional in that time is the only independent variable. Thus, the model requires that the two profiles be described as a function of time ( $f(t)$ ). In the case of an accident, the profiles are a numerical, subjective reconstruction of the relative decrease in occupant mobility and relative increase in fire hazards, both as  $f(t)$ , from a review of accident reports and information from accident investigators. Inevitably, many assumptions must be made to exercise the model, due to lack of complete information. Figure 1 illustrates these two profiles and how they are utilized to determine evacuation rates. The time of evacuation by the first survivor is  $t_p$ . The time the last survivor exits the aircraft is  $t_L$ .

Thermal and toxic hazard profile:  $P(t)$  versus time after aircraft stopped. As can be seen from figure 1, if  $P(t) = 1$ , no toxic or thermal hazards exist. If  $P(t) = 0$ , sufficient hazards exist to result in the incapacitation of all passengers. If all survivors were to successfully evacuate with time to spare,  $P(t)$  would exceed 0 at the time the last passenger exited the aircraft. Hazards that cause incapacitation include heat, toxic gases, oxygen depletion, smoke inhalation, and direct exposure to fire.

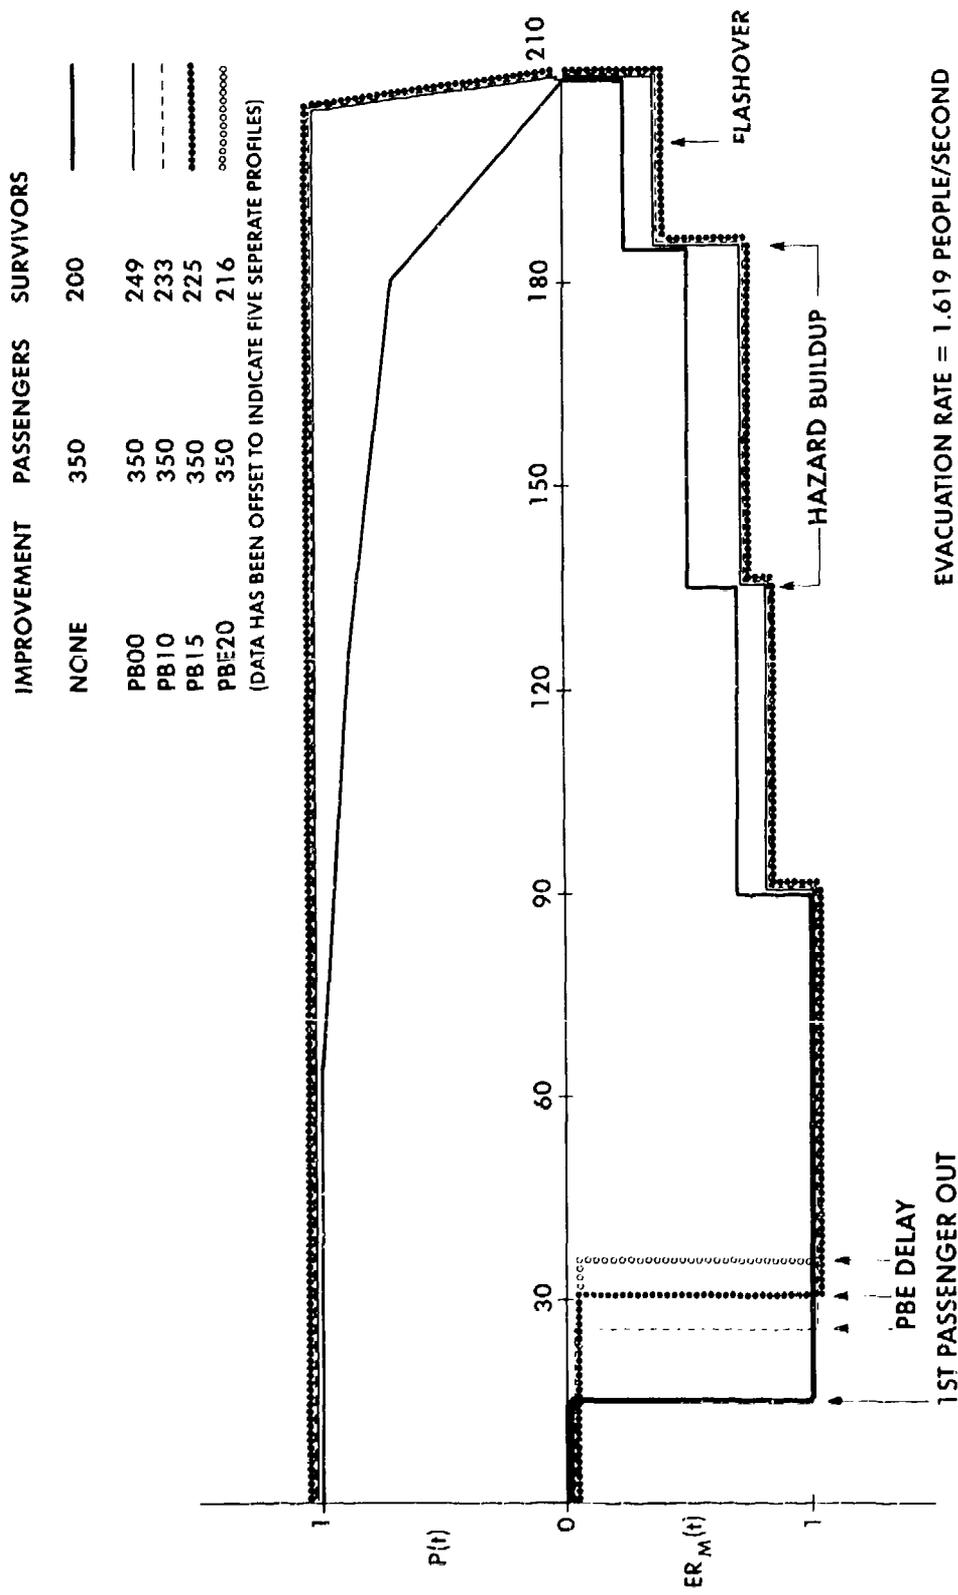
FIGURE 2. WIDE BODY PBE DELAY

WIDE-BODY SCENARIO. Figure 2 illustrates the profiles for a hypothetical accident fire scenario for a wide-body jet equipped to today's safety standards (lavatory extinguishers, fire blocking, floor proximity lighting). This is a theoretical accident scenario. There is a slow increase in thermal and toxic

Inspection of figures 2 and 3 shows a 2:1 ratio in lives saved comparing a 10-second quicker donning time of PBE versus a 10-second additional survival time after flashover. Quick donning saved 16 lives versus 8 lives saved by additional survival time after flashover. For this accident, 10 seconds of protection in the beginning is worth 20 seconds in the end, in terms of lives saved.

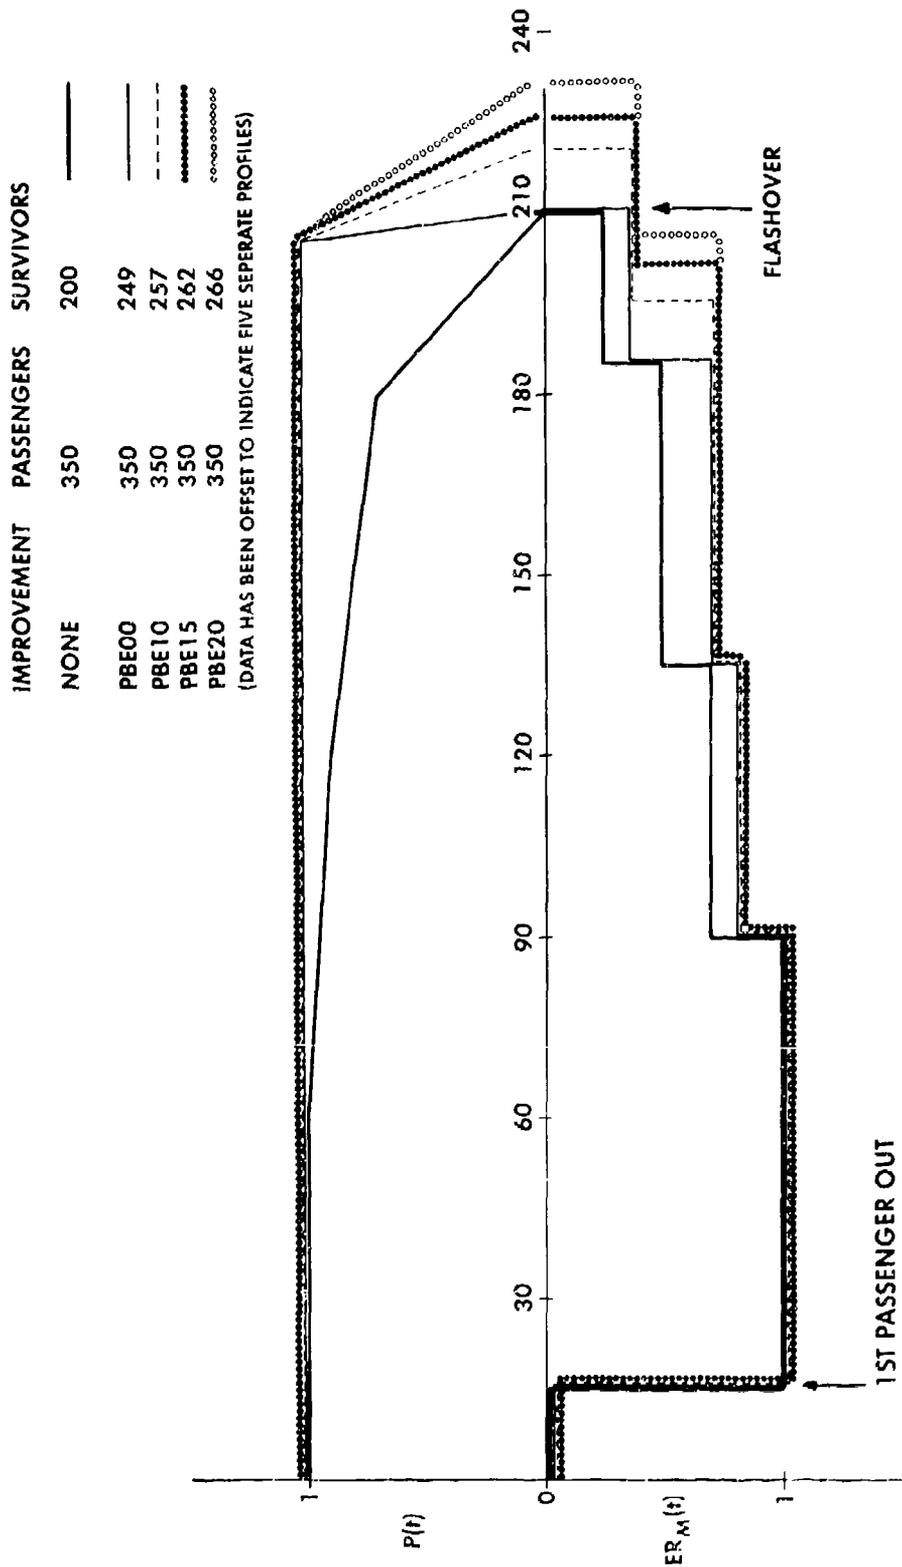
FIGURE 3. WIDE BODY PBE AFTER FLASHOVER

For all the accidents in which the model was exercised, the assumption was made that an aircraft is unsurvivable after flashover. Figure 3 illustrates the effect that a survivable window of time after flashover would have on the number of survivors for the same theoretical accident. This window of time could be due to survivable temperatures after flashover, or it could be due to the additional thermal protection afforded the user of PBE after flashover. Assuming no PBE delay, a 20-second escape window could result in 17 additional lives saved, increasing the number of survivors from 249 to 266.

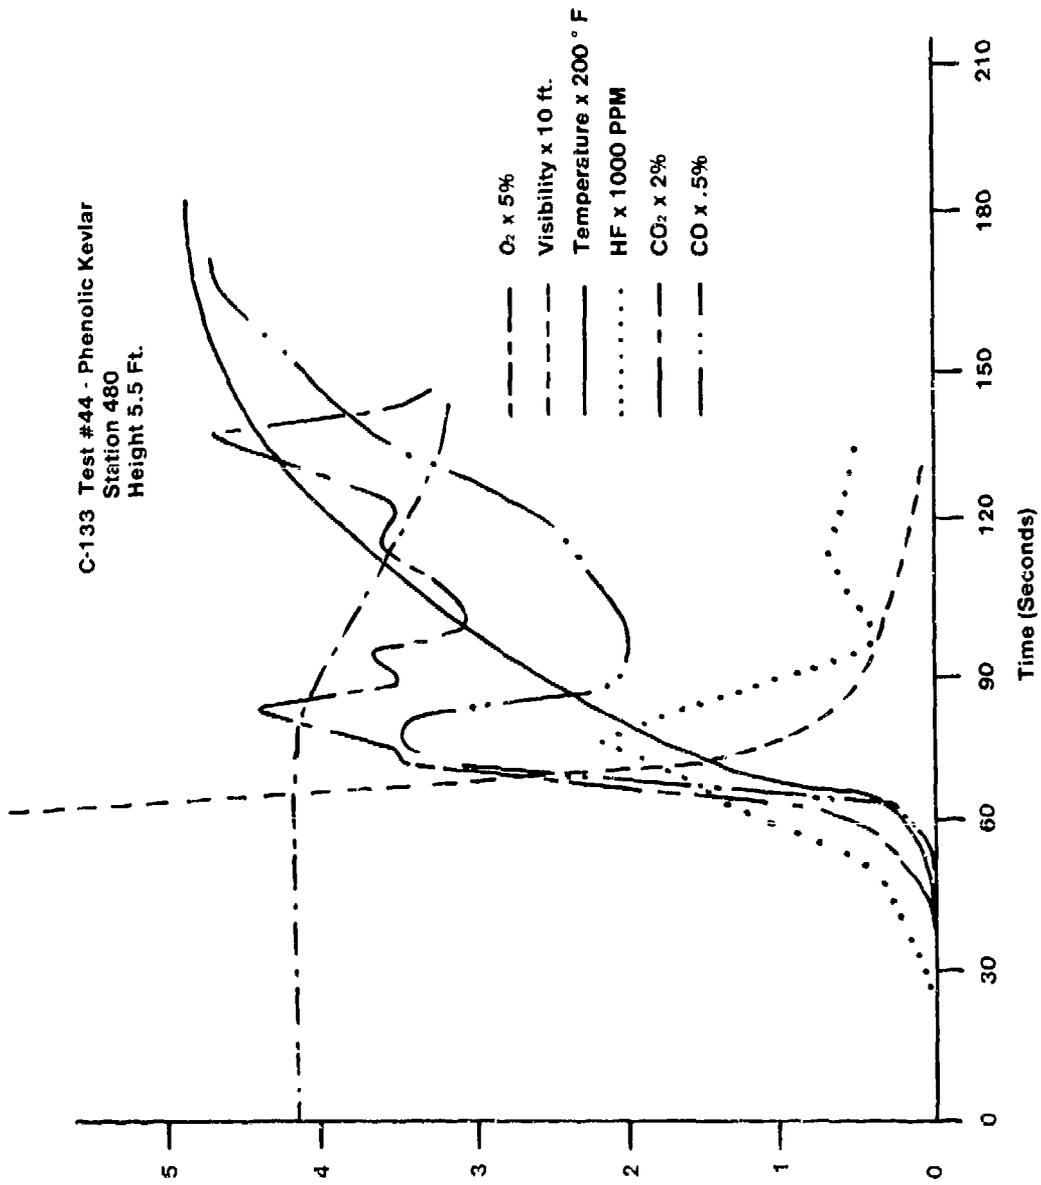
FIGURE 4. HAZARDS AS FUNCTION OF TIME IN C-133 TEST ARTICLE WITH POSTCRASH FIRE CONDITIONS

1. Flashover - Uncontrolled fires in aircraft cabins produce flashover conditions, a rapid propagation of flames through the fuselage. The onset of flashover is followed by a rapid loss of survivability throughout the cabin (references 5, 6, 7, 8, 9). Figure 4 illustrates a typical plot of the rapid increase in fire hazards associated with flashover. Based on this observed behavior in extensive full-scale tests, it was assumed flashover occurred in most accidents, and resulted in a rapid decrease in the  $P(t)$  curve to  $P(t) = 0$ .

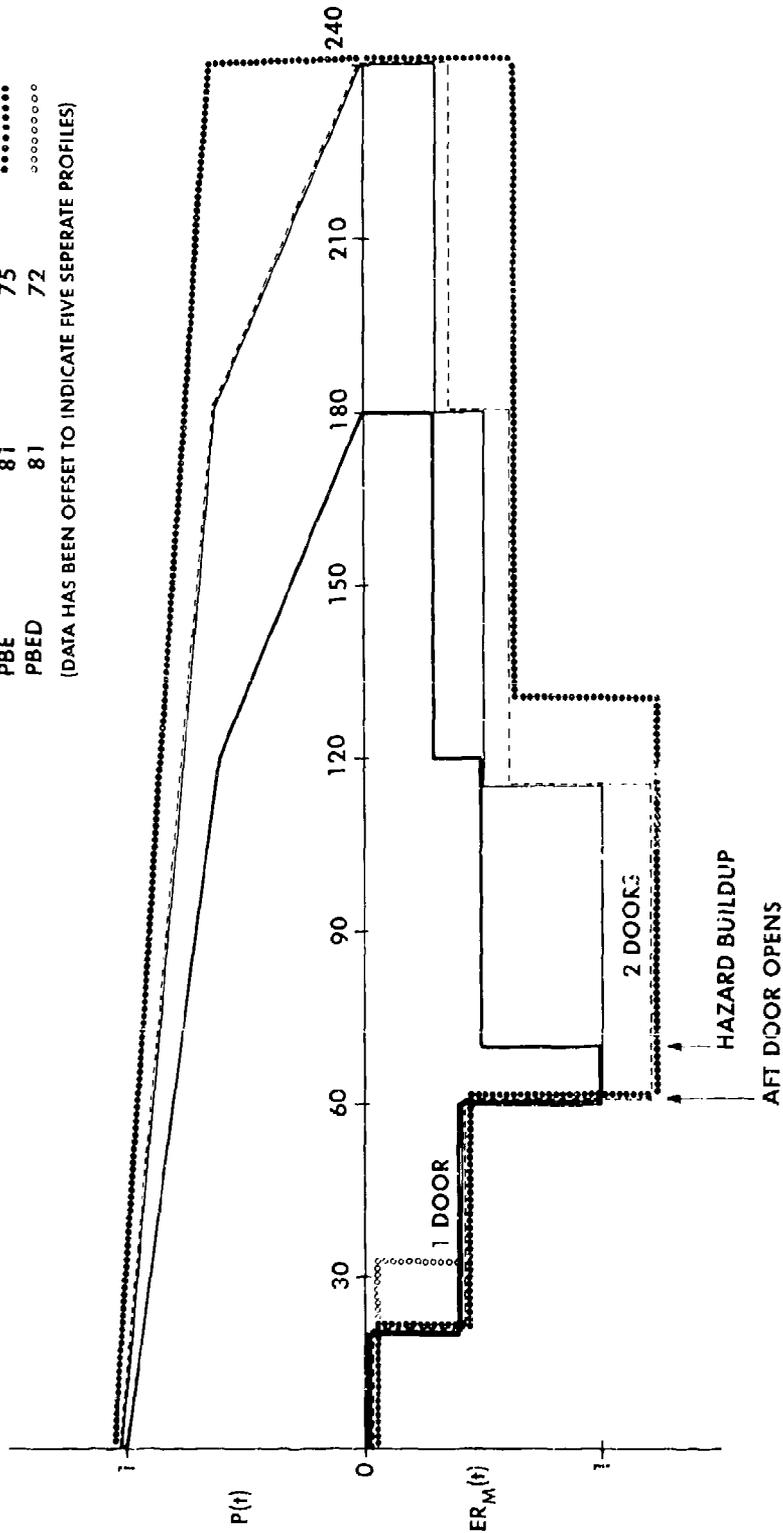
IMPROVEMENT	PASSENGERS	SURVIVORS
NONE	81	30
FB	81	59
FPL	81	68
PBE	81	75
PBED	81	72

(DATA HAS BEEN OFFSET TO INDICATE FIVE SEPERATE PROFILES)

EVACUATION RATE = 0.682 PEOPLE/SECOND

FIGURE 5. ACCIDENTS PROFILES FOR VARIG DC-8 3/5/67

1. 3/5/67 Varig DC-8 (Figure 5)

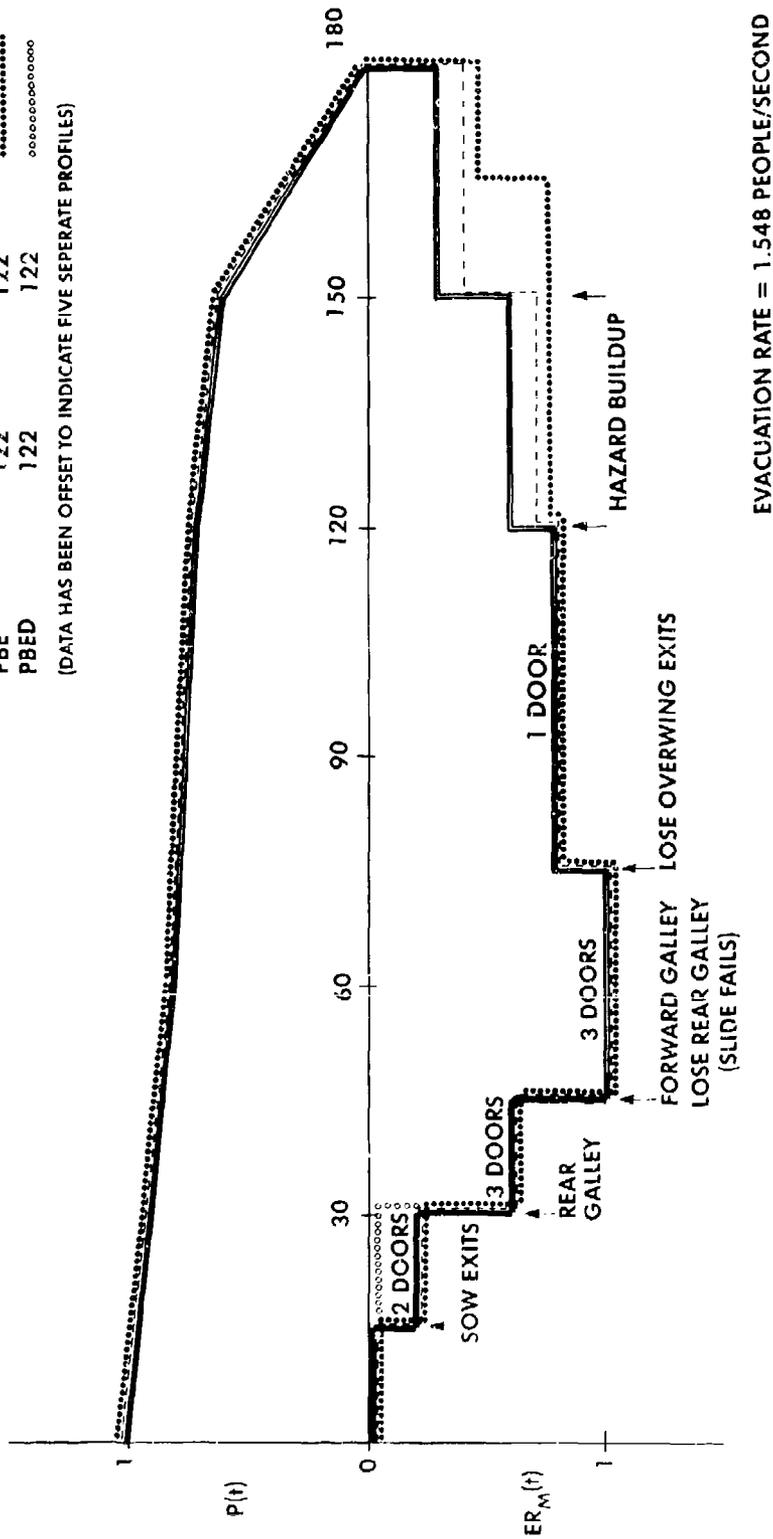
IMPROVEMENT	PASSENGERS	SURVIVORS
NONE	122	117
FB	122	117
FPL	122	121
PBE	122	122
PBED	122	122

(DATA HAS BEEN OFFSET TO INDICATE FIVE SEPERATE PROFILES)

FIGURE 6. ACCIDENTS PROFILES FOR B-707 4/8/68

2. 4/8/68 British Overseas B-707 (Figure 6)

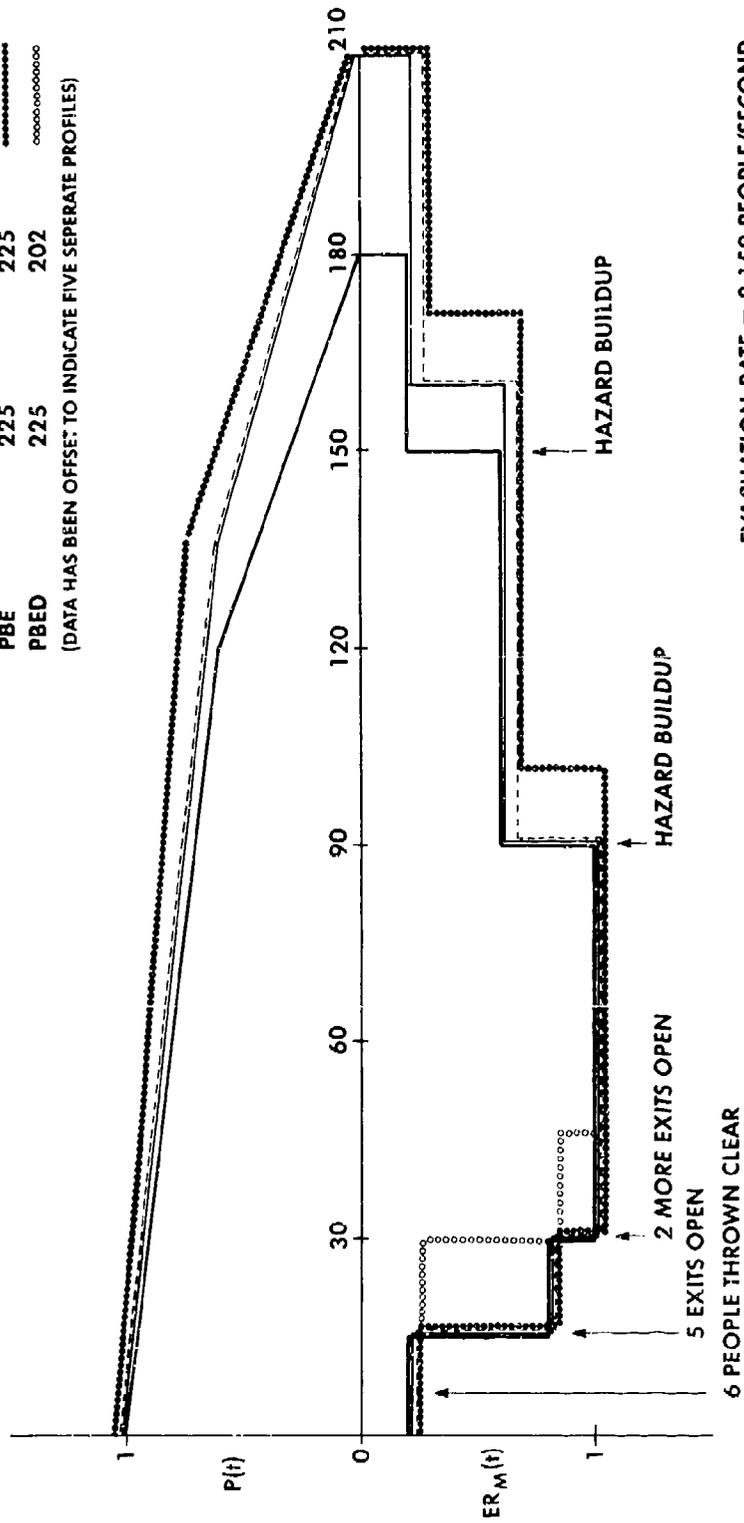
IMPROVEMENT	PASSENGERS	SURVIVORS
NONE	225	178
FB	225	196
FPL	225	201
PBE	225	225
PBED	225	202

(DATA HAS BEEN OFFSET TO INDICATE FIVE SEPERATE PROFILES)

EVACUATION RATE = 2.159 PEOPLE/SECOND

FIGURE 7. ACCIDENT PROFILES FOR CAPITOL AIRWAYS DC-8 11/27/70

3. 11/27/70 Capitol International DC-8 (Figure 7)

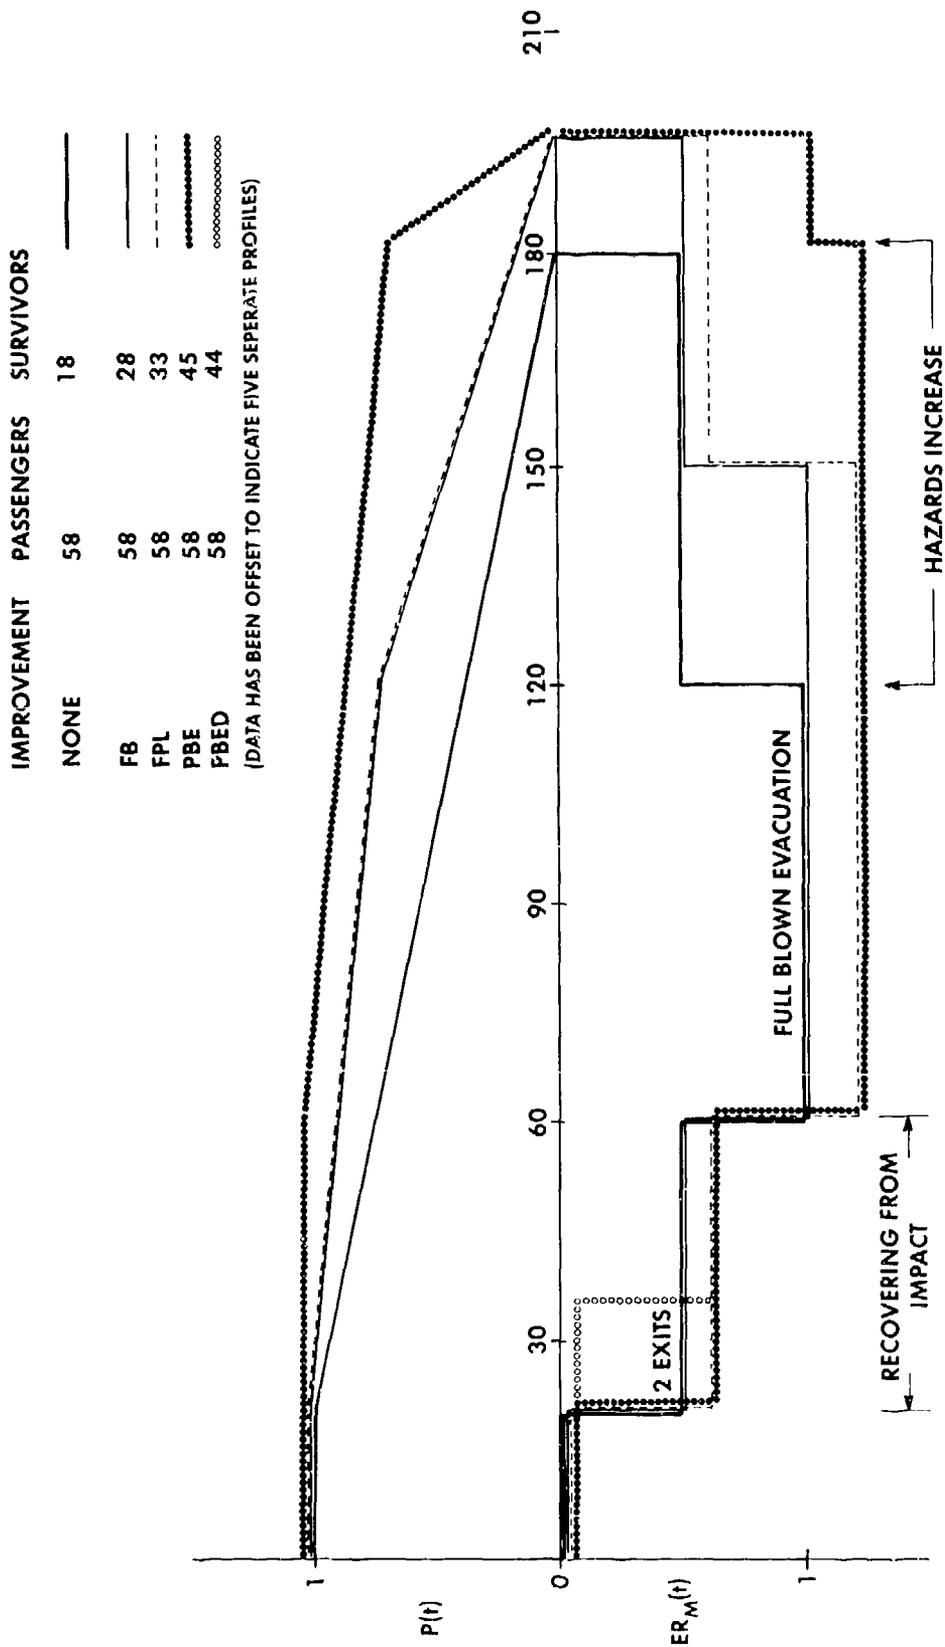
EVACUATION RATE = 0.318 PEOPLE/SECOND

FIGURE 9. ACCIDENT PROFILES FOR UNITED B-737 12/8/72

6. 12/8/72 United B-737 (Figure 9)

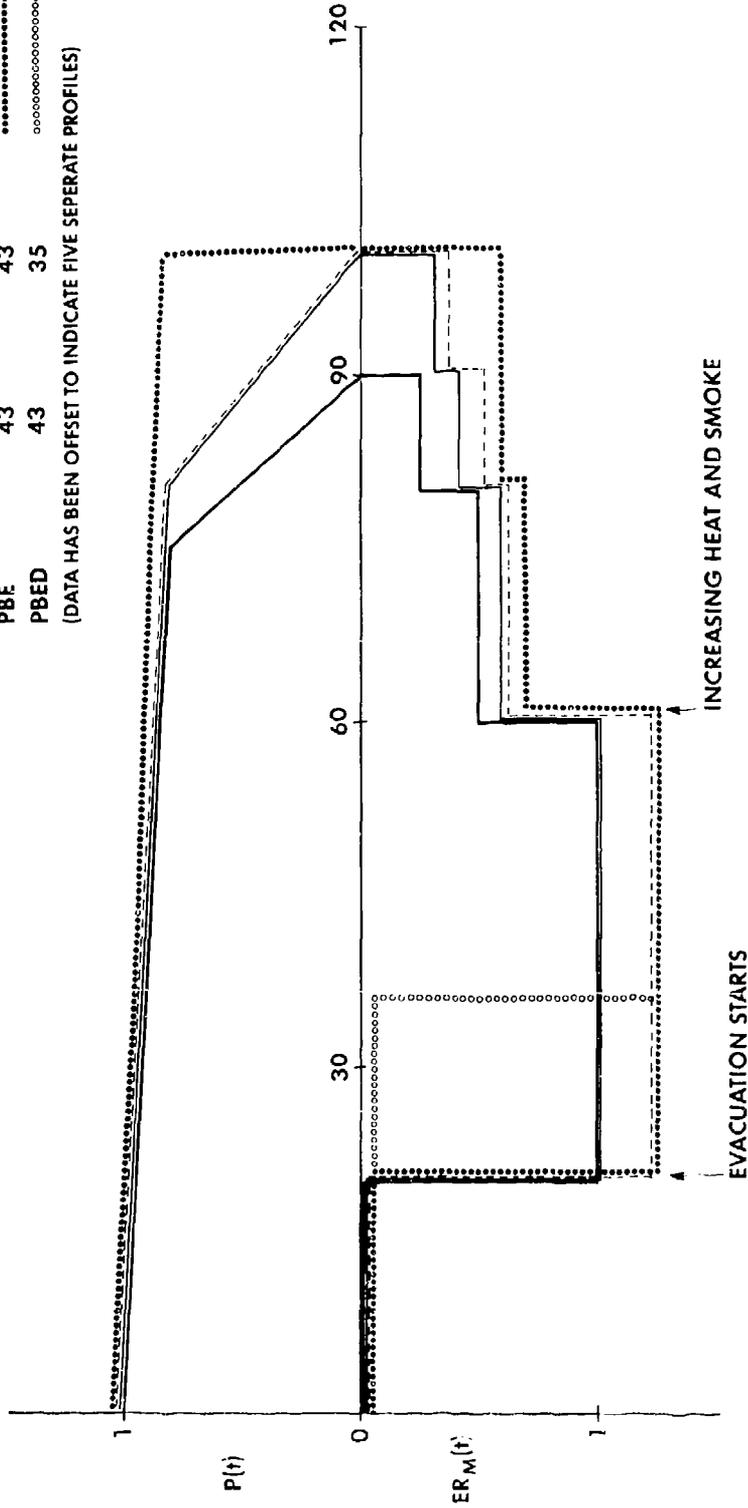
NONE	43	33
FB	43	35
FPL	43	42
PBE	43	43
PBED	43	35

(DATA HAS BEEN OFFSET TO INDICATE FIVE SEPERATE PROFILES)

EVACUATION RATE = 0.750 PEOPLE/SECOND

FIGURE 10. ACCIDENT PROFILES FOR NORTH CENTRAL DC-9 12/20/72

7. 12/20/72 North Central DC-9 (Figure 10)

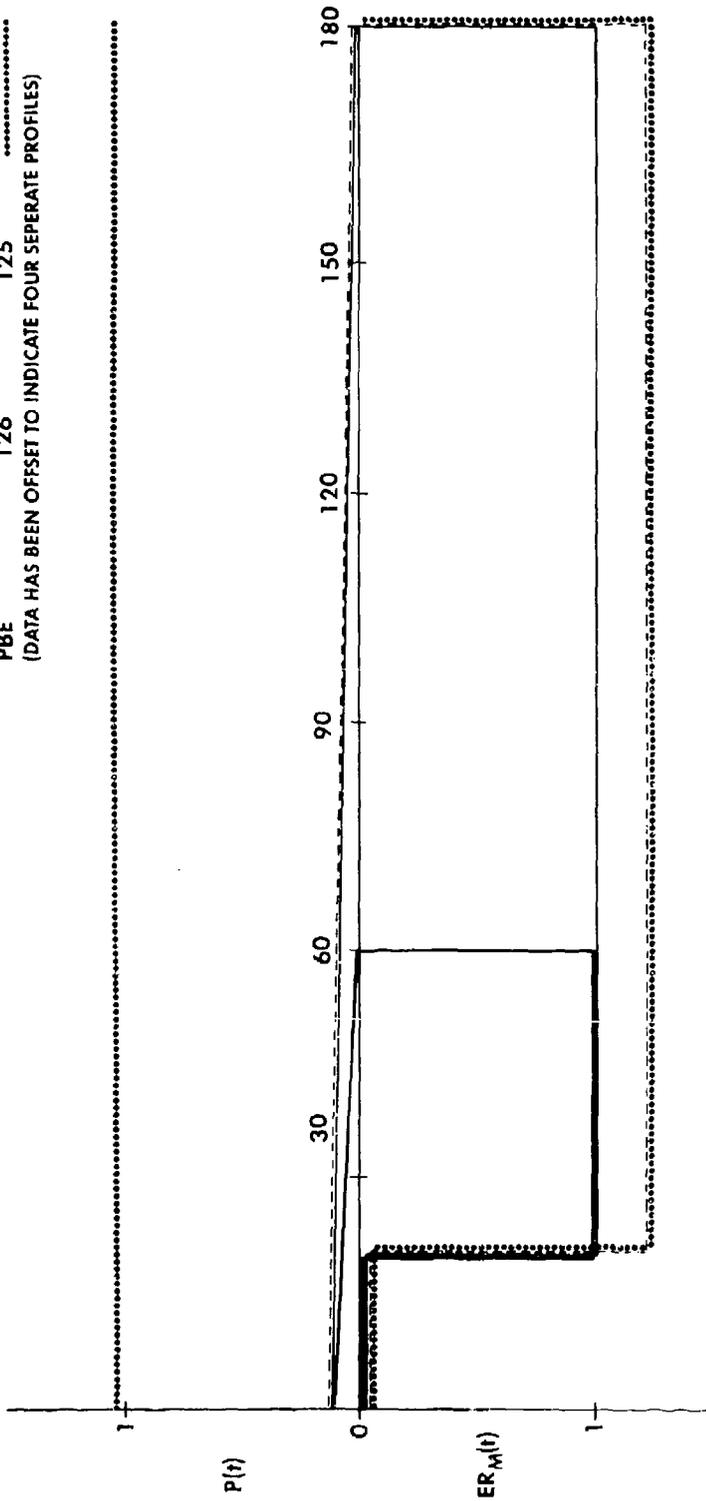
IMPROVEMENT	PASSENGERS	SURVIVORS
NONE	126	4
FB	126	22
FPL	126	26
PBE	126	125

(DATA HAS BEEN OFFSET TO INDICATE FOUR SEPERATE PROFILES)

EVACUATION RATE = 3.077 PEOPLE/SECOND

FIGURE 11. ACCIDENT PROFILES FOR VARIG B-707 7/11/73, NO EXTINGUISHERS

8. 7/11/73 Varig B-707 (Figures 11, 12)

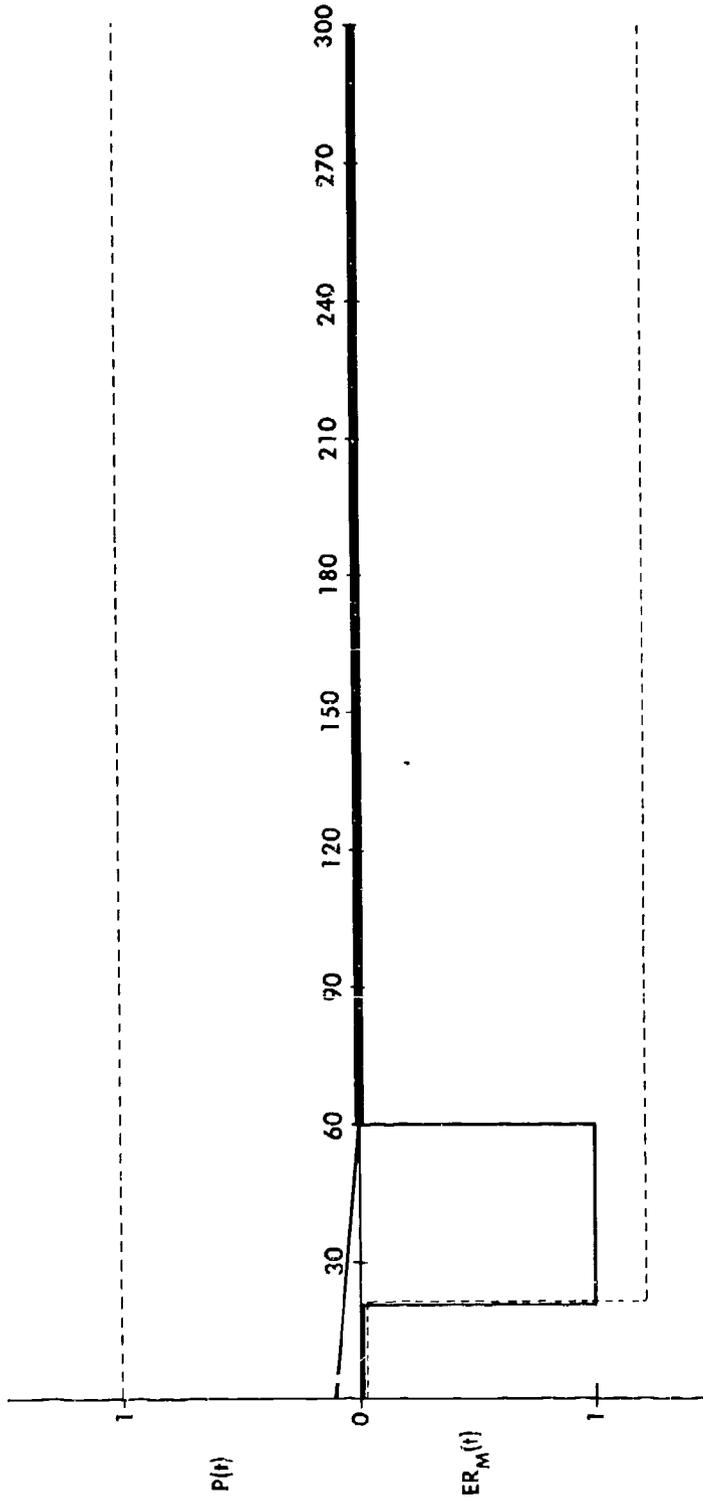
IMPROVEMENT	PASSENGERS	SURVIVORS
NONE	126	4
EXT	126	125

(DATA HAS BEEN OFFSET TO INDICATE TWO SEPERATE PROFILES)

EVACUATION RATE = 3.077 PEOPLE/SECOND

FIGURE 12. ACCIDENT PROFILES FOR VARIG B-707 7/11/73, WITH EXTINGUISHERS

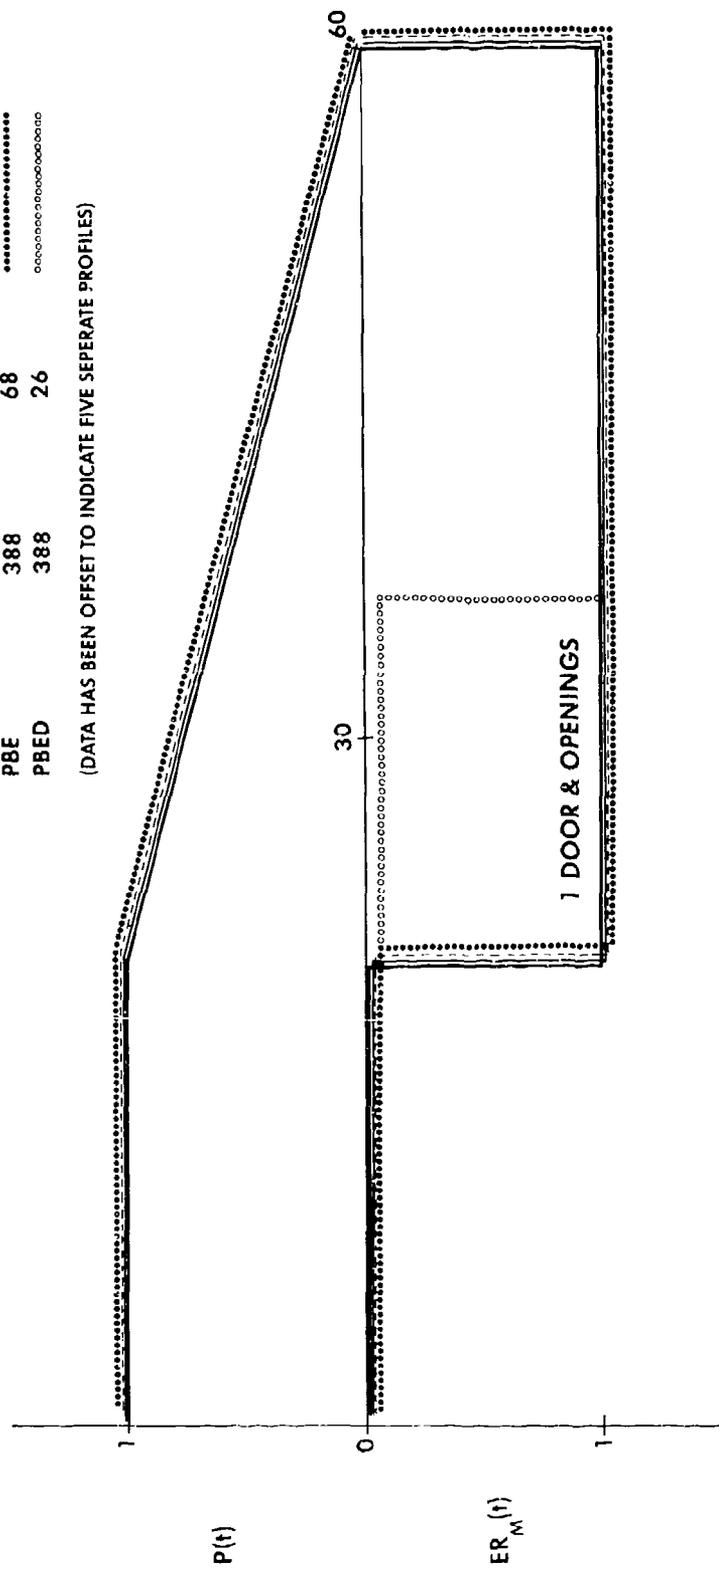
IMPROVEMENT	PASSENGERS	SURVIVORS
NONE	388	68
BL	388	68
FPL	388	68
PBE	388	68
PBED	388	26

(DATA HAS BEEN OFFSET TO INDICATE FIVE SEPERATE PROFILES)

EVACUATION RATE = 3.487 PEOPLE/SECOND

FIGURE 14. ACCIDENT PROFILES FOR PAN AM B-747 3/27/77

11. 3/27/77 Pan Am B-747 (Figure 14)

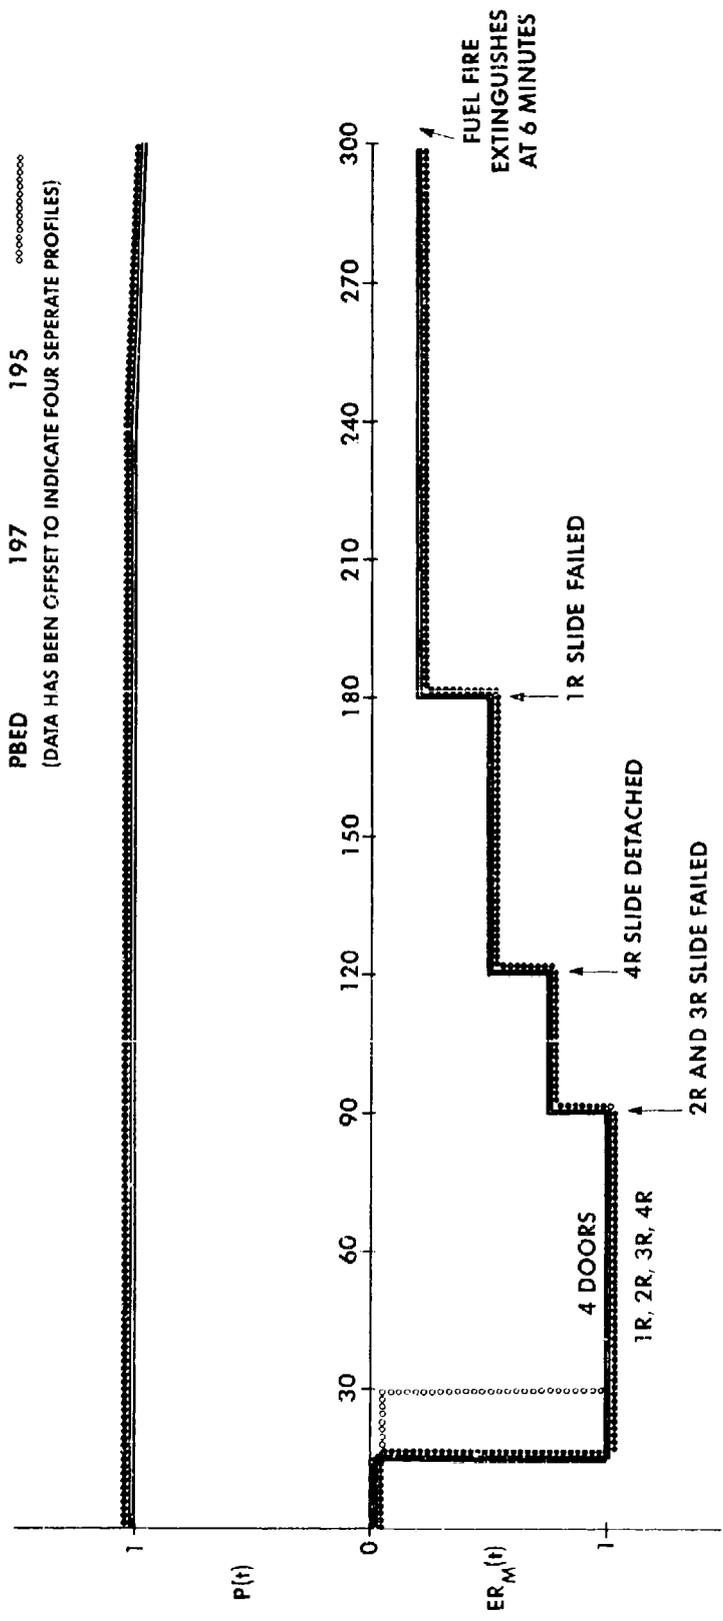
IMPROVEMENT	PASSENGERS	SURVIVORS
NONE	197	195
FB	197	195
FPL,PBE	197	195
PBED	197	195

(DATA HAS BEEN OFFSET TO INDICATE FOUR SEPERATE PROFILES)

EVACUATION RATE = 1.290 PEOPLE/SECOND

FIGURE 15. ACCIDENT PROFILES FOR CONTINENTAL DC10 3/1/78

12. 3/1/78 Continental DC-10 (Figure 15)

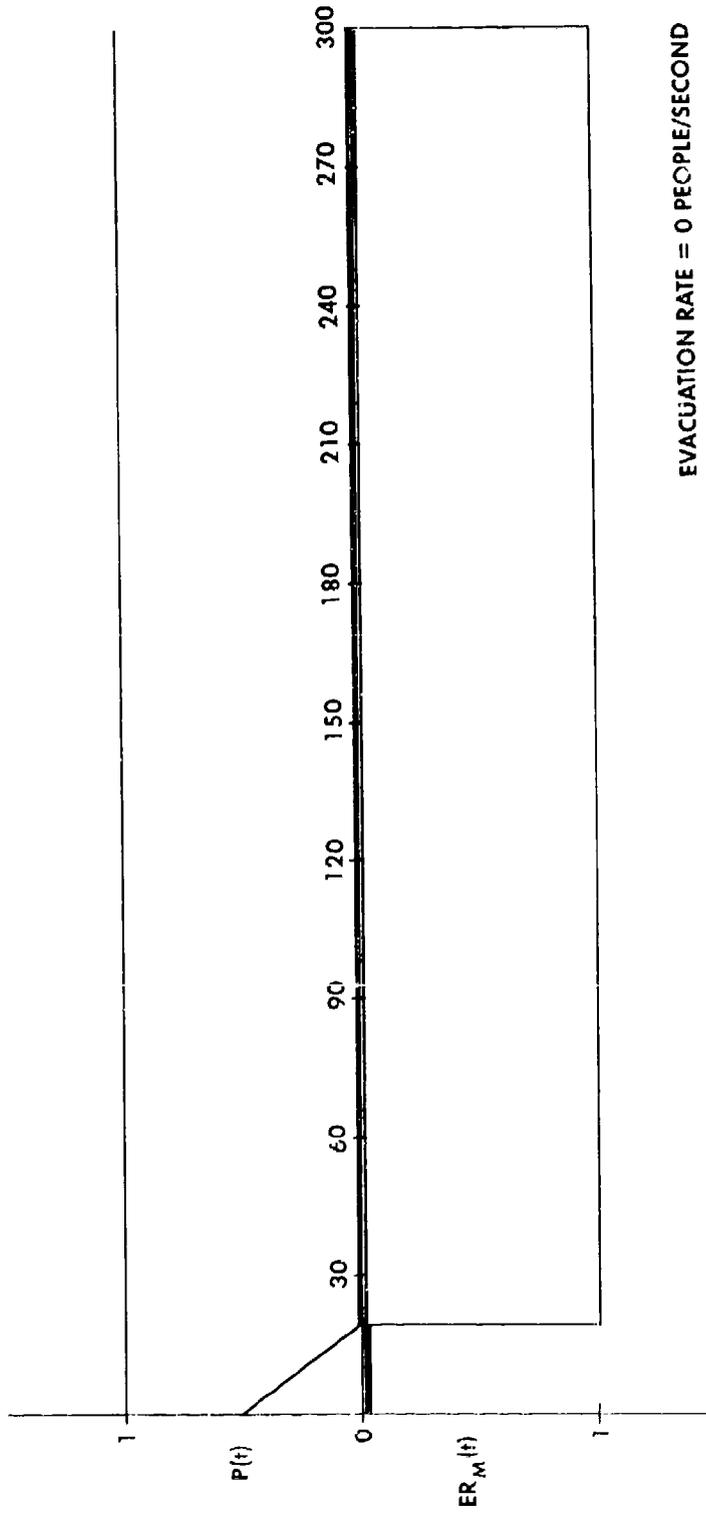
FB 298 298

[DATA HAS BEEN OFFSET TO INDICATE TWO SEPERATE PROFILES]

FIGURE 16. ACCIDENT PROFILES FOR SAUDI L1011 8/19/80

14. 8/19/80 Saudi Air L-1011 (Figure 16)

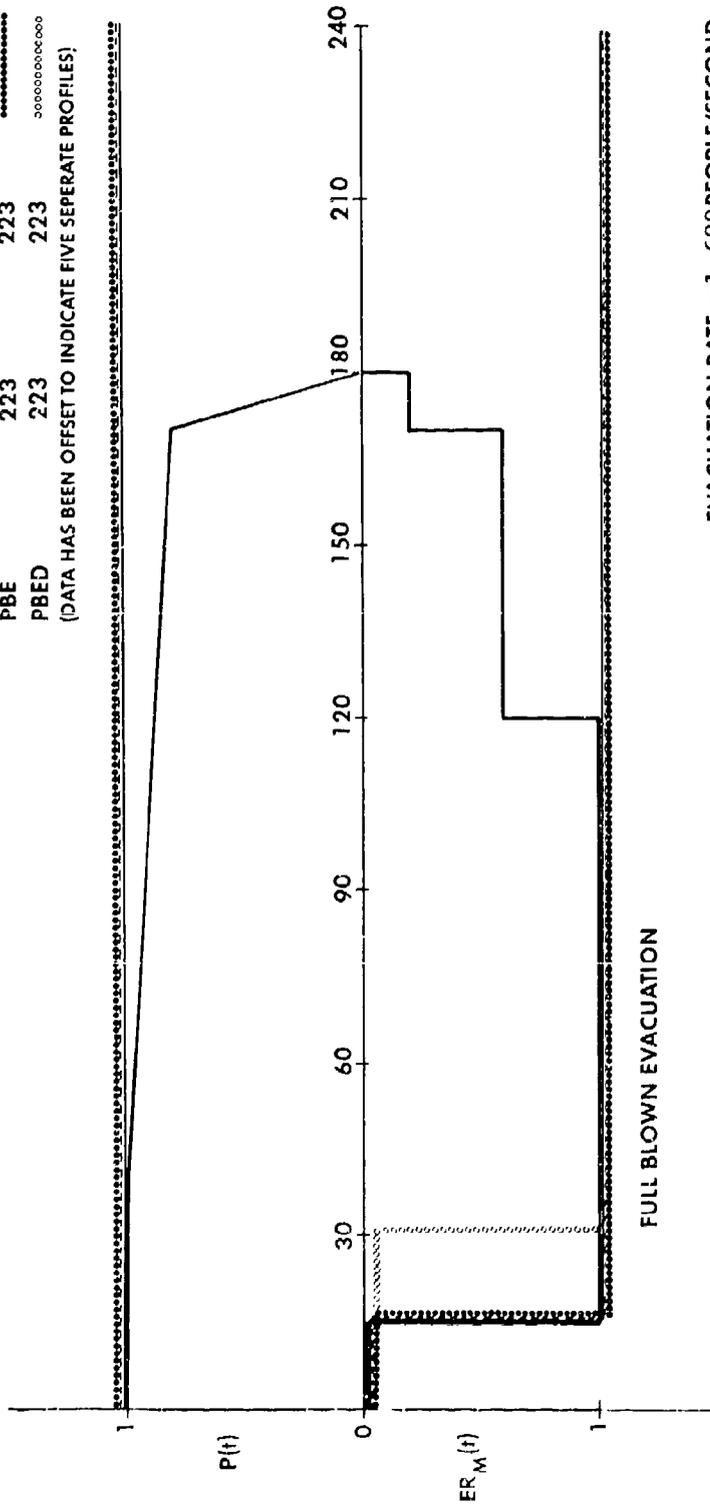
IMPROVEMENT	PASSENGERS	SURVIVORS
NONE	223	211
FB	223	223
FPL	223	223
PBE	223	223
PBED	223	223

(DATA HAS BEEN OFFSET TO INDICATE FIVE SEPERATE PROFILES)

FIGURE 17. ACCIDENT PROFILES FOR KOREAN AIRLINES B-747 11/19/80

15. 11/19/80 Korean Airlines B-747 (Figure 17)

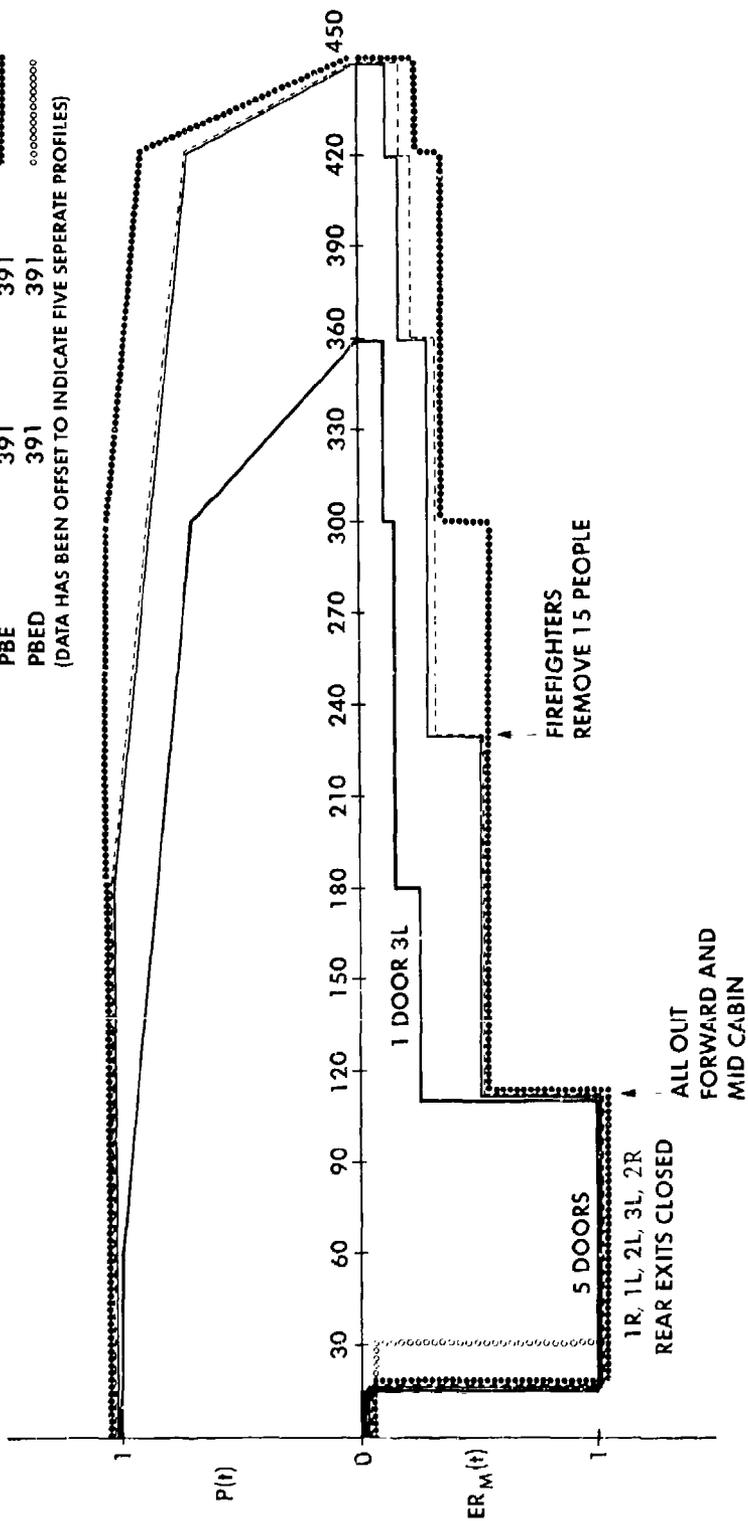
IMPROVEMENT	PASSENGERS	SURVIVORS
NONE	391	341
FB	391	391
FPL	391	391
PBE	391	391
PBED	391	391

(DATA HAS BEEN OFFSET TO INDICATE FIVE SEPERATE PROFILES)

EVACUATION RATE = 2.727 PEOPLE/SECOND

FIGURE 18. ACCIDENT PROFILES FOR SPANTAX DC-10 9/13/82

17. 9/13/82 Spantax DC-10 (Figure 18)

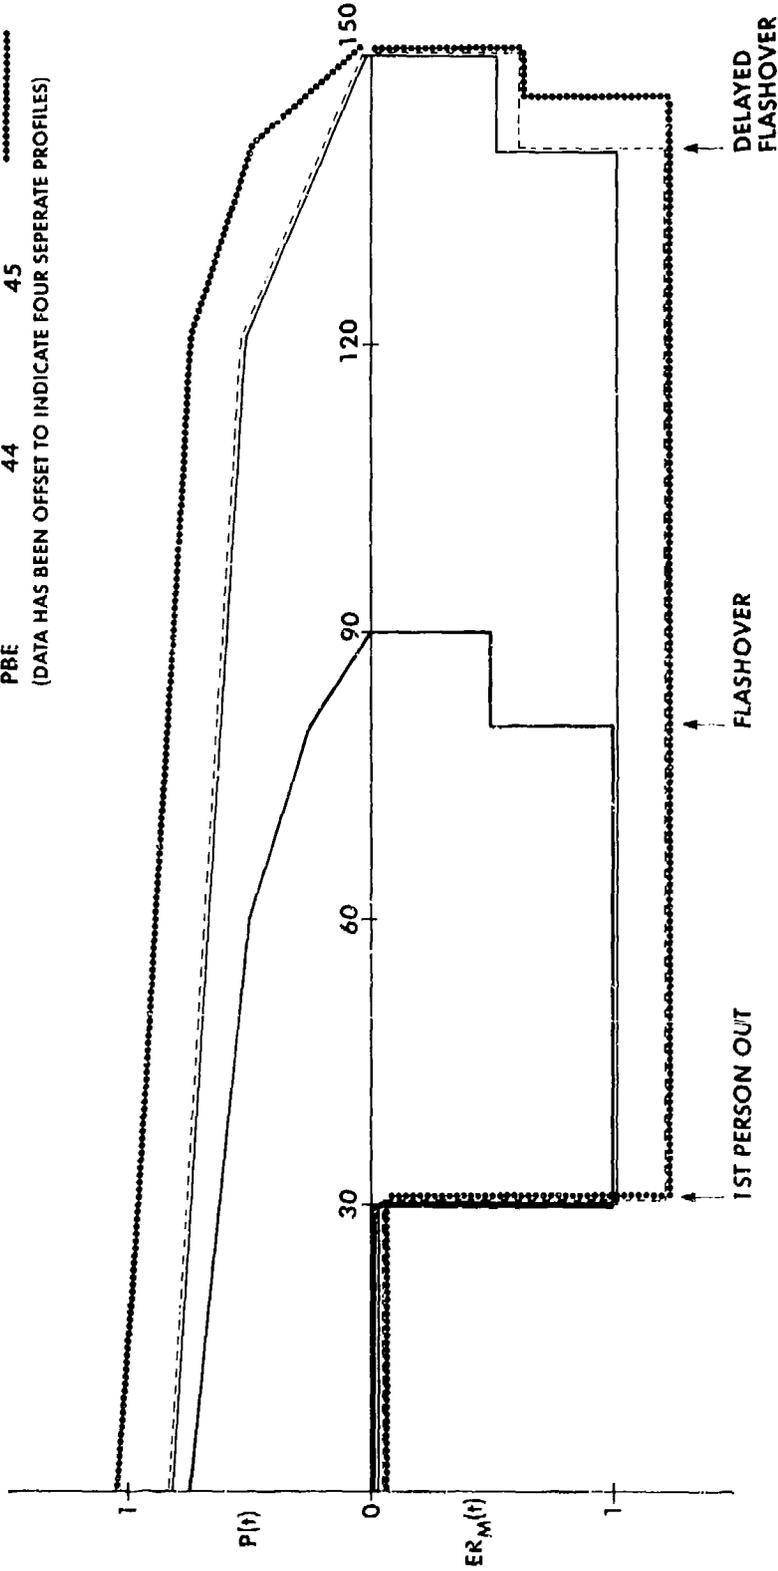
IMPROVEMENT	PASSENGERS	SURVIVORS
NONE	44	21
FB	44	44
FPL	44	44
PBE	44	45

(DATA HAS BEEN OFFSET TO INDICATE FOUR SEPERATE PROFILES)

EVACUATION RATE = 0.848 PEOPLE/SECOND

FIGURE 19. ACCIDENT PROFILES FOR AIR CANADA DC-9 6/2/83

18. 6/2/83 Air Canada DC-9 (Figure 19)
