✓  
DOT/FAA/CT-88/03

# Study of Benefits of Passenger Protective Breathing Equipment From Analysis of Past Accidents

Louise Speitel  
Richard G. Hill

Final Report

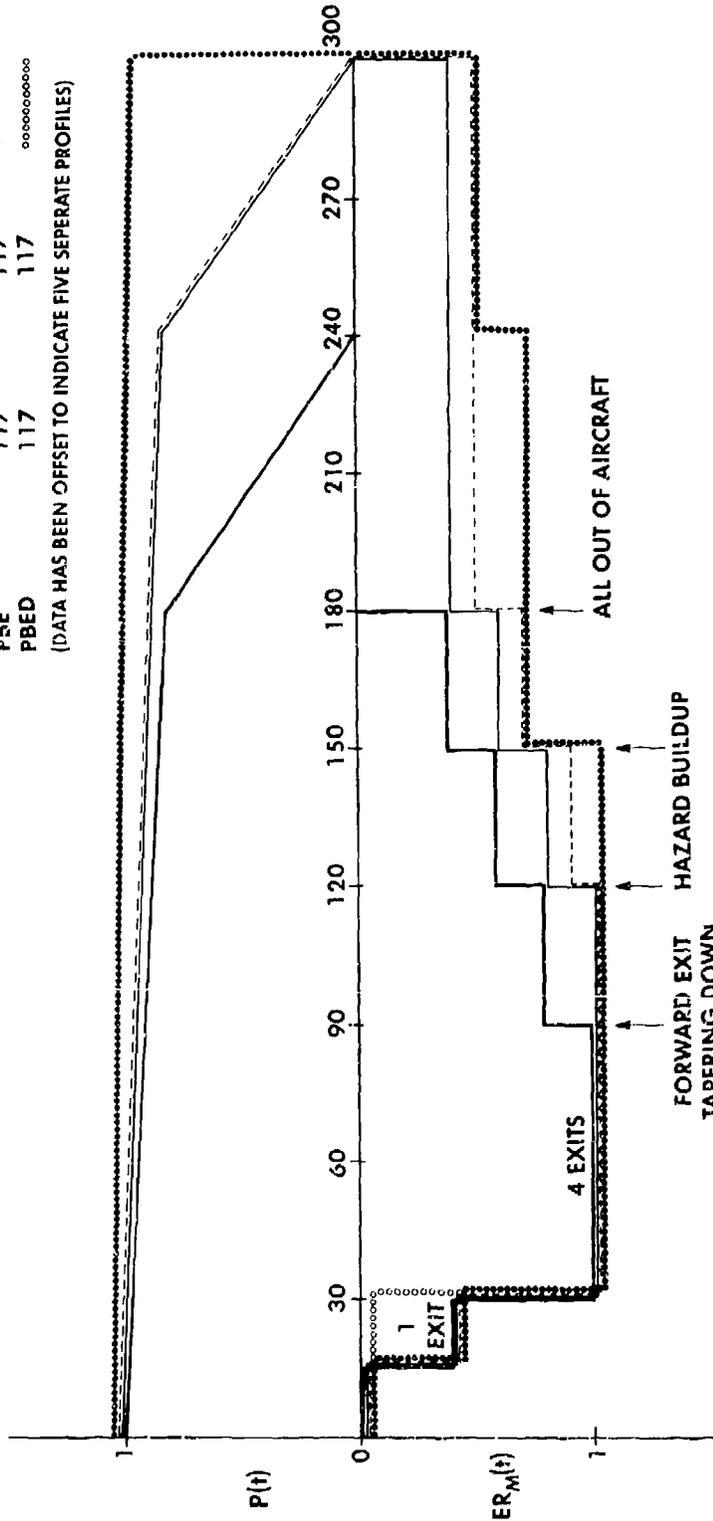
IMPROVEMENT	PASSENGERS	SURVIVORS
NONE	117	117
FB	117	117
FPL	117	117
PRE	117	117
PBED	117	117

(DATA HAS BEEN OFFSET TO INDICATE FIVE SEPERATE PROFILES)

EVACUATION RATE = 1.082 PEOPLE/SECOND

FIGURE 20. ACCIDENT PROFILES FOR PACIFIC WESTERN B-737 3/22/84

19. 3/22/84 Pacific Western B-737 (Figure 20)

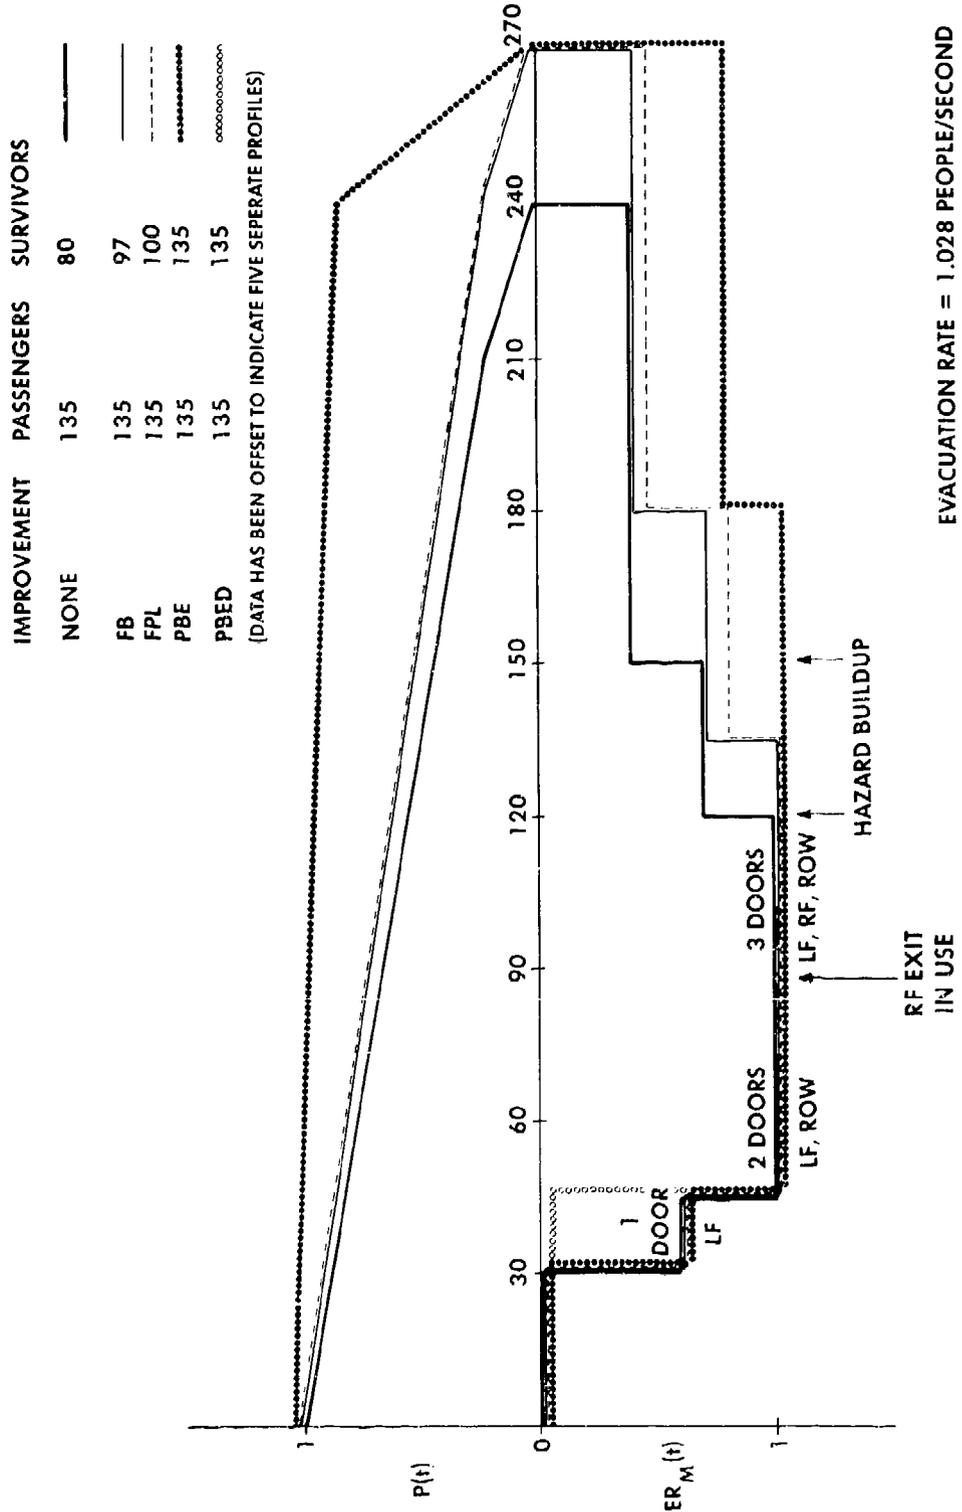
FIGURE 21. ACCIDENT PROFILES FOR BRITISH AIR TOURS B-737 8/22/85

20. 8/22/85 British Air Tours B-737 (Figure 21)

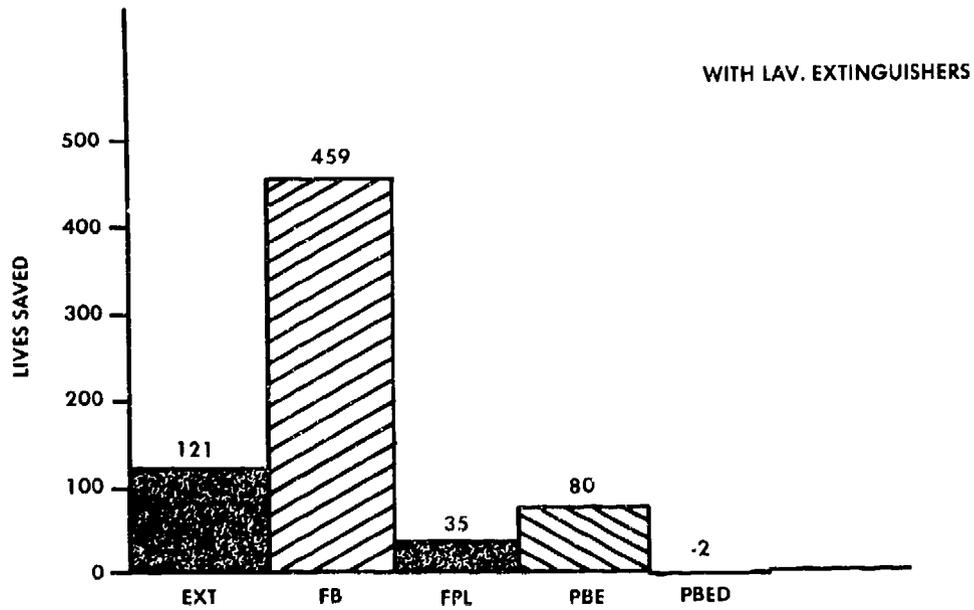
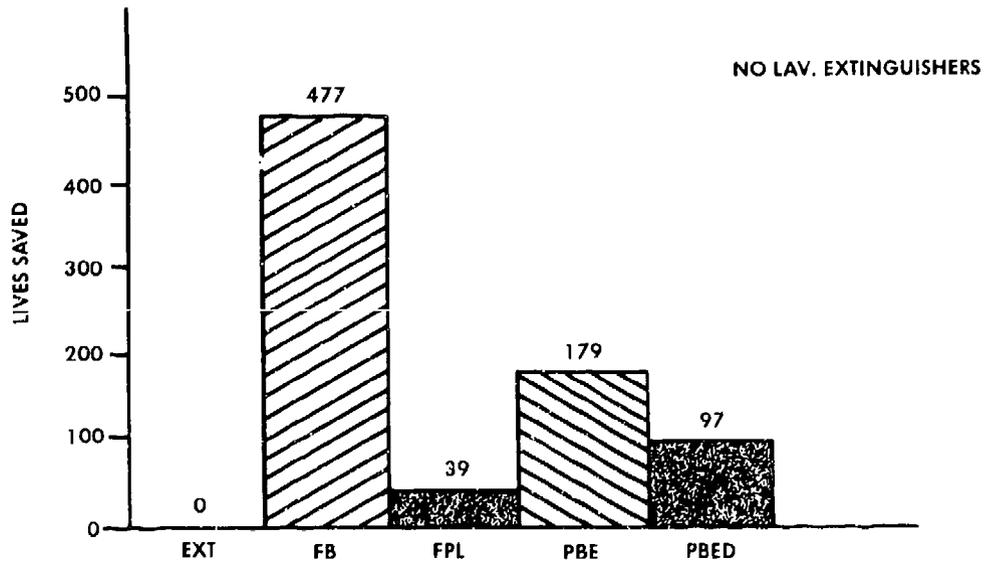
FIGURE 22. ESTIMATED LIVES SAVED WITH SAFETY IMPROVEMENTS

The results of the modeling analysis of the benefits of lavatory extinguishers, FB, FPL and PBE for 20 aircraft accidents is contained in table 3 and figure 22. The findings are discussed below.
