Report No. CG-D-04-93

## FIRE ENDURANCE TESTING OF FIBERGLASS PIPING

D. E. Beene, Jr.

U.S. Coast Guard  
Research and Development Center  
1082 Shennecossett Road  
Groton, CT 06340-6096

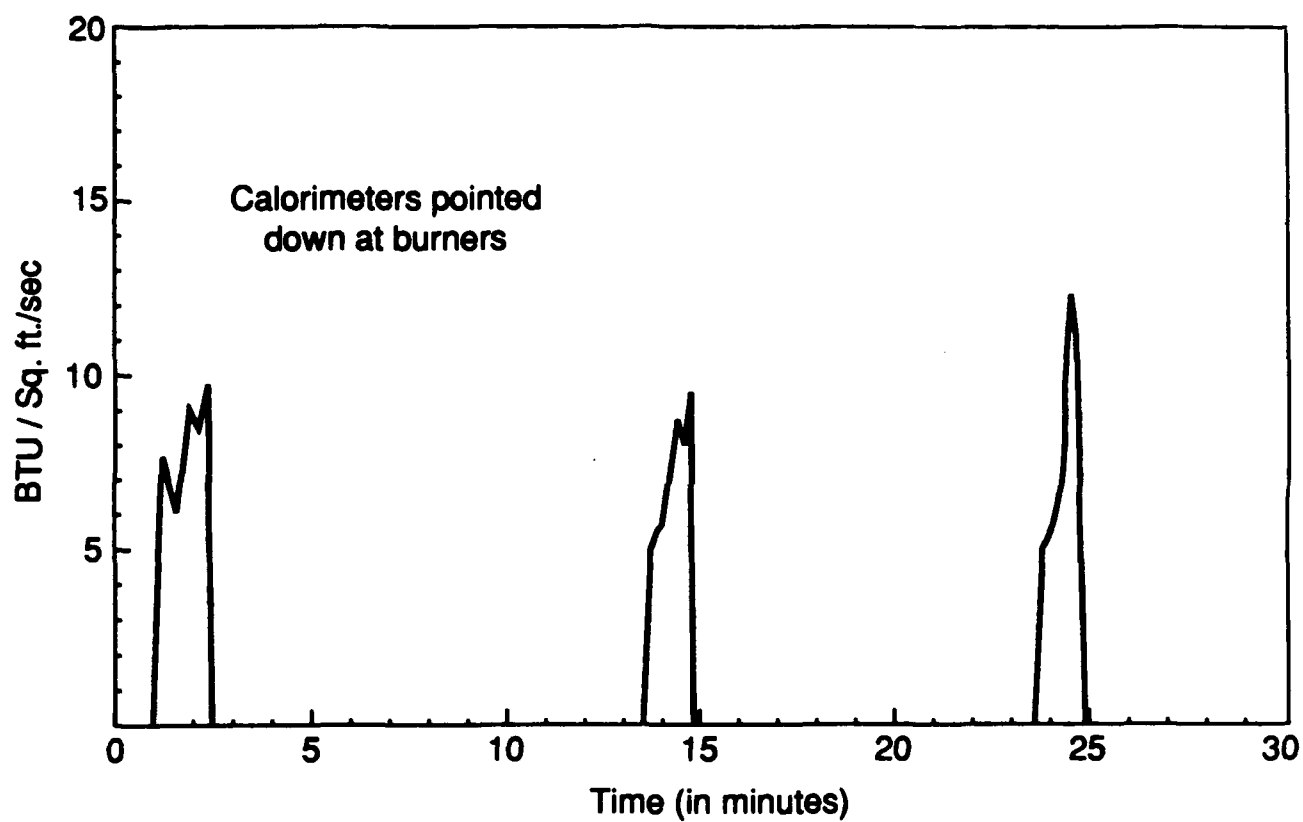
**FIGURE 4-4 Burner Test Average Heat Flux at  
125 mm (4.9 inches) Above Burners**

2. The 5 kg/hr (11 lb/hr) propane fuel flow specified in the test procedure produced a theoretical heat output rate of approximately 65 kW (221,800 BTU/hr). Heat flux data obtained at 125 mm (4.9 inches) above the burners during a calibration test with a 5.0 kg/hr (11 lb/hr) fuel flow rate is shown in Figure 4-4.

4. The heat flux ( $9.2 \text{ BTU/sq ft/sec}$  ( $1740 \text{ W/m}^2$ )) incident on the pipe sample at a height of 125 mm (4.9 in.) was approximately two-thirds the value measured in previous Coast Guard full scale hydrocarbon pool fire pipe testing. Based on this value and the fact that all the piping failed to meet the IACS fire test requirements, it appears that the intensity of the burner fire is too severe for an uninsulated FGP of the types tested.
