DOT/FAA/RD-93/2

## Rooftop Emergency Heliports

June 1993

Final Report

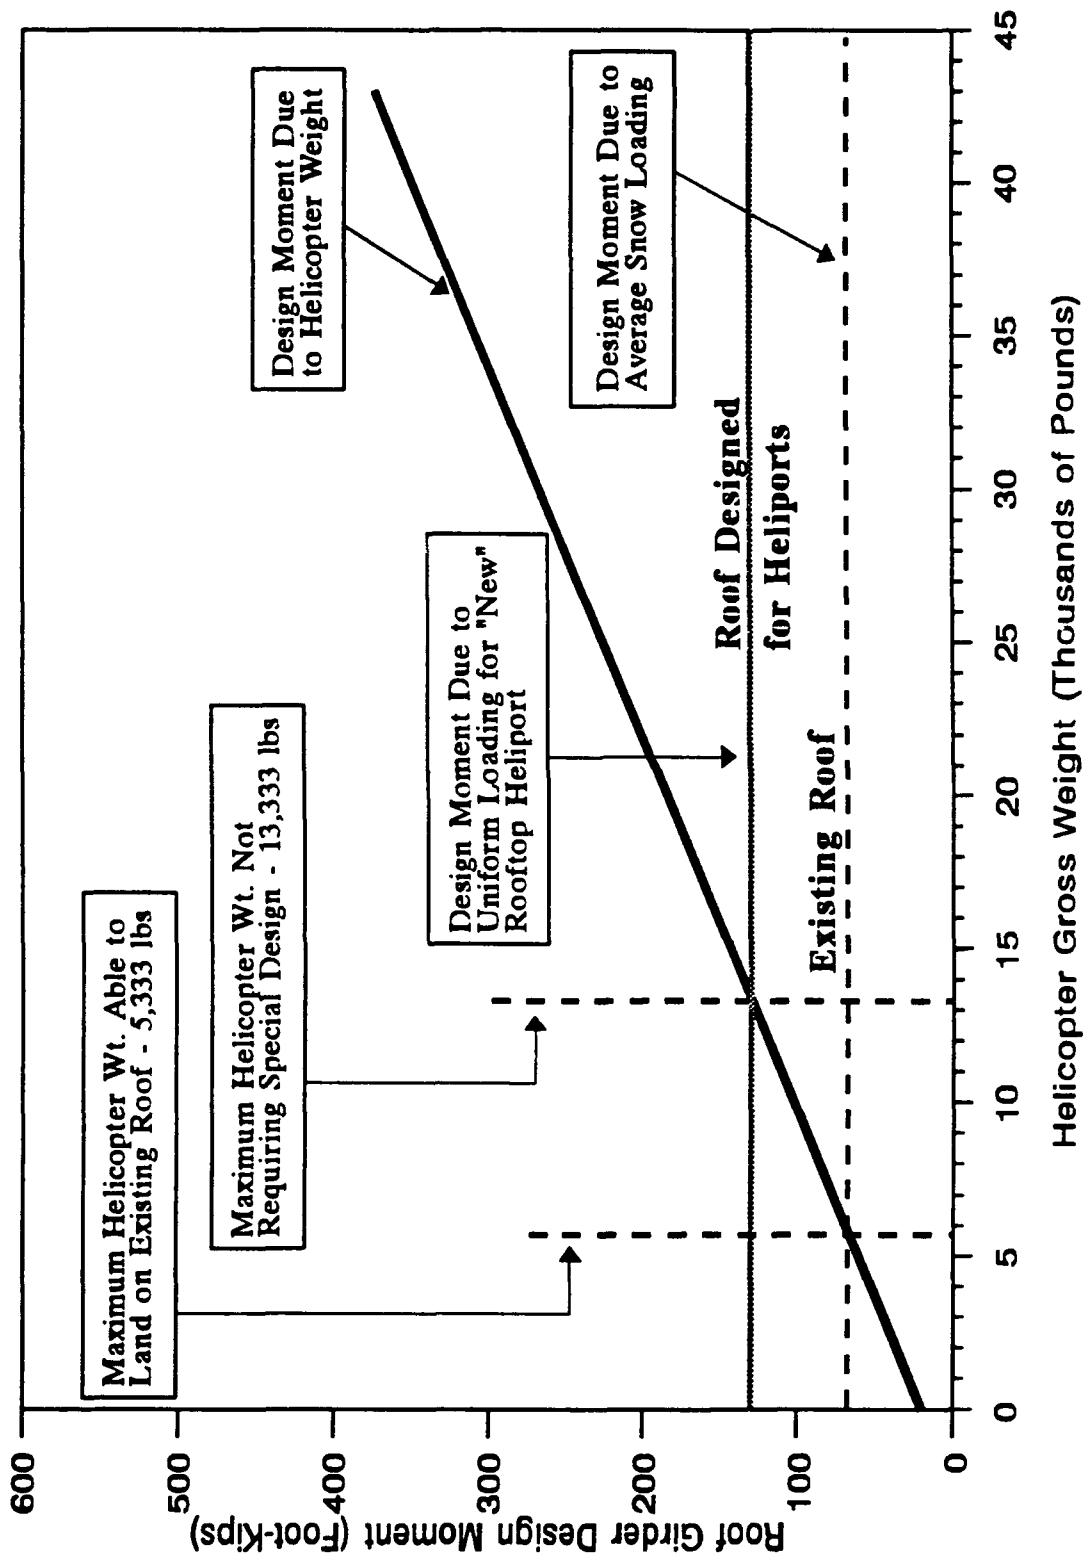
FIGURE 3 NATIONAL BUILDING CODE, 1991 - CASE 1: 20' X 20' BAY SPACING WITH 20 PSF DEAD LOAD

The results from figures 1 through 6 indicate that the NBC produces the greatest girder design moment. For this analysis the NBC produces the most rigid minimum design standard, followed by the UBC and the SBC. This is the case for both column spacings. Table 4 shows that the minimum design requirements spelled out in each code will result in the design of a main structural system (i.e., girders, columns, and foundations) to carry up to the "maximum helicopter weights" listed. Helicopters exceeding the listed weights would then require analysis using loading condition numbers 1 and 2.

Graphic representations of the results of the analysis are depicted in figures 1 through 6, showing the relationship between the three loading conditions for each of the three codes, and for both 20-foot and 30-foot column spacings, case 1 and case 2 respectively.

This would be a typical controlling loading condition for a standard (non-heliport) roof designed per the building codes and is indicated in the figures as a fourth loading condition. The design moment caused by this loading is represented by a horizontal dashed line in the figures and is labeled "existing roof."

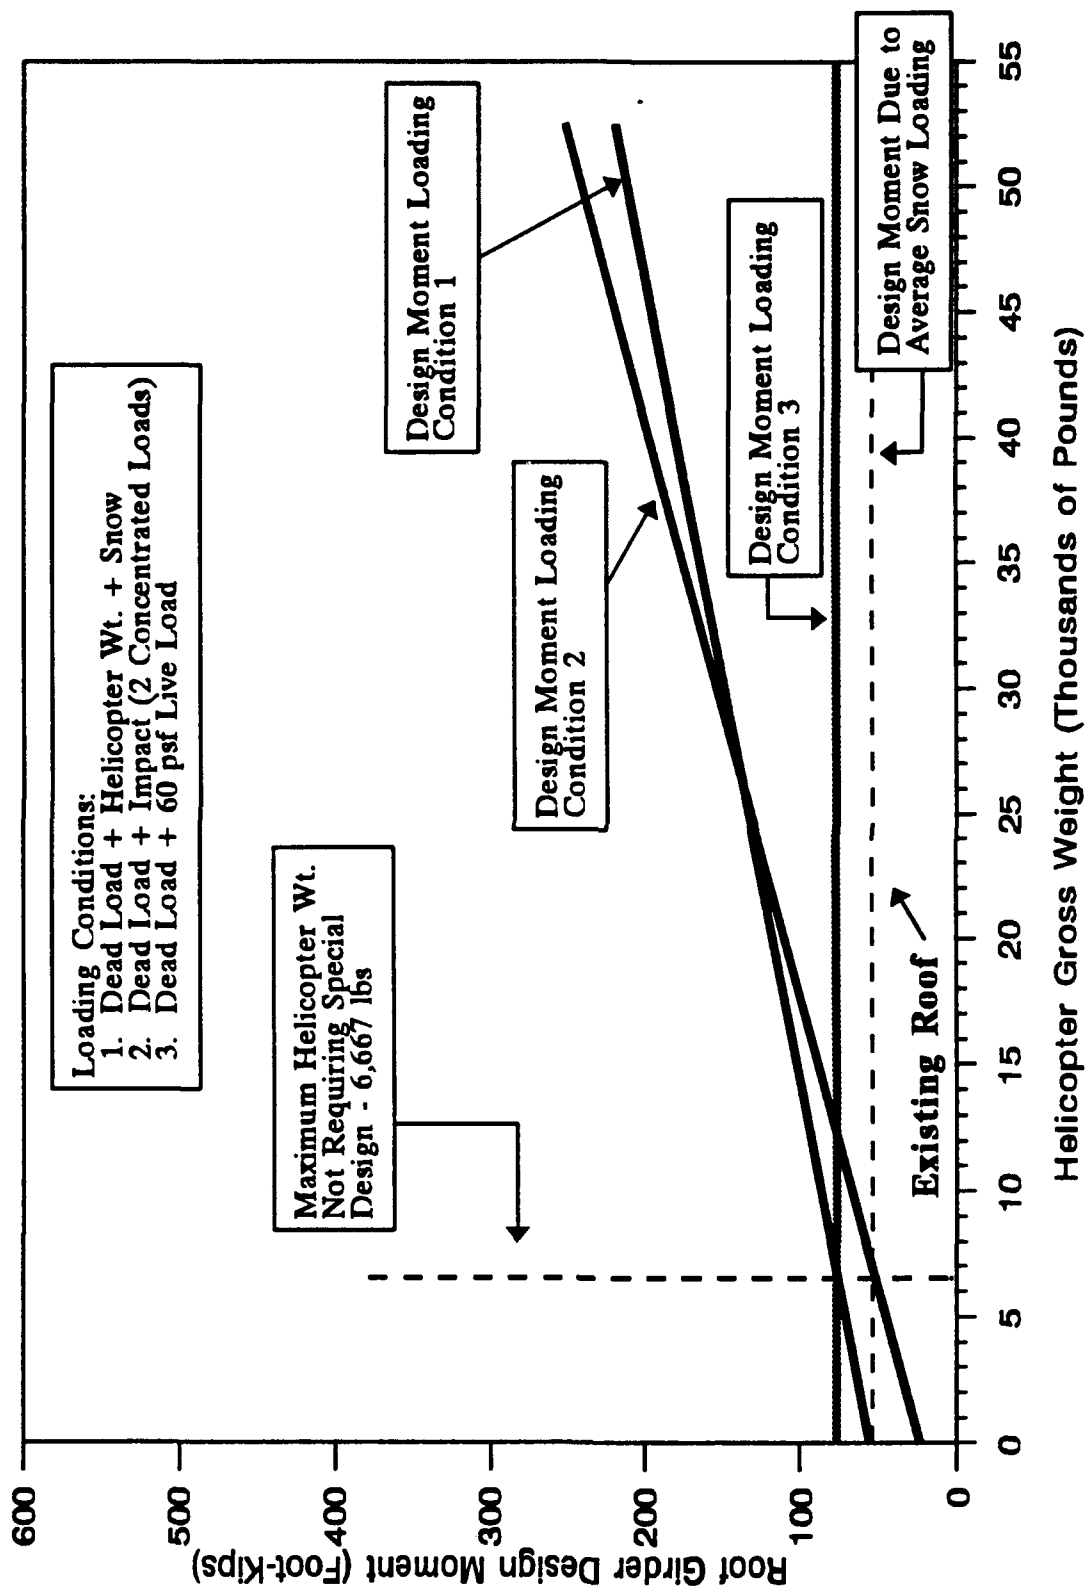
**FIGURE 5 STANDARD BUILDING CODE, 1991 - CASE 1: 20' X 20' BAY SPACING WITH 20 PSF DEAD LOAD**
