Technical Report HL-95-11
September 1995

Flood Control Structures Research Program

Toe Scour and Bank Protection Using Launchable Stone

by Stephen T. Maynard, Douglas M. White

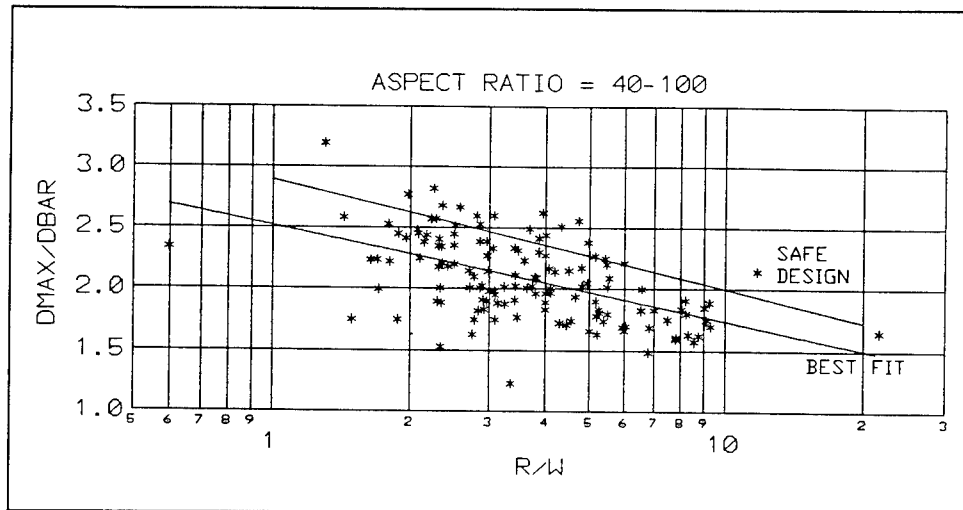
Figure 4. Dimensionless scour depth versus R/W for AR 40-100

The data for each range, plotted in Figures 3-6, clearly show increasing scour depth for increasing AR even though the correlation between dimensionless scour depth and R/W is poor. Because of the poor correlation, the best fit line cannot be used as a safe design curve to represent that range of AR. A safe design curve of 15 percent greater than the best fit curve is adopted in this study, as shown in Figures 3-6. The safe design curves are greater than about 80 percent of all data in each range of AR. Many of the data points falling above the safe design curves are for AR's greater than the average AR for that range. Using the safe design curves, only 10 points out of 222 (5 percent) had computed scour/observed scour less than 0.95, showing that the safe design curves are unconservative for only a small percentage of the data. The design curves with all data are shown in Figure 7. The scarcity of data for higher AR's suggests an upper limit of application of AR = 125. The advantage of Figure 7 over Figure 2 is that Figure 2 results in over-estimation of scour depth in channels having low AR.

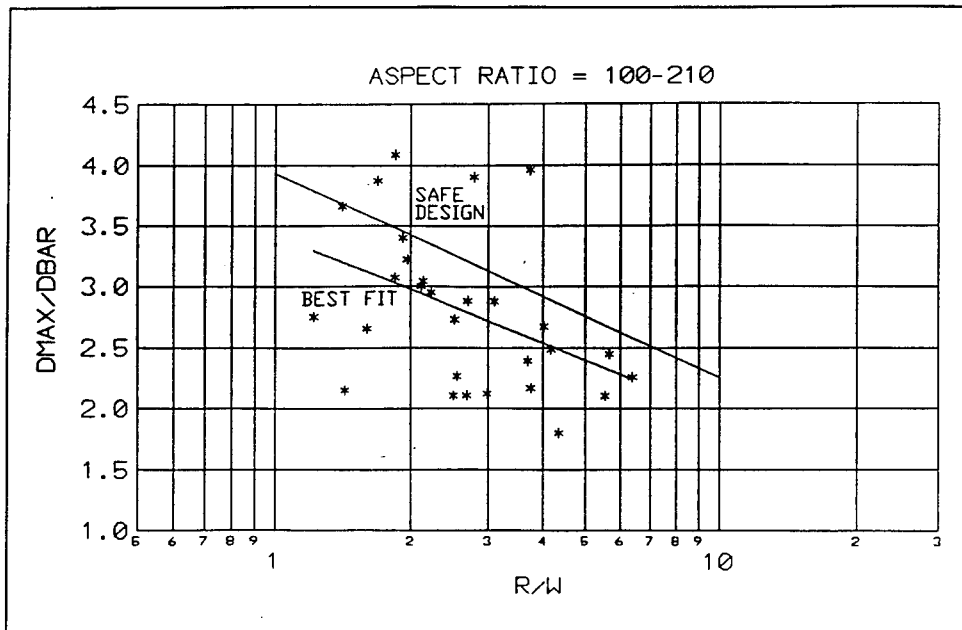
Figure 5. Dimensionless scour depth versus R/W for AR 100-210

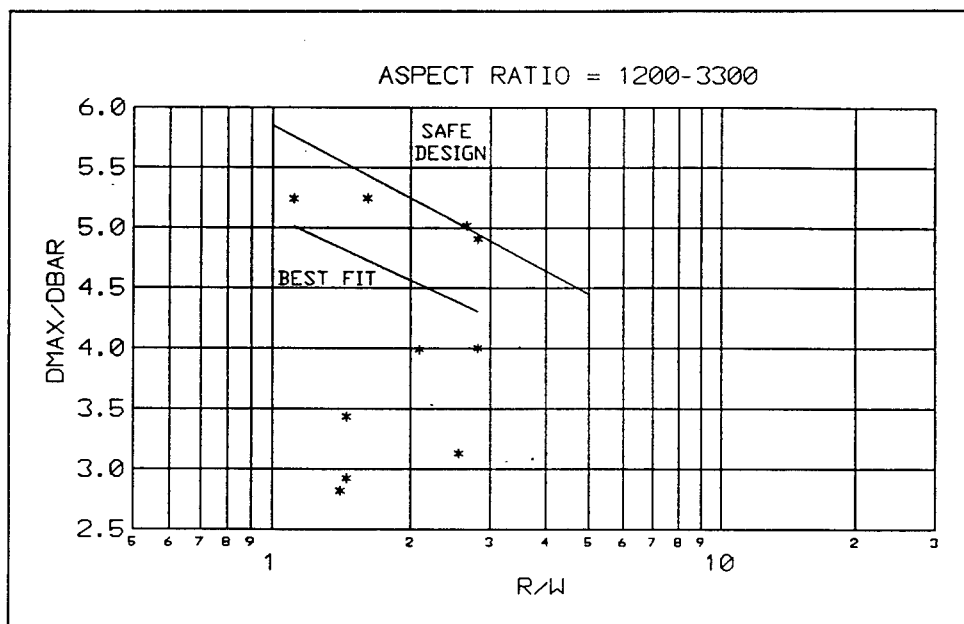
Figure 6. Dimensionless scour depth versus R/W for AR 1200-3300

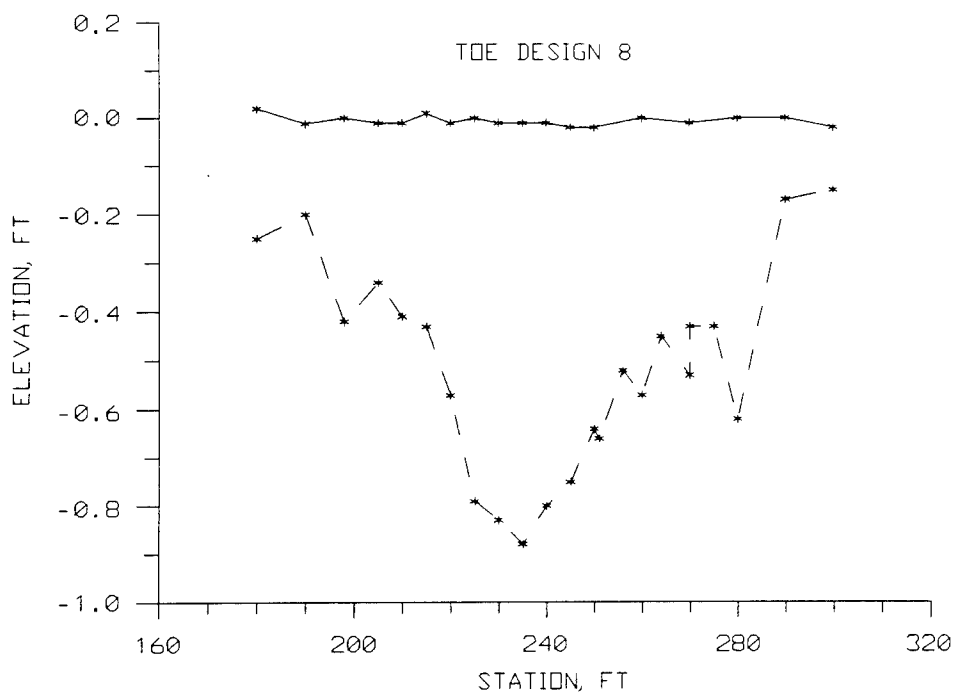
***** PRE-ELEVATION
 ***** POST-ELEVATION

TOE SCOUR ELEVATION
 TOE DESIGNS 7 AND 8
 RUN 1

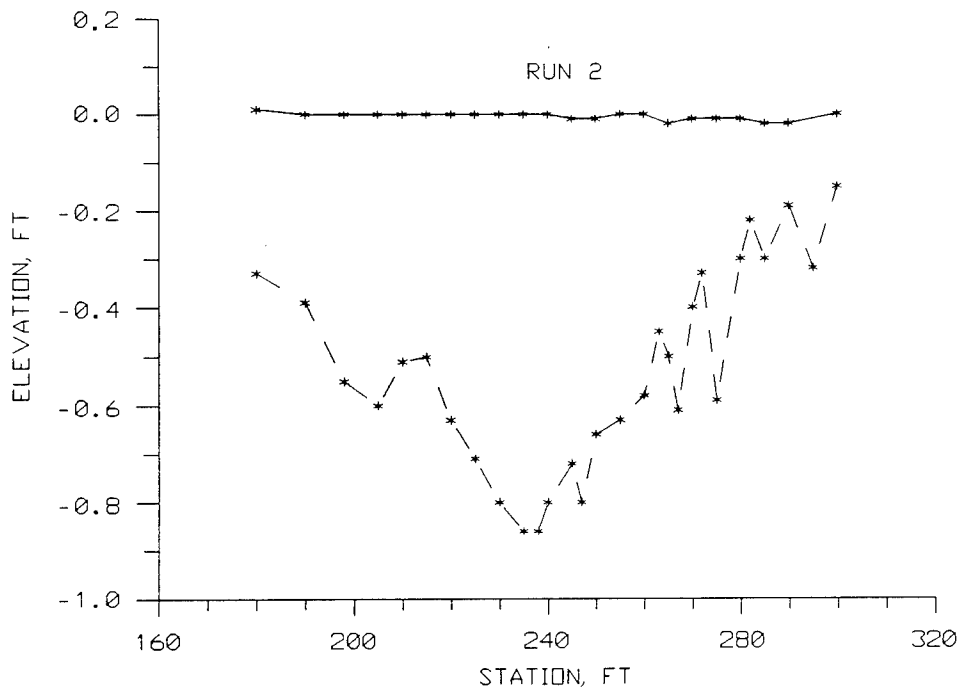
***** PRE-ELEVATION
 ***** POST-ELEVATION

TOE SCOUR ELEVATION
 TOE DESIGN 24
 RUNS 1 AND 2

23	2	Failure zone; station 2+27 to station 2+70. Filter fabric can be seen at stations 2+28, 2+35, 2+54, and 2+68. Dune locations (trough) at stations 2+44, 2+48, 2+64, 2+73, and 2+85.
24	1	Failure zone; station 2+29 to station 2+58. Filter fabric can be seen at stations 2+33, 2+37, 2+41, 2+46, and 2+50. Dune locations (trough) at stations 2+36, 2+47, 2+58, 2+67, 2+78, and 2+90. Note: This test was run for 13 hr.
24	2	Failure zone; station 2+35 to station 2+50. Filter fabric can be seen at stations 2+40 to 2+41, 2+44 to 2+46, and 2+47 to 2+49. Dune locations (trough) at stations 2+38, 2+47, 2+67, 2+75, and 2+95. Note: After completion of 13-hr test, model was restarted and velocity measurements were taken at stations 2+20, 2+30, 2+35, 2+40, 2+50, 2+60, 2+70, 2+80, 2+90, and 3+00.
25	1	Failure zone; station 2+36 to station 2+54. Filter fabric can be seen at station 2+43 to 2+44. Dune locations (trough) at stations 2+45, 2+53, 2+58, 2+71, and 2+85.
