FLIGHT TESTS OF A GROUND SPEED INDICATOR OVER MEASURED RUNS

N R L REPORT NO. R-3239

C. L. Estes and
E. F. McClain

February 11, 1948

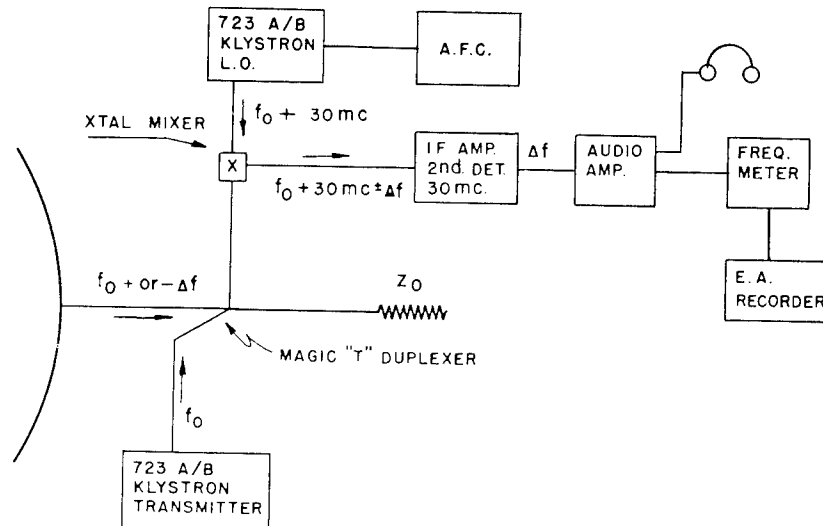
Fig. 1 - Block Diagram of Equipment

transmitter and local oscillator tubes are 723 A/B klystrons. The receiver incorporates a 30-megacycle intermediate-frequency strip followed by a diode detector and audio amplifiers. In order to suppress low-frequency microphonic noise, a low-pass filter having a cut-off frequency of 1000 cycles per second was employed. The over-all audio-frequency response curve is flat within 1 db over the useful range from 1000 to 2000 cycles per second, but drops off sharply on either side of this range. The radar system has been tested for performance and has been found to compare favorably with standard pulse radars when the differences in power output, antenna gain, etc., are taken into consideration. Figure 1 is a block diagram of the system.

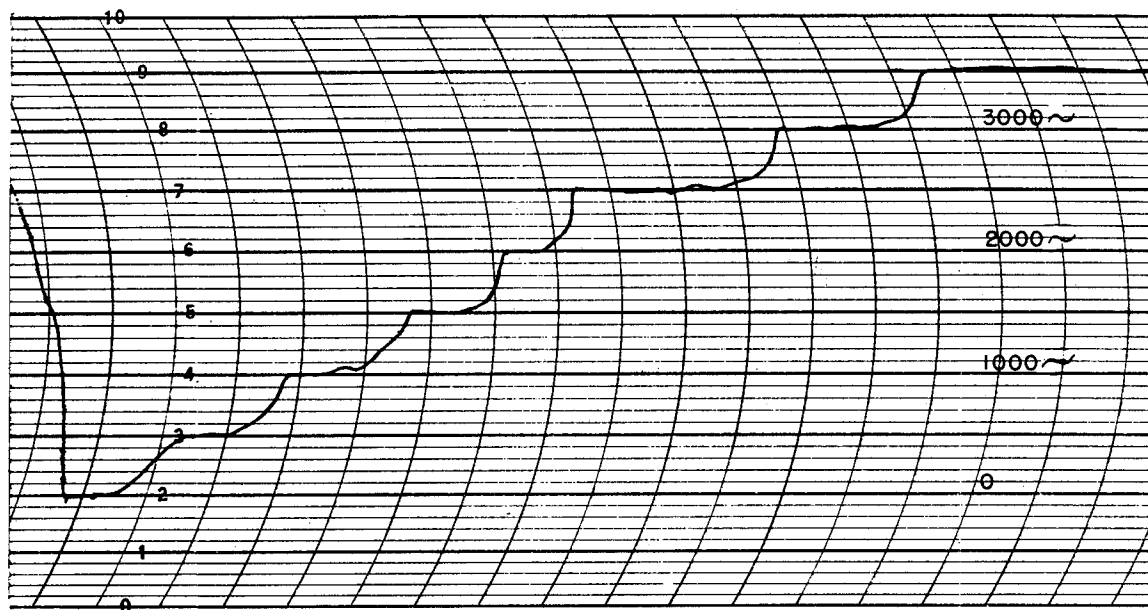
Fig. 2 - Sample Calibration Run

was found that with frequent zero settings the oscillator could be relied upon to indicate frequency within one percent. Ten-point calibration curves were taken before each run. A sample calibration run is shown in Figure 2. In addition, the oscillator output was wired in such a way that a 2000-cycle-per-second note could be fed to the recording setup by the throw of a switch. The recorder was checked frequently in this manner during the runs, and any drift in calibration was allowed for in the calculations.

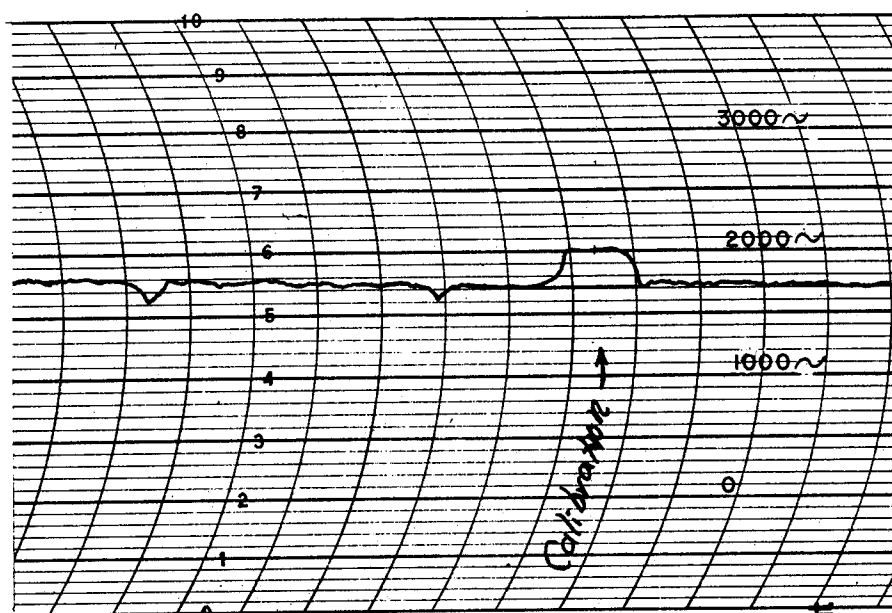
Fig. 3 - Sample Record with Calibration Check - Air Calm

A sample of a portion of a run during calm weather is shown in Figure 3. One of the 2000-cycles-per-second calibration checks is seen in the center of the trace. The nature of the record during bumpy flying is shown in Figure 4. This record was taken on the return trip from Jacksonville, Florida. A record taken during a sharp bank is shown in Figure 5.

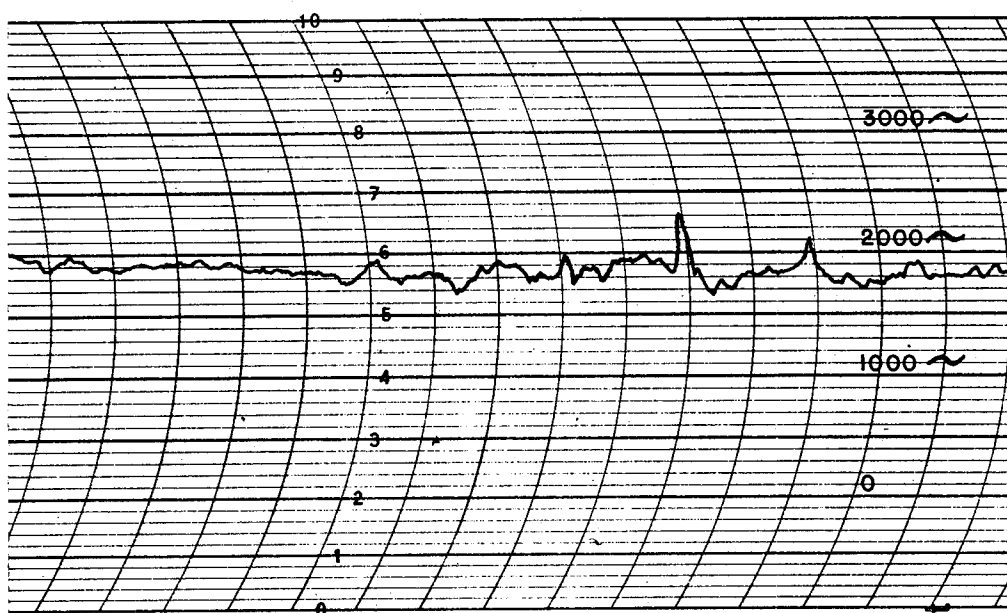
Fig. 4 - Sample Record - Air Rough

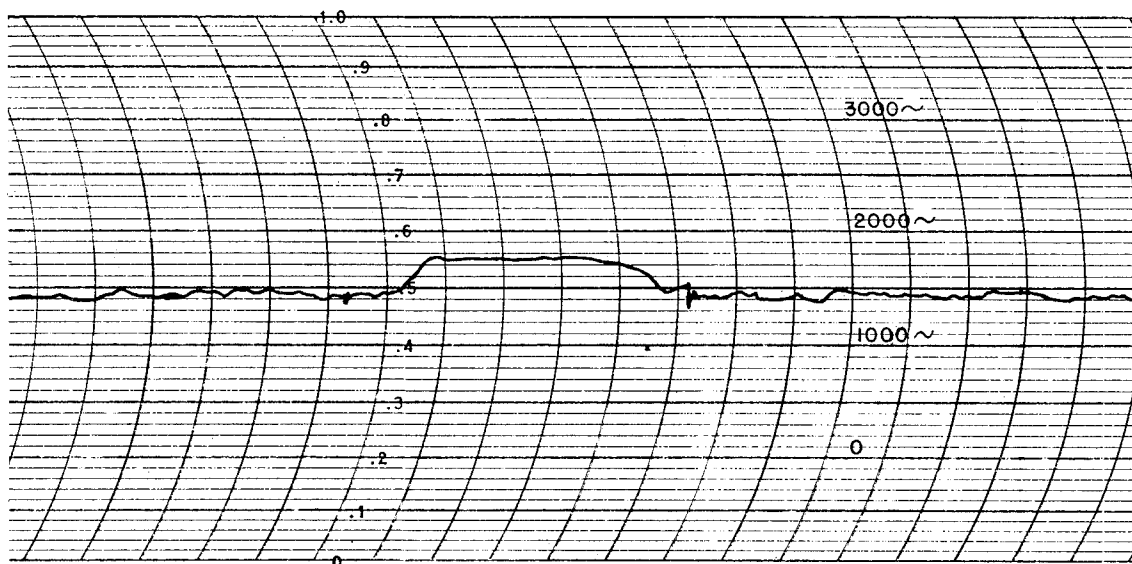
Fig. 5 - Sample Record During Bank

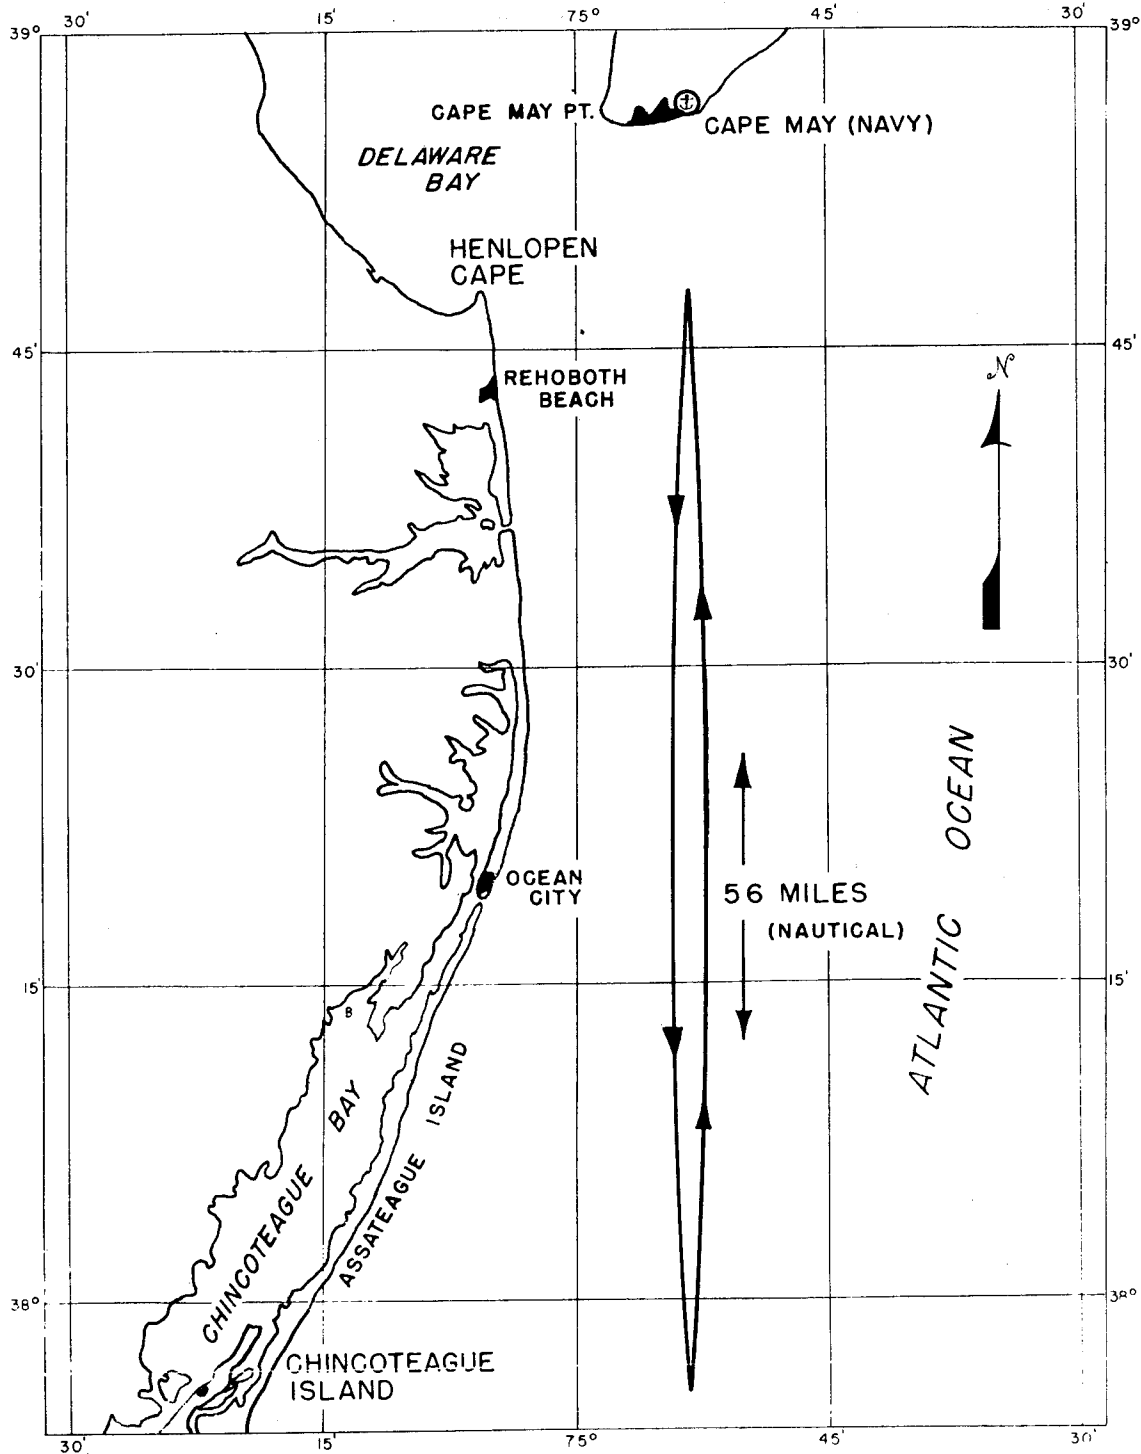
Fig. 6 - Cape Henlopen - Chincoteague Run.

The first run was off the Atlantic coast south of Cape May. (See Figure 6.) From the starting point, due east of Cape Henlopen, the pilot was directed to fly south to a point east of Chincoteague. The run distance was 56.0 nautical miles. The indicated velocity, 104 knots, is 0.6 percent lower than the true velocity. During this run the wind was light and from the northwest. One would therefore expect the error on the return run (i.e., northbound run) to be less negative by a small amount. The error on the Chincoteague to Cape Henlopen

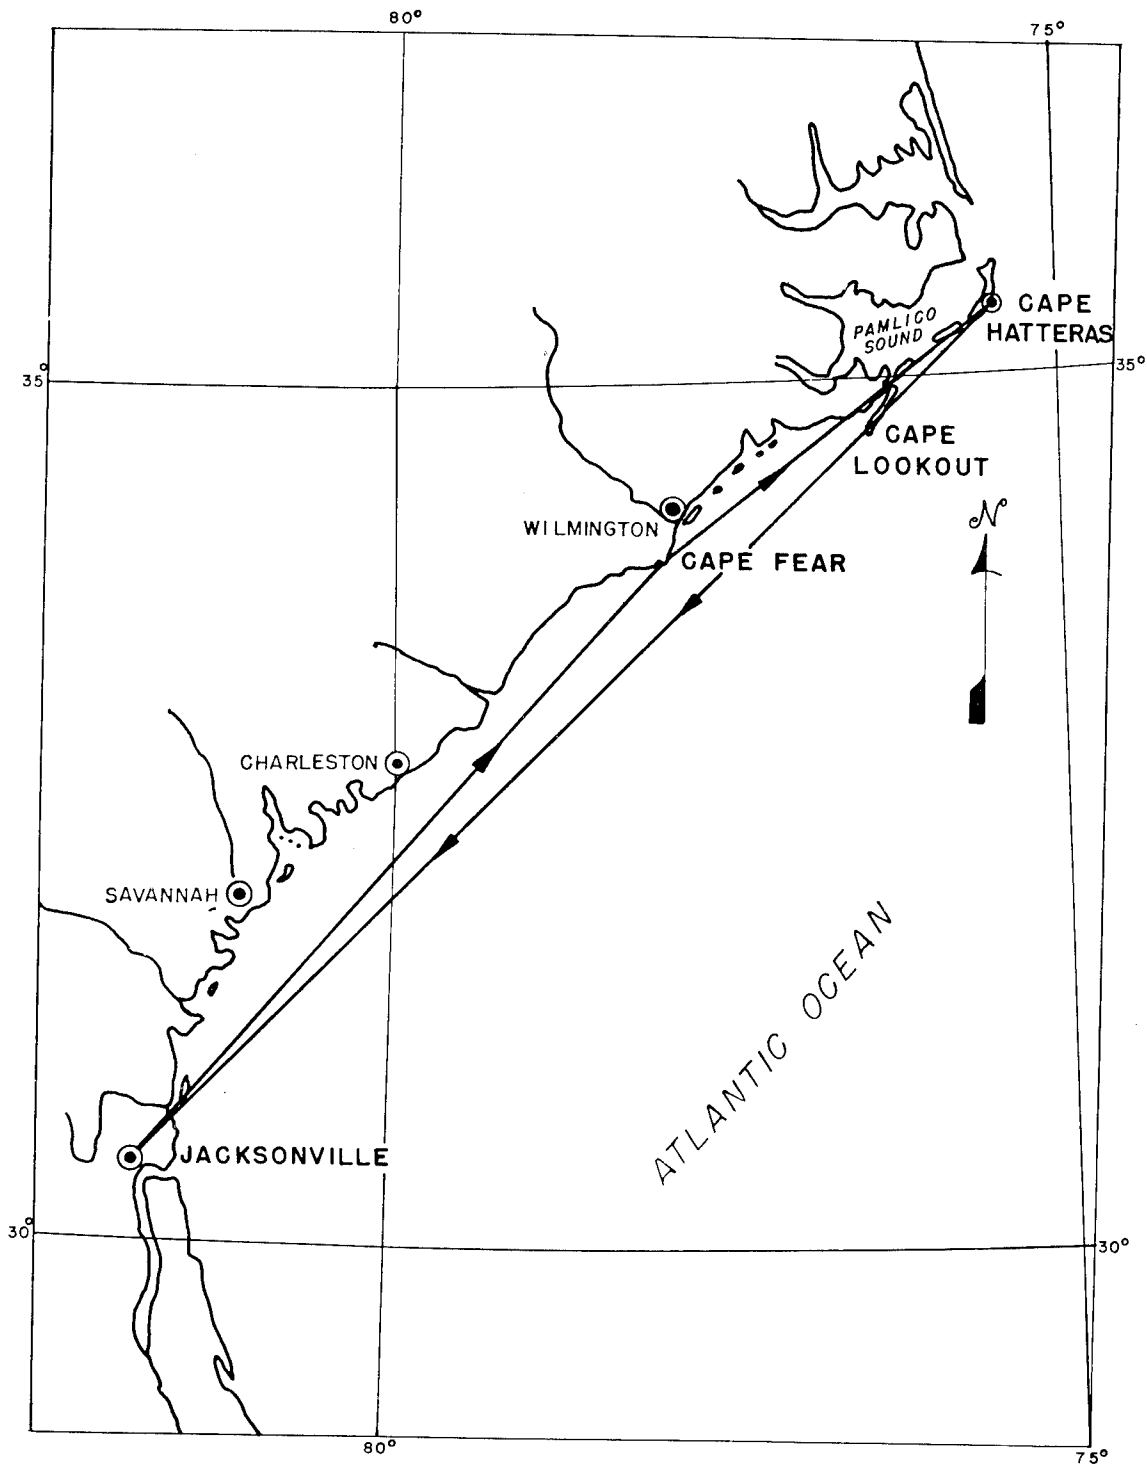
Fig. 7 - Cape Hatteras - Jacksonville Run

Following the Cape Henlopen-Chincoteague runs it was decided to make additional runs over greater distances. For this purpose a run between Cape Hatteras and Jacksonville was decided on (see Figure 7). This run, a distance in excess of 400 nautical miles, provided an opportunity for a good check on the reliability of the ground speed indicator under varying conditions of sea and weather. During the southbound run the weather was generally fair, and the wind moderate from a direction approximately at right angles to the ground track. The over-all error for the run was -1.3 percent.
