THESIS

**ANALYZING AND PREDICTING UNDERWATER
HULL COATING SYSTEM WEAR**

James R. Wimmer

March, 1997

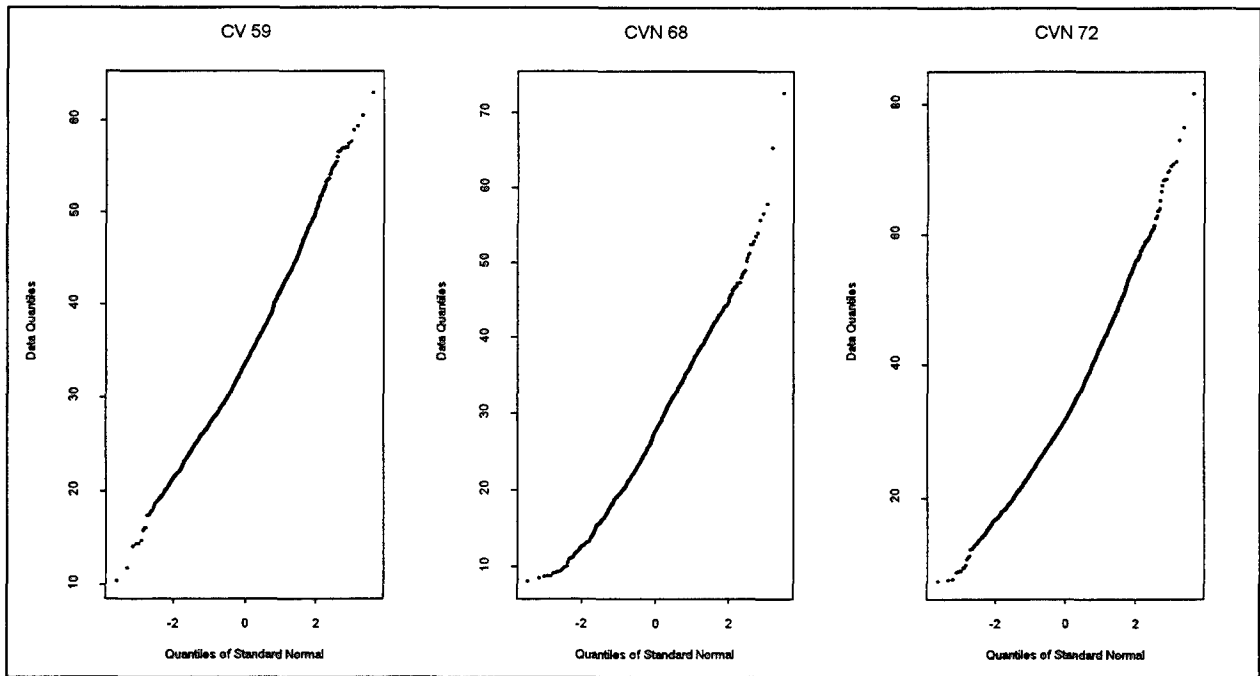
Figure 3. Normal probability plots for three freshly applied coating systems.

As suggested from the asymmetry of the data, illustrated in Figures 2 and 3, the Kolmogorov-Smirnov Goodness-of-Fit test rejects the null hypothesis of normality for CV 59, CVN 68, and CVN 72 with p-values less than 0.000001.

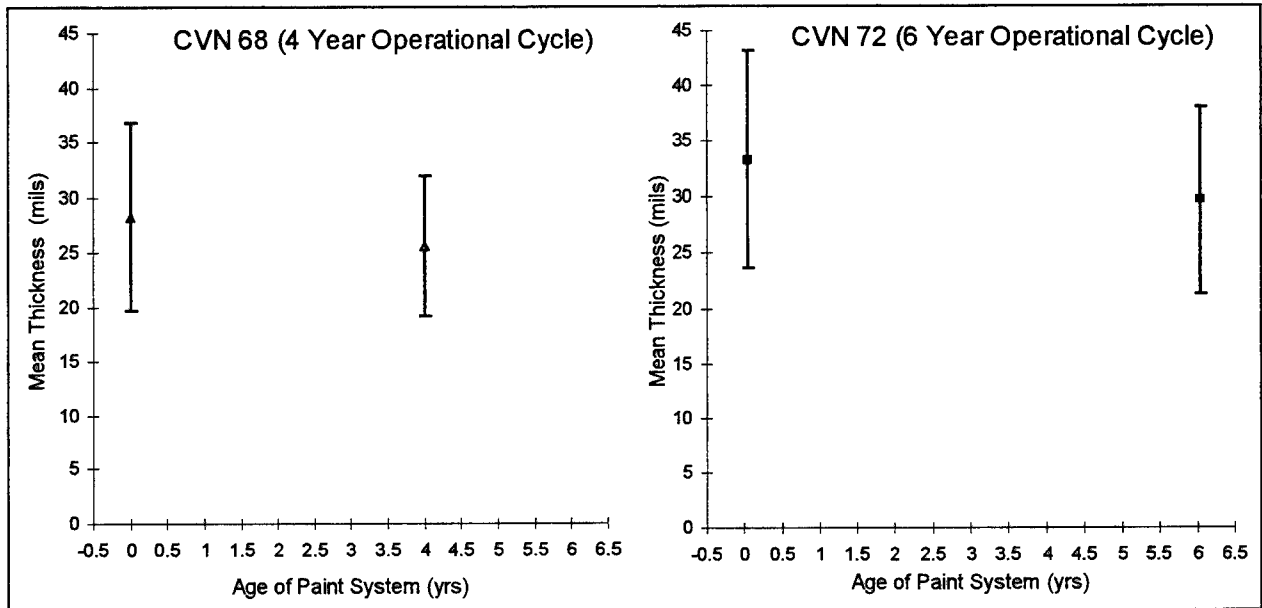
Figure 8. Mean coating thickness \pm standard deviation at application and following operational cycle.

During a four year operational cycle, the mean DFT for CVN 68 decreased from 28.20 mils to 25.57 mils, a net loss of 2.63 mils. CVN 72's mean DFT decreased from 33.36 mils to 29.61 mils, a net loss of 3.75 mils. As expected, the hull coating system with the longer operational cycle has a larger decrease in mean DFT, losing nearly 30 percent more paint. Since CVN 72's operational cycle was one-third longer than CVN 68's operational cycle, the net loss of approximately one-third more paint suggests that the rate of paint ablation remains relatively constant over time. Figure 8 also illustrates a reduction in the coating system's standard deviation over time. During CVN 68's four year operational cycle, its coating system's standard deviation decreased by 25 percent from 8.51 to 6.39. Although CVN 72's operational cycle was one-third longer than CVN 68's, its standard deviation decreased by only 13.75 percent from 9.75 to 8.41.

To obtain a general overview of the effects of paint ablation over time, Figure 8 depicts the mean and standard deviation of each coating system at the time of paint application and following each ship's respective operational cycle.

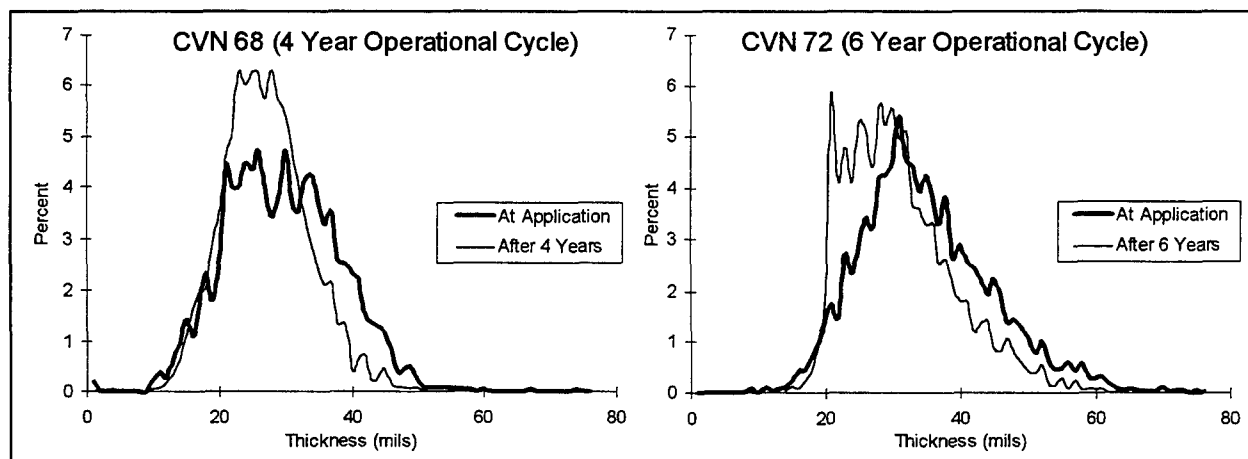
Figure 9. Distribution of coating system thickness before and after an operational cycle.

The shape of the paint thickness distributions for both ships change with wear rather than simply shifting to the left as would be expected if paint ablation were uniform. The heavy right tails of the distribution appear to retract with wear while the left tail of each distribution remains relatively unchanged. This suggests that during the first four to six years, the thicker paint ablates at a faster rate than the thinner paint thicknesses. To illustrate the changes in ablation properties over time, the empirical cdf's, shown in Figure 10, provide a quick yet detailed synopsis of the rate and manner of paint ablation experienced by each coating system.

The change in the standard deviation for each coating system suggests that the transformation of the paint thickness distribution is more complex than what would be caused by uniform paint ablation. Figure 9 illustrates the changes to the paint thickness distributions for both paint systems over time.

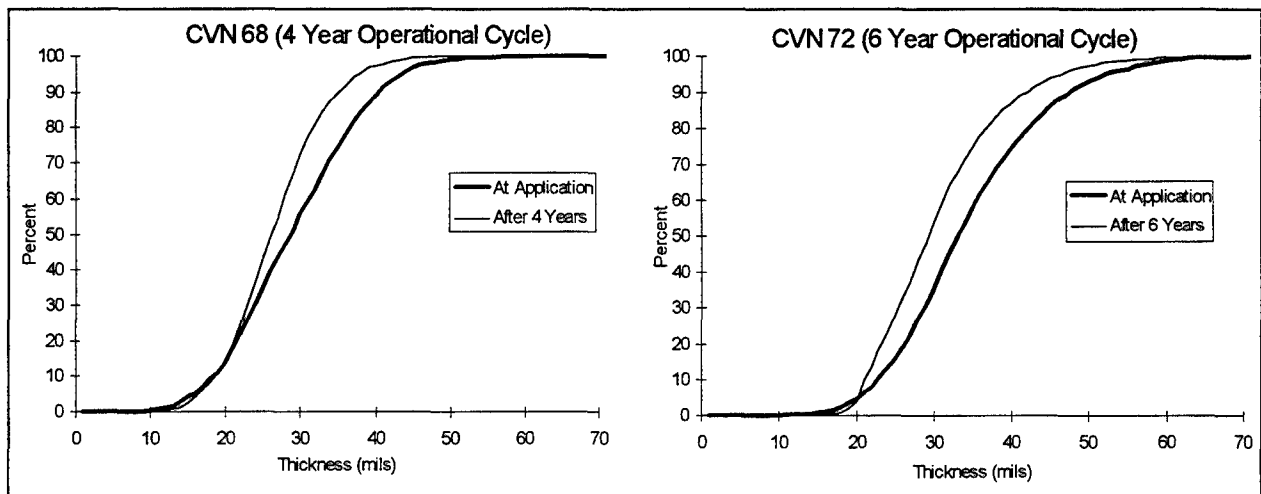
Figure 10. Empirical cdf's of coating system thickness before and after an operational cycle.

From the empirical cdf's in Figure 10, the first quartile of CVN 68's DFT measurements, representing the thinnest one-fourth of the coating system paint, experiences a decrease of only 0.8 mil during the four year operational cycle. In addition, there is negligible change in the thinnest 15 percent of CVN 68's coating system. CVN 72's first quartile decreases during its six year operational cycle from 26.6 mils in 1990 to 23.45 in 1996, three times that of CVN 68's. Moreover, the percent of the left portion of the tail which is "unaffected" drops from 15 percent to only six percent for an operational cycle that is only two years longer.

Hull treatment procedures, as shown in the empirical cdf’s in Figures 10 and 12, have a significant effect upon the service of a coating system and must be considered, as well. The effects of a hull cleaning and a hydro-wash upon a coating system’s quantiles are illustrated in Figure 16.

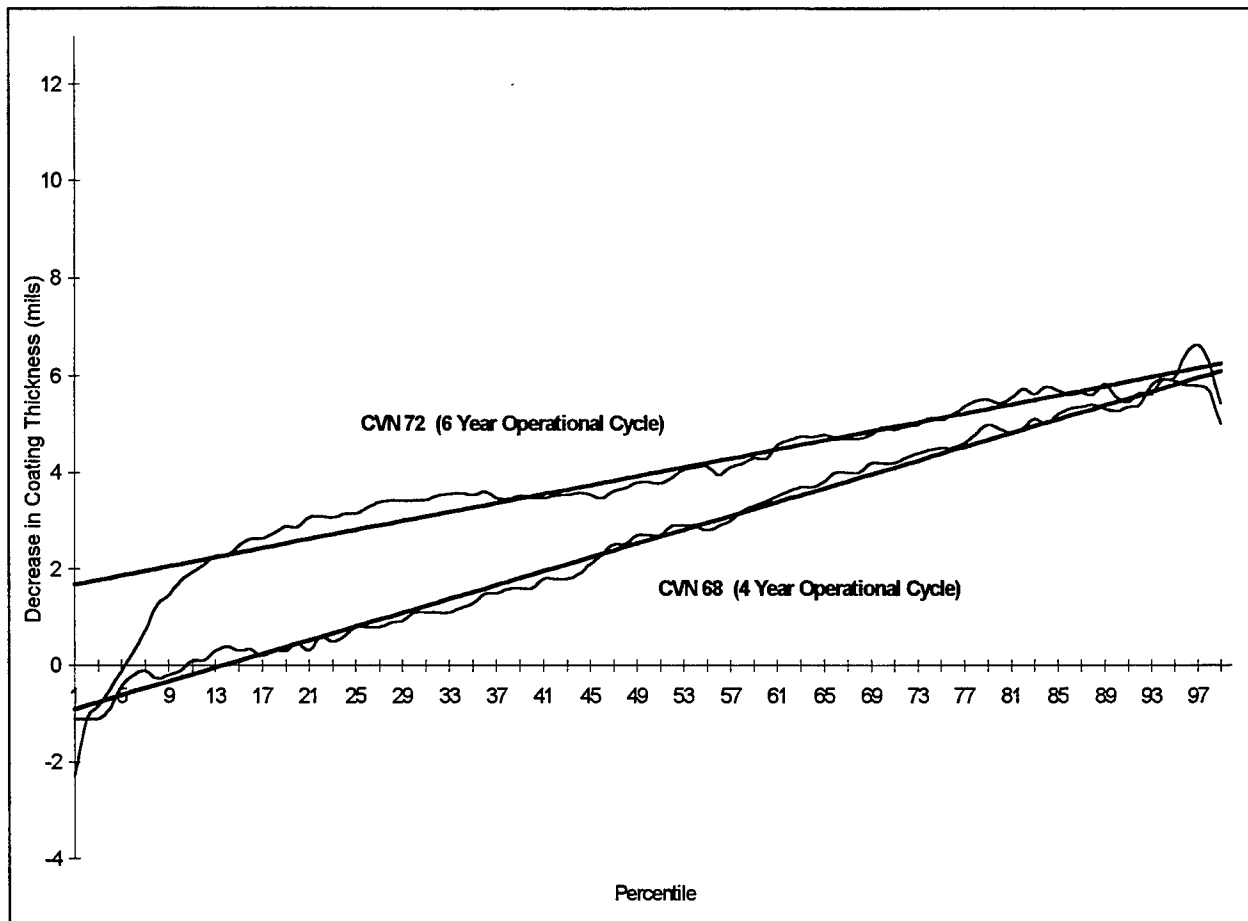
Figure 15. Change in coating system quantiles for a four and six year operational cycle.

Since no hydro-washes or hull cleanings were performed during either ship's operational cycle, changes to both coating system's quantiles are exclusively a product of the length of each ship's respective operational cycle. Figure 15 shows a linear relationship in the change in quantiles of DFT measurements across nearly all percents for both coating systems. With the exception of the smallest percents, the linearly increasing loss of paint is quite pronounced. This confirms the findings presented in Chapter III that a coating system does not exhibit uniform ablation across all coating thicknesses. The negative change in quantile thickness for both coating systems in the smaller percents indicates an increase in DFT for the coating systems' thinnest paint during these two operational cycles. The reason for this behavior is not certain. Since the smallest quantiles represent the "valleys" and "crevices" of a coating system, it is feasible that "dirt" or some other form of debris or oxidation could settle into these crevices. Slight creep or paint swell could be other potential reasons. It is suspected that following application in a "dry" environment, the

The first variable considered is the impact of a ship's operational cycle. Figure 15 illustrates the change in the quantiles of the total thickness distribution for the coating systems of CVN 68 following a four year operational cycle and CVN 72 following a six year operational cycle.

As illustrated in Figure 16, the decrease in quantile thickness for both types of hull treatments is more uniform over the entire coating thickness distribution than the aged coating systems in Figure 15. Moreover, the effects of hull treatment procedures produce a more consistent decrease in coating thickness over the entire coating system and can be adequately modeled with a least squares linear fit. Although for this data a hydro-wash removes over one mil of paint less than a hull cleaning, it appears that the hydro-wash may actually cause slightly more wear than the hull cleaning in the thinnest ten percent of paint. This observation needs to be confirmed with more data.

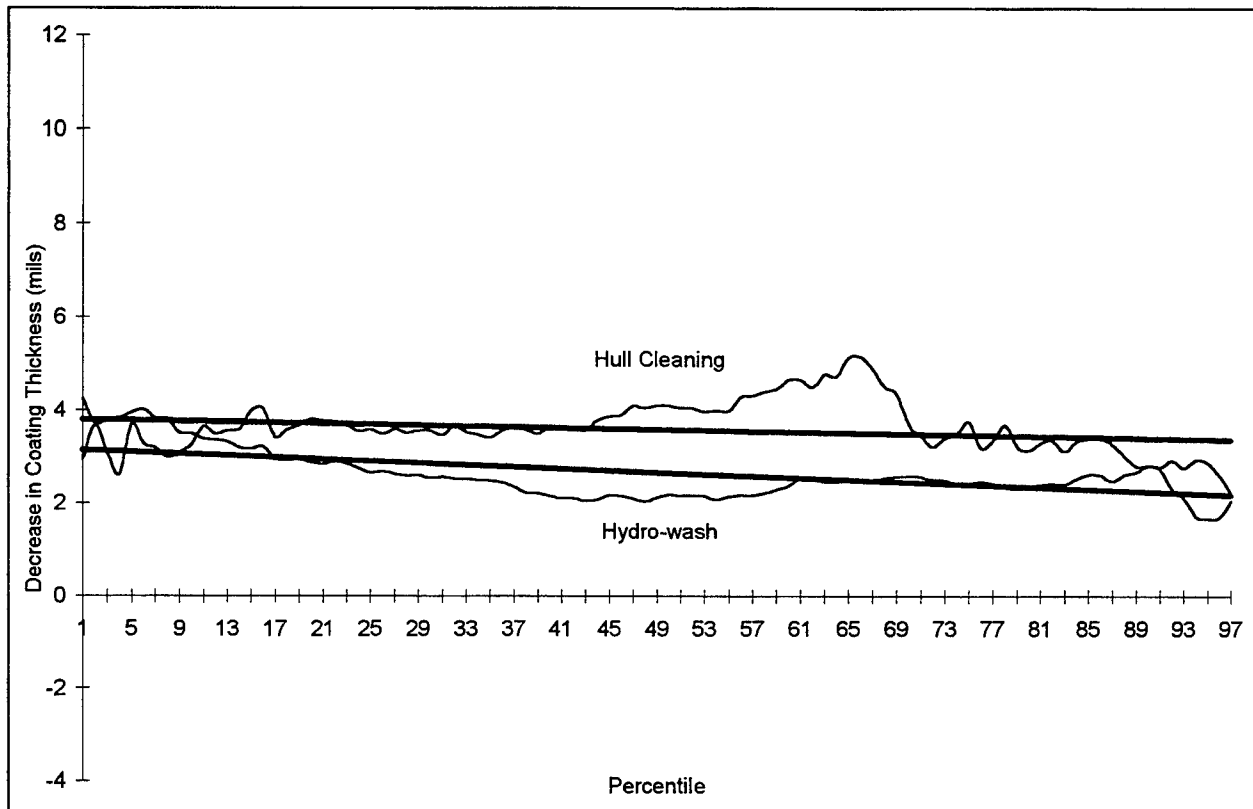
Figure 16. Change in coating system quantile for a hull cleaning and hydro-wash.

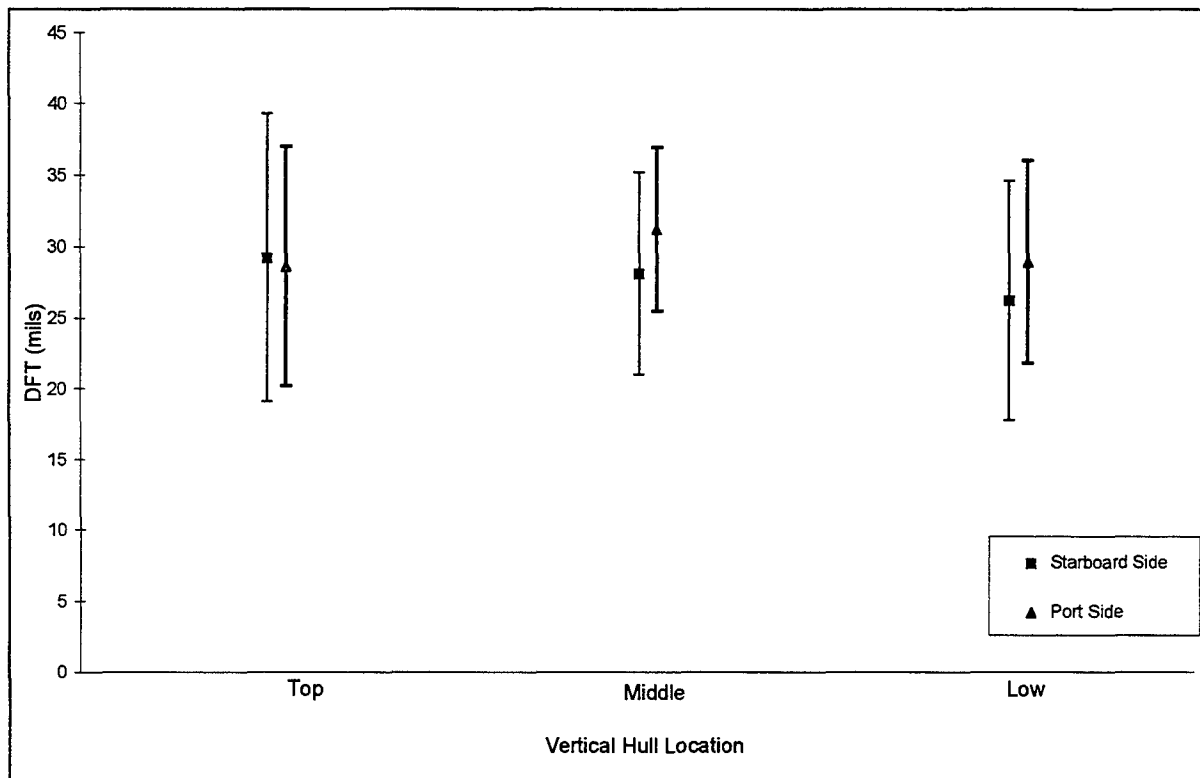
The second data, collected from USS Eisenhower's (CVN 69) eight year old coating system, is used to evaluate the effects of vertical location on paint ablation rates. All measurements are taken from the front one-third portion of the hull in three locations: near the waterline, midway down the hull, and at the bottom of the vertical portion of the hull. In Figure 3.2, the averages from the three vertical locations can be seen for both the port and starboard side of the hull.

Figure 24. Mean total coating thickness with standard deviation vs. vertical hull location.

Although a two-way analysis of variance with interaction easily rejects the null model of constant mean DFT between the six different hull locations ($p\text{-value} = 0.000002$), the difference between the means are small compared to the variability of thickness at each location. Further, Figure 24 clearly illustrates the absence of any distinct trend or practical difference in mean DFT as a result of vertical hull location.
