# NATIONAL TRANSPORTATION SAFETY BOARD

## AIRCRAFT ACCIDENT REPORT

UNCONTROLLED IMPACT WITH TERRAIN  
FINE AIRLINES FLIGHT 101  
DOUGLAS DC-8-61, N27UA  
MIAMI, FLORIDA  
AUGUST 7, 1997

**Abstract:** This report explains the accident involving Fine Airlines flight 101, a Douglas DC-8-61, which crashed after takeoff from runway 27R at Miami International Airport, Miami, Florida, on August 7, 1997. Safety issues in the report include the effects of improper cargo loading on airplane performance and handling, operator oversight of cargo loading and training of cargo loading personnel, the loss of critical flight data recorder information, and FAA surveillance of cargo carrier operations.

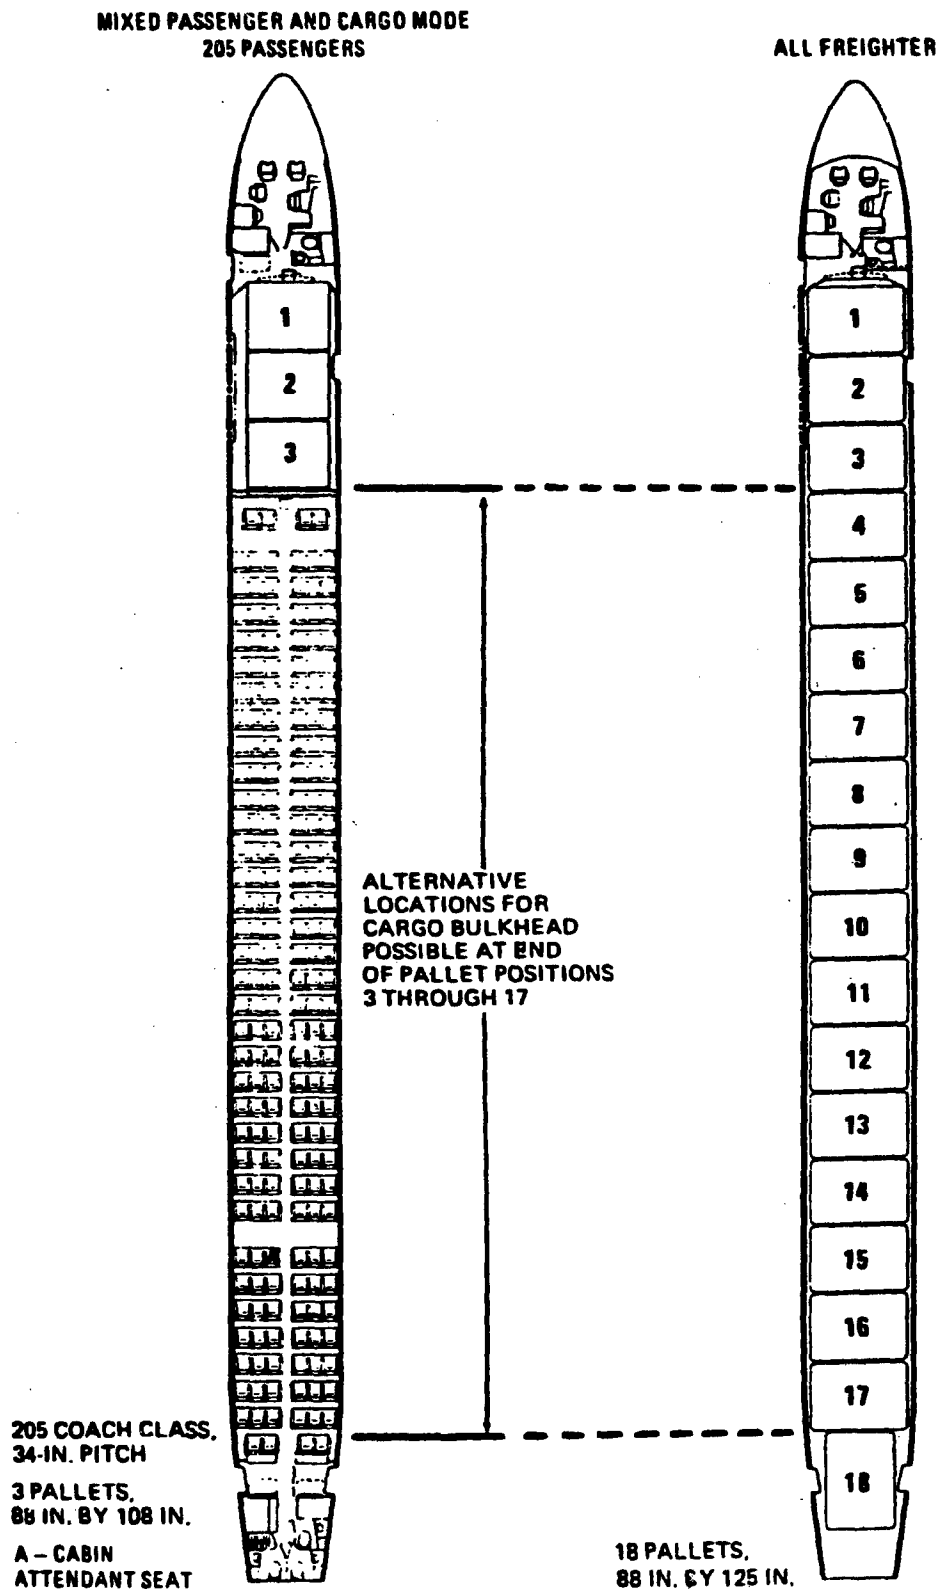
DC-8-61/-71 & -63/-73  
 CONVERTIBLE FREIGHTER AND ALL FREIGHTER

Figure 1.—DC-8-61 18-pallet cargo configuration diagram.

recalculated N27UA's weight and balance based on the revised pallet loading form and faxed the weight distribution form back to Aeromar.<sup>14</sup> The revised weight distribution called for zero-weight locations at pallet positions 2 and 13 and the 1,000-pound reduction of pallet "G" in pallet position 10. The Aeromar operations manager told Safety Board investigators that he forgot to issue the order to remove the 1,000 pounds from the cargo when he arrived at work at 1000, and that the weight was not removed.

The airplane was equipped with a cargo handling system designed to accommodate and restrain 18, 88-inch x 125-inch pallets. Five guide floor tracks with encased ball rollers were installed in the cabin floor to move cargo pallets forward or aft of the main cargo door. Retractable pallet locks (Pemco 50044-1 pallet lock assemblies), or "bear traps," were installed in the cabin floor along the five guide tracks (aligned in a row) at 89-inch intervals (see figure 2). Each of the 85 pallet locks included a folding lock mechanism (to allow pallets to move over them during loading) comprising a forward and aft facing pawl. When raised, the pawls engage the edges of adjoining cargo pallets and prevent forward, aft, or vertical pallet movement (see section 1.16.3 on load testing). Rails were attached along the cabin walls to prevent cargo from striking the fuselage. According to the loading system design, pallet positions 1 through 17 are loaded in the 125-inch (lateral) x 88-inch (longitudinal) position. Pallet position 18, located in the tapering end of the aft fuselage was reversed, loaded in the 125-inch (longitudinal) x 88-inch (lateral) position.

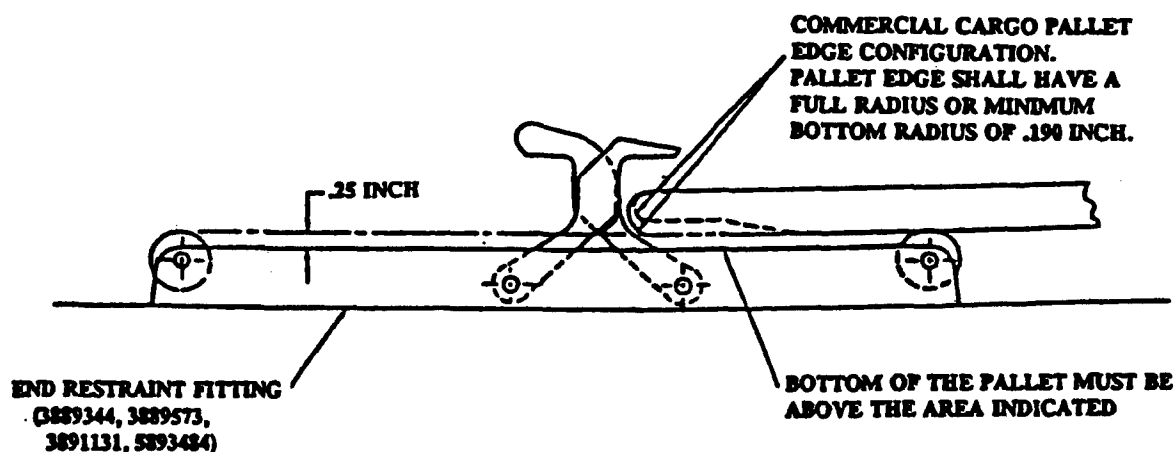
All commercial pallets used in cargo operations must conform to the restrictions shown in Figure 3, below. Specifically, the edges of pallets engaging the pawls of the end restraint fittings must have a full radius or a minimum bottom radius of .190 inch. In no case may the edge of a pallet be so configured that it extends into the shaded area shown in Figure 3.

Figure 2.—Pallet edge configuration requirements.

#### 6. Pallet Edge Configuration Fittings Required
