Technical Report REMR-CS-61
June 1999

An Evaluation of Equipment and Procedures for Tensile Bond Testing of Concrete Repairs

*by Alexander M. Vaysburd, Structural Preservation Systems, Inc.
James E. McDonald, WES*

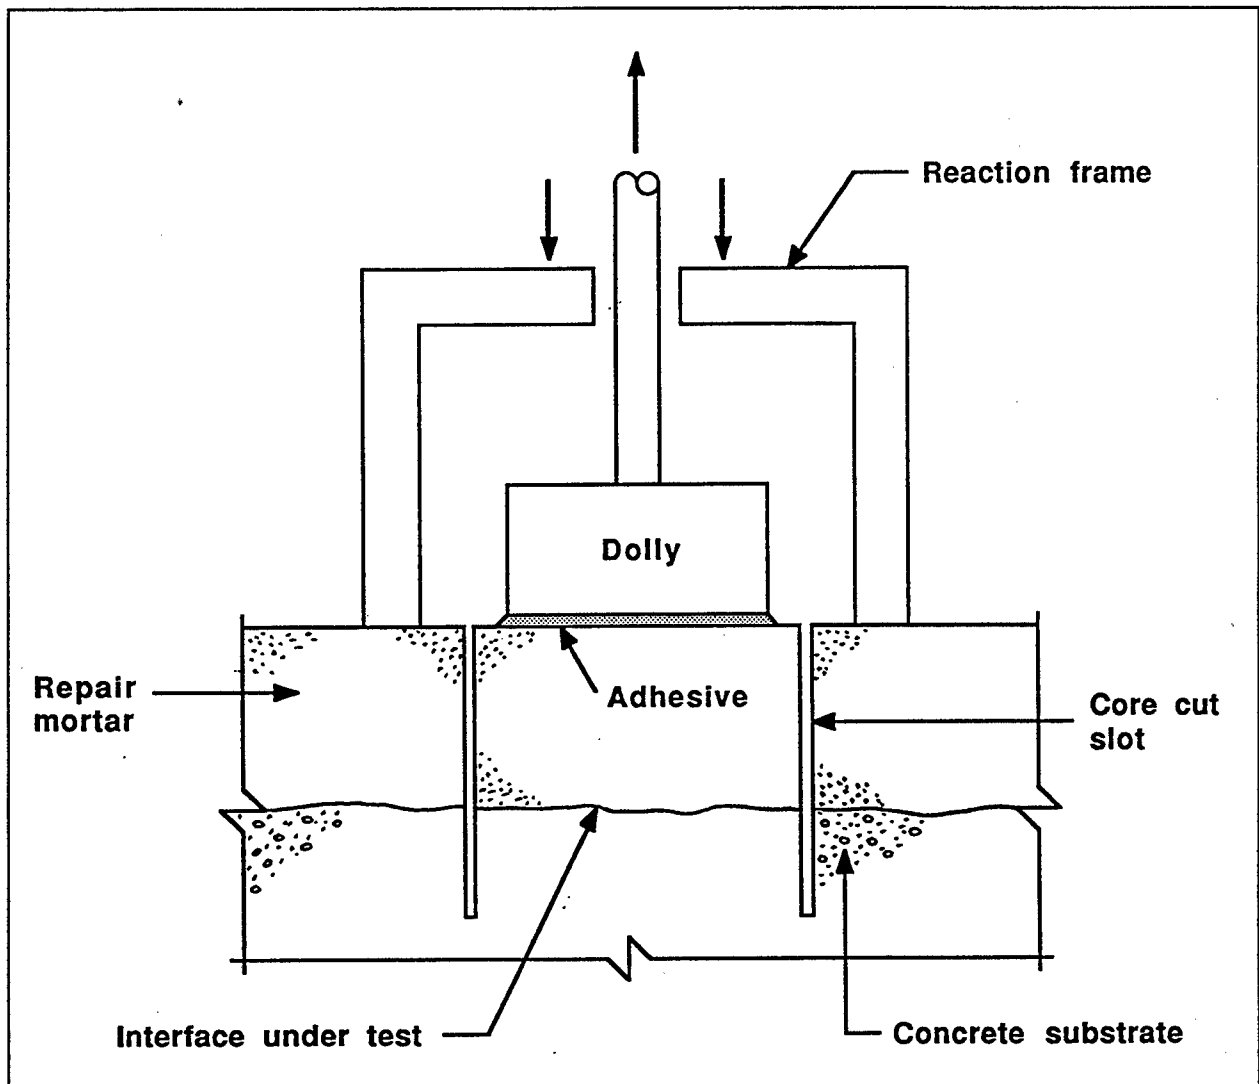
Although there are variations in the testing equipment and method of carrying out the pull-off tests, the general procedures can be described as follows (Figure 1):

Figure 1. Pull-off test principle

- c. Attaching the disc to the core, using an epoxy resin.
- d. Attaching a loading frame to the disc. A frame around the disc provides the reaction force to the load.
- e. Pulling the disc until the specimens fails.

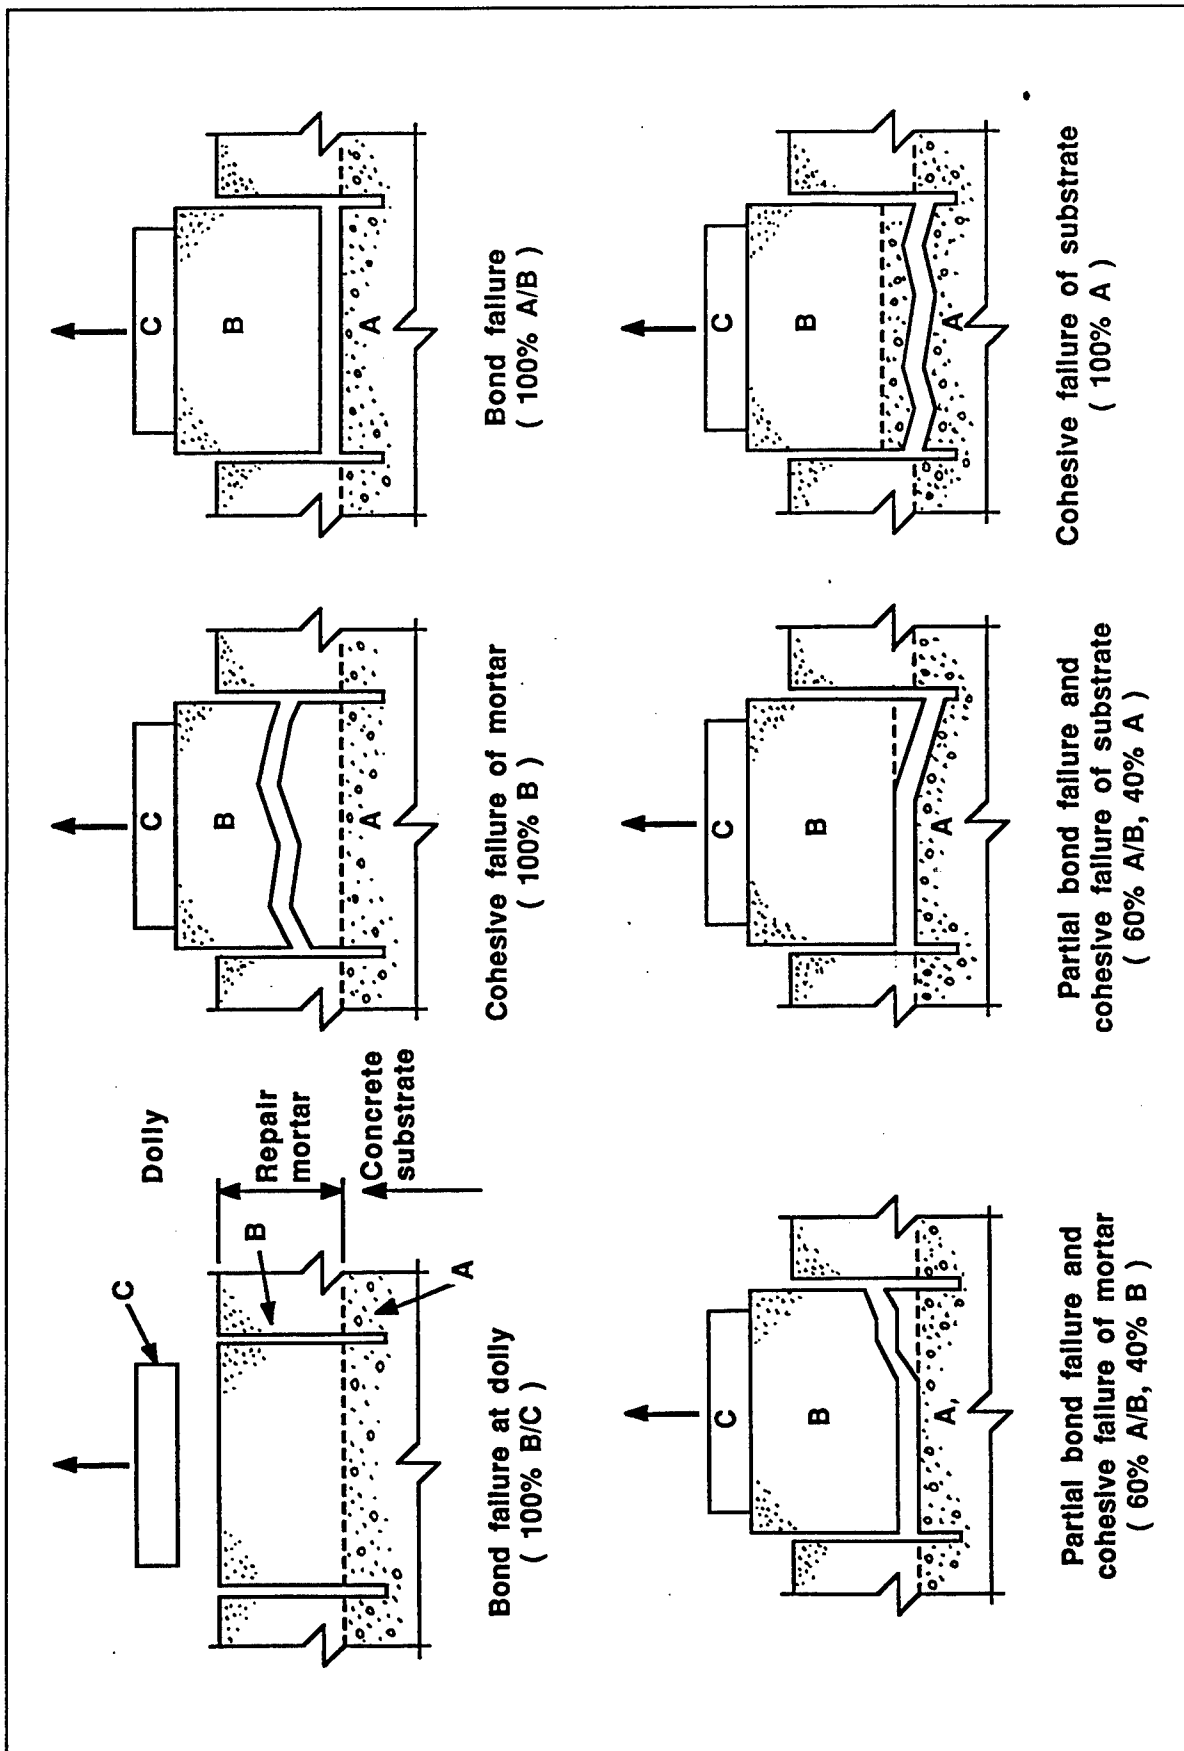
The failure stress load and the mode of failure are recorded (Figure 2).

Figure 2. Pull-off test core failure modes

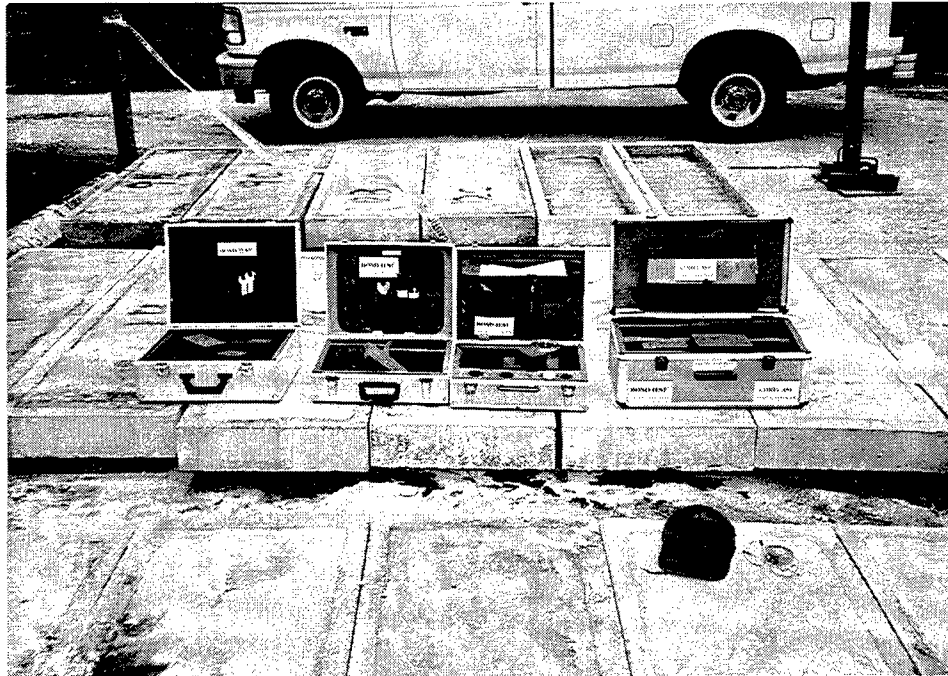
The equipment consists of four kits: preparation kit, pull machine kit, corecase kit, and DSV kit (Figure 3).

Figure 3. Germann Instruments testing equipment at the jobsite (Florida)

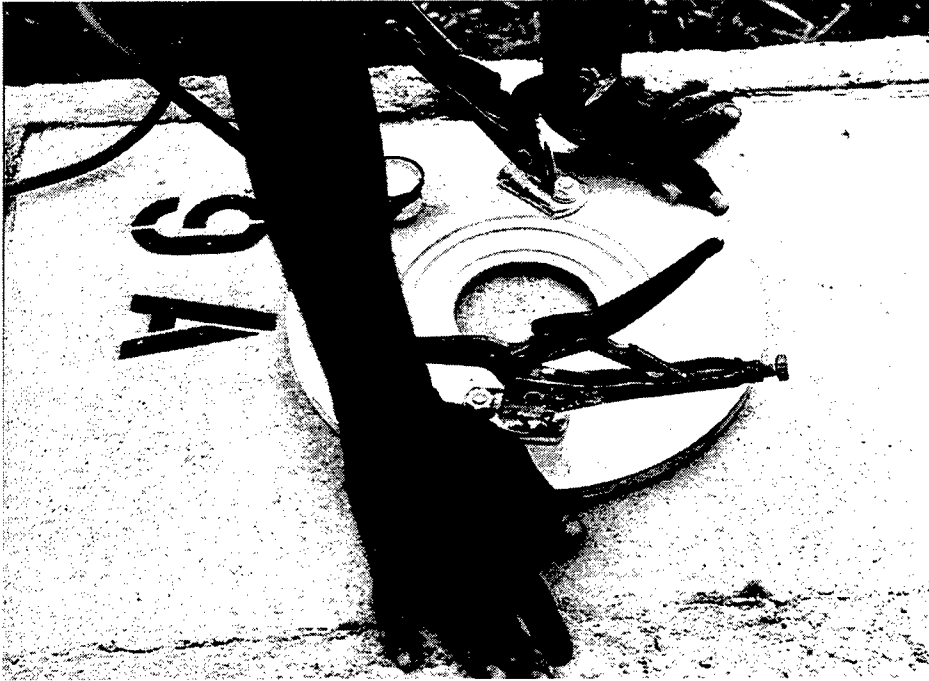
- a. The test surface is planed dry with the diamond surface planing wheel attached to the suction plate (Figures 4 and 5). The corner knob is removed with a grinder and the surface brushed free of all dust (Figure 6).

Figure 4. Attachment of vacuum (suction) plate

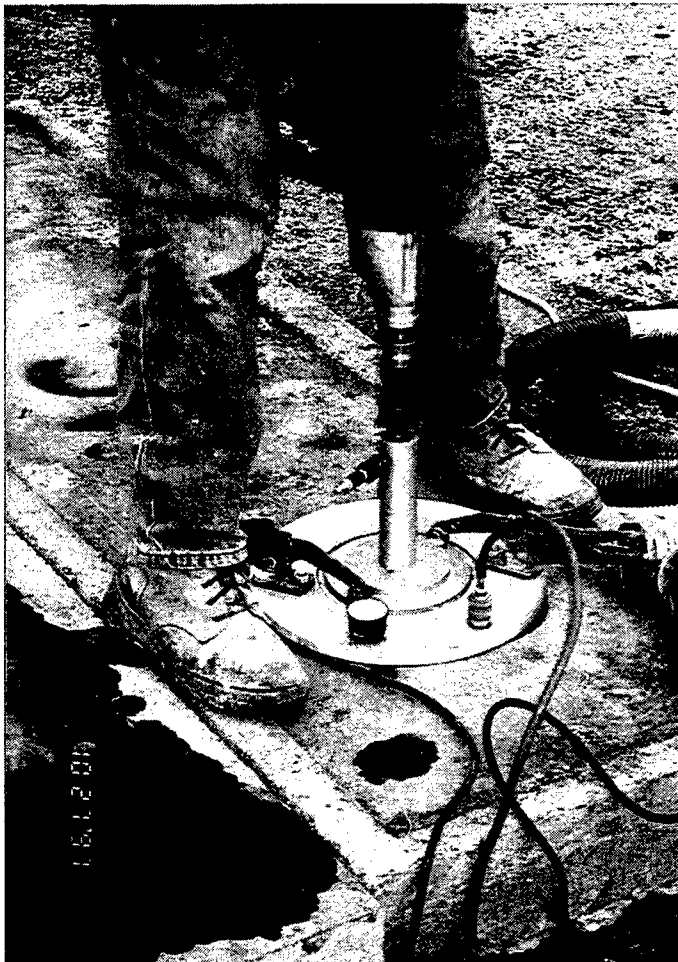
Figure 5. Repair surface grinding

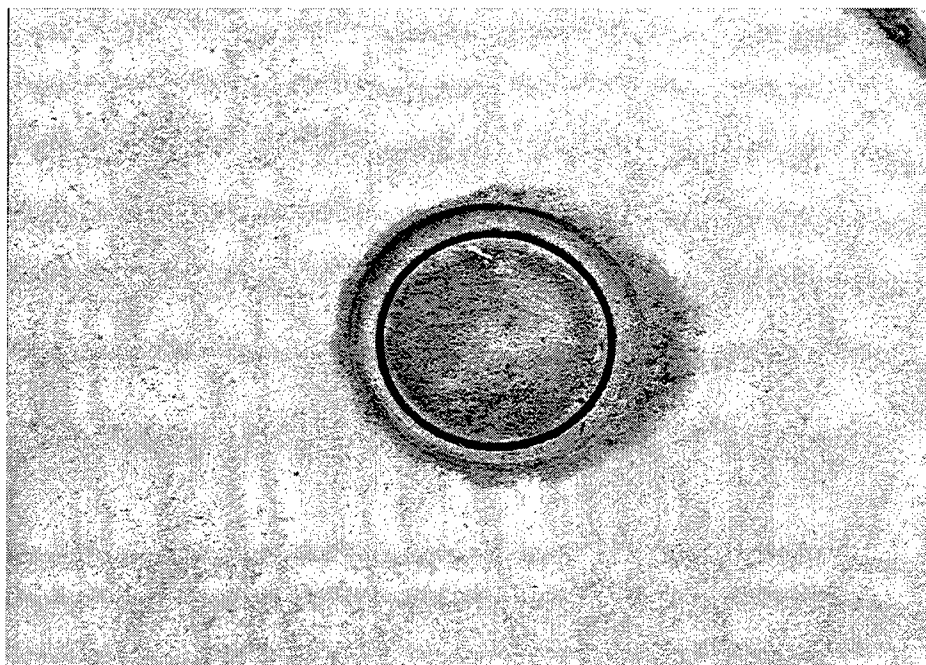
Figure 6. Typical ground surface of partial core

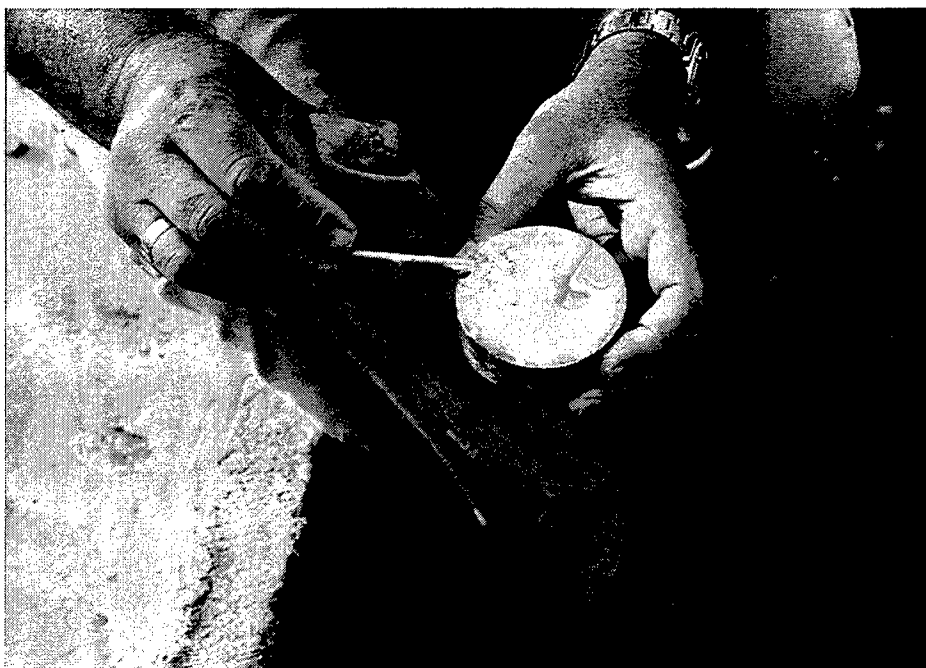
- b. A 75-mm (3-in.) diameter and 30-mm (1.2-in.) thick steel disc is applied with special fastsetting glue to the repair surface inside the suction plate by means of the centering plate and pressed firmly against the surface with the adjustable pliers (Figures 7 and 8).

Figure 7. Application of adhesive

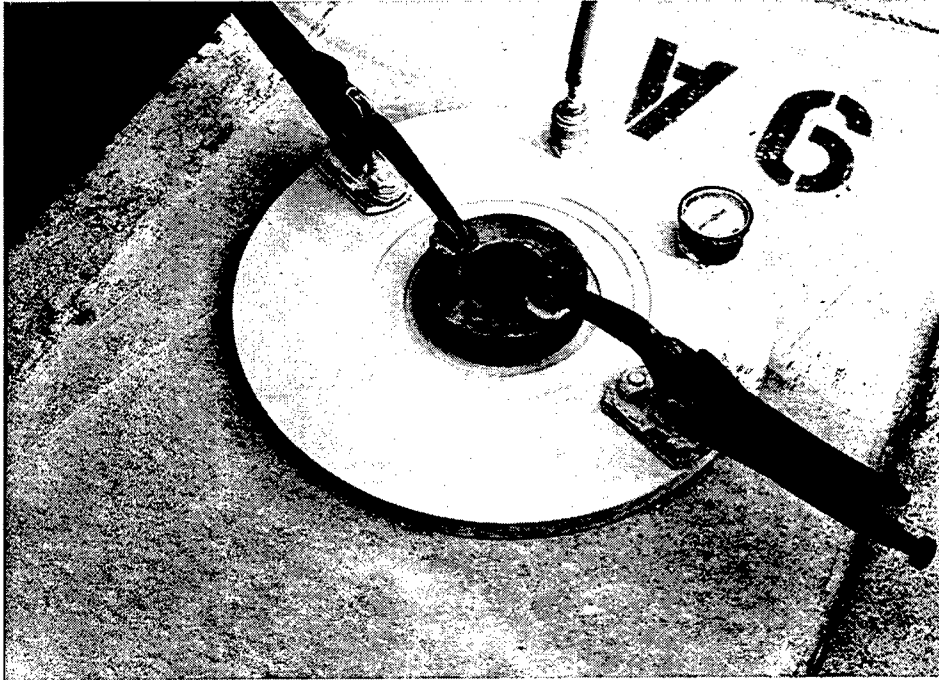
Figure 8. Attachment of steel disc to core surface

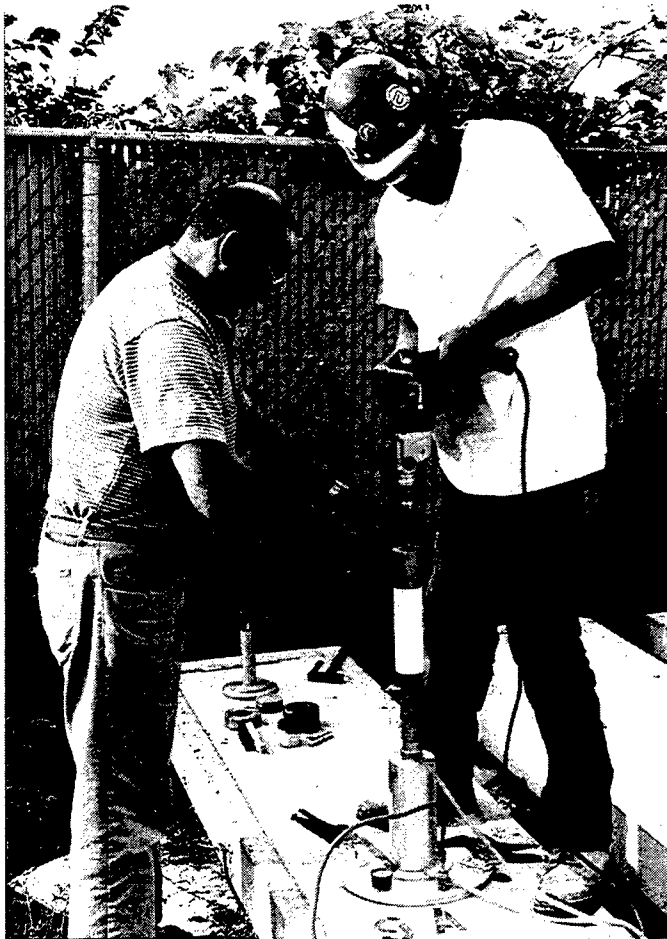
- c. The glue usually hardens in 2 to 5 min depending on ambient temperature.
- d. The corecase assembly is fitted around the disc and attached to the suction plate. Drilling takes place to the required depth (Figures 9 and 10).

Figure 9. Core drilling

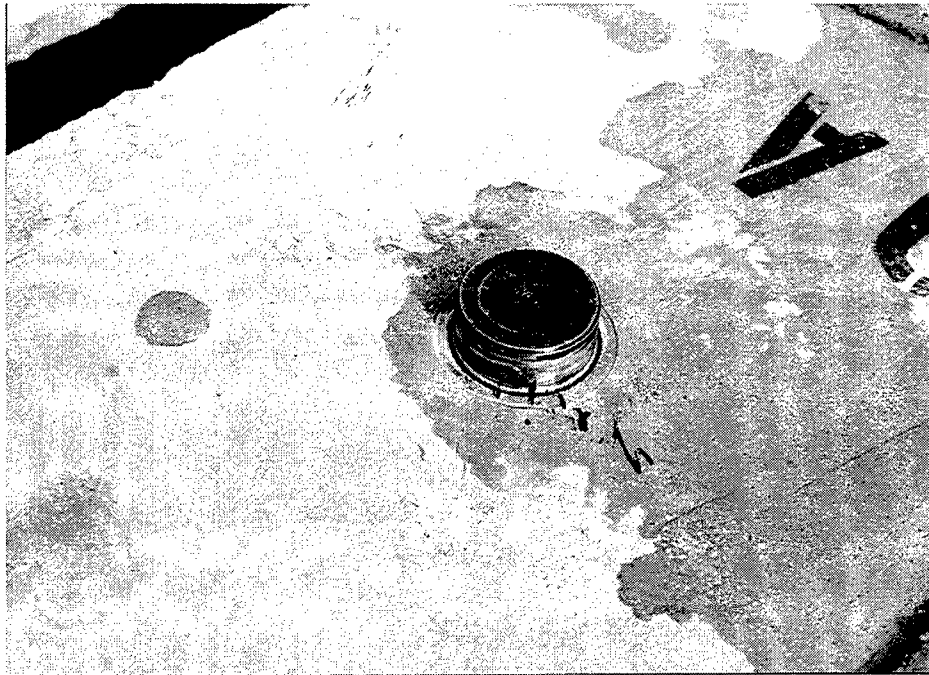
Figure 10. Partial core ready for testing

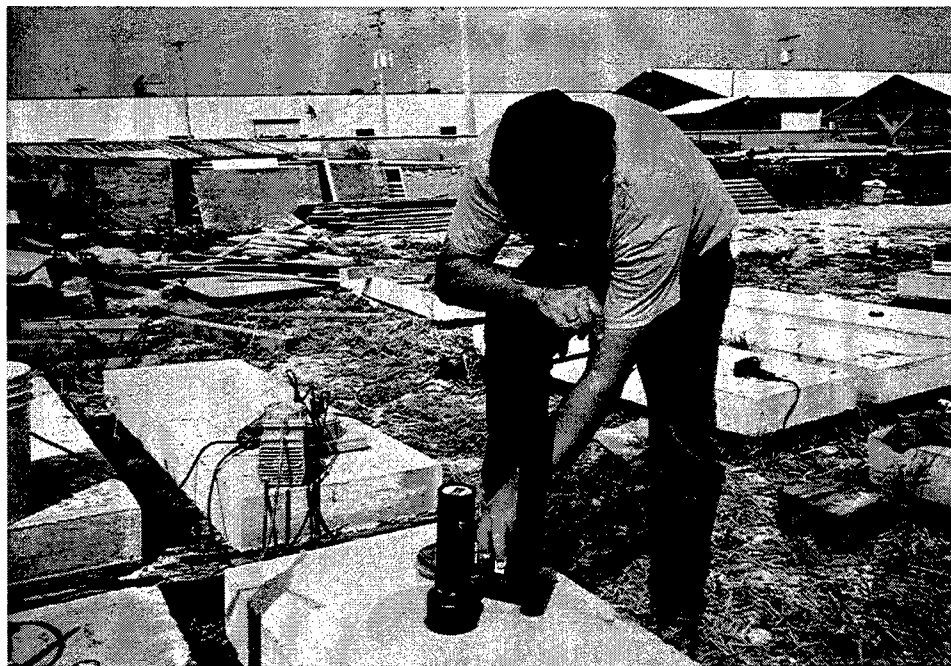
- e. The bond-test hydraulic apparatus is connected to the steel disc resting against the counterpressure frame and loaded by hand (Figure 11). Loading takes place with a constant loading rate to rupture the drilled core at the weakest location.

- f. The peak load is recorded to the nearest 0.1 kN (22.5 lb) and transformed to pull-off strength. The pull machine is equipped with an electronic Microprocessor Gauge.

Figure 11. Germann Instruments pull-off testing

According to the manufacturer, the Germann Instruments equipment allows the automatic application of load at a steady rate of 0.02 MPa (2.9 psi) per second with 0.2-percent accuracy. The peak value at failure is displayed, and test results are stored in the gauge's computer for subsequent printing with a personal computer.

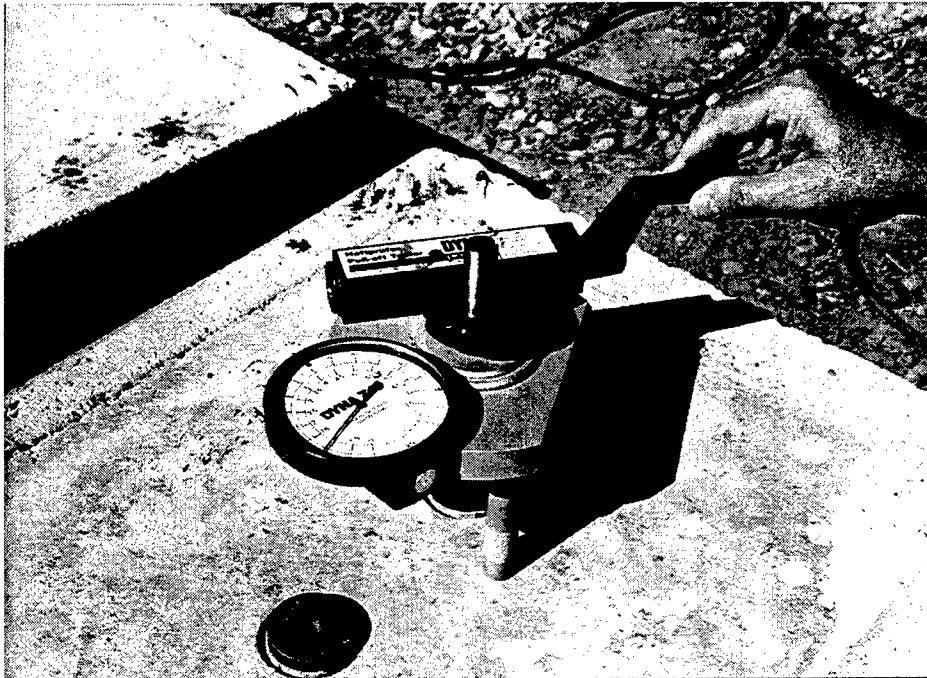
The apparatus is small, mobile (for use in any location), and has a mass of 3.5 kg (8 lb). The maximum tensile force is 16 kN. The pressure gauge has direct indication in kilonewtons and newtons per square millimetre. Scale graduations are 0.10 kN and 0.10 N/mm². The pressure gauge is equipped with a pointer that comes to rest when the specimen fractures.

The standing adjustable legs of the device can be shortened or lengthened to optimize the measurement to the test situation. This allows assurance that the pull-off takes place at right angles. The tester has an easy-running crank drive that allows for jerk-free increases in load. Testing with DYNA Z15 is shown in Figure 12.

Figure 12. Testing with Proceq DYNA Z15

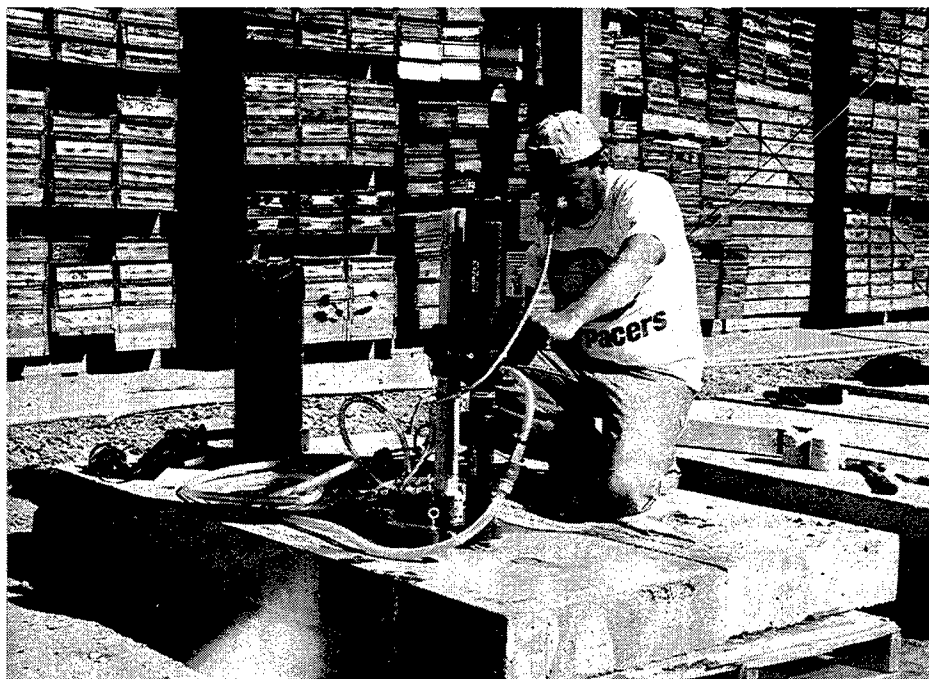
Drilling was accomplished with a Hilti core drilling machine using a 50-mm (2-in.) internal diameter bit (Figure 13). A 50-mm (2-in.) diam, 25-mm (1-in.) thick steel disc was secured to the surface of the core with a two-component epoxy adhesive. A Hilti HIT C-100 adhesive cartridge with a hand dispenser was used. The test disc was then pulled off with the DYNA pull-off tester (Figure 14).

Figure 13. Partial-depth core drilling for testing with DYNA and Hilti

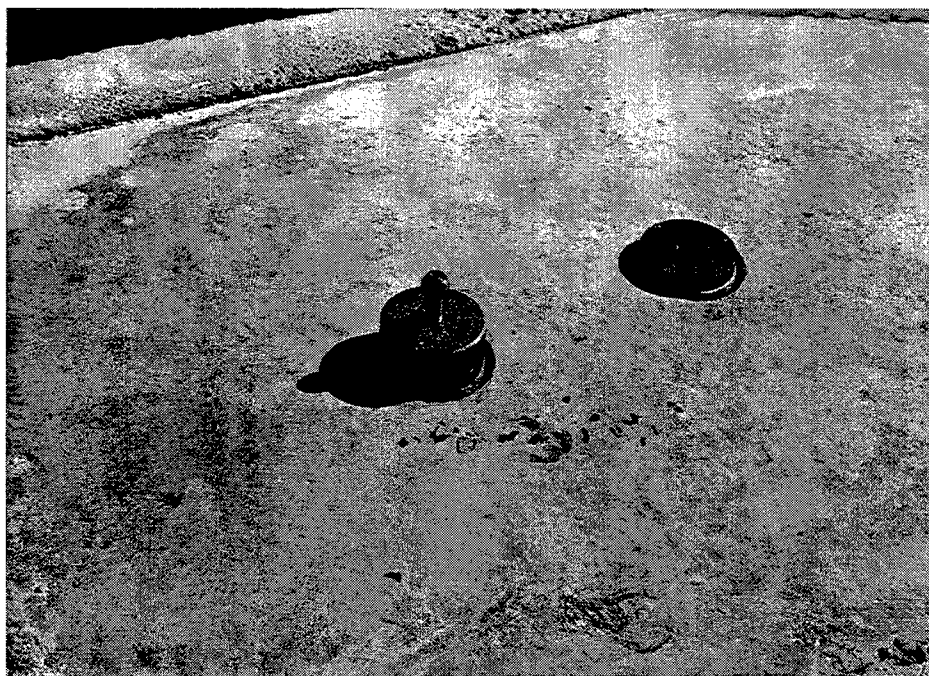
Figure 14. Partial-depth core (left) ready for testing with DYNA

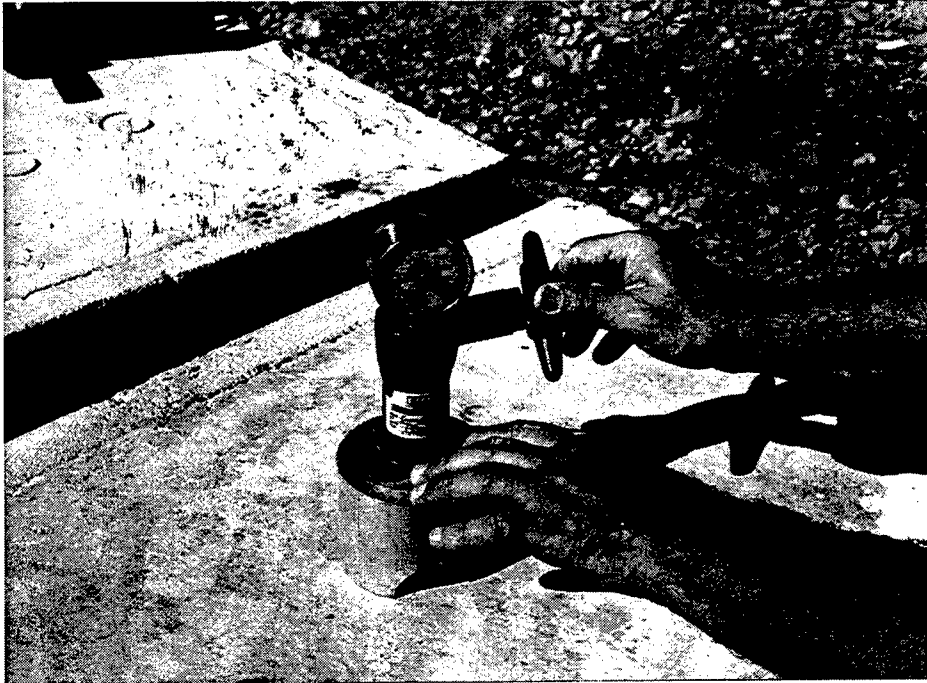
The Hilti tester is a special apparatus originally designed to measure the pull-out strength of embedded anchors. The apparatus was modified by Structural Preservation Systems, Inc., to measure pull-off bond strengths (Figure 15).

Figure 15. Testing with Hilti tester

The tester has a maximum tensioning force of 8.9 kN (2,000 lb), with gauge scale graduation to 89 kN (20 lb). The device is small, lightweight, and mobile to use in any location. It has an inconvenient hand-wheel drive that does not allow for uniform load increase. It is not equipped with any devices to position it at a right angle to the surface.

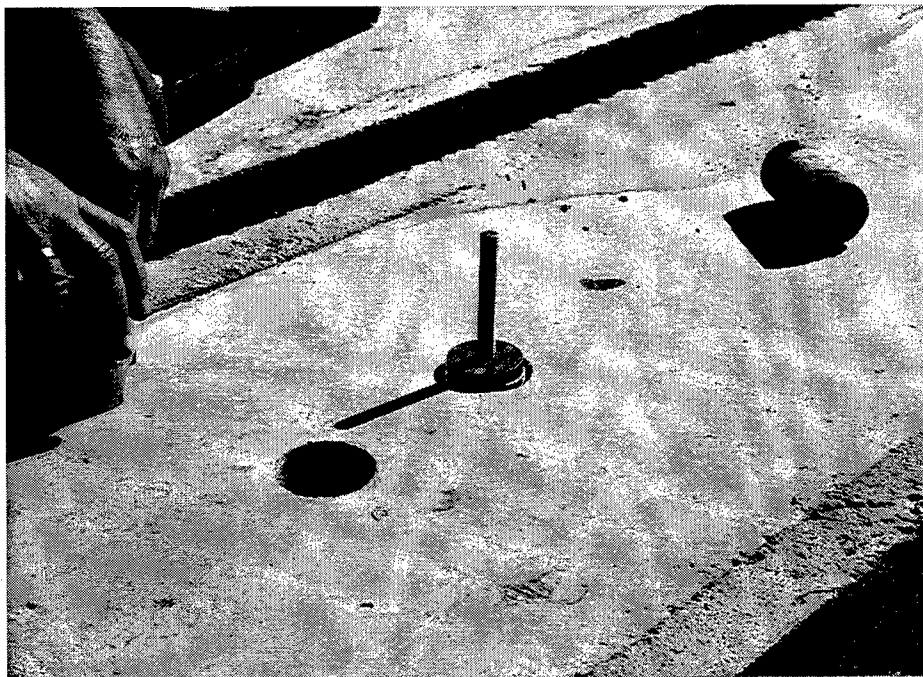
Figure 16. Partial-depth core ready for testing with Hilti tester

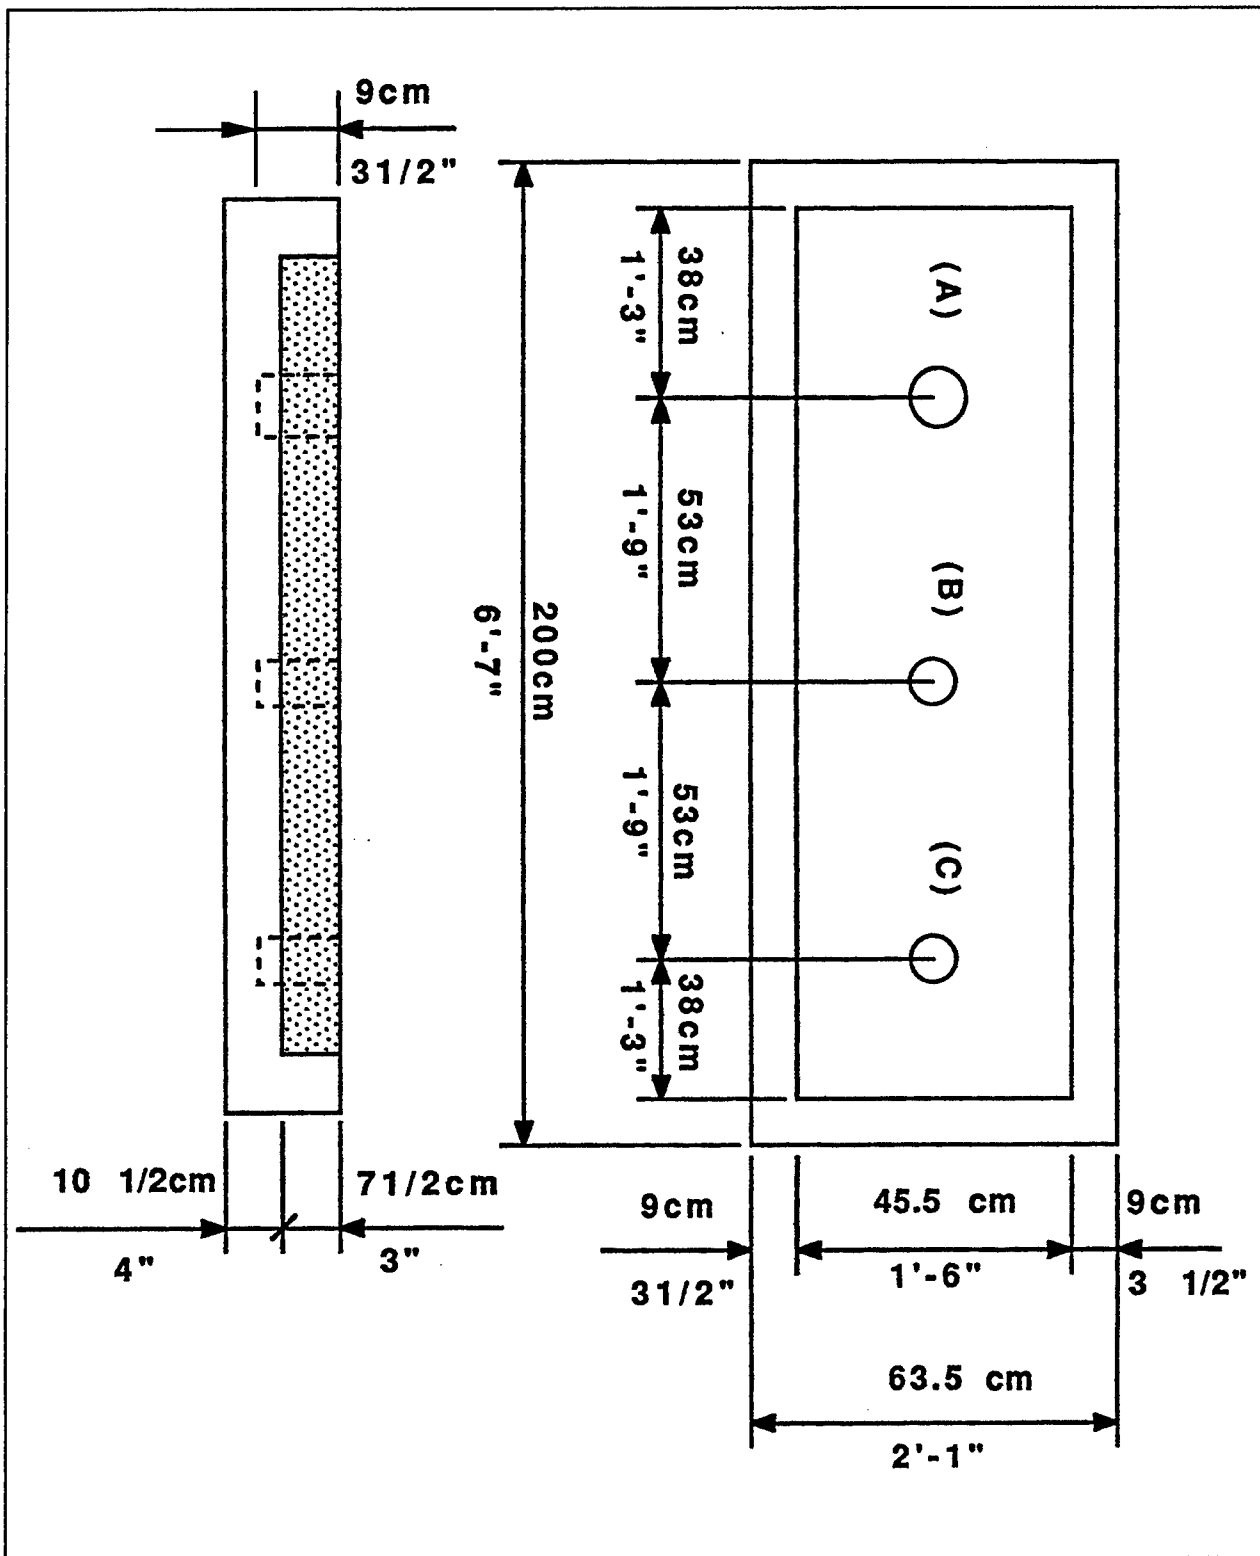
In this test series, two 50-mm (2-in.) diam and one 75-mm (3-in.) diam partial cores, 89 mm (3.5 in.) deep, were drilled 13 mm (0.5 in.) below the repair-substrate interface in each experimental repair slab (Figure 17).

Figure 17. Location of 75-mm (3-in.) and 50-mm (2-in.) diam cores used for pull-off tests

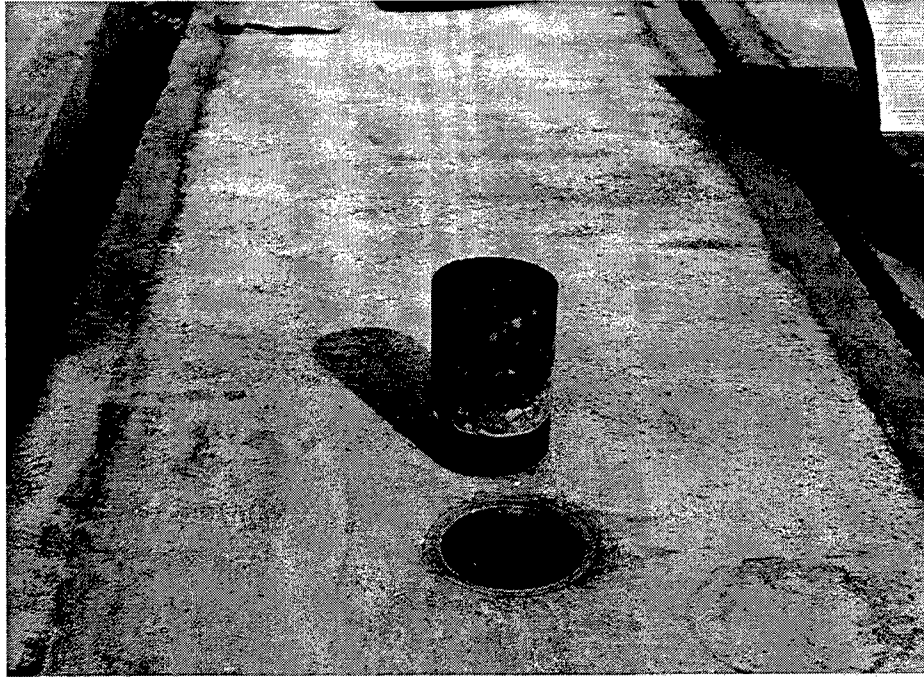
Figure 21. Failure at repair-substrate interface

The average test results for each material, mode of failure for each specimen, and standard deviation and coefficient of variation (COV) between the three pull-off tests for the same material performed by each testing device are presented in Tables 2-10. Examples of different modes of failure are shown in Figures 21-24.

An analysis of the modes of failure demonstrates that in the 239 tests performed in this series, 98 failures (41 percent) occurred in the concrete substrate, 61 failures (26 percent) occurred at the repair-substrate interface, 49 failures (20 percent) occurred in the repair material, and 31 failures (13 percent) occurred at the steel disc-repair interface. Of the 31 failures at the steel disc-repair interface, 22 failures occurred within the epoxy adhesive at bond strengths in excess of 1.4 MPa (200 psi).

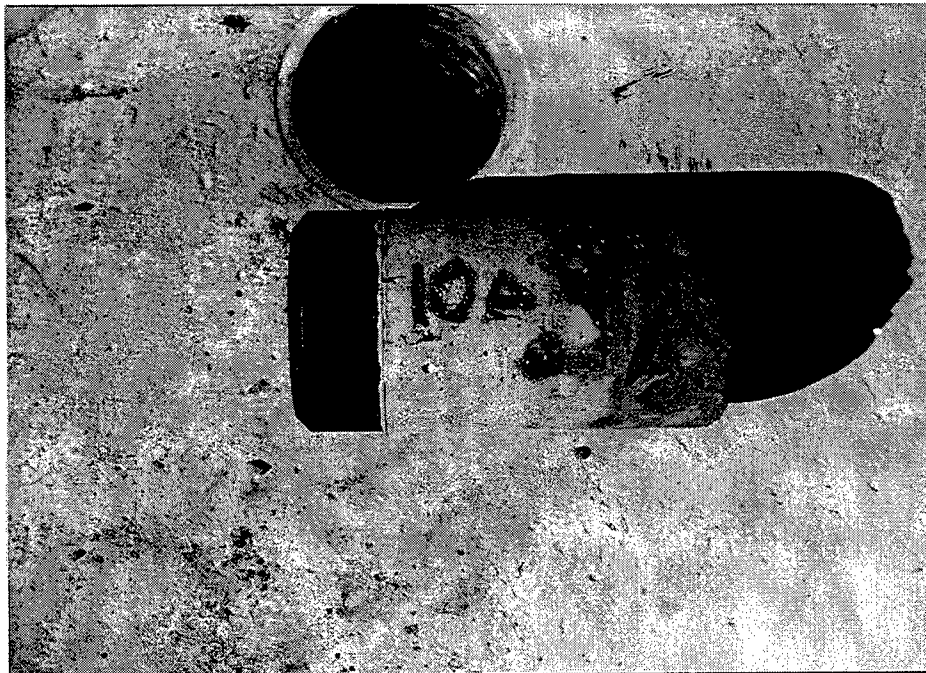
Figure 22. Failure in substrate concrete

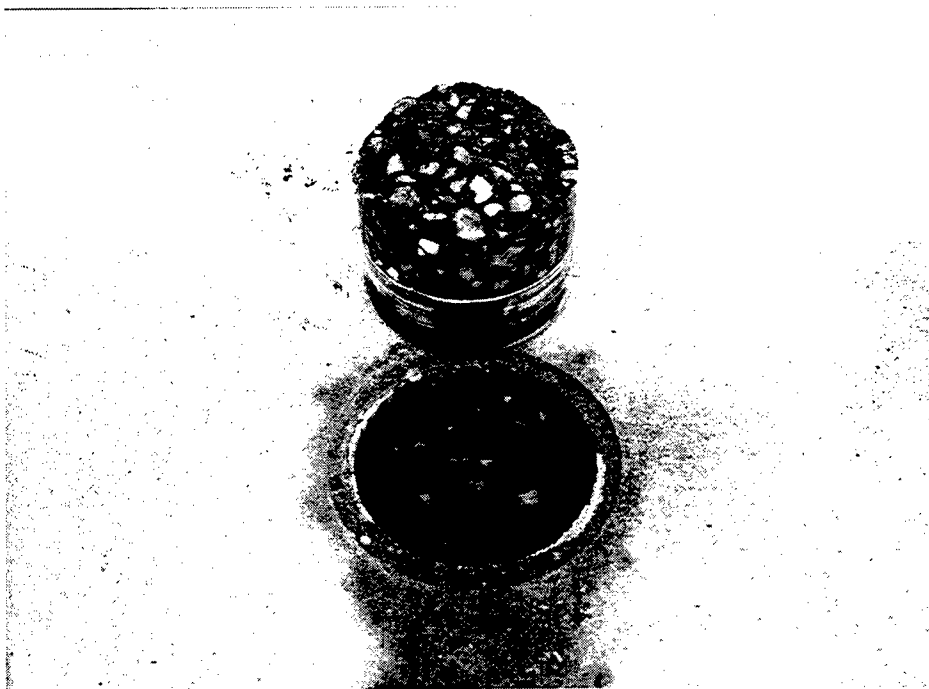
Figure 23. Failure in repair material

Two of the materials exhibited a relatively high number of failures in the repair. In 27 tests on Material No. 3, 21 failures (78 percent) occurred in the repair material. All failures in the repair material occurred at stresses significantly lower than the material's tensile strength of 3.5 MPa (513 psi) determined in laboratory tests. In 27 tests on Material No. 8, 13 failures (48 percent) occurred in the repair material. These failures in the repair material occurred at stresses significantly higher than the material's tensile strength of 1.5 MPa (215 psi) determined in laboratory tests.

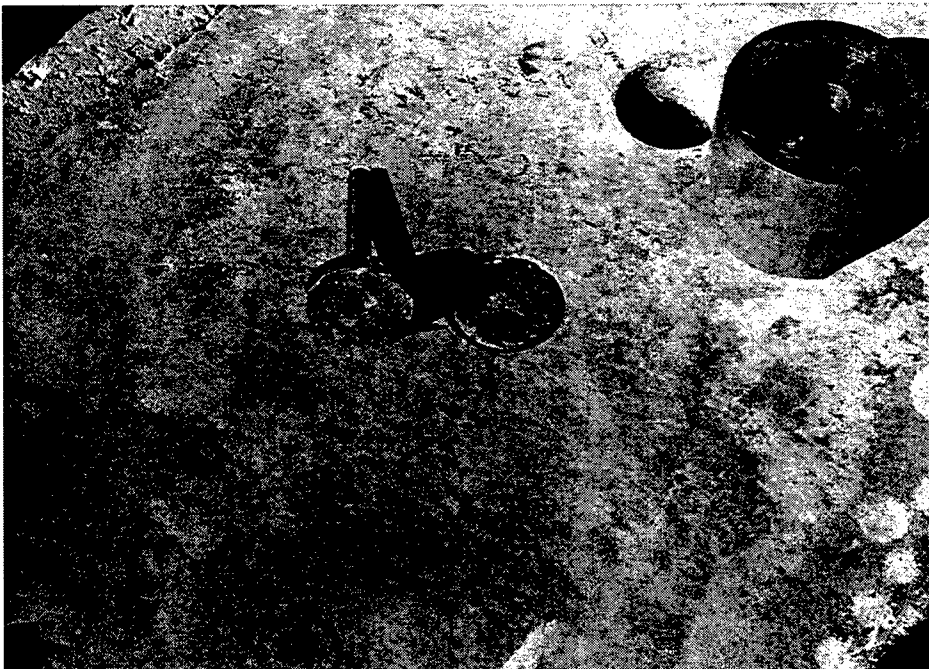
Figure 24. Failure at disc-repair interface

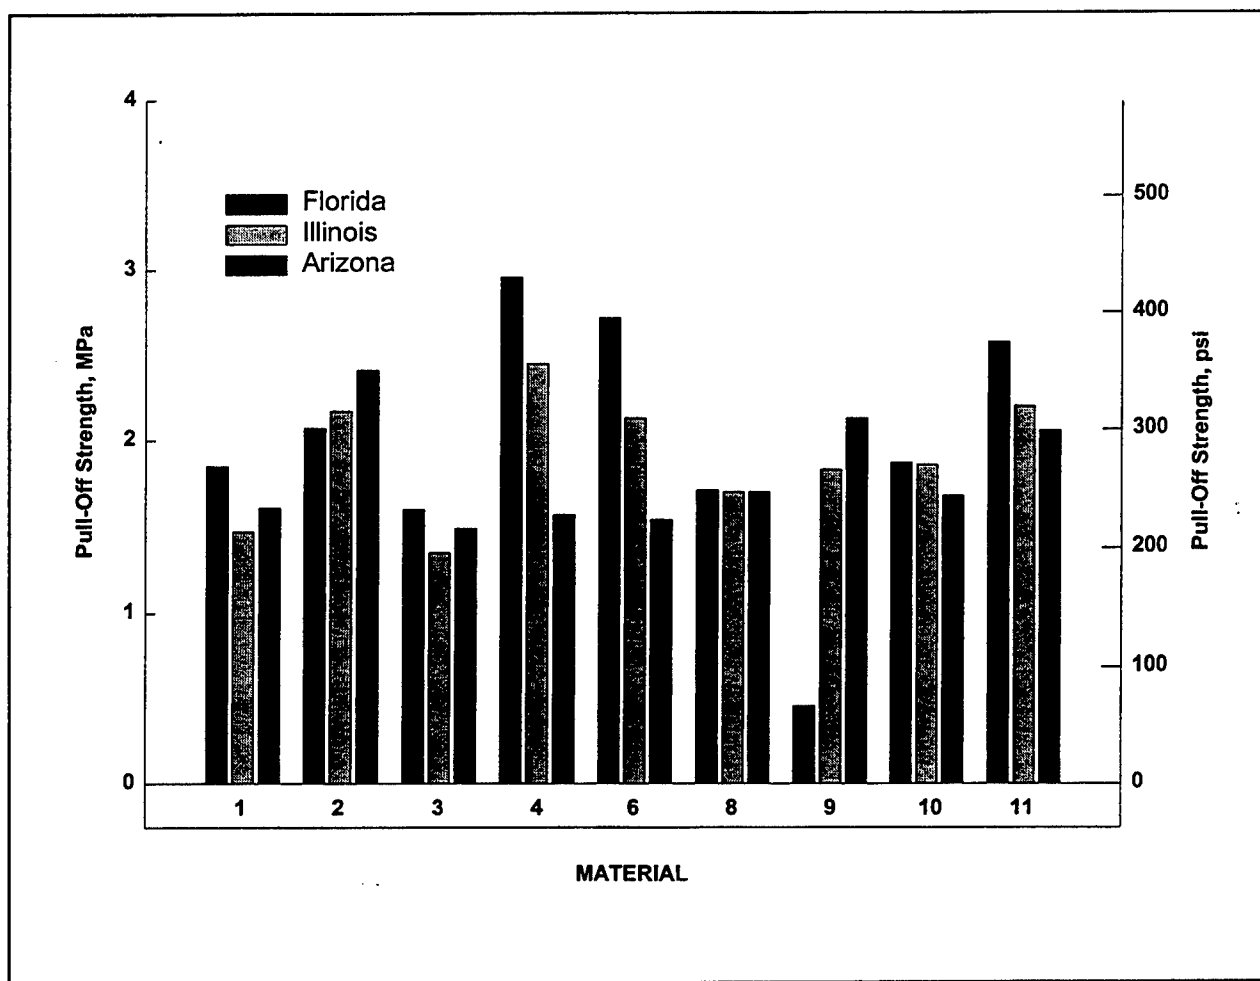
Figure 25. Effect of environment on pull-off strength of experimental repairs

The analysis of the test results indicates that exposure conditions did not affect the failure mode, nor did the exposure conditions affect the pull-off strength which is to be expected, because the majority of failures occurred in the concrete substrate.

The average pull-off strengths for all test sites ranged from 1.5 to 2.3 MPa (215 to 341 psi) with an overall average strength of 2.0 MPa (284 psi). Four materials (Nos. 2, 4, 6, 11) exhibited an average tensile bond strength in excess of 2.1 MPa (300 psi).

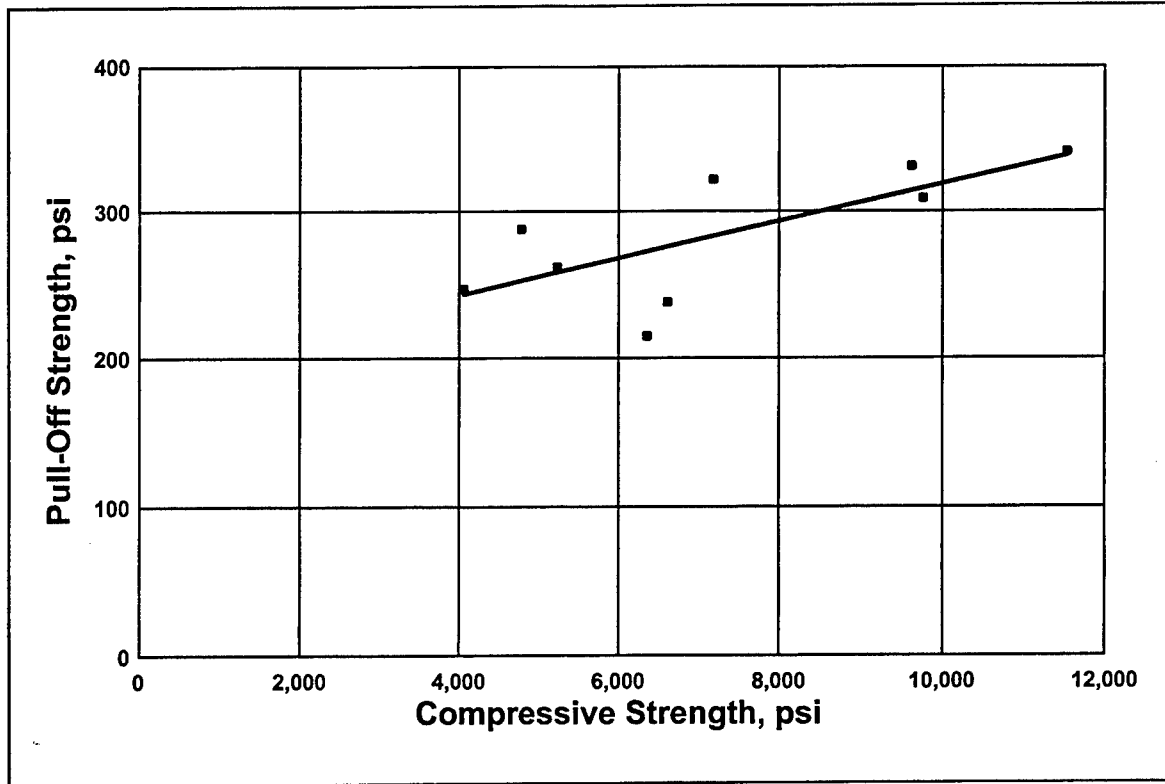
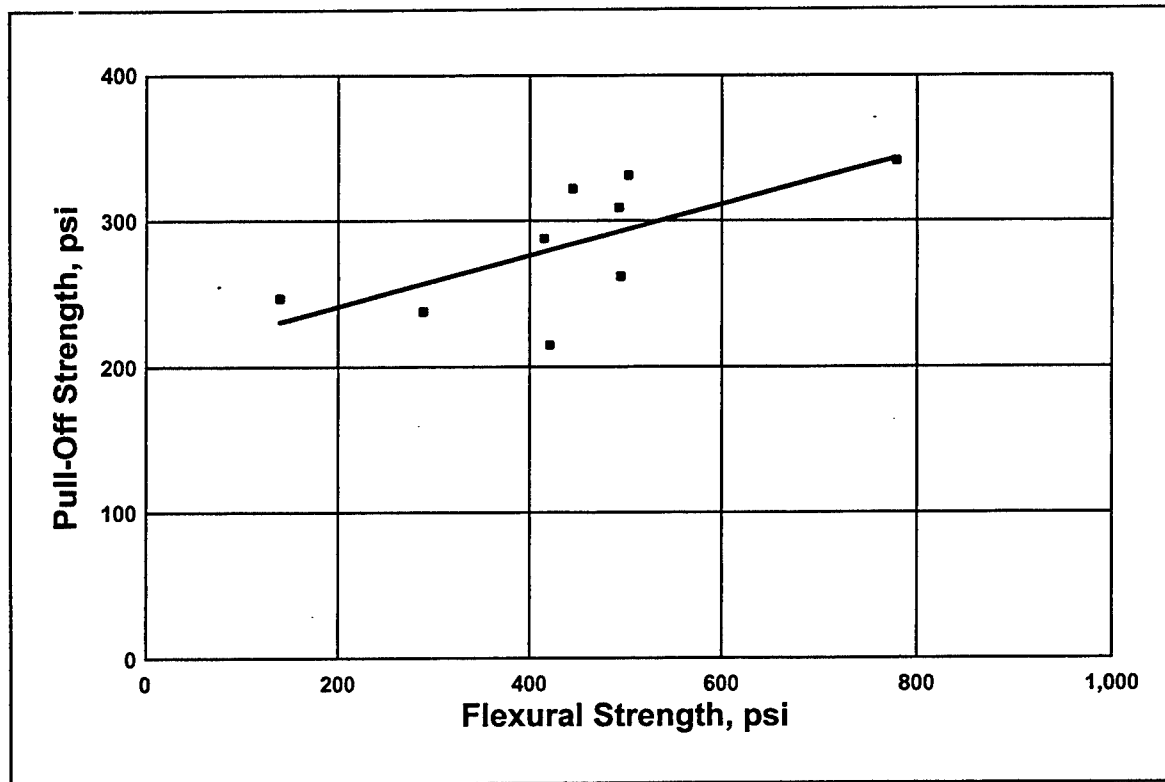
a. Compressive strength

b. Flexural strength

Figure 26. Correlation between results of laboratory strength tests and field pull-off tests

bond strength. However, results of this study indicate that there was a general correlation between higher compressive and flexural strengths, as determined in the laboratory, and increased pull-off strengths in field tests (Figure 26). In contrast, the overall trend was for decreased pull-off strengths with increased tensile strength. Excluding one material (No. 3), there was a significant correlation between the results of laboratory tensile tests and field pull-off tests (Figure 27).

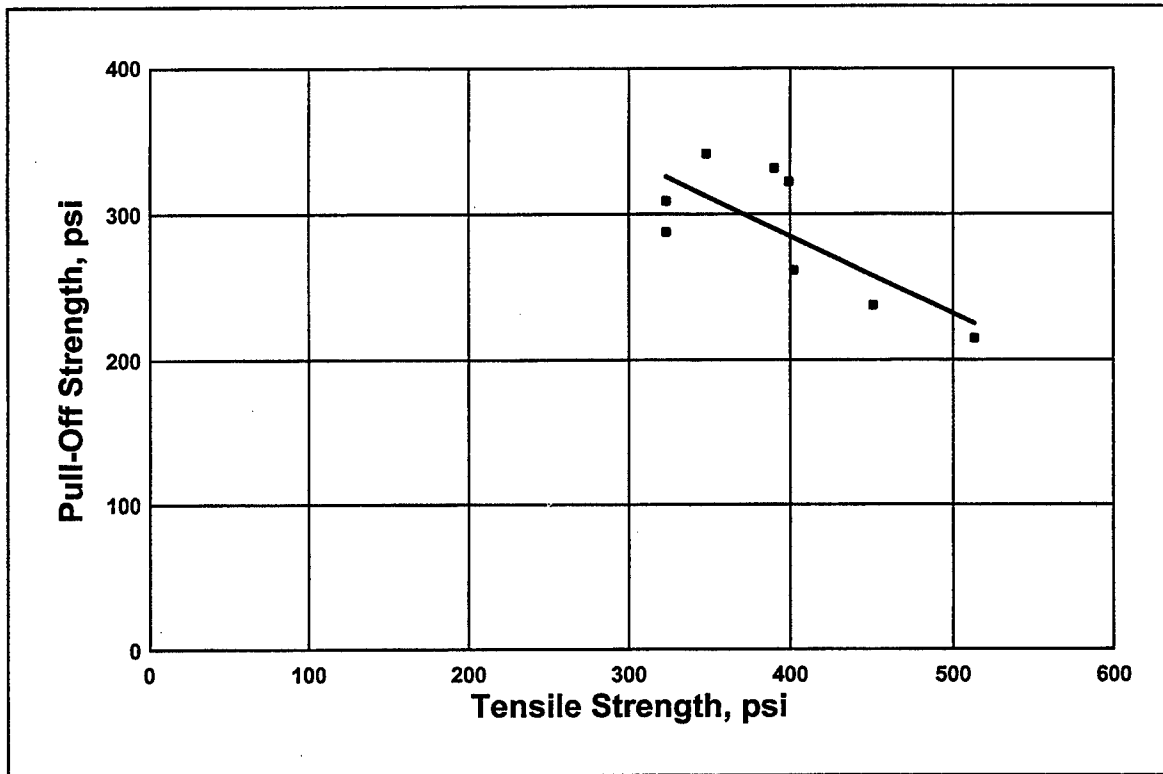
Figure 27. Correlation between results of laboratory tensile strength tests and field pull-off tests
