Technical Report REMR-CS-61
June 1999

An Evaluation of Equipment and Procedures for Tensile Bond Testing of Concrete Repairs

*by Alexander M. Vaysburd, Structural Preservation Systems, Inc.
James E. McDonald, WES*

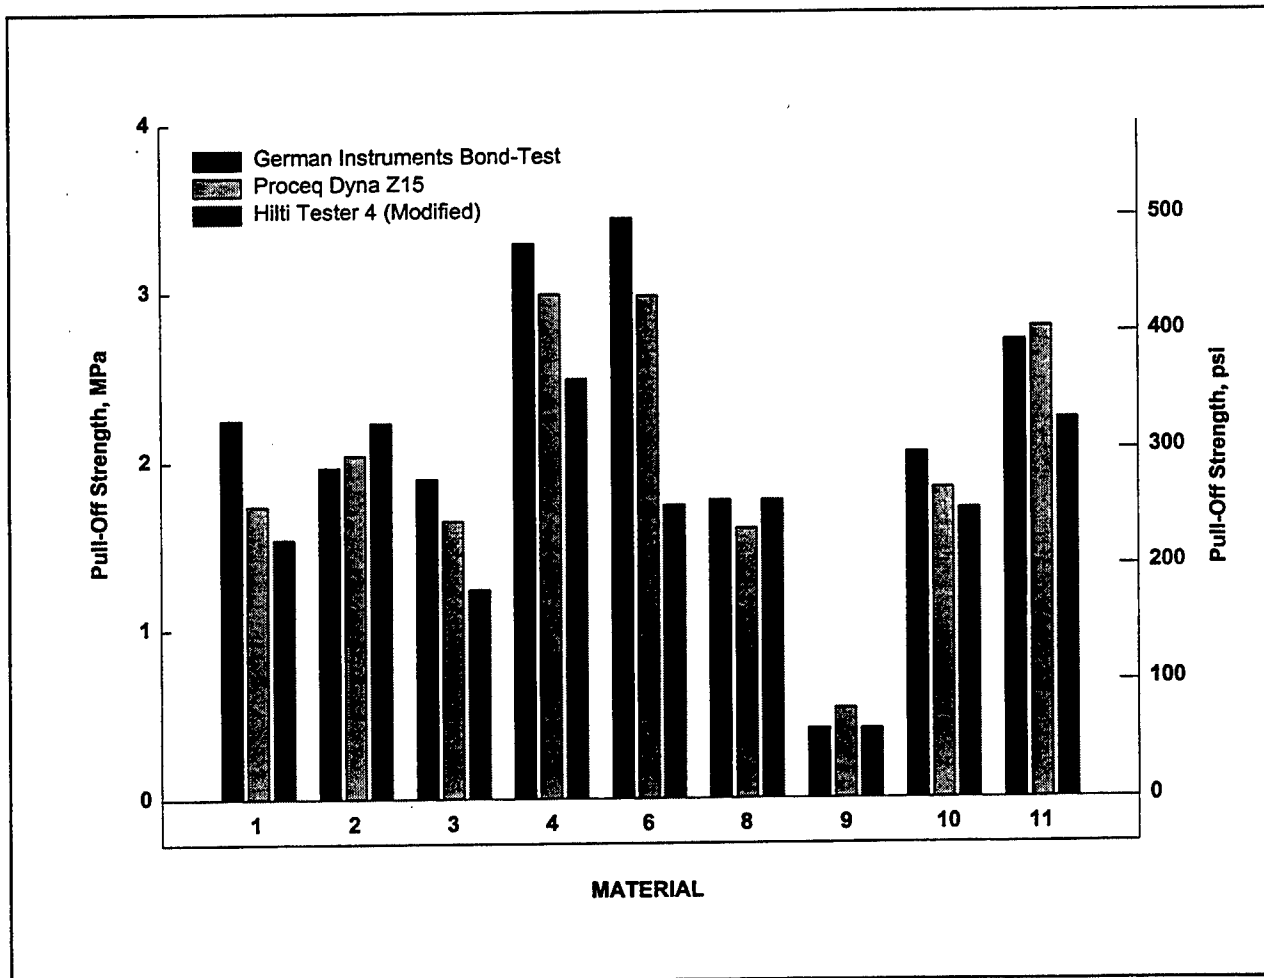
Figure 28. Effect of apparatus on pull-off strength of experimental repairs in Florida

The average pull-off strength for the repair materials as measured by each testing device in Florida, Illinois, and Arizona is presented in Figures 28-30. The summary of the performance analysis for each testing device is presented in Table 19 and Figure 31.

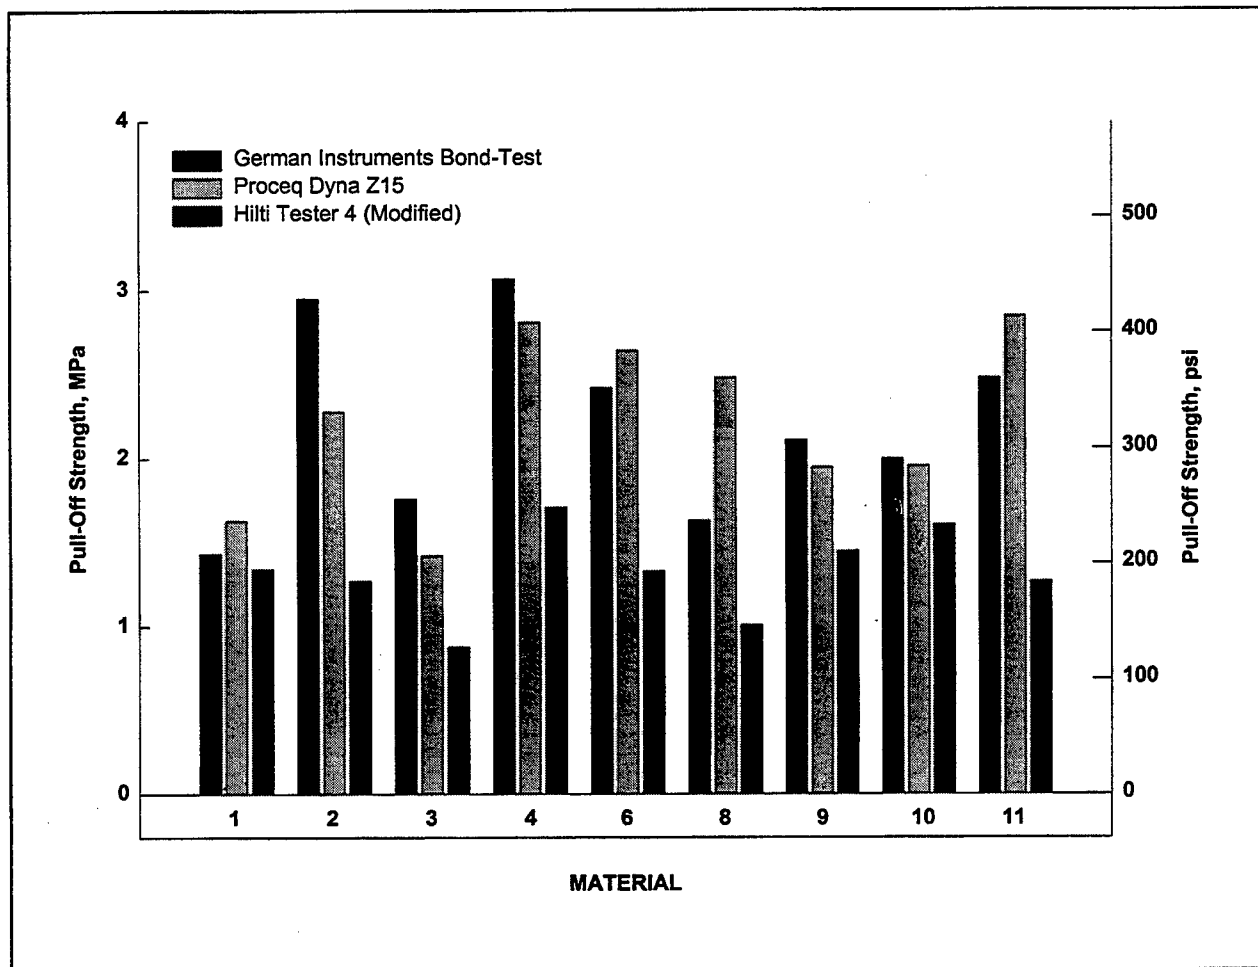
Figure 29. Effect of apparatus on pull-off strength of experimental repairs in Illinois

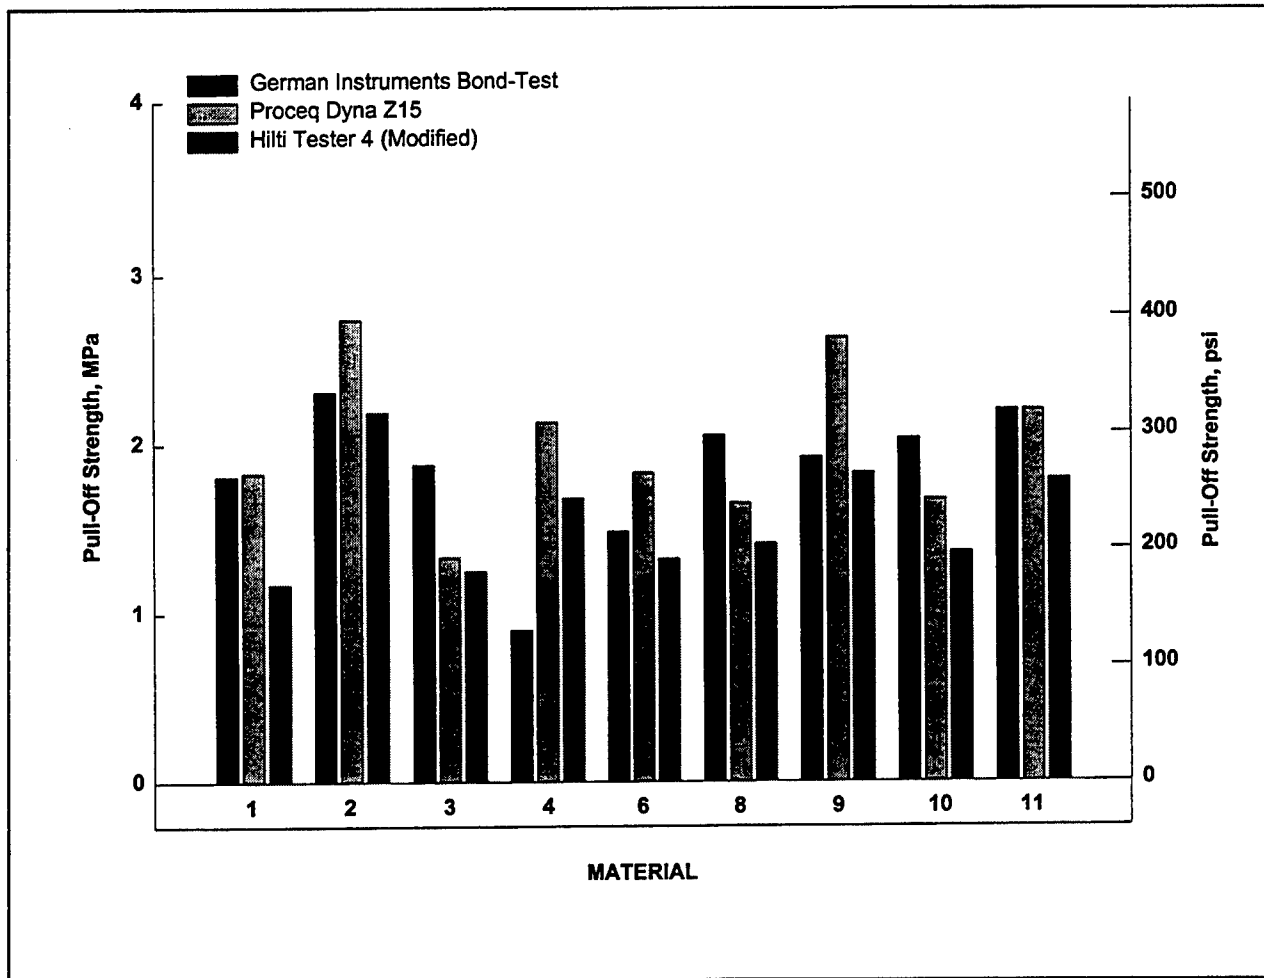
Figure 30. Effect of apparatus on pull-off strength of experimental repairs in Arizona

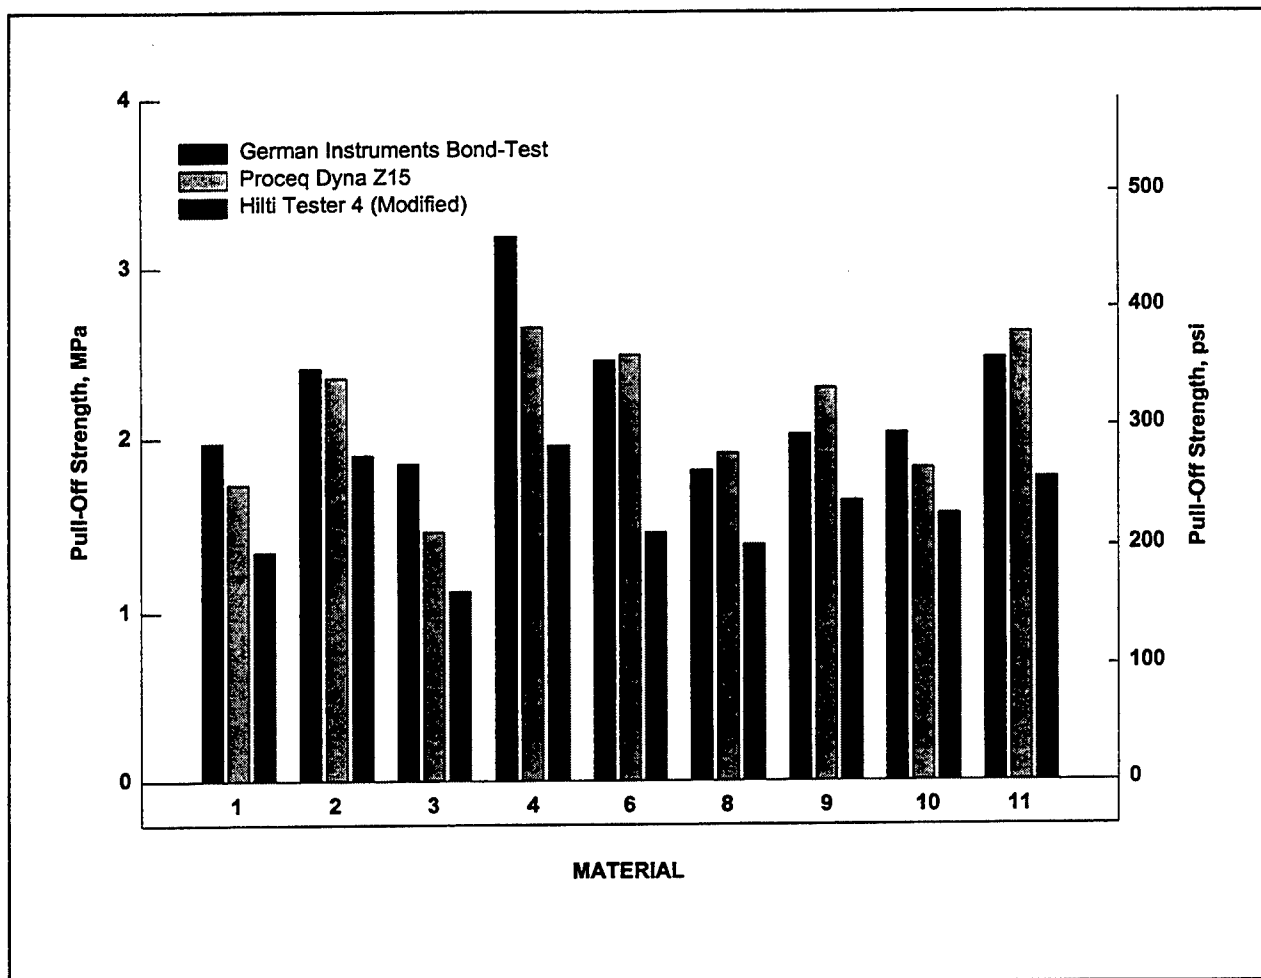
Figure 31. Average of pull-off strengths of experimental repairs tested by different apparatuses at three testing sites

Because the GI test results are relatively more precise and consistent, these test results are used as standards against which the other devices are compared (strength ratios in Tables 12-14).

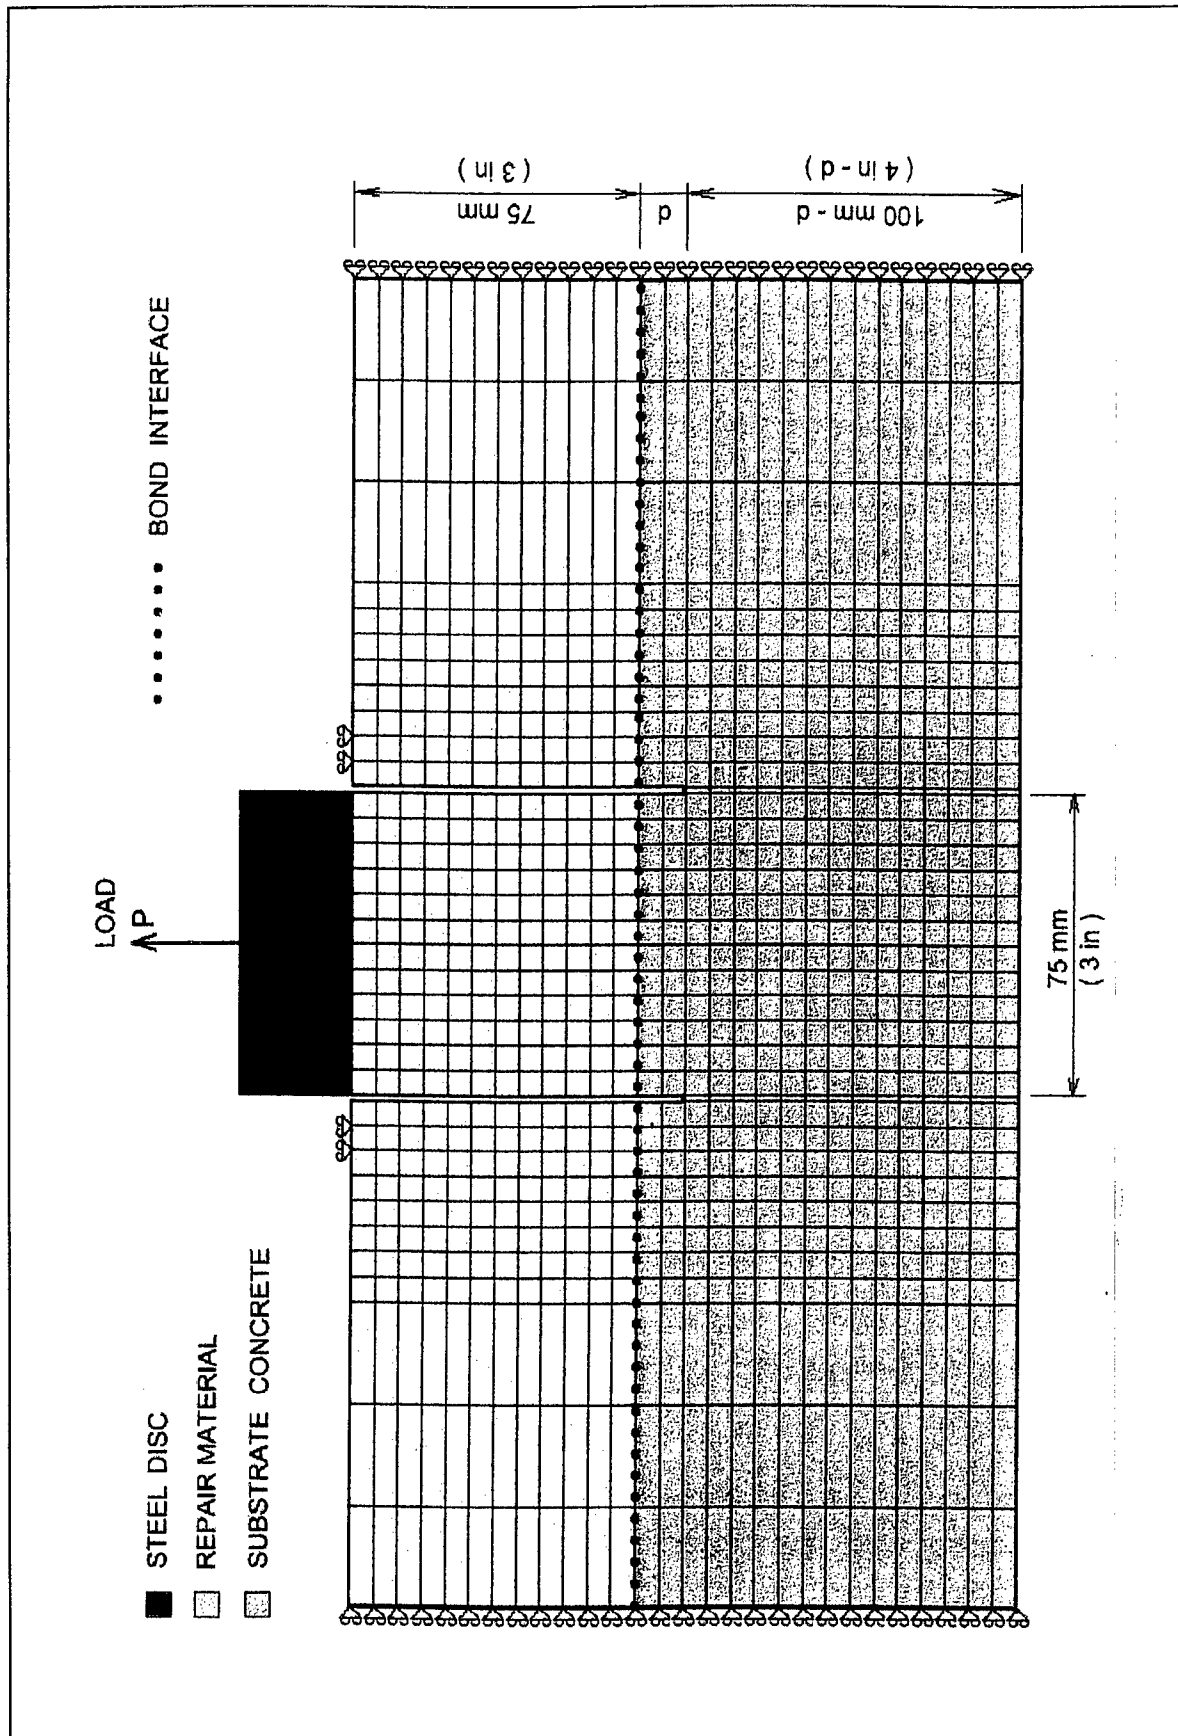
The theoretical analysis was based on the idealized assumption of a linear isotropic solid model. The 27 partial cores tested were modeled in finite elements using STAAD III Software. All specimens were modeled in a two-dimensional, 6.35-mm (0.25-in.) thick slice along the specimen (Figure 32). The model consists

Figure 32. Typical finite-element mesh

of 1,125 joints and 1,028 elements. The differences in partial coring depth (d) were modeled by adding or removing elements.

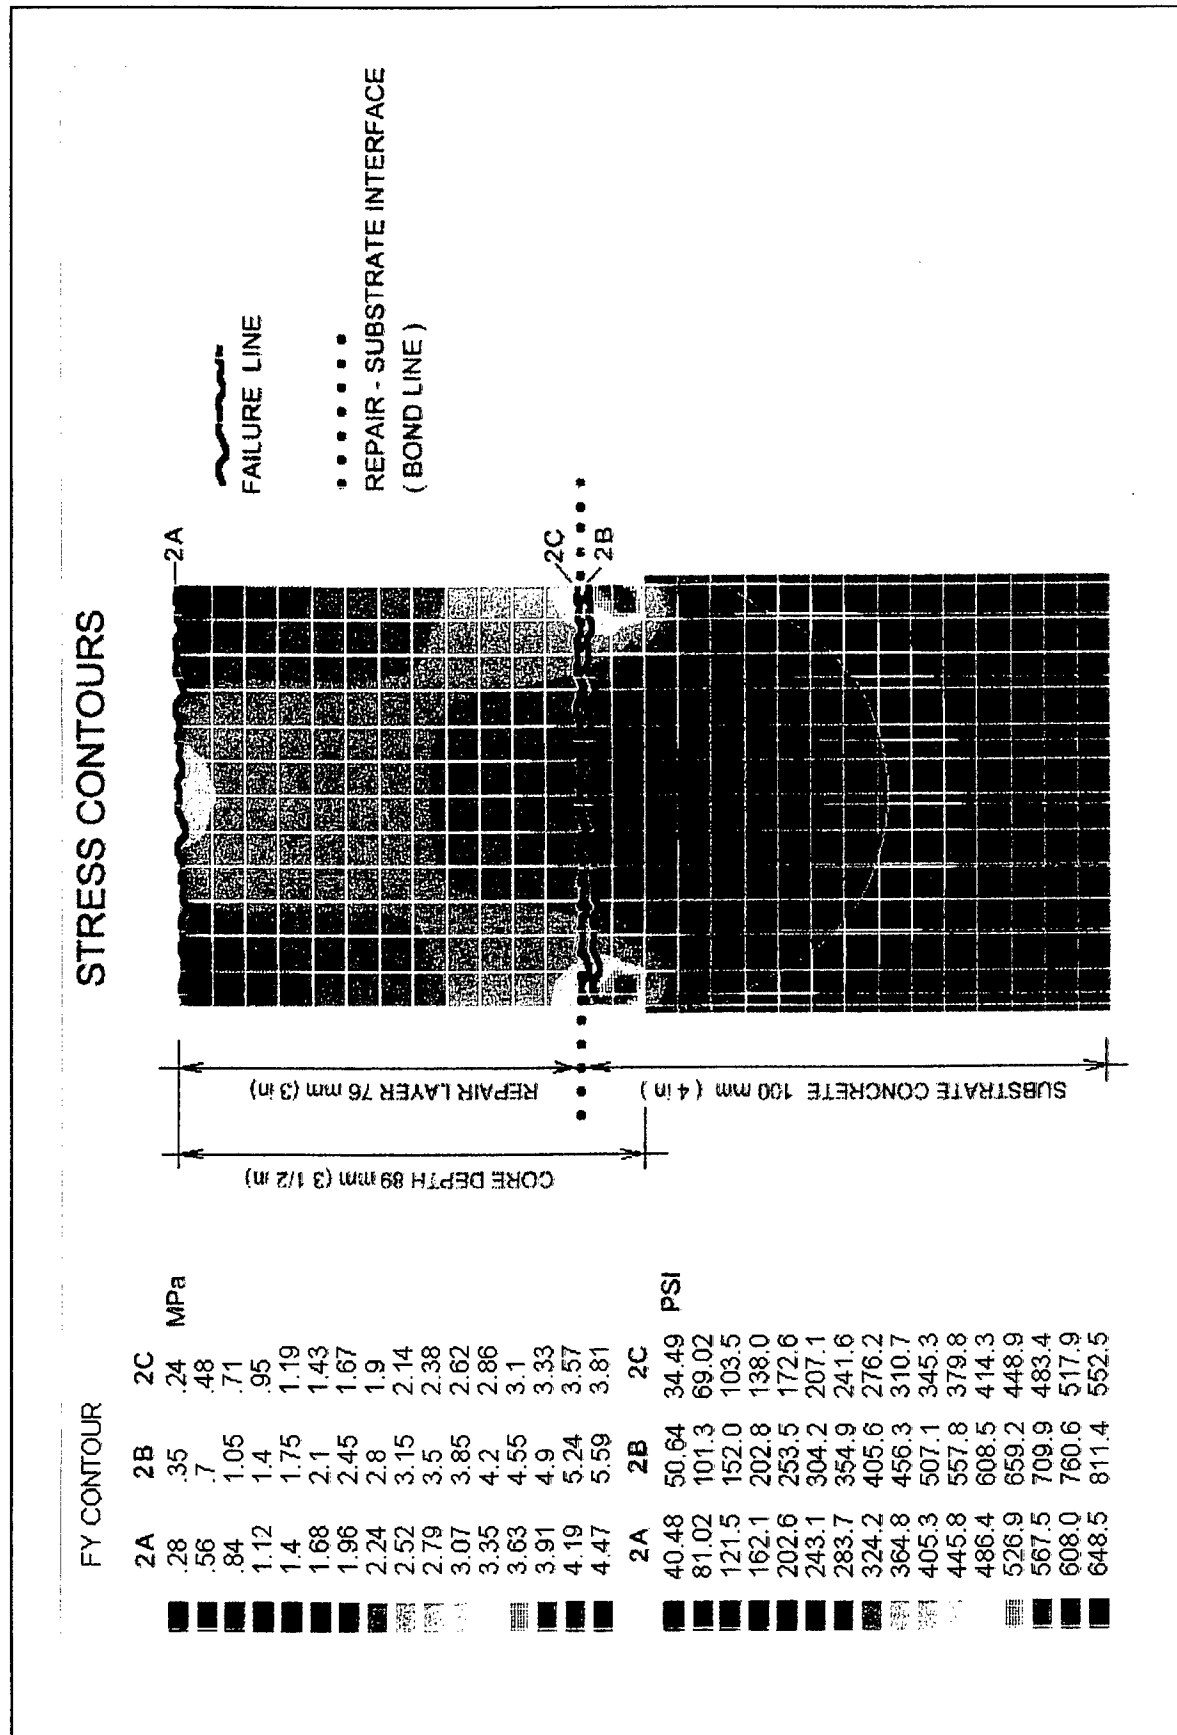
Figure 33. Stress contours—Material No. 2, core depth 89 mm (3-5 in.)

Results of the theoretical analysis demonstrates that the shallow depth of core drilling below the bond line puts the bond interface close to the zone of maximum stress concentrations at the bottom of the core, which corresponds to lower failure loads. In the pull-off bond test, deeper drilling into the substrate reduced stress concentrations at the bond interface and increased the measured bond strength.

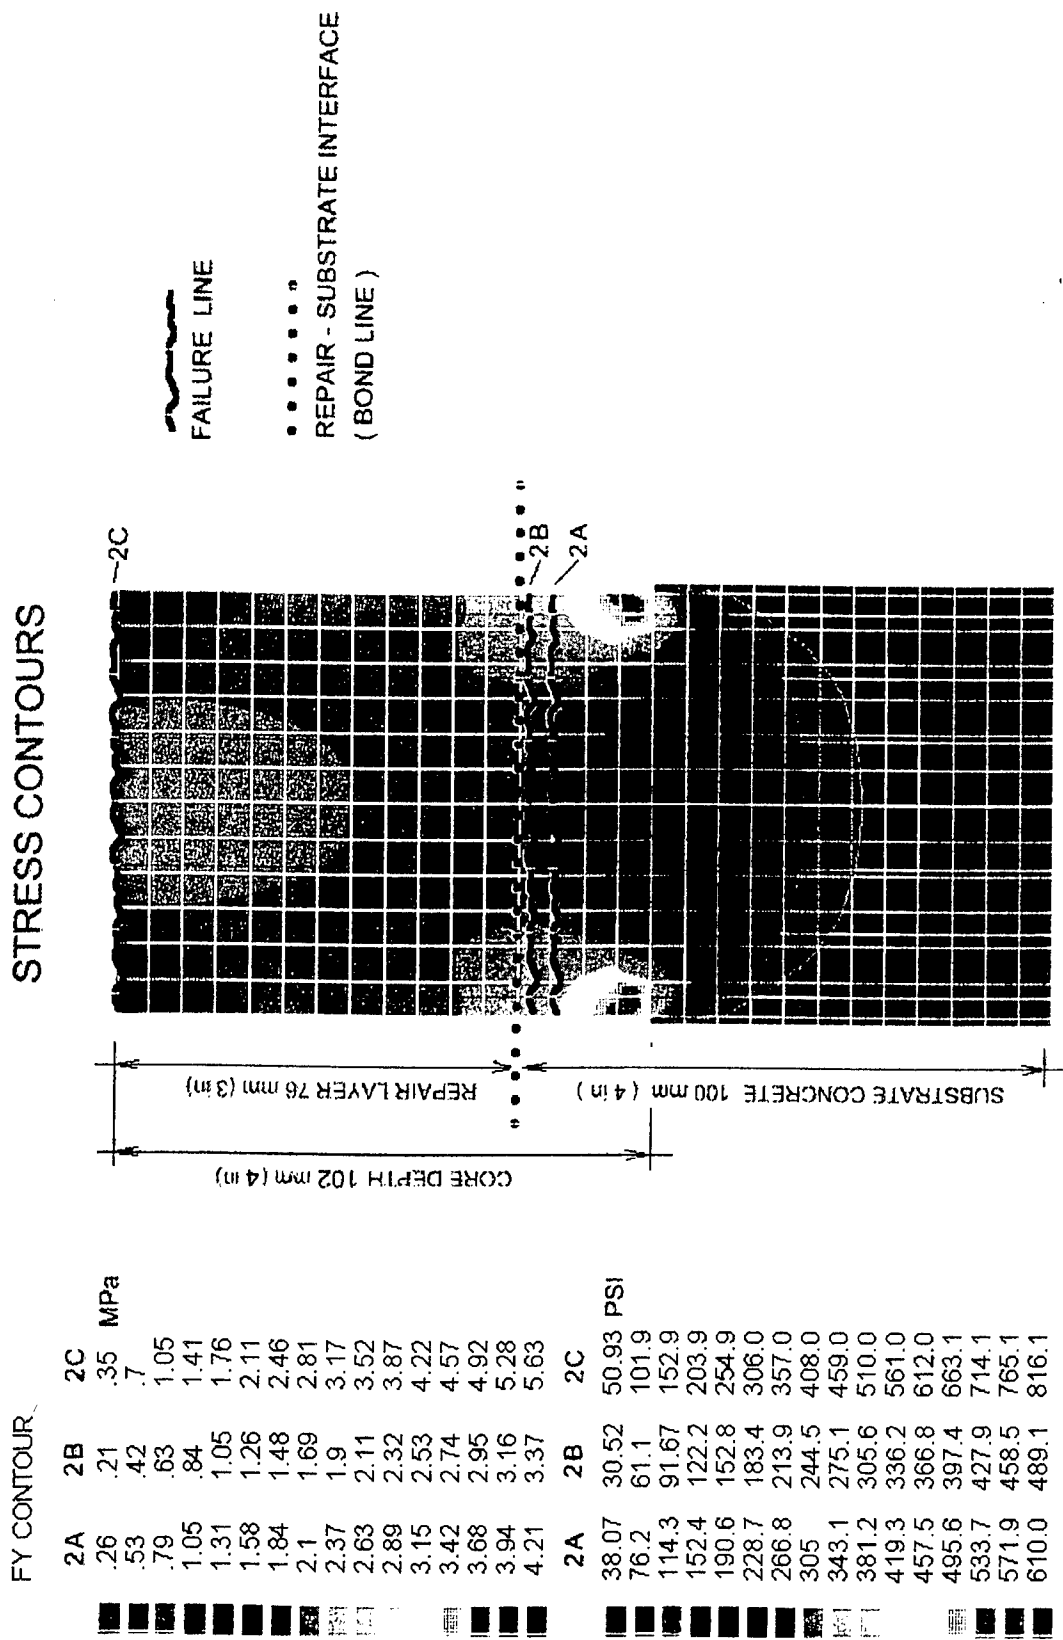
Figure 34. Stress contours—Material No. 2, core depth 101 mm (4 in.)

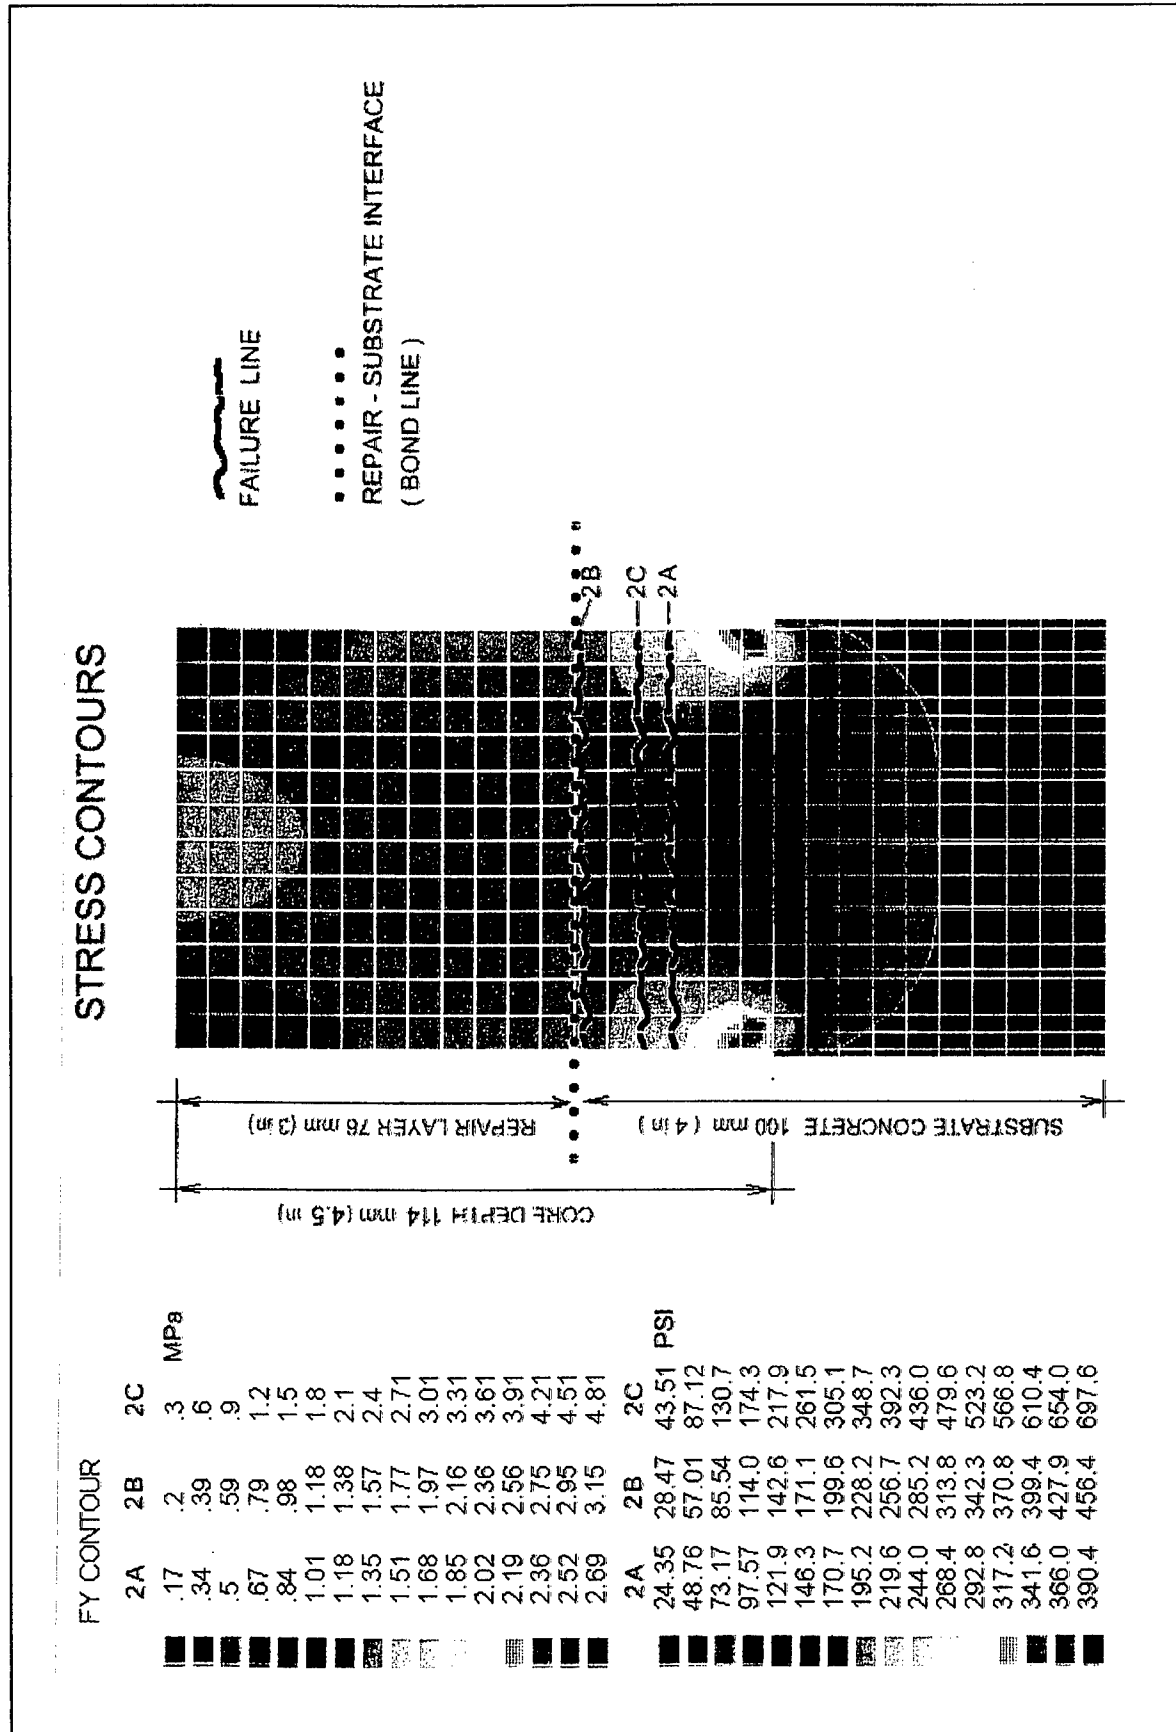
Figure 35. Stress contours—Material No. 2, core depth 114 mm (4.5 in.)

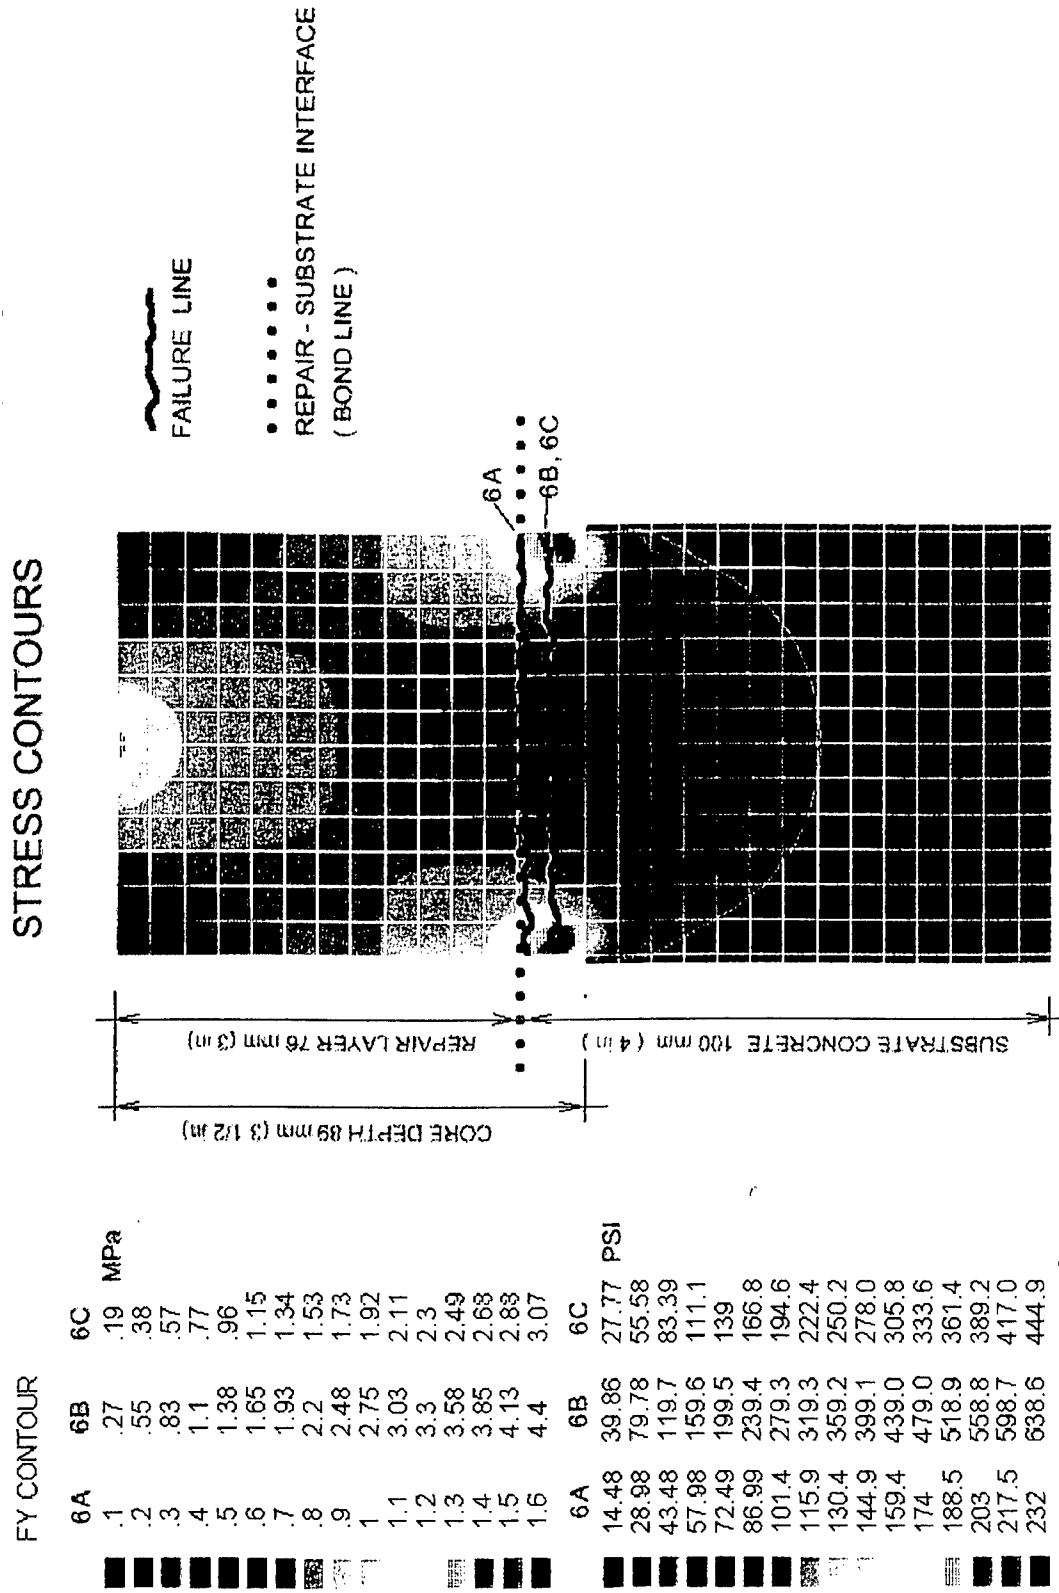
Figure 36. Stress contours—Material No. 6, core depth 89 mm (3.5 in.)

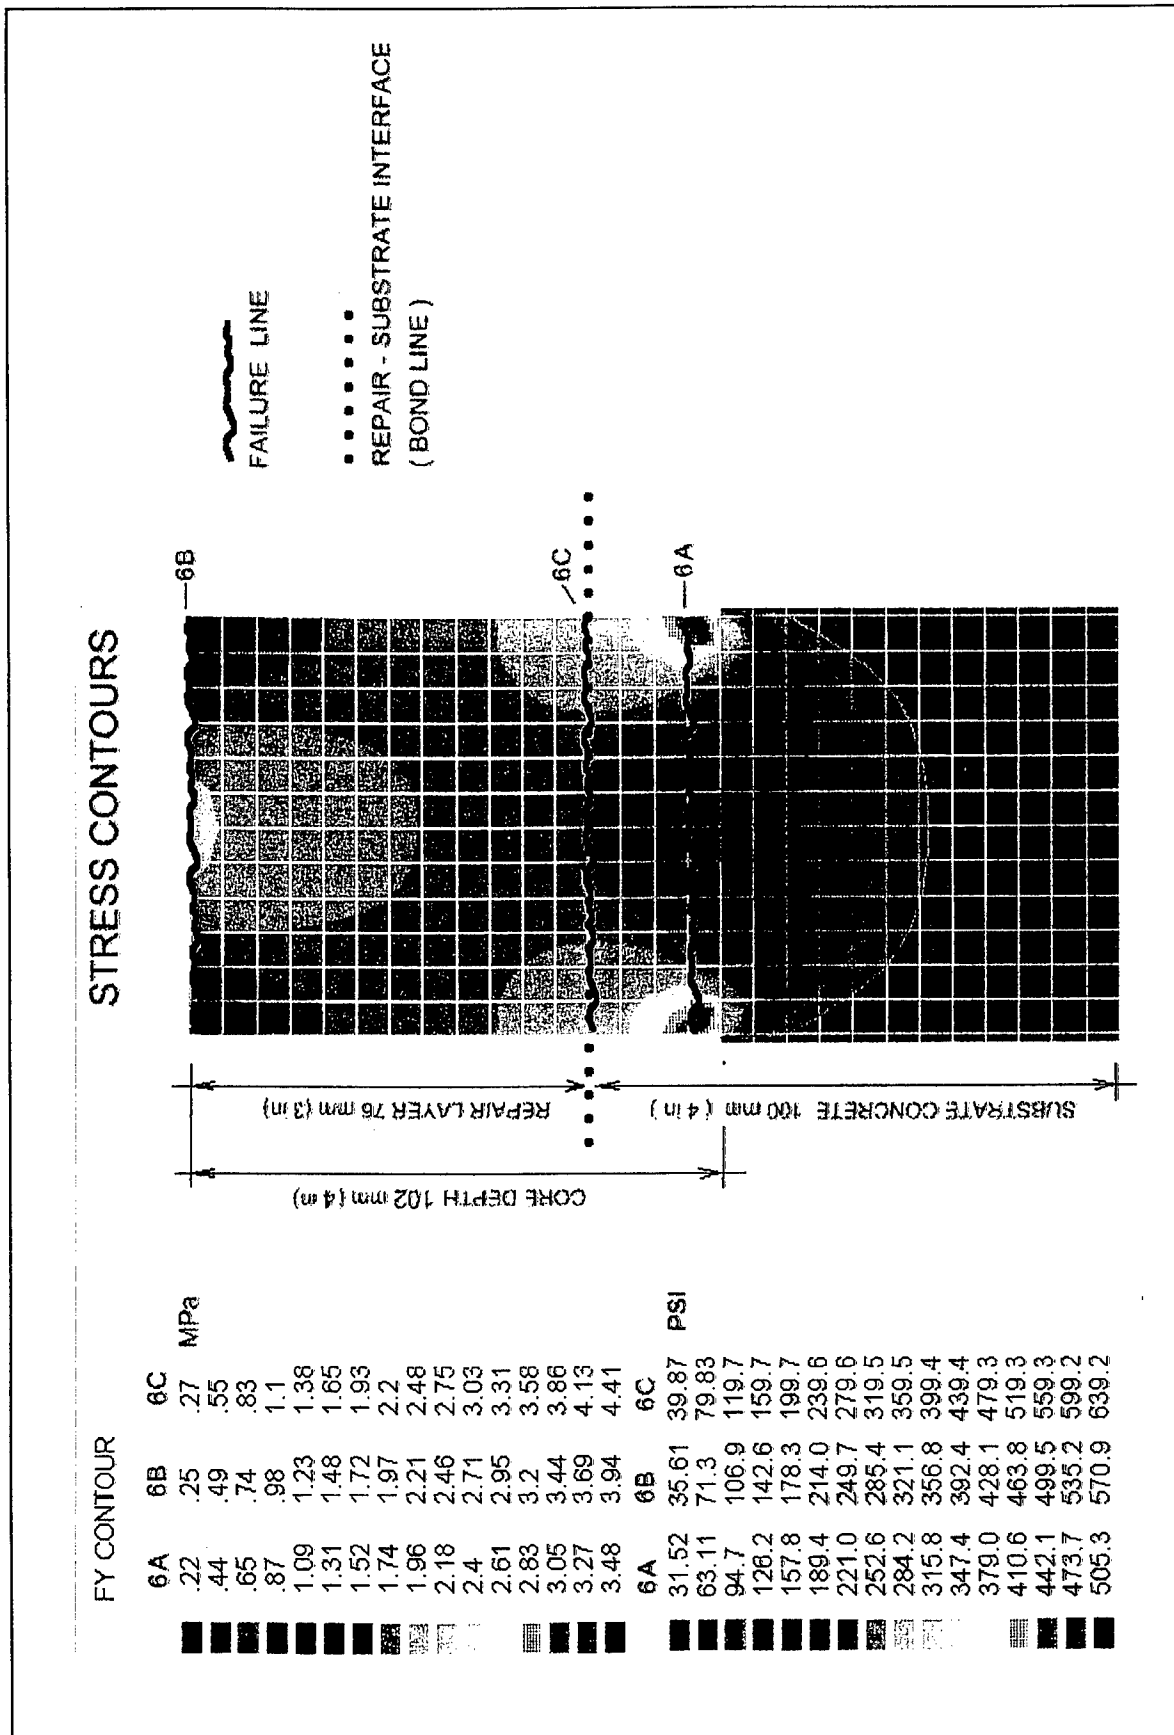
Figure 37. Stress contours—Material No. 6, core depth 101 mm (4-in.)

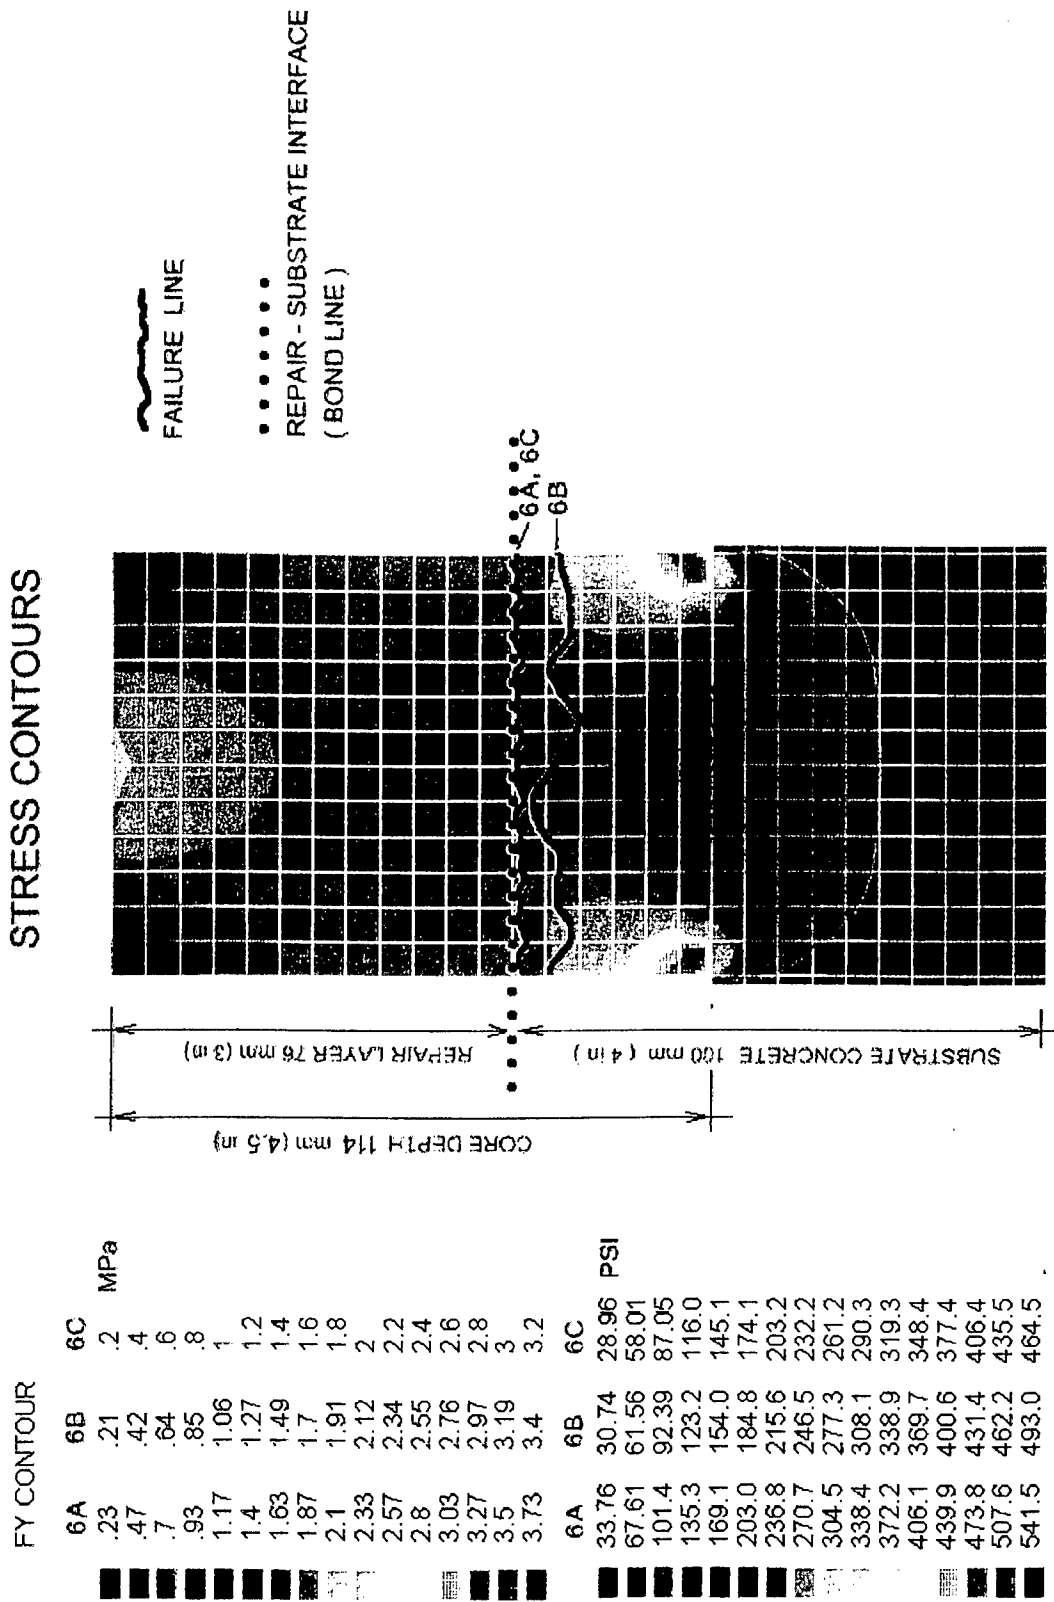
Figure 38. Stress contours—Material No. 6, core depth 114 mm (4.5 in.)

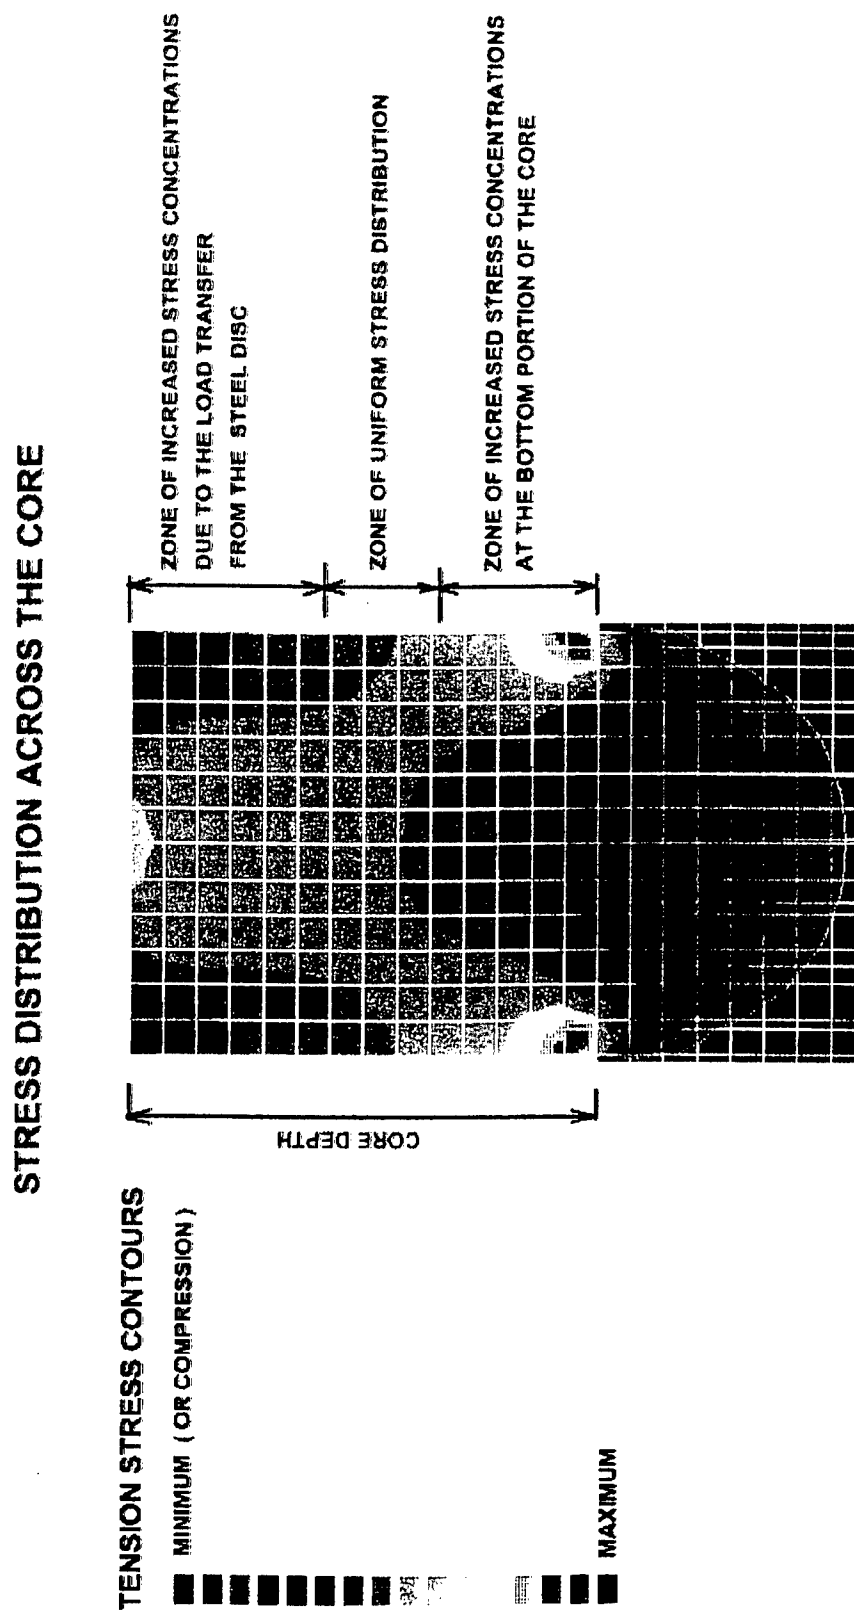
Figure 41. Stress contours—Material No. 10, core depth 114 mm (4-5 in.)

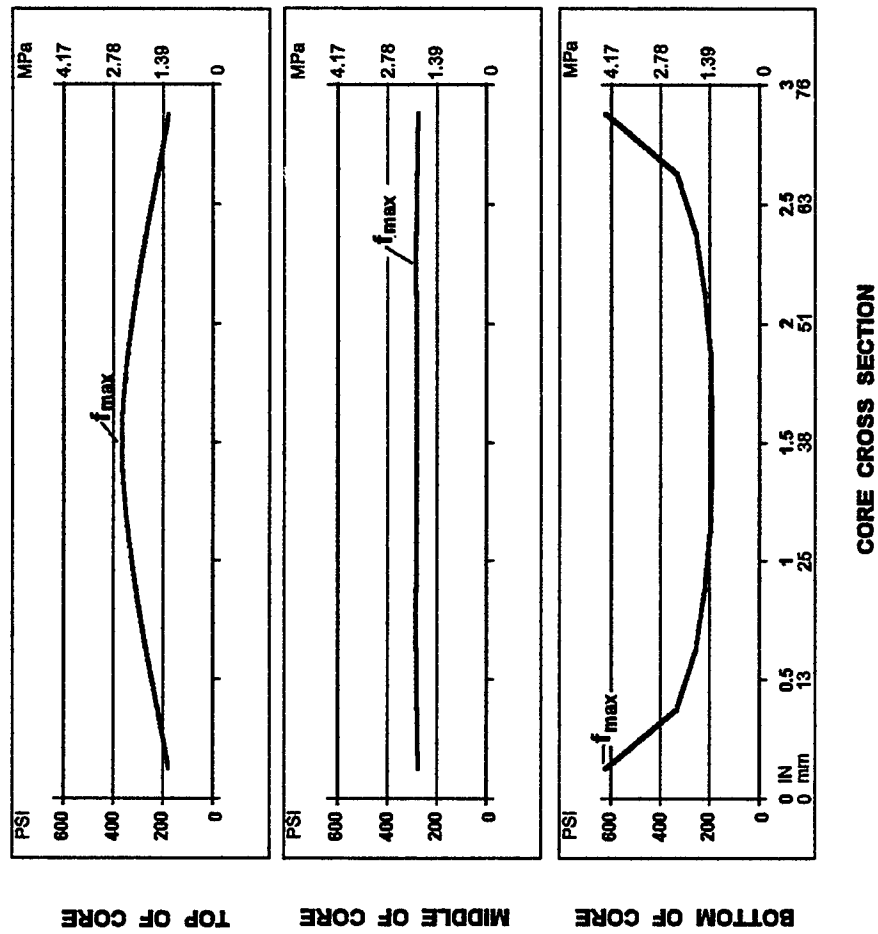
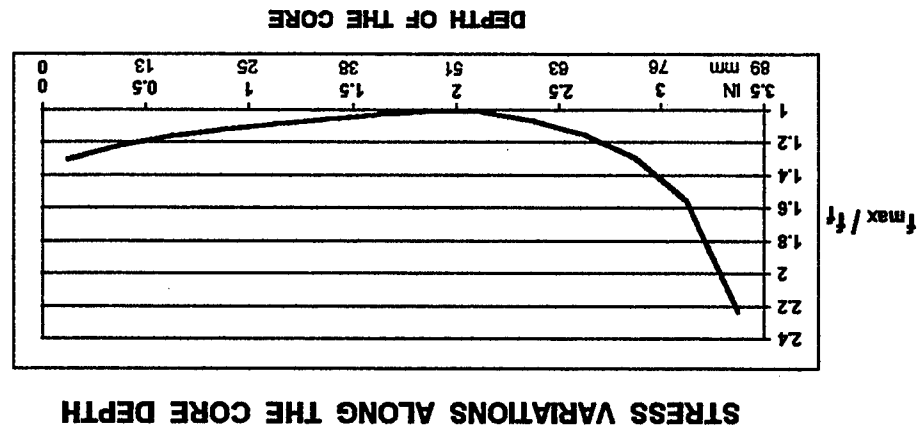
**EXAMPLE OF THE STRESS DISTRIBUTION ACROSS THE CORE 2C
WITH MEASURED PULL OFF STRESS $f_f = 1.92 \text{ MPa}$ (275.4 psi)**

Figure 43. Example of stress distribution in Core 2C

Based on finite-element analysis, an example of stress distribution within the different zones of the core in experimental repair 2C is shown in Figure 43. The example shows that the magnitude of the maximum stress concentration in the vicinity of the core bottom is 2.2 times higher than the result of the pull-off strength at failure—1.9 MPa (275 psi).
