Technical Report REMR-CS-61
June 1999

An Evaluation of Equipment and Procedures for Tensile Bond Testing of Concrete Repairs

*by Alexander M. Vaysburd, Structural Preservation Systems, Inc.
James E. McDonald, WES*

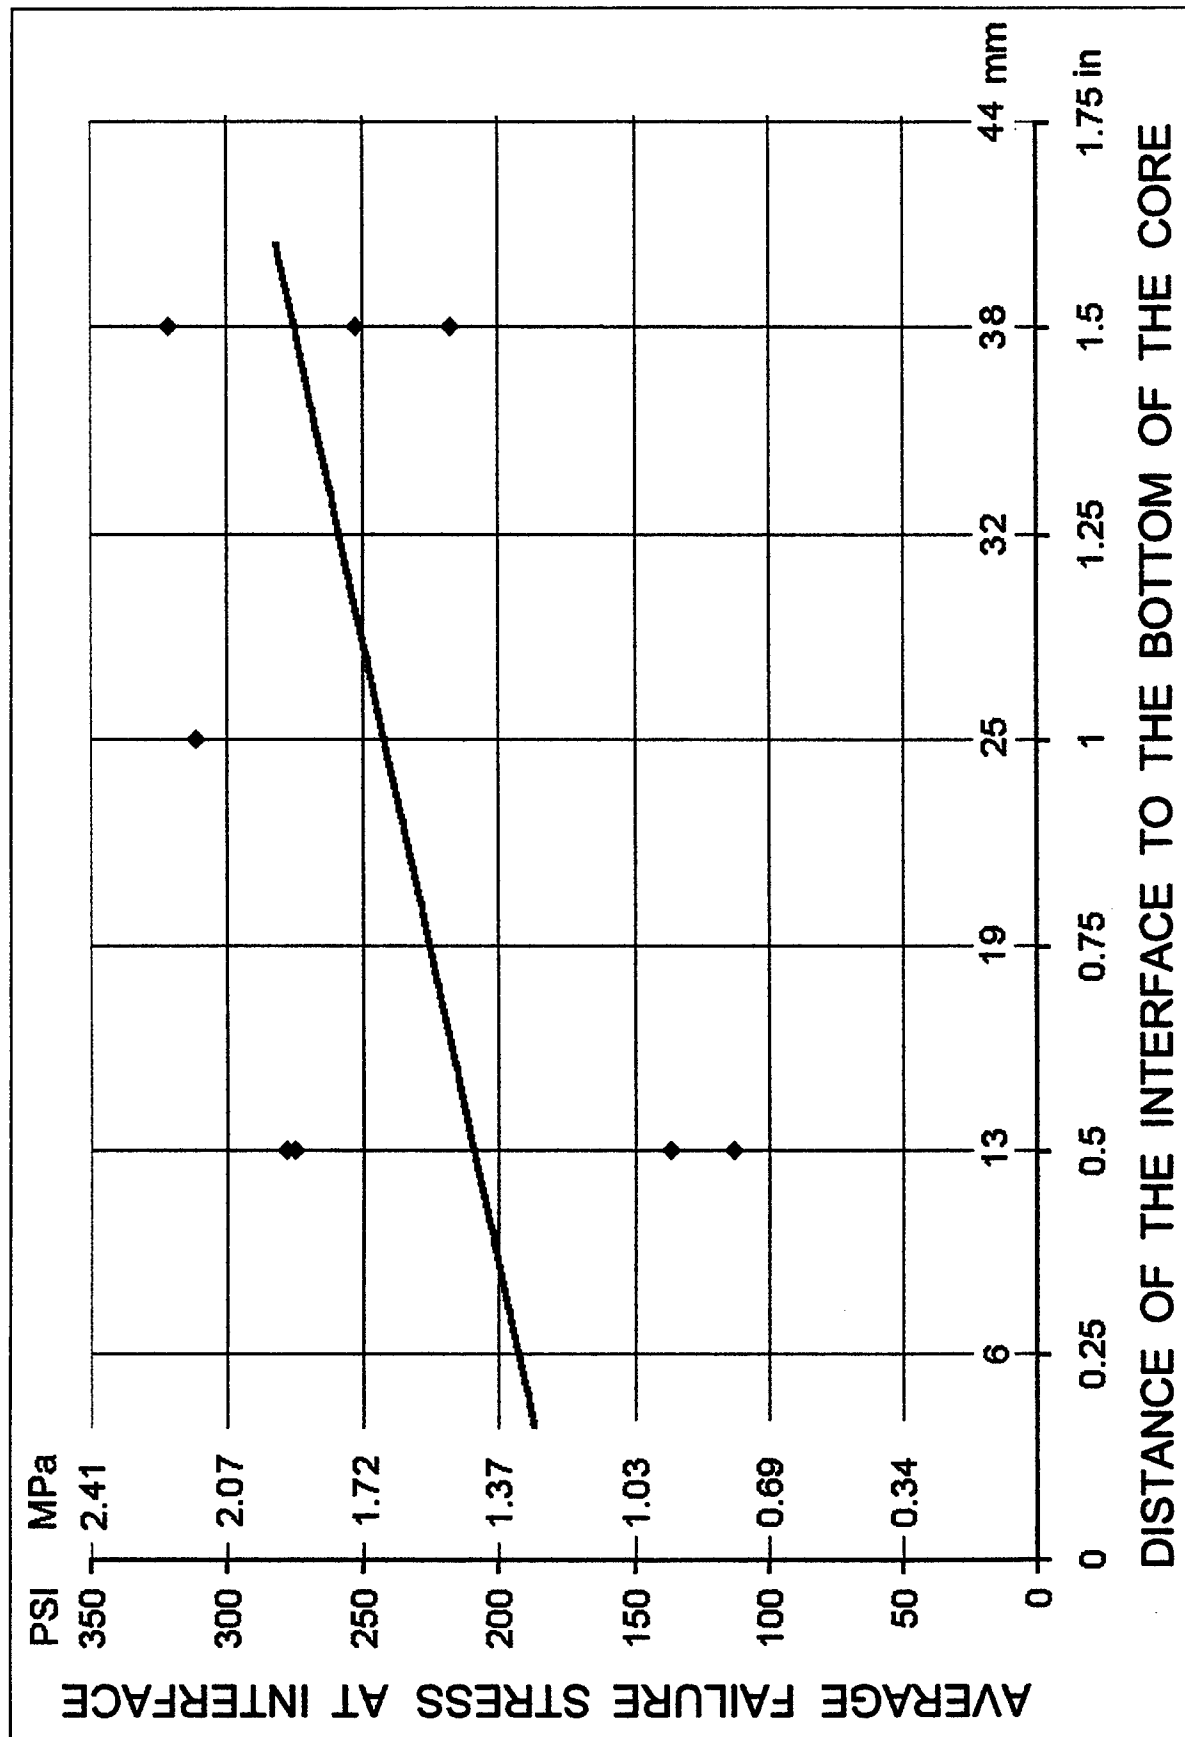
Figure 44. Effect of core drilling depth into substrate on tested bond strength

The results of experimental tests of pull-off bond strength (adhesive failure mode at the interface) are shown in Table 22. This table includes only the test results corresponding to mode of failures at the repair-substrate interface or within 2 mm (1/16-in.) from it. Linear interpolation of these results is shown in Figure 44.

The linear interpolation of the bond strength test results presented in Figure 44, despite the limited amount of real bond failures, confirms the conclusions of the theoretical analysis that shallow core drilling depths into the substrate give rise to significant stress concentrations and underestimate the real bond strength. Although these theoretical analyses relate to only 10 bond failure cases (37 percent of the total amount of pull-off strength tests in this series), they suggest trends that have been confirming the conclusions in other studies (Austin, Robins, and Pan 1995).
