DOT/FAA/AR-00/18

Development of Supplemental Inspection Report for the Fairchild Metro SA226 and SA227 Airplane

April 2000

Final Report

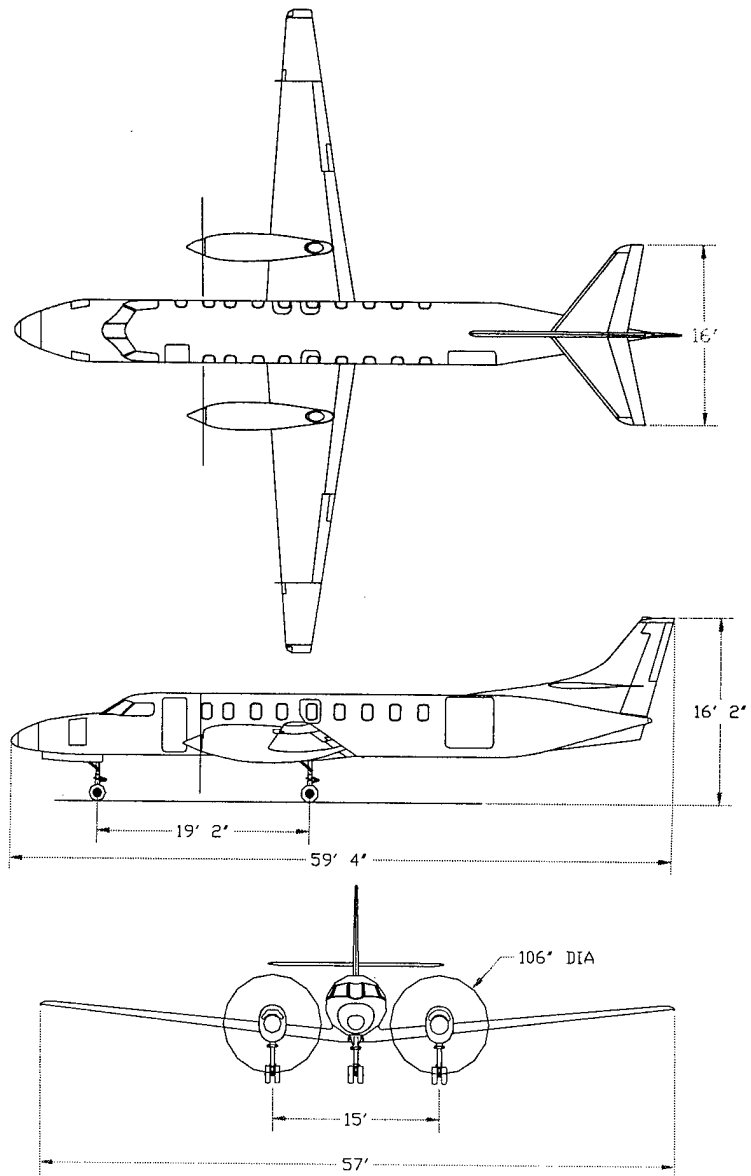
DATA	
BASIC DIMENSIONS	
LENGTH	59' 0"
HEIGHT	16' 8"
SPAN	57' 2"
WING DATA	
AREA:	
WING (TOTAL)	308.1 SQ FT
AILERON (TOTAL)	14.12 SQ FT
FLAP SLOTTED (TOTAL)	40.66 SQ FT
AIRFOIL:	
ROOT	NACA65 A215
TIP	MODIFIED NACA64 A415
ASPECT RATIO, AR	10.59
MAC	72.3 IN
SWEEP AT QUARTER CHORD	0.9 DEG
TAPER RATIO	.257
DIHEDRAL (WRP AT 32% CHORD)	5 DEG
ANGLE OF INCIDENCE:	
ROOT	+1 DEG
TIP	-2.69 DEG
GEOMETRIC TWIST	-3.69 DEG
POWERPLANT DATA	
ENGINES:	
TWO AIRESEARCH TPE331-12UA-701G (MAX CONT.)	1100 SHP
PROPELLERS:	
TWO 4 BLADED FULL FEATHERING	106 IN DIA
LANDING GEAR DATA	
MAIN GEAR (DUAL WHEELS)	
TOTAL STRUT STROKE	10 IN
TIRE (TUBELESS) 19.5 X 6.75-8,PLY RATING=10	
WHEEL	18 X 5.5
NOSE GEAR (DUAL WHEELS)	
TOTAL STRUT STROKE	8 IN
TIRE (TUBELESS) 18 X 4.4, PLY RATING=10	
WHEEL	18 X 4.4
SPECIFICATIONS	
WEIGHTS:	
TAKEOFF WEIGHT	16,500 LBS
EMPTY WEIGHT	8,680 LBS
LANDING WEIGHT	15,675 LBS
ZERO FUEL WEIGHT	14,500 LBS
PERFORMANCE	
SPEEDS:	
$V_{LO} = V_{LE} = 248$ KNOTS, CAS

$V_{LO} = 311$ KNOTS, CAS	
MAX. OPERATING ALTITUDE	25,000 FT
EMPENNAGE DATA	
HORIZONTAL TAIL:	
AREA, TOTAL (INCLUDING FUSELAGE)	75,970 SQ FT
AREA, STABILIZERS (TOTAL)	54.7 SQ FT
AREA, ELEVATORS (TOTAL)	21.27 SQ FT
AIRFOIL SECTION:	
ROOT	MODIFIED NACA66A009
TIP	MODIFIED NACA63A009
INCIDENCE	VARIABLE
DIHEDRAL	0 DEG
VERTICAL TAIL:	
AREA, TOTAL (INCLUDING DORSAL)	56.0 SQ FT
AREA, (VERTICAL STABILIZER)	24.036 SQ FT
AREA, RUDDER	19.38 SQ FT
AREA, DORSAL FIN	10.583 SQ FT
AIRFOIL SECTION	
ROOT	MODIFIED NACA66A009
TIP	MODIFIED NACA63A009
AREA, VENTRAL	5.48 SQ FT

FIGURE 1. SA227 BASIC GEOMETRY

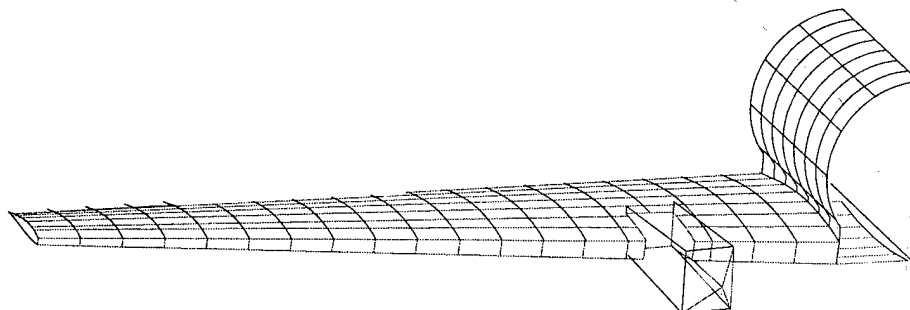
The wing finite element model shown in figure 2 was used to analyze the SA227 wing [1]. The results were checked during the SA227 wing static test [2] and shown to be within about 1% of the measured stress for the more heavily loaded portions of the wing. The finite element model was therefore used as an aid for selecting critical PSE areas and determining stress at locations on the wing other than strain gage locations.

FIGURE 2. SA227 WING FINITE ELEMENT MODEL

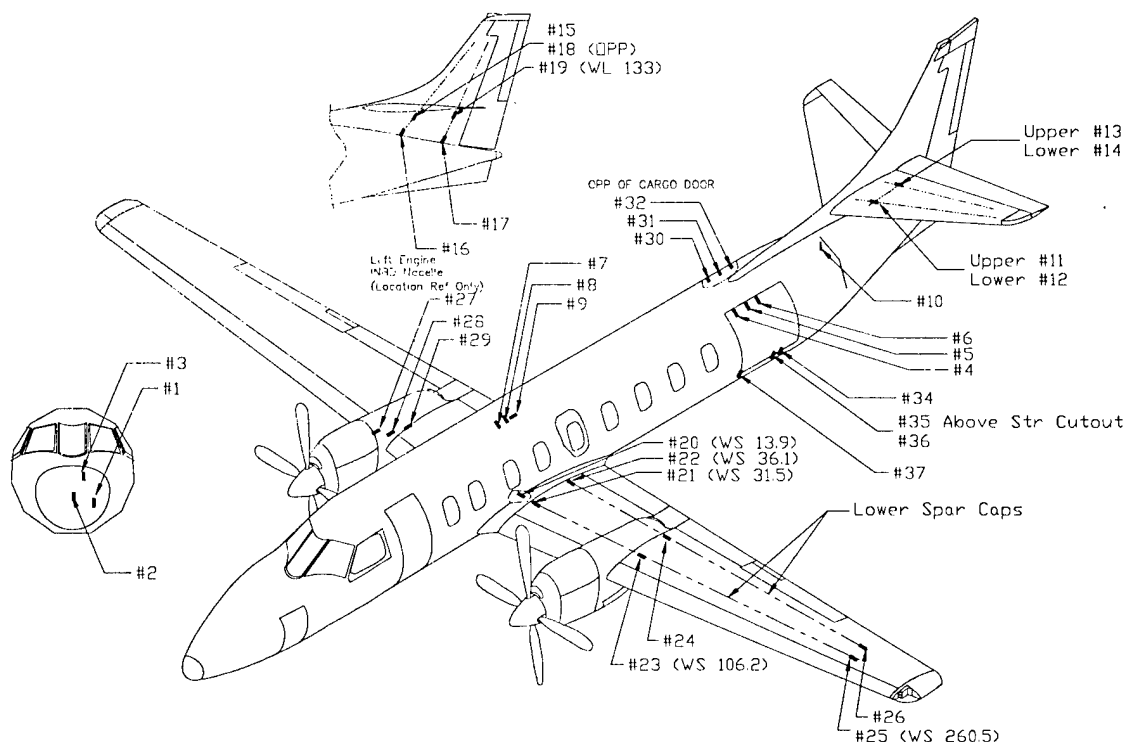
In support of the SID program, an SA227-DC aircraft was instrumented to measure strains at numerous locations during typical flight maneuvers. The details and results of these flight tests were reported at length in reference 3. Figure 3 shows the strain gage locations.

FIGURE 3. STRAIN GAGE LOCATIONS

Figure 3 in section 2.2.2.1 showed the locations of strain gages used to measure stresses on the aircraft during typical flight maneuvers. This data was used to help transform flight loads to stresses at critical areas of the principal structural elements. Further discussion of the methods and results of the strain survey is available in reference 3.

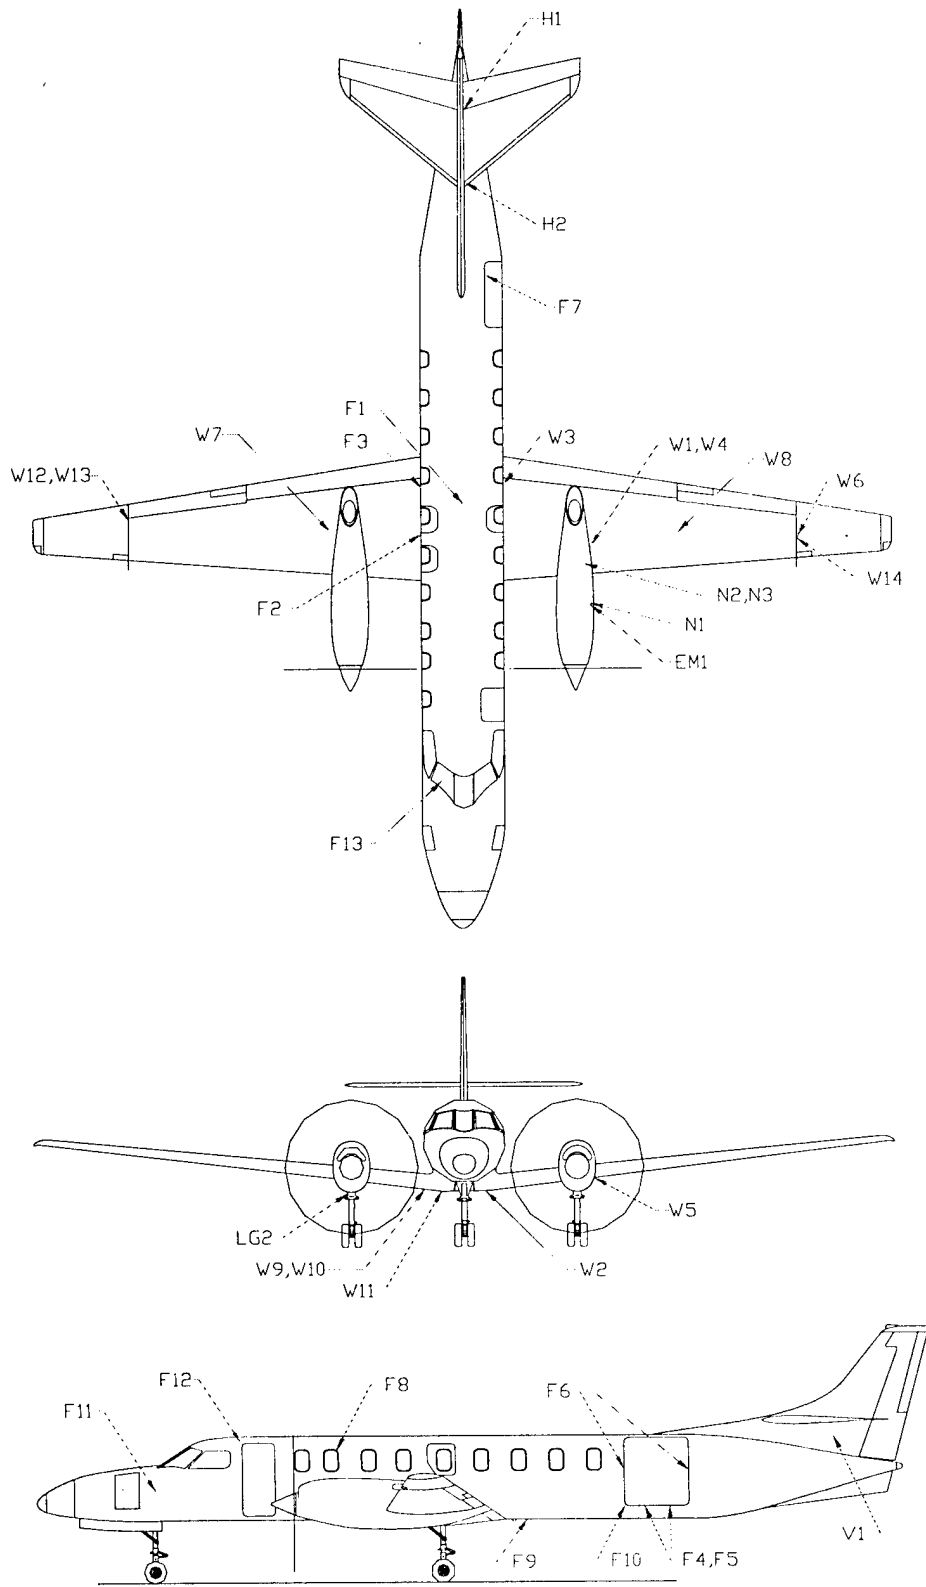
Table 4 presents the PSE critical areas selected for damage tolerance analysis. Figure 4 shows the locations of the critical areas. They are also depicted in reference 3.

FIGURE 4. LOCATIONS OF CRITICAL AREAS

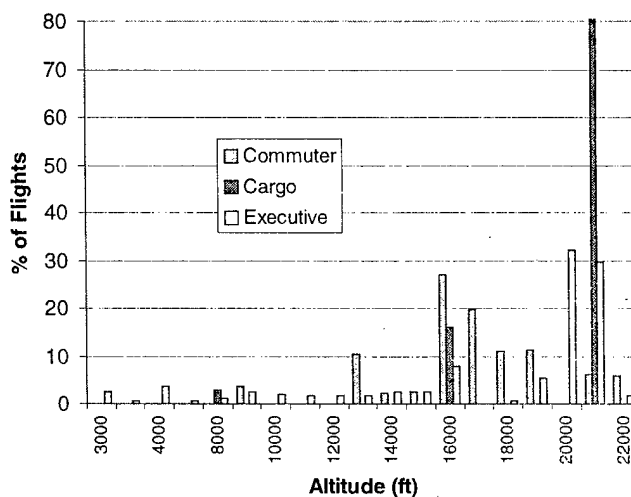
The surveys covered a total of 70 aircraft and 871 flights: 32 aircraft and 535 flights with two commuter operators, 31 aircraft and 248 flights with a cargo operator, and 7 aircraft and 190 flights with an executive operator. Table 5 and figures 5 and 6 summarize the findings of the surveys. The complete set of data is provided in reference 3.

FIGURE 5. CRUISE ALTITUDE FREQUENCIES

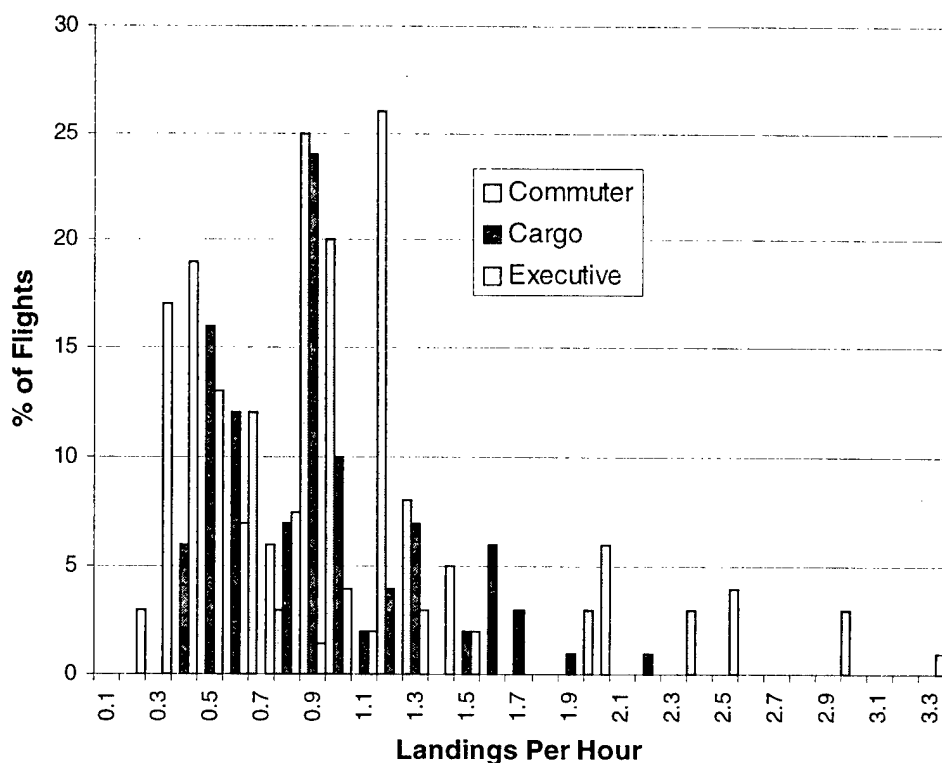
FIGURE 6. LANDINGS PER HOUR DISTRIBUTION

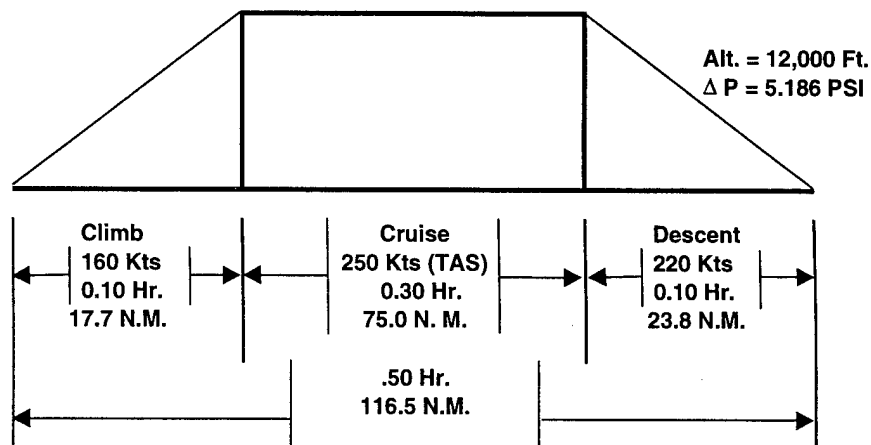
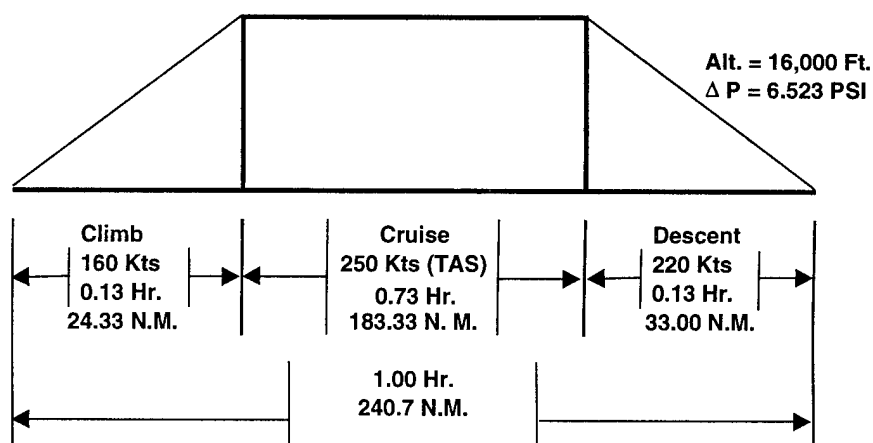
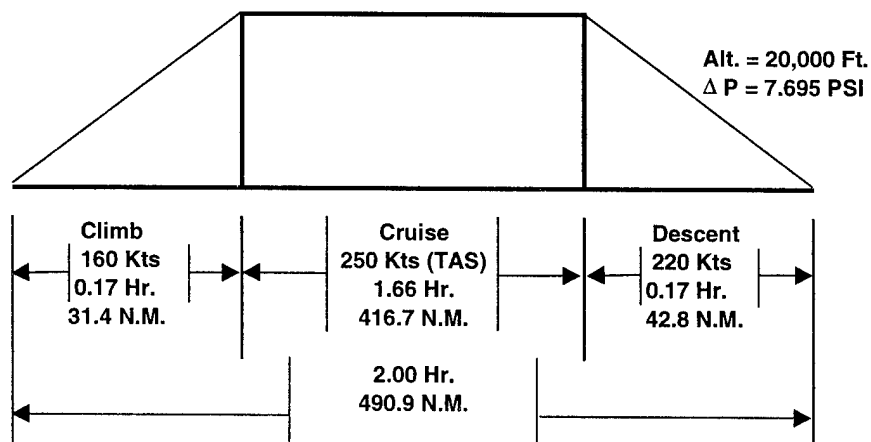
After reviewing the flight length, cruise altitude, and takeoff weight data of surveyed aircraft, three profiles were developed to represent flights typical of the three types of operation (commuter, cargo, executive). Table 6 shows the mission parameters and figure 7 illustrates the flight profiles.

FLIGHT PROFILE - COMMUTER

FLIGHT PROFILE - CARGO

FLIGHT PROFILE - EXECUTIVE

FIGURE 7. SA227 FLIGHT PROFILES

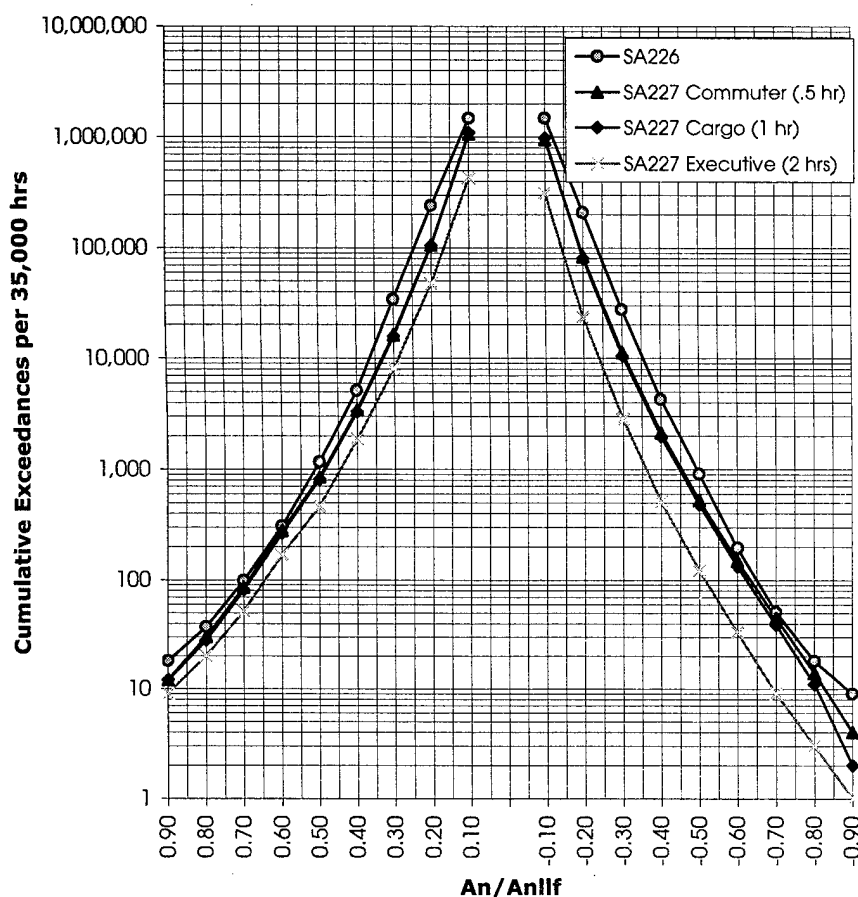
Figure 8 shows the gust and maneuver load spectra for the SA226 and each of the three SA227 mission profiles.

FIGURE 8. GUST AND MANEUVER LOAD SPECTRA

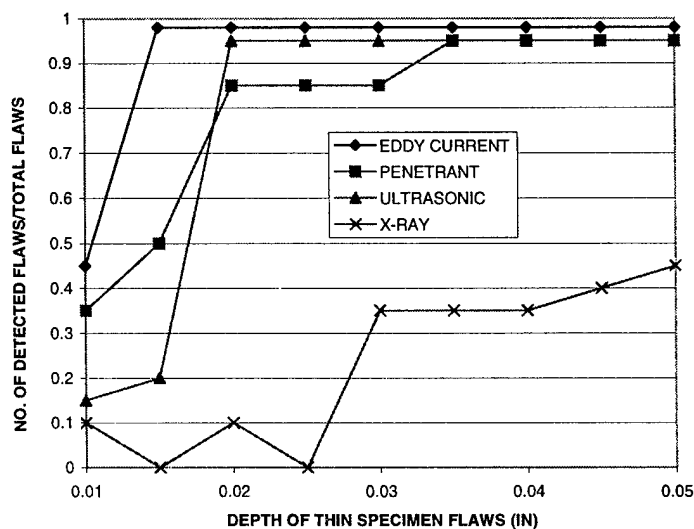
Figure 9, reproduced from reference 12 page 4-85, shows probability of detection for uncovered flaws in thin aluminum. Table 11 lists quoted minimum detectable crack sizes from specific installations in the Cessna 402 [13]. Reference 14 gives the following formula for detectable crack size of surface eddy-current probes: Detectable Crack Length = (Fastener Head DIA – Fastener Shank DIA) / 2 + Coil DIA

FIGURE 9. SAMPLE CRACK DETECTION PROBABILITY CURVES

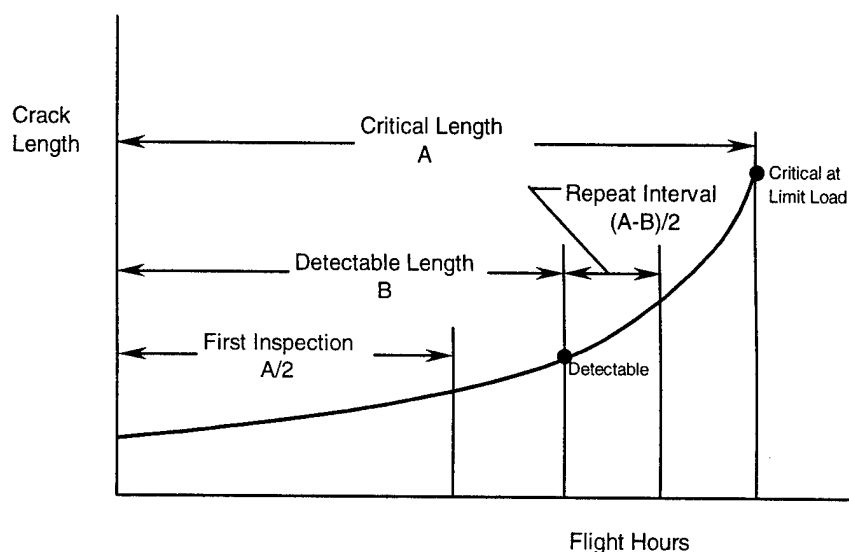
The recommended repeat inspection intervals for each PSE are presented in the SA226 and SA227 SID [16]. Figure 10 summarizes how the inspection intervals were obtained based on crack growth analysis. Scatter factors of 2 are assumed.

FIGURE 10. INSPECTION INTERVAL AND CRACK GROWTH CURVE RELATIONSHIP

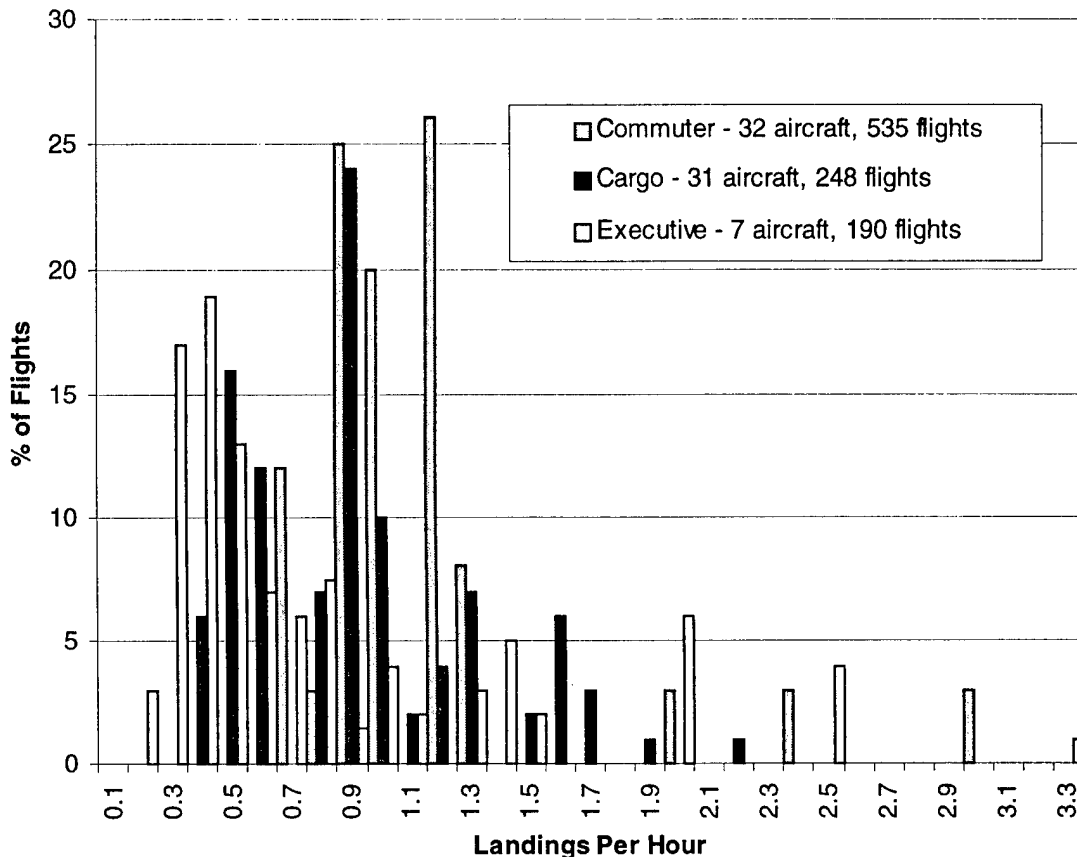
Additional information was gathered from the Official Airline Guide and teleconferences with operators. A graphical summary of the usage data from the survey is shown in Figure 1.

Figure 1. Flight Length Summary (Sheet 1)

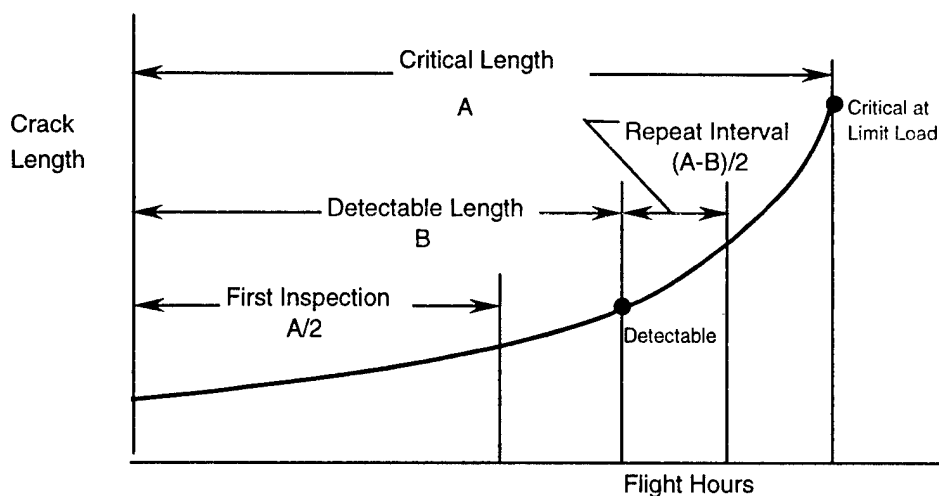
Initial inspections were based on the shorter of analytical crack growth curves, fatigue test results, or service experience. Where analytical crack growth was used, the initial inspection was set at $c_{crit}/2$, where c_{crit} is the crack size at which the structure can no longer support limit load. The initial crack size was assumed to be 0.05 inch in most cases. Figure 2 shows a typical crack growth curve and the inspection intervals determined therefrom.

Figure 2. Typical Crack Growth Curve

A very important part of the SID program is selecting and evaluating state-of-the-art nondestructive inspection (NDI) methods applicable to each PSE and determining a minimum detectable cracks length, c_{det} , for each NDI method. The minimum detectable crack length is used in conjunction with the critical crack length, c_{crit} , to define the life interval for the crack to grow from c_{det} to c_{crit} . This interval, $(c_{crit} - c_{det})/2$, is used to define the repeat inspection frequency for the SID program's required inspections. The threshold inspection generally occurs at $c_{crit}/2$. For a given NDI method and PSE, c_{det} corresponds to a crack size with 90% probability of detection. An example of repeat and initial inspection interval determination is shown in Figure 2.

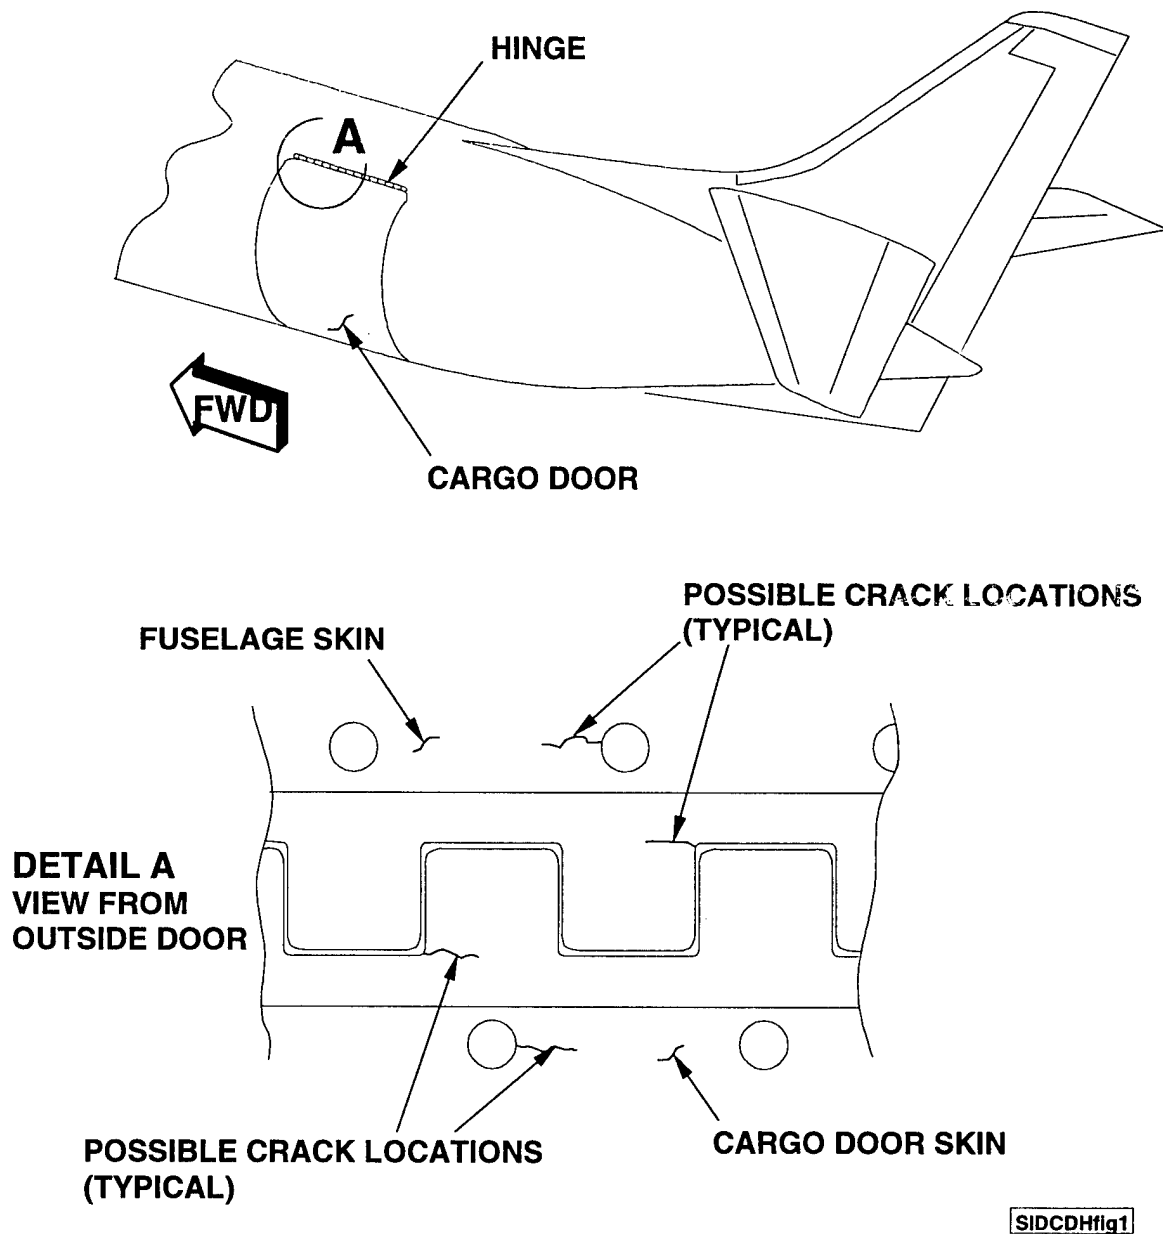
1. Adhere to procedures for Eddy-Current Inspection given in the SA226/227/227CC Structural Repair Manual, Chapter 51-30-07.
2. Refer to Figure 1. Inspect the hinge tabs and around fastener holes along the length of the hinge. Inspect the top piece (on fuselage) and bottom piece (on cargo door). Observe the phase and amplitude changes on the instrument.
3. Cracks are most likely to occur near the ends of the hinge.
4. If an indication is noted, carefully repeat the inspection pass in the opposite direction to verify the indication.
5. All cracks detected shall be reported to Fairchild Service Engineering. Report the location, direction, and length of each crack.

Figure 1. SA226/SA227 Cargo Door Hinge

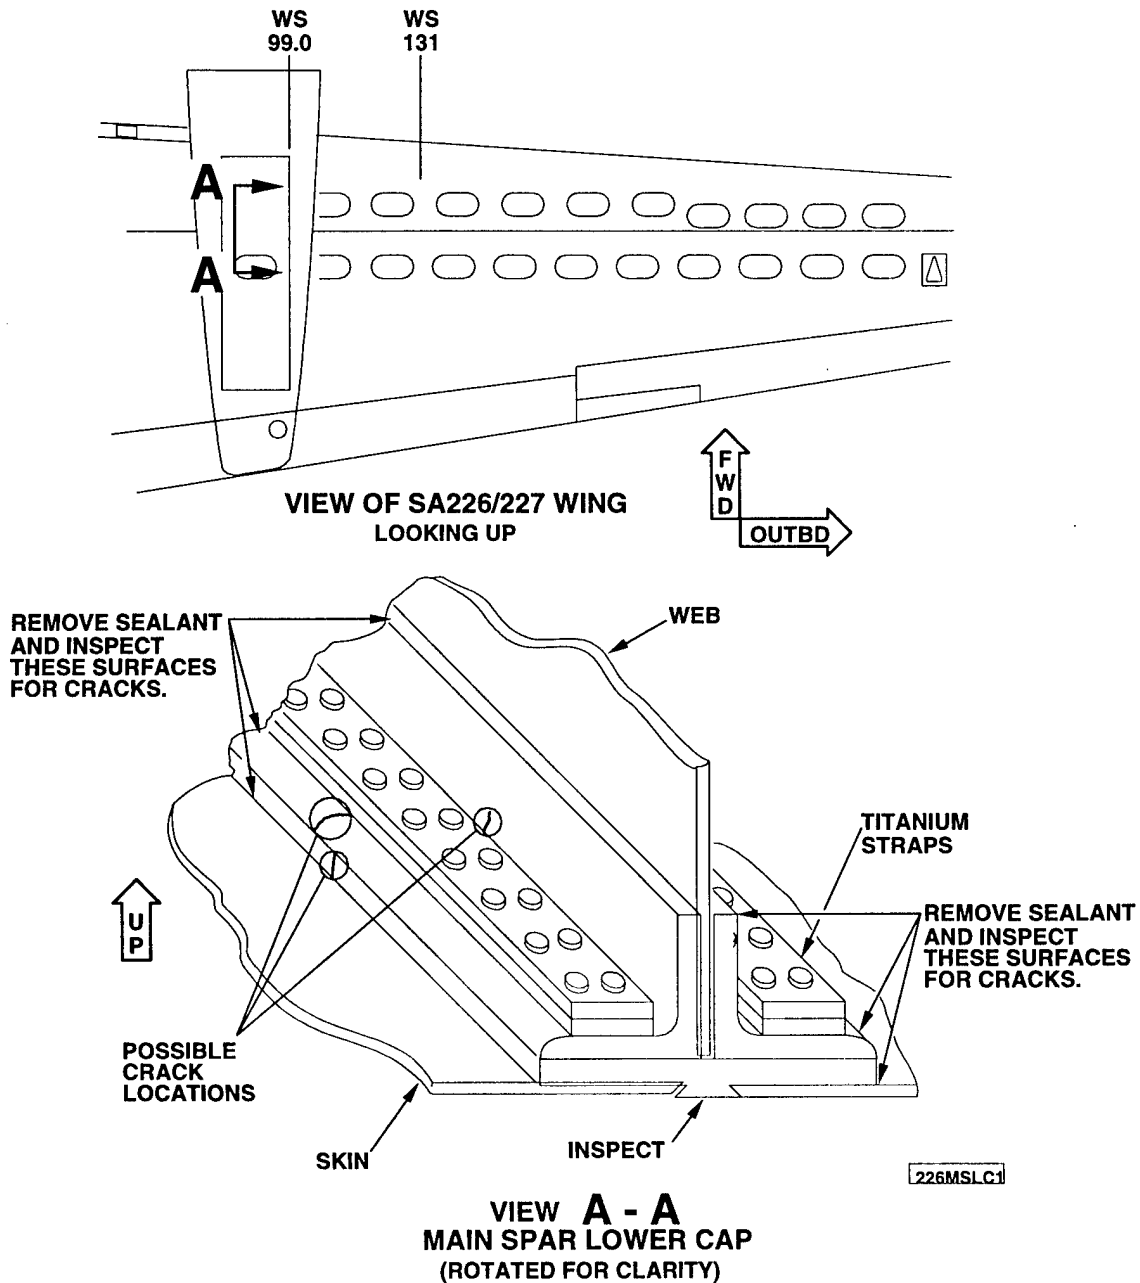
6. If an indication is noted, carefully repeat the inspection pass in the opposite direction to verify the indication.
7. All cracks detected shall be reported to Fairchild Service Engineering. Report the location, direction, and length of each crack.

FIGURE 1. SA226/227 WING MAIN SPAR LOWER CAP WS 99

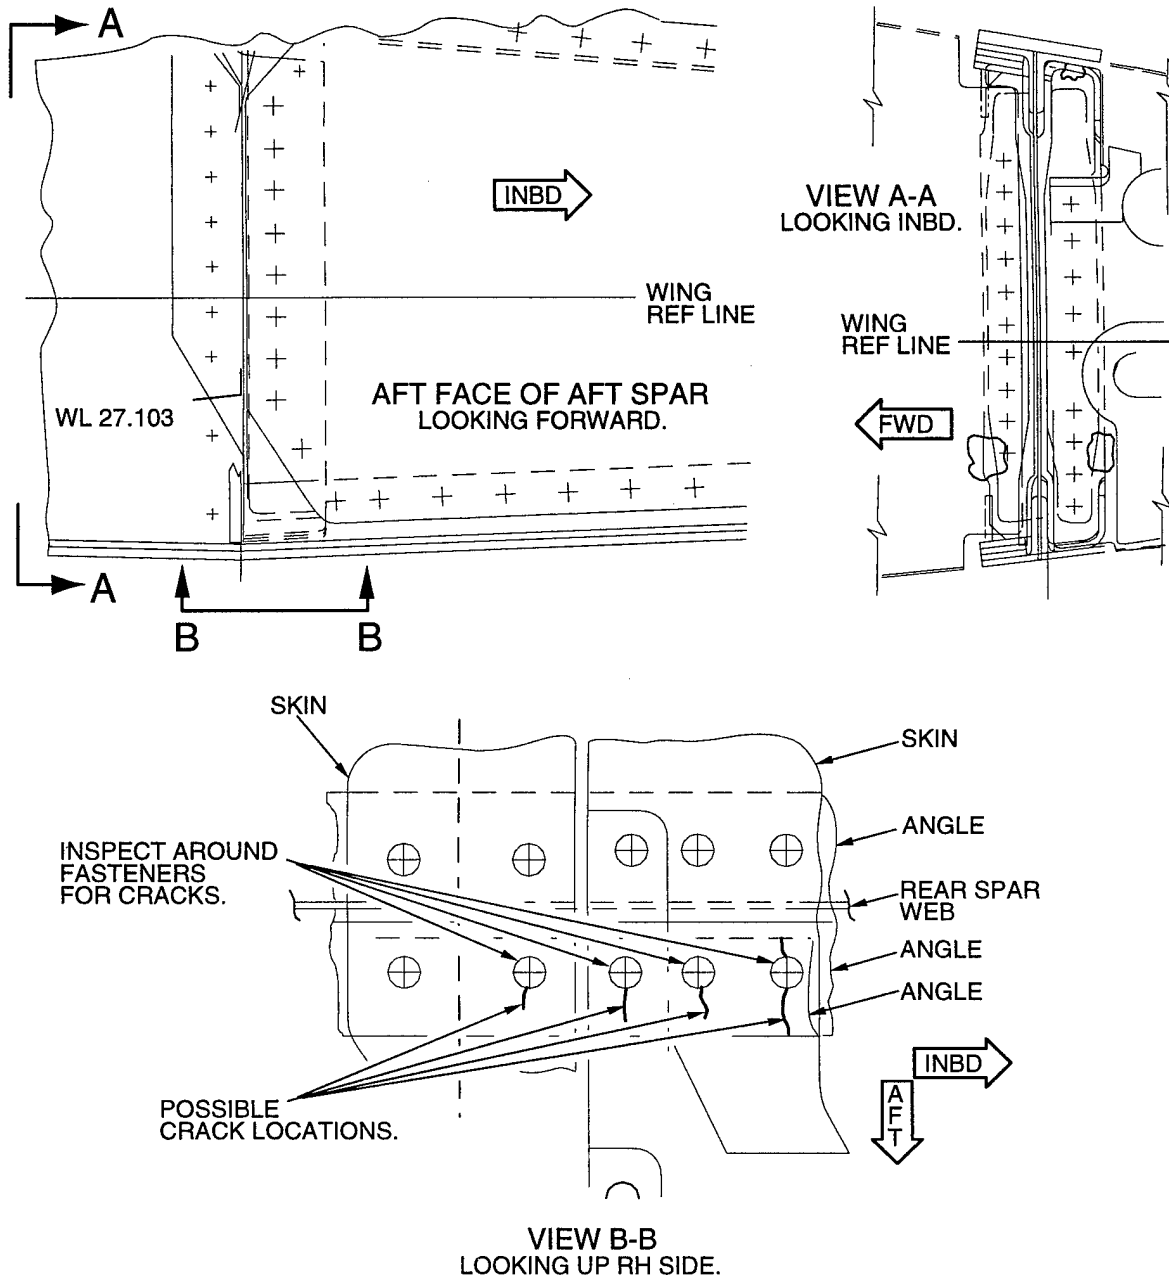
226RSLC1

1. Adhere to procedures for Eddy-Current Inspection given in the SA226/227 Structural Repair Manual, Chapter 51-30-07.
2. Refer to Figure 1. Inspect aft aluminum spar cap angle around the fastener holes between stations 24 and 27, left and right wing. Observe the phase and amplitude changes on the instrument.
3. If an indication is noted, carefully repeat the inspection pass in the opposite direction to verify the indication.
4. All cracks detected shall be reported to Fairchild Service Engineering. Report the location, direction, and length of each crack.

SA226 WING REAR SPAR LOWER CAP AT WS 27
 FIGURE 1

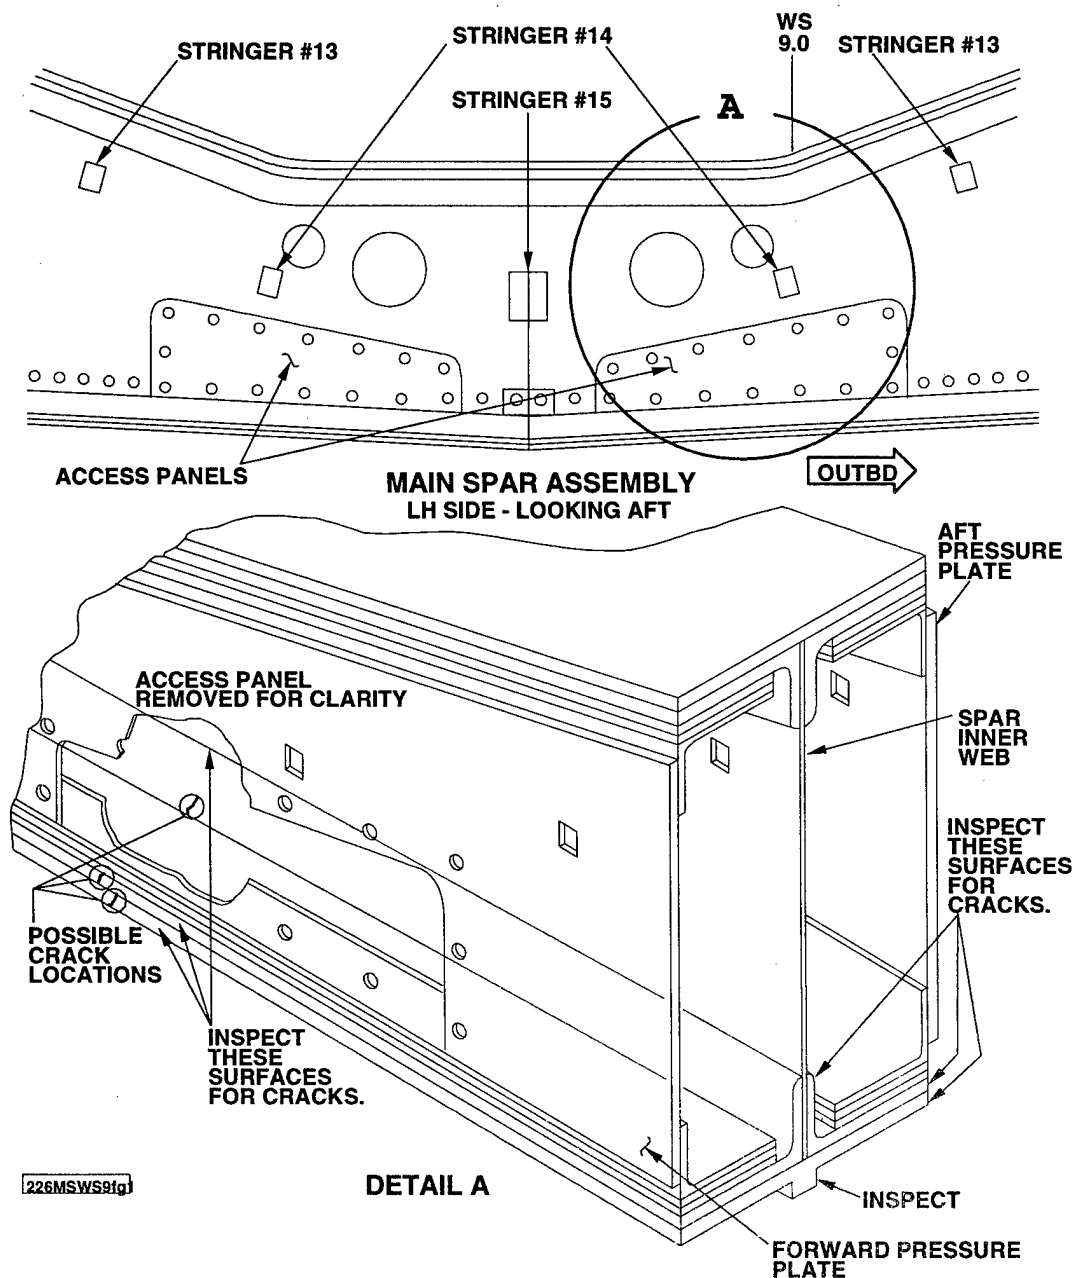
5. Detection of a crack may indicate complete failure of the part.
6. If an indication is noted, carefully repeat the inspection pass in the opposite direction to verify the indication.
7. All cracks detected shall be reported to Fairchild Service Engineering. Report the location, direction, and length of each crack.

Figure 1. SA226 Main Spar at WS 9.0

1. If the forward and aft pressure plates do not have access panels installed at station 9, accomplish Fairchild Service Bulletin 226-57-006 (T) and (TB), 226-57-007 (AT), or 226-57-008 (TC).
2. Gain access to the main spar lower cap at station 9 by removing access panels on forward and aft pressure plates.
3. Inspect left and right wing. Refer to Section IV (NDI Inspection), Supplemental Inspection Number 57-10-02 for specific inspection instructions.
4. Reseal in accordance with SRM 51-30-03
5. Close out access panels in accordance with the Maintenance Manual.

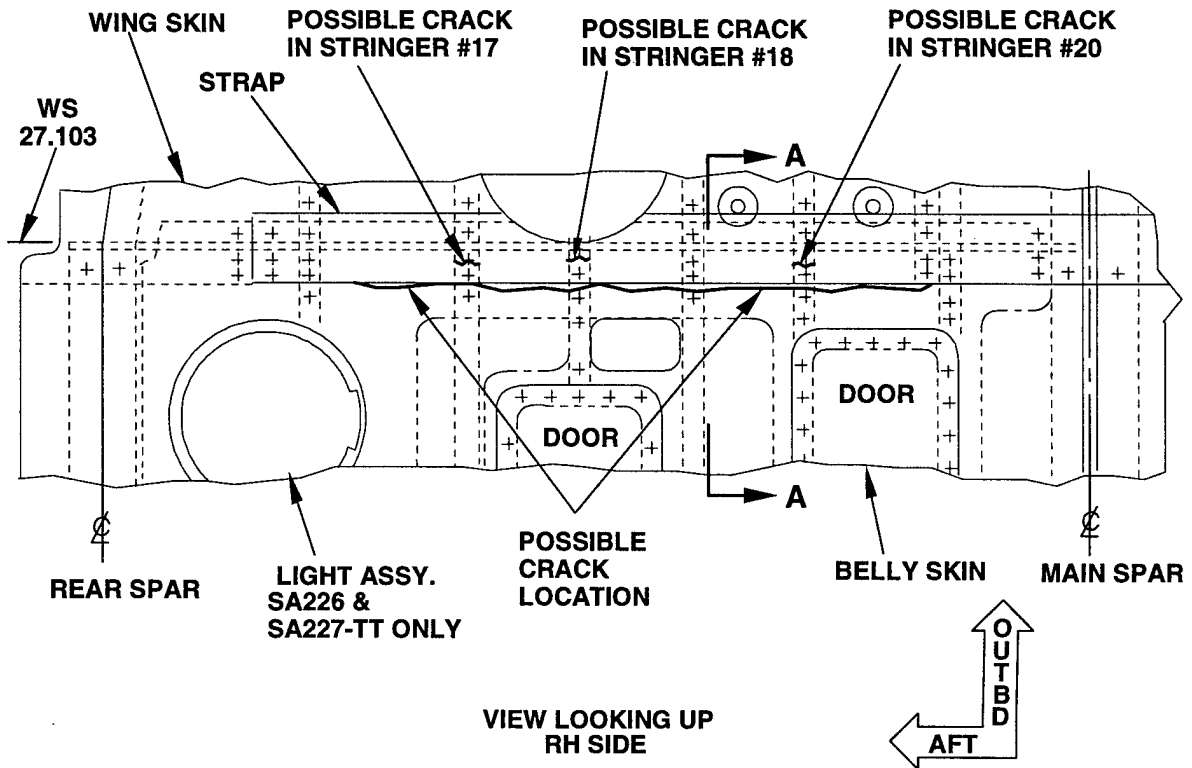
SIDlws27f1-1

1. Adhere to procedures for Eddy-Current Inspection given in the SA226/227 Structural Repair Manual, Chapter 51-30-07.
2. Refer to Figure 1, Sheets 1 and 2. Inspect the outside surface of the belly skin just inboard of the splice strap at WS 27, left and right side, from main spar to rear spar.
3. Inspect the inside surface of the belly skin around the fastener holes in the splice just inboard of WS 27, left and right side, from main spar to rear spar. Refer to Figure 1, Sheet 2.
4. Inspect stringers 16 through 21 around the fastener holes just inboard of the rib at WS 27, left and right side. Refer to Figure 1, Sheets 1 and 2.
5. If an indication is noted, carefully repeat the inspection pass in the opposite direction to verify the indication.
6. All cracks detected shall be reported to Fairchild Service Engineering. Report the location, direction, and length of each crack.

Figure 1. SA226/SA227 Lower Wing Skin Splice at WS 27 (Sheet 1)

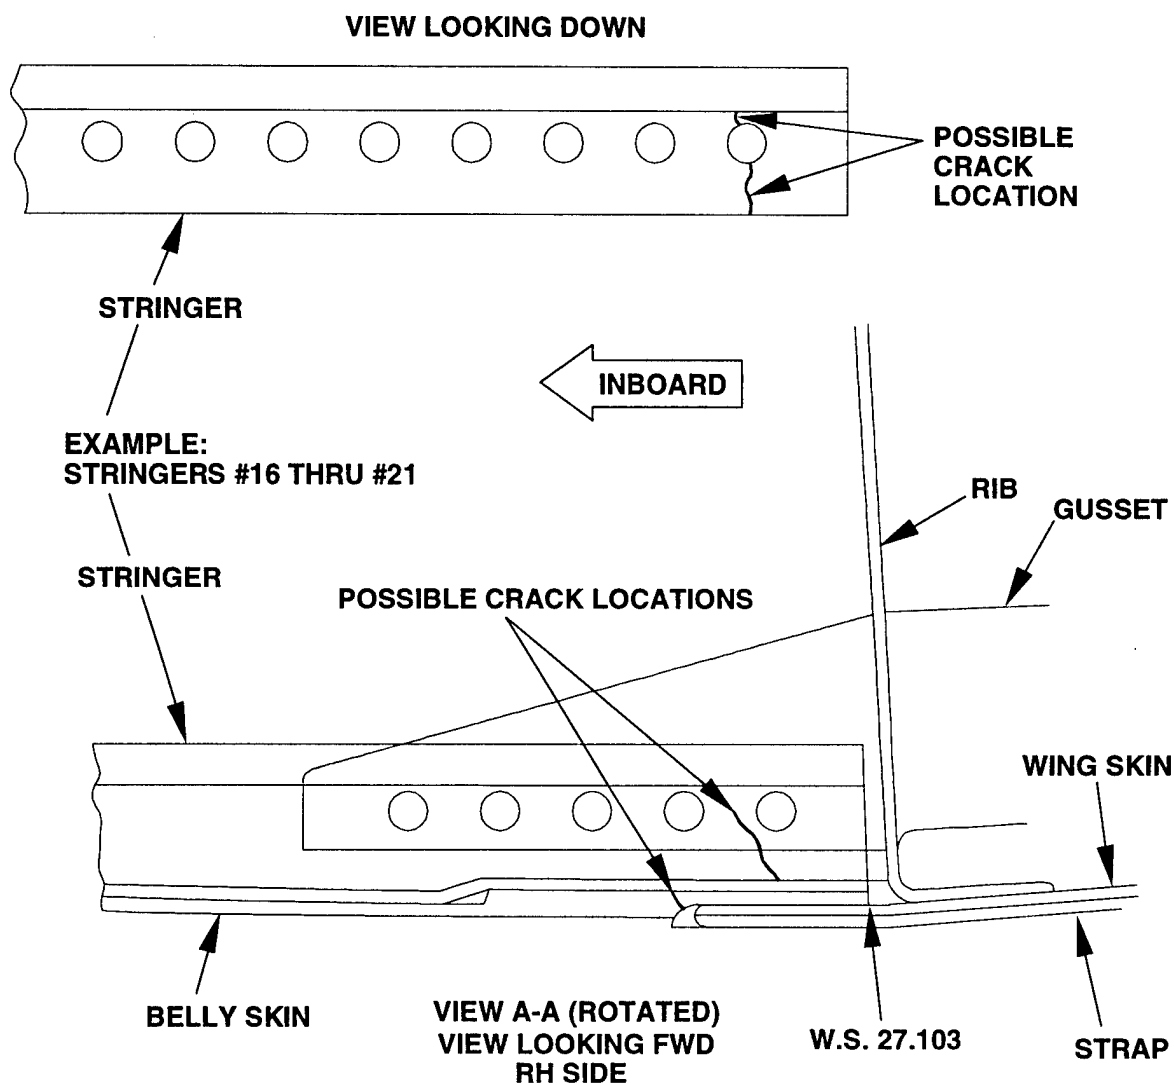
SIDIws27f1-2

Figure 1. SA226/SA227 Lower Wing Skin Splice at WS 27 (Sheet 2)

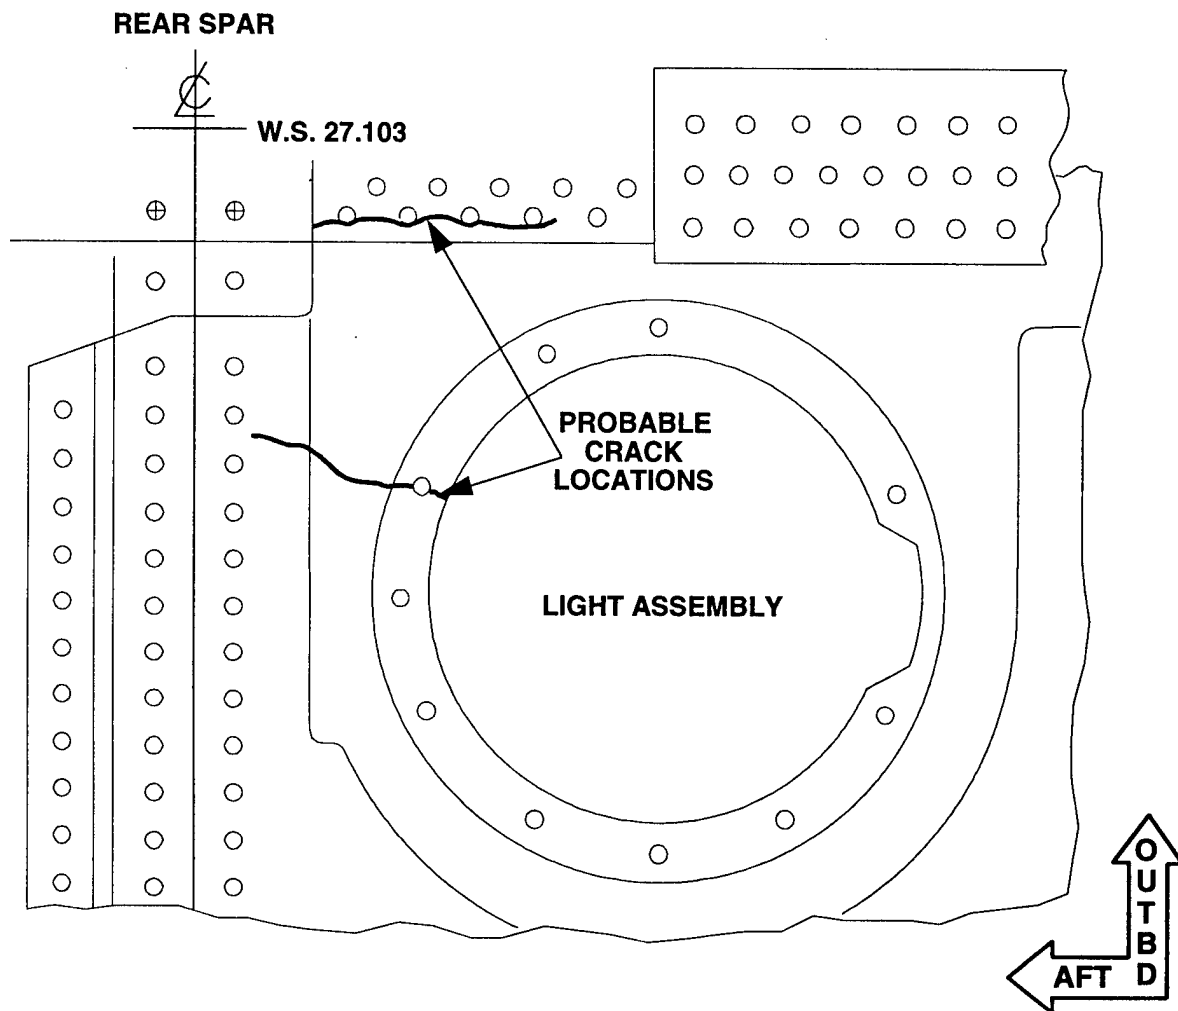
SID226WLCf1

1. Adhere to procedures for Eddy-Current Inspection given in the SA226/227 Structural Repair Manual, Chapter 51-30-07.
2. Refer to Figure 1. Inspect belly skin around landing light cutout and at splice of belly skin to center wing skin. Observe the phase and amplitude changes on the instrument.
3. If an indication is noted, carefully repeat the inspection pass in the opposite direction to verify the indication.
4. All cracks detected shall be reported to Fairchild Field Support Engineering. Report the location, direction, and length of each crack.

Figure 1. SA226/SA227 Wing Center Section Skin at Landing Light Cutout

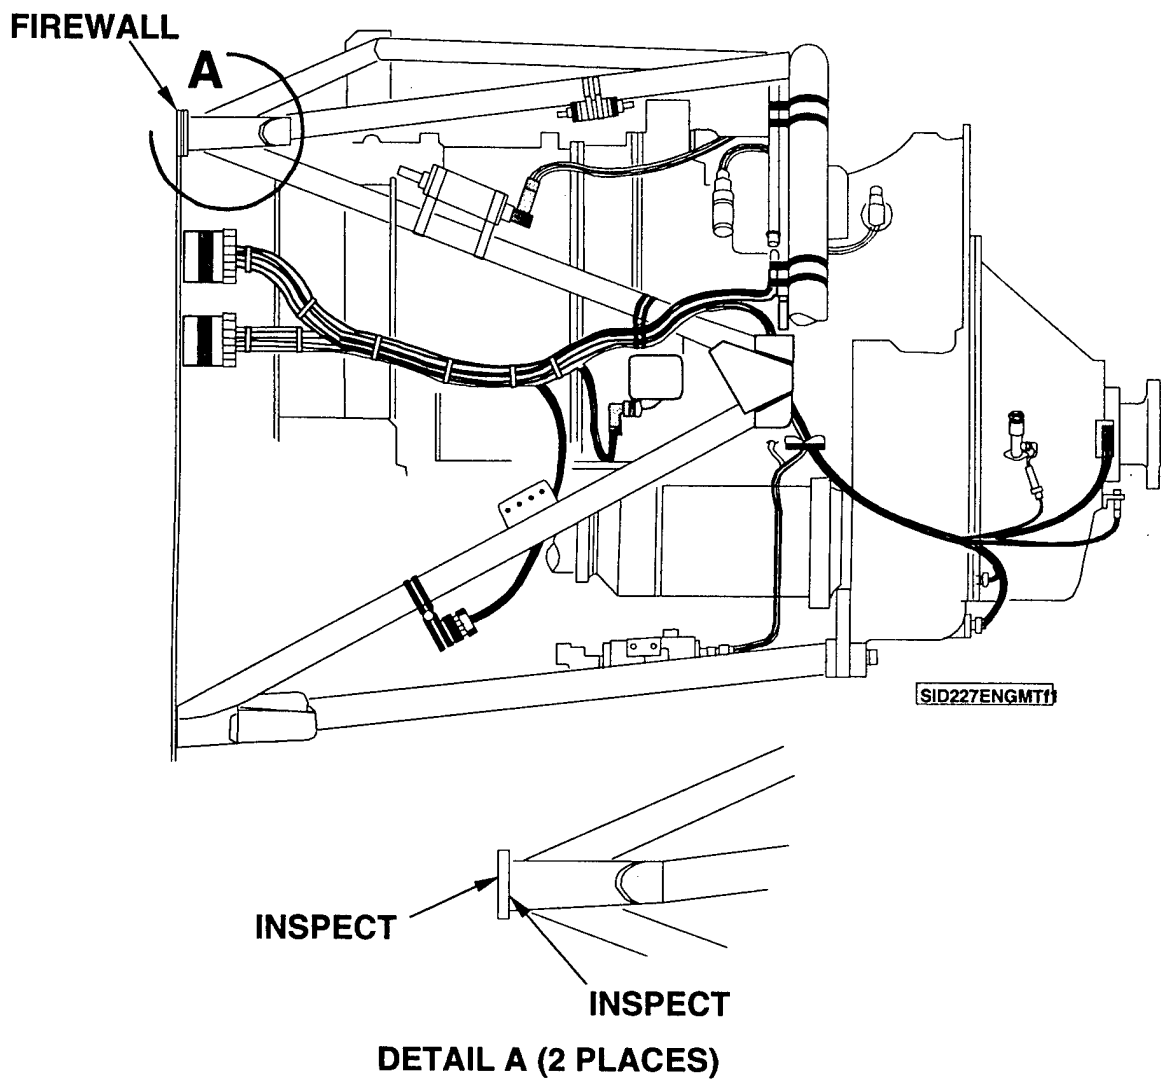
LH/RH ENGINE

Figure 1. SA227 Engine Mount at Firewall
