Expedient MESL Construction in Cold Weather

Jeffrey A. Stark, Rosa T. Affleck, and Sherri A. Orchino

ERDC/CRREL TR-00-8

Technical Report ERDC/CRREL TR-00-8

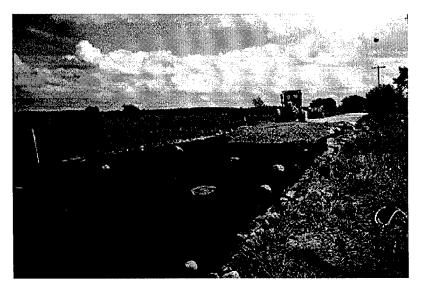
Figure 7. Spreading the gravel wearing course on the MESL.

The gravel for the wearing surface was brought to the site in 20-ton dump trucks. Once again the trucks had to back to the edge of the MESL to dump the gravel to avoid damaging the membrane. The D-7 dozer and a bucket loader were used to spread the gravel over the MESL. On the final day of construction a grader was brought from another construction site to spread the gravel to a 152-mm (6-in.) lift (Fig. 7). The gravel was compacted by vehicle traffic.

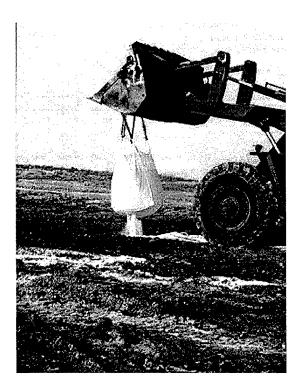
Figure 8. Bucket loader spreading lime.

small gullies formed by erosion. The one-ton supersacks of lime were loaded on a lowboy trailer using a forklift and were then delivered to the site where a bucket loader was used for unloading. The supersacks were picked up with the loader using four chains placed through loops on the bag. The bucket loader carried the bags to the mixing area where three holes were cut in the bottom of the bags. The loader then drove back and forth to spread the lime (Fig. 8) in lines with piles of lime where the bags were opened and where the loader changed directions. Water was then spread on the lime to hydrate it and wet the clay. The clay was dry because the soil was sloped and exposed to the sun.

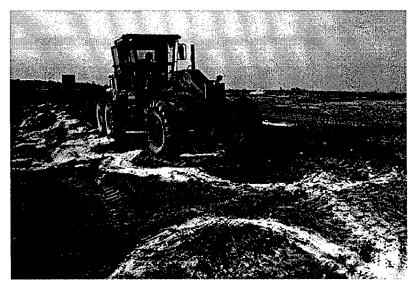
Figure 9. Grader mixing soil and lime.

The scarifying teeth of a grader were used to mix lime into the soil to a depth of approximately 102 mm (4 in.) (Fig. 9); the soil also was bladed. Water was added several times until there was enough moisture for compaction.

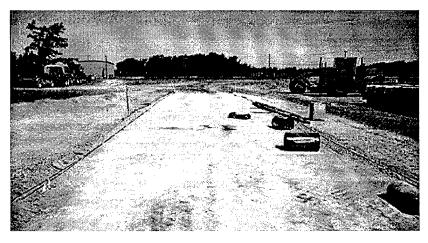
Figure 10. Compacted clay layer used to simulate the top of a MESL.

pan. These trenches provided an area to wash the gravel into when the test was completed. Next, six inches of clay was placed on the test section. Water was added to the clay, scarified, and compacted to simulate the top of a finished MESL, prior to placement of the upper membrane (Fig. 10).

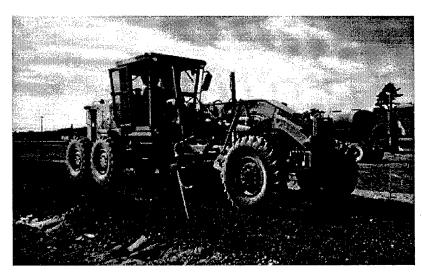
Figure 13. Grader spreading gravel.

Normally, vehicles should not be allowed to drive on the geotextile while placing the gravel. This was not possible in this case because dump trucks were not available during test section construction. Instead, pans were used to place the gravel and a grader was used to spread the gravel (Fig. 12 and 13). Six inches of gravel was placed on the test section. The gravel used was 100% crushed stone with angular shape and 51-mm

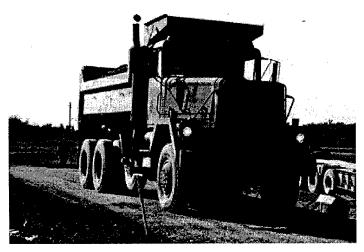
Figure 14. Trafficking the puncture test.

The test section was trafficked with a loaded 20-ton dump truck for 170 passes (Fig. 14). The truck made a loop to traffic and traveled at approximately 10 mph on the test section. The truck also followed approximately the same path each time, simulating a worst-case scenario.

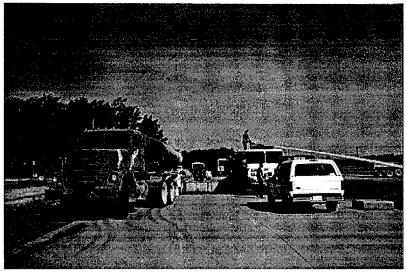
Figure 15. Equipment used to wash gravel off the test section.

After trafficking, the gravel was removed to observe any membrane damage. A grader removed the top few inches of gravel from the test section. The Fort Drum Fire Department then used one of its fire trucks to remove the rest (Fig. 15 and 16). This procedure worked well and mini-

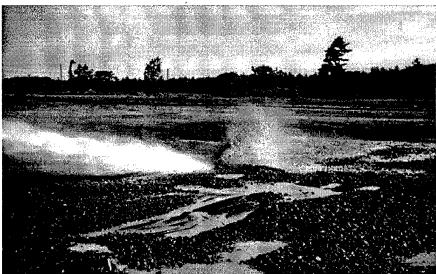
Figure 16. Washing gravel.

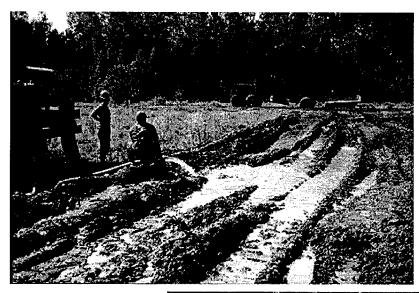
Figure 17. Adding water to the absorbent test section at Ethan Allen Firing Range, Vermont.

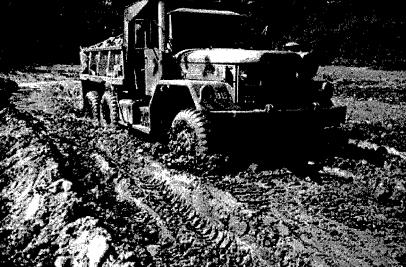
Figure 18. Trafficking the absorbent test section.

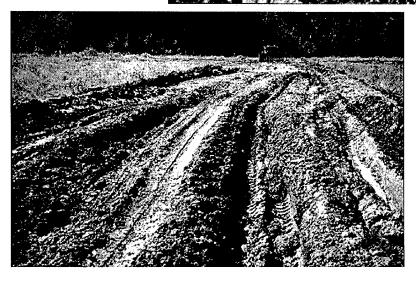
Figure 19. Wheel ruts after one pass.

The test site was an old gravel pit. Because of the low quality of the gravel (due to a high fines content), it was typically used as a fill material at least 0.61 m (2 ft) below the road surface. A thin organic layer had formed on the gravel and supported grass growth. A test section approximately 4.57 m (15 ft) wide by 130 m (100 ft) long was prepared for the test. The existing material was mixed together using a dozer, and additional silty sand was added. Water was added to make the soil muddy (Fig. 17). The wet layer was approximately 305 mm (1 ft) deep with a solid layer underneath. When trafficked, a 5-ton truck (Fig. 18) would sink to the hard layer, and in some places the soil was too weak to maintain the wheel ruts (Fig. 19).

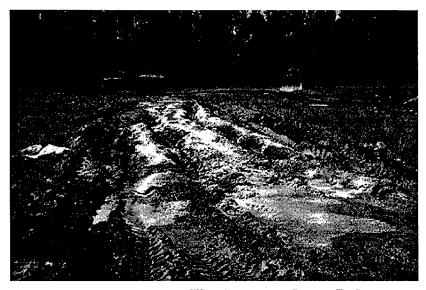
Figure 20. Absorbent spread on test section.

Next, 136 kg (300 lb) of the absorbent was added (Fig. 20) and mixed with a grader (Fig. 21). The grader trafficked only the test section and did not use its blade or scarifying teeth to mix the soil and absorbent. After mixing, a dozer was used to back-blade the test section and provide a smooth surface. The center of the section was dryer than the ends. This was due to standing water before the absorbent was added at the far end of the test section and not enough absorbent being added to the near end of the test section.

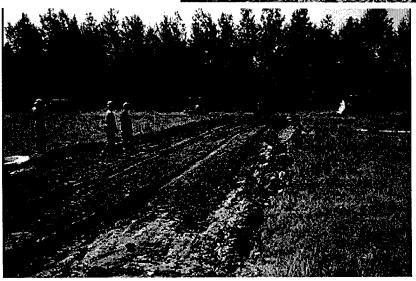
Figure 22. Test section after one pass with a CUCV.

A Commercial Utility and Cargo Vehicle (CUCV) was driven across the test section leaving approximately 51-mm- (2-in.-) deep ruts in the center of the section and 152-mm (6-in.) ruts on either end (Fig. 22). The CUCV was able to drive through the test section in 2-wheel drive when

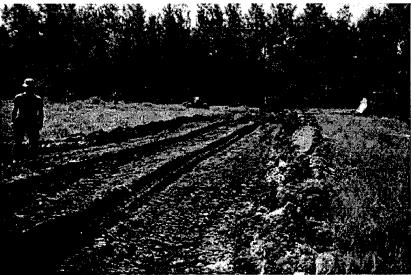
Figure 24. Test section after one pass with a 5-ton dump truck.

the test section would have been impassable in 4-wheel drive before treatment. A loaded 5-ton dump truck was then driven through the test section (Fig. 23 and 24). It left approximately 102mm- (4-in.-) deep ruts in the center and 203-mm-(8-in.-) deep ruts on either end. The 5-ton dump truck then trafficked the section 30 times and left 178- to 279-mm- (7- to 11-in.-) deep ruts in the center and far end and 356-mm- (14-in.-) deep ruts at the near end (Fig. 25). The rutting was not caused by the soil being too "wet" but the result of a lack of cohesion. At the end of the test the soil looked dry and friable. The average water content of the top 76 mm (3 in.) of soil was 17.8%. Its grain size distribution was not determined. The cone penetrometer test results were not valid because the cone hit the larger gravel pieces.

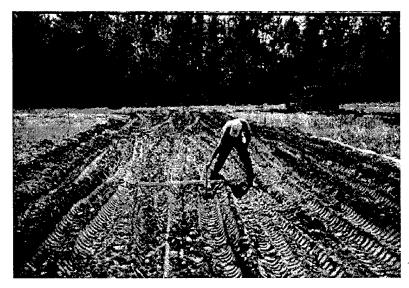
Figure 25. Test section after 30 passes with a 5-ton dump truck.
