# **Maintenance Program and New Materials on Boeing Commercial Aircraft**

**Joseph H. Osborne  
The Boeing Company  
Seattle, WA**

- **Summary of Maintenance Program**
- **Drivers for implementing new materials**
- **Replacement of Alodine 1000**
- **B787 Finishes**

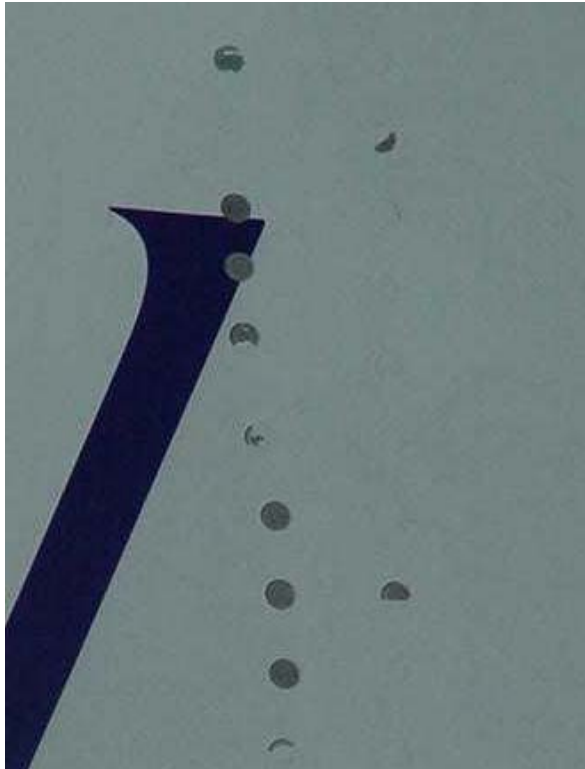
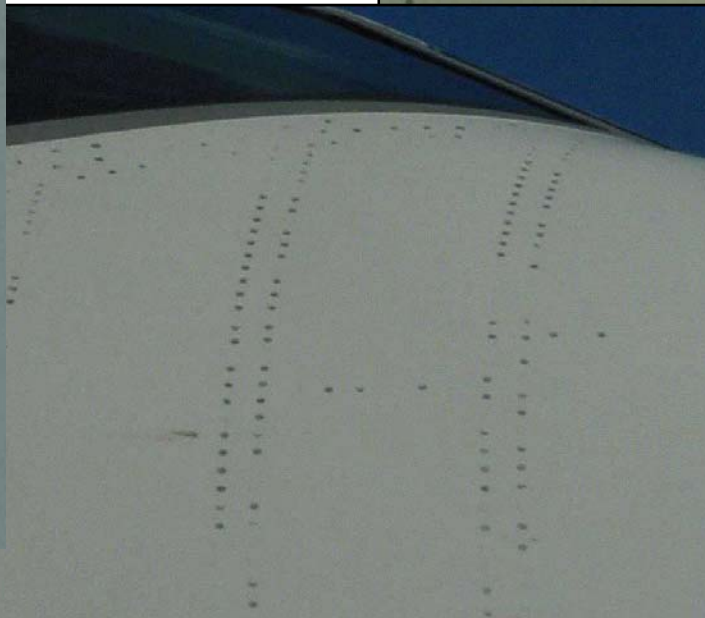
# Performance Driver - Rivet Rash Reduction

Paint delaminates from rivets but not fuselage skins

- Affects all models and decorative paint systems
- Conventional conversion coating identified as contributing factor

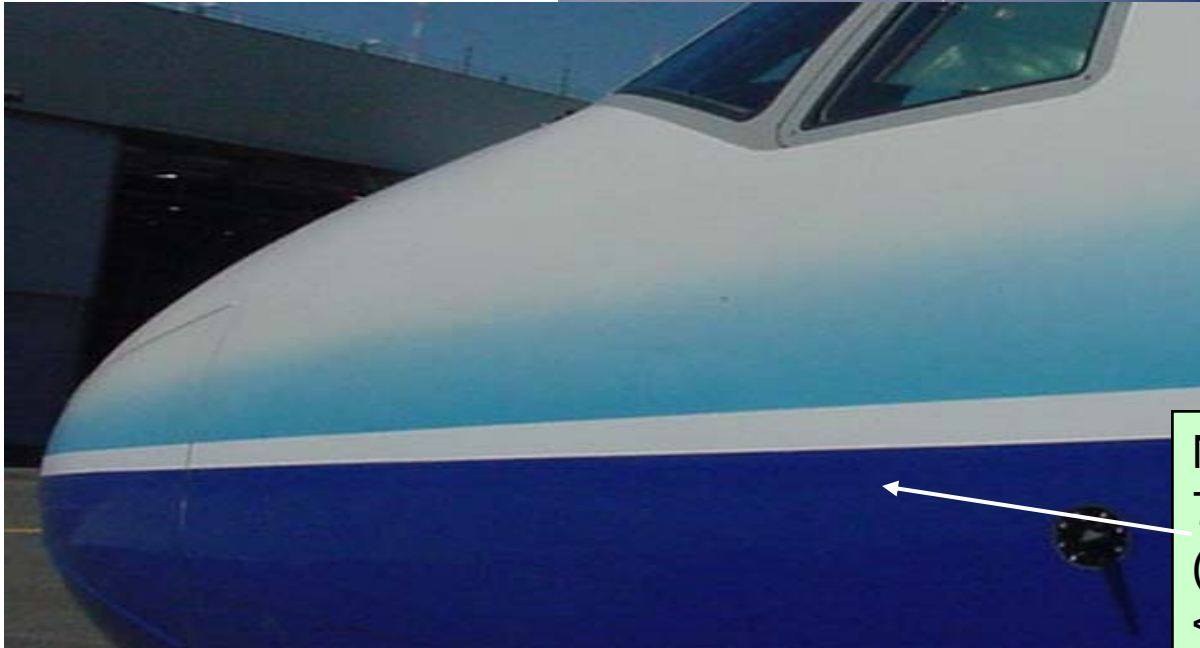
No Rivet Rash on 2nd  
777-200LR  
(**AC131-CB / Boegel EPII**)  
<400 Flight Hours

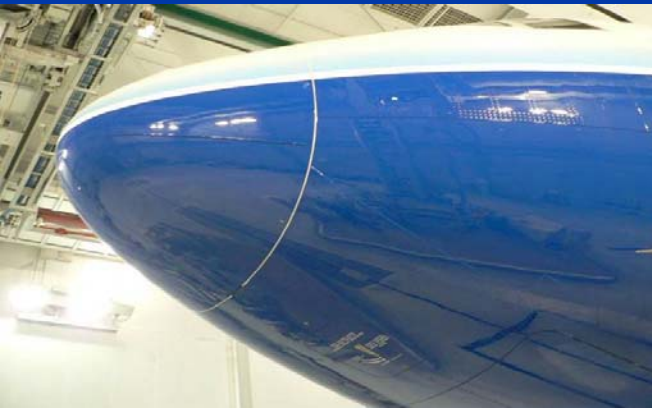
4-12 mils of paint

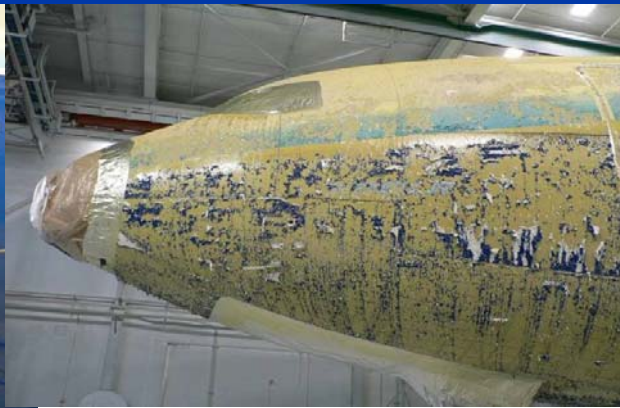
1<sup>st</sup> Strip Coat  
6.5 hours dwell

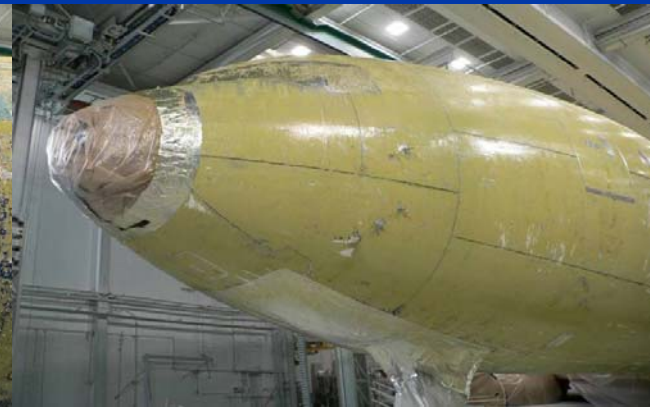
1<sup>st</sup> Strip Coat  
8 hours dwell + squeegee

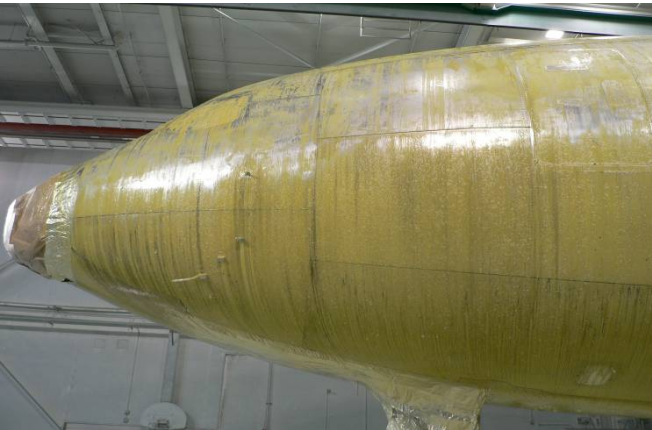
2<sup>nd</sup> Strip Coat  
6 hours dwell + squeegee

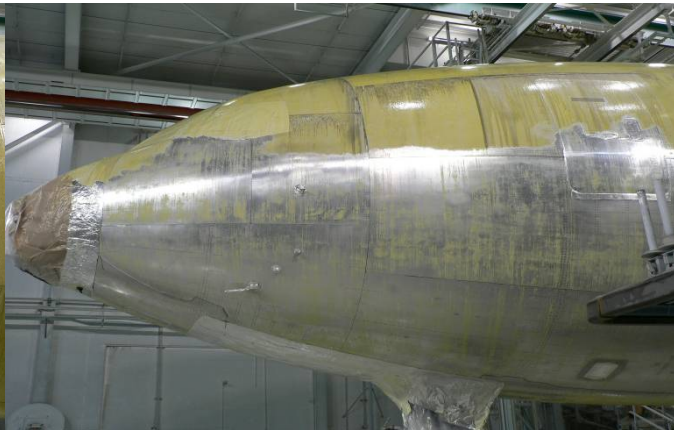
4<sup>th</sup> Strip Coat  
8 hours dwell + squeegee

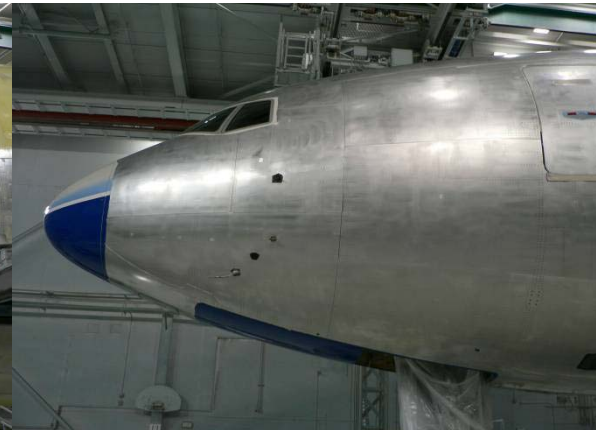
Abrade and rinse

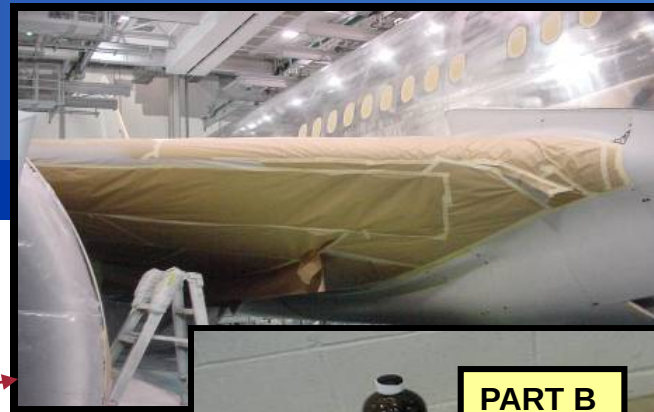
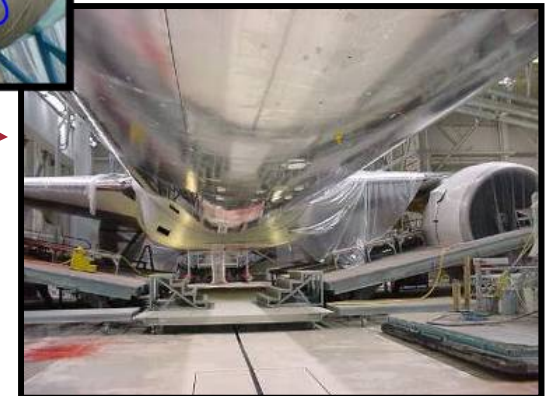
# Process Optimization

- Solvent clean
- Deoxidize (chemical or mechanical)
- Water break free check
- Mask for Prime

1. Mix 2-part kit & shake 5 Min
2. 30 minute induction time
3. 24 hour pot life
4. Apply with air-assisted airless paint gun with small fluid tip
5. Spray top down
6. Apply minimum amount to wet surface
7. Allow 10 minutes drip
8. Wipe off excess, if necessary
9. Tape after dry, 1 hour min

- Complete mask for prime

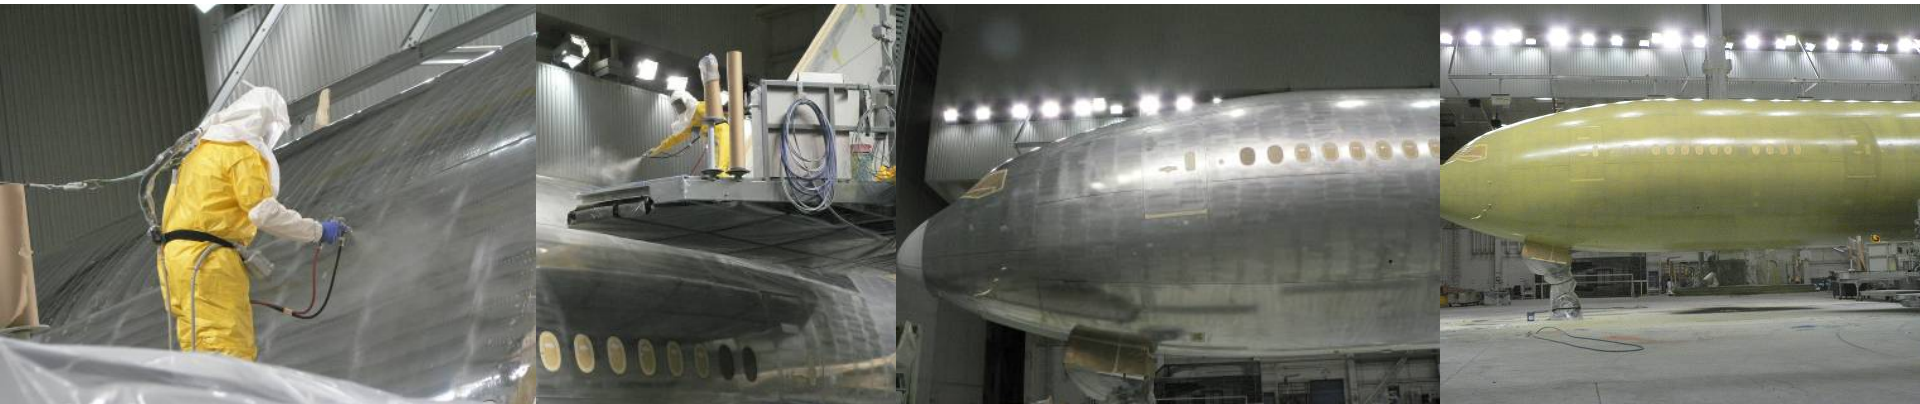
# Implementation

**Everett Decorative Paint Operations implemented AC131-CB/Boegel EPII for 777s in March 2007**

**Elimination of ~ 400 gallons of chromated pretreatment and wastewater material per 777**
