TECHNICAL REPORT REMR-CS-6

**IN SITU REPAIR OF DETERIORATED  
CONCRETE IN HYDRAULIC STRUCTURES:  
FEASIBILITY STUDIES**

**R. P. Webster, L. E. Kukacka**

Process Sciences Division  
Brookhaven National Laboratory  
Upton, New York 11973

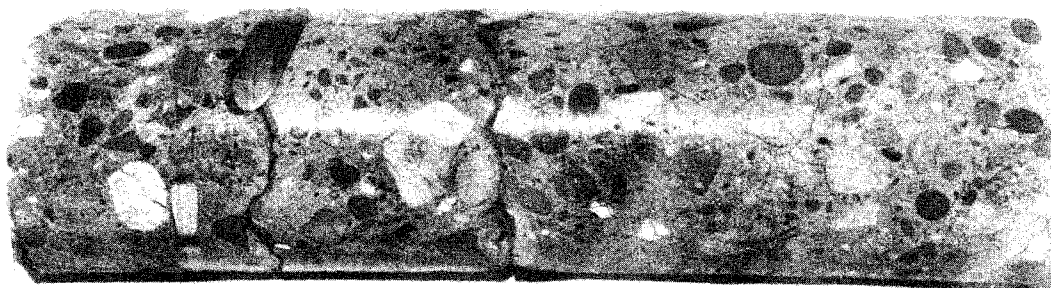
Figure 13. Cores taken from Pier 39 before and after epoxy injection.

Upon completion of the pulse velocity tests, concrete cores were taken from various locations to further evaluate the effectiveness of the repair. Presented in Figure 13 are photographs of cores taken before and after the pier was repaired. Cores removed from the pier top contained numerous random and crudely parallel diagonal cracks as well as many fractured aggregate particles. Only 5 to 10% of the cracks were filled with epoxy, explaining the difficulty in obtaining pulse velocity readings.

LOCK&DAM 20  
PIER 39

#2 10-14-82  
EPOXY INJECTED  
HORIZONTAL CORE  
D/S FACE OF PIER

The cores taken from the downstream face were not as severely cracked as the core removed from the pier top. The cracks were finer and more randomly distributed throughout the length of the cores. Fifty to ninety-five percent of the cracks were filled with epoxy. Tests for resistance to freezing and thawing subsequently run on two of these cores indicated the epoxy injection was successful in rebonding the concrete and in holding it together under freezing and thawing conditions. Most of the failure observed in these tests resulted from crumbling of the non-air entrained mortar and cracking of the coarse aggregate particles. In general, it was concluded that the epoxy in the fractures tended to hold the concrete together during the freezing and thawing cycles and aided in slowing down the deterioration of the concrete. Based on the tests, the performance of the concrete in the structure cannot be predicted absolutely; however, it is expected that while the exposed concrete surface would be subjected to damage due to freezing and thawing, the deeper interior concrete may be cemented together well enough to form an integral whole and to perform satisfactorily.
