✓  
USAAVRADCOM-TR-81-D-4 ✓

**COMBAT MAINTENANCE CONCEPTS AND REPAIR  
TECHNIQUES FOR HELICOPTER AIRFRAME STRUCTURES**

Sikorsky Aircraft Division  
United Technologies Corporation  
Stratford, Connecticut 06602

January 1981

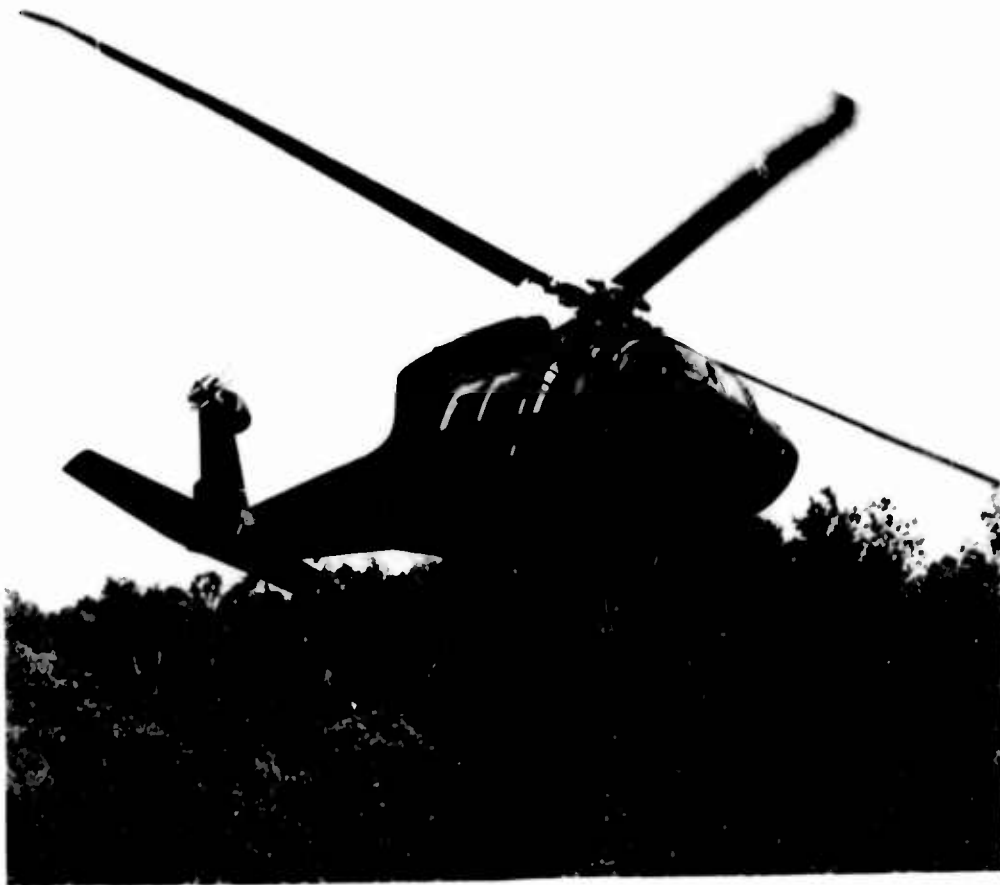
Figure 18. Black Hawk Helicopter in Nap-of-the-Earth Flight

The values given in Table 2 were developed around a scenario in which the helicopter is flying at low altitudes in a terrain-following or NOE mode, executing frequent and extreme maneuvers to avoid obstacles and evade detection (Figure 18). The model is adaptable to any other scenario, however. For example, by modifying the means and standard deviations of the appropriate variables, shotlines can be generated for an aircraft operating at high altitudes in straight and level flight at large standoff distances from the threat. The distribution of simulated hits on the aircraft would differ substantially for the two scenarios.
