EFFECT OF EXPOSURE TIME ON CAVITATION DAMAGE

Milton S. Plesset and Robert E. Devine

Division of Engineering and Applied Science CALIFORNIA INSTITUTE OF TECHNOLOGY Pasadena, California

Report. No. 85-31

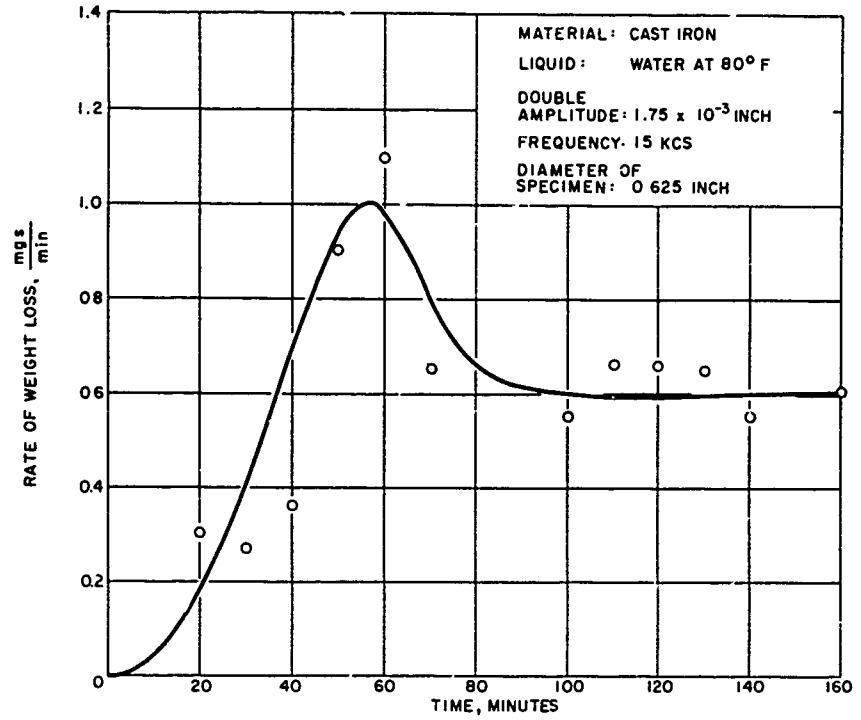
Figure 1 - Rate of cavitation weight loss with "zones of cavitation" as described by Thiruvengadam and Preiser (Refs. 3 and 5).

In a recent series of publications by Thiruvengadam and collaborators $[1-5]^1$ emphasis has been placed on the changes in the rate of cavitation damage with the duration of the exposure time. The cavitation damage process is divided by these writers into four zones which are described as follows: Zone 1 - the incubation or no-weight-loss zone, Zone 2 - the accumulation zone, Zone 3 - the attenuation zone, and Zone 4 - the steady-state zone. Typical graphs which are presumed to show these zones are reproduced in Figs. 1 and 2. These figures are reproduced from Ref. 3; they have also been published in Ref. 5. The important "zone" of cavitation damage is considered in these papers to be zone 4 which is taken to be the region of theoretical significance. The cavitation damage in these experiments was produced by oscillating a specimen immersed in water at an amplitude of the order of 10^{-3} in. at a frequency of approximately 14×10^3 cycles/sec. The accelerations of the specimen are produced by means of a magnetostrictive oscillator.

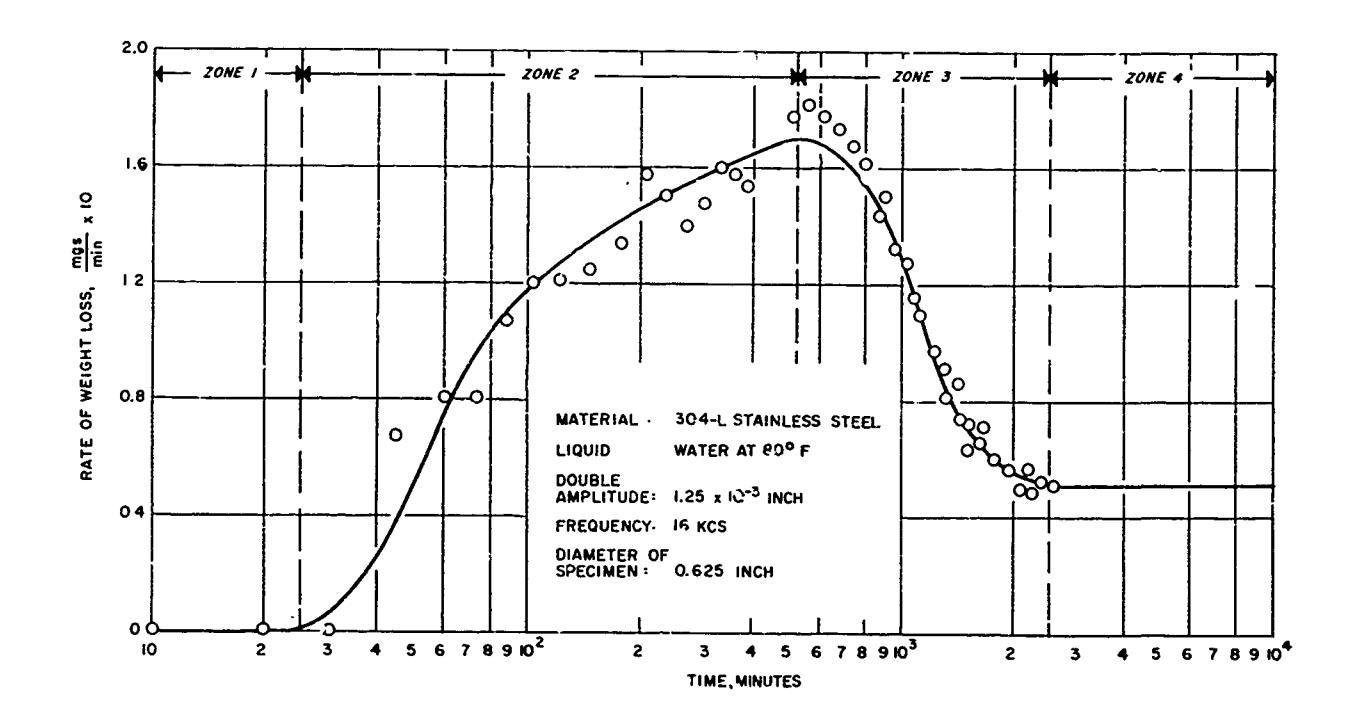
Figure 2 - Rate of cavitation weight loss as given by Thiruvengadam and Preiser (Refs. 3 and 5).

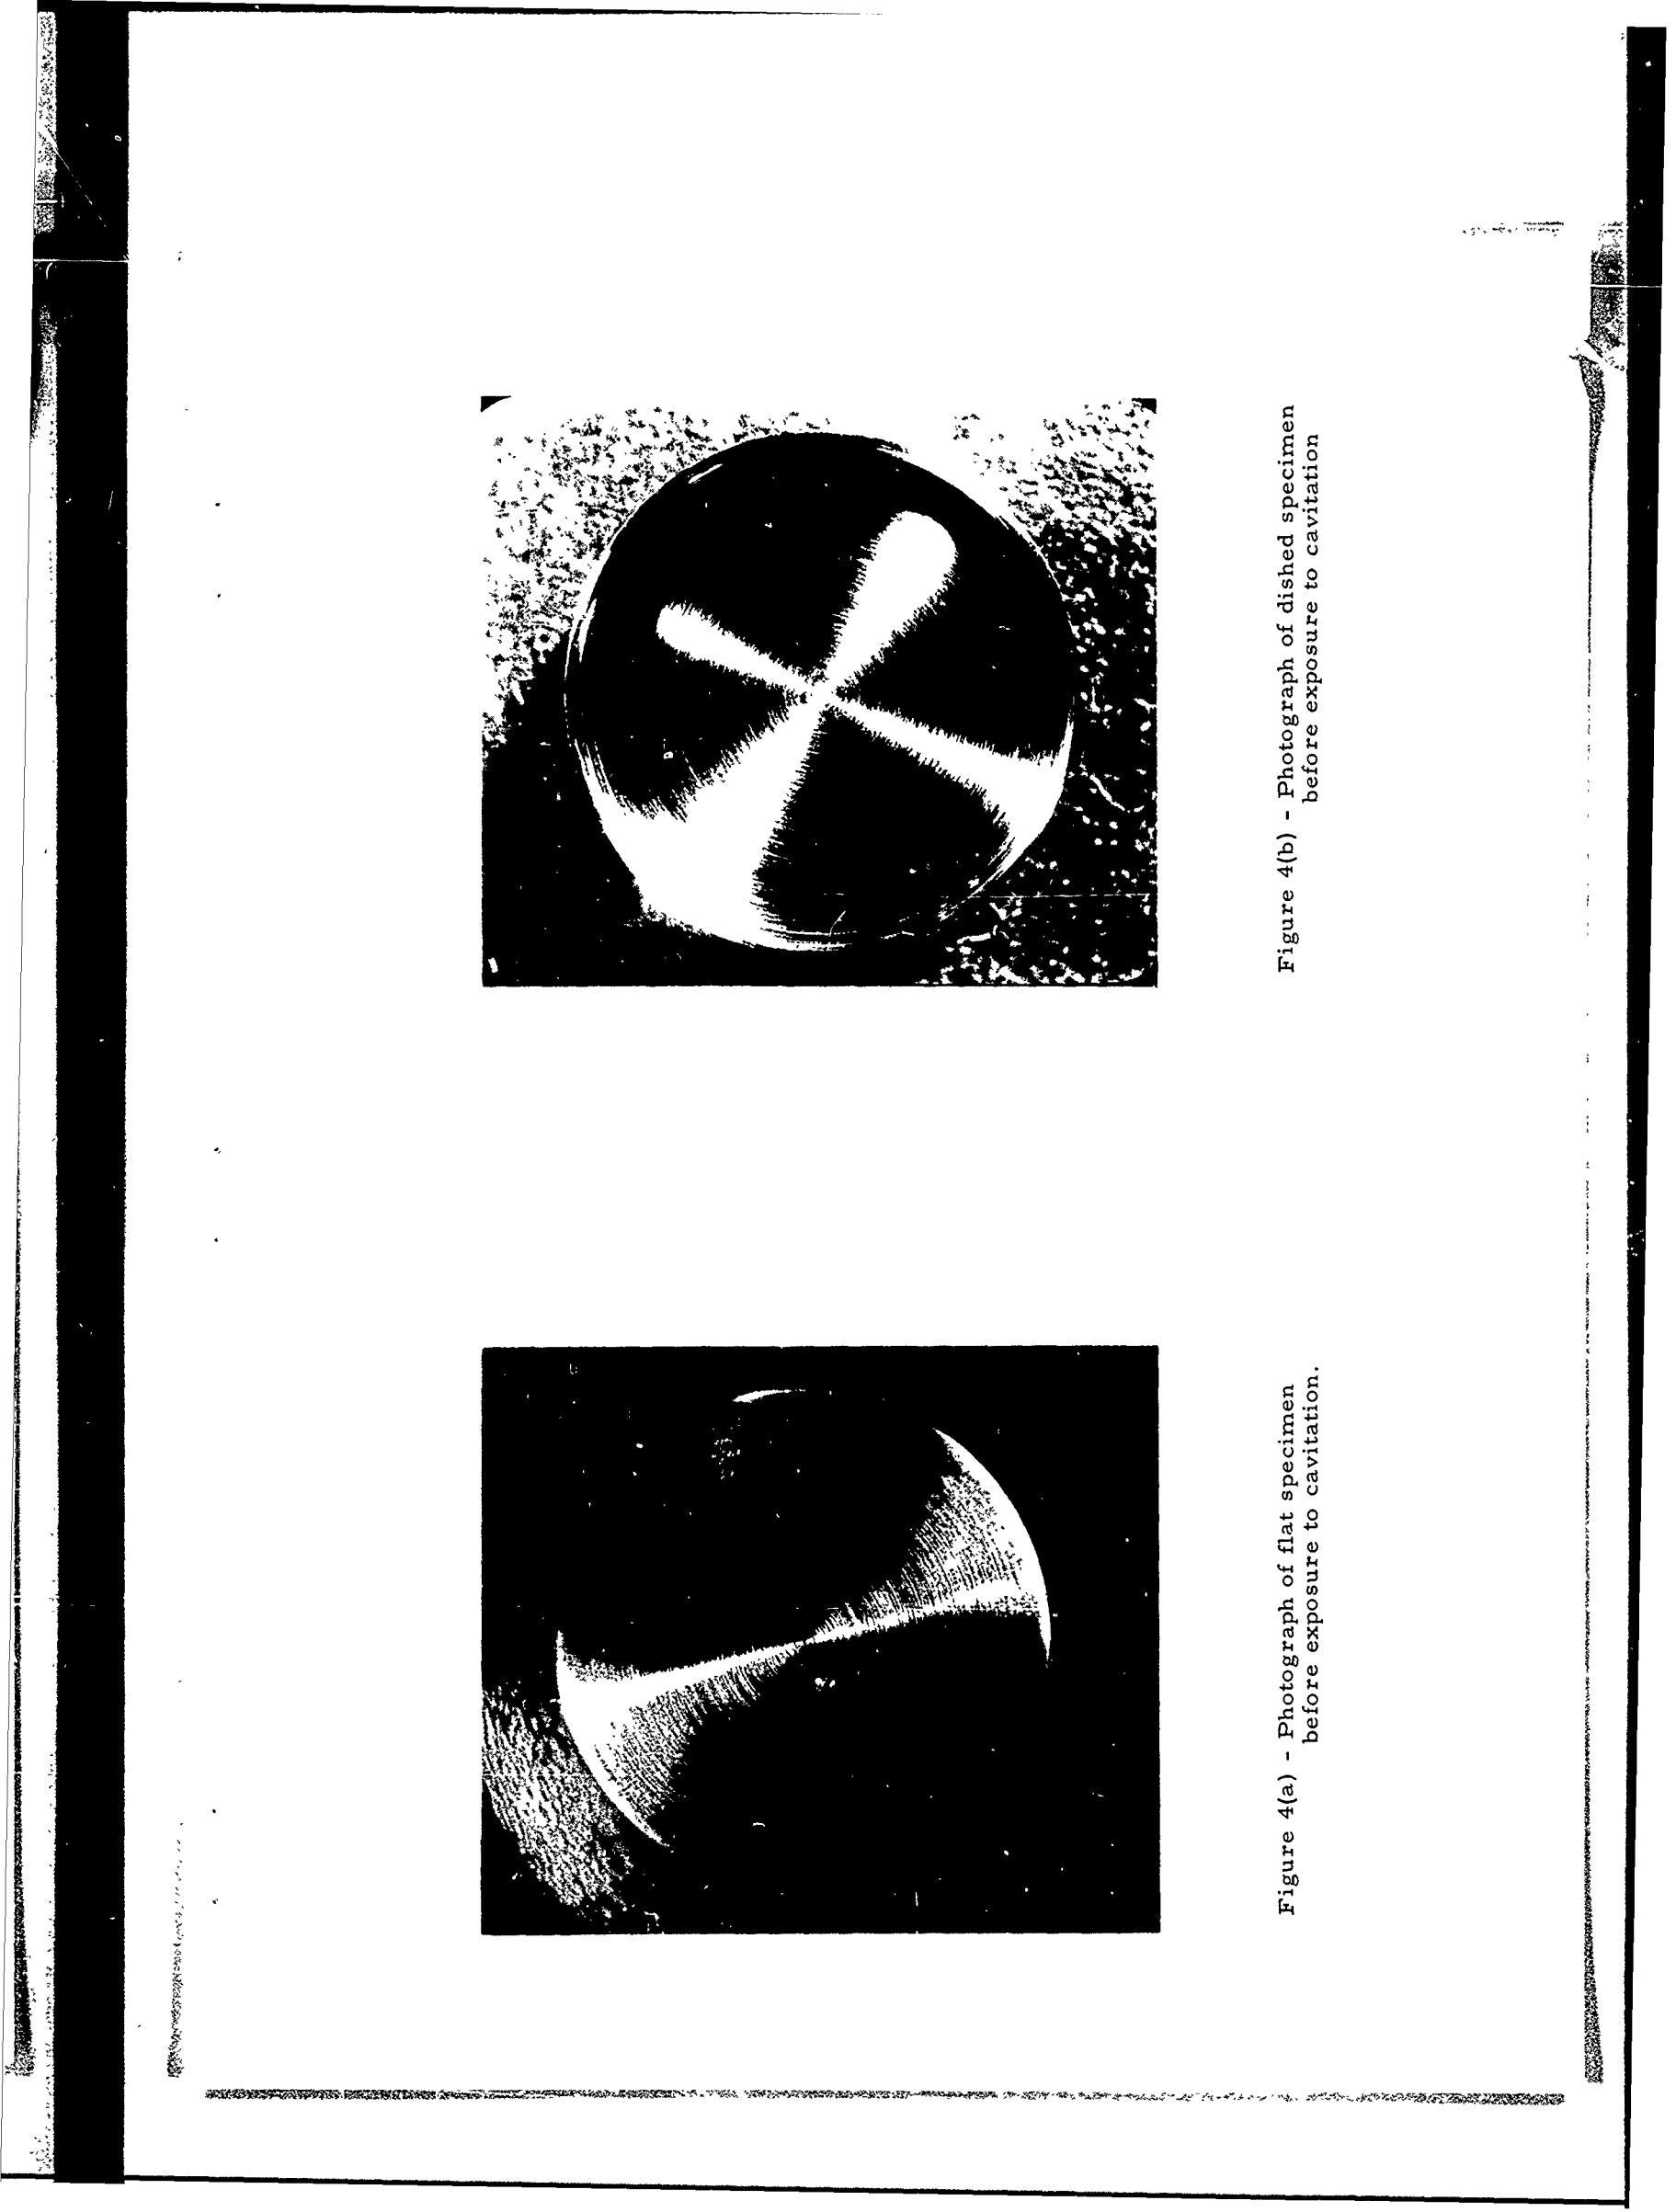
350 4340 STEEL IN DISTILLED WATER AT 25°C DISHED SPECIMENS 0, • △,▲ FLAT SPECIMENS 300 250 WEIGHT LOSS, mg 200 150 100 50 5 15 10 20 25 0 CAVITATION DAMAGE TIME, HOURS Figure 5 - Cumulative cavitation weight loss in milligrams as a funcation of cavitation exposure time in hours for 4340 steel, Brinell hardness number 173.

as the test material 4340 steel. All the specimens were made from the same stock which was annealed and had a Brinell hardness number of 173(3,000 kg scale). It was useful to use annealed specimens since our observations included X-ray analyses. Our measurements were made both with flat-faced and with dished specimens (see Fig. 4). The cumulative weight loss is shown as a function of time of exposure in Fig. 5 and the rate of cuvitation damage is shown in Figs. 6 and 7. The data which are given in these latter figures have a general trend similar to that shown by Thiruvengadam and his co-authors. We find that the so-called zone 2 has a much more nearly constant rate of weight loss than indicated by Thiruvengadam. This region corresponds to the "linear" portion in Fig. 5. It is our observation that this region of damage has a more nearly constant rate of weight loss and has a more extended duration when the face of the specimen has been carefully prepared to have a smooth, plane surface. The so-called zone 4 in our measurements does not show a precisely constant rate. It is very clear that the damage rate has fallen to an appreciably lower value than that characteristic of the linear region.

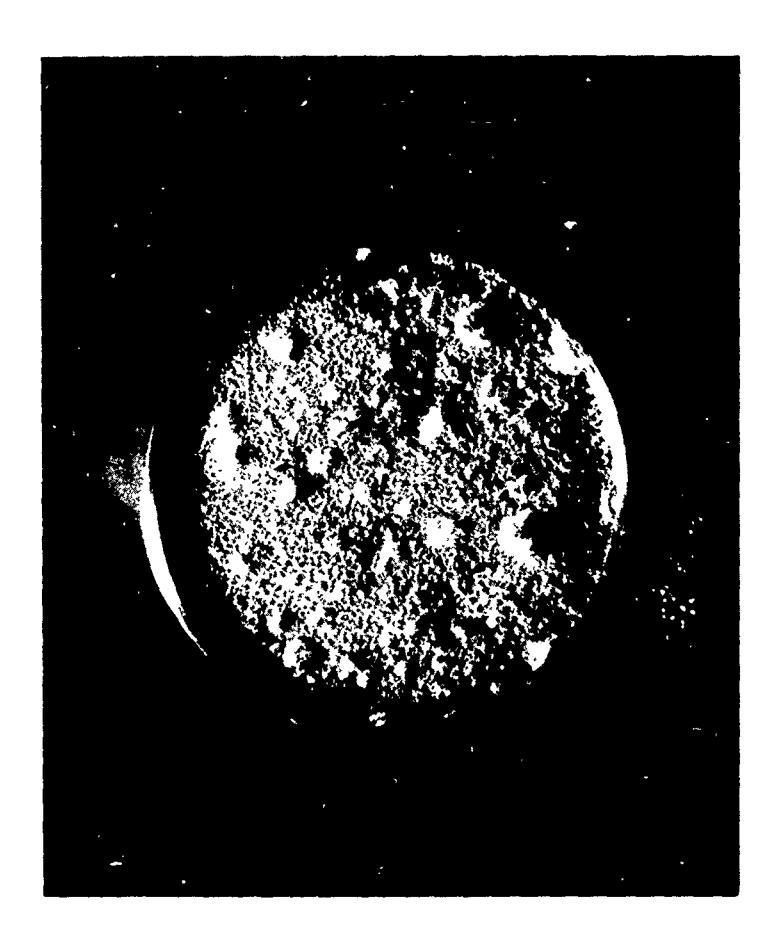
Figure 9 - Photograph of maximum cavitation cloud over dished 4340 specimen before appreciable exposure to cavitation damage ("zone 1"). Photographic exposure time 2 microseconds.

Pictures were taken of the cavitation cloud with an exposure time of 2 microseconds which is short compared with the 70 microsecond period with which the specimens were oscillated by the magnetostrictive driver. The short exposure was obtained by means of a pulse which fired an FX 2 flash lamp. The pulse was phased with the 14 kc/sec magnetostrictive driving voltage so as to photograph the bubble cloud at its maximum over the specimen face. Figure 9 shows the maximum bubble cloud over a dished specimen before visible damage has developed; this bubble cloud occurs in the so-called zone 1. Figure 10 shows the maximum bubble cloud over a dished specimen when the cavitation damage is taking place in the region of linear weight loss; this region is the socalled zone 2 of Thiruvengadam, et al. There is no essential difference between the bubble cloud in these two regions. Figure 11 shows the maximum bubble cloud over a dished specimen which has been heavily damaged; this is the so-called zone 4, or the "steady-state" zone. It is very evident that the bubble cloud is considerably reduced in intensity as a consequence of hydrodynamic damping effects over the deeply damaged surface. It is apparent that the reduced rate of weight loss is a result of the reduced density of the bubble cloud. Figures 12, 13, and 14 show that flat-faced specimens have the same behavior as the dished specimens.

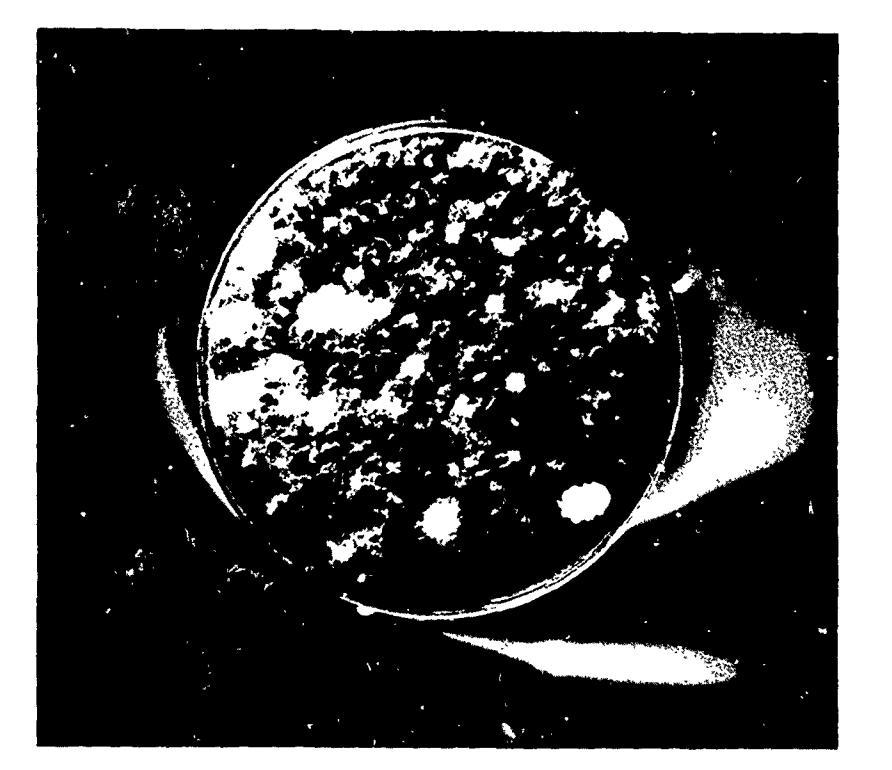
Figure 11 - Photograph of maximum cavitation cloud over dished 4340 specimen after long exposure to cavitation ("zone 4"). Photographic exposure time 2 microseconds. 55. A

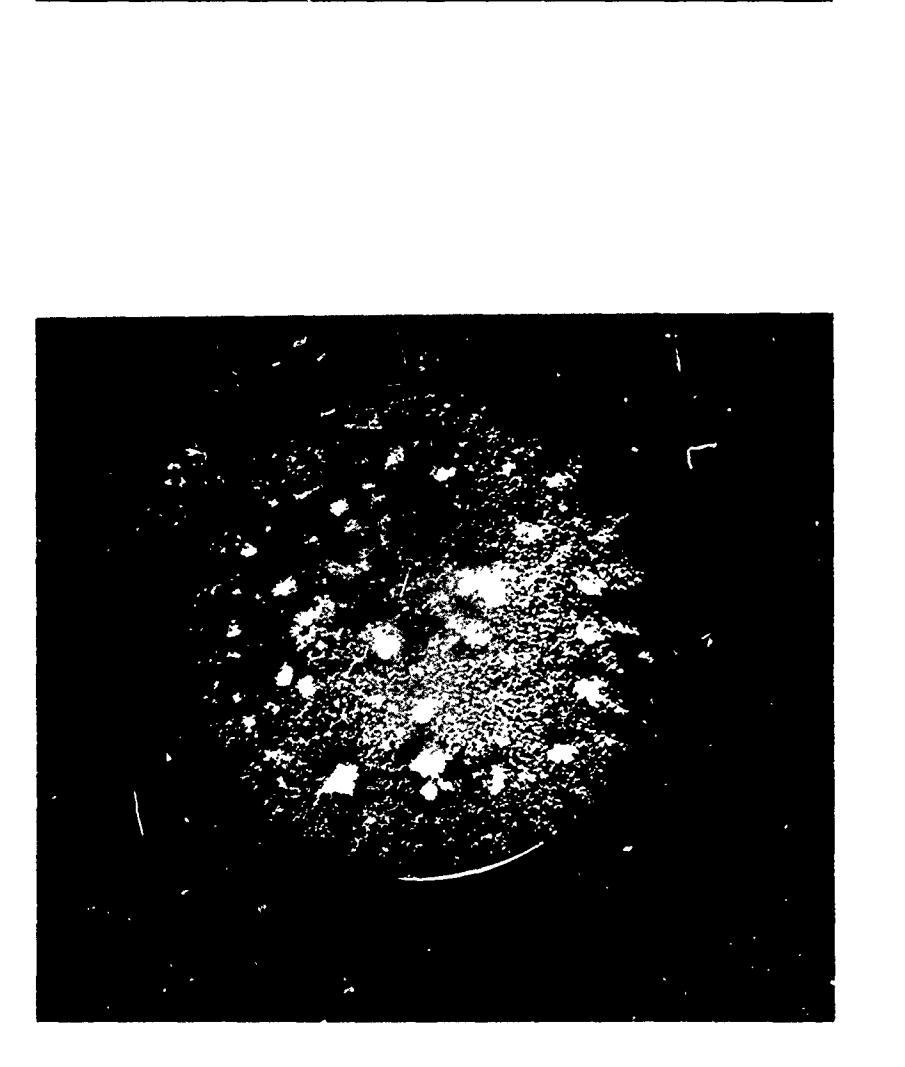
Figure 12 - Photograph of maximum cavitation cloud over flat 4340 specimen before appreciable exposure to cavitation damage ("zone 1"). Photographic exposure time 2 microseconds.

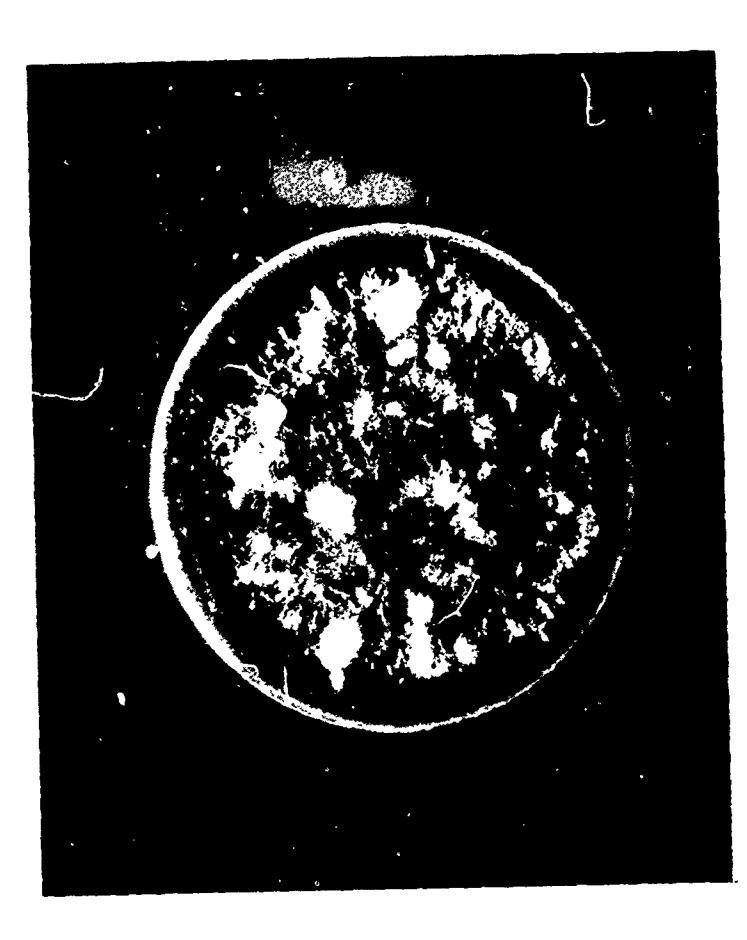
Figure 14 - Photograph of maximum cavitation cloud over flat 4340 specimen after long exposure to cavitation ("zone 4"). Photographic exposure time 2 microseconds.

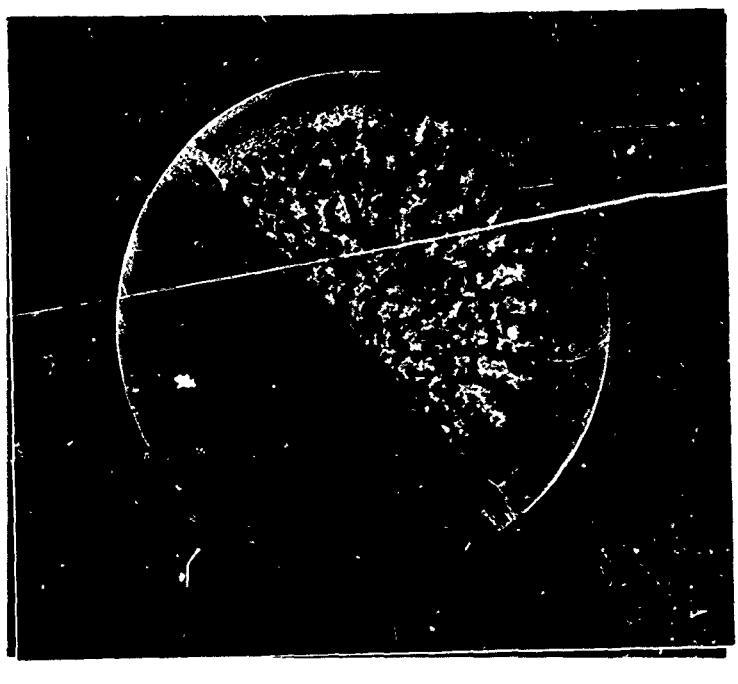
Figure 15 - Flat-faced 4340 specimen with one half of the face ground and polished smooth; the remaining half of the face has been left as it was after long exposure to cavitation ("zone 4").

reached the so-called zone 4 one half of the face was smoothed off and the remaining half was left unchanged as shown in Fig. 15. Figure 16 is a flash photograph of the cavitation cloud over the face of such a specimen; it shows the great difference in the cavitation cloud for the surface in these two conditions. The effect of holes in a surface on the cavitation cloud may also be illustrated by making small holes in an undamaged flat surface as illustrated in Fig. 17. These holes were made electrolytically with a bundle of fine wires; the holes are approximately 0.019 in. in diameter, 0.050 in. in depth, and approximately 0.015 in. apart. Figure 17 shows the maximum bubble cloud over the specimen face as the specimen is oscillated sinusoidally by the magnetostrictive oscillator. The bubble cloud is clearly very sparse compared with that over a specimen with smoother surface.

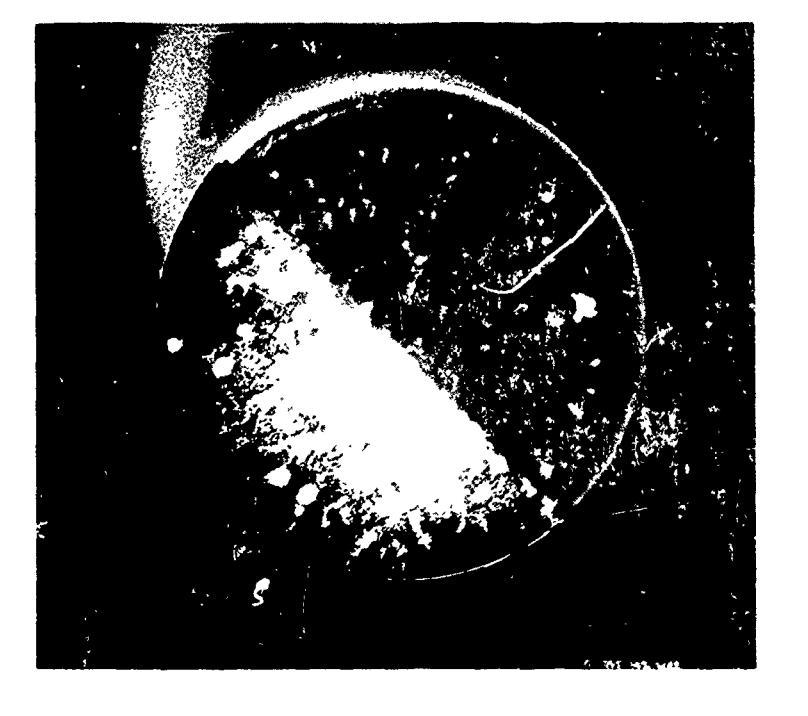
Figure 16 - Photograph of maximum cavitation cloud over the specimen with the face as shown in Fig. 15. Photographic exposure time is 2 microseconds. の日本のないないないである

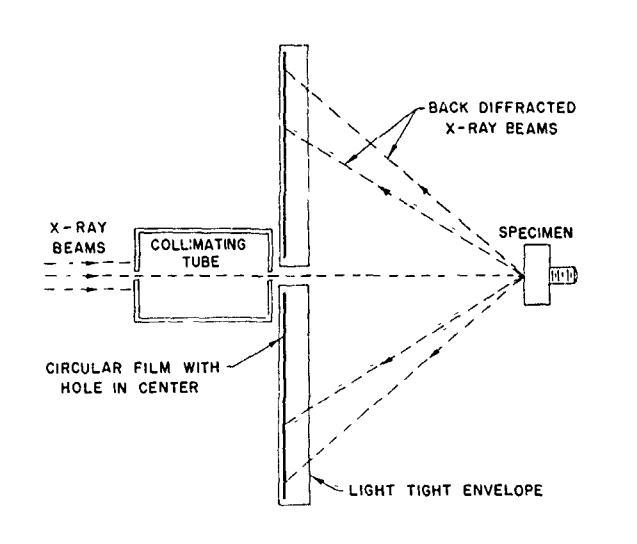
Figure 18(a) - Diagram of arrangement for obtaining X-ray diffraction pattern.

Laue X-ray diffraction patterns were obtained from 4340 steel specimens before exposure to cavitation and after exposure to cavitation for various times. The X-ray beam was circular in cross section with a diameter of 0.030 in. and was well collimated. The X-ray line used was the Cobalt K_{α} line which has a wavelength of 1.790 Angstroms. The beam was directed normally on the face of the specimen, and the backreflected diffraction pattern was recorded on photographic film. The maximum depth of penetration of these X-rays into the specimen material is about 25 μ ; the important contribution to the diffraction pattern comes from the first 10 μ below the specimen surface.

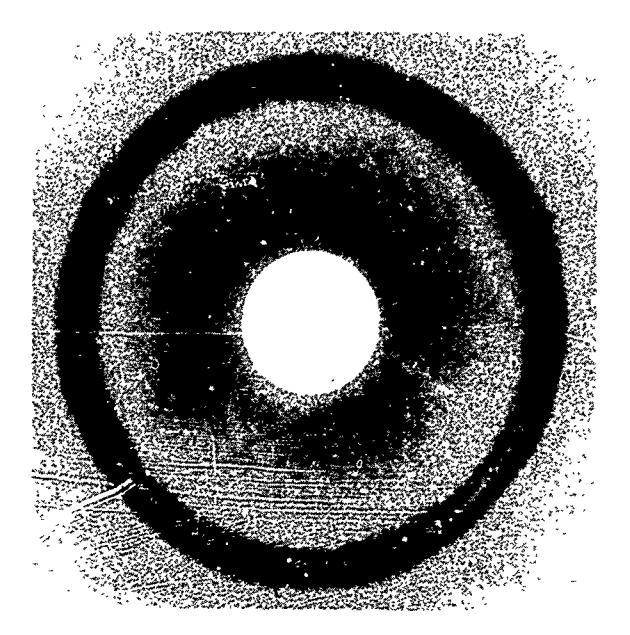
Figure 19(a) - The X-ray Laue diffraction pattern of the specimen after a 10 second exposure to cavitation.

exposure to any cavitation; the sharp spots are indicative of a well-defined crystal structure. The progressive smearing of the spots into a continuous ring upon exposure to cavitation is illustrated in the series of patterms shown in Fig. 19 and the distortion of the structure is thereby demonstrated. Loss in definition of the spots is already evident in Fig. 19a which corresponds to only 10 seconds exposure to cavitation. It is evident that the plastic deformation of the crystal structure begins immediately upon exposure to cavitation. The plastic deformation sets in before the surface shows damage which is evident from optical examination. Plastic deformation of the depth available to examination by the X-rays appears to be fairly complete in 5 minutes and is clearly complete in 30 minutes to 1 hour of exposure to the cavitation. The depth of penetration of the plastic deformation after 1 hour exposure to cavitation may be found by removal of surface layers by means of electrolytic polishing until the crystal pattern is restored. The X-ray patterns after successive removals of surface layers are shown in Figures 20 a, b, and c. It is evident that the removal of 31μ from the damaged surface does not restore the sharp spot pattern completely. It is, however, restored completely after 46µ has been removed.

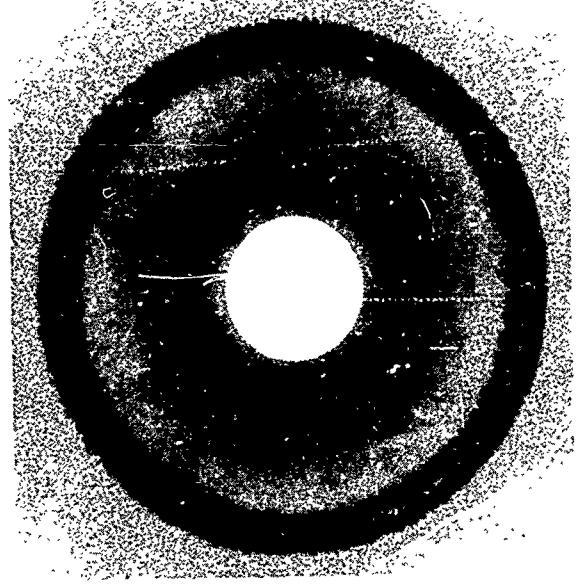
Figure 20(c) - The X-ray Laue diffraction pattern is shown for a specimen exposed to cavitation damage for one hour. Forty-six μ of the surface have been peeled off by electrolytic polishing
