D6- 22978 June 1969

The Effect of Heat Treatment on the Fracture Toughness and Subcritical Crack Growth Characteristics of a 350-Grade Maraging Steel

C. S. Carter

Boeing Commercial Airplane Group Renton, Washington

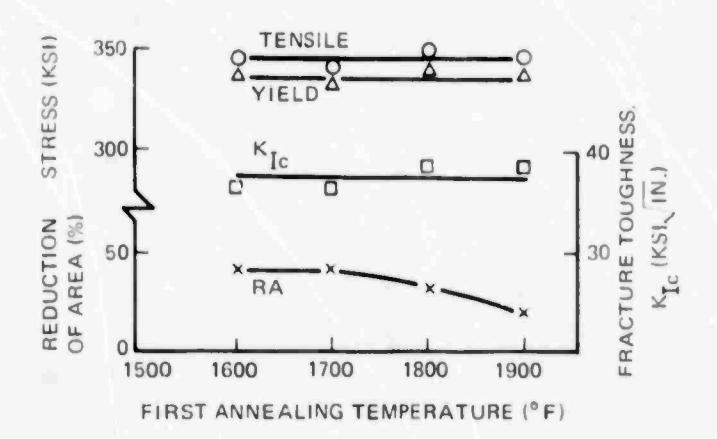
Fig. 1. Effect of first annealing temperature on mechanical properties (second anneal at 1500° F/1 hr and aged 900° F/8 hr).

The effect of double solution annealing on the properties of the 4-in.-square billet was examined, and the results are shown in Figs. 1 and 2. The first annealing temperature had no significant effect on tensile properties except that the reduction of area was less when the annealing temperature exceeded 1700° F (Fig. 1). This

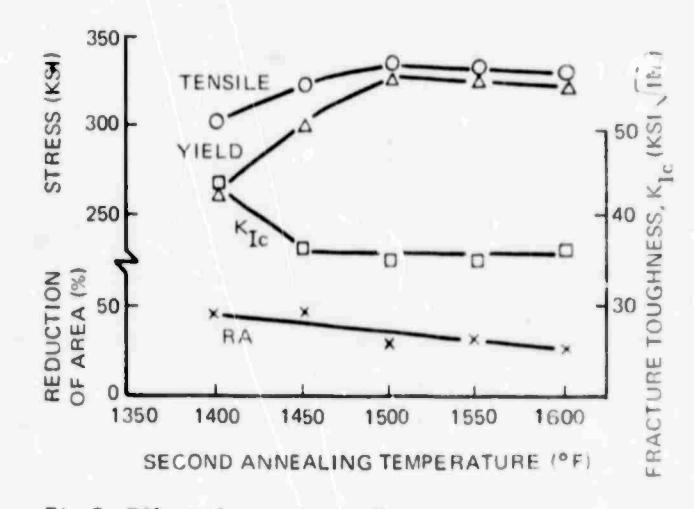
Fig. 2. Effect of second annealing temperature on mechanical properties (first anneal at 1700° F/1 hr and aged 900° F/8 hr).

could be associated with grain growth. Fracture toughness K_{1c} , however, was independent of annealing temperature. As indicated in Fig. 2, the second annealing temperature should exceed 1450° F. Annealing below this temperature gave lower tensile properties since some austenite was present. Therefore, for the remainder of this study, the specimens were double solution annealed at 1700° F for 1 hr followed by 1500° F for 1 hr.

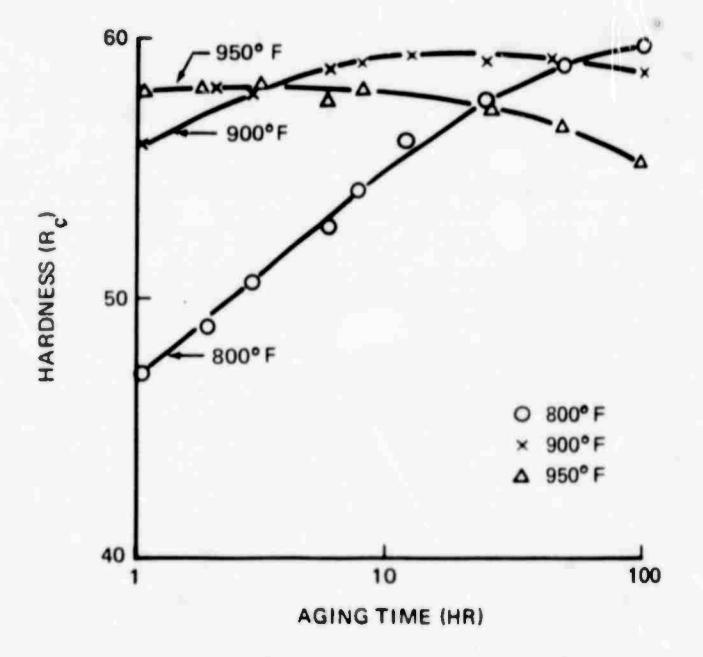
Fig. 3. Effect of aging on hardness (double solution annealed 1700°F/1500°F).

The hardness behavior of the 4-in.-square billet aged at various temperatures for times up to 100 hr is shown in Fig. 3. The curves are typical of precipitation hardening alloys, with maximum hardness being achieved after aging at the lower temperature for a longer time.

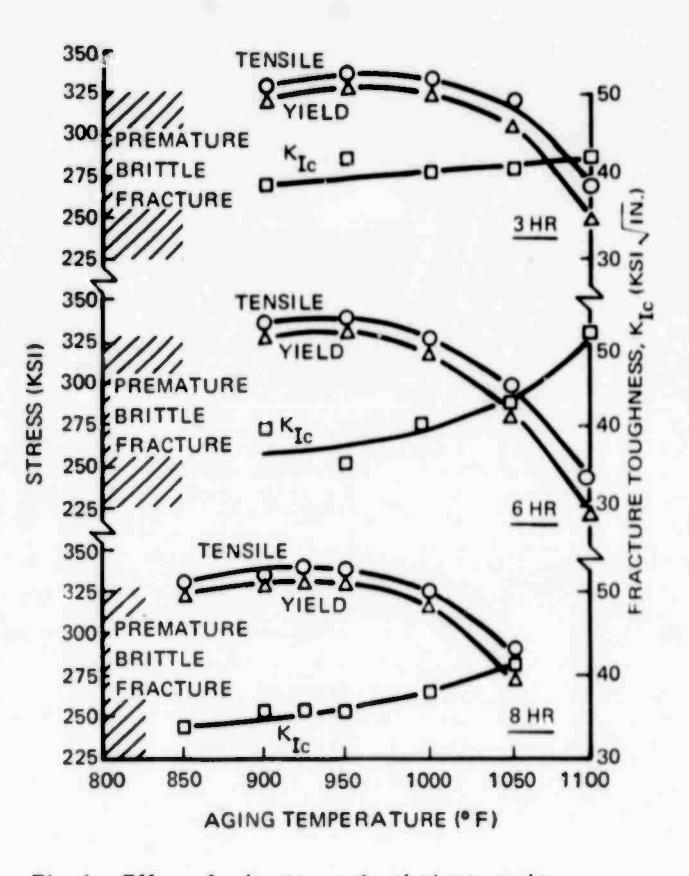
Fig. 4. Effect of aging on mechanical properties (double solution annealed 1700° F/1500° F).

The effect of aging temperature on the tensile properties and fracture toughness of the same material is shown in Fig. 4. Significant differences in behavior were observed between specimens aged at less than 900° F and those aged at higher temperatures. Because of this, the two temperature regimes are discussed separately below.

Aging at temperatures above 1000° F led to a marked reduction in tensile properties (Fig. 4). The amount of reverted austenite retained after aging at various temperatures for 3 hr is shown in Fig. 10, and comparison with Fig. 4 shows the decrease in strength could be associated with reverted austenite; however, some of the austenite formed during aging may have transformed to virgin (unaged) martensite upon cooling to room

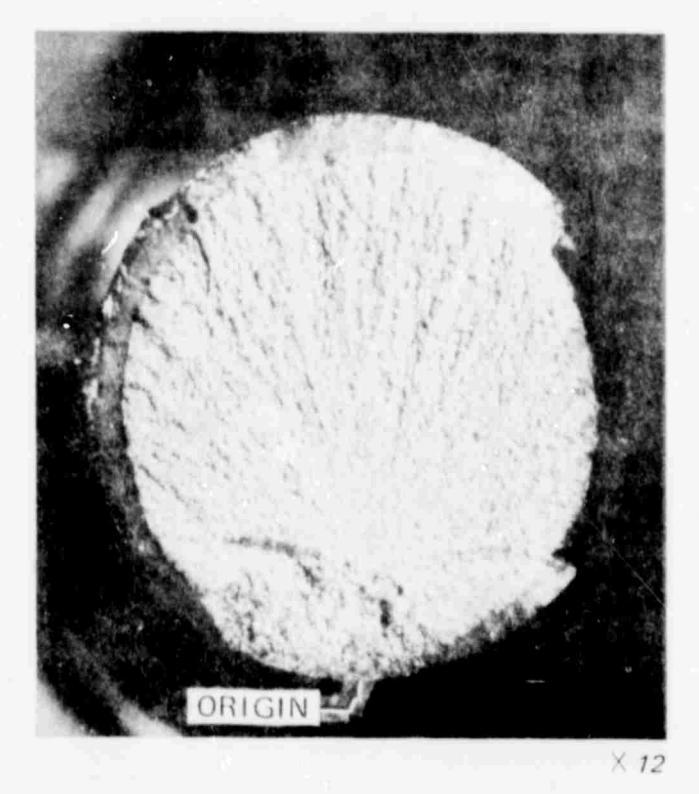
Fig. 5. Tension specimen that prematurely failed in laboratory air (aged 850° F/3 hr).

This suggested that the thumbnail region was due to subcritical crack growth during the rising load tension test and not to preexisting defects. Tension specimens that had been aged at either 800° F for 8 hr or 850° F for 3 hr were therefore tested in two additional ways. In one test series, the specimens were rapidly tension loaded to failure in laboratory air at a crosshead travel speed of 2 in./min as compared with 0.005 in./min in the tests discussed above. All the specimens tested in this way broke in a ductile manner with a cup-and-cone-type fracture (Table III), thus confirming that the cracks were not preexisting but only developed after loading for a definite period of time. In the second series of tests, 0.4 in. of the 1.25-in.-long gage section of the tension specimens were surrounded with Seattle tap water and the specimens tension loaded to failure at a crosshead travel speed of 0.005 in./min. Premature brittle fracture occurred in the section exposed to tap water at a similar stress level and in an identical manner to the specimens tested in air. These results, included in

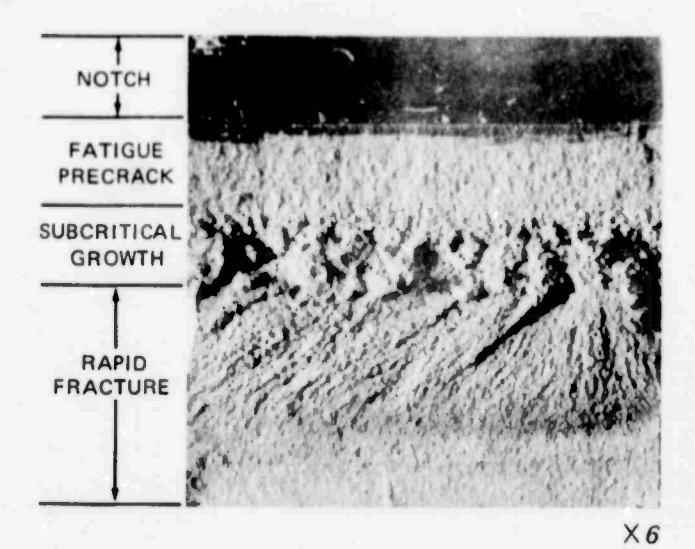
Fig. 6. Subcritical crack growth in a notched bend specimen tested under rising load in laboratory air (aged 800° F/3 hr).

Metallographic examination of the subcritical crack growth region revealed an intergranular mode of cracking with the cracks tending to branch on a microscopic scale (Fig. 7). Possibly these microscopic branch cracks were sufficient to dissipate the applied load and effectively blunt

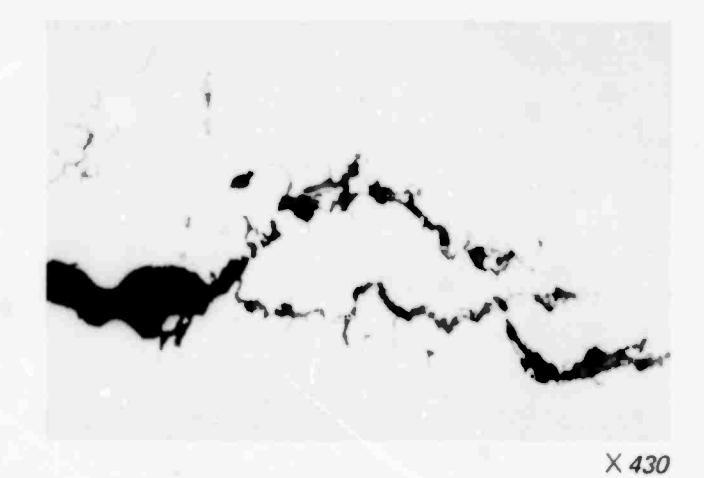
Fig. 7. Microscopic crack branching in a notched bend specimen tested under rising load in laboratory air (aged 800° F/8 hr).

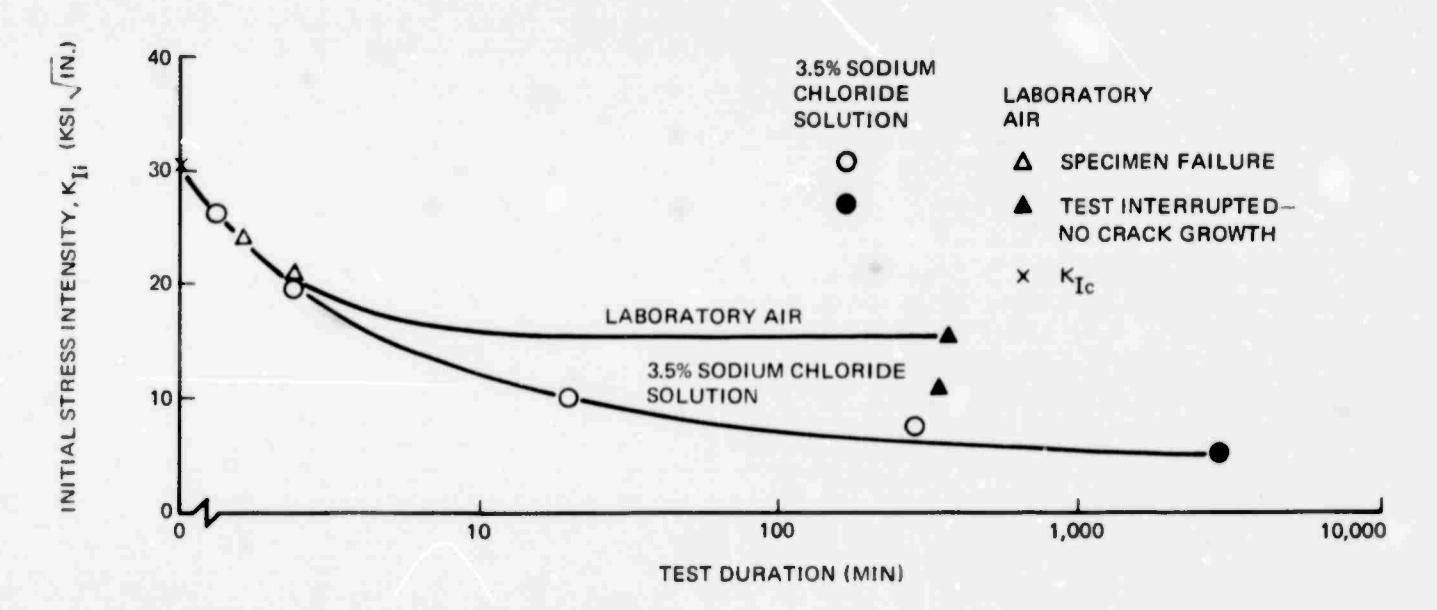
Fig. 8. Subcritical crack growth resistance (aged 800° F/8 hr).

To quantitatively measure the resistance to crack growth, precracked Charpy specimens were cantilever loaded to selected stress intensity levels in laboratory air and the time to failure established. The results, shown in Fig. 8, indicate that crack growth did not occur below a stress intensity level of 15 ksi \times in. This information can be used to explain the mechanics of fracture in the tension specimens.

Resistance to crack growth was similarly determined in 3-1/2% aqueous sodium chloride solution (Fig. 8). Threshold stress intensity was

reduced to 5 ksi \sqrt{in} . in this environment although the times to failure at stress intensities exceeding 20 ksi \sqrt{in} . were similar to those recorded in air. Crack growth measurements revealed that crack velocity was directly proportional to applied stress intensity (Fig. 9).

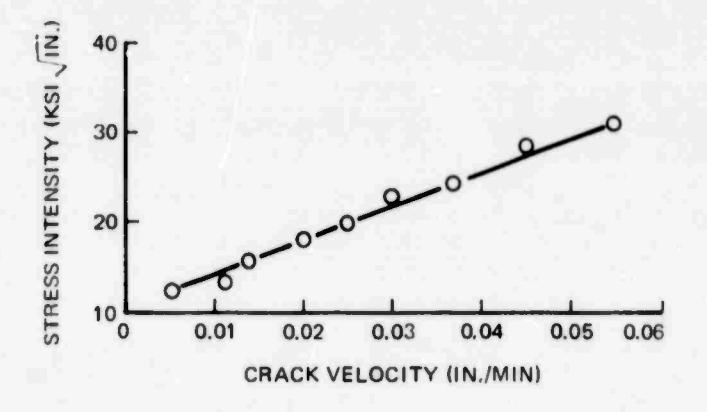
Fig. 9. Relationship between stress intensity and crack velocity (aged 800° F/8 hr).

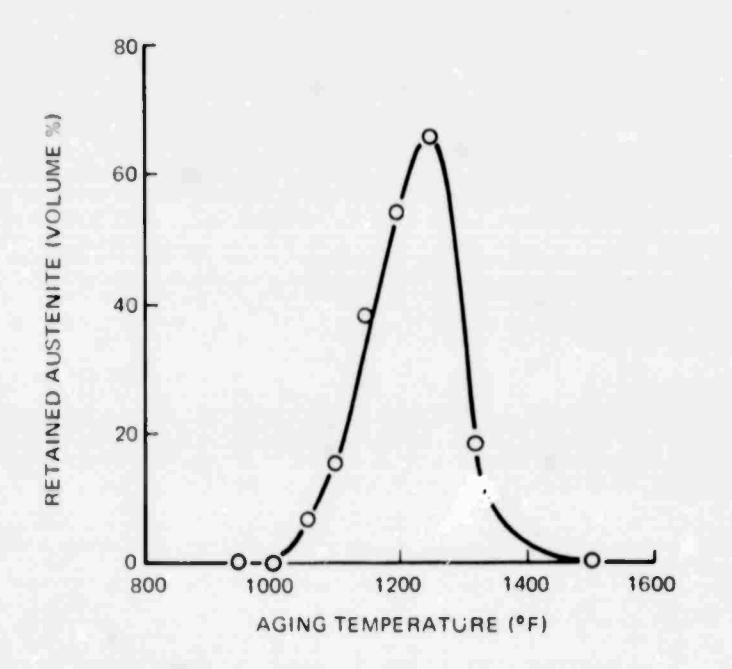
Fig. 10. Austenite retained at room temperature after aging for 3 hr (bar material).

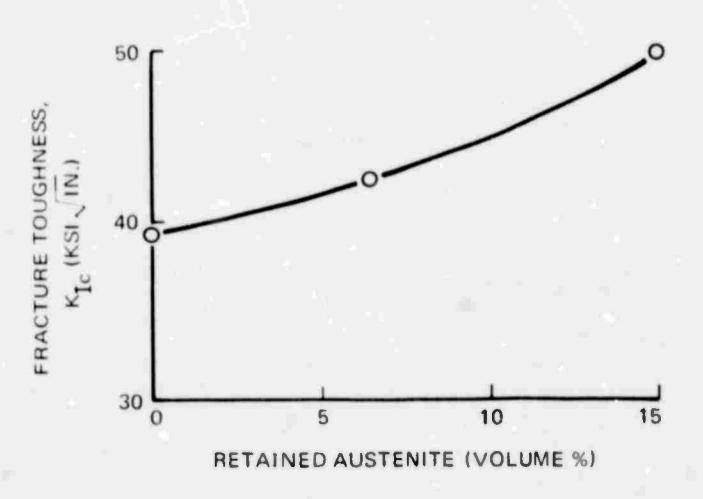
Fig. 11. Influence of retained austenite on fracture toughness.

temperature and would also contribute to the observed strength reduction. Unfortunately, the reverted austenite only slightly improved the fracture toughness (Fig. 11). This may be

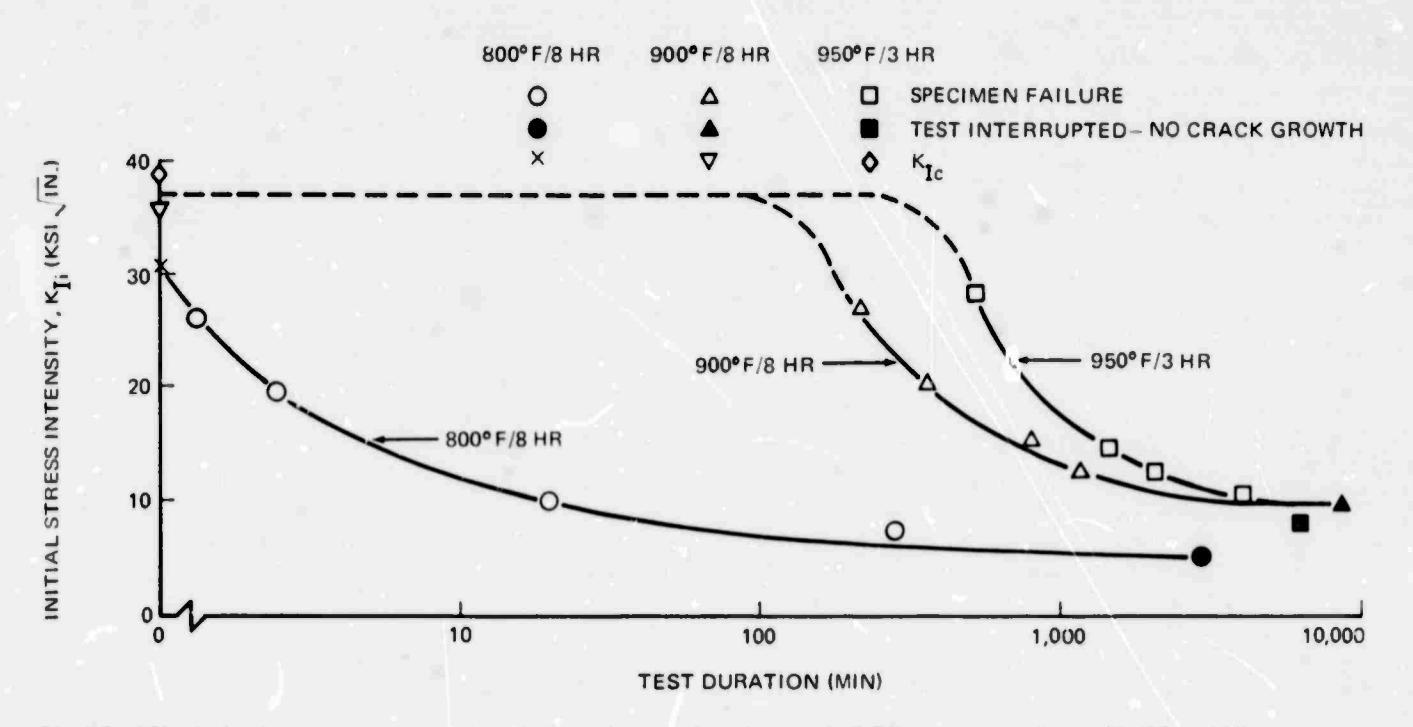
Fig. 12. Effect of aging treatment on subcritical crack growth resistance in 3.5% aqueous sodium chloride solution.

The crack growth resistance of 900° and 950° F aged specimens, statically loaded in 3.5% aqueous sodium chloride solution, is shown in Fig. 12, The threshold stress intensity was 10 ksi \sqrt{in} , and the crack velocity was constant (independent of stress intensity) at approximately 0.0006 in./min, for both heat treatment conditions. Both the threshold level and the time to failure at a given initial stress intensity were increased relative to the 800°F aged condition, which is shown for comparison in Fig. 12. It was not apparent why the crack velocity changed from a stress intensity dependancy to a constant, and much slower, rate when the aging temperature was increased from 800° to 900° or 950° F; the fracture mode was intergranular for all heat treatments,

The time to failure at a given initial stress intensity level was increased by raising the aging temperature from 900° to 950° F. This can be attributed to an increase in the incubation time for crack initiation since the crack velocity and fracture toughness (hence the critical crack length for ligament rupture) were similar for both heat treatment conditions. It has been proposed that the incubation period can be explained as either the time for the environment to permeate a crack tip film or diffusion of the active species to a critical site in the crack tip region (15). The latter seems to be unlikely because the crack velocities were identical for both heat treatment conditions and, therefore, suggests the crack-tip film was more impervious in the 950° F aged condition.

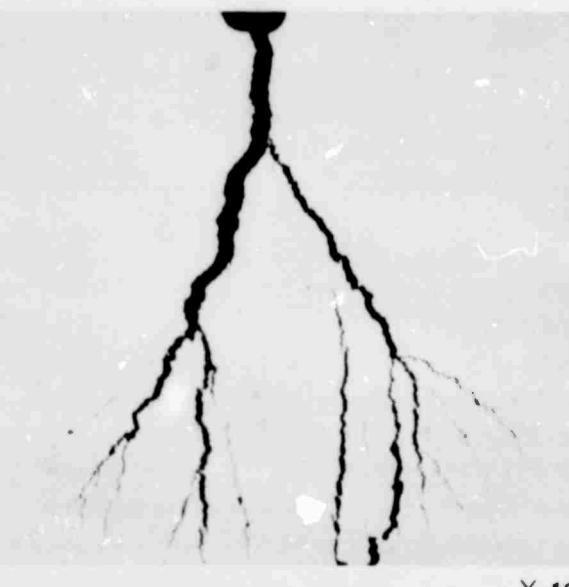
Fig. 13. Macroscopic crack branching in notched bend specimen loaded to $K_{Ii} = 27 \text{ ksi} \sqrt{\text{in. in } 3.5\%}$ aqueous sodium chloride solution (aged $900^{\circ} \text{ F/8 hr}$).

The cracks were extensively branched on a macroscopic scale in both heat treatment conditions (Fig. 13). This can be contrasted with 800° F aged specimens in which there was no evidence of macroscopic branching and the crack velocity was directly proportional to stress intensity. As discussed elsewhere, branching only occurs when the crack velocity is essentially constant and a critical stress intensity level is attained (16).

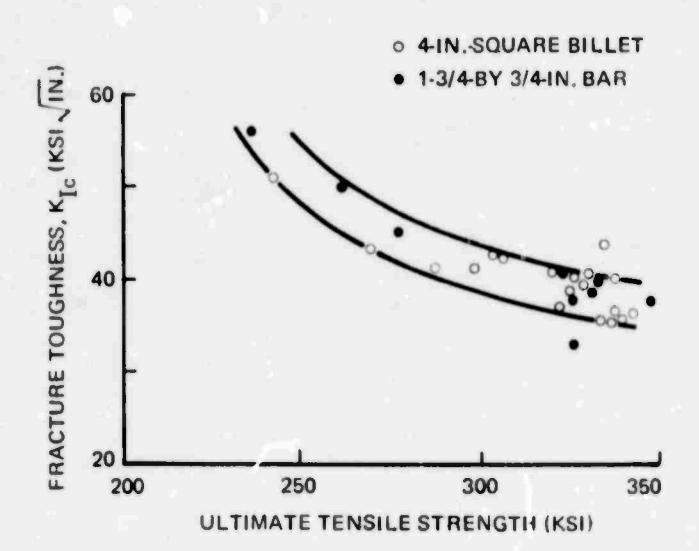
Fig. 14. Relation between strength and toughness for bar and billet (aged at various temperatures above 850°F).

be achieved. Therefore, the individual results are not recorded here, but the relationship between strength and K_{Ic} for material aged at temperatures in the range 900° to 1100° F is shown in Fig. 14 for both billet and bar material. The poor tradeoff between decreasing strength and toughness is apparent and emphasizes the ineffectiveness of revorted austenite as a crack stopper.

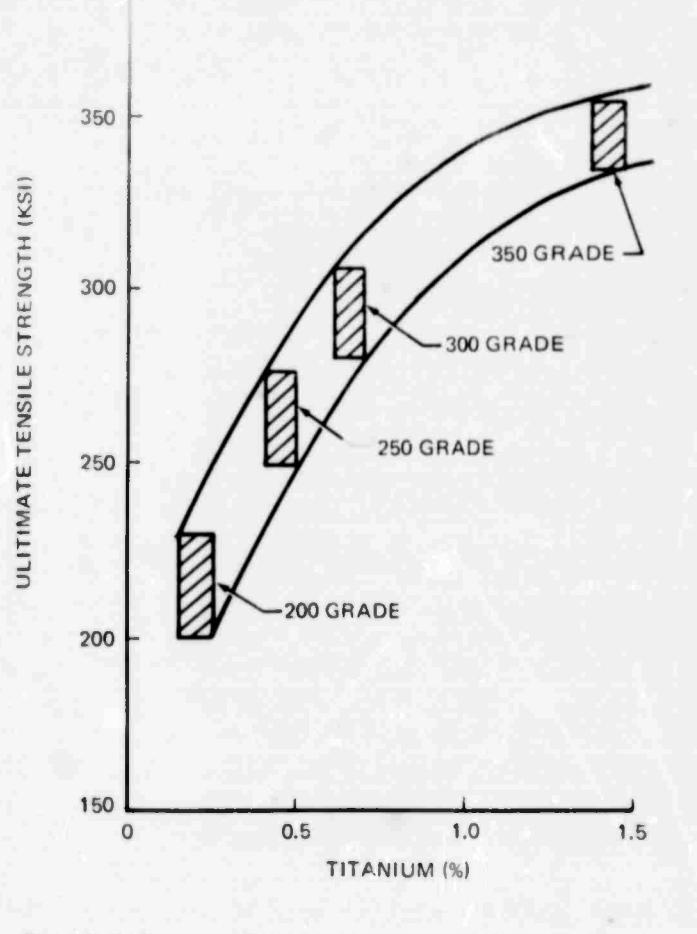
Fig. 16. Influence of titanium content on ultimate tensile strength.

In the tensile strength range 180 to 350 ksi, the strength level of maraging steels is primarily increased by raising the titanium content. The effect of this element is shown in Fig. 16 using typical values of strength and titanium content for each grade. It is apparent that titanium is much less effective in strengthening when the content exceeds 1%, particularly when it is remembered that the cobalt content of the 350 grade is approximately 4% higher than in the other grades.

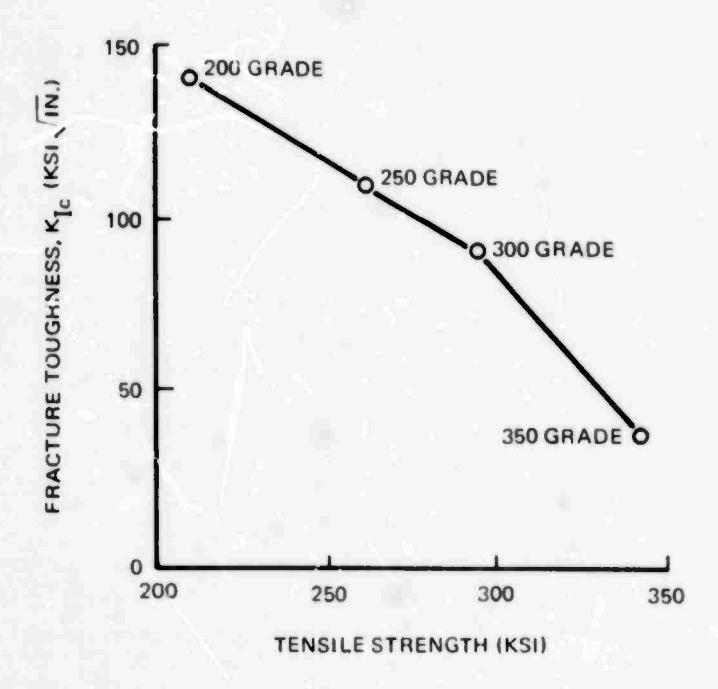
Fig. 17. Relationship between tensile strength (typical) and fracture toughness (optimum).

The relationship between strength and fracture toughness (Fig. 17) indicates that K_{1c} rapidly decreases with strength level in the range 300 to 350 ksi. This can be associated with the high titanium contents (1.0% to 1.5%) in this strength range because, as shown in Fig. 18, the fracture toughness is inversely related to the titanium content.

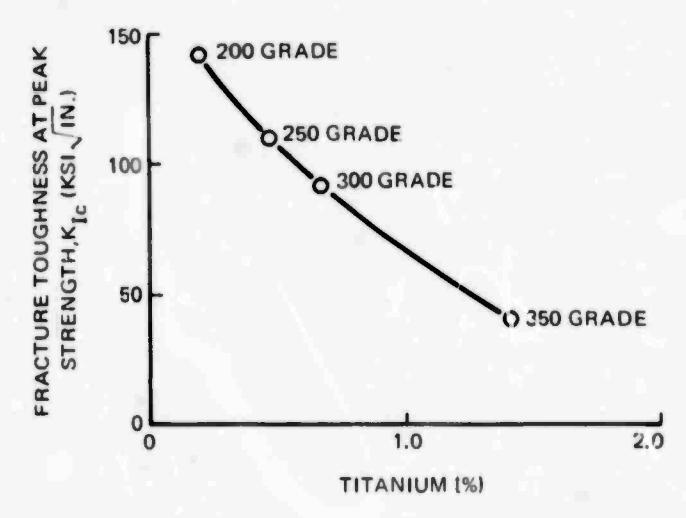
Fig. 18. Influence of titanium content (typical) on fracture toughness (optimum) values.

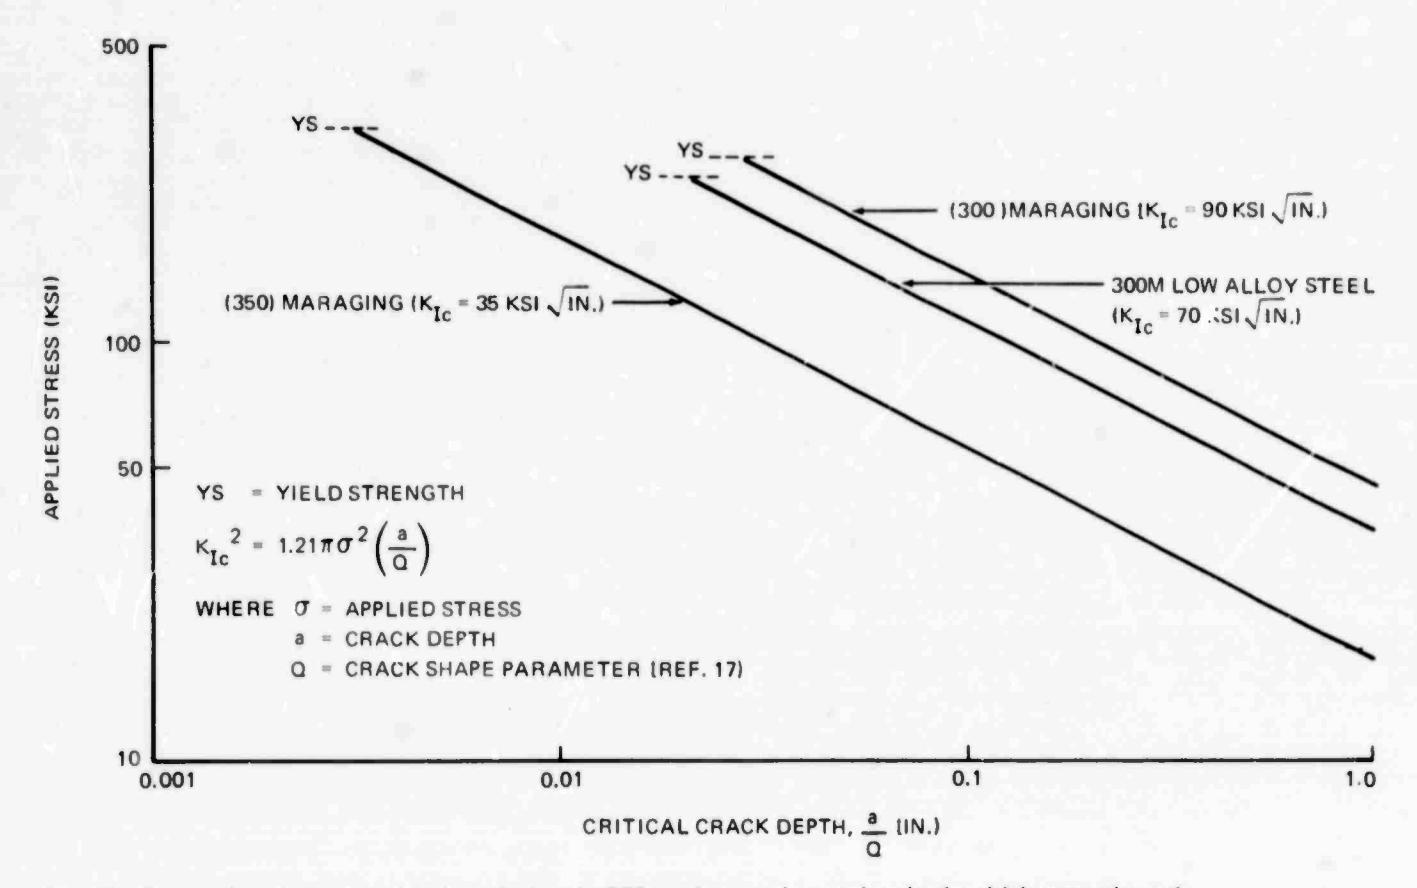
estimate can be made of the critical crack size as a function of applied stress. Such a plot is shown in Fig. 19 for 350-grade maraging steel (at maximum strength) and compared with similar relationships

tor 300-grade maraging and 300M low-alloy steels heat treated to the 280 ksi ultimate tensile strength, evel 1 or a given applied stress level, the critical crack size is significantly less than the lower strength steels l'urthermore, it must be remembered that design stresses are often a function of ultimate tensile strength. Allowing for such an increase in applied stress indicates that the critical crack size in 350-grade steel will be approximately five times less than in 300M (a widely used landing gear alloy). This does not of course mean that brittle fracture will occur in structural components made from this maraging steel, but this significant decrease in critical crack. size must be carefully considered in relation to the structural weight saving offened.
