# NORSAR PHASE 2

OPERATION AND MAINTENANCE 1 DEC 68 TO 31 MAY 69

# NORSAR (NORWEGIAN SEISMIC ARRAY) PHASE 2

#### OPERATION AND MAINTENANCE 1 DECEMBER 1968 TO 31 MAY 1969

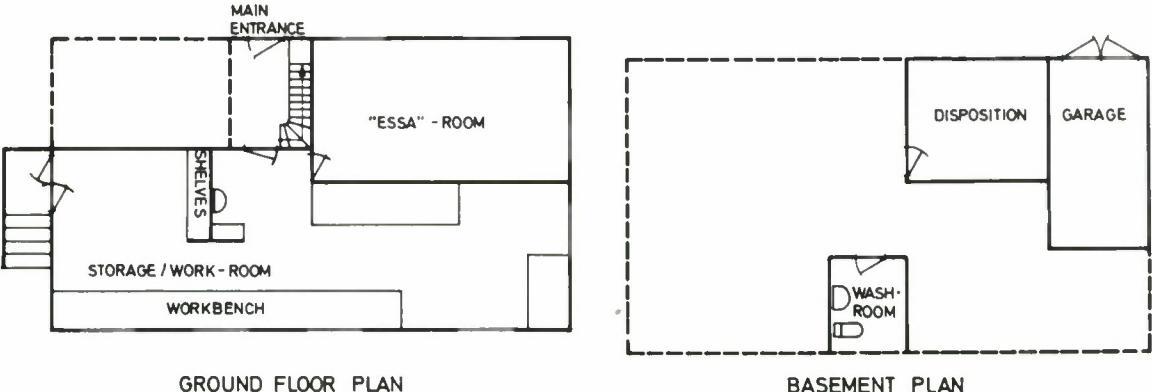
# Figure 3.1 Brumunddal storage and field base

the O&M staff during December 1968. This base (see Figure 3.1), located in Birger Langmoensvei 43, Brumunddal, some 15 km north of Hamar, consists of combined work-room/store for field components, approximately 125 m<sup>2</sup>, and a garage where snowscooters are stored.

One part of the Brumunddal storage (see Figure 3.1) was singled out for use by a US noise study group from the Environmental Science Service Administration (ESSA). Approximately 10 man-days of field support were devoted to assisting this group, from 6 January to 10 April 1969.

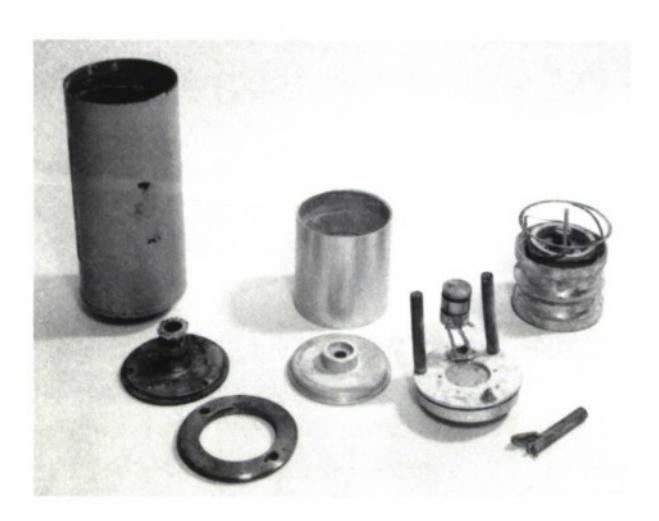
Figure 4.1 Details of deformed seismometer at 1F1

Sensor 1F1 at Øyer was found to be out of operation on 13 March. An attempt was made to replace the seismometer, but ice in the casing tube made this impossible. During the following days several attempts were made to remove the ice. The pipe was cleared to a depth of about 75 cm, but it was still impossible to move the seismometer. It was decided to delay further work until the spring. When finally brought

up to the surface, the seismometer proved to be deformed by the high pressure developed below the ice plug.
