USATEA REPORT 71-36 RESEARCH MEMORANDUM

A SHIPMENT OF RADIOACTIVE CONTROL RODS

FROM GATUN, CANAL ZONE, TO WEST JEFFERSON, OHIO

DECEMBER 1971

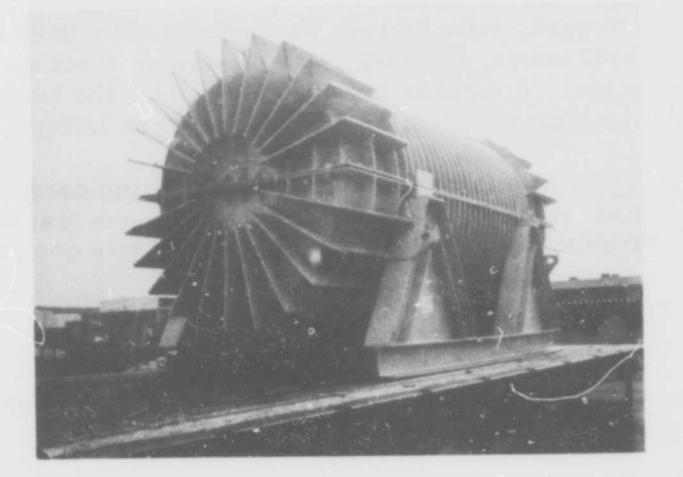
Figure 1. Shipping Cradle for MH-1A Sturgis Control Rod Cask.

The cargo consisted of a number of spent reactor control rods contained in a storage cask, which was assembled inside a special shipping cask (see Figure 1). Shipping weight and overall dimensions of the complete cargo assembly are as follows:

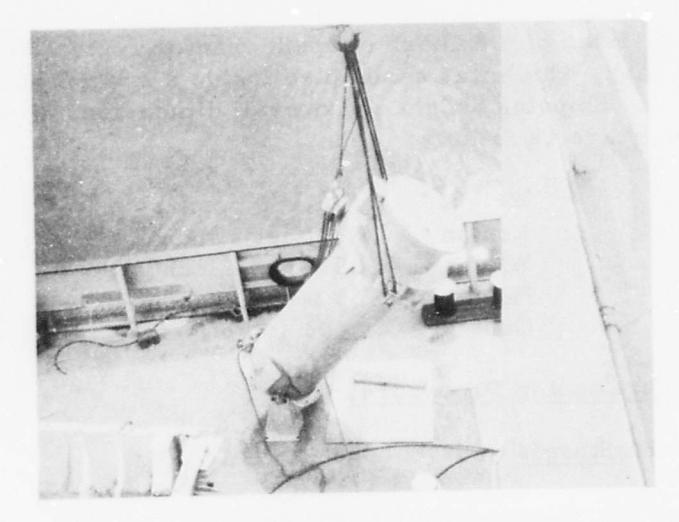
Figure 2. Reorienting Storage Cask From Upright to Horizontal Attitude.

The storage cask is cylindrical and is normally handled in the upright position. The shipping cask accommodates the storage cask in a horizontal position. To facilitate reorientation of the storage cask, it was equipped with trunnions at the base, and stanchions to accept the cask trunnions were installed on the deck of the ship. The storage cask was then lowered into the stanchions and tilted so that it could be further lowered to the deck of the ship (Figure 2). Slings were then secured at both ends of the storage cask, and it was placed in the shipping cask in a horizontal attitude as shown in Figure 3.

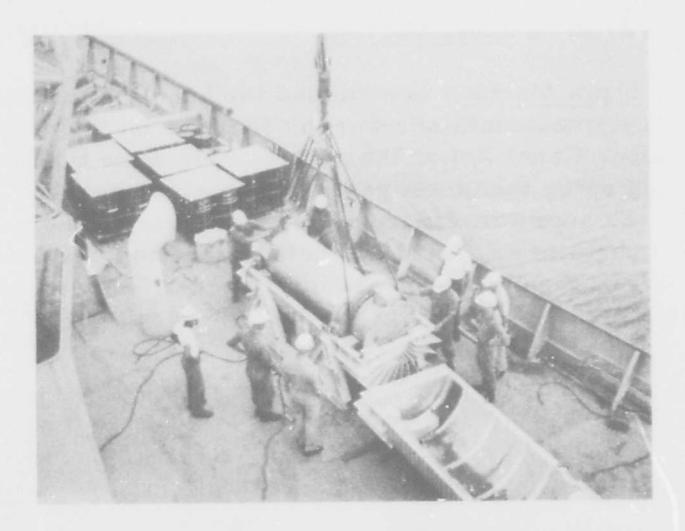
Figure 3. Storage Cask Being Placed in Shipping Cask for Trial Assembly.

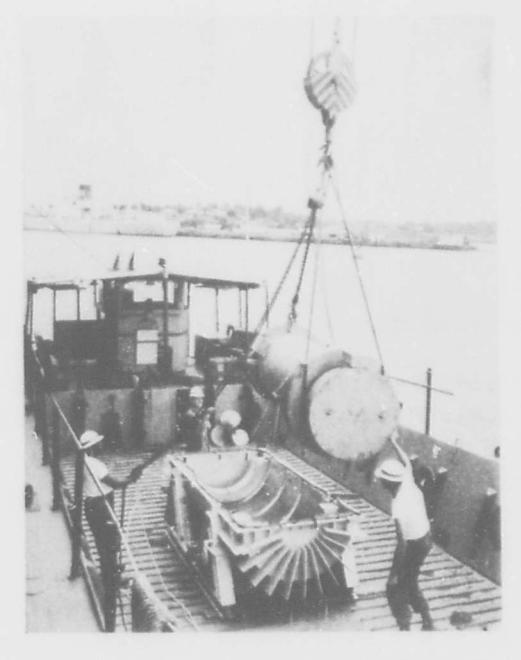
Figure 4. Transferring Storage Cask from MH-1A <u>Sturgis</u> to LCM 8028 for Reassembly with Shipping Cask.

The crane on the <u>Sturgis</u> did not have sufficient capacity to handle the full weight of the cargo assembly. Consequently, after the trial assembly was made and necessary minor cask modifications completed, the casks were transferred separately and reassembled aboard the LCM 8028. Figure 4 shows the storage cask being lowered with the <u>Sturgis</u> crane into the shipping cradle which had previously been placed aboard the LCM. Because the cradle base was not designed for skidding, it was necessary to use the crane for each movement of the base. Although this presented no serious obstacle, minor relocations would have been made easier in some cases if the base had been designed for skidding.

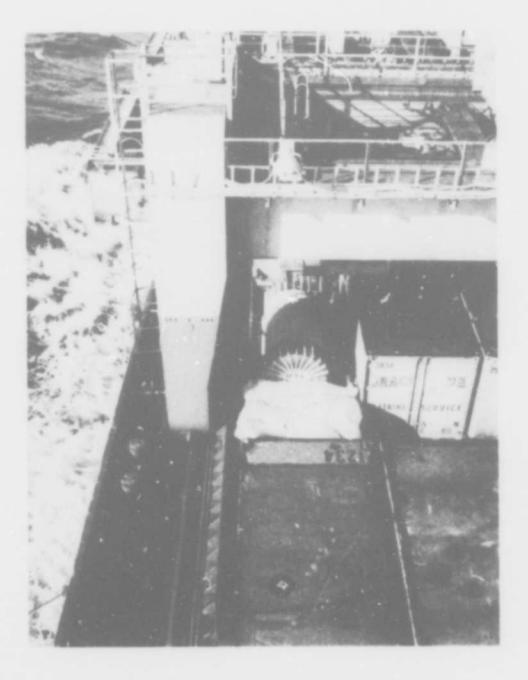
Figure 6. Control Rods on SS Santa Mariana.

The SS <u>Santa Mariana</u> is equipped for handling containers. In this case, a flatbed container was set in place on the deck of the ship. At Balboa, Canal Zone, the control rods were transferred from the LCM using the ocean vessel's container handling gear with slings, as shown in Figure 5. Figure 6 shows the cargo on the flatbed container. The polyethelene sheeting shown at the end of the cask in Figure 6 protects instrumentation used for monitoring the shipment.

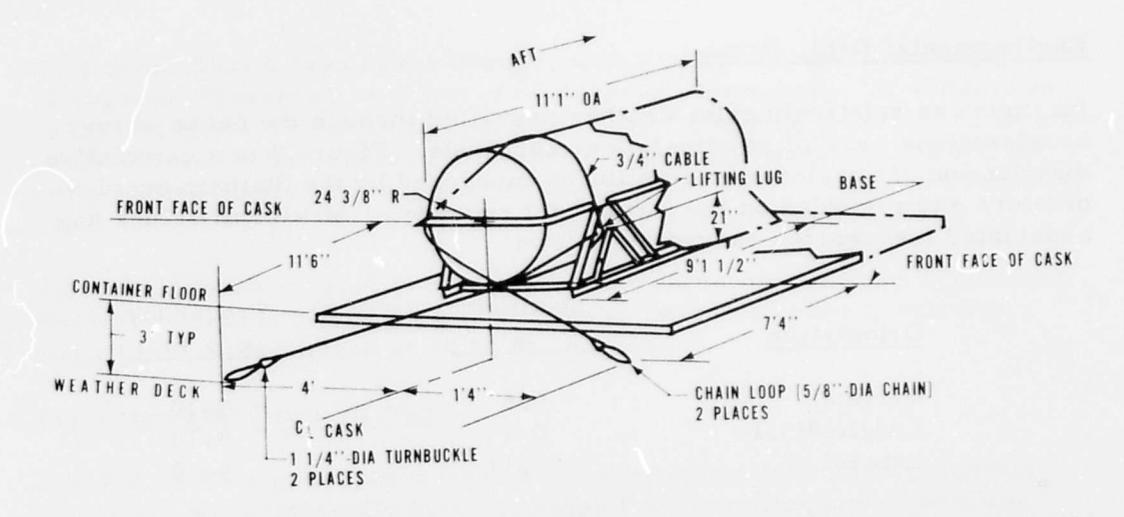
Figure 7. Cask Tiedown Arrangement Used on SS Santa Mariana (Front Quarter View).

The combination of high density, low center of gravity, and effective friction surfaces enhanced the stability of this cargo during shipment. No dislocation of cargo occurred in transit. The relatively low lateral and longitudinal accelerating forces measured (0.1 to 0.125g range in both ocean and highway modes) were not large enough to overcome normal static friction. Under such conditions the cask would not be expected to move relative to the supporting surface even if no tiedowns were used. For the ocean move, a 3/4-inch-diameter wire rope was looped over each end of the cask through the tiedown eyes. Both ends of each cable were clamped into a 1-1/4-inch-diameter turnbuckle, which, in turn, was secured to a deck cleat with a loop of 5/8-inch steel chain. The tiedowns are shown diagrammatically in Figures 7 and 8. Estimated safe working load for the cable is at least 14,100 pounds. Estimated safe working load for the chain loop is 13,200 pounds. Estimated safe working load for the turnbuckle is 10,700 pounds (using a safety factor of 5). Therefore, the weakest element of this tiedown configuration is the turnbuckle.

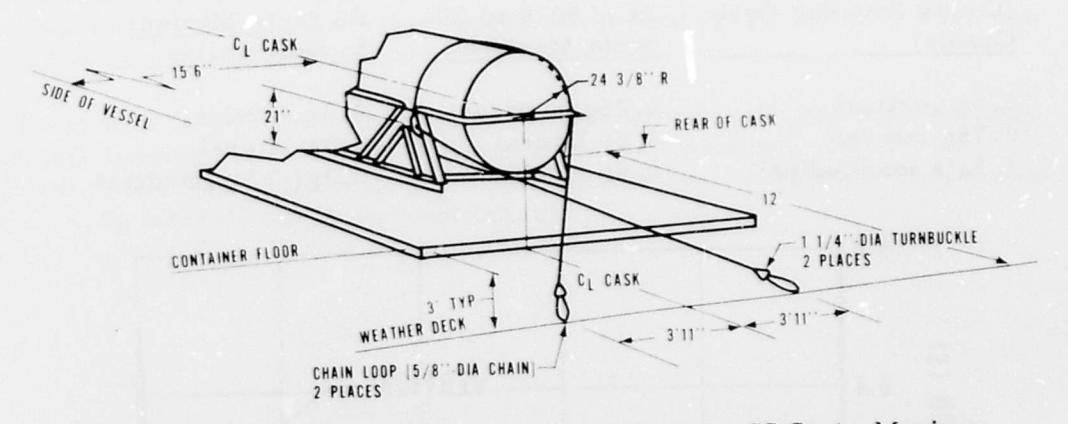
Figure 8. Cask Tiedown Arrangement Used on SS <u>Santa Mariana</u> (Rear Quarter View).

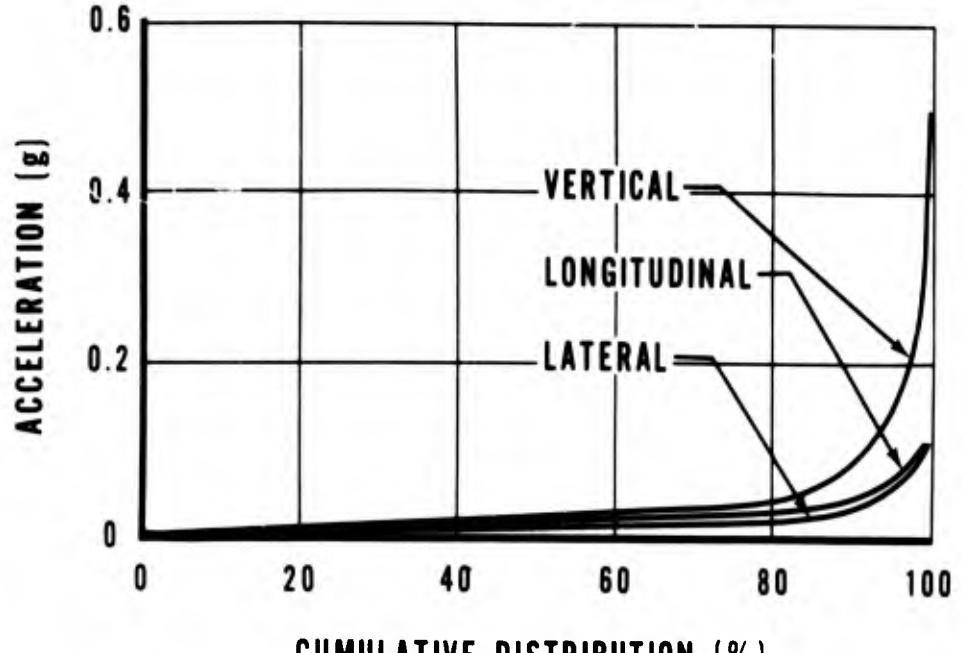
Figure 9. Cumulative Distribution of Peak Accelerations, Ocean Mode, MH-1A Spent Control Rod Shipment.

Inasmuch as relatively calm weather prevailed through the ocean voyage, accelerations were of relatively low magnitude. Figure 9 is a cumulative distribution of acceleration amplitudes measured by the Statham accelerometers and recorded on the strip chart recorder. Maximum values and associated frequencies ranged as follows:

| <u>Orientation</u> | Maximum (g) | Frequency (c.p.m.) |
| Vertical | 0.5 | 9-10 |
| Longitudinal | 0.1 | 9-10 |
| Lateral | 0.11 | 9-10 |
