REPORT NO. NADC-72049-VT

TEST PLAN FOR A STRUCTURAL INTEGRITY INVESTIGATION FOR THE CH-46 AFT TRANSMISSION PLANETARY CARRIER BEARING NUT IN SUPPORT OF THE ANALYTICAL REWORK PROGRAM

The CH-46D mishaps in 1967 and 1971 precipitated a contractor designed fix of the aft transmission planetary carrier bearing nut. This test plan proposes tests to determine if a mode of failure other than that assumed by the contractor could be present. Static and fatigue tests are proposed on both the original and modified versions.

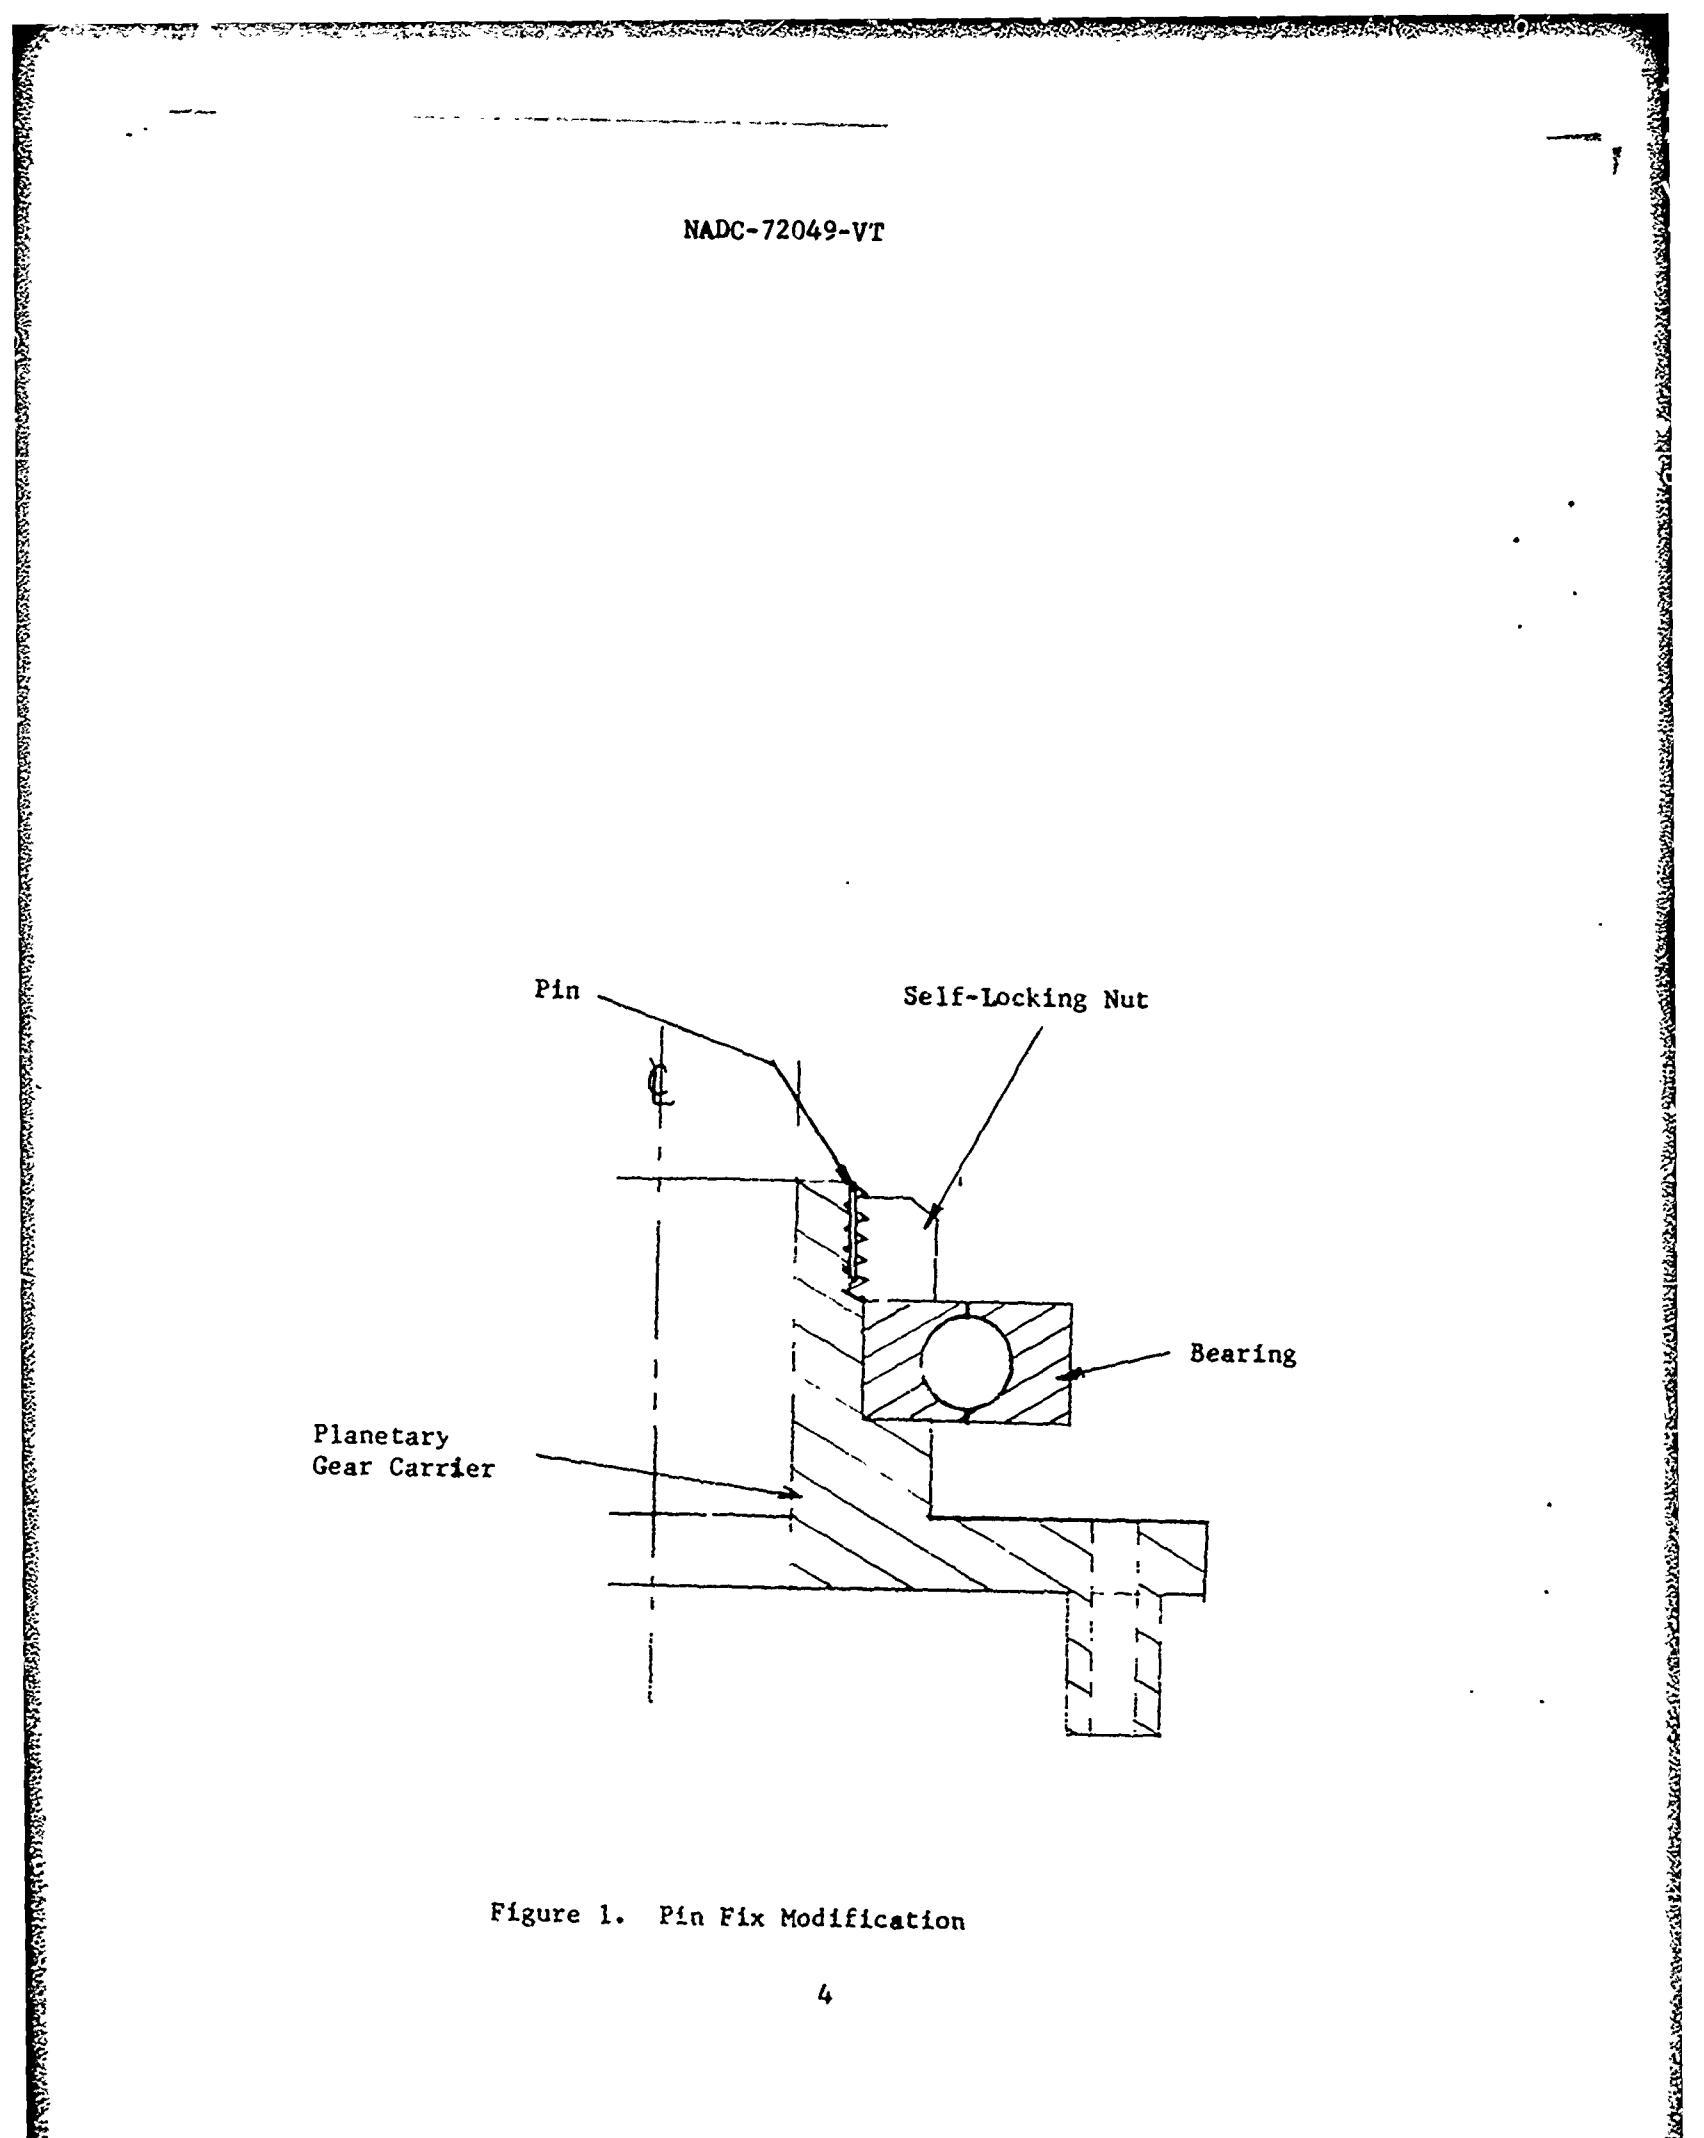
Figure 1. Pin Fix Modification

As a result of this mishap, a contractor designed fix of pinning the self-locking nut to the planetary gear carrier through the threads, figure (1), was incorporated in CH-46 helicopters. During the installation of this fix, it was noted that torque values on the self-locking nut varied from 300 to 1800 lb-ft. During a meeting between NARF CHPT (Naval Air Rework Facility, Cherry Point) and NADC (Naval Air Development Center) personnel, it was discussed that another cause of nut loosening might be shock loads imposed during hard landings. It is considered possible that the loading condition could cause to be developed, axial loads of sufficient magnitude to pop the nut off the planetary carrier, or at least over a single thread, thereby relieving the torque. Subsequent axial shock loads might pop off the nut one thread at a time. At the time of the investigation of the 1967 accident NARF CHPT had performed a test and determined that the bearing retaining nut could be removed from the planetary carriers by an axial force without damaging the threads. However, records of this test have been destroyed. If this is the case, pinning as shown in figure 1, would not eliminate the problem since the forces would be along the pin.

The second test specimen will be identical to the first specimen except that the self locking nut will be pinned in two places 180 degrees apart as shown in figure 1.

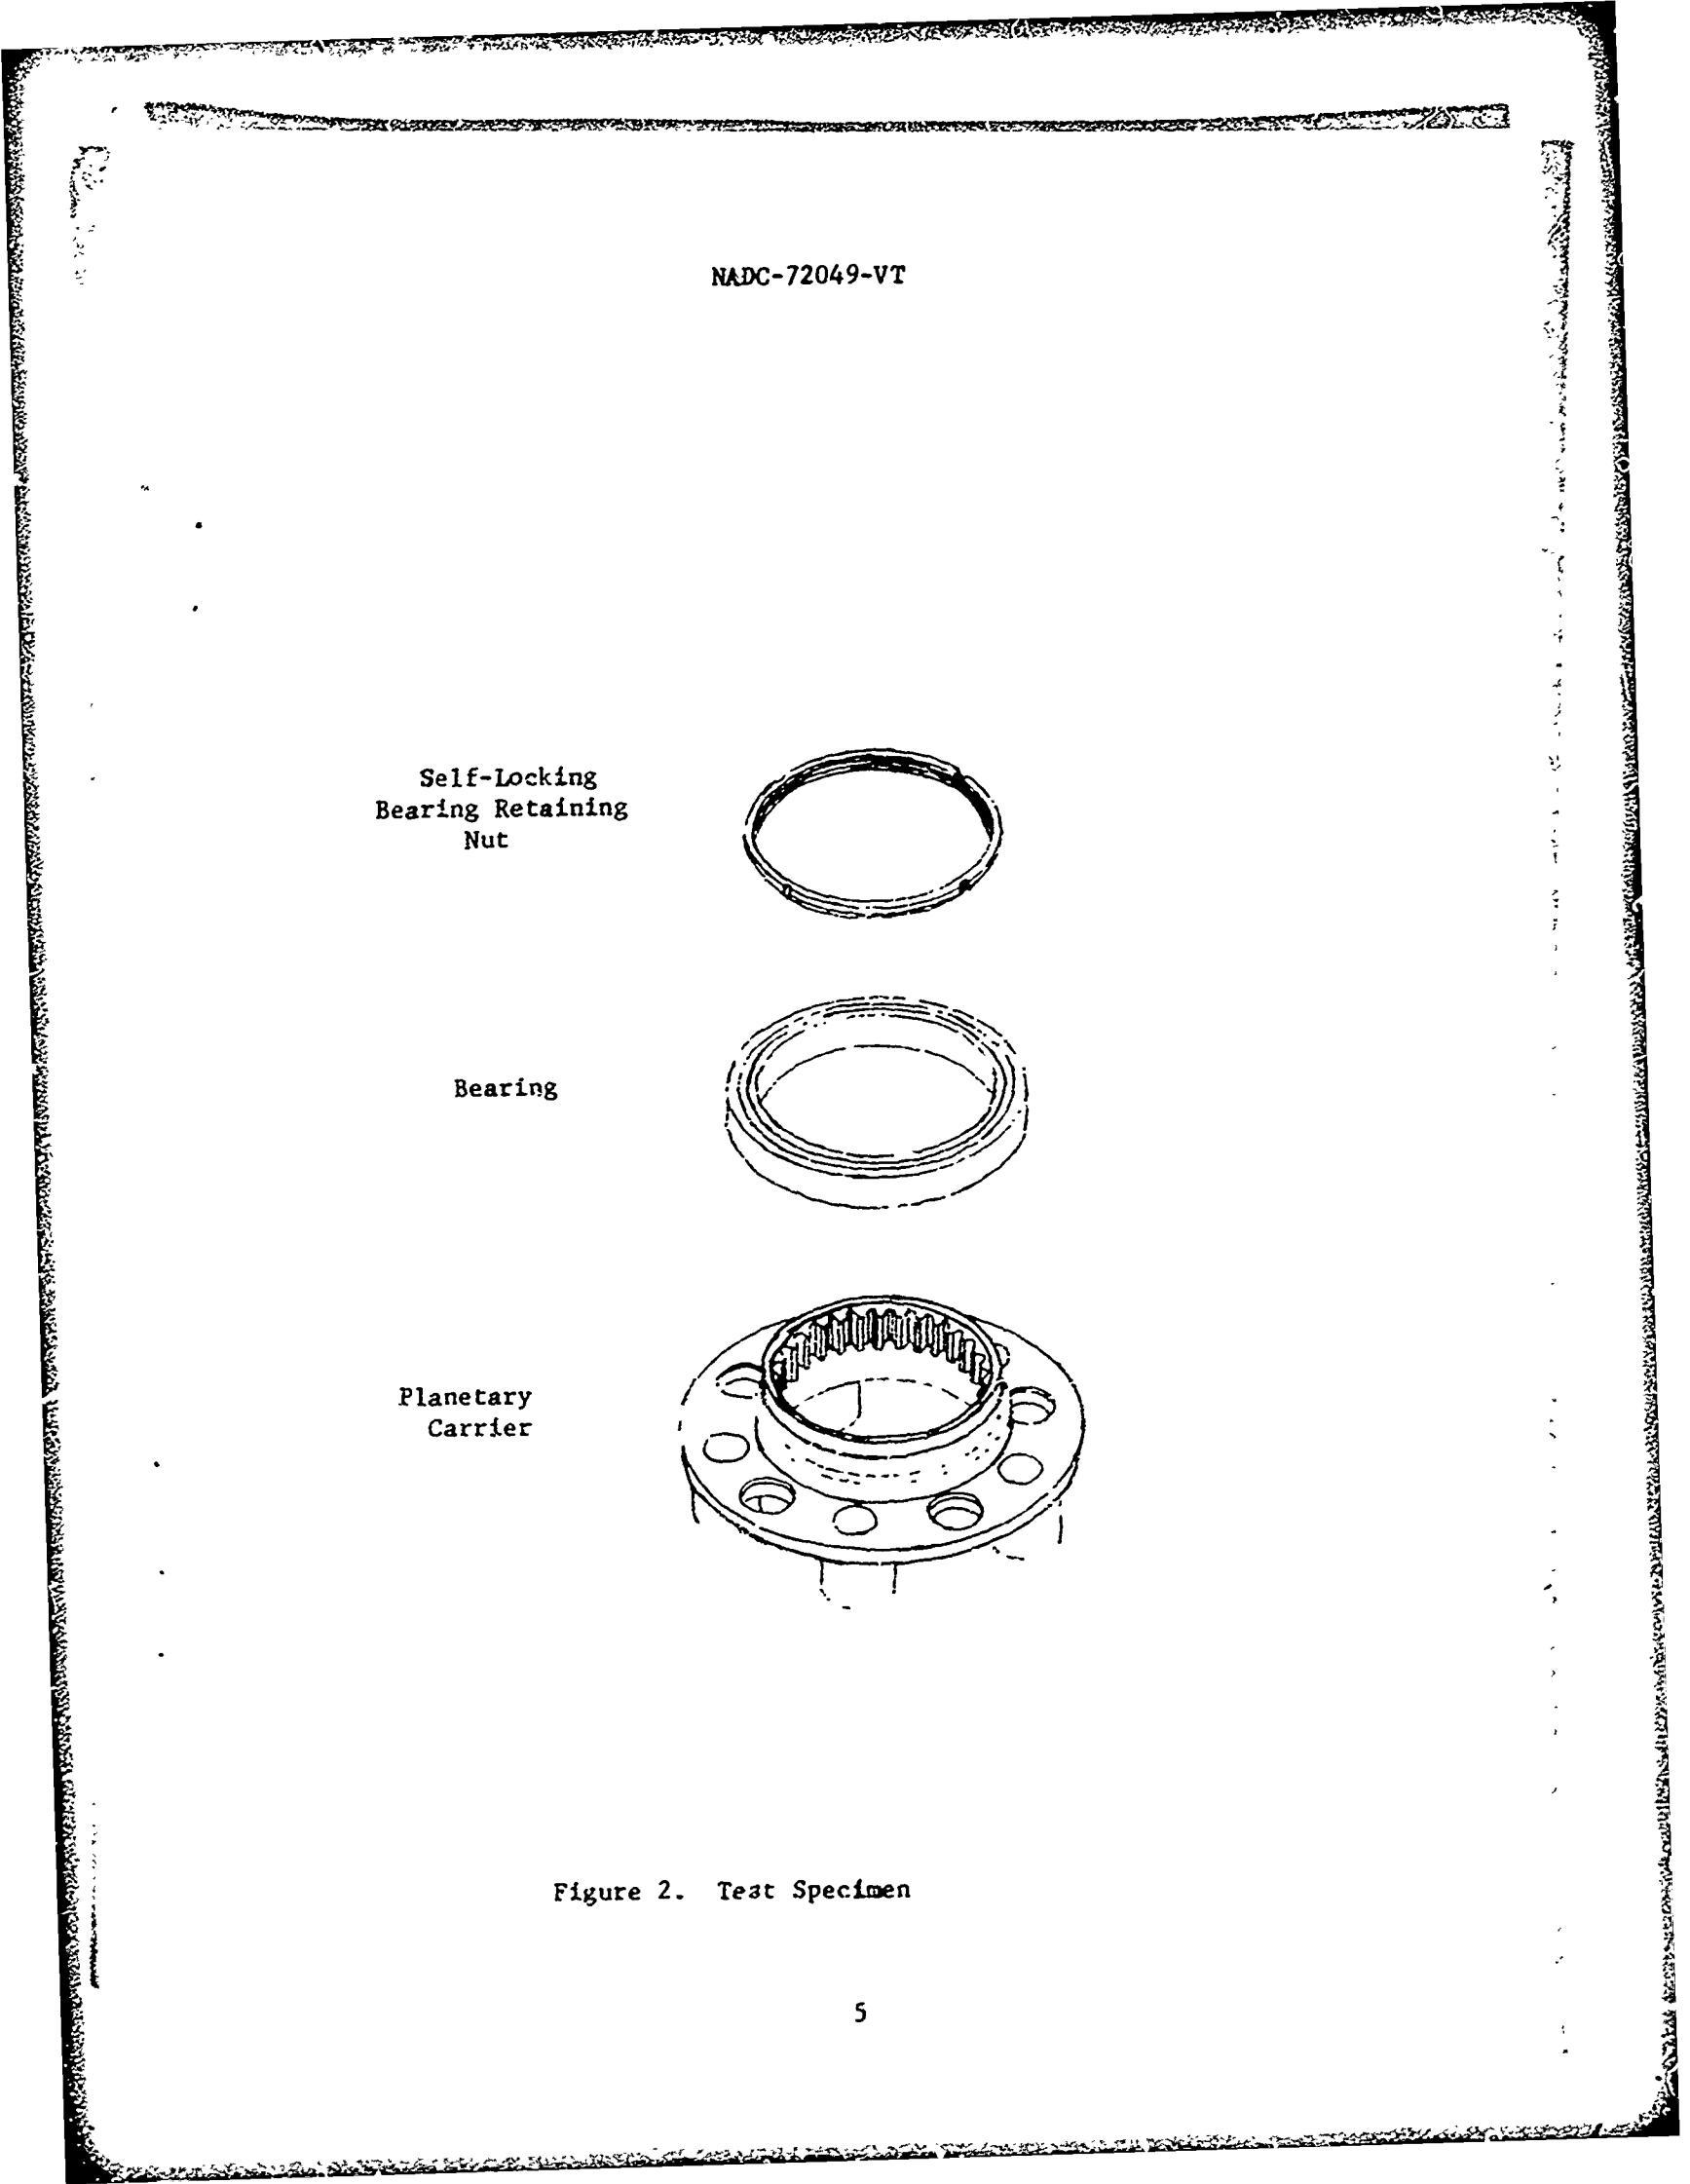
Two configurations of the planetary gear carrier assembly will be required for this investigation. The first test specimen will consist of the planetary gear carrier P/N A02D2419, bearing P/N A02DS270 and planetary gear carrier locking nut P/N BACN lOGR39. These parts are shown in figure 2 in their relative positions. The threads of the locking nut and the planetary gear carrier engage only 3-4 threads when assembled. The specimen will be received from NARF CHPT assembled and torqued to the high torque value.

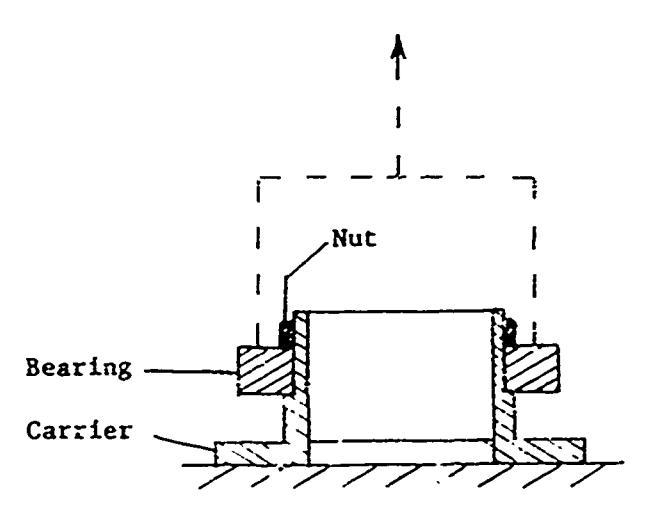
An unpinned specimen of the planetary carrier assembly will be mounted in a suitable rigid test fixture. Axial loads will be applied to the bearing to determine the force required to pop the nut off the planetary carrier, figure 3. This test will be performed on both the unpinned and pinned versions of the planetary carrier assembly to determine the difference in force required to remove the nut.

The second part of the test will be to apply a repeated shock load with the specimen mounted in the same test fixture. These loads will be of a lower magnitude than that obtained from the static test. Periodically during the cycling the torque value of the nut will be checked to determine if there has been a change. The nut will then be retorqued and the test continued. Again, both pinned and unpinned versions of the planetary carrier assembly will be tested.
