DEVELOPMENT OF MANUFACTURING METHODS FOR BALLISTICALLY TOLERANT FIBERGLASS TUBULAR BELLCRANKS

I. E. Figge, Sr.

Army Air Mobility Research and Development Laboratory Fort Eustis, Virginia

House Task 71-12 USAAMRDL Technical Memorandum 3 January 1974

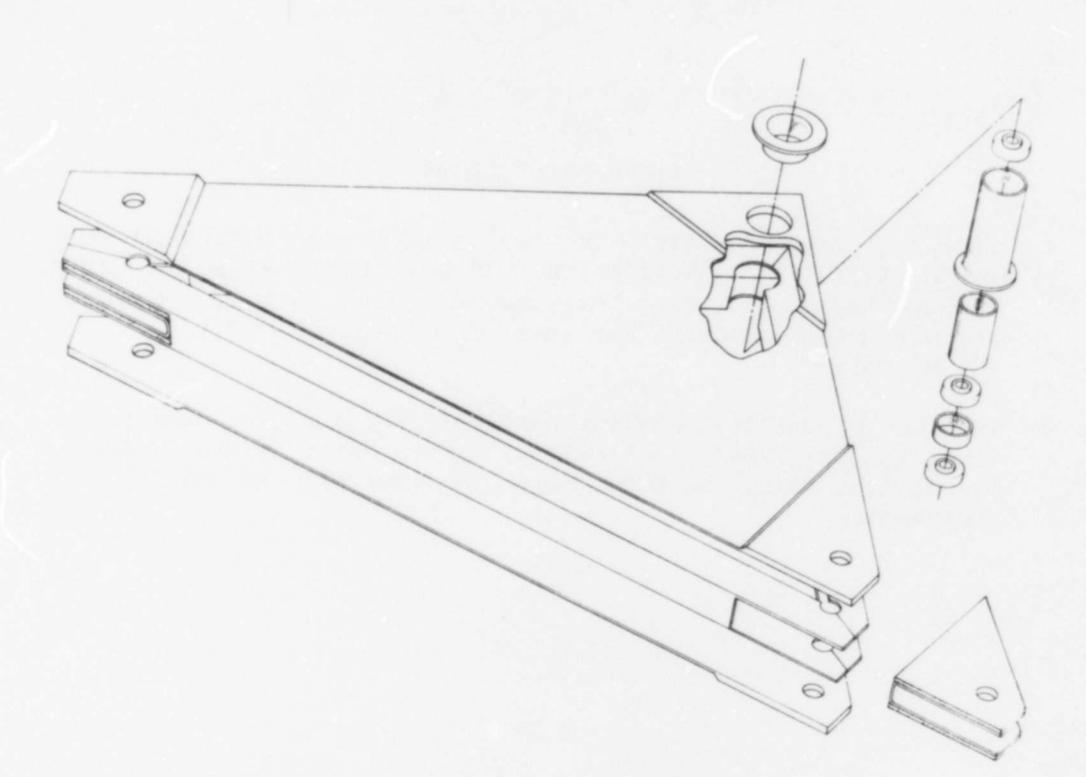
Figure 1. Exploded View of Square Tube Bellcrank.

The basic tubular concept developed in Reference 1 was selected for further study since it permitted straightforward use of existing low-cost fabrication techniques. A schematic of the tubular bellcrank is shown in Figure 1, and a detailed drawing of the bellcrank is presented in Appendix I. Prepreg cloth, 181-style, was used in the construction of all components of the bellcrank except the bearings and bearing sleeves. Complete material properties and cure cycles are presented in Appendix II. The bellcrank consisted of three major elements: face sheets, tubular members, and end attachments. In all cases, matched metal molds were used to fabricate the major elements. The elements were then assembled and bonded using FM-1000 adhesive (see Appendix III). The fabrication of each element is discussed in detail in the following sections.

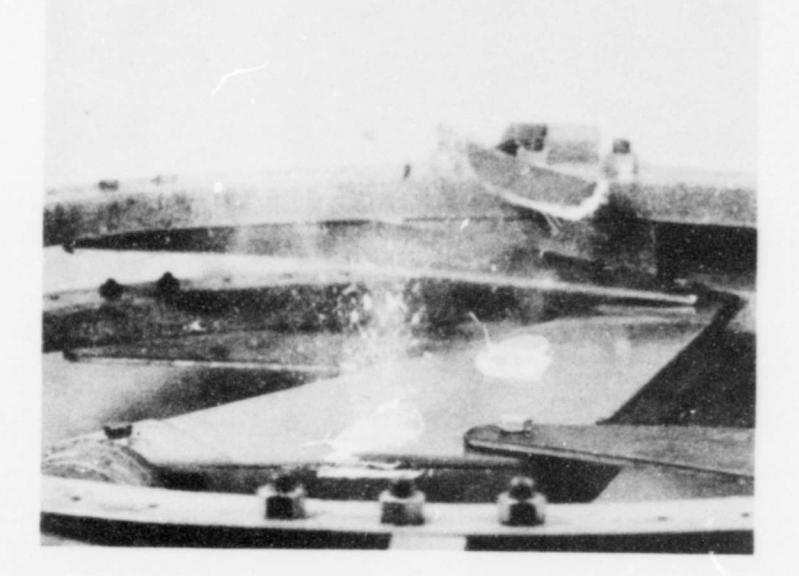
Figure 2. Delamination of Exit Face Sheet Caused by Tumbled .30 Caliber Impact.

Although research indicated that the concept developed in Reference 1 provided significant increases in ballistic tolerance, one deficiency was observed during ballistic testing in that investigation. It was found that when the projectile impacted the tubular portion of the bellcrank, it invariably caused gross delamination of the exit face sheet (see Figure 2). Numerous adhesive systems and overwrapping techniques were used in Reference 1 to no avail. No distinguishable differences in the extent of delamination were observed between ductile or brittle adhesive systems.

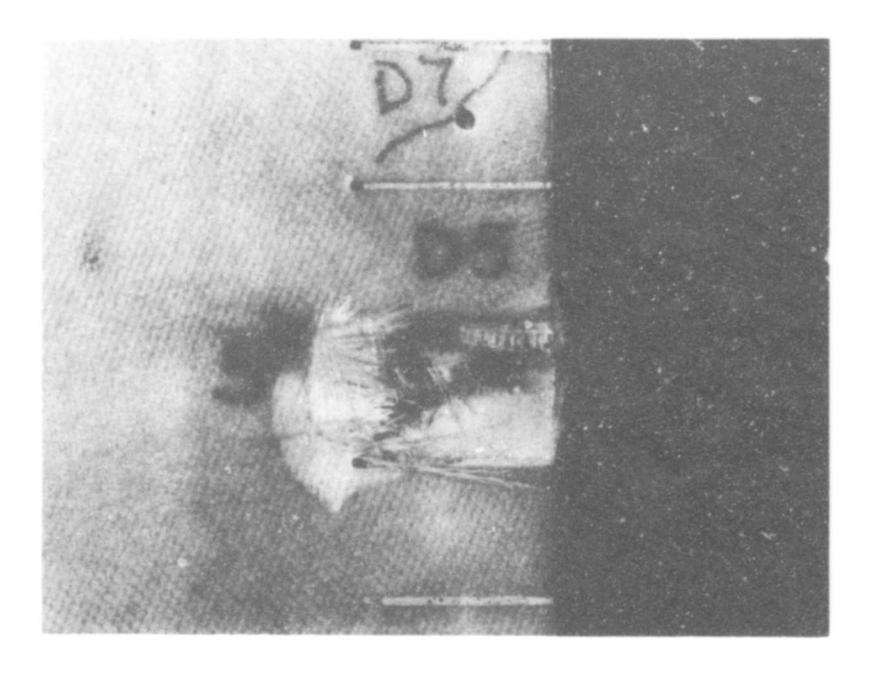
Figure 3. Localized Delamination of Exit Face Sheet Resulting From "Slotting".

In the current program, it was found that preferential slotting of the exit face (see Figures 3 and 4) confined the delamination to the impact area. The slotting did not significantly reduce the undamaged structural strength, since the face sheets were designed as secondary load paths in the event of tube failure. The forward bellcrank is located close to the transmission housing and, as such, can be impacted only from one side. Since the delamination occurs only on the exit face, it was necessary to slot only that face for this application.

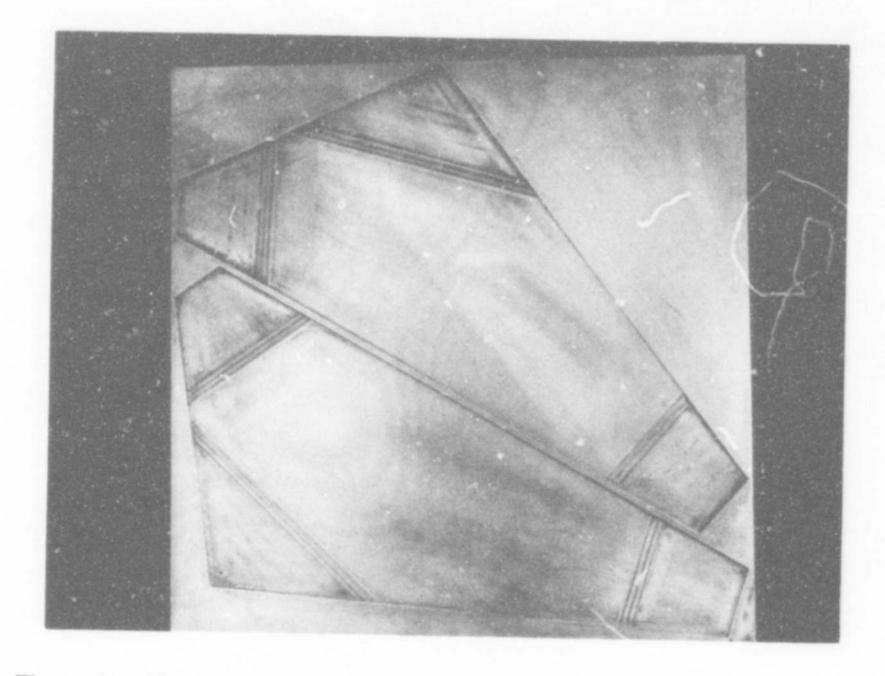
Figure 5. Aluminum Matched Metal Molds Used To Fabricate Face Sheets.

The face sheets were fabricated in pairs using matched metal molds as shown in Figure 5. Three plies of prepreg 181 cloth were pattern cut to size and placed in the molds to form the stepped doublers for the attachment and pivot bearing areas. Four additional plies of 181 cloth were pattern cut and placed in the molds to complete the face sheet.

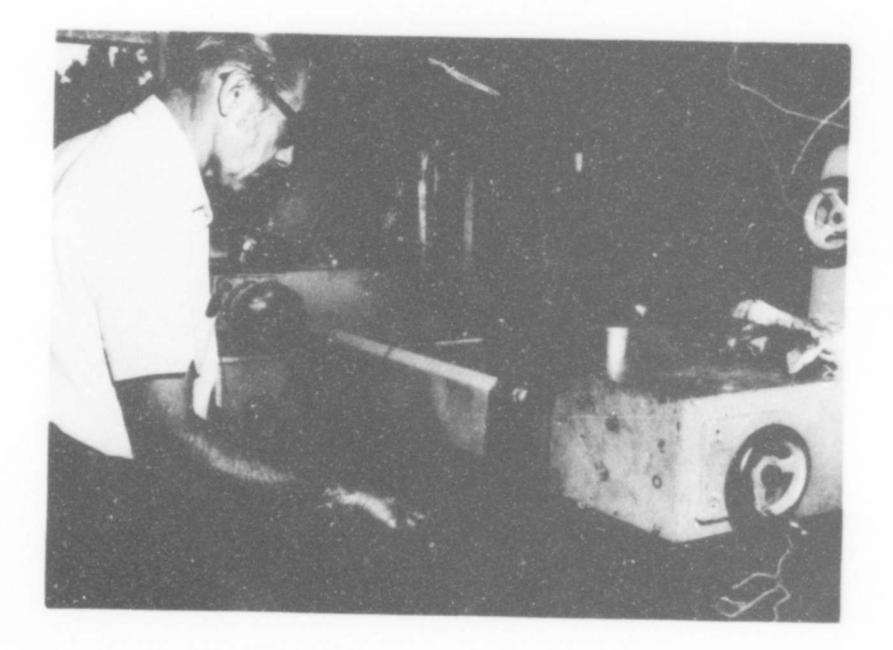
Figure 6. Winding of Glass Cloth Tubular Elements.

The tubular elements were wound with six plies of 181 cloth on a square mandrel, as shown in Figure 6. Again, peel ply was used. The uncured tube/mandrel was placed in the matched metal molds and placed in the press for curing (see Figure 7). After curing, the mandrels were removed and the angles on each tube were cut to final dimensions to allow assembly into a triangular platform, using the jigging shown in Figure 8. The slots to accept the end attachment were then cut, completing the operation.

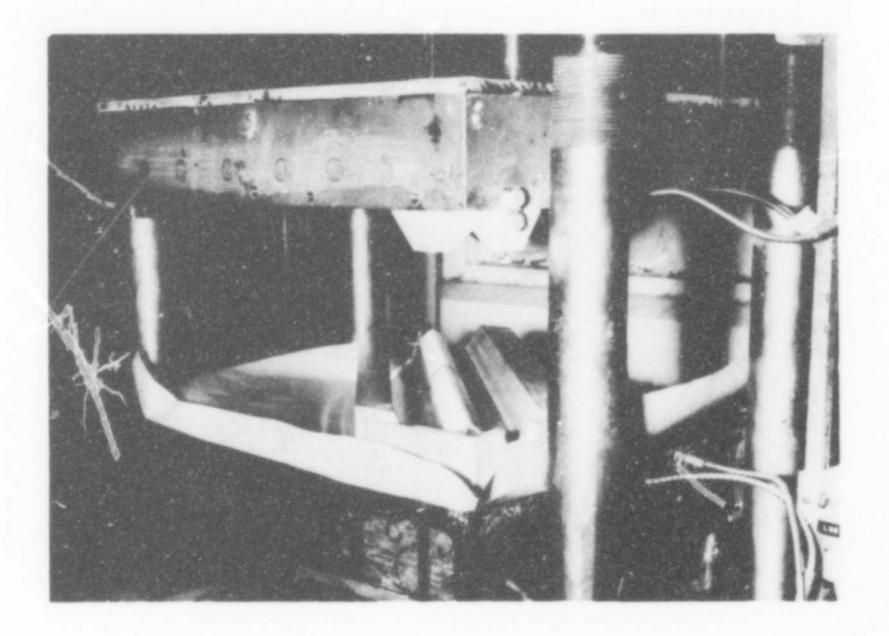
Figure 7. Aluminum Matched Metal Molds Used To Fabricate Tubular Elements.

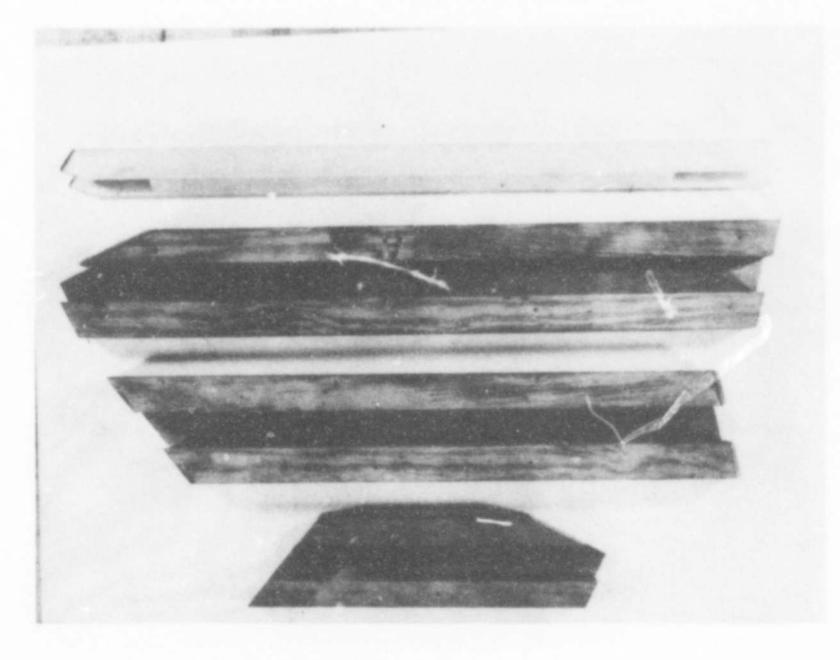
Figure 8. Jigging Used To Cut Tubular Elements to Final Dimensions.

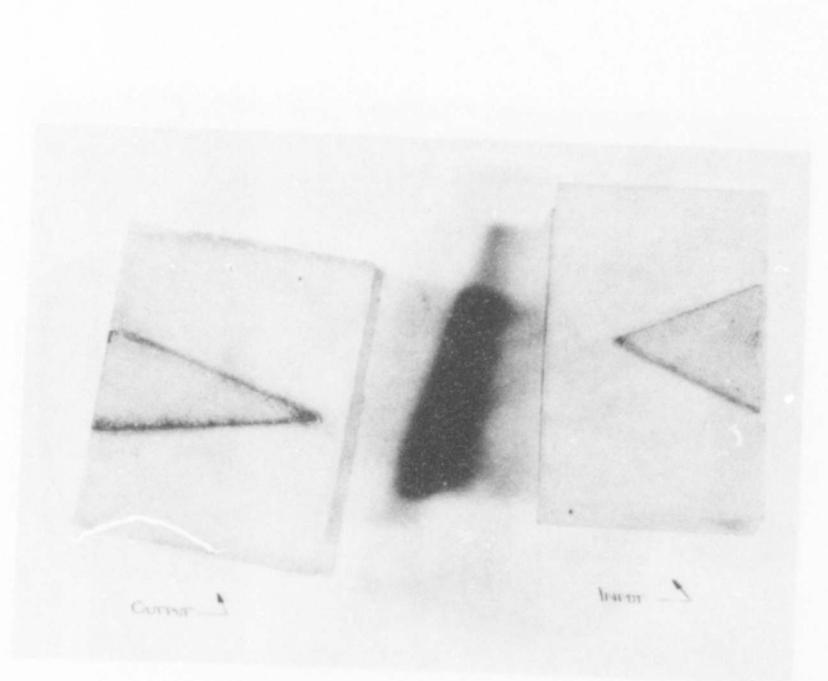
Figure 9. End Attachments.

The end attachments shown in Figure 9 were fabricated in pairs in the matched metal mold shown in Figures 10 and 11. Eight-ply triangular-shaped doublers were integrally fabricated as part of the end attachments. These doublers served to align the tubular element during final assembly and to provide additional stiffening and bond area for the face sheet. The end attachments were four plies thick on the output attachment and twelve plies thick on the input attachment.

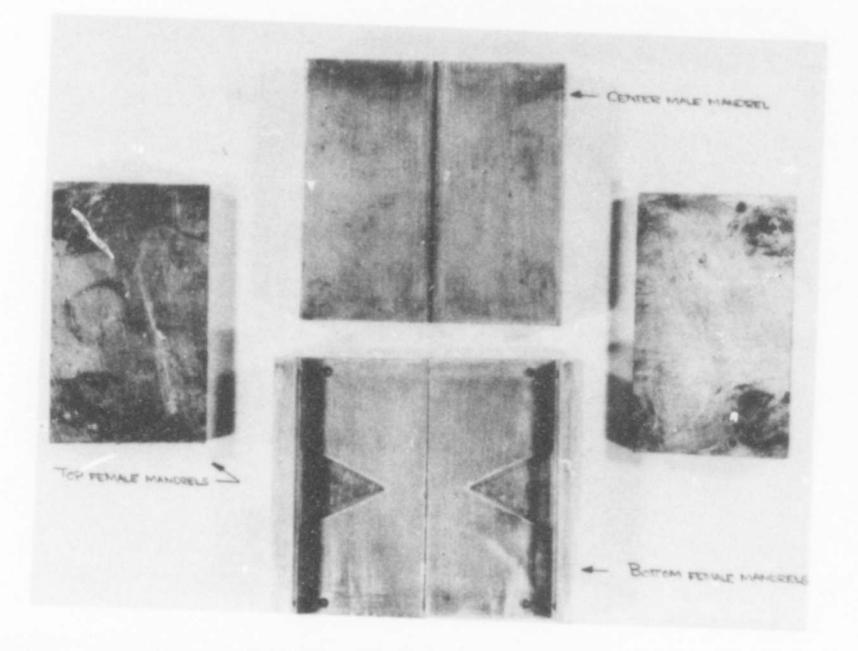
Figure 10. Aluminum Matched Metal Molds Used To Fabricate End Attachments.

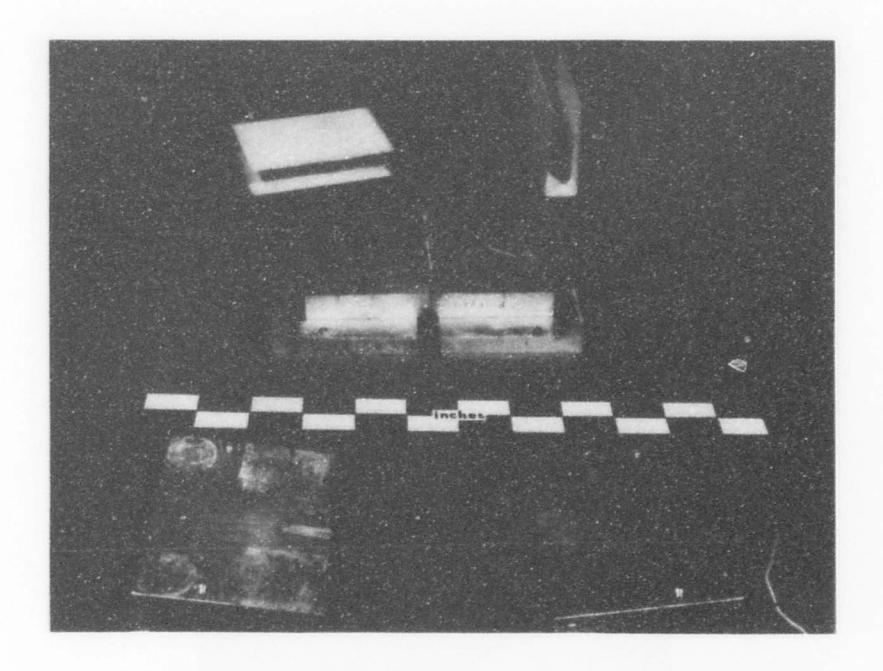
Figure 11. Exploded View of Aluminum Matched Metal Molds Used To Fabricate End Attachments.

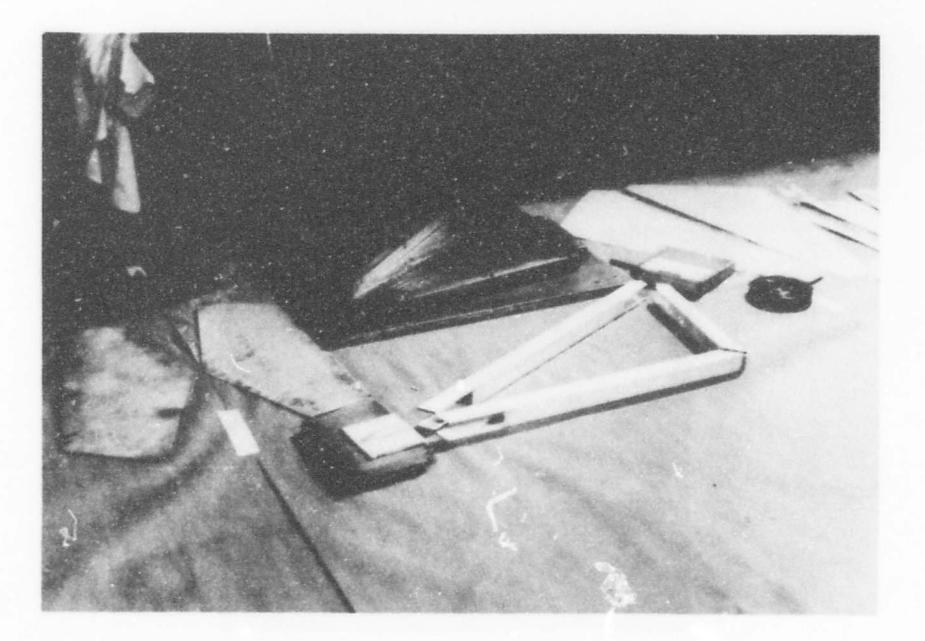
Figure 12. Final Assembly Jigging.

Final assembly was achieved by placing the elements in a precision positioning jig, as shown in Figures 12 and 13. FM-1000 adhesive was used in all bonded areas. The FM-1000 adhesive was cured in a hydraulic press at 350°F and with a nominal pressure on the bonded areas of 50 psi. After curing, the completed assembly was precision jig trimmed to final dimensions in a tensile cutter (high-speed router). Holes for the pivot and sleeve bearings were then jig drilled. The pivot bearing assembly was coated with Epon 828 resin/DTA catalyst and was inserted in the bellcrank, and the retainer sleeve was press-fit into place. The sleeve bearings for the input and output attachments were slip-fit into place. No adhesive was used since the bearings are designed to slide to accommodate and position the self-aligning rod end bearings. The completed bellcrank is shown in Figure 14.

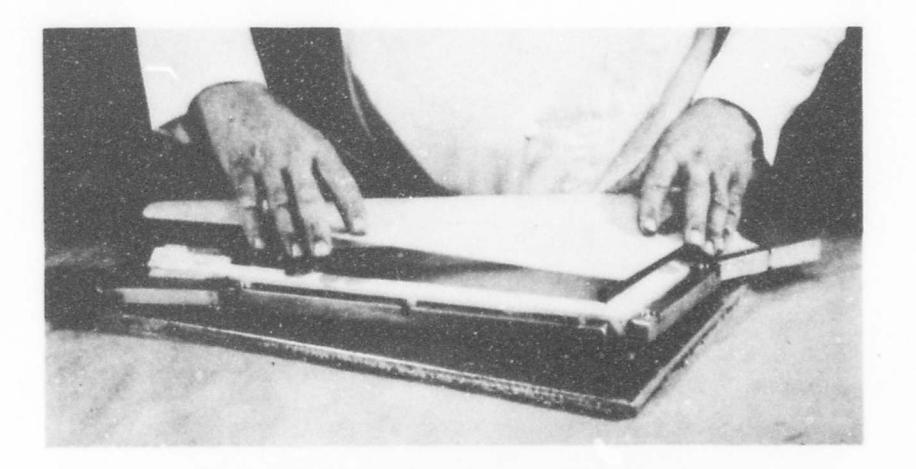
Figure 13. Bellcrank Being Assembled.

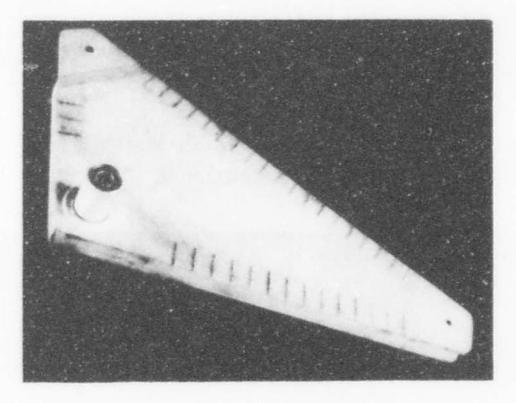
Figure 14. Completed Bellcrank.

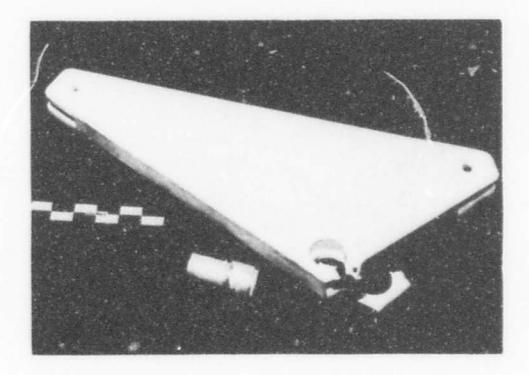
Figure 15. Typical Failure Mode.

In general, the fiberglass tubular bellcranks behaved as anticipated, based on the results in Reference 1. Test results are presented in Table III. The "slotting" technique limited the damage to only those "tabs" (material between slots) that were impacted. Temperatures of approximately  $-65^{\circ}F$  resulted in the highest failing loads. The results for both the undamaged and the ballistically damaged bellcrank at  $-65^{\circ}F$  were identical. The lowest failure loads were recorded at  $+180^{\circ}F$ . In the undamaged specimen at  $+180^{\circ}F$ , an FM-1000 adhesive failure was observed between the skin and the tubular elements. This was the only test in which the primary mode of failure was an adhesive failure. Typically, a shear failure of the skin and tube in the pivot area was observed (see Figure 15).
