LASER WINDOW SURFACE FINISHING AND COATING TECHNOLOGY

Hughes Research Laboratories

December 1973

4. TITLE (and Subtitle)		S TYPE OF REPORT & PERIOD COVERED						
	Semiannual Tech. Rpt. 1							
LASER WINDOW SURFACE FI	1 May 73 - 31 Oct 73							
AND COATING TECHNOLOGY	6 PERFORMING ORG REPORT NUMBER							
7 AUTHOR(s)		B. CONTRACT OR GRANT NUMBER(s)						
Morris Braunstein	F19628-73-C-0243							
PERFORMING ORGANIZATION NAME AND ADDRESS		10 PROGRAM ELEMENT PROJECT, TASK						
Hughes Research Laboratorie	S	61102E. 2415. T&WU						
3011 Malibu Canyon Road		n/a BPAC n/a						
Malibu, CA 90265

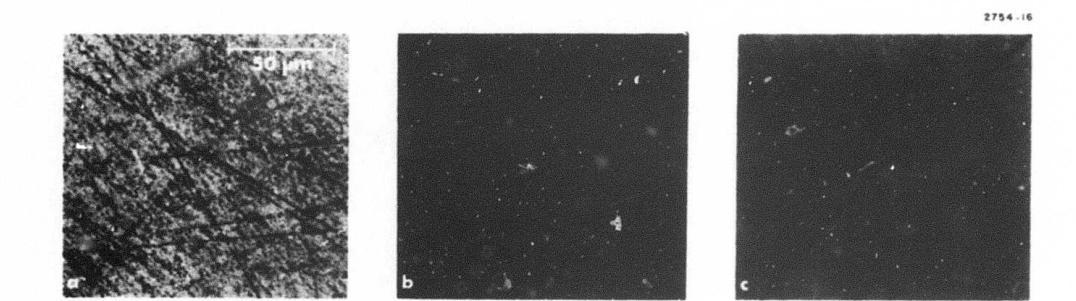
Fig. 1. Optical micrographs of KCl under bright field illumination, magnified 500 times.

An optically polished window blank of the size referred to above, flat to approximately two fringes at 6328 Å was characterized immediately after polishing by absorption calorimetry, dark, bright, and oblique field optical microscopy and phase contrast microscopy. The latter technique tends to show subsurface damage that normally cannot be seen with the other optical microscope techniques. The same tests were repeated after two thirty-second etches in concentrated HCl with agitation followed by ethanol rinsing and drying as discussed above. The results are shown in Figs. 1 through 4(a), (b), and (c), respectively. Figure 5 shows a scanning electron microscope photograph (SEM) taken at  $\sim$ 15,000x. In Fig. 6(a), (b), and (c) are shown additional SEM photographs of a typical etched sample KCl surface at 9,000x, 18,000x, and 18,000x, respectively, at a beam voltage of 20 kV and  $\approx 70^{\circ}$  tilt to the sample surface. Views a and b are of a surface region near grain boundaries and c is of a more typical surface region. The photograph in Fig. 1(c) shows no scratches or blemishes observable at 500x magnification other than grain boundaries. Twyman-Green interferometer photographs indicate that the flatness deteriorated by about a factor of two as a result of the total one-minute etch. The 10.6 µm absorption was reduced for KCl surfaces etched in HCl using the above procedures. Hughes Research Laboratories RAP grown KCl crystals after mechanical polishing have absorptions in the range of  $0.0003 \text{ cm}^{-1}$  to  $0.0005 \text{ cm}^{-1}$ , after chemical etching absorptions are in the  $0.00015 \text{ cm}^{-1}$  to 0.00020 cm range.

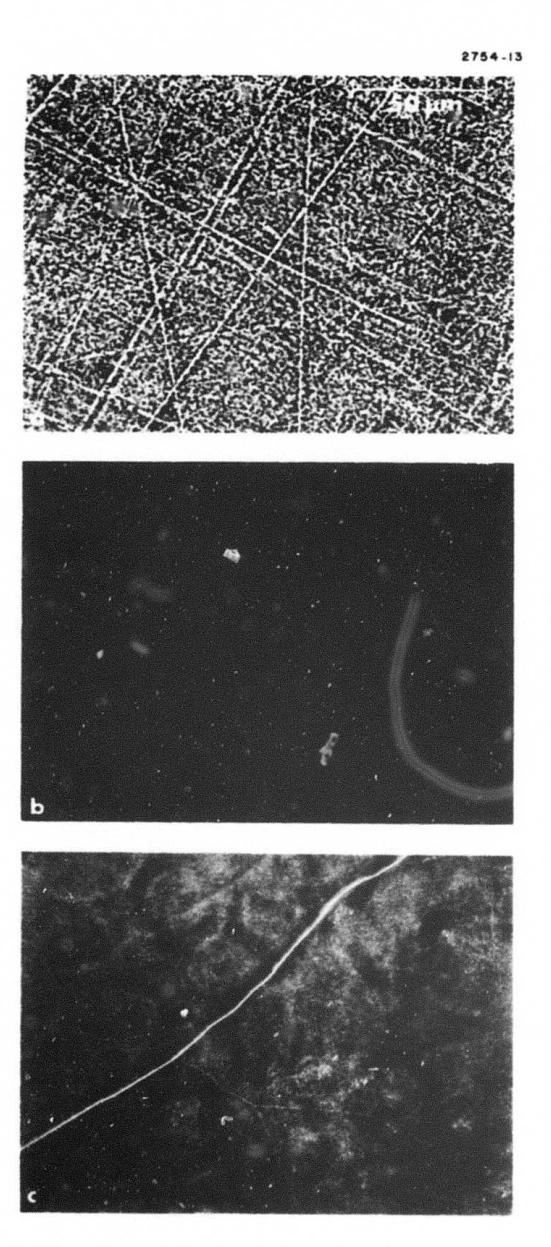
Fig. 2. Optical micrographs of KCl under oblique lighting conditions, magnified 500 times.

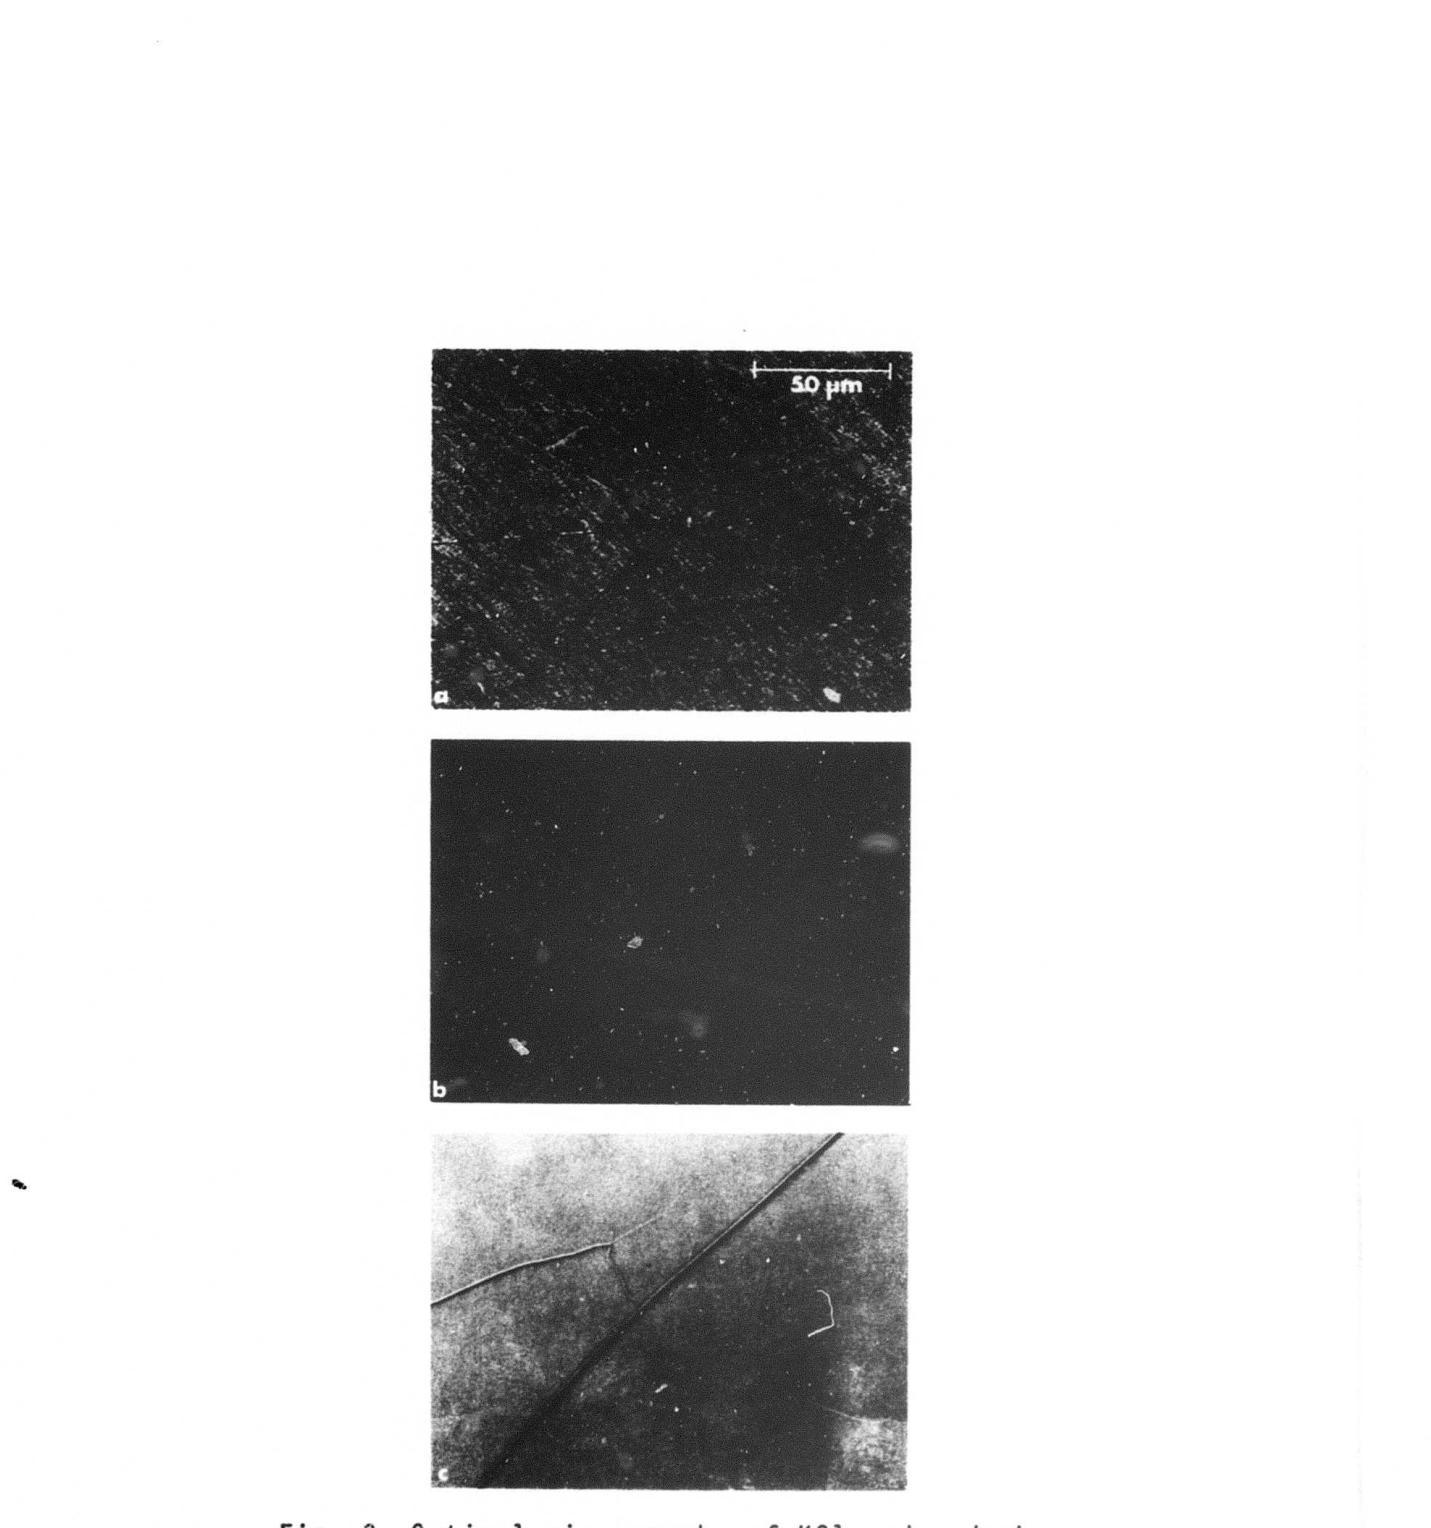
Fig. 3. Optical micrographs of KCl under dark field illumination, magnified 325 times.

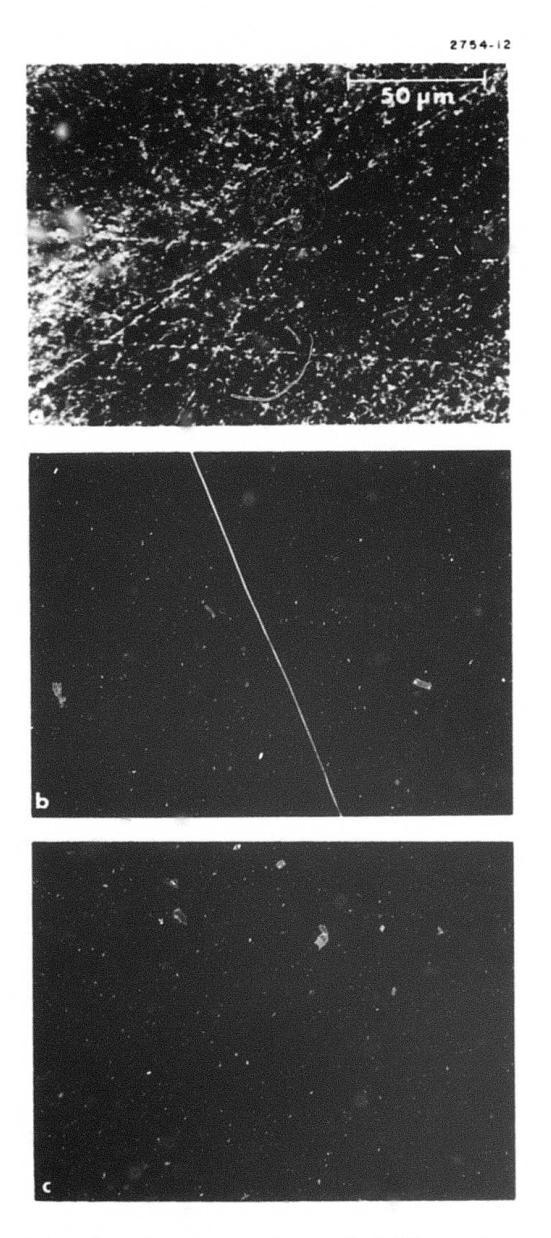
Fig. 4. Optical micrographs of KCl under phase contrast illumination, magnified 325 times.

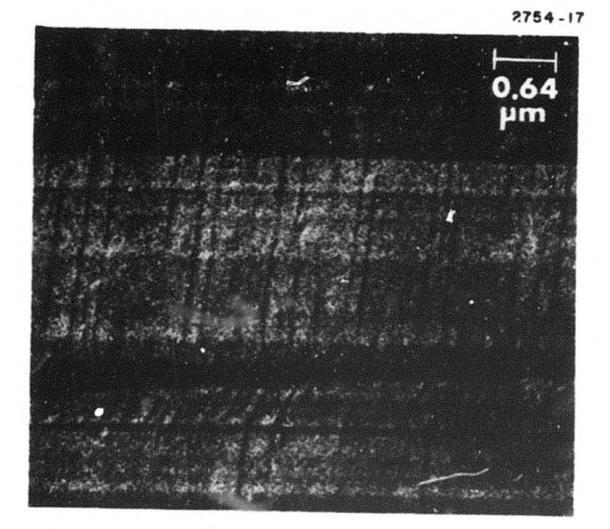
Fig. 5. SEM surface topography of KCl sur-face mechanically polished and etched in HCl at a magnification of 15,000 times.

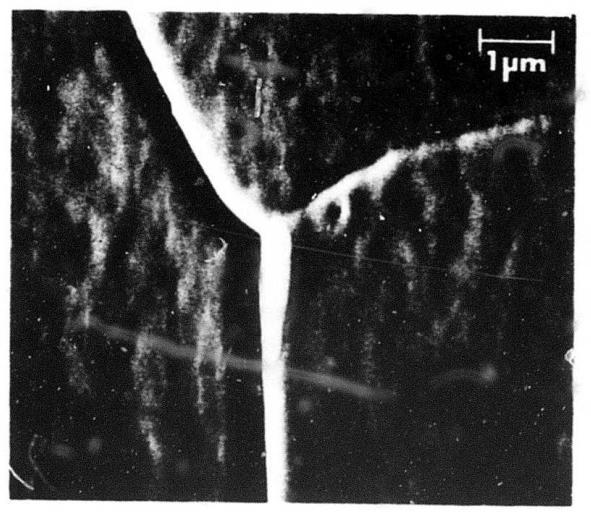
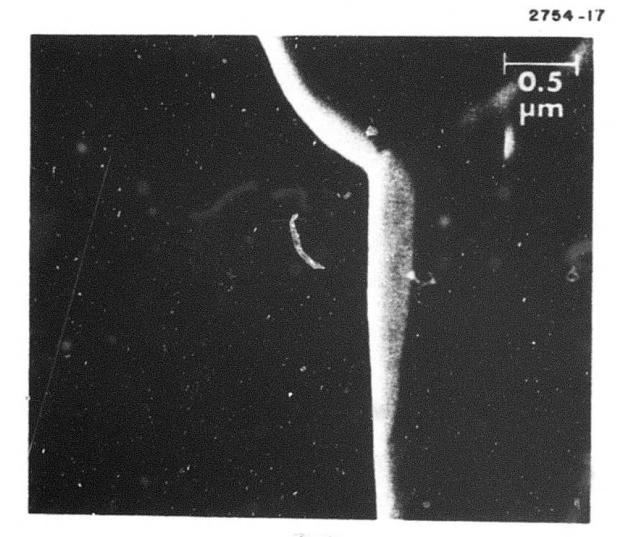
Fig. 6. SEM photographs of KCl surface at a beam voltage of 20 kV.

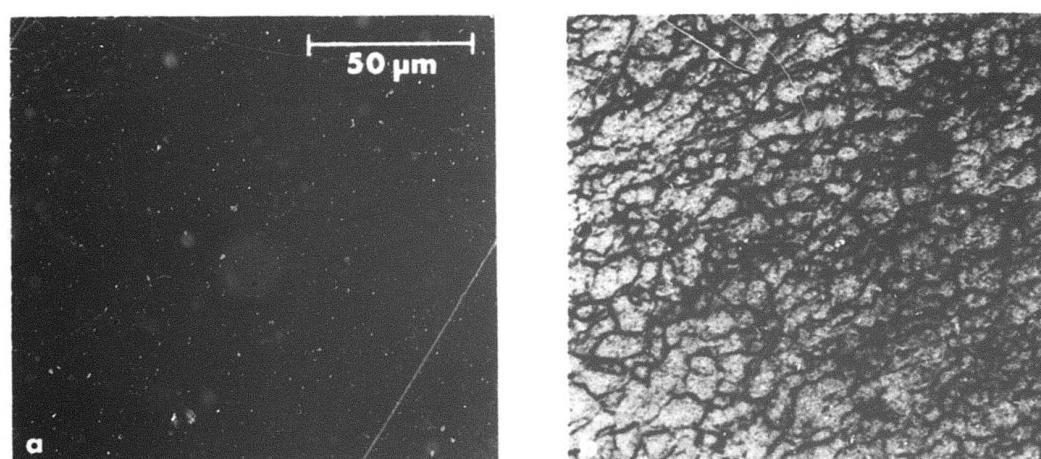
Fig. 7. Optical micrographs of pressforged KCl after 1 min HCl etch.

Figure 7(a) and 7(b) show some recent results we have obtained for HCl etching of two press-forged KCl samples. One had been forged some time ago (2-20-73) and the second shown in view (b) was forged recently (10-31-73). These results indicate that the recrystallization induced by forging of undoped halides (to provide increased strength to the material) under the circumstances of the forging conditions used here did not result in a stable crystal structure. Upon aging, the sample produced earlier has reverted back to a predominately larger grained single crystal structure. The forging conditions used for the two samples which were pressed from starting blanks 1 in. thick are:

2-20-73 was deformed in two steps, 60% at  $200^{\circ}$ C and 15% further at 150°C at a strain rate of 0.050 in. min<sup>-1</sup>/ in. of remaining length.

10-31-73 was deformed 72% at  $150^{\circ}$ C at a strain rate of 0.050 in. min<sup>-1</sup>/in. of remaining length.

The final pressure for the above two samples was 4000 psi; sample 2-20-73 when first forged evidenced a grain size of 1  $\mu$ m to 10  $\mu$ m after forging. Measurements made on the same piece 10-19-73 showed very large grains (several mm) with some small areas of 1 to 10  $\mu$ m crystallites. Sample 10-31-73, when measured after HCl surface

etching of the forging, indicated material with 1 to 10  $\mu$ m grain size over the entire surface as shown in Fig. 7(b). Both samples were HCl etched for 1 min.

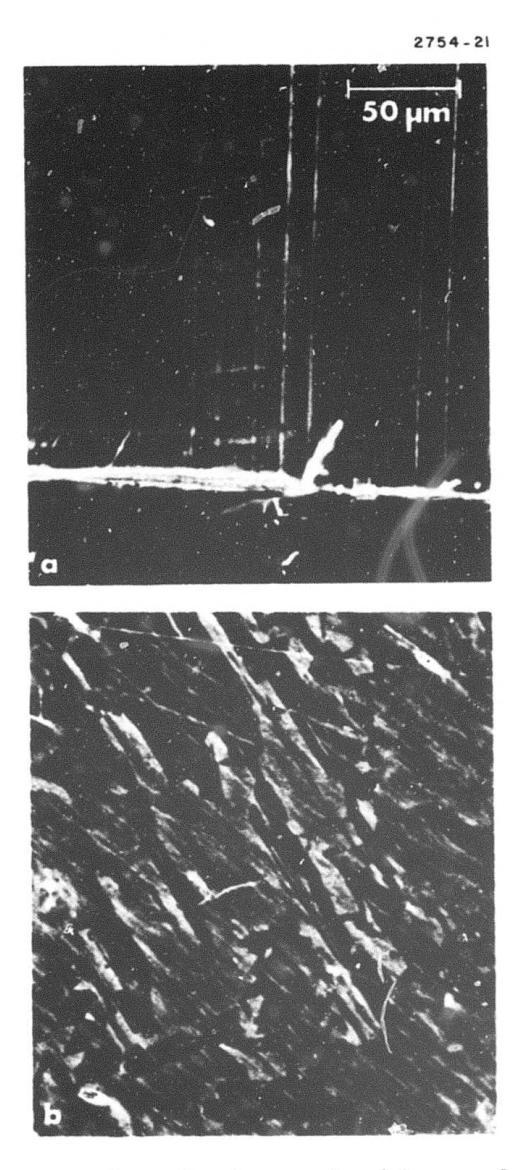
Fig. 8. Photomicrographs of zinc selenide surfaces at 325 times magnification after removal of polished surface layer.

Mechanical removal of surface material by scraping with a metal blade revealed the well-defined twinned structure as seen in the photograph, Fig. 8(a), at 325x magnification. This has led us to deduce the following:

- a. The mechanically polished ZnSe surface layer is softer than the underlying crystalline substrate.
- b. The surface layer is caused by smearing of the surface during lapping in the near-final polishing stages, since scratches are positioned within the layer and result from finer abrasives.
  - 22

c. We have estimated that the surface layer is thin, about 5000 Å, and amorphous, since no structure is seen in the layer itself.

Removal of most of the surface layer of the ZnSe has been done in our preliminary work by metallographic polishing (fine alumina on a slow fine-cotton lap) as shown in Fig. 8(b). Our efforts to remove this smeared layer were based on our belief that removal of this 1 yer would reduce surface optical absorption at 10.6  $\mu$ m and contribute to the application of better adhering optical coatings to the ZnSe surfaces.

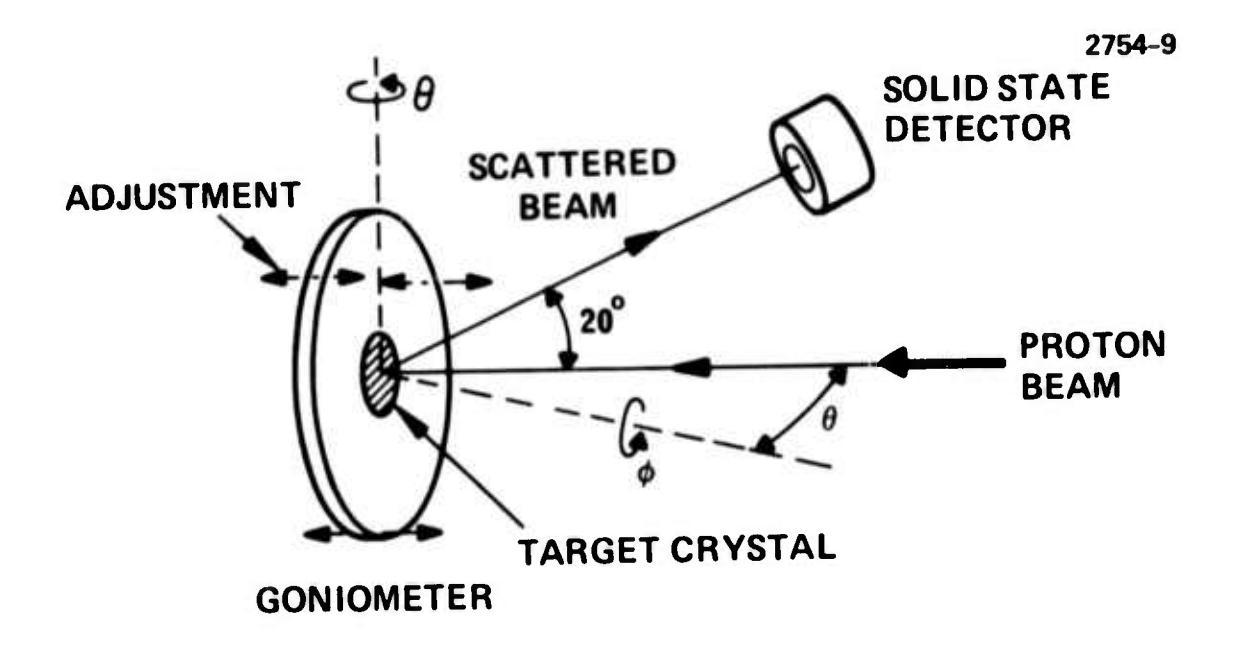
Fig. 10. Schematic of ion backscattering target chamber.

The experimental arrangement is illustrated in Fig. 10. Backscattered particles are detected at an angle of  $160^{\circ}$  with respect to the incident beam using a cooled Si detector (full width at half maximum

$\sim 5$  keV for H<sup>+</sup>). The sample is mounted on a goniometer to permit either <100> or random alignment of the crystal with respect to the incident beam. An oven assembly which encloses the sample holder permits in situ anneals. A biased W filament may be used to provide electron flooding of the target when necessary to prevent beam charging effects.

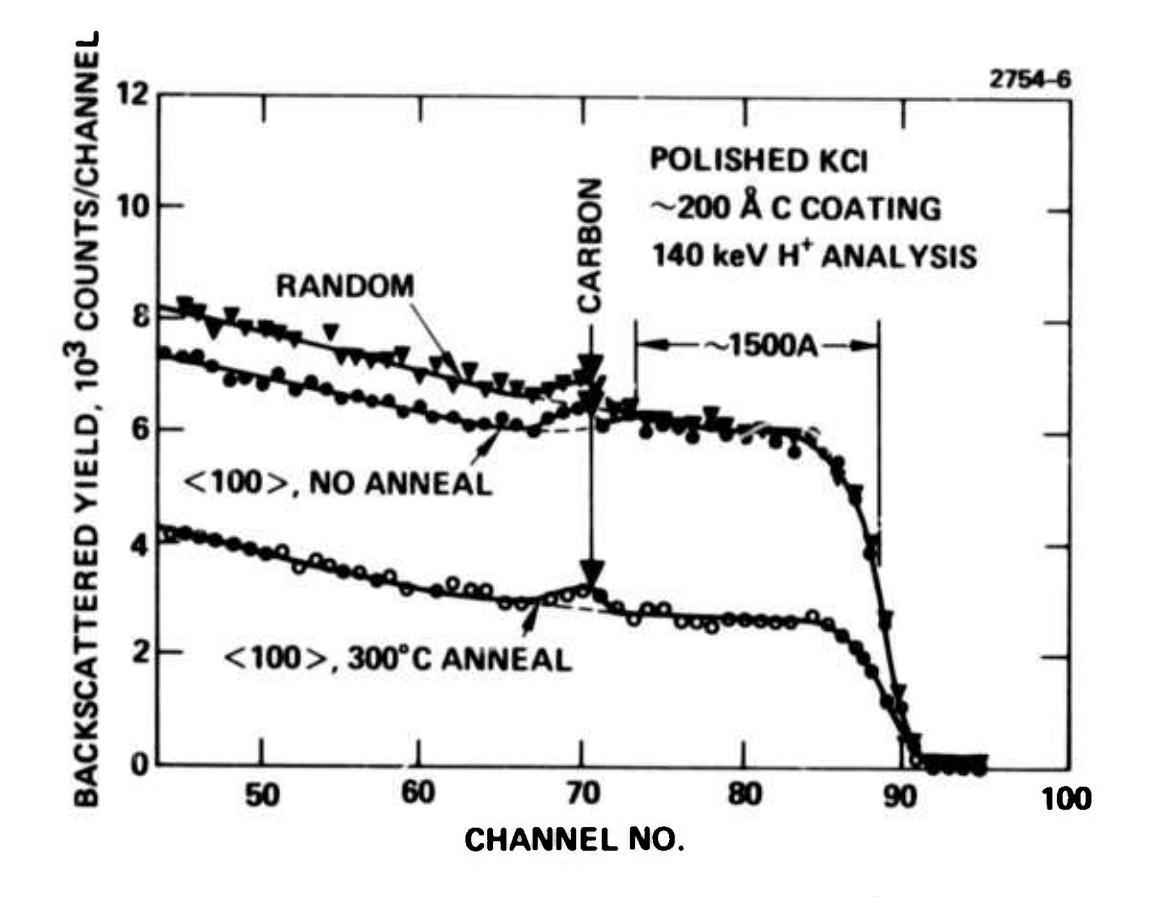
Fig. 11. 140 keV H<sup>+</sup> channeling analysis of polished KC1 before and after 300°C anneal.

The samples used for this work were single crystal platelets of KCl (Optovac) which were cleaved along {100} planes and then polished with either Linde A or Linde B abrasive on flannel using methanol. Backscattered energy spectra of 140 keV H<sup>+</sup> incident in random and <100> directions before and after 30 min anneal at  $300^{\circ}C$ on a Linde B polished sample are shown in Fig. 11. In this case, a 200 Å carbon layer was deposited on the specimen to prevent beam charging. Before anneal the coincidence of the <100> and random yields from the surface to a depth of about 1500 Å indicates that an amorphous layer was formed to this depth by the mechanical polishing. At deeper depths (smaller channel numbers), the <100> yield is less than the random yield as a result of ion channeling in at least partially crystalline material. However, long range disorder or strain is suggested since, even though the beam is significantly dechanneled in traversing the amorphous layer, the <100> yield does not decrease as much as expected if the substrata were perfectly crystalline below the amorphous layer. The small peaks near channel 70 are caused by the carbon coating. A <100> backscattered energy spectrum taken after the anneal sequence is also shown in Fig. 11. As can be seen, the <100>yield is about one-half of the random yield, indicating about 50% recrystallization of the amorphous layer and thus comparable ion channeling. Clearly, either longer times or higher anneal temperatures are required to effect complete recrystallization. Nevertheless, the data of Fig. 11 indicate that significant reduction in polishing damage occurs after relatively mild thermal treatment.

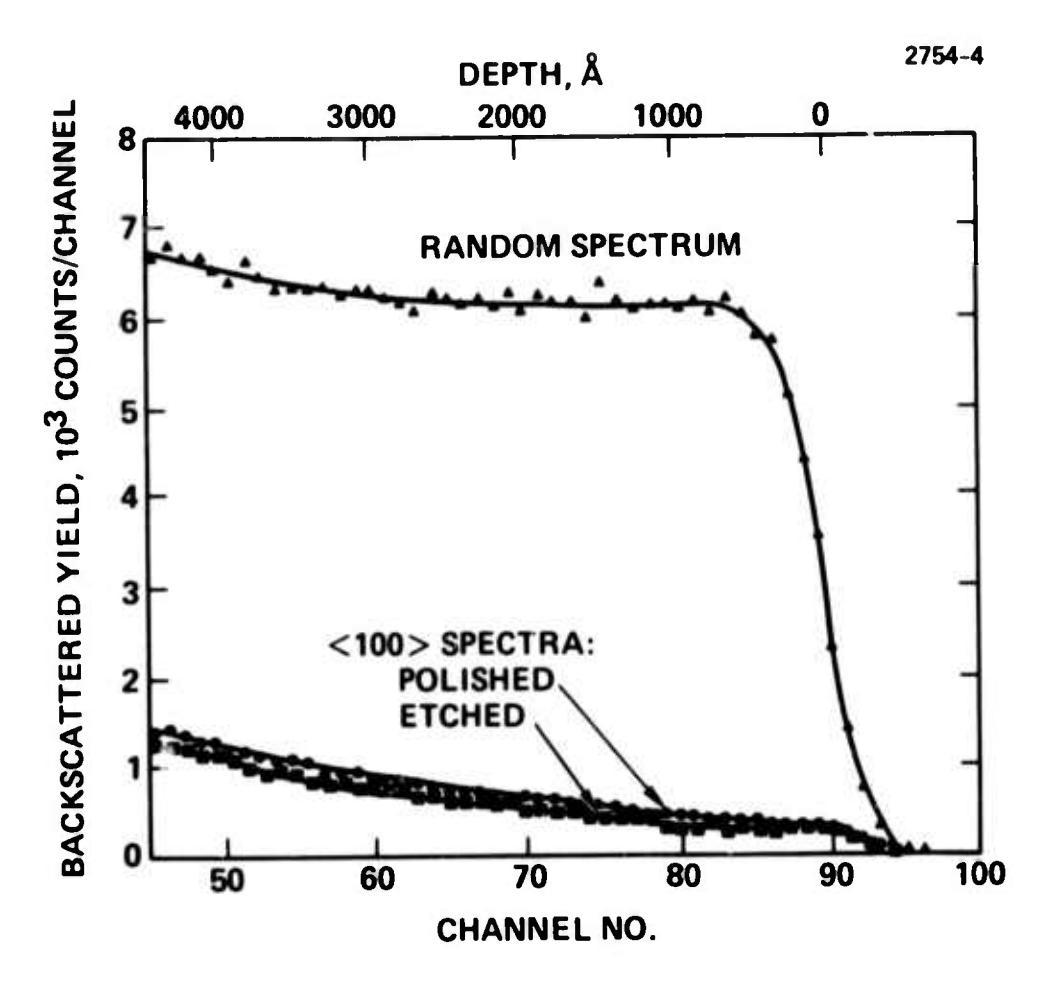
LINDE A - METHANOL ON FLANNEL

30 sec IN HCI

Fig. 12. 140 keV H<sup>+</sup> channeling analysis of polished and etched KCl.

Backscattered energy spectra of 140 keV  $H^+$  from both a Linde A polished sample and a sample etched for 30 sec in HCl are shown in Fig. 12. In these cases electron flooding prevented beam charging. As can be seen in Fig. 12, the <100> backscattered yield of the etched sample near its surface is about 1/20 of the random yield. Such a ratio is consistent with good crystalline qualities. The small peak at the surface (channel 90) is probably caused by a thin surface oxide. Although the <100> yield of the polished sample is somewhat greater than that of the etched sample, indicating some lattice disorder or strain, it is remarkable that no amorphous layer is observed as was seen on the Linde B polished sample of Fig. 11. In fact, greater than 90% of the beam remains channeled in the surface region.

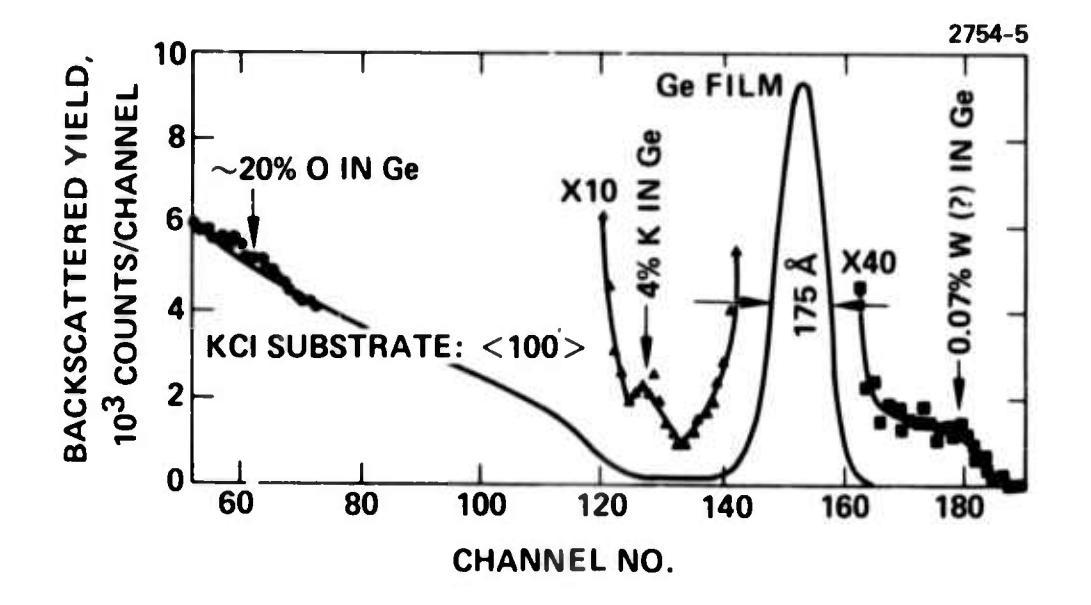
DEPOSITION CONDITIONS: RATE: 0.6 Å/sec PRESSURE: 8X10 -10 Torr SUBSTRATE TEMP.: 150°C

2700 Å Ge ON KCI,  $a = 94 \text{ cm}^{-1}$

Fig. 13. Backscattered energy spectrum of 280 keV He<sup>++</sup> incident on a 175 A UHV deposited Ge film on KCl.

Rutherford backscattering analysis has been used in some preliminary experiments to compare the properties of Ge films on KCl produced in ultrahigh vacuum (UHV) and by ion beam sputtering. Figures 13 and 14 show the results of a comparison of UHV-prepared thin Ge films deposited on KCl at a low rate and a somewhat higher rate, 0.6 Å/sec and 27 Å/sec, respectively. A 2700 Å film deposited at the low rate has a 10.6  $\mu$ m absorption coefficient of 94 cm<sup>-1</sup> and the more rapidly deposited film with a thickness of 8800 Å has a lower absorption of 24 cm<sup>-1</sup>. The backscattered energy spectra also reveal, when compared, that there is some evidence for presence of heavy metal impurity (possibly tungsten), oxygen, and potassium. The concentration of these impurities is somewhat lower

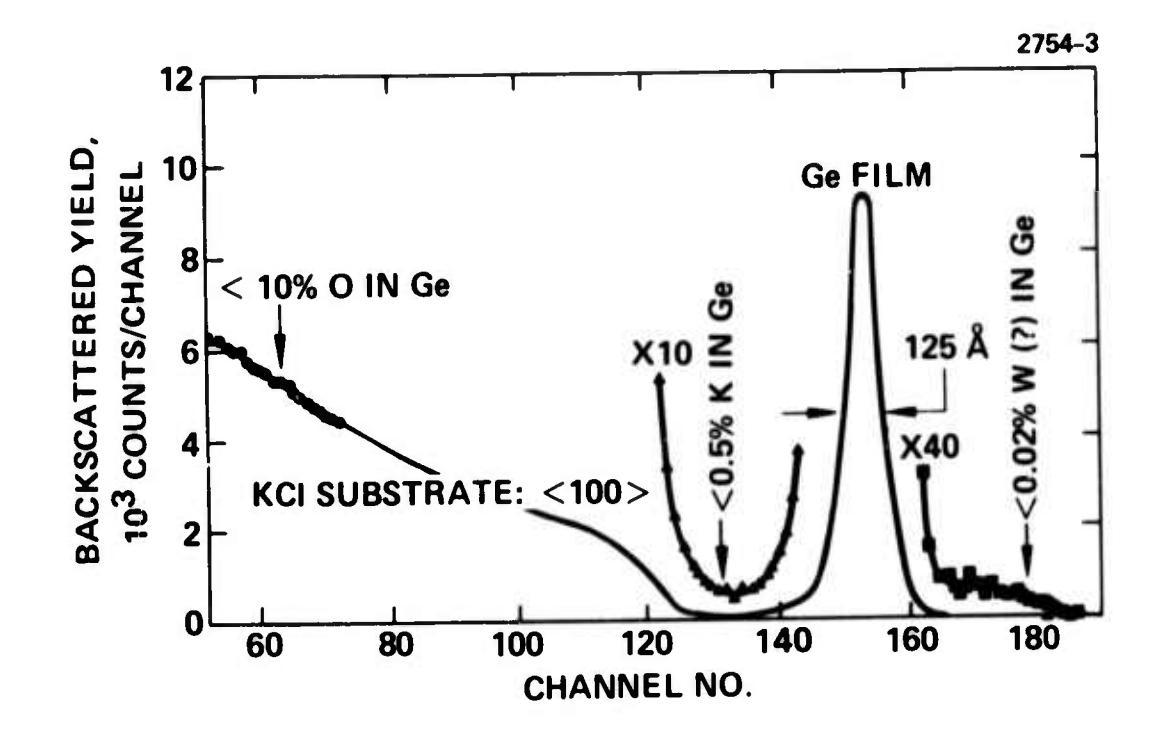
DEPOSITION CONDITIONS: RATE: 27 Å/sec PRESSURE: 2X10<sup>-8</sup> Torr SUBSTRATE TEMP.: 150°C

8800 Å Ge ON KCI, a = 24 cm<sup>-1</sup>

Fig. 14. Backscattered energy spectrum of 280 keV He<sup>++</sup> incident on a 125 Å UHV deposited Ge film on KCl. in the data shown in Fig. 14 for the more rapidly deposited Ge film. The most surprising result of the analysis of these films has been the presence of the potassium which we believe diffuses into the Ge film from the substrate. We do not know at the present time the influence the potassium content has on the optical absorption properties of the Ge films.

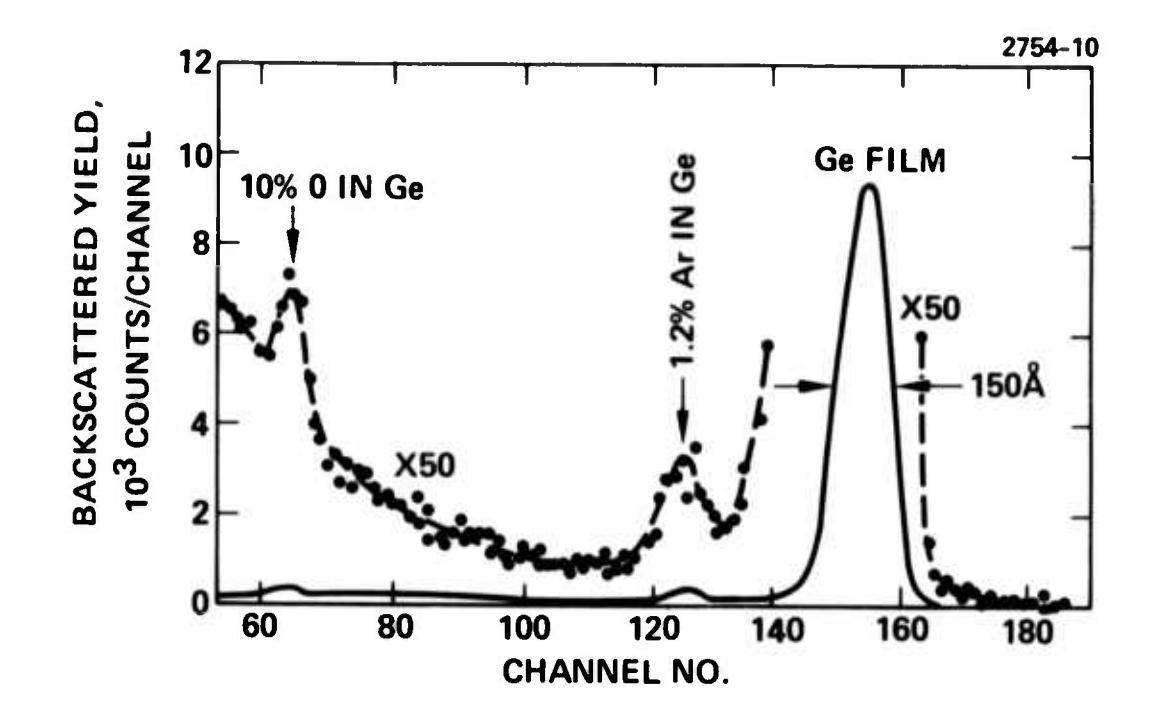
DEPOSITION CONDITIONS: RATE: 0.5 Å/sec ION: Ar<sup>+</sup> AT 7.5 keV PRESSURE: 2X10<sup>-5</sup> Torr (Ar), 5X10<sup>-7</sup> Torr (BASE) SUBSTRATE TEMP.: 80°C

6000 Å Ge ON KCI,  $a = 36 \pm 12 \text{ cm}^{-1}$

Fig. 15. Backscattered energy spectrum of 280 keV H<sup>++</sup> incident on a 150 Å Ge film sputter-deposited onto a carbon substrate.

Figure 15 slows the backscattering energy spectrum for a Ge film produced by ion beam sputtering onto a carbon substrate. The carbon substrate was used to enable our achieving increased sensitivity for the analysis of oxygen content in the film. In previous experiments we have determined that the carbon support structure had an oxygen level very much reduced below that shown in the data of Fig. 15. The spectrum shown indicates the presence of 1.2% argon and 10% oxygen in the Ge film. A 6000 Å Ge film produced on KCl during the same ion sputtering deposition had an optical absorption coefficient at 10.6  $\mu$ m of 36 ± 12 cm<sup>-1</sup>.

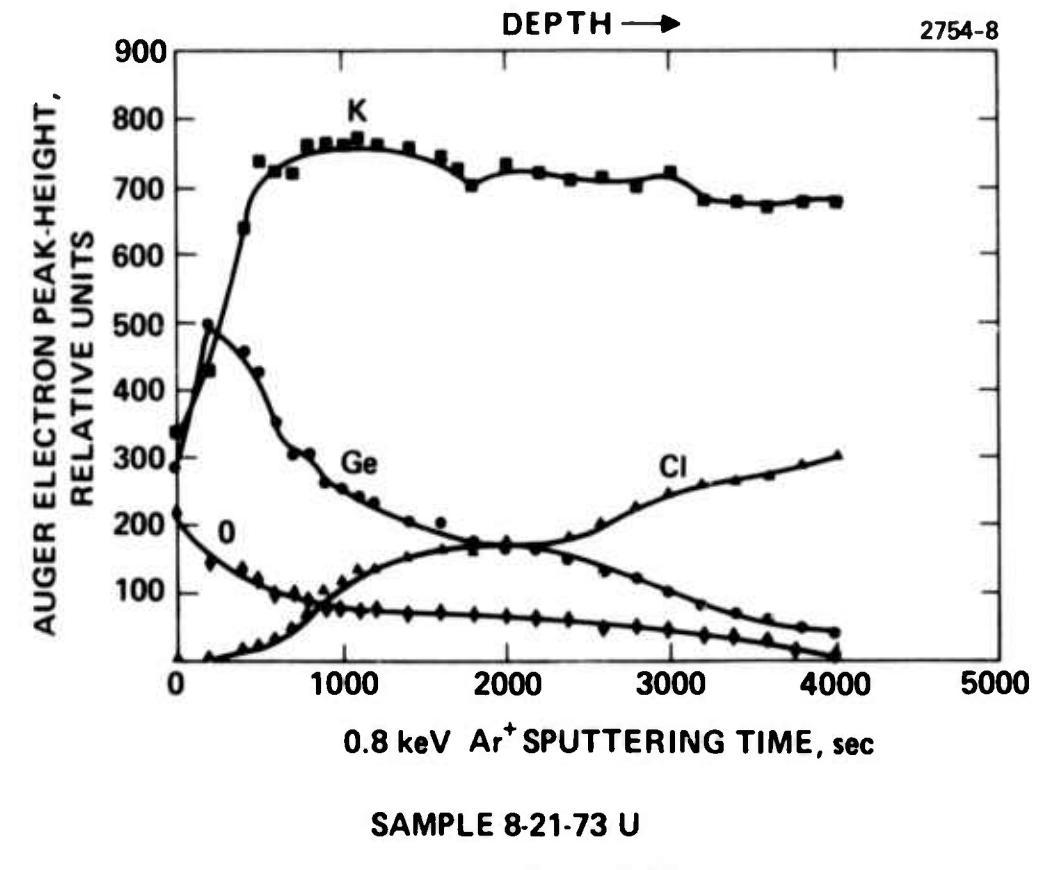
DEPOSITION CONDITIONS: RATE: 0.6 Å/sec PRESSURE: 8X10<sup>-10</sup> Torr SUBSTRATE TEMP.: 150°C

2700 Å Ge On KCl,  $a = 94 \text{ cm}^{-1}$

Fig. 16. Auger electron analysis of a 175 Å UHV deposited Ge film on KCl.

Auger electron analysis of the Ge film produced in UHV at the low rate of 0.6 Å/sec was performed to determine if the potassium found in the film using ion backscattering analysis would be confirmed by Auger analysis. As can be seen in Fig. 16, the Auger spectra produced by ion beam sputter profile analysis do indeed provide further evidence that the Ge film deposited on KCl does indicate possible diffusion of the substrate material into the film, as evidenced by the Cl and K peaks.

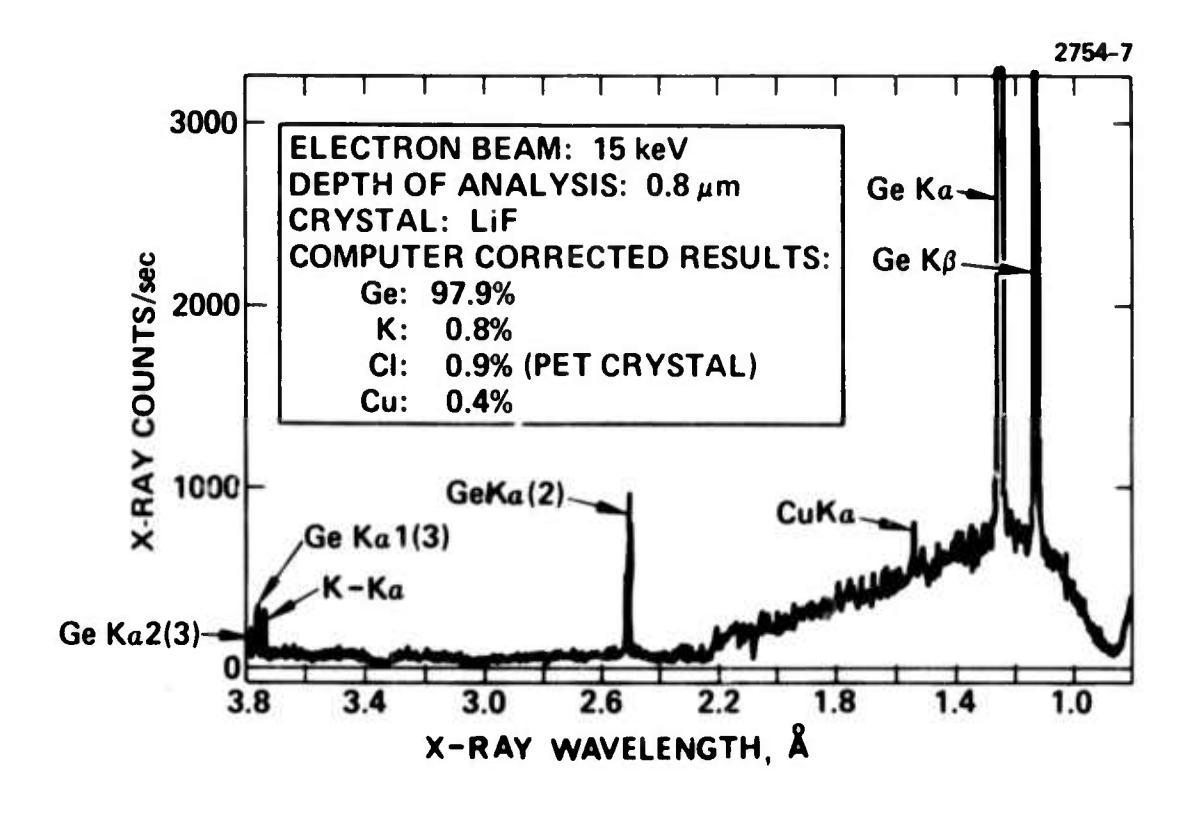
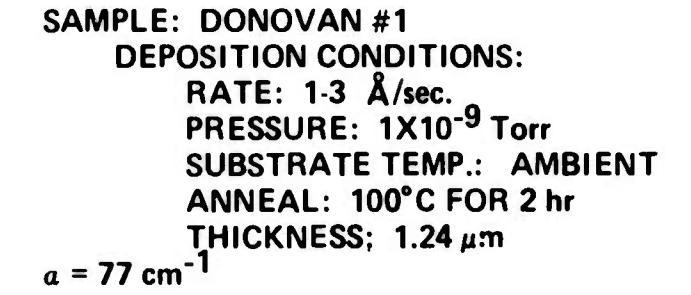
Fig. 17. Electron microprobe analysis of a 1.24  $\mu m$  UHV deposited Ge film on KCl. Film produced at Naval Weapons Center, China Lake.

In Fig. 17 electron microprobe analysis of UHV deposited Ge on KCl is shown for a Ge film produced by T. Donovan of the Naval Weapons Center, China Lake. The 10.6  $\mu$ m absorption coefficient for this film was measured at HRL to be 77 cm<sup>-1</sup>. The probe analysis showed the presence of K, Cl, and Cu impurities in the film at 0.8%, 0.9%, and 0.4% levels, respectively. It should be noted that the relatively high, 77 cm<sup>-1</sup> value, for the Ge film absorption occurs for a rate of deposition which is low compared with the data for our film shown in Fig. 14, which was 27 Å/sec. This trend for Ge films showing high absorption when produced at low rates is consistent for films

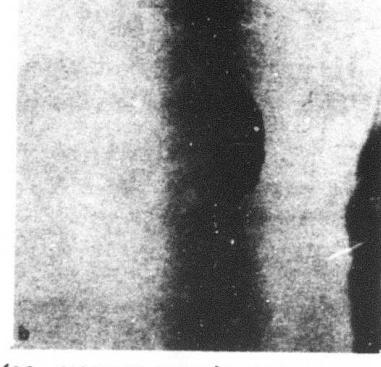
(ACTUAL SIZE) LASER BEAM ENTRY FROM THE RIGHTHAND SIDE OF PHOTO

(20x MAGNIFICATION)LASER BEAM ENTRY FROM THE RIGHTHAND SIDE OF PHOTO

Fig. 18. Photographs of zinc selenide window damaged by a 10.6 µm pulsed laser beam.

The laser damage effort under the present ARPA-supported program discussed in this report will not start according to plan until the latter part of November 1973. However, some preliminary data have been obtained for some of the KCl and ZnSe samples having surface finishes as described in the surface finishing section of this report. For HRL RAP-grown KCl single-crystal material having HCl chemical etched surfaces, damage thresholds achieved are  $>140 \text{ J/cm}^2$  at power densities of >230 MW/cm<sup>2</sup>. Zinc selenide windows (Raytheon CVD material) polished at HRL and provided with antireflection coatings show no surface damage to the windows or coatings at the power levels we have available in our test laser (≈230 MW/cm<sup>2</sup>). However, damage does occur to the interior region of the bulk material at energy densities of 17 to 20  $J/cm^2$  and at power levels of 28 to 33  $MW/cm^2$ . Damage sites occur at regions in the window which show ZnSe material nonuniformity as evidenced by dark bands which show up in the window material when a window blank is viewed through the window edge using visible light. Figure 18(a) shows a photograph of such a damage site when viewed through the diameter of a window from a polished edge. Figure 18(b) is an enlarged view at 20x magnification of the same test sample.
