ENGINEER RESEARCH AND DEVELOPMENT LABORATORIES

#### 2.4 EXPERIMENTAL PLAN FOR FIELD EXPOSURES

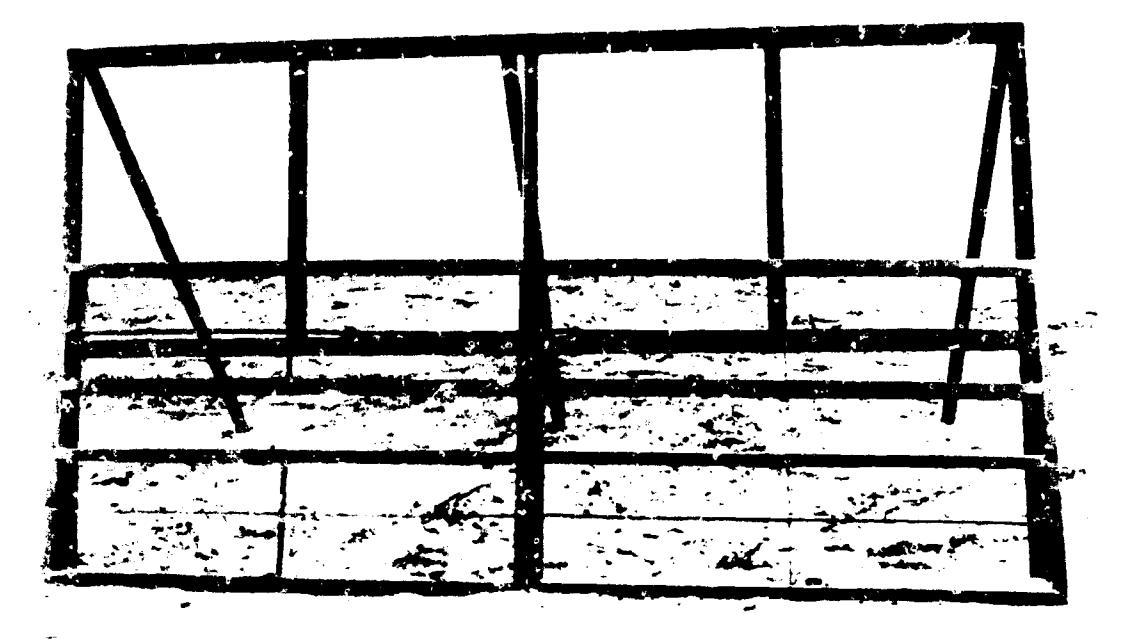
Fig. A.1 Construction Of Racks Used For Field Exposure

The rack, itself, was 5' x 10' with two 3' x 5' panel sections that were 2' off of the ground. The rack and panel sections were so constilled that they reinforced each other. The panel sections were secured to the rack frace by three bolts, thus permitting quick easy removal of the samples to an uncontaminated area where a careful eximination of the panels could be mide and a fresh series prepared for the next shot.
