AFFDL-TR-66-43 PART XI

# **AIRCRAFT GROUND-FLOTATION INVESTIGATION**

## PART XI -- DATA REPORT ON TEST SECTION 10

U. S. ARMY ENGINEER WATERWAYS EXPERIMENT STATION

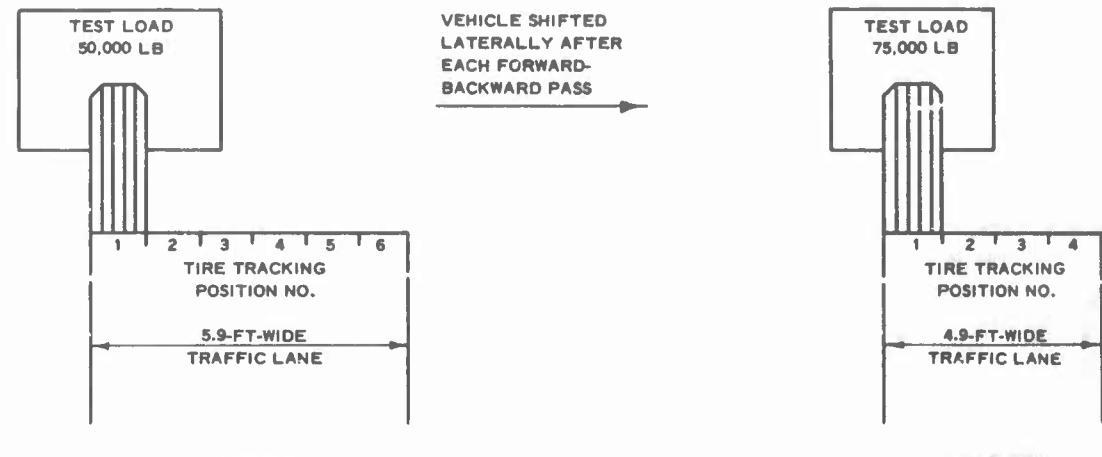
Figure 1. Application of traffic on Test Section 10

The load vehicle was operated to produce uniform traffic coverage on the test lanes. The load cart was driven forward and backward along the same track, then shifted laterally and the forward-backward operation repeated. In this manner, two coverages of traffic were applied to the test lane as the vehicle progressed from one side of the lane to the other. Figure 1 is representative of the general method of applying uniform coverages to the test lanes.

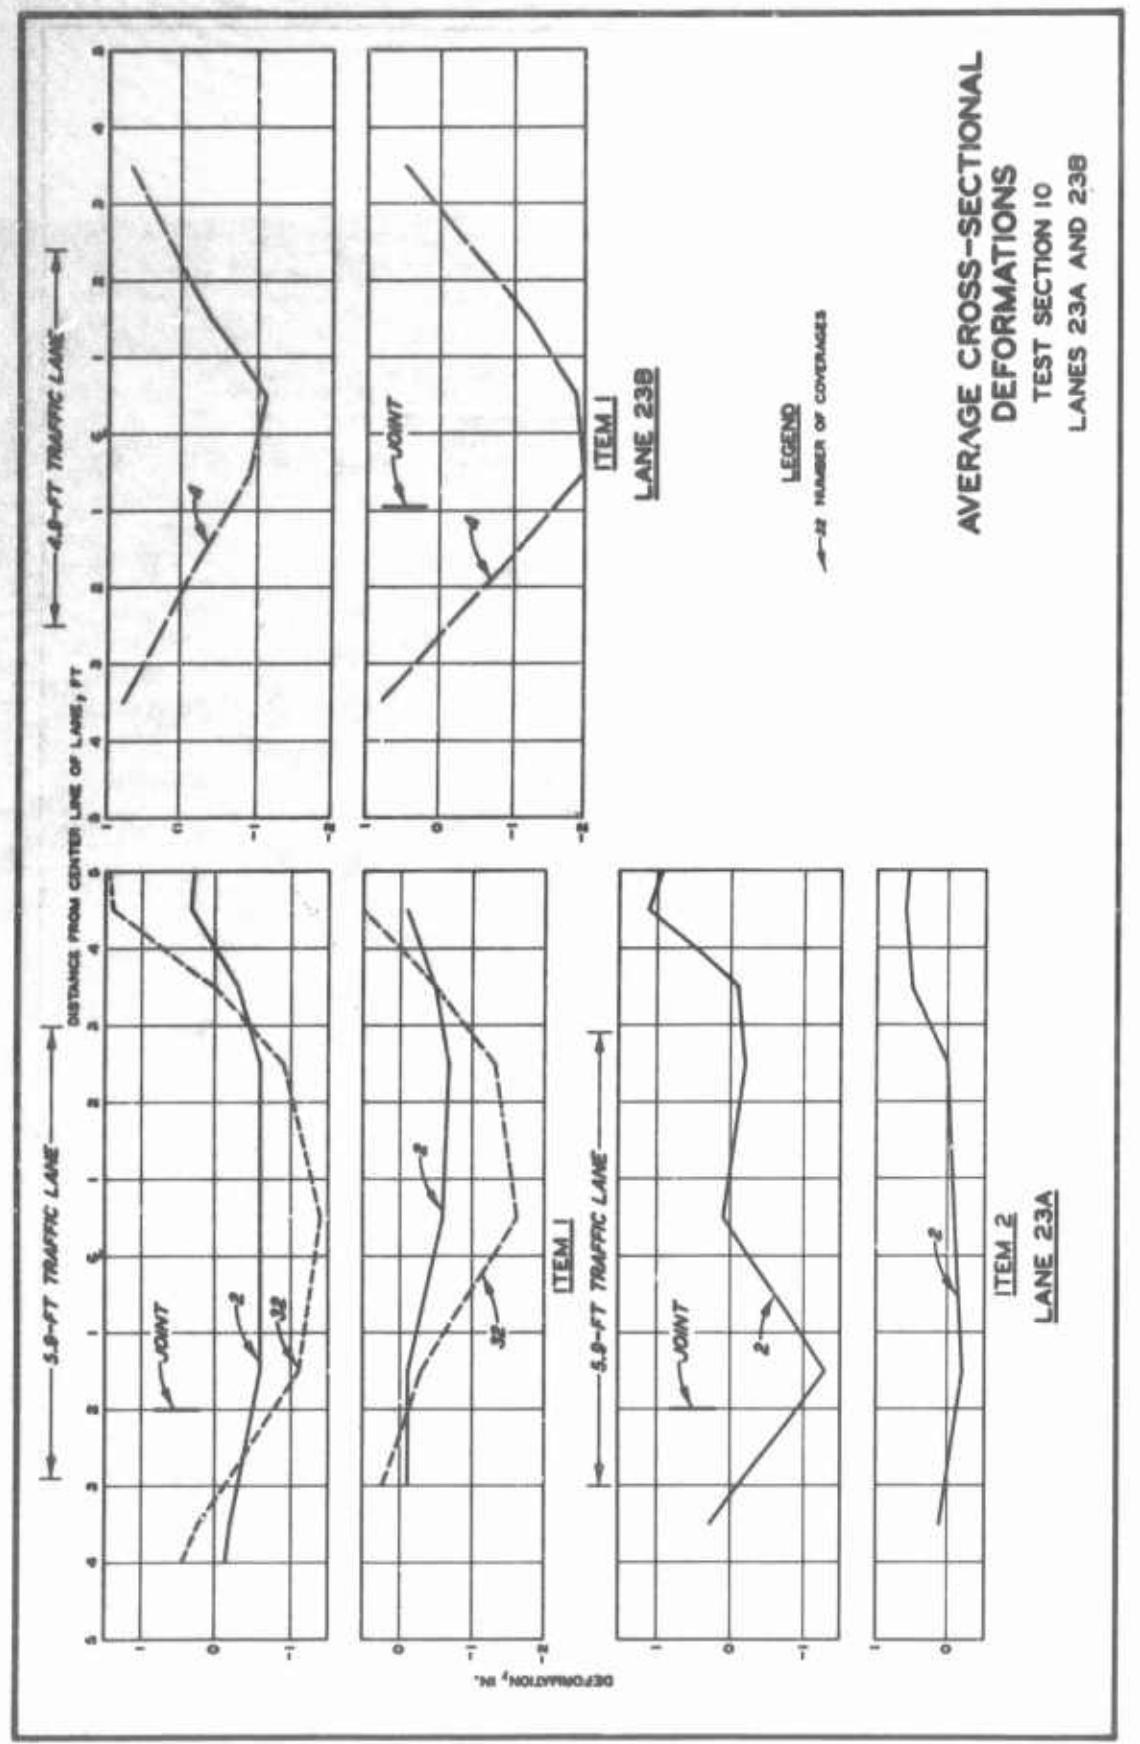
- b. <u>Deformations</u>. Figure 12 shows average cross-section deformations at 2 and 32 coverages for each of two typical mat runs. Figure 13 shows a profile plot of the item at the same coverage levels. Severe transverse differential deformations are evident and were the principal roughness factor contributing to failure.

- b. Deformations. Average cross-section deformations at 2 coverages for two typical mat runs are plotted in figure 12. A very significant factor in cross-section deformations was the mat uplift along both sides of the lane. Figure 13 shows the longitudinal irregularities that contributed to early failure of the item.

- b. <u>Deformations</u>. Figure 12 shows average cross-section deformations at 4 coverages for two typical mat runs. Mat uplift at the lane edges contributed to the cross-section deformation. No profile deformation data were obtained on this item.

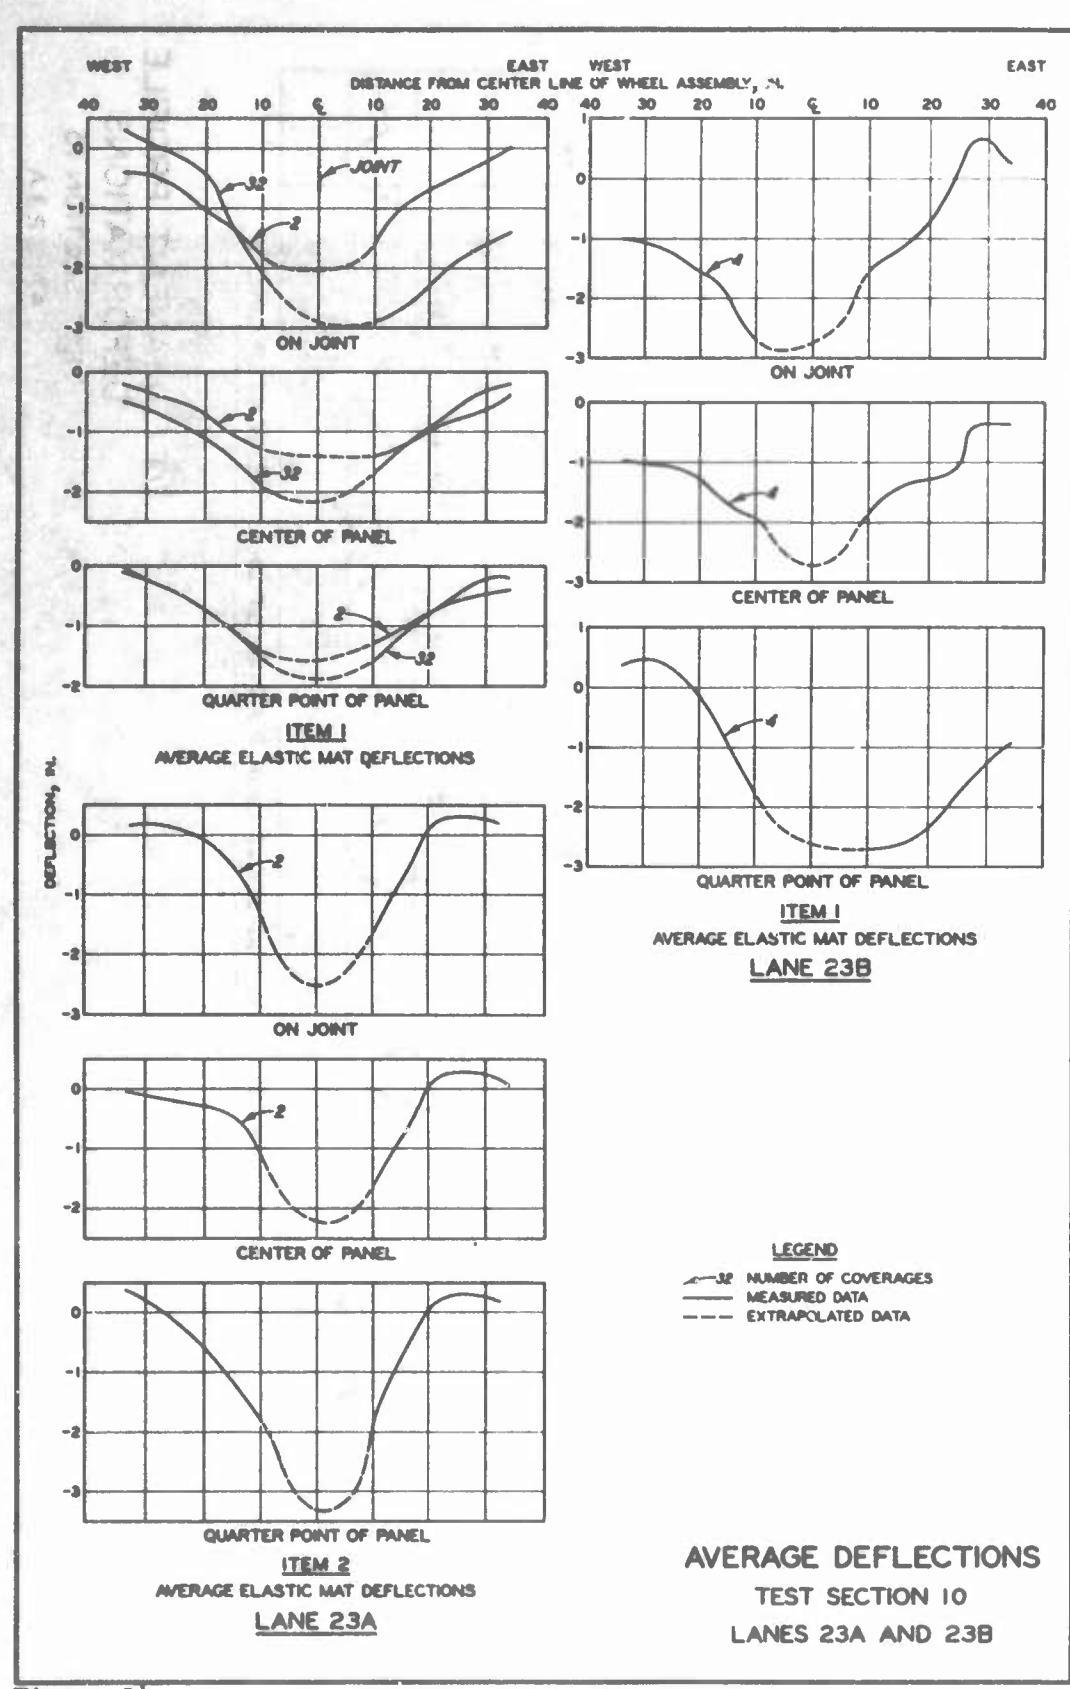
Figure 14

- c. <u>Deflection</u>. Average elastic mat deflections under static load of the load wheel assembly for three positions of the assembly relative to mat end joints are plotted in figure 14. Deflection at 32 coverages was greatest for each position. Elastic soil deflection at failure was 1.6 in.

- c. <u>Deflection</u>. Average elastic mat deflections under static load of the wheel assembly are plotted in figure 14 for three positions of the assembly relative to mat end joints.

- c. <u>Deflection</u>. Average elastic mat deflections under static load of the wheel assembly for three positions of the assembly relative to mat end joints are plotted in figure 14. Only small differences in deflection occurred for the different positions.
