Ground-Penetrating-Radar Profiles of Interior Alaska Highways

Interpretation of Stratified Fill, Frost Depths, Water Table, and Thaw Settlement over Ice-Rich Permafrost

Steven A. Arcone and Kevin Bjella

August 2016

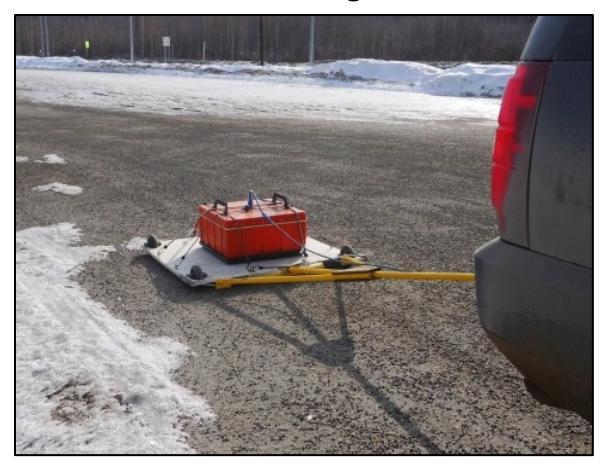
Figure 1. A GSSI Model 5106A "200 MHz" antenna unit in tow on a metal-free sled and on a high-density polyethylene (ε = 2.4) platform. The actual center frequency of pulses received was closer to 150 MHz. The Model 5103 "400 MHz" unit is of identical design but smaller.

We used a GSSI SIR3000 16-bit control unit and the GSSI bistatic Model 5103 "400 MHz" and Model 5106A "200 MHz" antenna units. After impedance loading by pavement contact, the center frequencies were about 320 and 150 MHz, respectively. We towed the antennas very close to the surface by using the polyethylene platform shown in Figure 1. The antenna height above the surface was 5.7 cm, which added 0.6 ns (nanoseconds) to the delay of subsurface events, accounting for the 2.54 cm of high-density polyethylene.

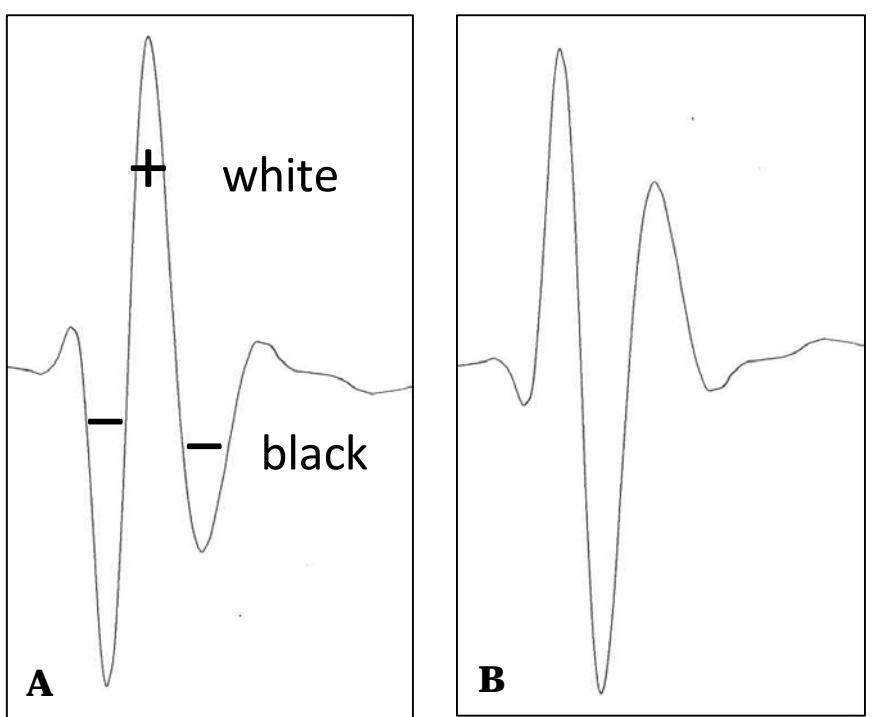
Figure 2. (*A*) Transmitted pulse shape and (*B*) its inversion after reflection from an interface between material of relatively lower permittivity above and higher below (e.g., frozen soil/unfrozen soil). The pulse does not invert if the higher permittivity material is above the interface. These are also the waveforms for thin embedded layers of relatively low permittivity (*A*) and relatively high (*B*). In the profiles, positive half cycles are white; and negative are black.

Transmitted pulse waveforms for all antennas were mainly 1.5 cycles with a - + -polarity sequence for the sequential half cycles (Figure 2A). This sequence also occurs for a reflection from an interface between a relatively higher s_{T} medium (e.g., thaw) above a relatively lower s_{T} one (e.g., frozen) and from an isolated electrically thin (less than 0.4 wavelengths) layer with s_{T} lower than that of the surrounding matrix, such as a thin layer of remnant seasonally frozen material above and beneath unfrozen material. The opposite cases reverse the sequence. Pulse lengths in frozen sands and gravel ($s_{T} = 5$) at 150 and 320 MHz are approximately 1.34 and 0.63 m,

The profiles provide stratigraphic sections in a line-intensity format with a nonlinear proportion between intensity and signal strength to give weaker signals greater amplification. Black bands represent negative amplitude half cycles, and white bands are positive. An isolated pulse has either black–white–black (- + -) or white–black–white (+ - +) banding.

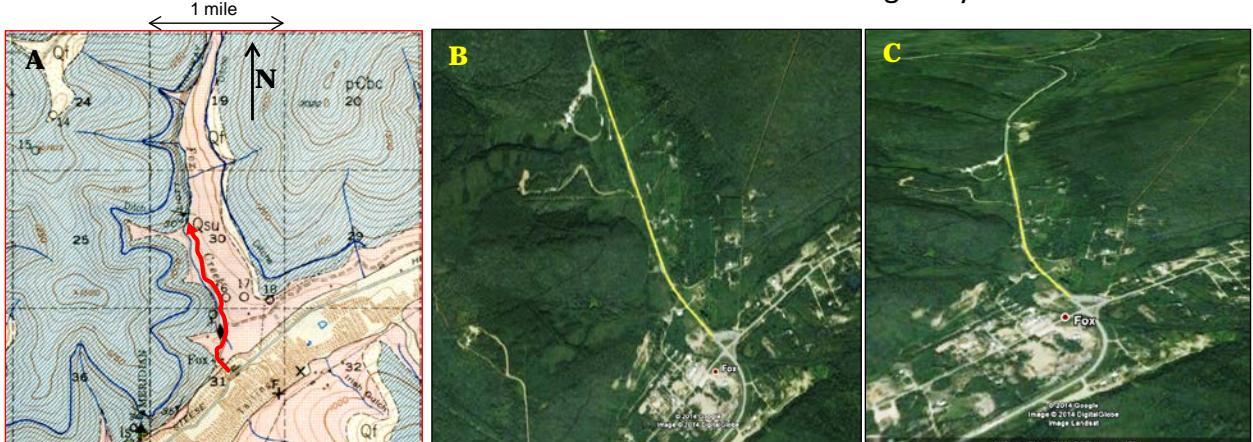
Figure 4. (*A*) 1958 surficial geology map (Péwé 1958) showing that the Elliott (superimposed 1.8 km long *red line*) is along a section of frozen silt. The highway was realigned and widened since 1958. (*B*) Google Earth image of the present day highway. The Elliott starts at Fox; the *yellow line* is 1.86 km long. (*C*) Google Earth perspective view showing that the highway is in a valley.

Figure 4A shows the general surficial geologic setting of the Elliott Highway from where it starts at the truck weigh station in Fox and then for the ensuing 4 km. The highway section is within a valley filled with Quaternary undifferentiated and reworked silts, consisting mostly of quartz, feldspars, and micas, with little clay size content. The valley walls are exposed Birch Creek schist. Figure 4B shows the present alignment, and Figure 4C gives a perspective looking north and reveals that the valley walls are not steep.

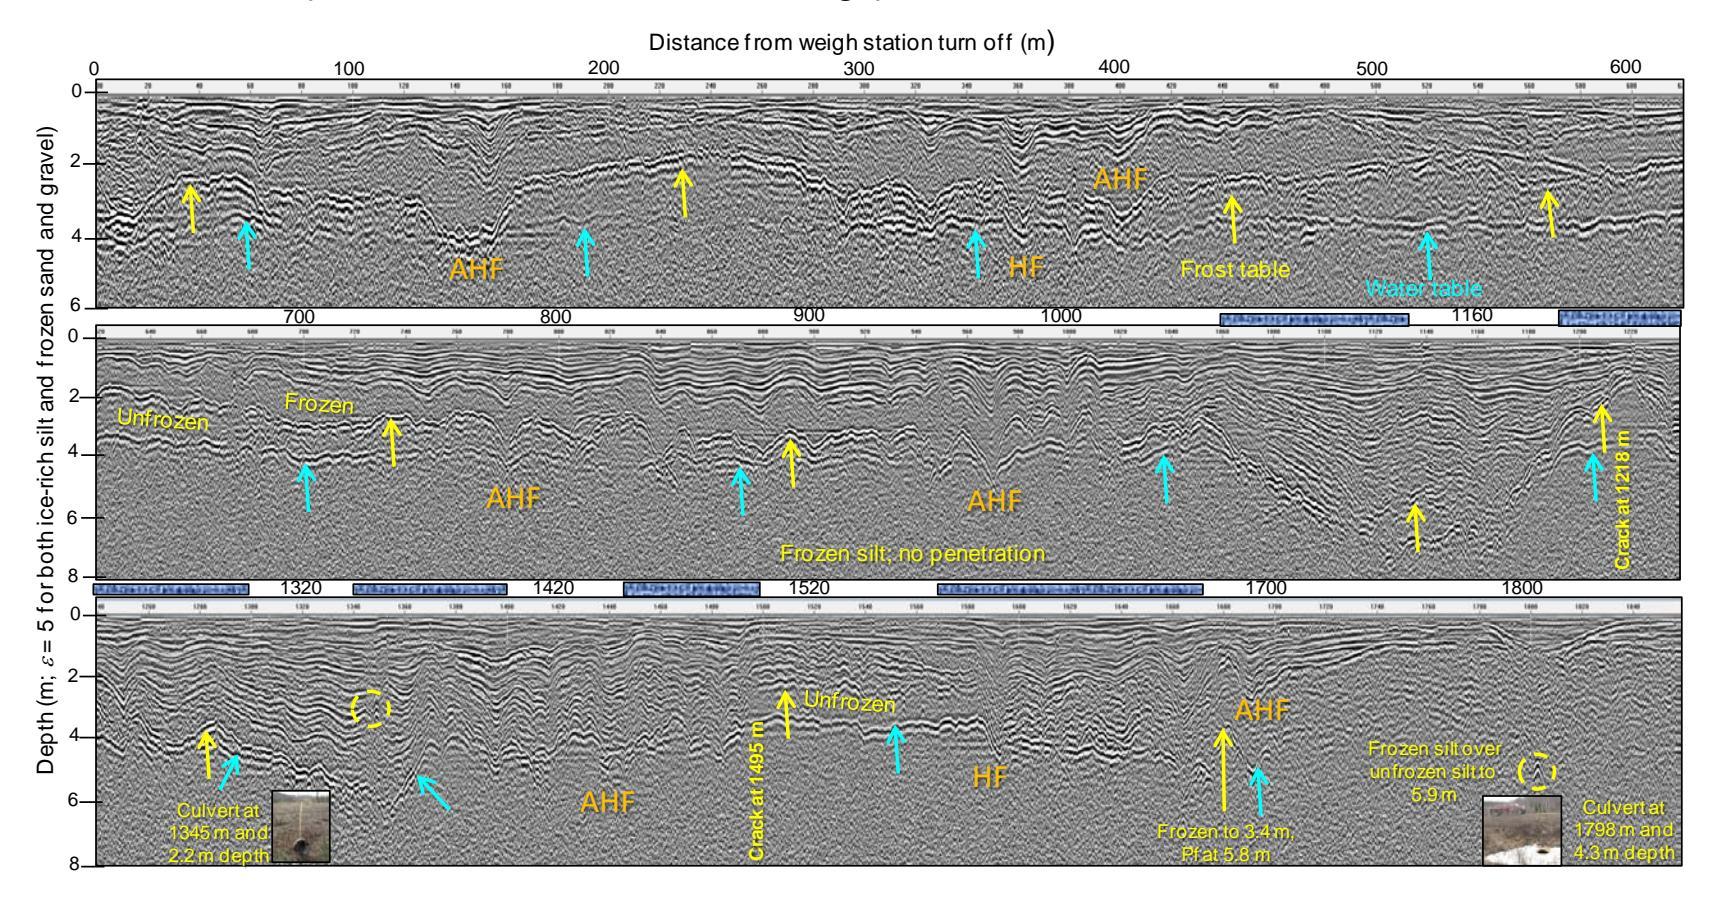
Figure 5. A 320 MHz profile of the first 1860 m of the Elliott Highway, recorded 4 April 2014. The start is at the truck weigh station at Fox. The *speckled blue bars* show where the road was patched during summer 2014 because of thaw settlement. *Yellow arrows* indicate the bottom of seasonal frost, and the *turquoise arrows* indicate the water table. The seasonal frost delineates the fill. HF and AHF labels are below the appropriate folding features, caused by selective thaw settlement above ice deep within the permafrost. The water table often sits right on the permafrost because there is no deeper horizon. There are no hyperbolic diffraction signatures to indicate massive ice. The photos are of the culverts, whose responses are within the *dashed circles*. The stratigraphic note at the lower left is from borehole records.

Figure 5 shows the first 1.86 km of the 320 MHz profile, which we recorded on the east-side shoulder going north. This length contains all the interesting thaw settlement features. The 150 MHz profile showed no greater penetration beneath the water table, which means that the underlying material is highly attenuating.

The speckled blue bars along the distance scale above each section show where the road was patched during summer 2014 due to thaw settlement. The uppermost horizons are reflections from the stratified sand and gravel fill substrate beneath the pavement. The yellow arrows indicate the bottom of seasonal frost; turquoise arrows indicate the water table. These horizons are recognized by their white–black–white banding, which indicates a horizon between low dielectric material above and high material below. In the seasonal-frost case, this means frozen sand and gravel above thawed silt or sand and gravel. In the water-table case, it means thawed material above saturated material. There is no indication of a further horizon beneath the water table, which would be that of the permafrost surface; and there are no hyperbolic diffraction signatures to indicate massive ice.

Figure 5 also shows photos of the culverts, whose responses are within the dashed circles; and there also synopsized notes from borehole records. The culvert at 1798 m gave the best response to migration to verify $\varepsilon_{\rm f} = 5$ (Figure 6B).

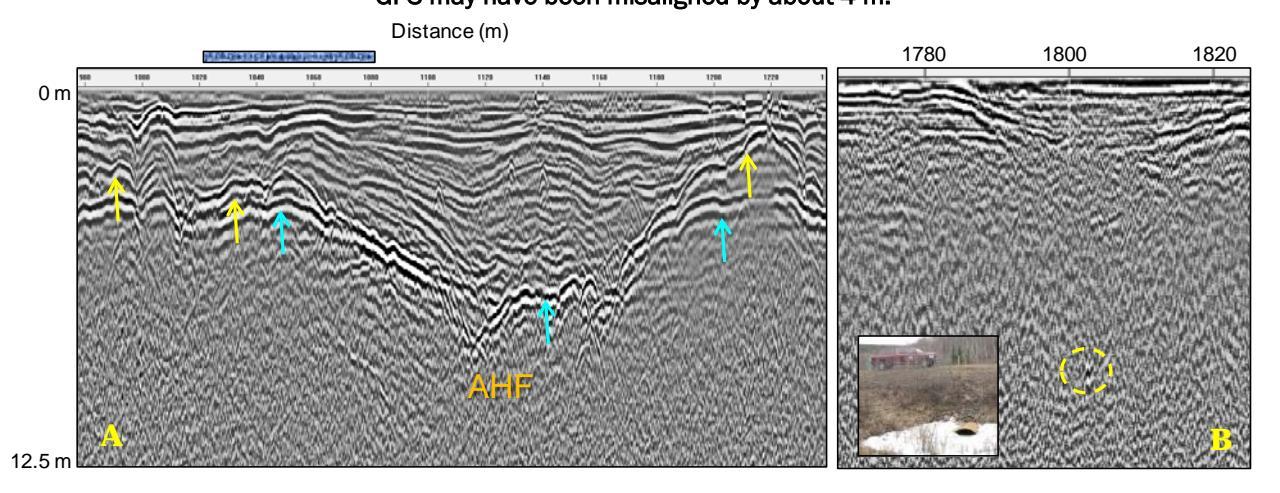
Figure 6. (*A*) Detail of a deeply frozen section recorded with the larger, 150 MHz antenna unit, showing the inability of lower frequency and 8× more power to penetrate any deeper. The underlying material is likely icerich loess. AHF indicates anharmonic folding above. (*B*) Migration for $\varepsilon = 5$ of the culvert (shown in *inset*) response at 1798 m distance (within *dashed circle*). The collapse of the hyperbolic diffraction to just a few traces justifies the use of this dielectric constant. The placement of the migrated diffraction shows that our GPS may have been misaligned by about 4 m.

The seasonal frost delineates the fill and reaches a maximum depth of about 7 m at a 1140 m distance (Figure 6A). Within this detail, not only does the entire fill section sag but also close examination along the water table and frost depth horizons shows a folded character.

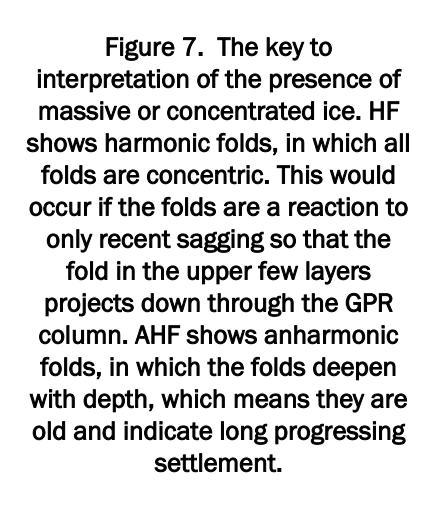
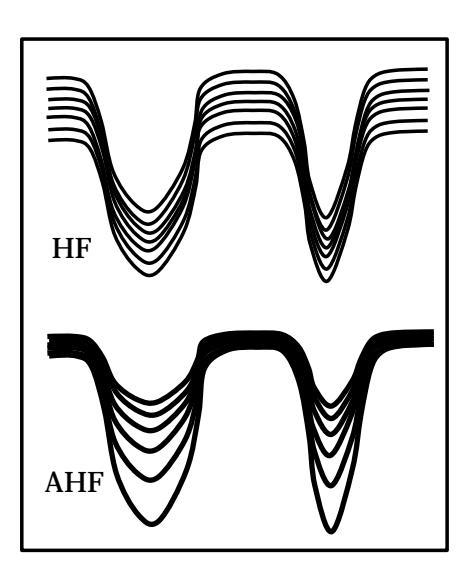
The most interesting features are the wavy horizons, which are pseudofolds caused by thaw settlement over ice deep within the permafrost. The HF and AHF labels indicate either harmonic folding or anharmonic folding, as explained in Figure 7. Harmonic folds (HF) are concentric, which occurs if the folds are a reaction to only recent sagging so that the fold in the upper few layers projects down through the GPR column (i.e., the fold at the top affects deeper strata). Layer slippage during compression also causes this. The deeper folding is then just a velocity "pull-down" from recent surficial sagging. Anharmonic folds (AHF) deepen with depth, which means they are old and indicate a long history of settlement. With each episode of road repair, the layers continually deepen and fold. The labels in Figure 5 are below the appropriate folding features.

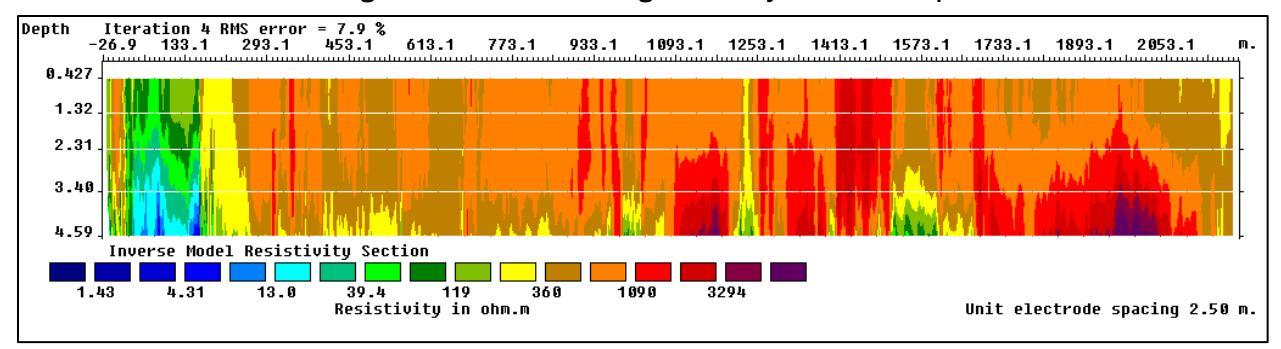
Figure 8 shows the OhmMapper capacitive-coupled electrical-resistivity profiles. Consistently, the highest resistivity is at the 1000–1220 m distance, where the deepest gravel fill occurs; at 1250–1500 m, where thaw settlement is indicated by folding; and at 1700–1800 m, where no horizons greater than 1 m suggest high attenuation (e.g., *barely* frozen, such as ice-rich silt, or thaw). At this location, the borehole log at 1752 shows frost to 4.3 m, wet silt to 5.9 m, and then frozen silt.

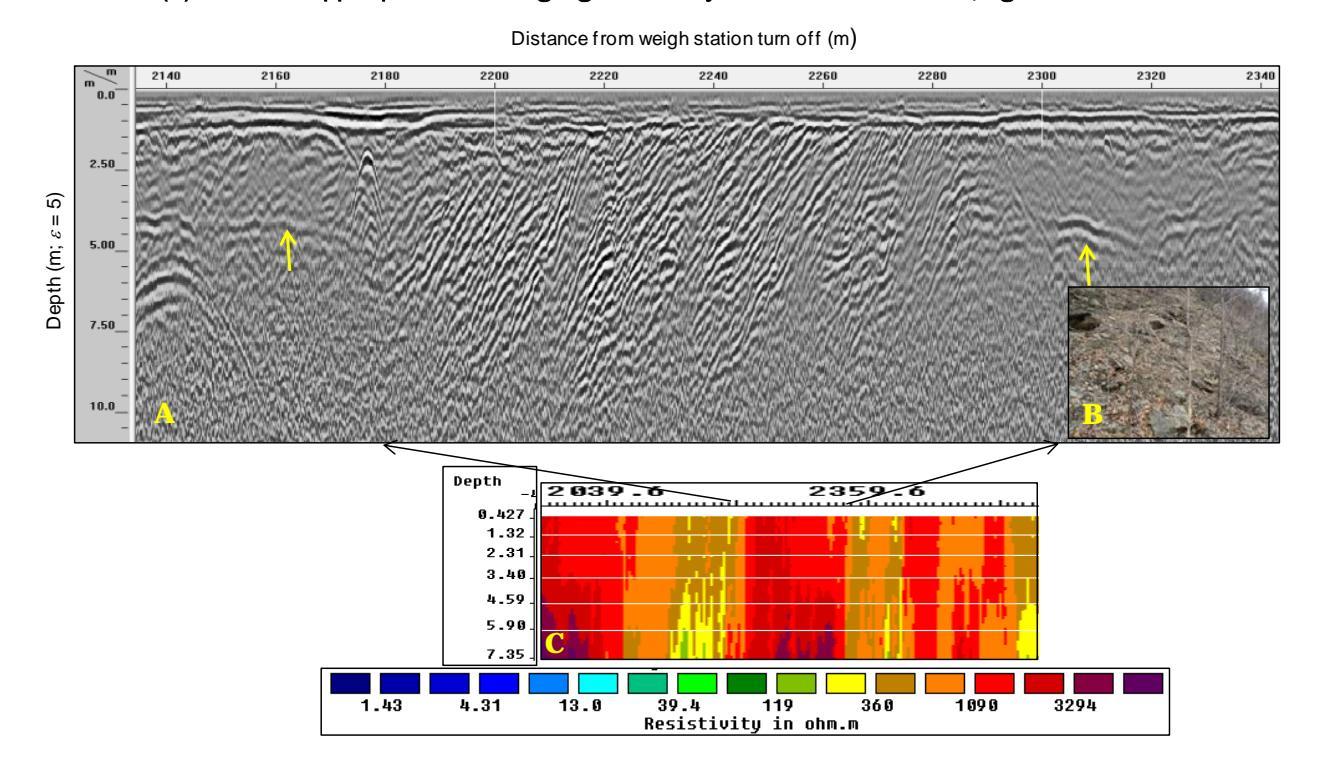
Figure 9. (*A*) Another 150 MHz GPR section showing about 10 m penetration into the underlying schist. There is no clear frost depth horizon, but there are hints (*arrows*) that it dives deeper within the schist. (*B*) A photo showing schist exposed above the road from 2200 to 2280 m. The Péwé map (Fig. 4) shows a 30° dip to the south for the schistosity, and with strike (orientation of the dipping planes) across the road. The profile shows 21°. (*C*) An OhmMapper profile showing high resistivity from 2180 to 2300 m, right over the schist.

Figure 9 shows a section where the road is paved over schist bedrock with only marginal sand gravel grading. The schistosity (foliation) of the formation is evident. We calculated a dip of 21° while Péwé listed 30°. The difference is likely due to the angle the road transect makes with the geologic strike. There is no indication of a water or frost table within the schist horizons. However, there are to either side. The Ohm-mapper shows very high resistivity values. Figure 8. The OhmMapper resistivity profile (2.5 m electrode spacing) along the Elliott Highway. *Red* to *dark red* indicates high ice content. The maximum profile depth is 4.6 m, similar to the profile horizons. The highest resistivity is at 1000–1220 m (deepest gravel fill), 1250–1500 m (thaw settlement under folding), and 1700–1800 m where no horizons greater than 1 m suggest high attenuation (e.g., *barely* frozen, such as ice-rich silt, or thaw). A borehole at 1752 shows frost to 4.3 m, wet silt to 5.9 m, then frozen silt, which is consistent with this figure because it shows high resistivity to a 4.6 m depth.

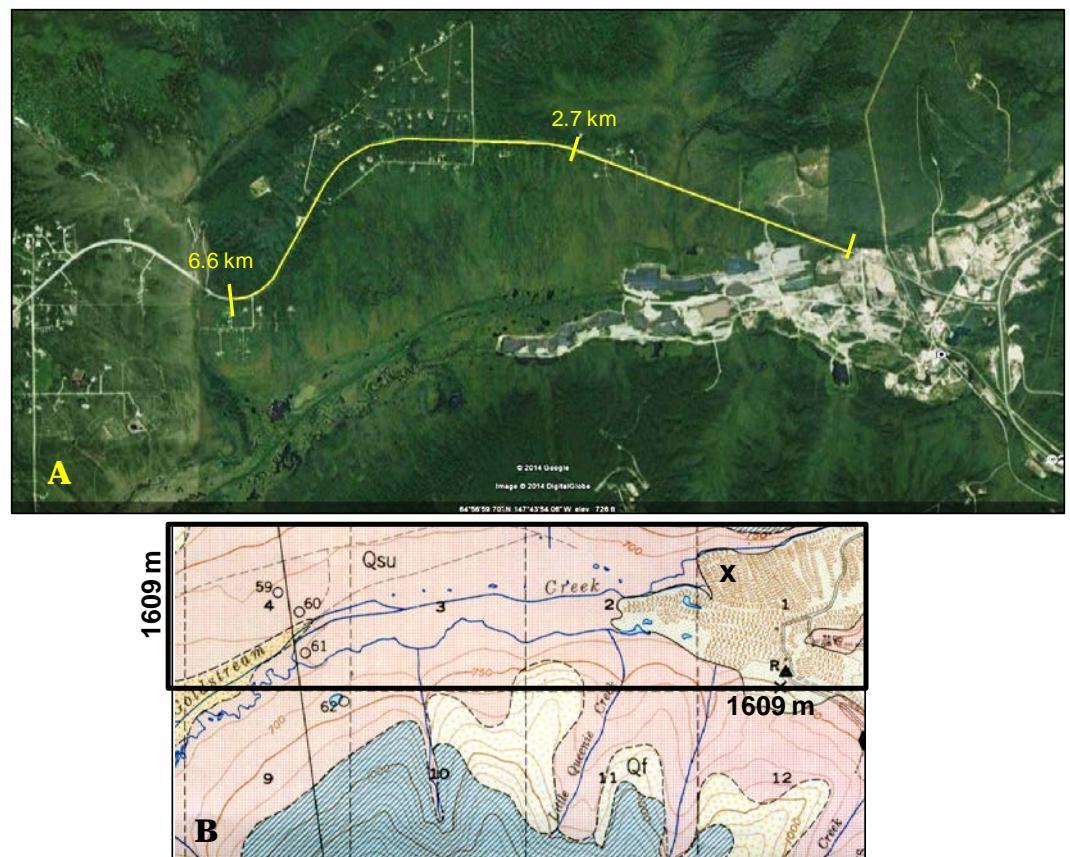
Figure 10. (*A*) 6.6 km of Goldstream Road, starting 100 m past the fire station. The start is approximately at the X mark in the geologic map (*B*) of Péwé (1958), and the transect is within the rectangular box. Qsu (*pink area*) means undifferentiated quaternary silt.

This paved road (Figure 10) also lies along a valley. It was mapped by Péwé as having the same silt composition as along the Elliott. The 1958 map does not locate the road but does indicate its approximate location. The photograph of the antenna unit in Figure 1 was taken at the start of the profiling at the east end 100 m west of the fire station. As with the Elliott, the profile was recorded along the shoulder. We were able to record at only 150 MHz due to the length of the profile and time constraints. We used $\varepsilon_{\rm f} = 6$ for our depth calibration, based on conduit diffractions.

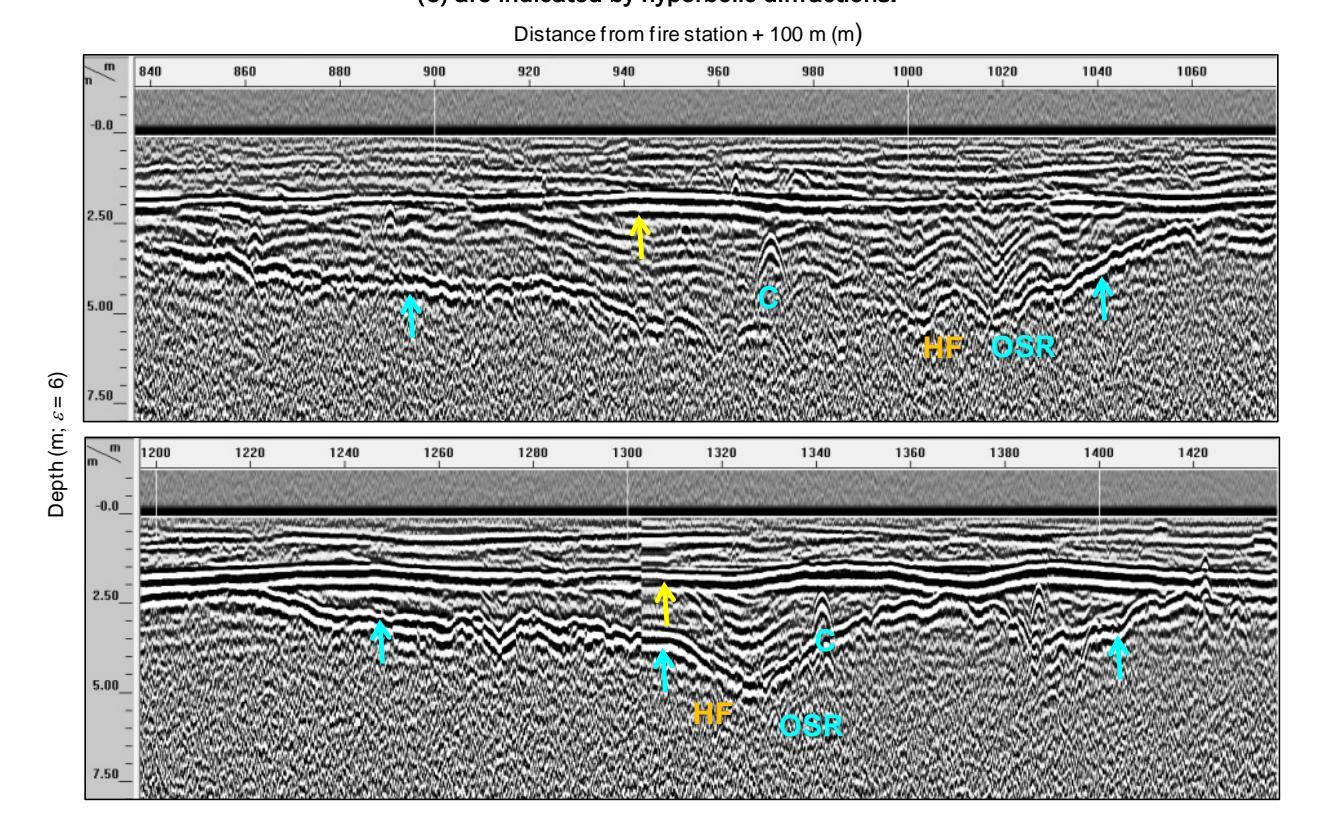
Figure 11. 150 MHz profile sections between 840 and 1440 m along Goldstream Road, recorded 9 April 2014. *Yellow arrows* indicate the frost depth, and *turquoise arrows* indicate the water table. Folds indicate thaw settlement. Old thaw settlement repair (OSR) occurs where folds do not continue to the surface. Conduits (C) are indicated by hyperbolic diffractions.

Figures 11–15 show the most interesting sections and include a feature not seen along the Elliott: a buried remediation surface from repair of old thaw settlement. Both sections in Figure 11 show two prominent horizons, the phases of which indicate the frost depth and water table. The frost depth is at about 1.5 m, which is about 1 m less than along the Elliott. Folding occurs directly below this horizon in both profile panels and so occurs in older sand and gravel fill. Because there is no folding above it, this thaw settlement has been remediated; and there is currently no indication of continued settlement. Consequently, it appears that the frost depth has reached only the depth of the new sand and gravel fill. When the remediation occurred is not known. The folds appear harmonic, which means all settlement happened concurrently. Close examination of the lower panel near 1320 m shows that the remediated section was initially planed, thus presenting an artificial erosional unconformity.

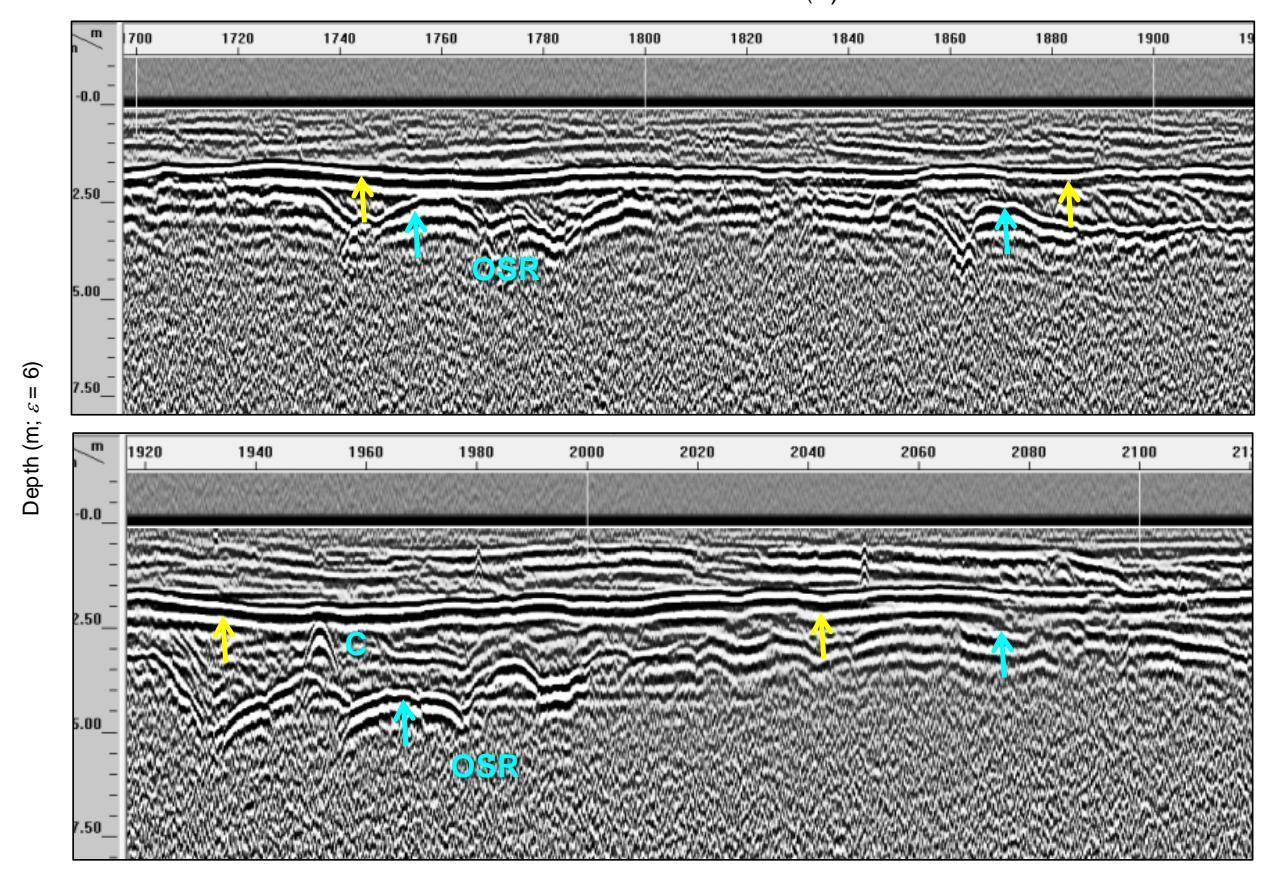
Figure 12. A 150 MHz profile section between 1700 and 2120 m along Goldstream Road, recorded 9 April 2014. *Yellow arrows* indicate the frost depth, and *turquoise arrows* indicate the water table. Folds indicate thaw settlement. Old thaw settlement repair (OSR) occurs where folds do not continue to the surface. Conduits (C) are indicated by hyperbolas.

Figure 12 shows two profile panels that exhibit the same phenomenon of remediated settlement. Above the frost depth, there is no folding, while harmonic folds appear below it. As in Figure 11, the water table exceeds 5 m in depth in one spot.

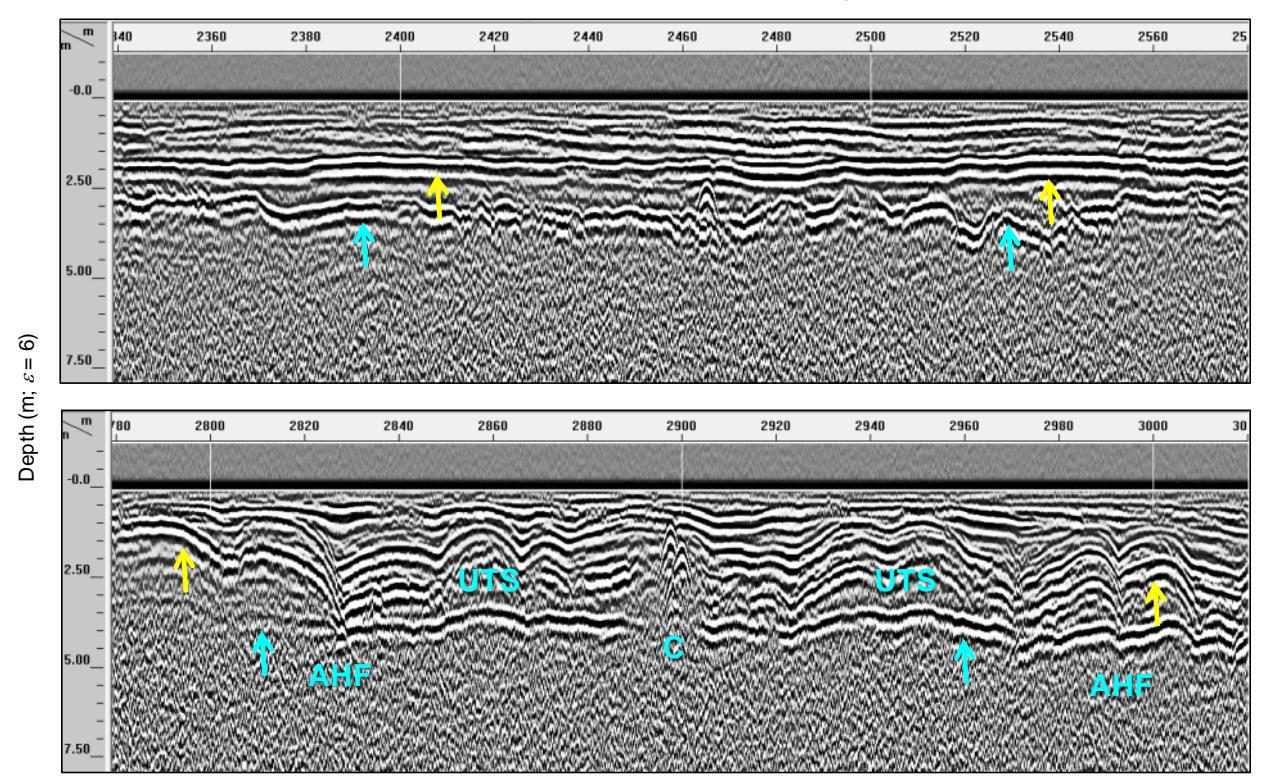
Figure 13 presents two panels with different situations. In the upper panel, the frost depth and water table horizons are evident; but there is little evidence of any thaw settlement. The lower panel, however, shows unrepaired thaw settlement (label UTS) folding that begins near the surface and continues down to the water table. The fold limbs increase with depth, which is an example of anharmonic folding (Figure 7). At 2900 m, there is a cluster of diffractions, which indicates several conduits. Near these diffractions, the water table horizon is not visible. We surmise that this is because of better heat conduction by the conduits. Figure 13. Selected 150 MHz profile sections between 2340 and 3020 m along Goldstream Road, recorded 9 April 2014. *Yellow arrows* indicate the frost depth, and *turquoise arrows* indicate the water table. Folds

indicate thaw settlement. Old thaw settlement repair (OSR) occurs where folds do not continue to the surface. Unrepaired thaw settlement (UTS) is indicated by folds that continue to the surface. Conduits (C) or clusters of conduits are indicated by hyperbolas.

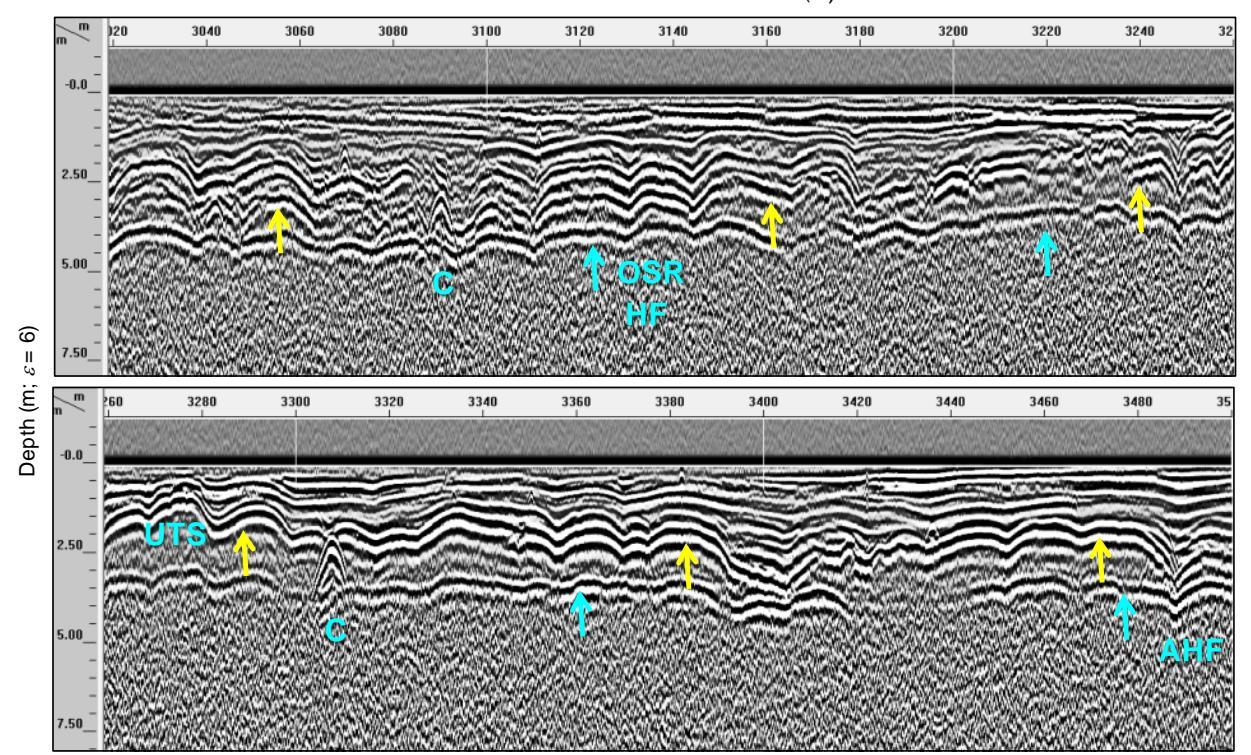
The upper panel of Figure 14 appears to show a hybrid of the previous situations. Here we find thaw settlement that may have been remediated because there is a 1 m layer of unfolded strata above it. However, the frost depth has penetrated as much as 4 m in depth and nearly to the water table. In contrast, the lower panel shows evidence of settlement folding to the surface and no remediation. Figure 14. Selected 150 MHz profile sections along the first 3.3 km of Goldstream Road, recorded 9 April 2014. *Yellow arrows* indicate the frost depth, and *turquoise arrows* indicate the water table. Folds indicate thaw settlement. Old thaw settlement repair (OSR) occurs where folds do not continue to the surface.

Unrepaired thaw settlement (UTS) is indicated by folds that continue to the surface. Conduits (C) or clusters of conduits are indicated by hyperbolas.

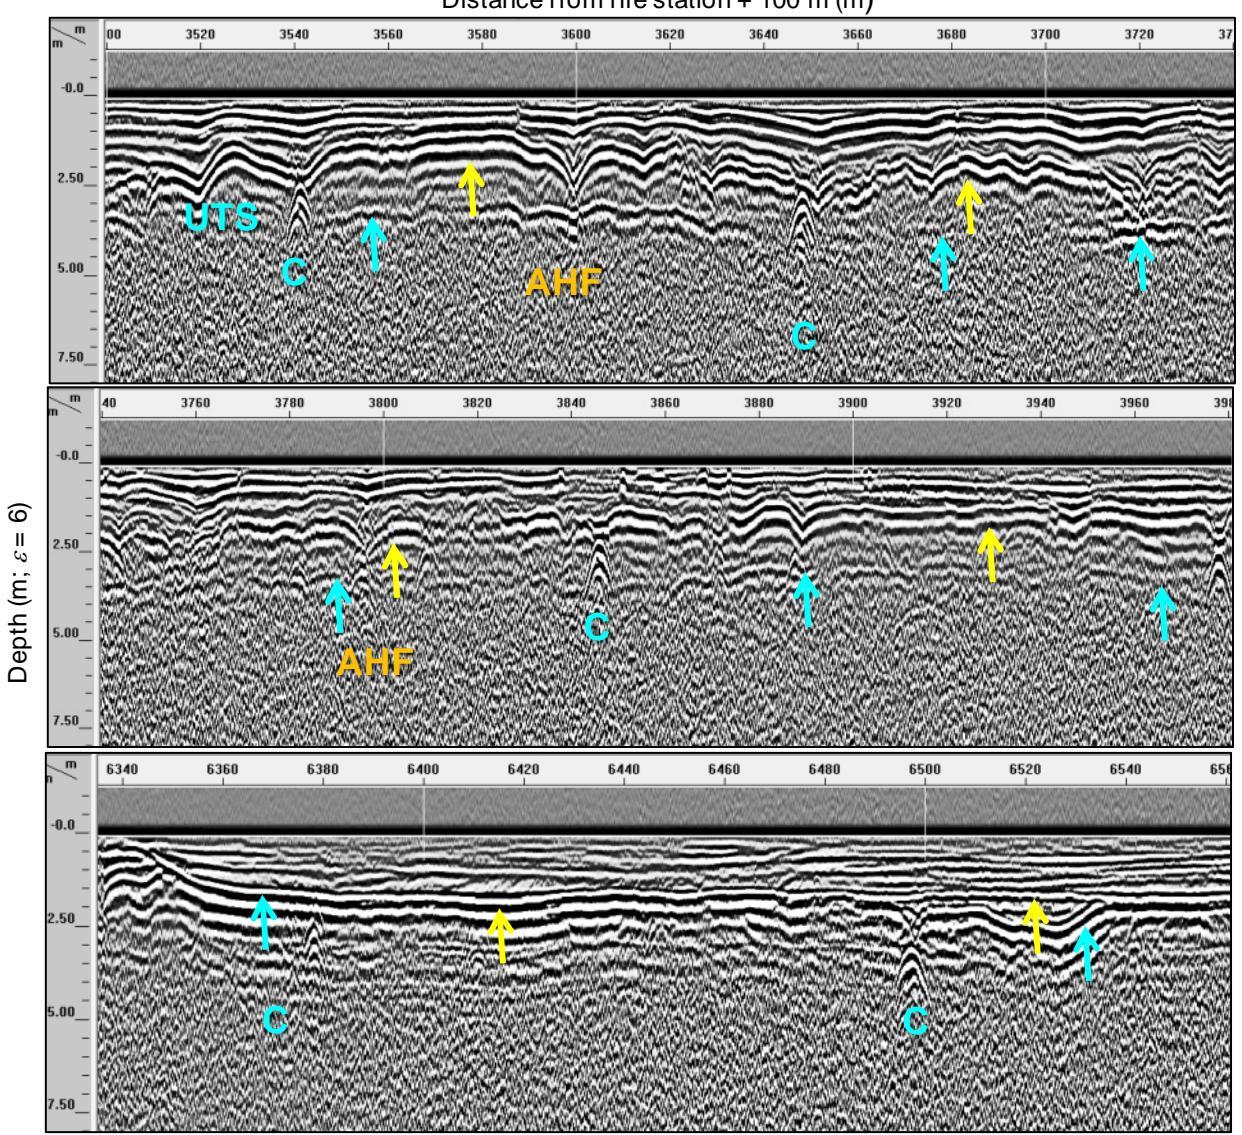
The upper panel of Figure 15 shows the best example of anharmonic folding, which is centered at 3600 m. The dip is severe enough to cause a secondary diffraction that interferes with the water table horizon. From 3640 to 3710 m, the water table is hardly visible, which indicates wet silt. The central panel also shows a strong dip, anharmonic folding, and a diffraction artifact, all centered at 3795 m. After 3900 m, there is no indication of thaw settlement; and a shallow water table reaches about 3 m in depth at most. The lower panel shows a typical section. Figure 15. Selected 150 MHz profile sections along the first 3.3 km of Goldstream Road, recorded 9 April 2014. *Yellow arrows* indicate the frost depth, and *turquoise arrows* indicate the water table. Folds indicate thaw settlement. Old thaw settlement repair (OSR) occurs where folds do not continue to the surface.

Unrepaired thaw settlement (UTS) is indicated by folds that continue to the surface. Conduits (C) or clusters of conduits are indicated by hyperbolas. The lower profile shows contact of the water table to the frozen layer.

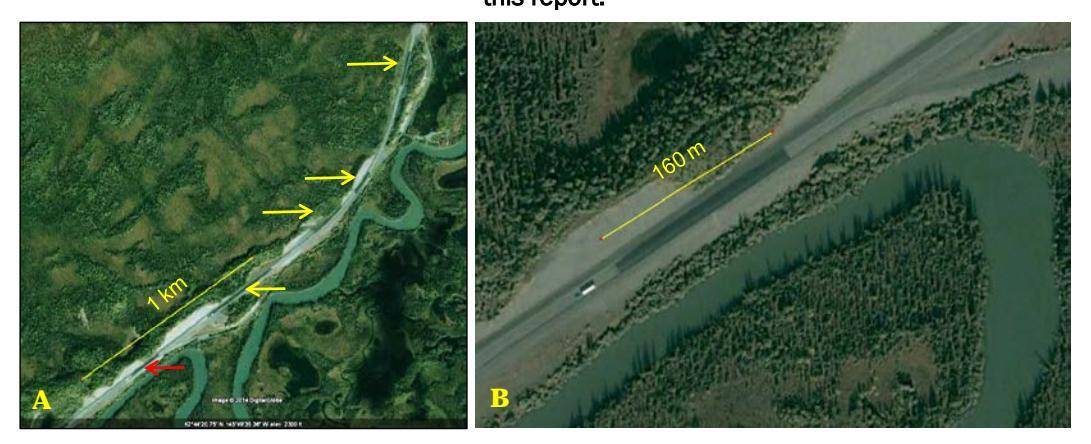
Figure 16. (*A*) An image from 9 April 2013 of the section of Tok Highway that has been repeatedly repaired since at least 1997. *Arrows* indicate black patches where thaw settlement has been repaired. (*B*) Detail of the area (indicated by *red arrow* in *A*) discussed in this report.

Although these profiles were recorded 20 March 1998, we discuss them because they are the only example where buried ice was encountered within a natural deposit of sand and gravel. The site is near Mile 62 (100 km) along the Tok Cutoff Road that runs northeast from Glenallen to Tok Junction (Figure 16). The particular section that we profiled was cut into a glacial moraine that likely emanated from Mt. Wrangle, the peak of which is about 75.6 km to the south. Consequently, limited stratification should be expected. The nearest present glacier is about 43.4 km away. When the cut was made (estimated 1990–1997), the road crew encountered blue ice that appeared to be of glacial origin. An unknown thickness of insulating layer of Styrofoam was placed on the ice, and the cut was refilled to a 5 m thickness. At the time we surveyed, the road was uneven with obvious thaw settlement. Today (Figure 16), there are numerous patches in this area, showing that the thaw settlement has continued.

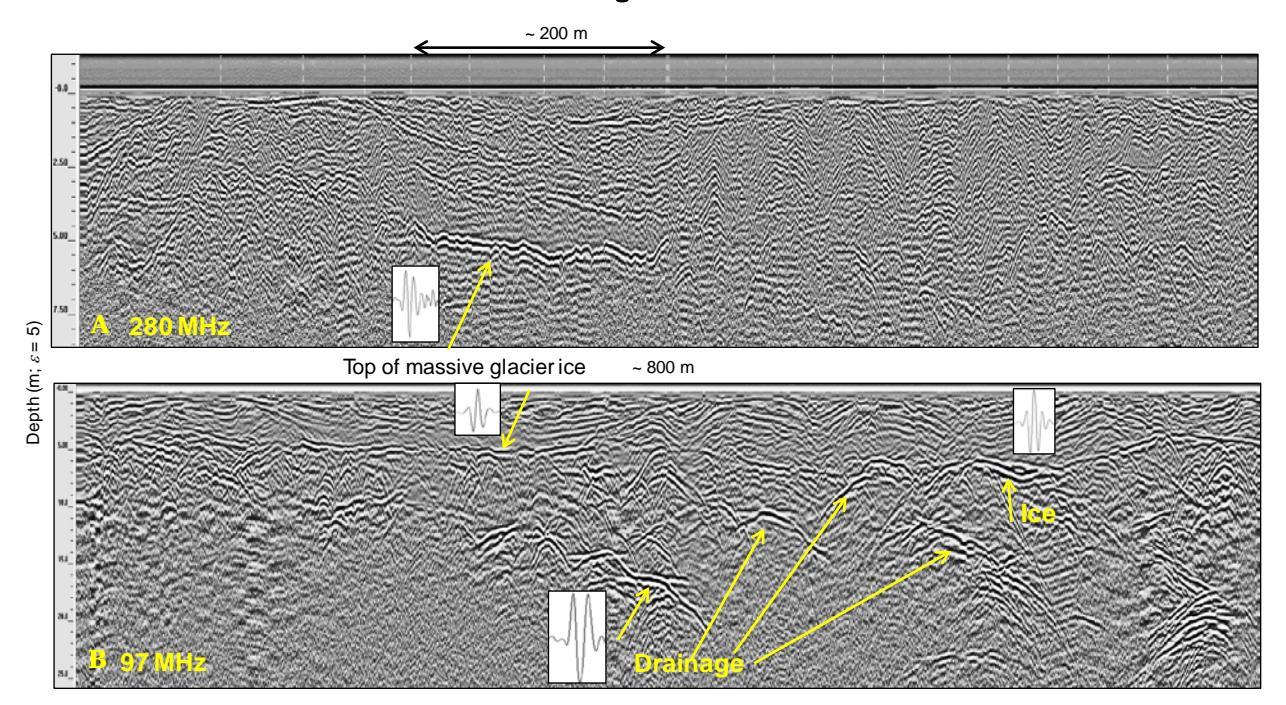
Figure 17A shows a 280 MHz profile recorded with the "400 MHz" antenna. The arrow indicates the ice/insulating board response. The polarity of reflected pulse is + - + (white-black-white banding), which indicates a low over high dielectric contrast. This polarity sequence is consistent with the Blue Board insulation being thick enough to present a layer of air over the ice. The rest of the profile comprises mainly diffractions, as would be expected of till.

Figure 17B shows a 97 MHz profile recorded with a prototype to the Model 5106A. In this case, the insulating board is not thick enough to present the same dielectric contrasts; and so the ice horizon has the opposite half-cycle - + - (black–white–black banding) polarity sequence (left and right inserts) to indicate a relatively higher (wet sand and gravel) material over a relatively lower one (ice). In strong contrast are the waveforms associated with horizons that descend from the massive ice. These exhibit + - +(white–black–white banding), which, along with their intensity, can only indicate water. Figure 17. (*A*) A 280 MHz profile of Tok Cutoff Road recorded 20 March 1998 over an area of thaw settlement, shown in Fig. 5 (*red arrow*). A layer of insulating Styrofoam (Blue Board) sits atop this ice, which makes the reflection waveform white-black-white (insert; arrows points to where it occurs) as if it came from a wet surface. (*B*) A 97 MHz profile of same section showing complicated massive ice and melting. The massive ice in (*B*) now has a black-white-black band (*left* waveform insert), which is correct for solid ice under frozen sand and gravel and Blue Board too thin to change the waveform polarity. A massive ice horizon also occurs at the far right. The strong white-black-white banded horizons at the center (*center insert*) are likely meltwater draining off this massive ice.

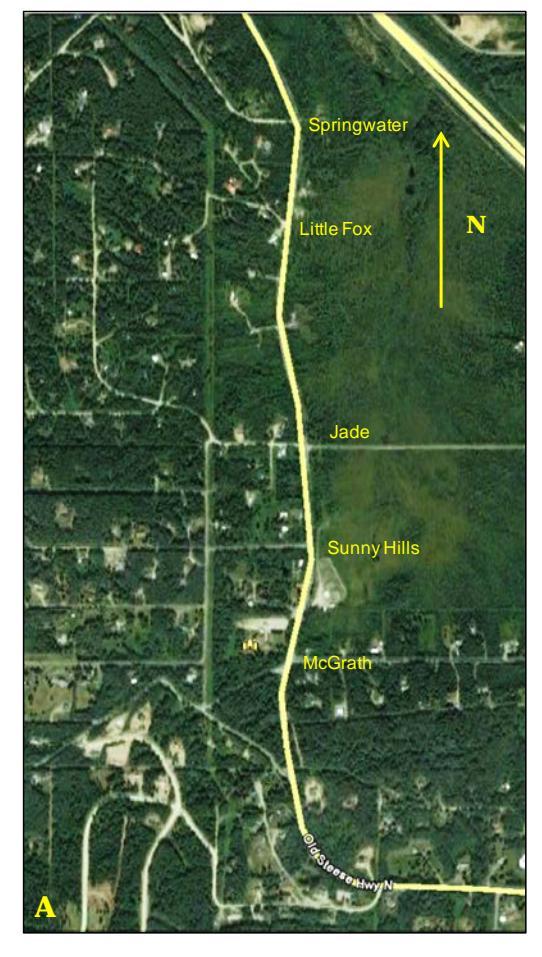
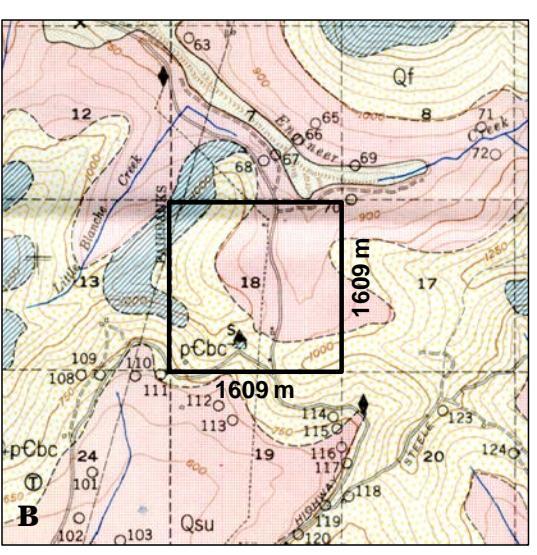
Figure 18. (A) A section of the Old Steese Highway going N–S profiled August 2013. The distance from Springwater to Little Fox is 250 m and 1350 m to McGrath Road. The section lies entirely within the pink Qsu (Quaternary undifferentiated silt) unit of Péwé (1958) that resides within the box in (*B*).

Figure 18 shows a residential section transected by the Old Steese Highway. It is located within the loess deposits mapped by Péwé (1958). We recorded our 150 MHz profile (Figure 19) between Springwater and McGrath Roads on 9 August 2013. By this time of year, seasonal frost should be gone.

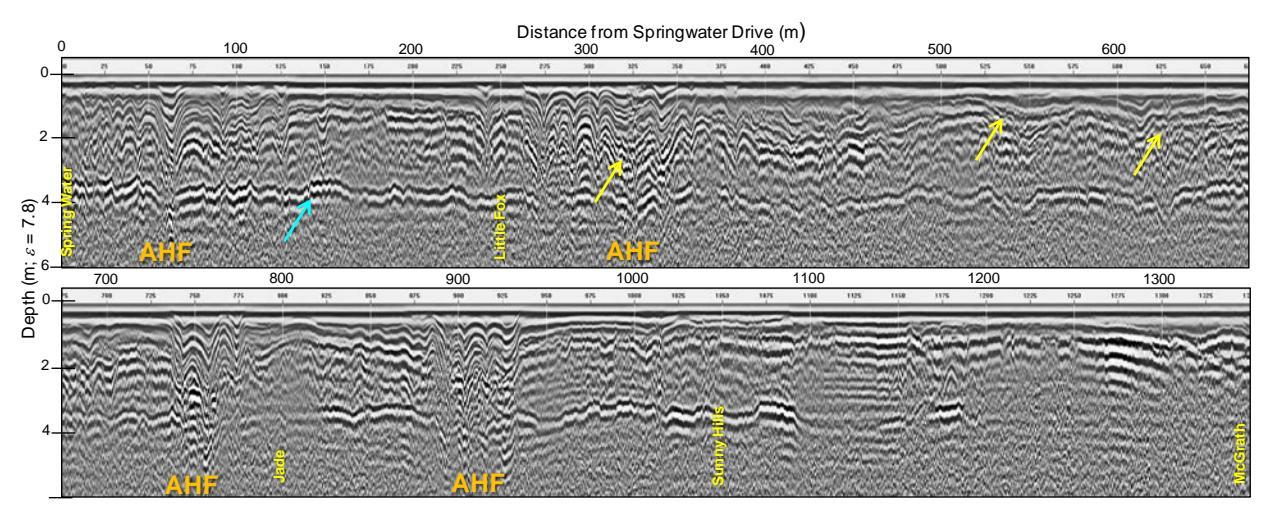
Figure 19. A 150 MHz profile of a section of the Old Steese Highway going N–S and recorded 9 August 2013. The black-white-black horizon (*turquoise arrow*) means thaw over frozen. The α = 7.8 is the average for several conduit diffractions (*yellow arrows* at 325, 545, and 628 m), which are not discernible because of the horizontal compression used for display, and indicates well-drained sands and gravel. Diffractions generated within the nadir of a dip were not considered for interpretation of relative dielectric permittivity.

The profile shows only one consistent horizon, which is at about a 3.5 m depth. The black–white–black banding of this horizon means that it is a response to an interface between a relatively higher dielectric medium above and a relative lower one below. The medium above is unfrozen sand and gravel, which is well drained because its $\varepsilon_{\rm f} = 7.8$, an average obtained from the diffraction responses to several conduits and indicative of about 15% volumetric water content, assuming a volumetric felsic mineral content of 0.52. The medium below is either frozen or dry, the latter of which is unlikely because of drainage. Therefore, we think it is permafrost because the profile also shows discrete sections of folded strata within thaw

settlement. Only Little Fox Road lies within one of these sections; the other roads do not. The folding is severe and anharmonic, meaning that the settlement has progressed for many years. The medium below is also not likely to be seasonal frost or else a second reflection from either a water table or from permafrost would appear.
