EVALUATION OF THE BRAZILIAN RUN-FLAT TIRE

Nevada Automotive Test Center

Army Tank-Automotive Command

Final Report NATC Project 20-1-872 Technical Report No. 11923 Contract DAAE07-74-C-0109

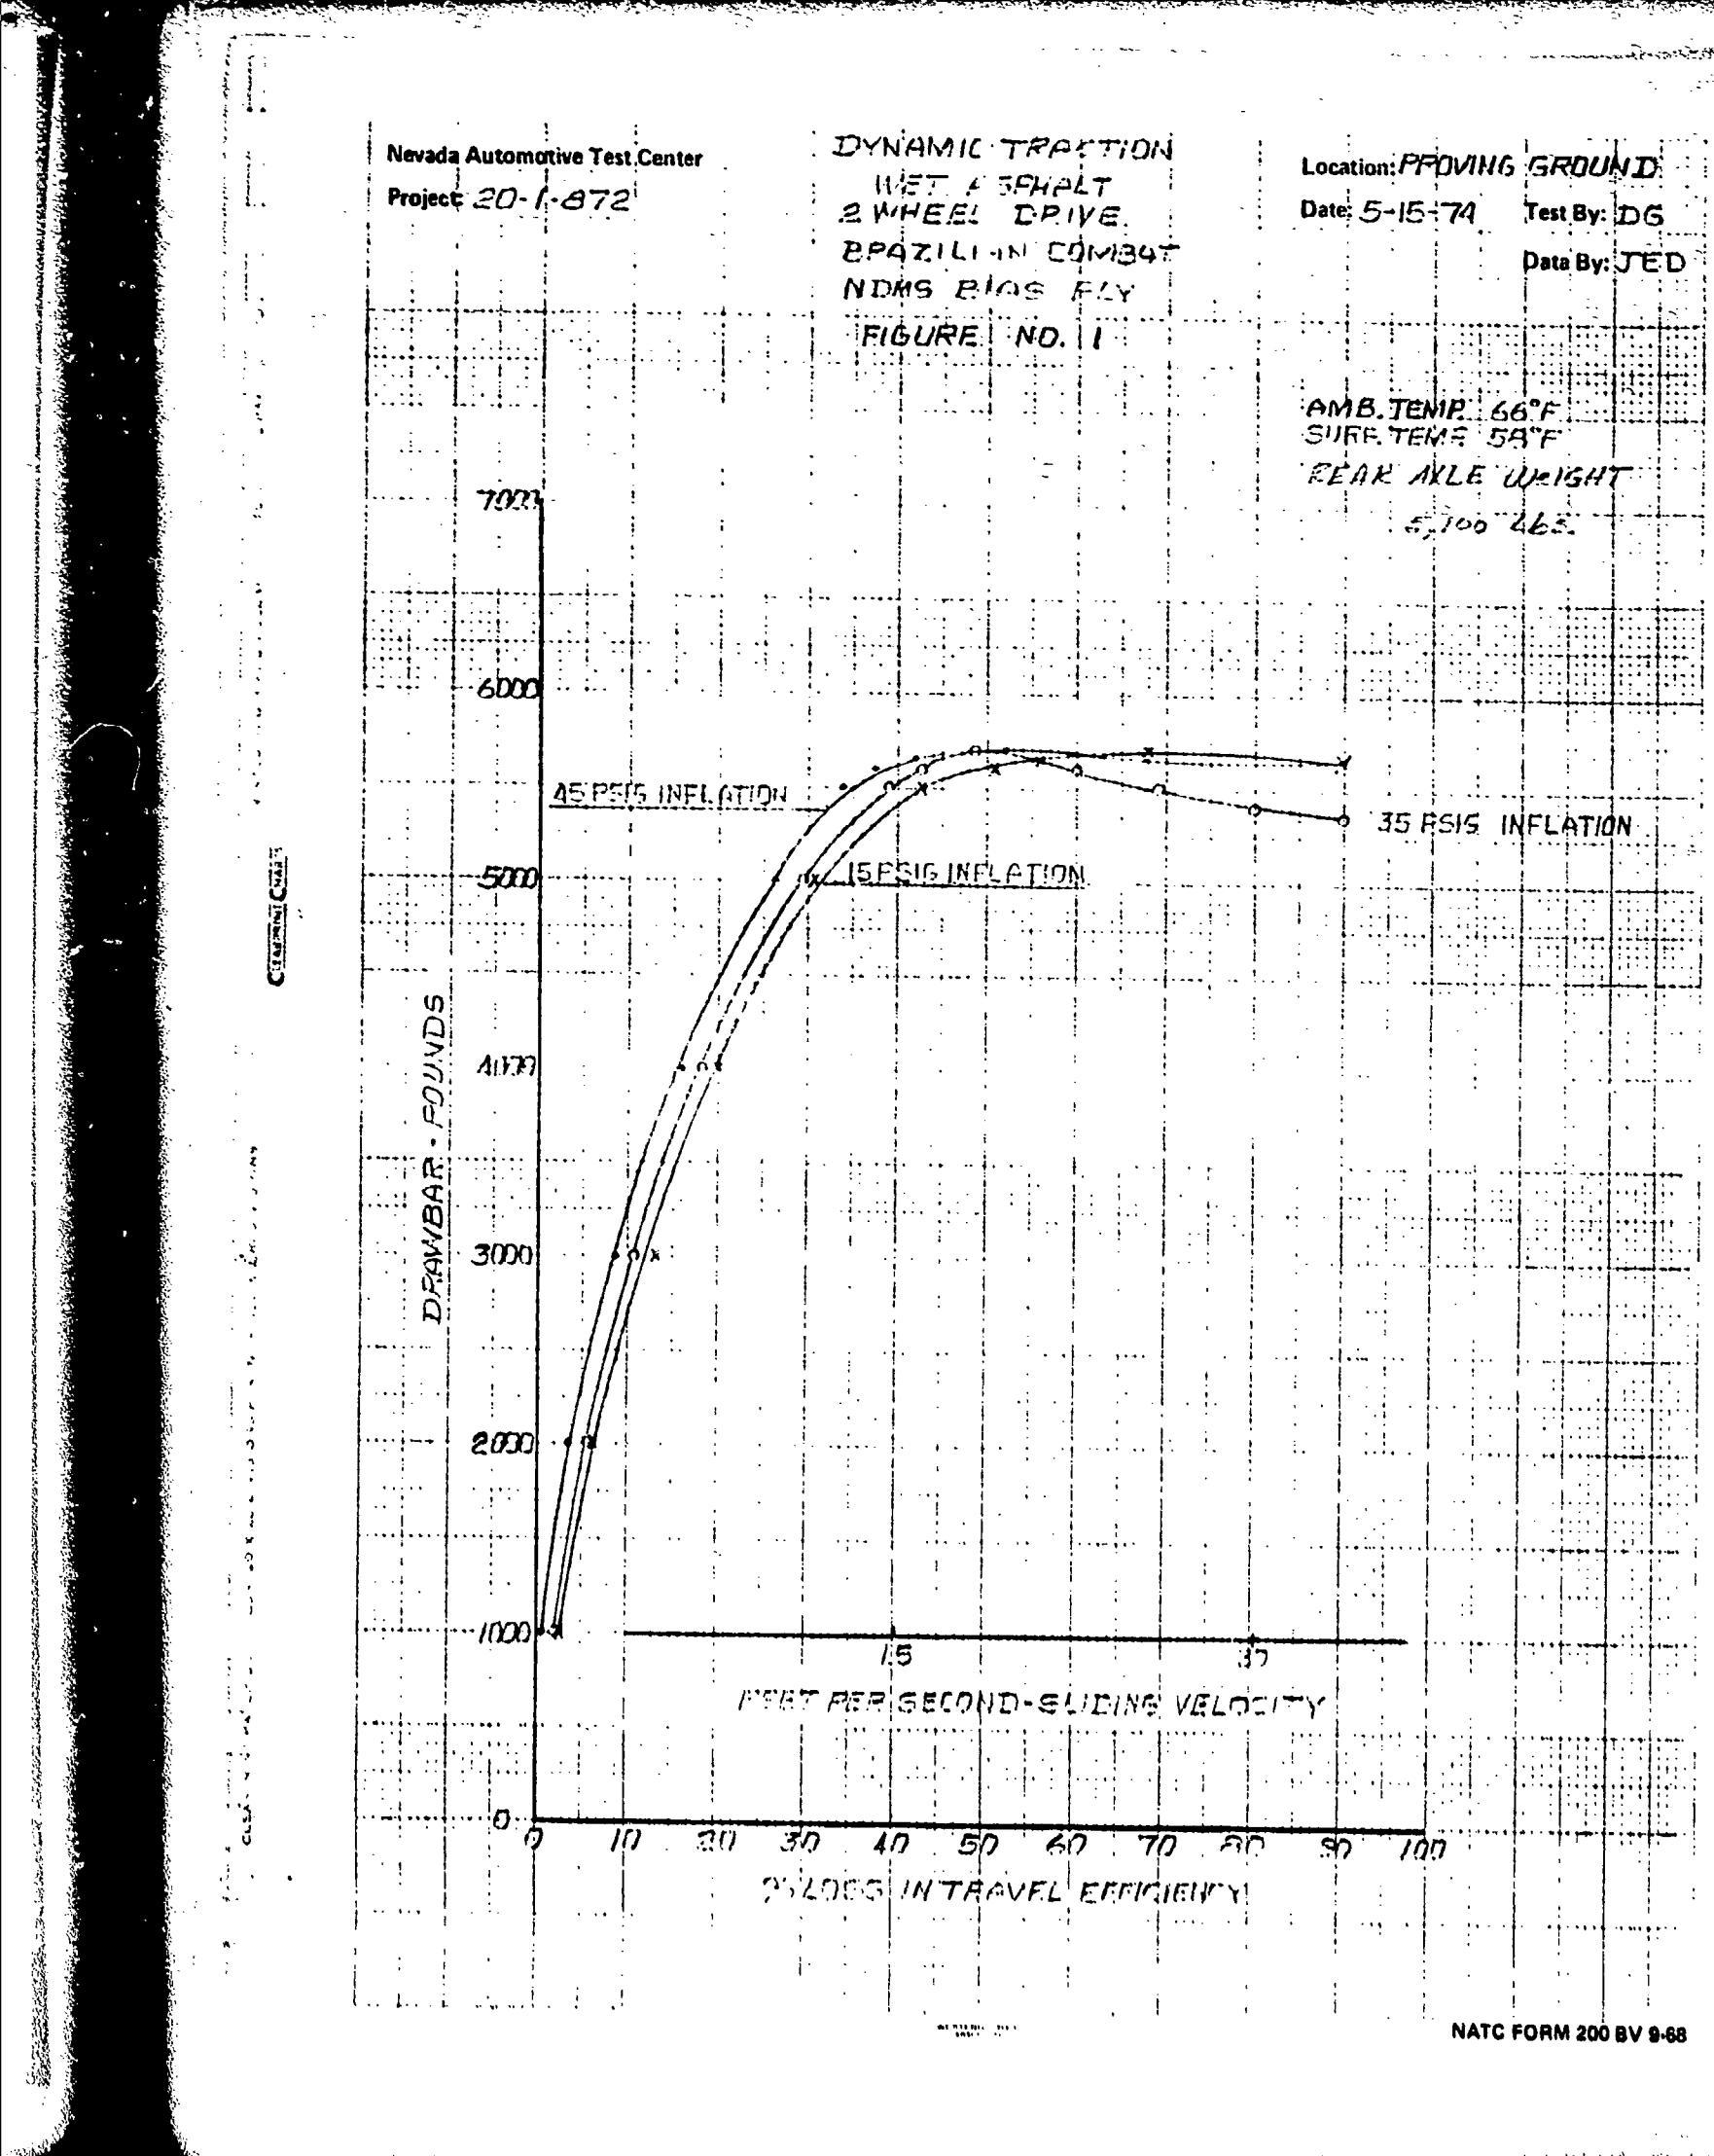
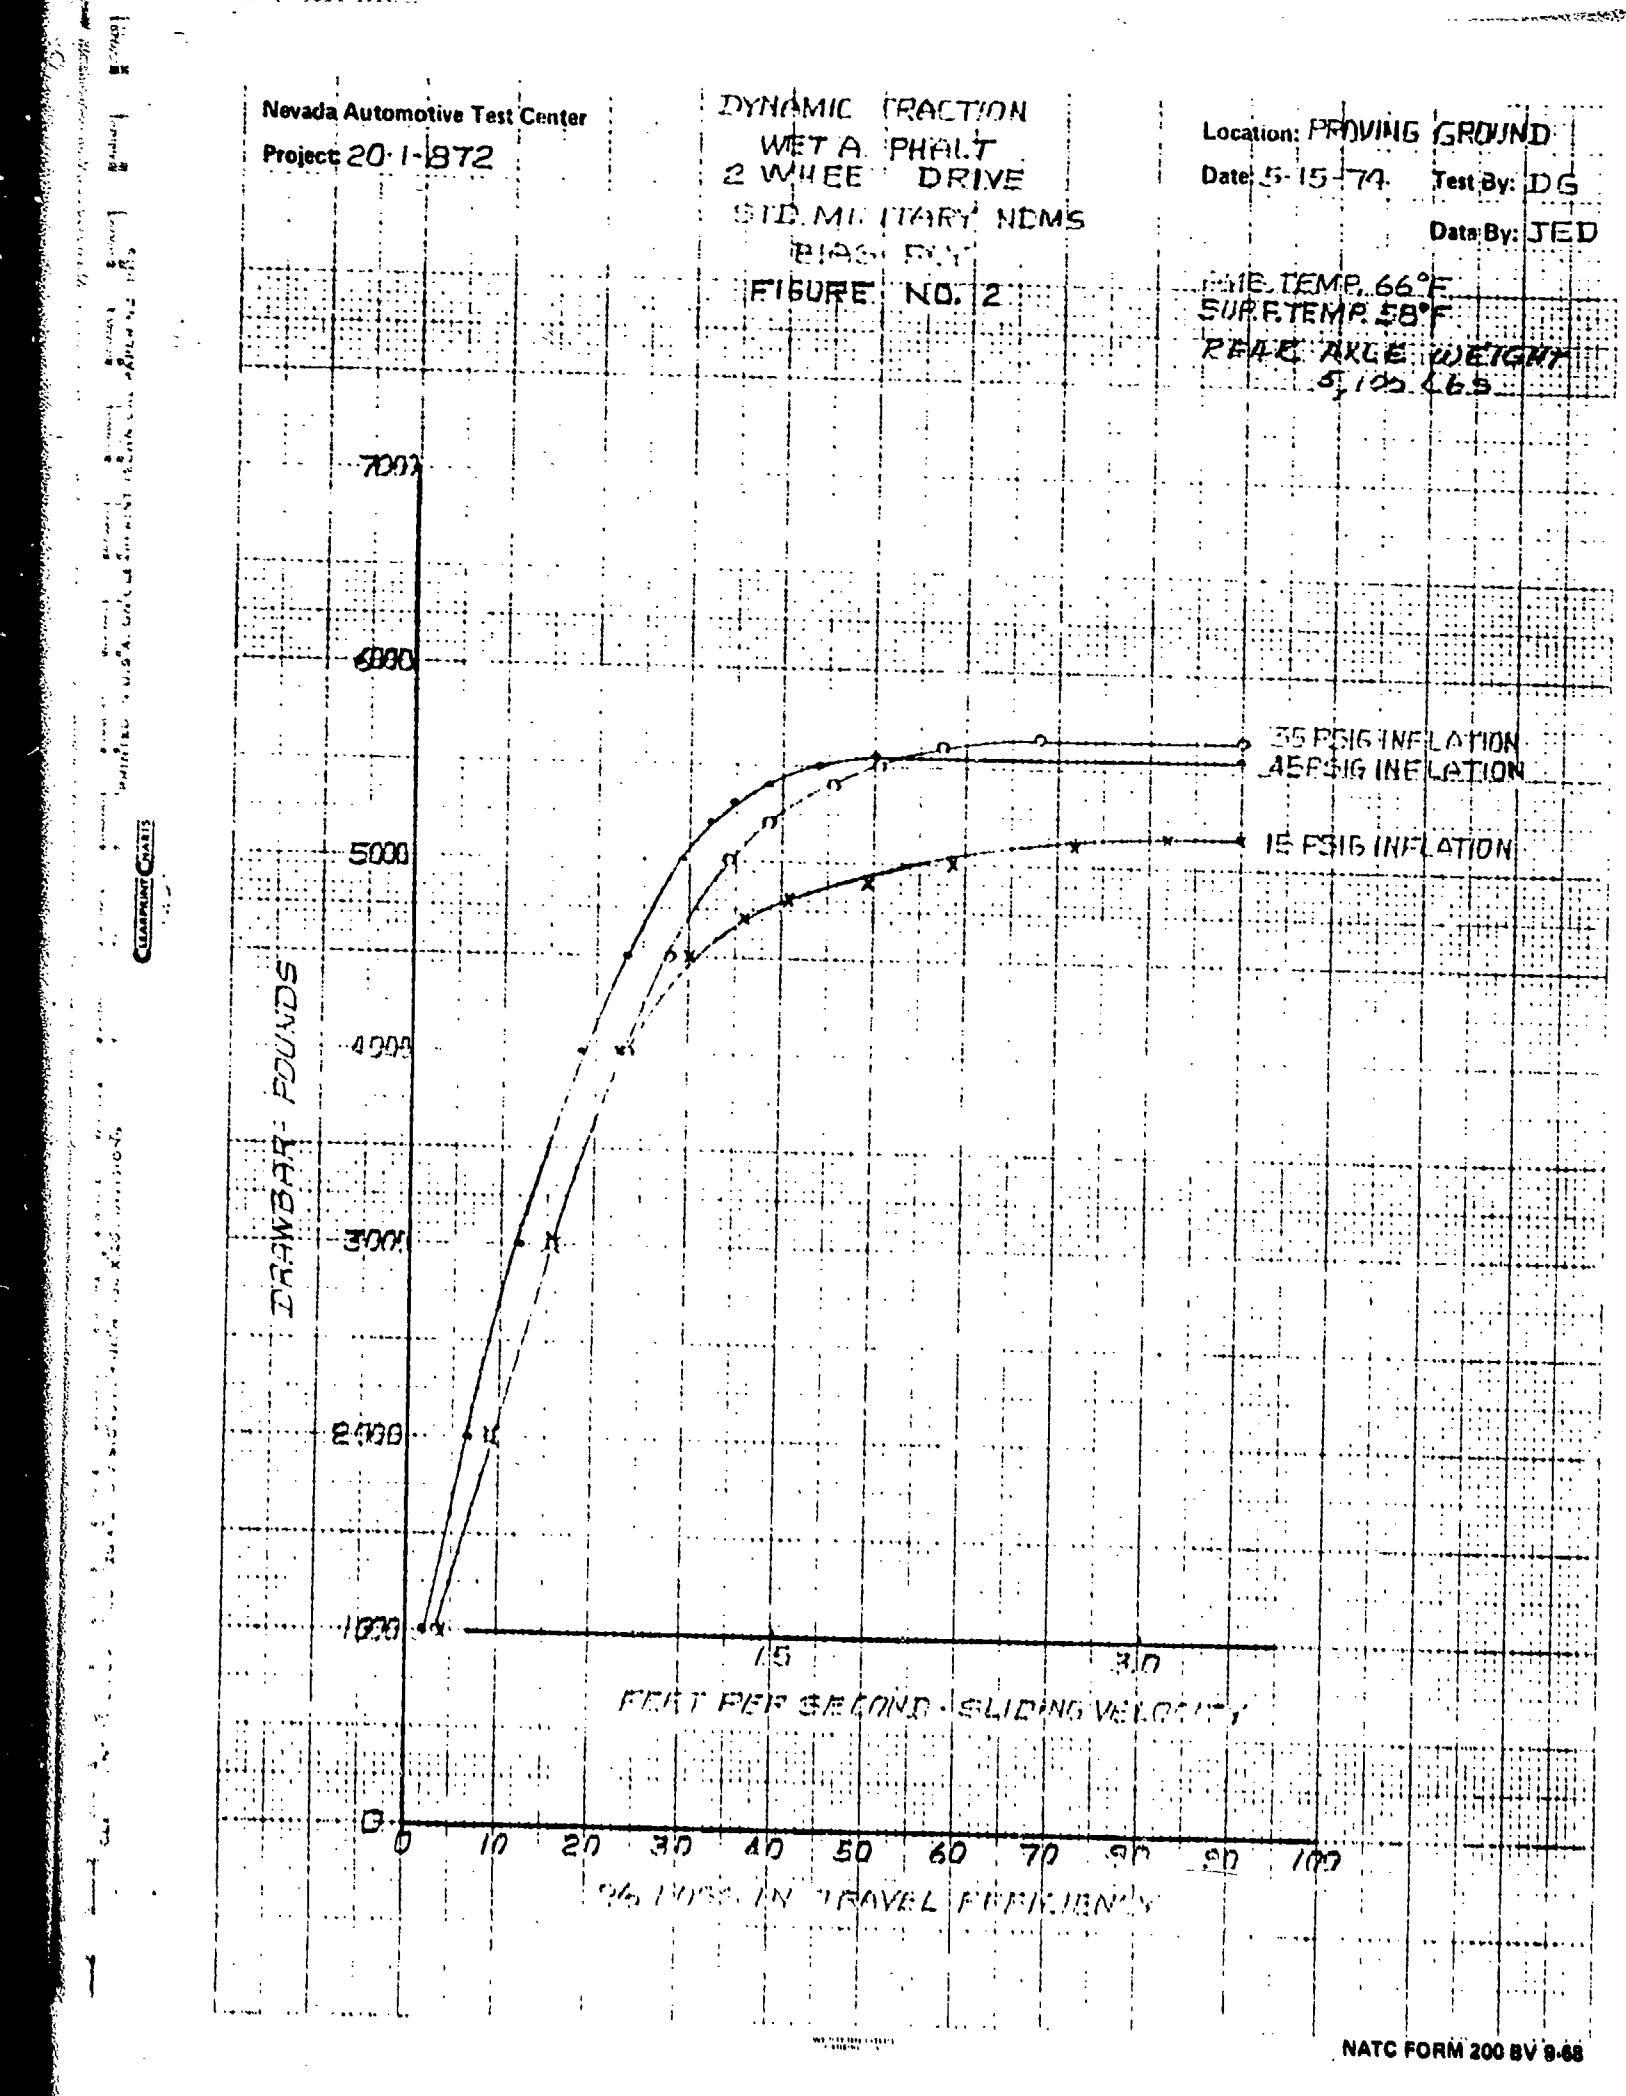
Figures 1 and 2 graphically summarize the traction results and Figure 3 summarizes the rolling resistance results.

wolling realectance was concatially the same for both tire groups. Migure 5 requirely illustrates this comparison.

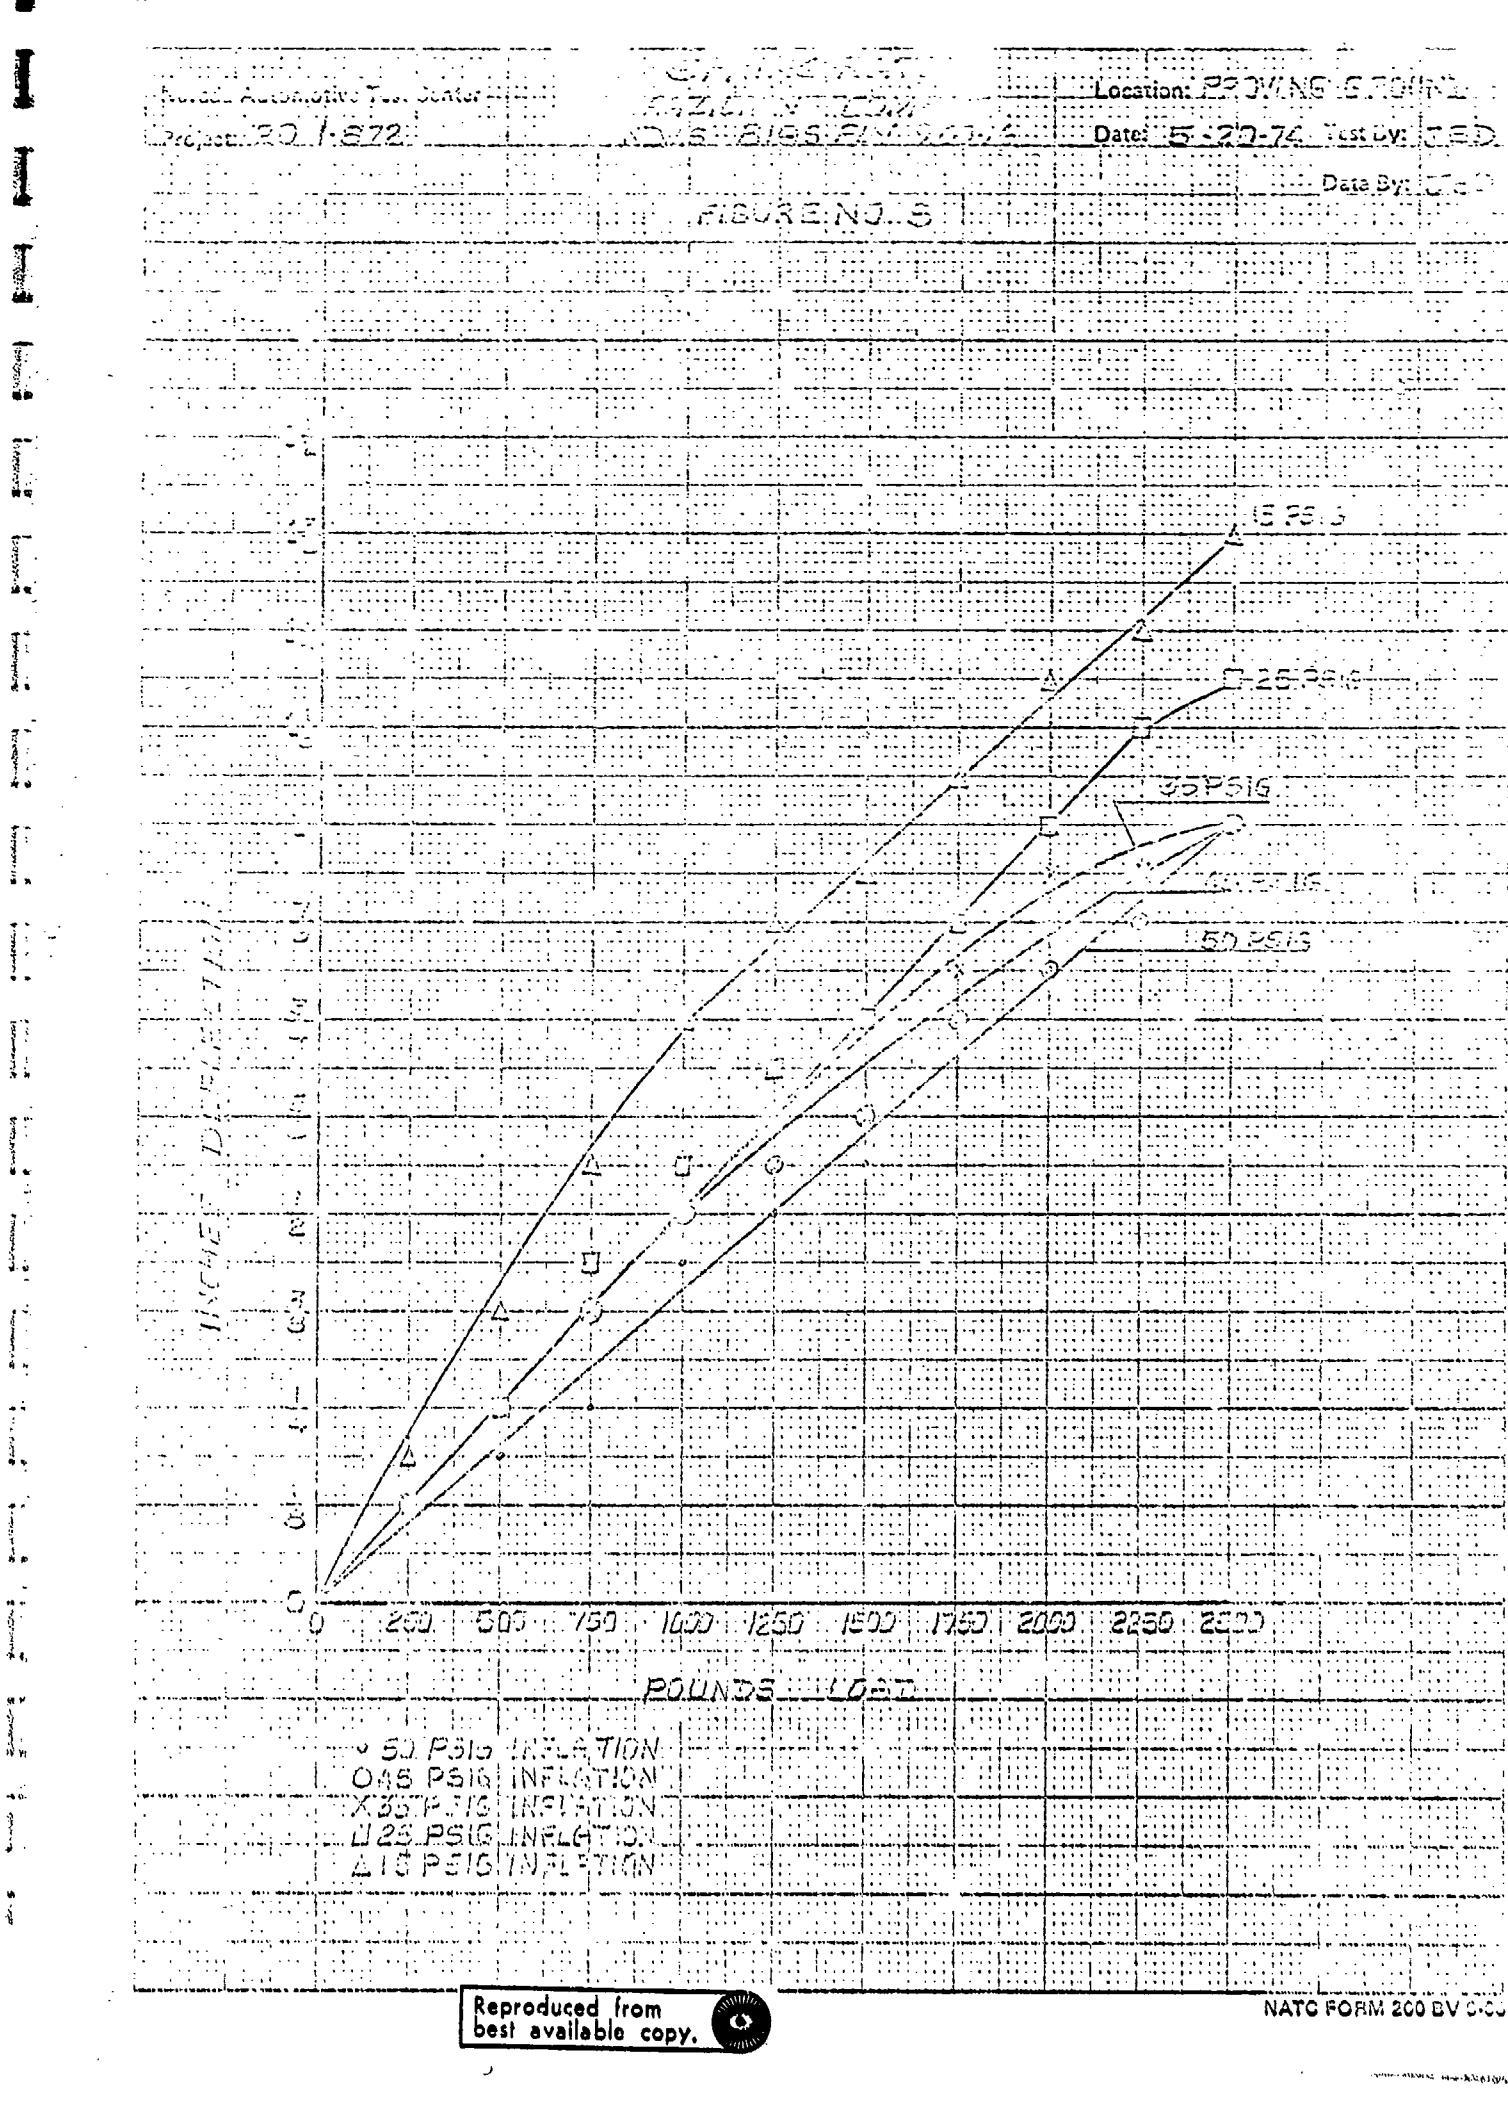
Figure No. 8 graphically displays the spring rates.

Spring rates from Chart No. 4 and pounds per square inch ground pressure from Chart No. 6 indicate the high stiffness of this tire system. This analysis clearly shows how rock damage was sustained by the nylon fabric plies with resultant tire failures as experienced during the durability phase of the test program.

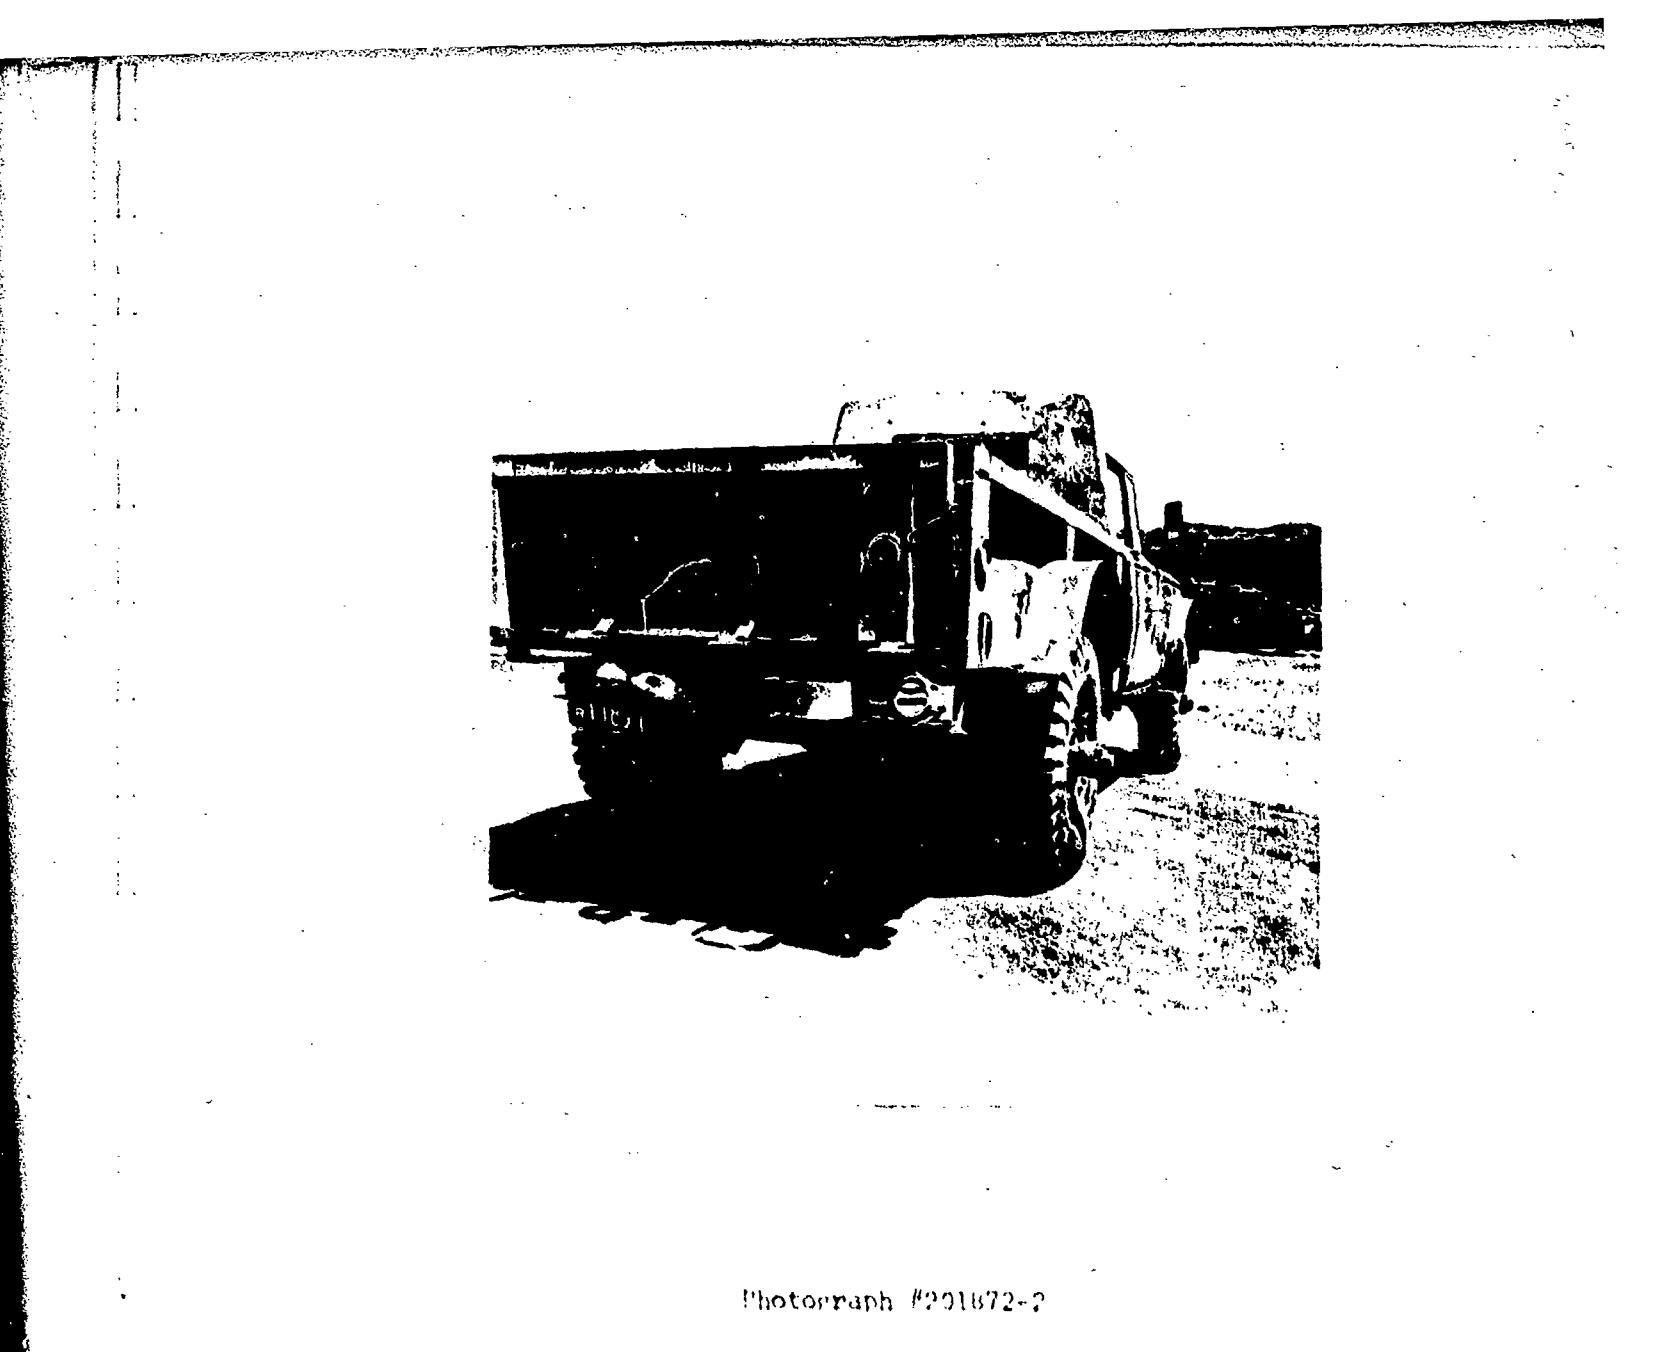
lest Les with test tires inflated to recommended inflation pressures - 25 psig front, 45 psig rear

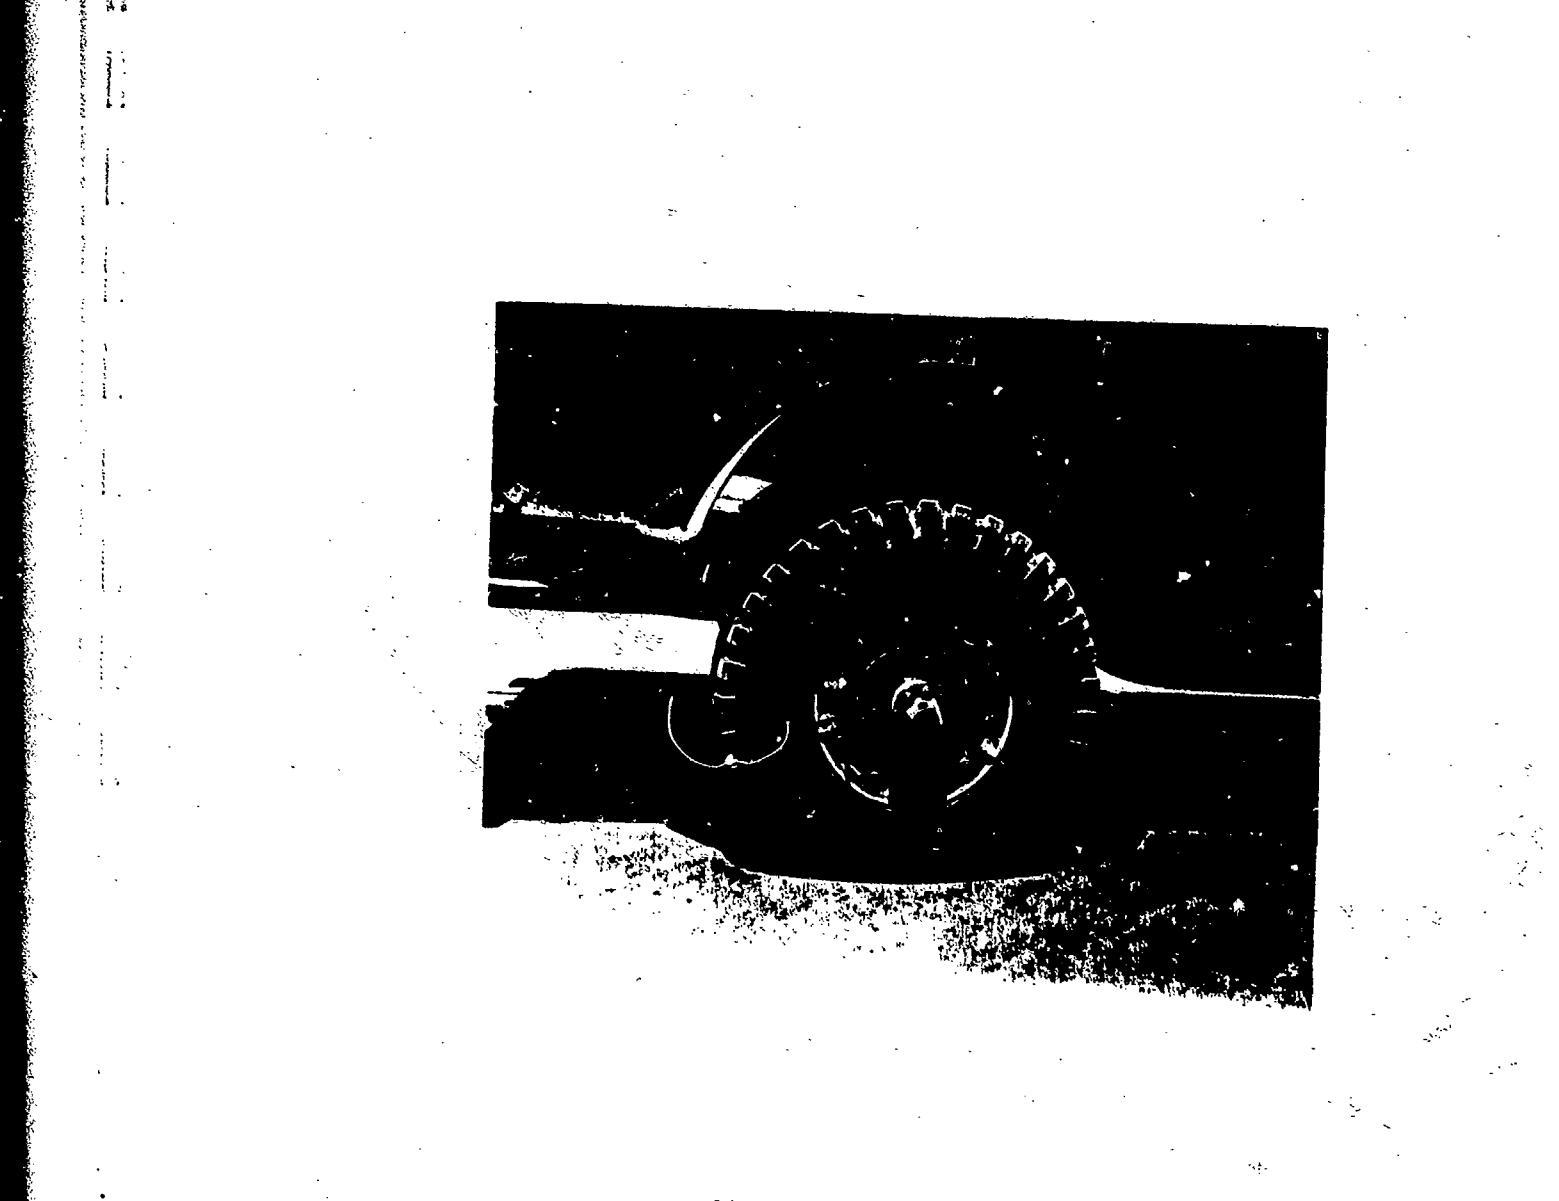
Thotomark #201872-4

Deflection of near test tire with zero inflation pressure
