Unclassificd	
REPORT DOCUMENTATION PAGE	READ INSTRUCTIONS BEFORE COMPLETING FORM
1. REPORT NUMBER 2. GOVT ACCESSION N	0. 3. RECHELENT'S CATALOG NUMBER
Instruction Report H-77-1	(9)

A. TITLE (and Subtitio)	5. State of the
DEMONSTRATION PROJECTS; SECTION 32 PROGRAM	Final report. Jun 76-yean
STREAMBANK EROSION CONTROL EVALUATION AN	0 6. PERFORMING ORG. REPORT NUMBER
DEMONSTRATION ACT OF 1914	8. CONTRACT OR GRANT NUMBER(*)
Ellis B. Pickett	
Bobby J. Brown

GUIDELINES FOR MONITORING AND REPORTING DEMONSTRATION PROJECTS

Section 32 Program Streambank Erosion Control Evaluation and Demonstration Act of 1974

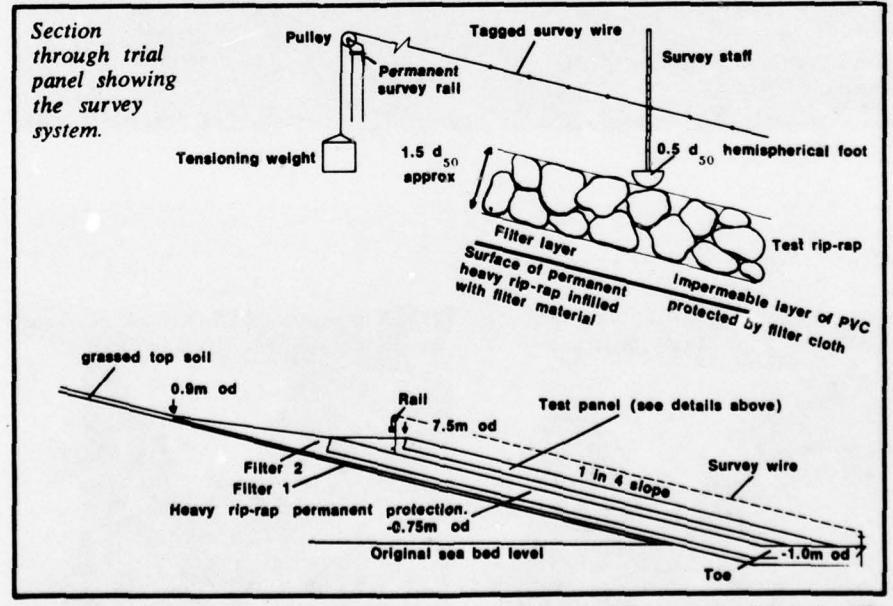
Figure 1. A profiling scheme

Winter storms have caused considerable damage to two out of four rip-rap test panels built on the offshore trial bank in the Wash estuary, providing important data for developing a rip-rap design method. The panels were completed last October as part of CIRIA's research into the design of rip-rap protection for reservoirs, barrages and harbour works.

Stone sizes range from 230mm (panel 1) through 400mm and 500mm to 560mm (panel 4). The first panel failed within three weeks, when a two-day storm on 16/17 November caused the largest waves so far recorded at the offshore bank site. The 0.9m-high waves, battering the panels over four tides almost totally destroyed the lightweight protection, washing away the rip-rap and the underlying course filter material and ripping holes in the three-layer membrane separating the trial panel from the permanent armouring of the trial bank.

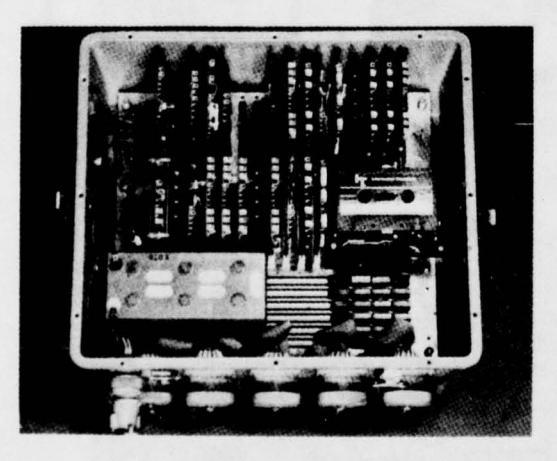
Figure 5. (sheet 4 of 5)

RECORDER

- SPECIFICATIONS
- NUMBER OF DATA CHANNELS (OR SENSORS) 30
- SAMPLING RATE 8 CHANNELS/SECOND
- SAMPLING INTERVALS 3, 5, 10, 15, 20, 30, 40, 60, 120, AND 240 MINUTES
- POWER SOURCE 4.5 AMPERE HOUR (+12 VOLT) RECHARGEABLE BATTERY
- DATA STORAGE 1/4-IN. CASSETTE TAPE CARTRIDGE
- WEIGHT 10.9 KG (24 LB)
- SIZE 20 × 40 × 46 CM

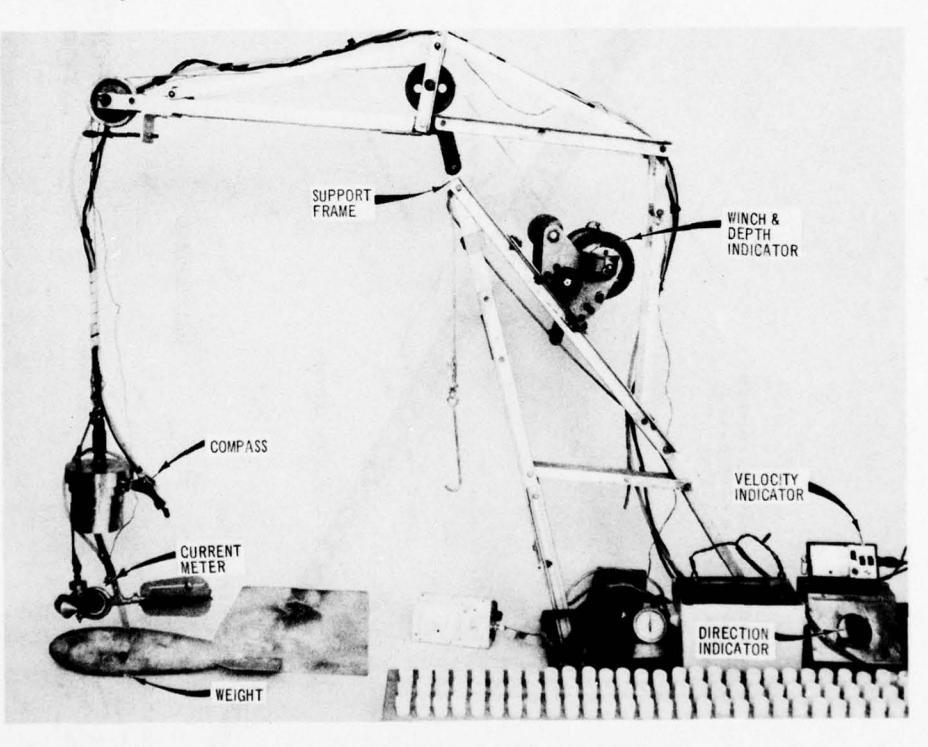
Figure 6. (sheet 3 of 3)

The direction indicator is a remote reading magnesyn compass designed by the WES such that it indicates the magnetic north azimuth of the direction from which the current is flowing. The readout device has a precision of ± 2 deg, but accuracy is dependent upon the balance of the streamlined weight and the strength of current available to turn it. For currents greater than 0.5 fps, the accuracy is ± 10 deg. For lower velocities, accuracy is reduced to ± 25 deg, particularly when waves cause boat motion and when tidal currents slacken and turn.

The winch used to raise and lower the submerged unit operates an indicator that shows the depth of the unit below the water surface. This indicator is used to measure the total water depth and to position the current meter for each reading.

a. Instrumentation for monitoring tidal currents

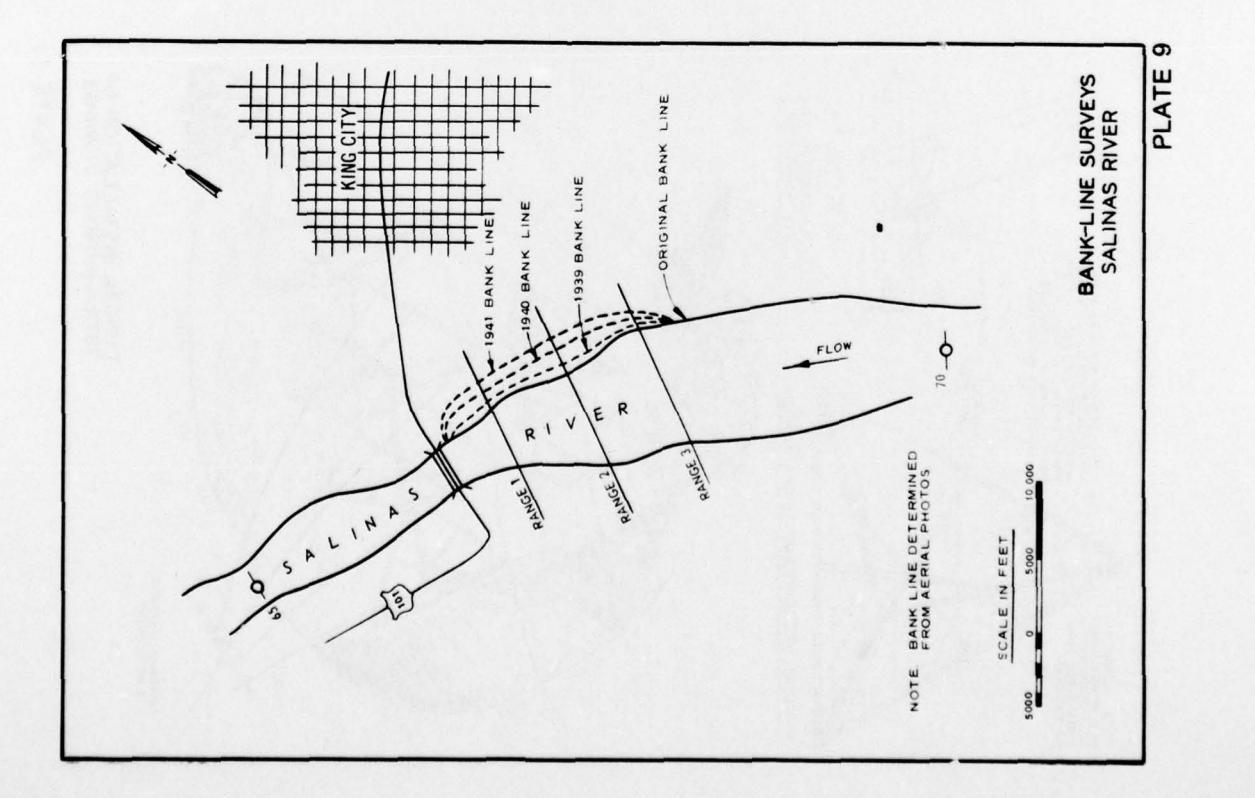
PLATE 10

(3) <u>Bank Erosion Tendencies</u>. The test site (Plate 2) had been eroding at a rate of approximately 1 to 2 feet per year for the past several years. Plate 9 shows the successive bank line as taken from aerial photographs. The flood of record in 1938 caused the most damage with the bank line receding approximately 4 feet during the flood. After, and sometimes during, flood or high water, individual owners have installed revetment works. These revetment works that have been installed over the past three or four decades, have demonstrated a measure of success, and are tabulated in Plate 10.
