MINUTEMAN (LGM-30)

IMPALER TEST

2705TH AIRMUNITIONS WING OGDEN AIR MATERIEL AREA (AFLC) UNITED STATES AIR FORCE Hill Air Force Base, Utah

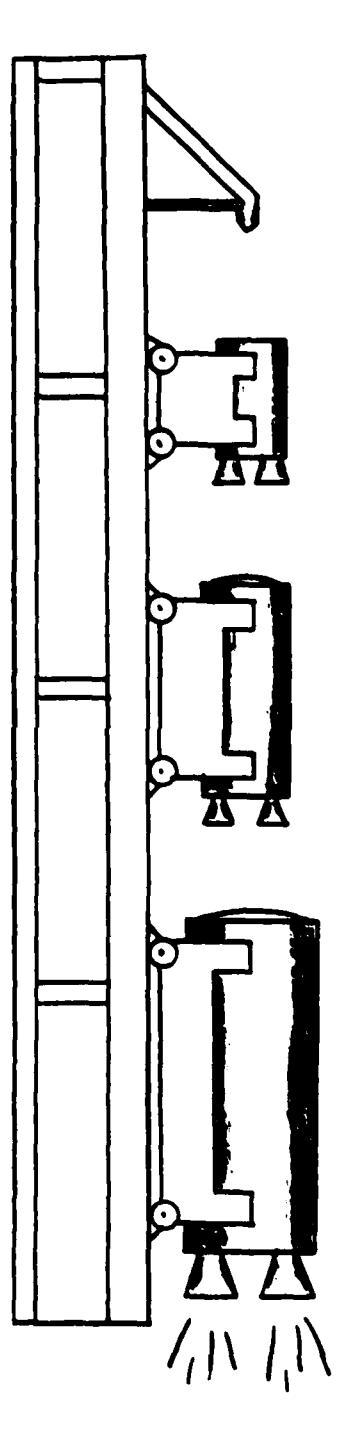
Figure 1 is a schematic drawing of the test configuration. Figure 2 is a photograph of the actual set up. Three solid propellant motors (stage one, two and three) were mounted on carriages and placed on rails about five feet above the ground. Wheel chocks were placed against the carriage wheels. A destruct package was designed for the test and was attached to each motor. One impaler was mounted to the end of the rails. The stage one motor was ignited by means of the normal ignition system. High speed cameras were used to photograph the results.

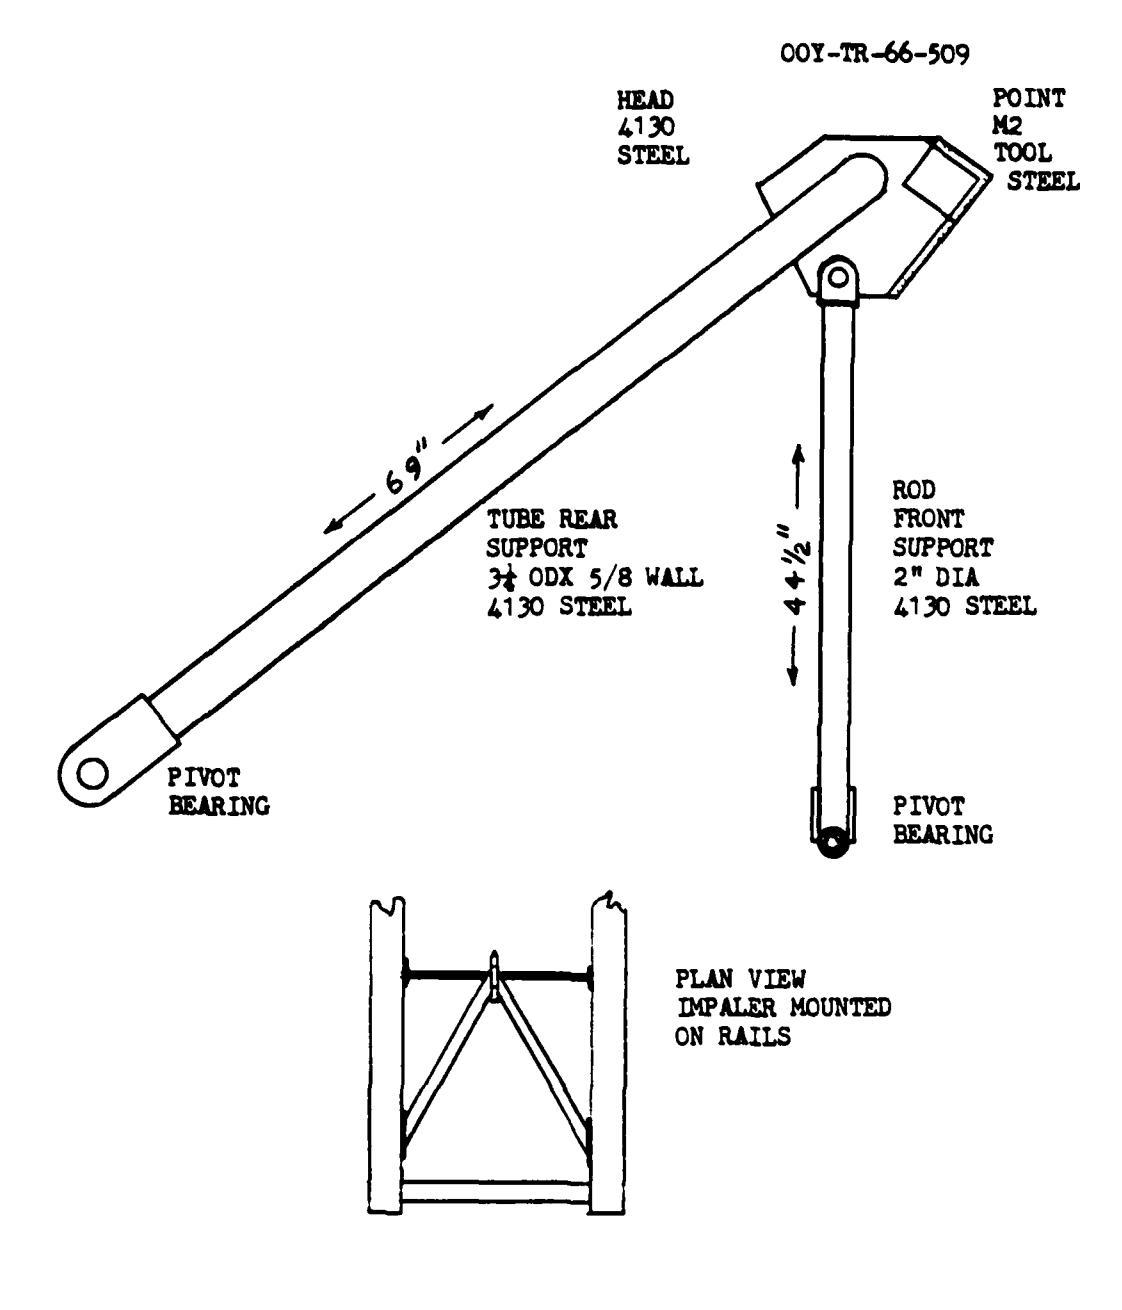
The impaler (Figure 6) consisted of a steel head supported by four steel legs. A hardened steel point was silver soldered into the head. The impaler has been designed to mount between the rails and to pivot downward to allow passage of motor carriages.

The impaler was mounted at the front of the Boeing rails in the identical manner to those used in MAMS. Standard Mounting Plates and bolts were used. The point of the impaler was $24\frac{1}{2}$ inches above the top of the rails.

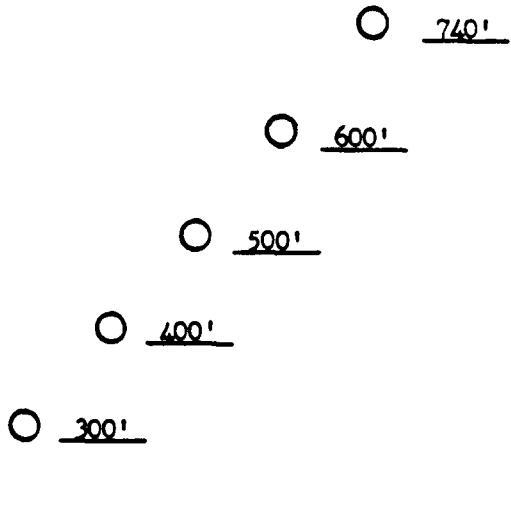
Bikini type blast gauges were used to record any over pressure that might have developed. Aluminum foil of 0.001 inch thickness was used in the gauges. These gauges were positioned "face on" (Figure 7).

BLAST GAGE CONFIGURATION 100' DISTANCE MEASURED FROM FORWARD DOME OF STAGE III AND NOZZLE OF STAGE I, RESPECTIVELY. THE OVER-PRESSURE WAS CALCULATED TO BE 2 TO 3 PSI AT THE 100' MARK WITH NO INDICATION BEYOND THIS MARK.

No detonation occurred. The first stage motor did experience a pressure burst that yielded a 2-3 psi overpressure at the 100 foot radius. The second and third stage motors burned out with only minor pressure bursts.
