Survey of Forced and Precautionary Landing Costs

by Emil Spezia SSG G. D. Kimel T. Neese

Directorate for Investigation, Analysis, and Research COL J. J. Mikuta Director

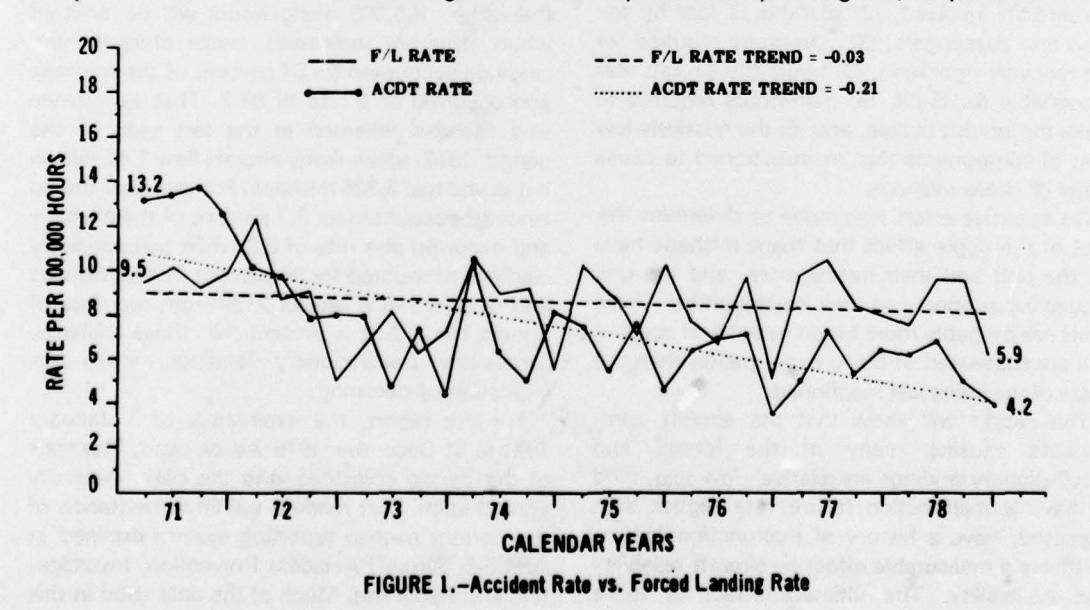
Figure 1, which is a combination of fixed wing and rotary wing experience, reveals a relationship between forced landings and accidents that has an effect on the accident rate and also focuses on the objective of this report. It can be interpreted from the data that the corrective measures taken to decrease accidents seemingly have not had a like effect on the causes of forced landings. Why is this? Are the causes of forced landings the same as or different from the causes of accidents? If their causes are the same, were the corrective measures taken against accident causes applied to the causes of forced landings and to what degree? If the causes of forced landings and accidents are different, what new and different measures are needed to prevent forced landings?

From the data in figure 1, it can be reasoned that the ability of Army aviators to cope with in-flight emergencies that cause forced landings is being maintained. Had this ability deteriorated, the accident rate would increase with each unsuccessful forced landing. The forced landings made during survey period 1 March-10 October 1978 were examined to test the reliability of this observation. No change in the aviators' ability was indicated. Of 75 reported in-flight emergencies, 57 (75 percent) of the forced landings were successful, i.e., autorotations were made with no damage to aircraft. Figures 1A and 2A, appendix A, compare the forced landing and accident rates for rotary wing and fixed wing aircraft.

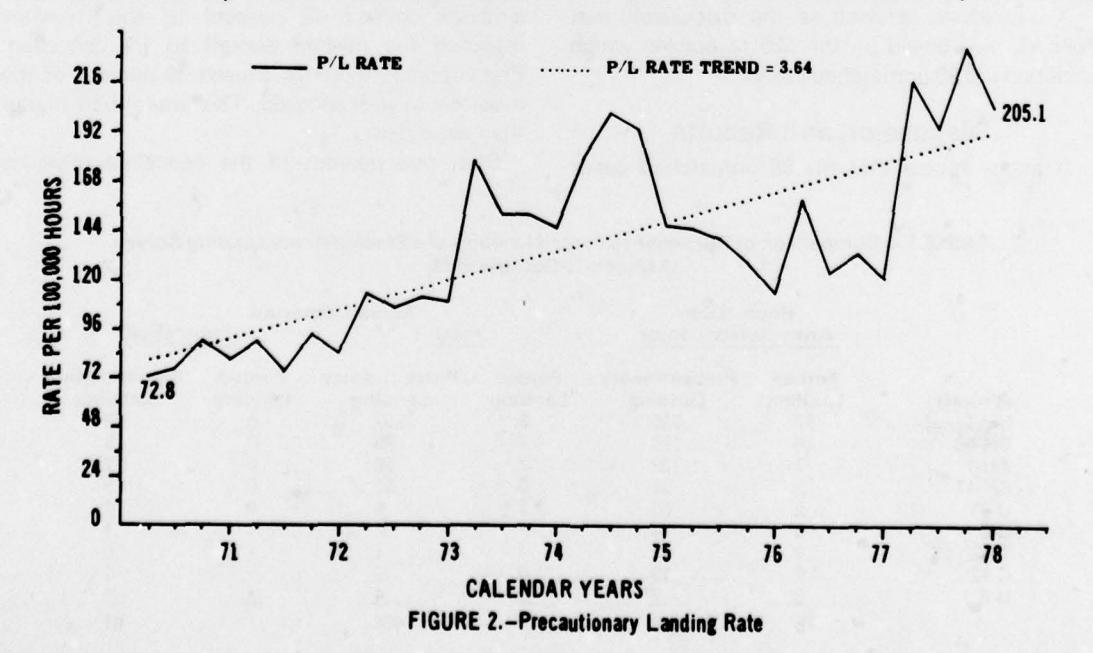
Army Safety Center records show that precautionary landings were first recorded officially in September 1963. Records have since shown the precautionary landing rate to be many times greater than the forced landing rate and that the precautionary landing rate has steadily increased (see figure 2). At the beginning of CY 1971, the precautionary landing rate was 72. Precautionary landings have increased at a rate of 3.64 per quarter for a three-fold increase to a rate of 205 at the close of CY 1978. Much of the quarterly increase, in addition to change in reporting criteria that began early in 1978, was due to the increase in the fixed wing precautionary landing rate. The fixed wing increase was 4.4 per quarter in comparison to 3.5 for rotary wing aircraft shown in figures 1B and 2B of appendix A. An explanation of this finding was not pursued. However, figure 2B shows that much of the fixed wing difference may be attributable to an increase that began early in 1974 and lasted until early in 1976.
