Research Paper FPL 433

# Condensation Potential in High Thermal Performance Walls — Cold Winter Climate

by G. E. Sherwood

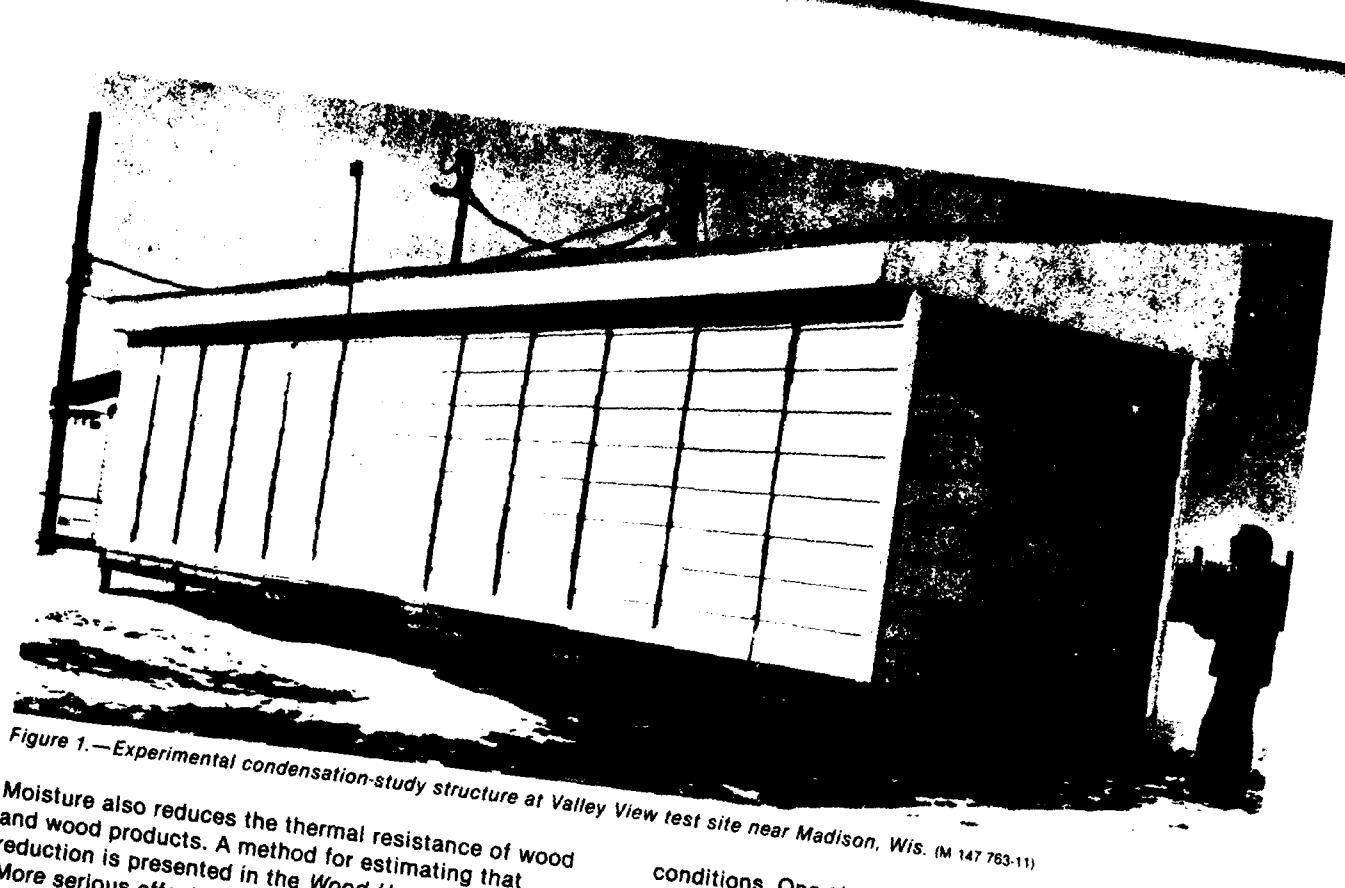
The buildings are long and narrow, 8 feet wide by 48 feet long, with the long axis east-west for maximum exposure of north and south walls (fig. 1). The center 8 feet is an instrument room. The remaining length of the building is partitioned every 4 feet resulting in ten 4- by 8-foot rooms (fig. 2) connected by doors in partitions. The only exterior door is in the instrument room. Support for the roof and ceiling is provided by partitions (fig. 3), so exterior wall panels can be removed and replaced while the building remains intact,

After installation of test panels, all joints with floor, ceiling, and partitions were caulked. On the outside, vertical joints between panels were caulked and the joint between floor framing and the bottom edge of the wall panel was caulked. Six-mil polyethylene taped to each face of the partitions extends out between adjoining panels to prevent transfer of moisture between panels (fig. 1).

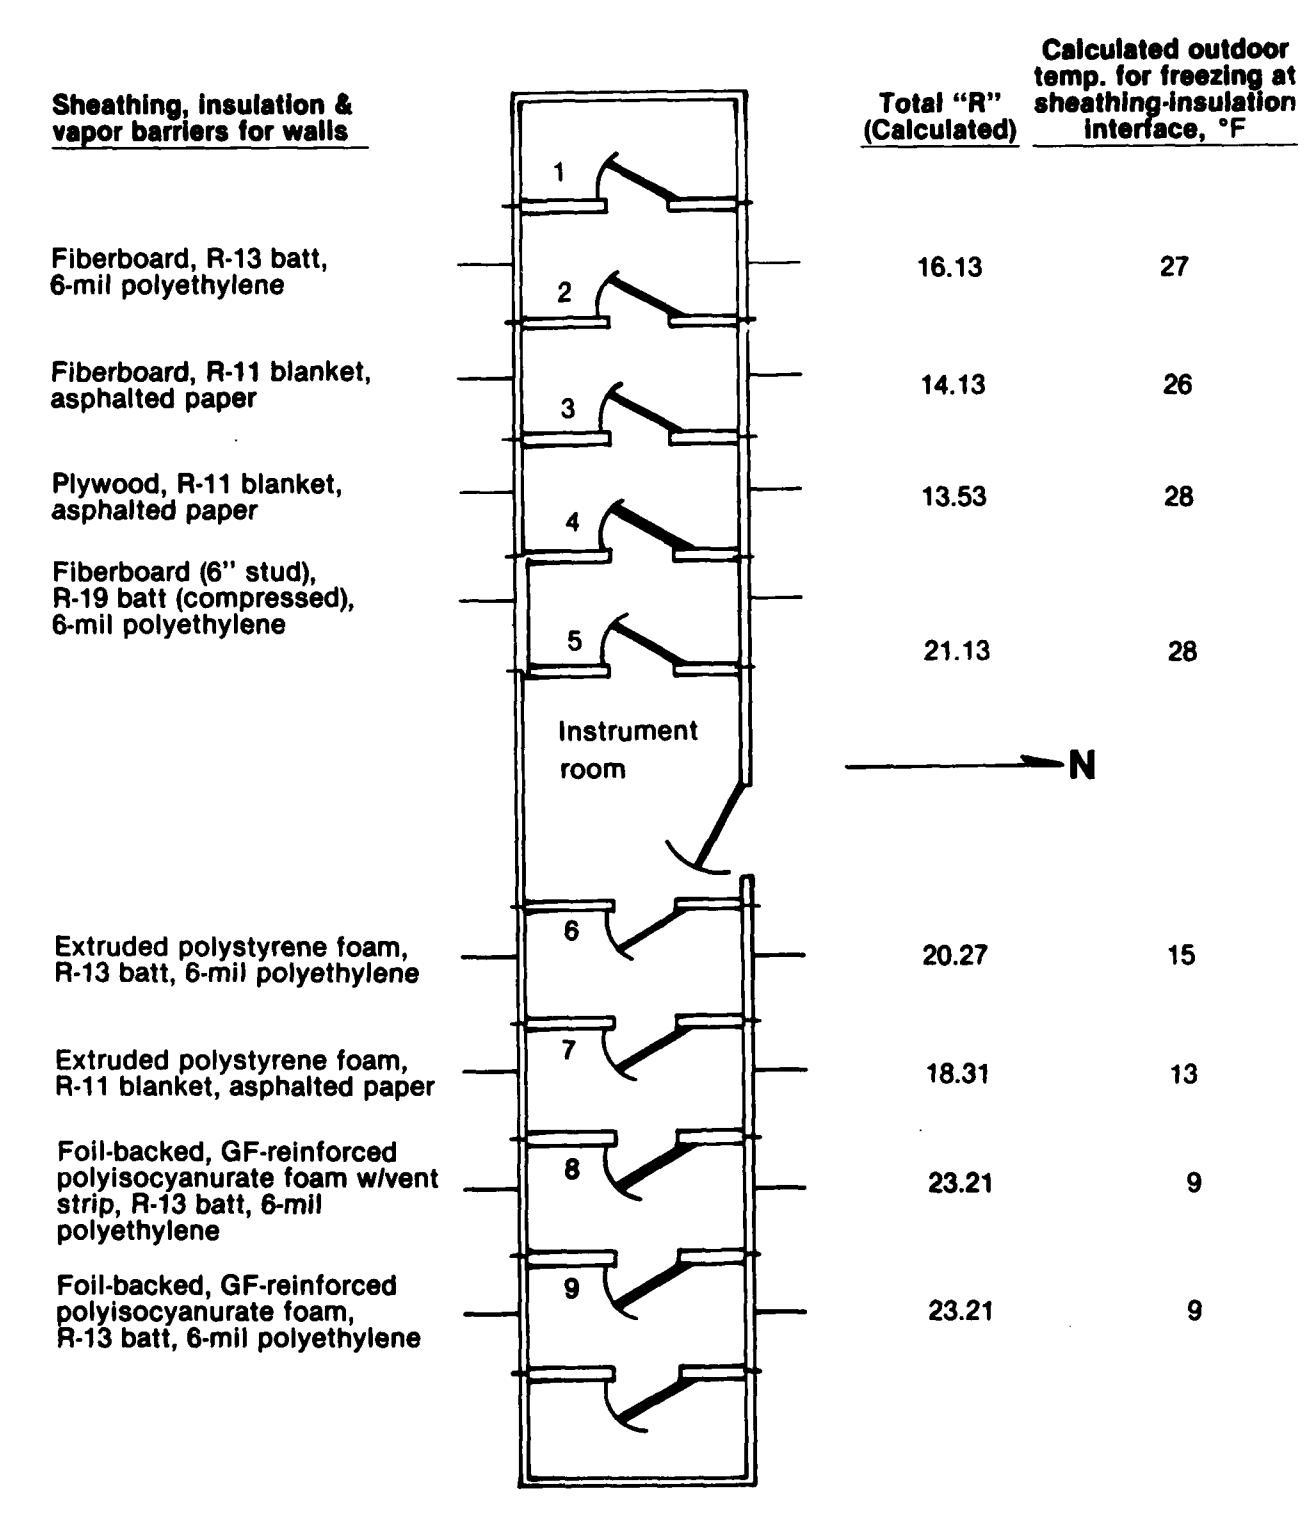
Figure 2.—Plan of experimental structure showing variables of construction of each wall panel. Note that both "R" values and interface temperature are based on calculation methods shown in the ASHRAE Handbook of Fundamentals (2). (ML83 5060)

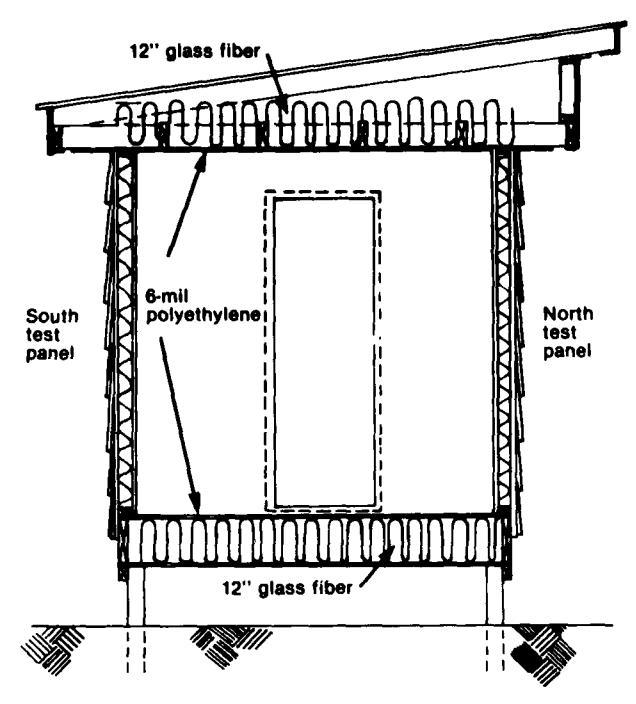
Figure 3.—Cross section of experimental structure showing construction details. (M83 5061)

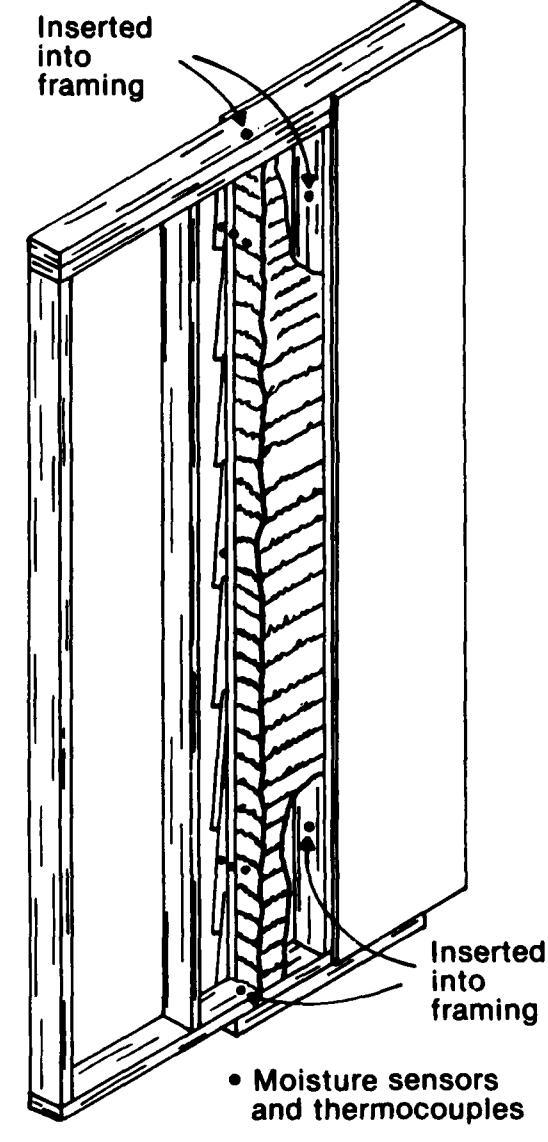
Figure 6.—Moisture sensor locations in each test panel. Four sensors are in framing; two are in the center of insulation; two are at the insulation-sheathing interface; and three are at the sheathing-siding interface. (ML83 5062)

Each test panel was instrumented with moisture sensors at 11 locations in the wall (fig. 6). A thermocouple was also placed at each moisture sensor location. At heights of 1 foot and 7 feet above the floor, moisture measurements were made at the sidingsheathing interface, at the sheathing-insulation interface, at the center of the cavity insulation, and in the adjacent stud. Sensors were also located in the top plate, the sole plate, and between siding and sheathing at the midheight of the wall. Lead wires from all these data points were brought into the room through the vapor retarder and gypsum board at two points (1 foot and 7 feet above the floor). The punctures in the vapor

Moisture conditions were measured at 189 locations (fig. 6) using small wood sensors. The moisture content (MC) of the wood sensor was converted to MC of the members in which they were imbedded, based on the relative humidity of the air in the immediate vicinity. Relative humidity in the rooms, outdoors, and at interfaces between two materials was also recorded.

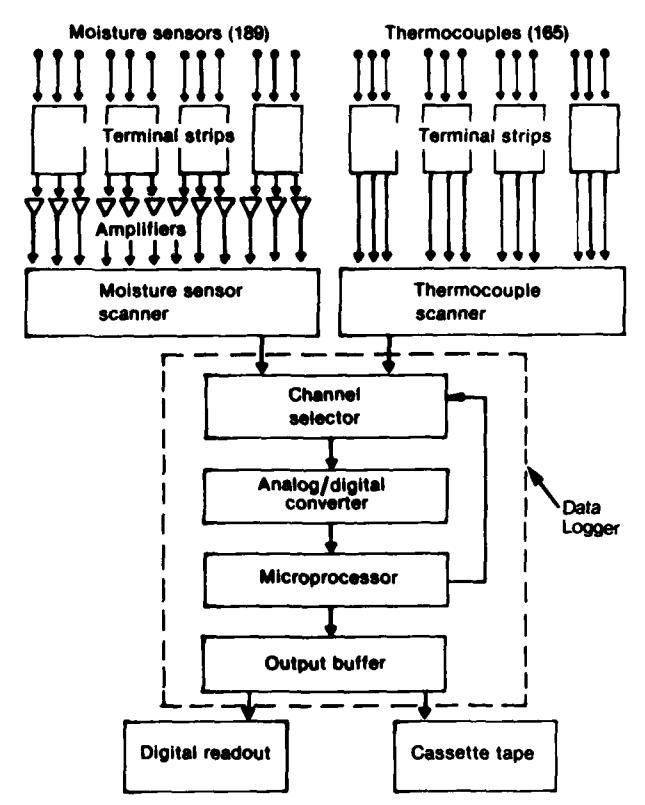
Figure 7.—Flow chart of instrumentation and data recording system. (ML83 5063)

to the logger, amplifiers were located as close to the test wall, as close to each sensor as practical; their output was connected to the data logger and calibrated (fig. 7).

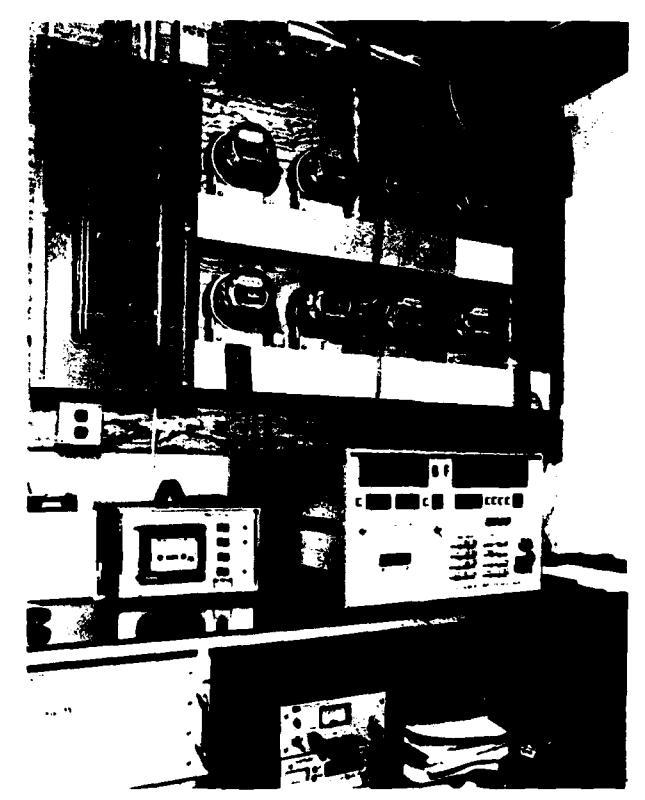
Figure 8.—Instrumentation room showing data logger and electric meters for individual rooms. (M 147 451-11)

All of the moisture and temperature data were digitized and recorded on cassette tape using a multichannel, programmable data logger (fig. 8). Because of equipment malfunctions often caused by local storms, hand readings were required much of the time. Data were collected three times a week.

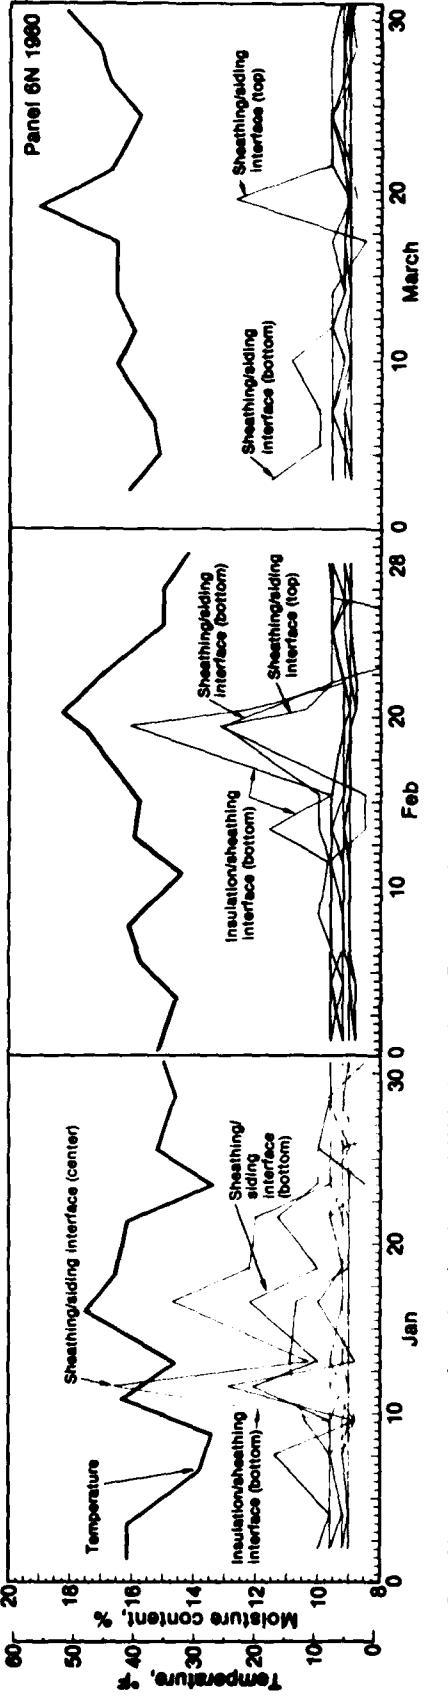
Figure 13. — Moisture content of wood probes in panel 6N (polyethylene, R-13 glass fiber, polystyrene) and corresponding temperature on the warm face of sheathing, January through March 1980. (ML83 5068)

Wall cavities with both polyethylene vapor retarder and low-permeance foam sheathing had no indication of condensation. Moisture content at the insulationsheathing interface in the wall with polystyrene sheathing (6N) (fig. 13) did rise significantly by December and remained high until March. Both walls with foil-backed foam (8N, 9N) had increases in MC at the insulation-sheathing interface only during periods of extreme cold in January and February (figs. 15 and 16).

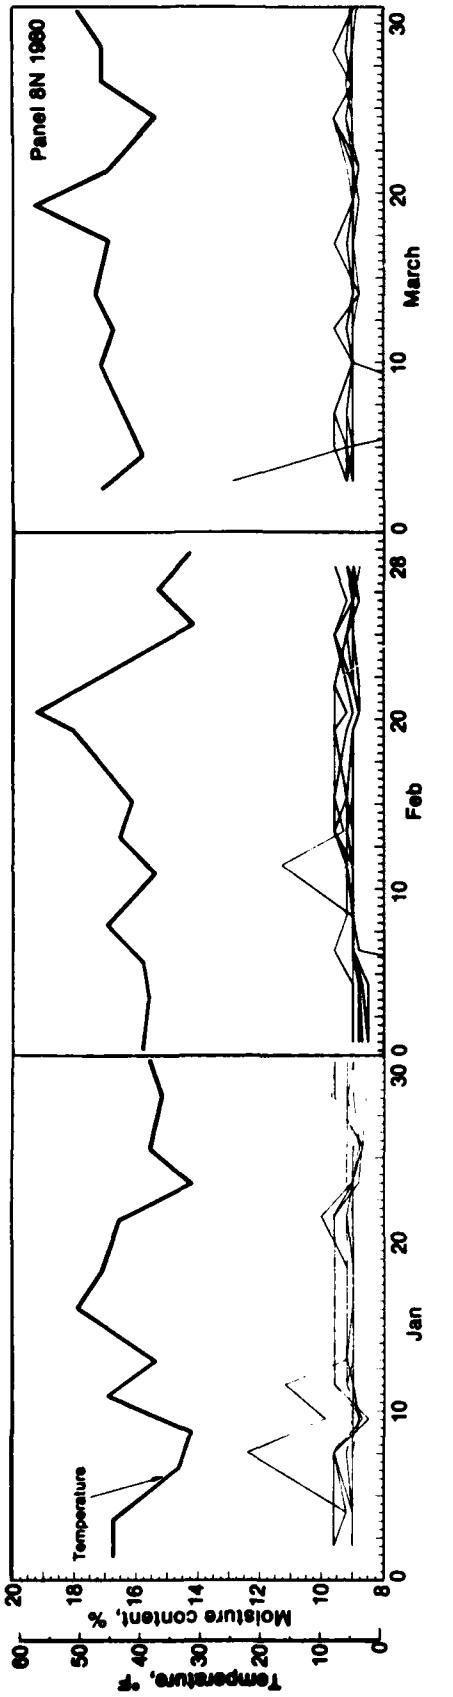
- Moisture content of wood probes in panel 8N (polyethylene, R-13 glass fiber, vented foil-backed isocyanurate) and corresponding temperature on the warm face of sheathing, January through March 1980. The only probe showing MC exceeding 10 percent was at the insulation-sheathing interface (top). (ML83 5070) Figure 15.

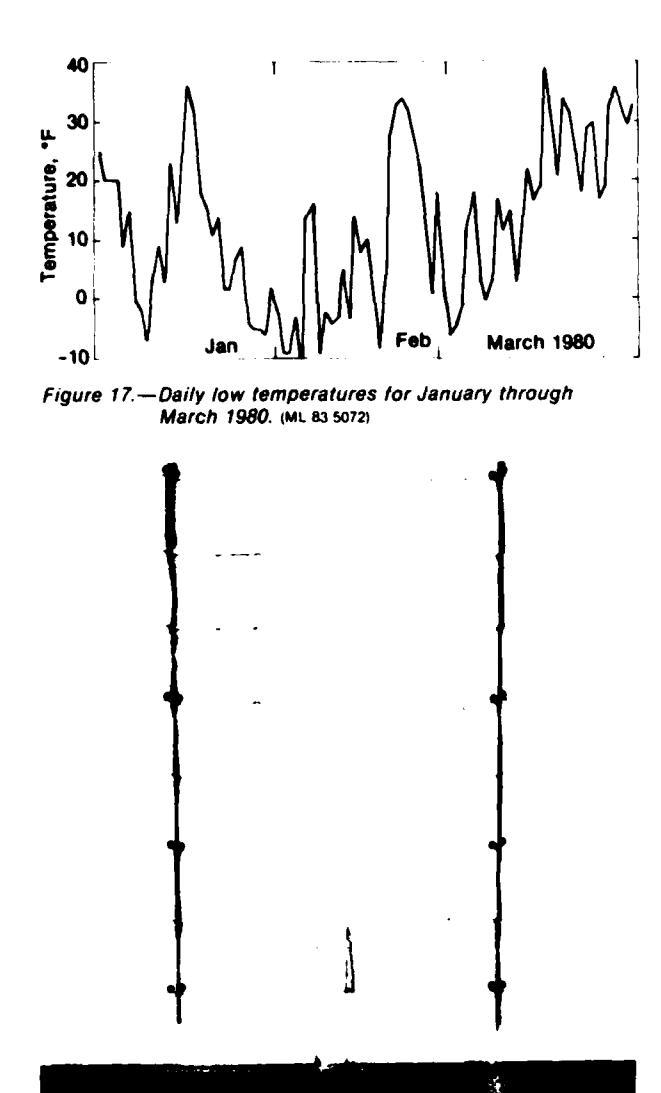
Figure 18. — Severe staining on panel 3N (north side) due to condensation on the back of siding. (M 147 763-2)

Condensation occurred on the back of the siding in all panels with fiberboard sheathing. It remained through

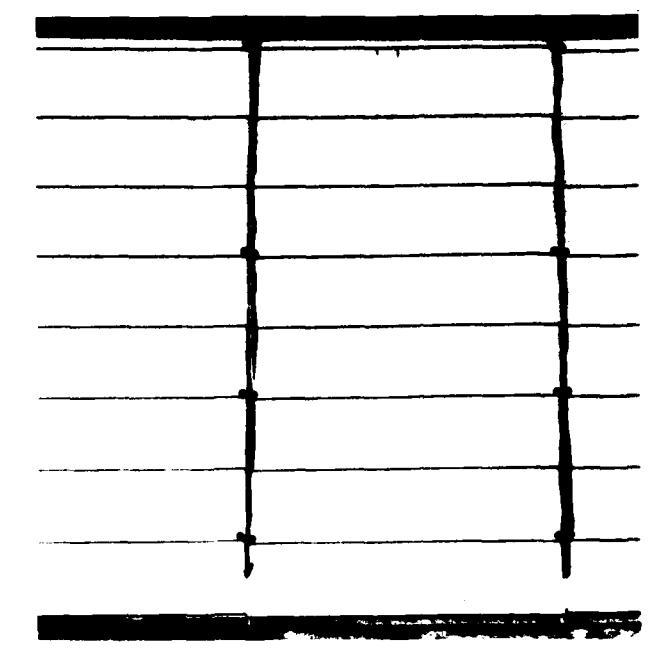
Figure 19. -Slight staining on panel 3S (south side). (M 147 763-9)

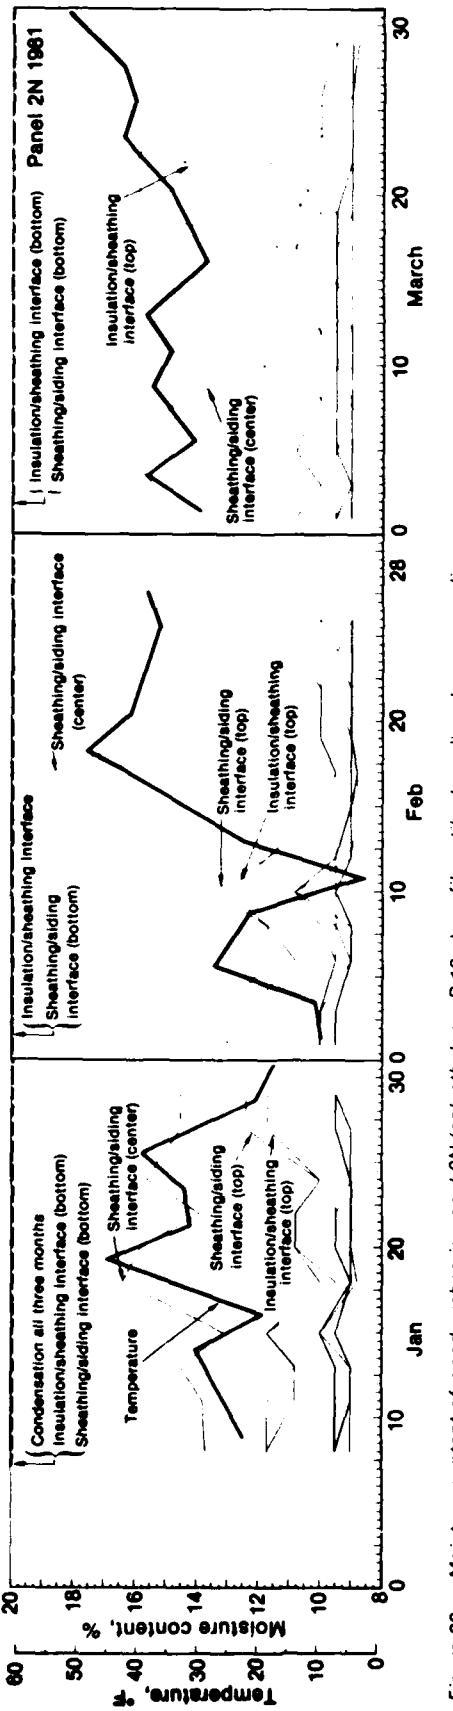
Figure 20. – Moisture content of wood probes in panel 2N (polyethylene, R-13 glass fiber, tiberboard) and corresponding temperature on the warm face of sheathing, January through March 1981. (ML83 5073)

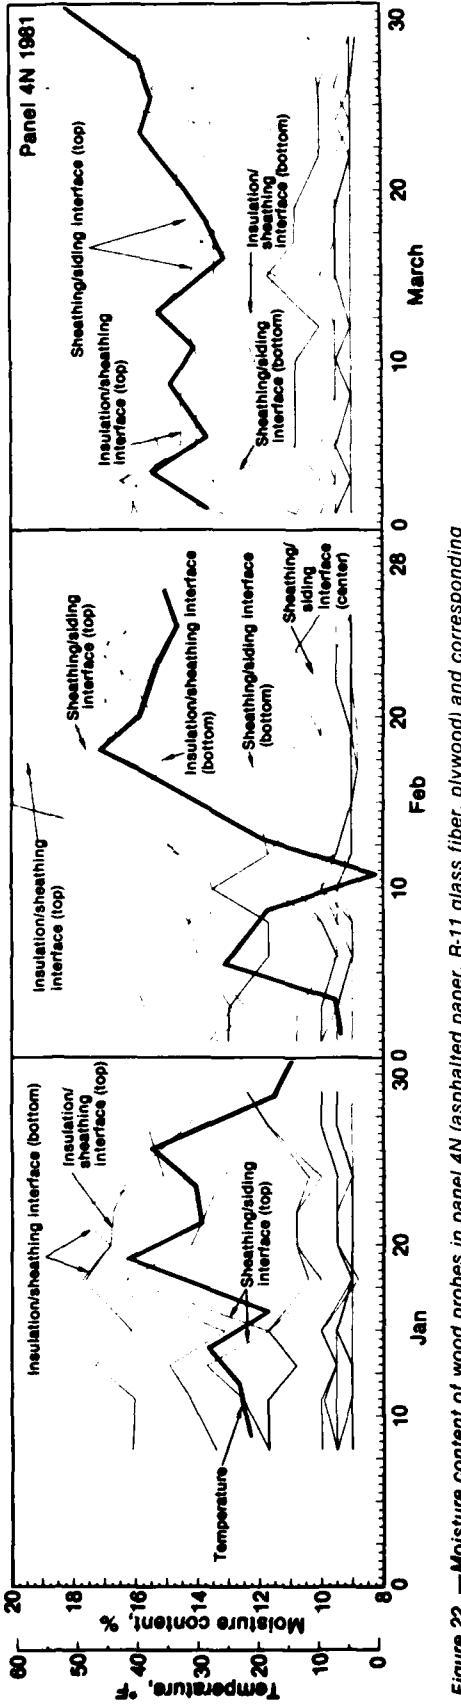
Figure 22. — Moisture content of wood probes in panel 4N (asphalted paper, R-11 glass fiber, plywood) and corresponding temperature on the warm face of sheathing, January through March 1981. (ML83 5075)

Panels 4N (asphalted paper, R-11 glass fiber, plywood) and 5N (polyethylene, R-19 glass fiber, fiberboard) (figs. 22 and 23) also had extended periods when condensation was apparently present on the sheathing near the top of the wall. Because these two types of walls indicate the lowest sheathing temperatures, condensation could occur at lower cavity humidity conditions than in any other wall tested. The warmest and coldest sheathing temperatures for January, February, and March 1981 (fig. 29) illustrated a range of up to 20° F temperature difference at this critical interface for the various types of construction.

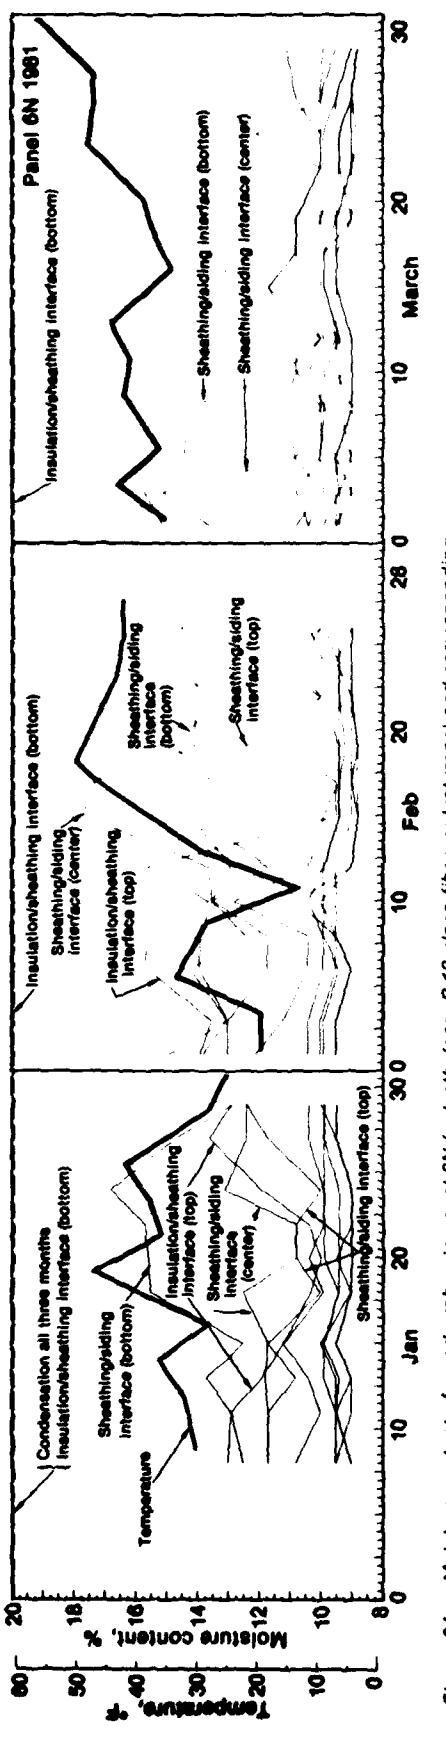
Figure 24. — Moisture content of wood probes in panel 6N (polyethylene, R-13 glass fiber, polystyrene) and corresponding temperature on the warm face of sheathing, January through March 1981. (ML83 507).

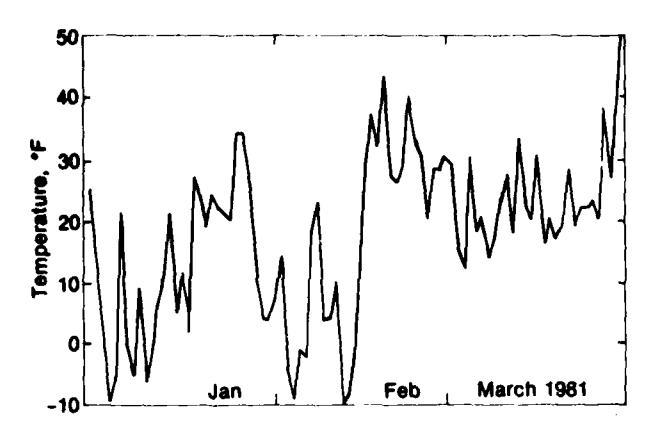
Figure 28.—Daily low temperatures for January through March 1981. (MLB3 5081)

Moisture in all north panels during January, February, and March 1981 is plotted in figures 20 through 27. Temperatures at the insulation-sheathing interface are also shown for each panel. Daily low temperature during January, February, and March is plotted in figure 28.

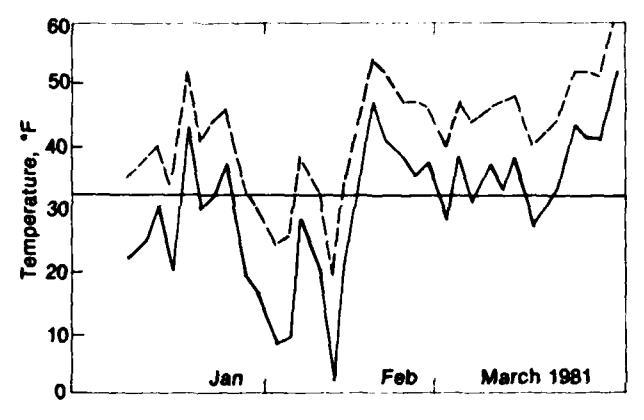
Figure 29.—Warmest and coldest north-side sheathing temperatures (panels 5N and 9N) for January through March 1981. (ML83 5082)
