TECHNICAL REPORT ARFSD-TR-85004

COPPERHEAD CONTAINER LATCH

FEBRUARY 1986

U. S. ARMY ARMAMENT RESEARCH AND DEVELOPMENT CENTER FIRE SUPPORT ARMAMENT CENTER

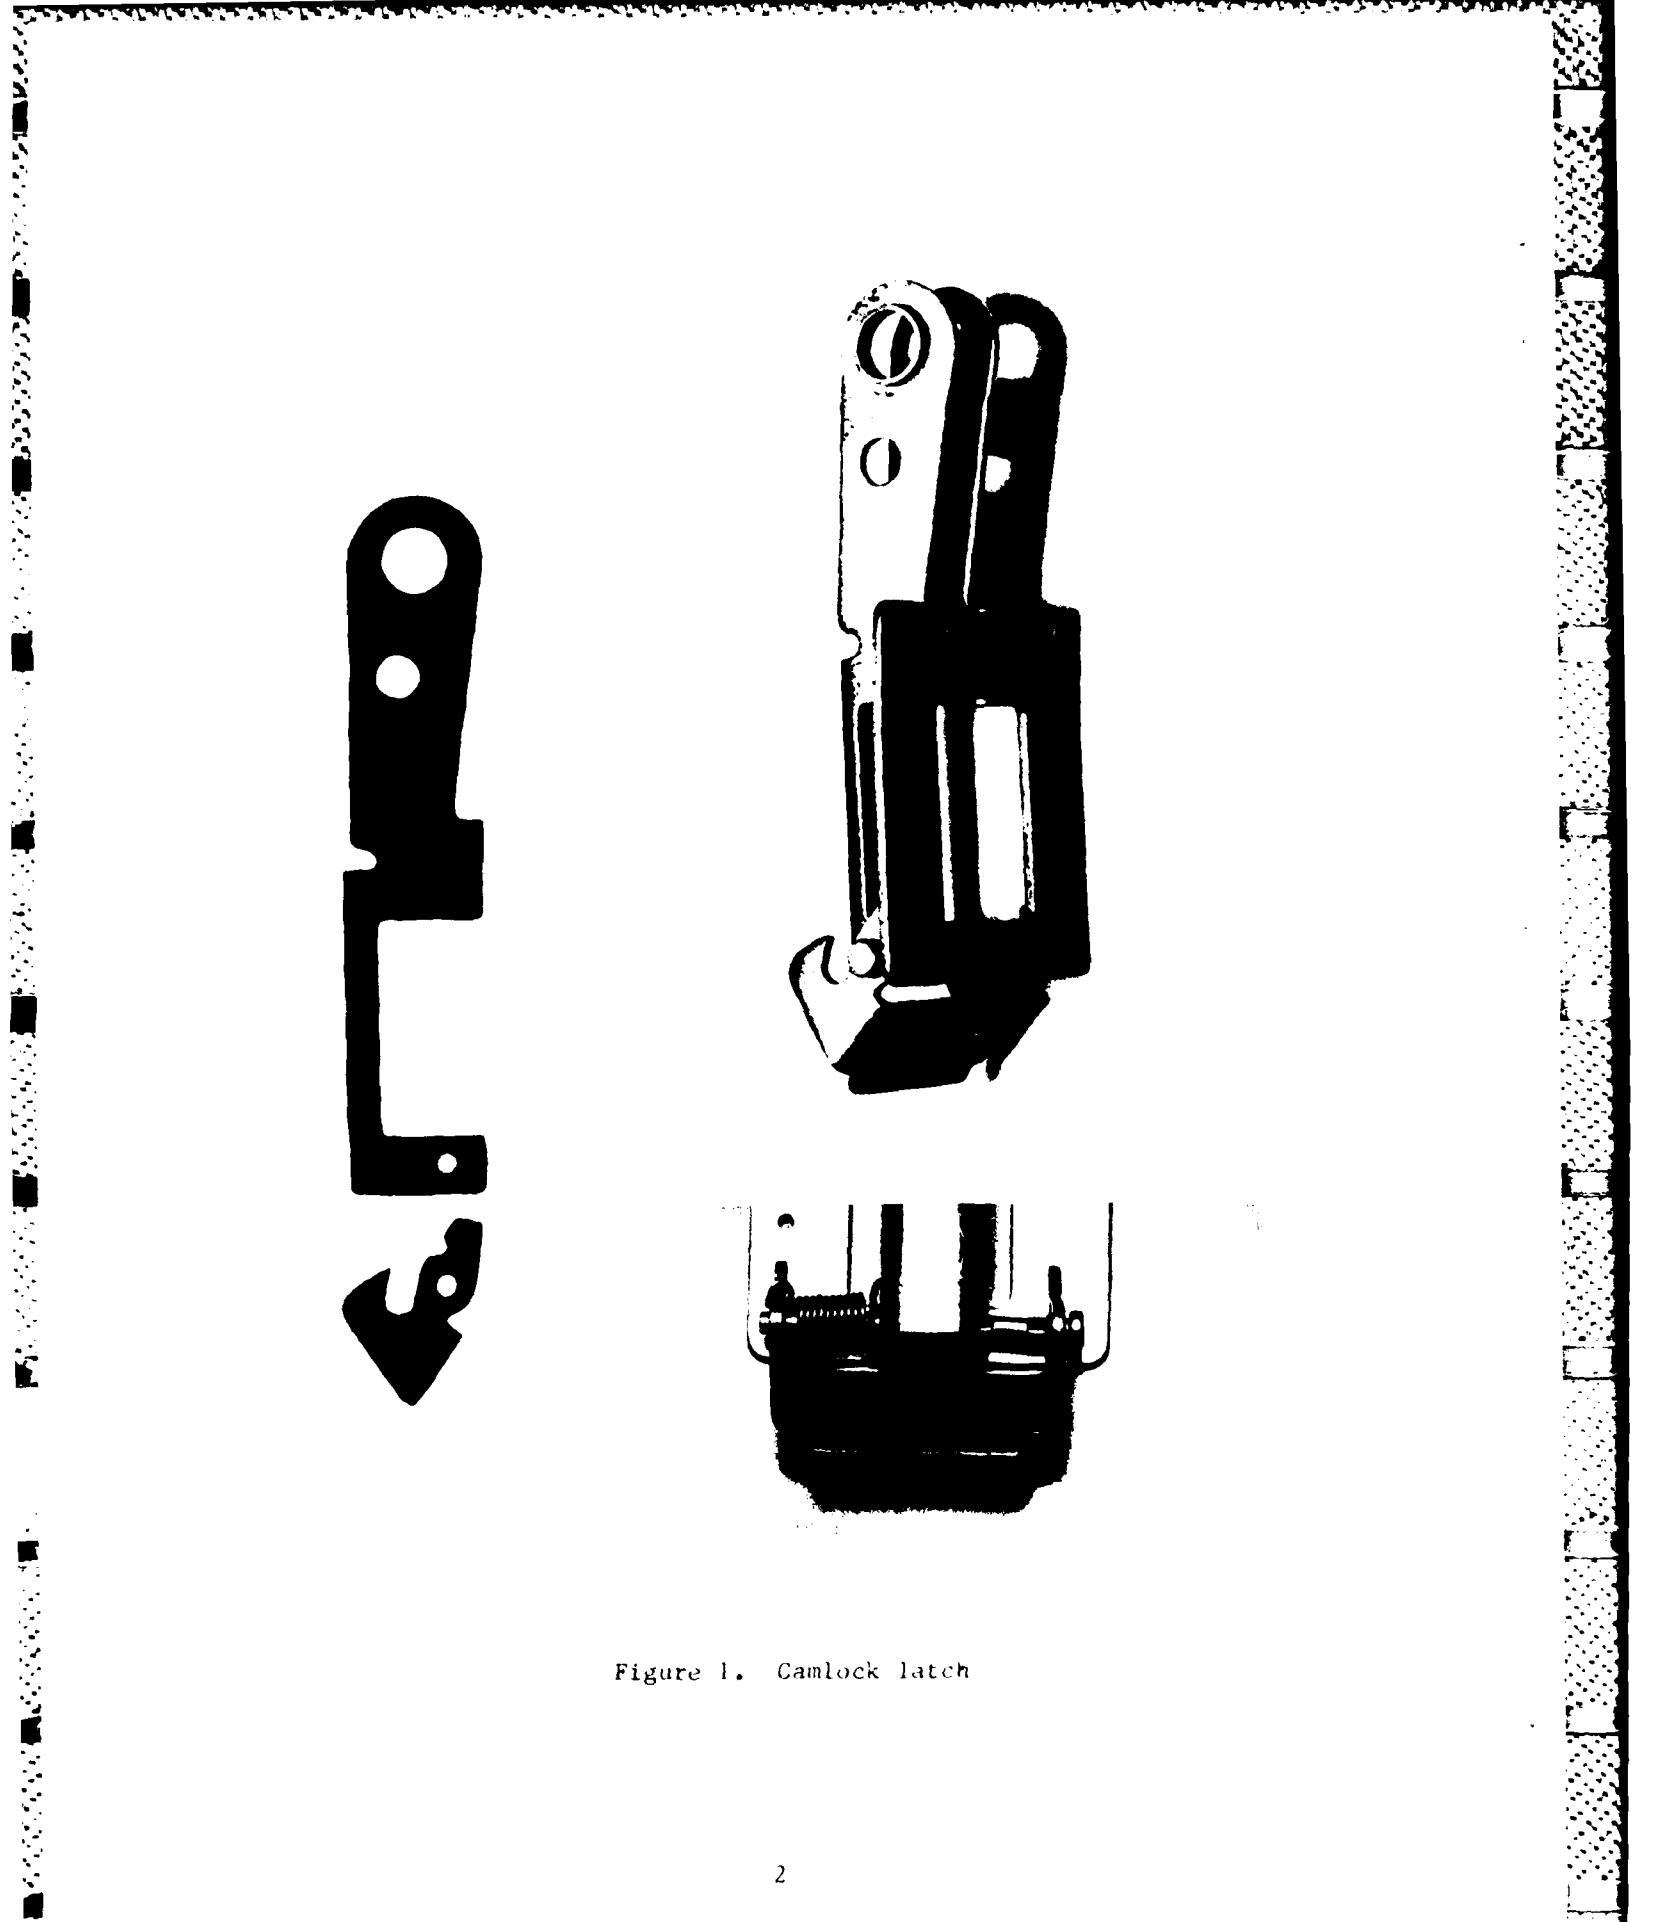
Camlock Latch (fig. 1)

An over-center type latch is a bolt which fastens the lid to the trunk. The end of the bolt has a nut or hook and seats on an accessory of the lid known as

the strike or keeper. The head of the bolt does not seat directly on the trunk but is linked to an accessory known as the cage. When the link is pointing away from the lid, the bolt is at maximum tension. The link is not stable in this position because the tension in the bolt can rotate it in erther of two directions. When securing the latch, the link is rotated beyond the point of maximum tension by an amount known as the toggle angle. The tension in the bolt then presses the link against the trunk or against an accessory fixed to the trunk such as a plate. To further secure the link, spring loaded hooks can grap the edge of the plate. This set of hooks is often reterred to as the secondary lock.

The Camlock was normally supplied with its own cage plate and striker. These pieces were tailored to engage the lock and nest the barrel nut properly. Lanson had integrated these parts into their container weldment, resulting in excessive toggle. The over-center hump which the handle had to swing through was too severe.

After 30 containers were manufactured, it was discovered that a latch tight enough to compress the rubber gasket and seal the container was also difficult to open. Containers that had passed the pressurized leak test required as much as 70 lb of pull to release the handle, depending upon the unlatching sequence. These were not true field containers because tools were needed to open them.

The Camlock latch (fig. 1), originally selected for the Copperhead container, was difficult to open. Lanson Industries discovered the problem early in production.

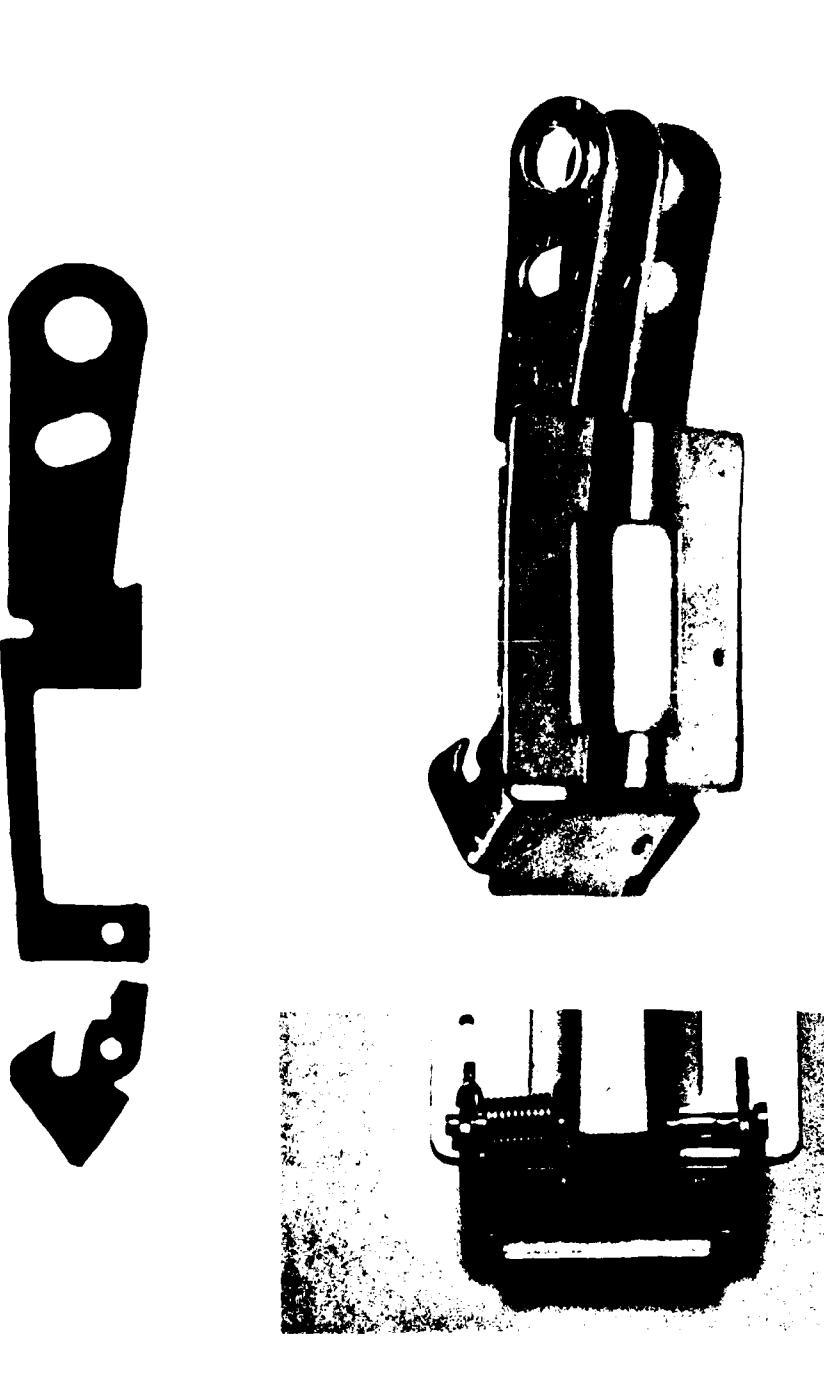
Figure 2. Baseline latch

To expedite round deliveries, the government allowed Lanson to modify the handle. The circular hole which pivots the T-bolt was changed to a slot. When the latch was closed, the clevis pin was seated on the outboard end of the slot. This reduced the over-center resistance that the handle had to rotate through thereby reducing the force necessary to pull the latch handle open. When the handle was swung open, the pin would fall to the bottom of the slot. The washer and cotter pin cleared the irregular aluminum extrusion where the handle pivoted.

Containers equipped with these latches could be sealed with pulls around 25 lb. This lower force was due to the slotted hole; however, Lanson maintained good flatness on the flanges of the clamshell halves which also kept the opening force down. Nevertheless, there were practical limitations on tolerances for a weldment this size. The baseline was realistic and allowed Lanson to go as high as 50 lb to seal the container.

The human interface of the depot-styled latch was still not optimized for the field environment anticipated by the Army. The device could only be grasped with two fingers, and a tool to pry it open might not be handy. Yet the container could not be changed. A substantial investment had already been dade to qualify the projectile around its vibration profile. The only solution remaining was to further modify the latch within the framework of existing tooling.

The baseline latch (fig. 2) was shocked inside the test cage after having been adjusted to 8 lb. It remained closed up to 145 g's.

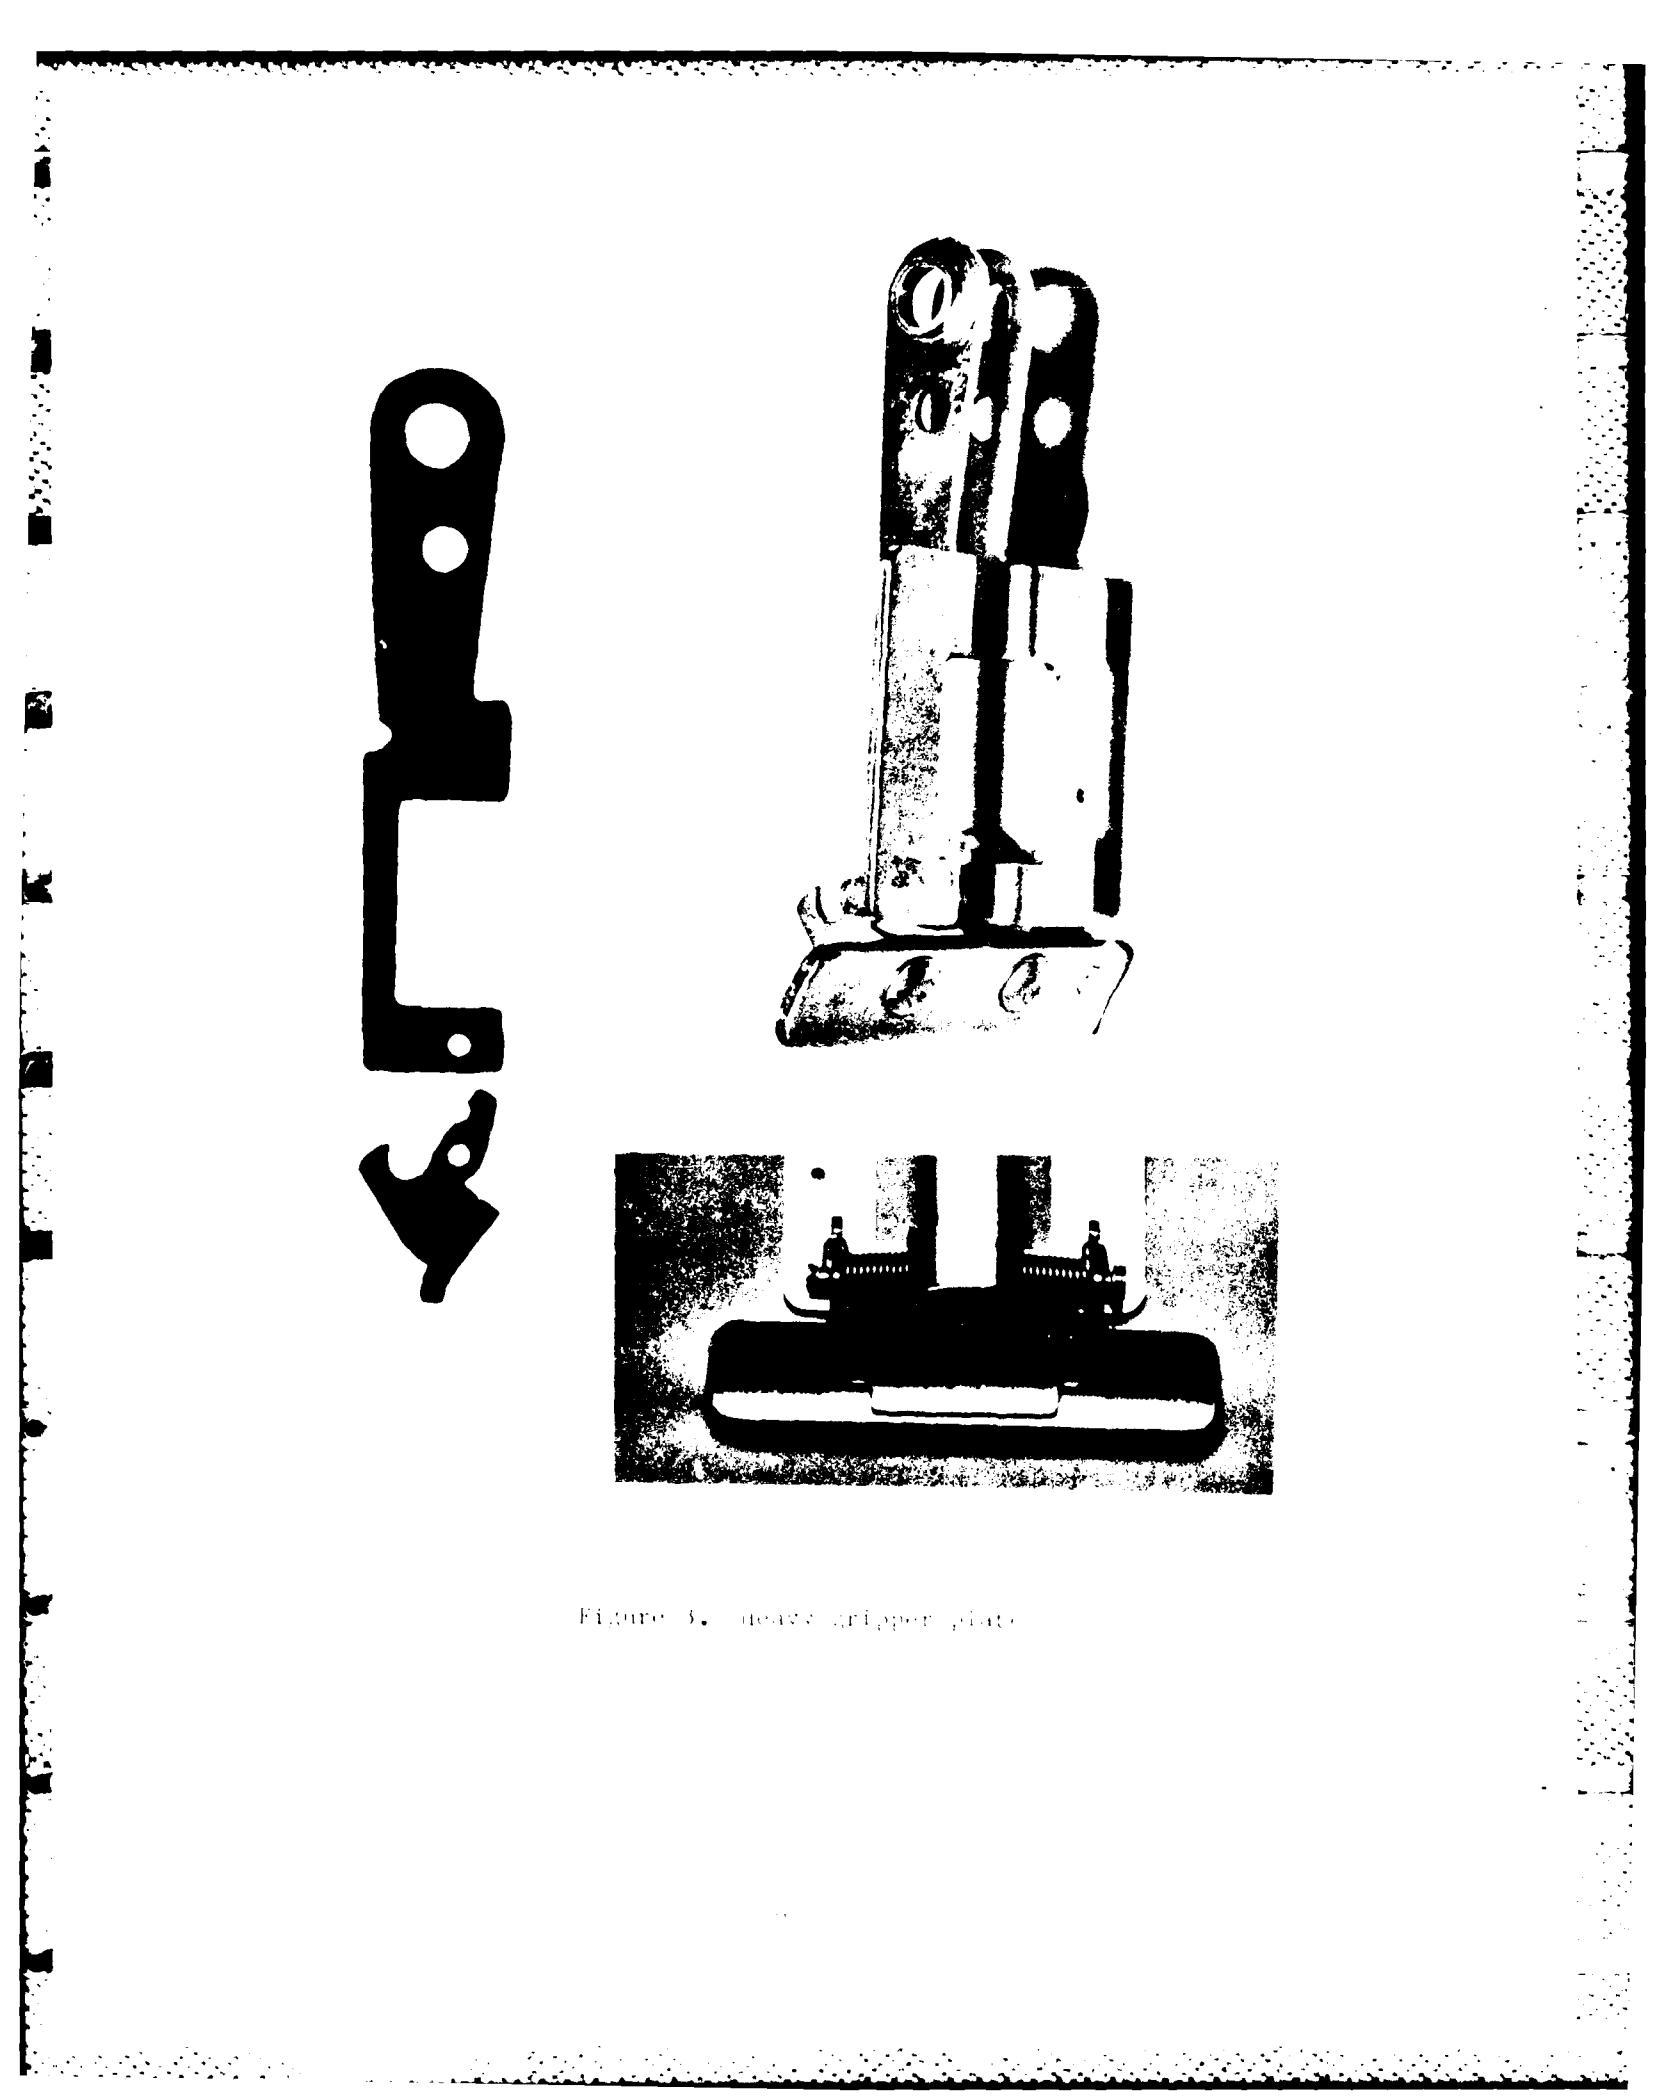
Heavy Gripper Plate (fig. 3)

The slotted holes, which cut across most of the width of the handle, were eliminated. The round hole was resurrected and relocated for an easy over-center movement of the handle. This placement also eliminated interference of the clevis pin and its washer and cotter pin with the weldment of the latch cage.

The round hole in the handle worked quite well. At least tour containers on Lanson's assembly line were equipped with this latch and passed the leak test with pull forces that averaged 24 lb. The prototypes were then removed and the leak test repeated on the same containers with the baseline latcnes. The average pull force for the production latch was 25 lb.

The design for the wider grip was fairly straightforward. No tooling changes to the dies for the lock were required. Modifications from secondary operations on the formed part were used instead. Two holes in the lock face, originally intended as forming guides, were reamed larger and a wide steel plate was riveted through them. Calculations indicated that the additional mass of the plate might cause the lock to unhook following a mild jolt. In fuze terminology the plate could act as a g-weight. To compensate for the added weight, the single spring was replaced by two springs, each ten times stifter than the original.

This prototype failed the preliminary shock test. The gripper plate was too heavy to be restrained, even by stiffer springs. Furthermore, the shape of the lock hooks was found to affect shock vulnerability.

The prototype of the heavy gripper plate (fig. 3) was adjusted to a pull force of less than 5 lb. It had two opening g thresholds, depending upon its initial position in the cage. If the closed latch were pulled outboard so as to contact the teeth of the hooks, then 170 g's for 7 ms were necessary to open it. If the closed latch were pushed inboard so as to contact the stems or shanks of the hooks, then only 70 g's for 8 ms opened it. In the latter case, it is likely that the handle moved in the direction of setback causing the lock to glance off the cage plate. It was concluded that the wide hooks of this prototype contributed to its vulnerability to shock.

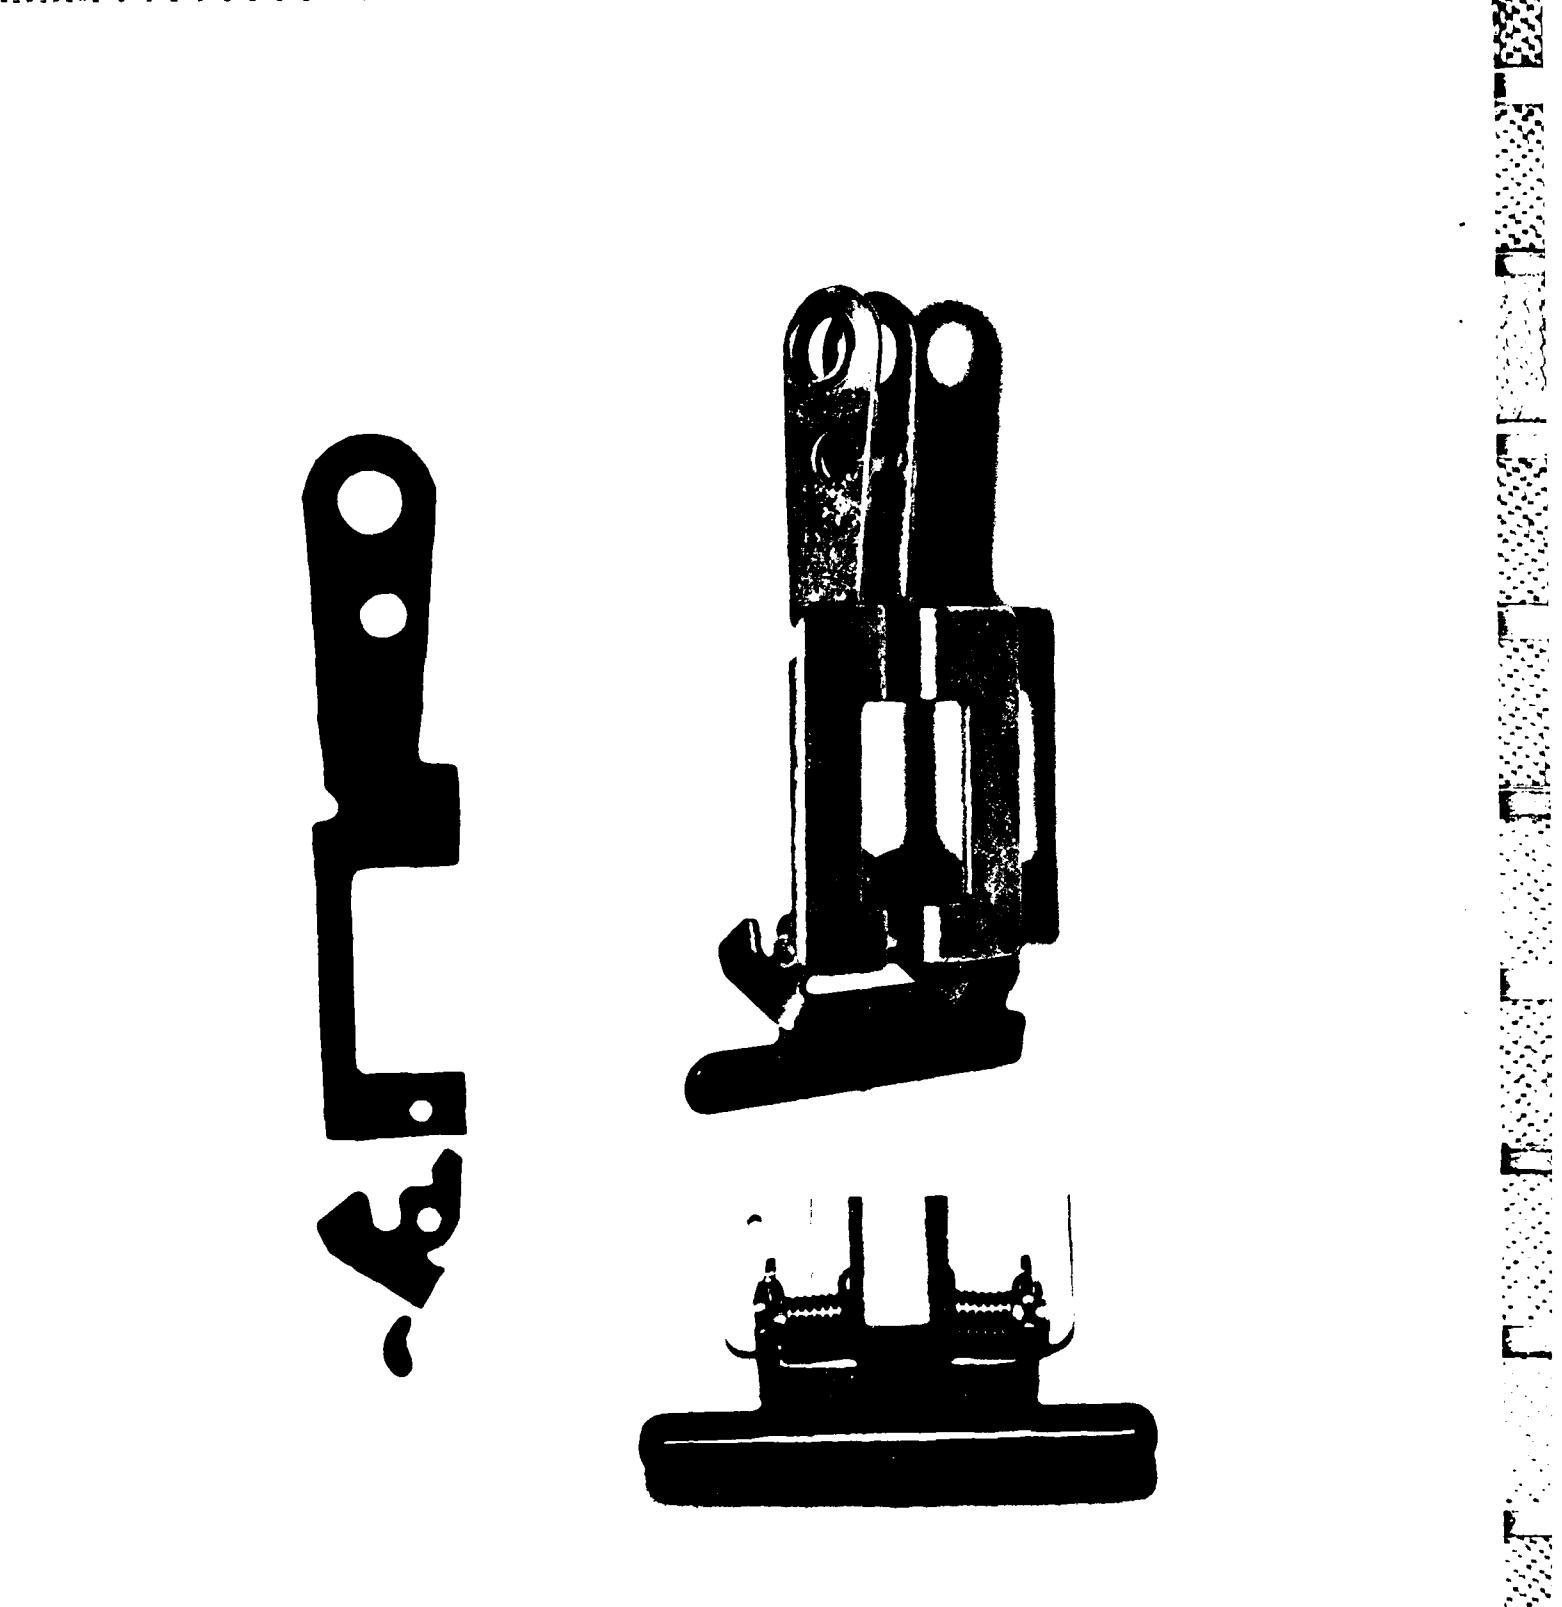
Figure 6. Plastic coated grip

The ears of the latch can be coated with a rubbery, widely used thermophastic material. This versatile composition of polyvinyl chloride is not new and

dates back to 1931 when early development was done in Germany. The paste was a mixture of vinyl resin and plasticizers that would gel into a flexible solid when heated. During that decade the manufacture of fabric coatings spread throughout Europe, and by 1949 the Americans had coined the name plastisol.¹

The metal part to be coated is heated to 350° F, lacquered, dryed, and then dipped in liquid vinyl while still hot. The thickness of the coating is governed by the rate of withdrawal.² Most of the vinyl beads on the lower edge of the grip; this area is just where the cushion is needed. Coloration of green or black is available.

The improved latch (fig. 5) and the latch with the plastisol grip (fig. 6) were tested in the same cage and at the same pull force as the baseline latch. Both remained closed up to the shock limit of the machine. The two dual spring latches were then modified. The lock pin was partially slipped out from each handle, one spring was removed, and the pin was reinserted to restore the assembly. The single spring version of the improved latch remained closed up to 195 g's. The single spring version of the latch with the plastisol grip remained closed up to 180 g's.

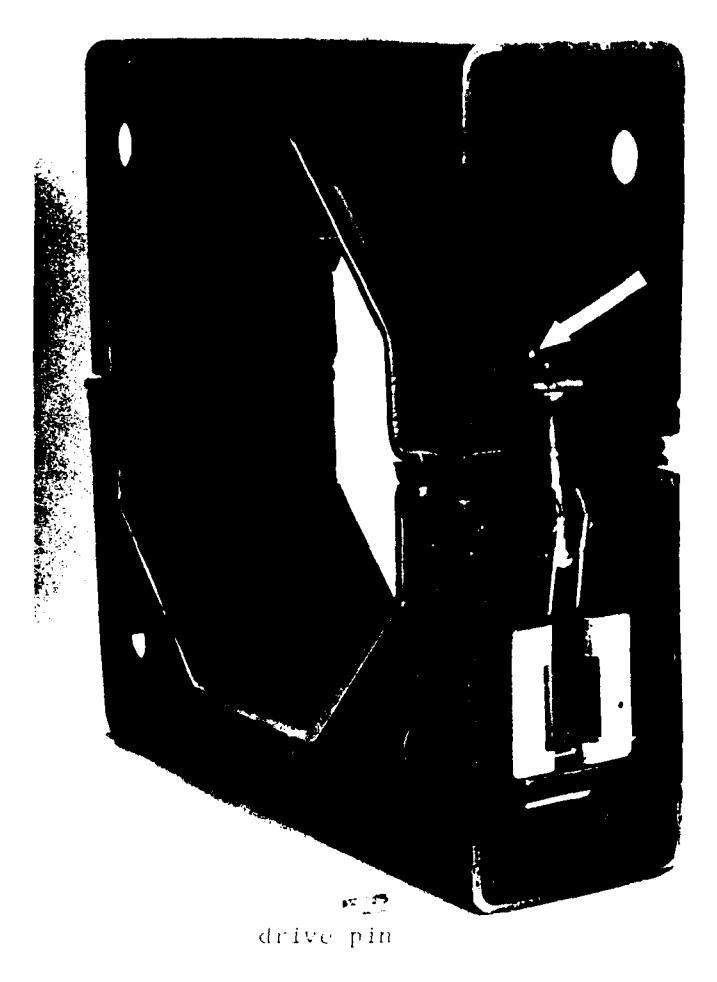
Figure 10. Sawed-off bulkhead from the Copperhead container [The baseline latch is installed on the near side of the bulkhead. The T-bolt is assembled with a clevis pin but the drive pin can be used instead. Early in production it was discovered that a T-bolt that was too long interfered with the opening. Threads protruding beyond the top of the barrel nut engraved the strike (arrow).]

The shock machine for this test had limited capacity and could not hold a complete container. The sawed-off bulkhead (fig. 10), which included two latch cages, was bolted to the shock platform of figure 11. The bulkhead was mounted on its side so that the shock pulse would be in the direction of opening the latch located on the lower face. The fixture provided enough space around each latch to allow it to swing open.

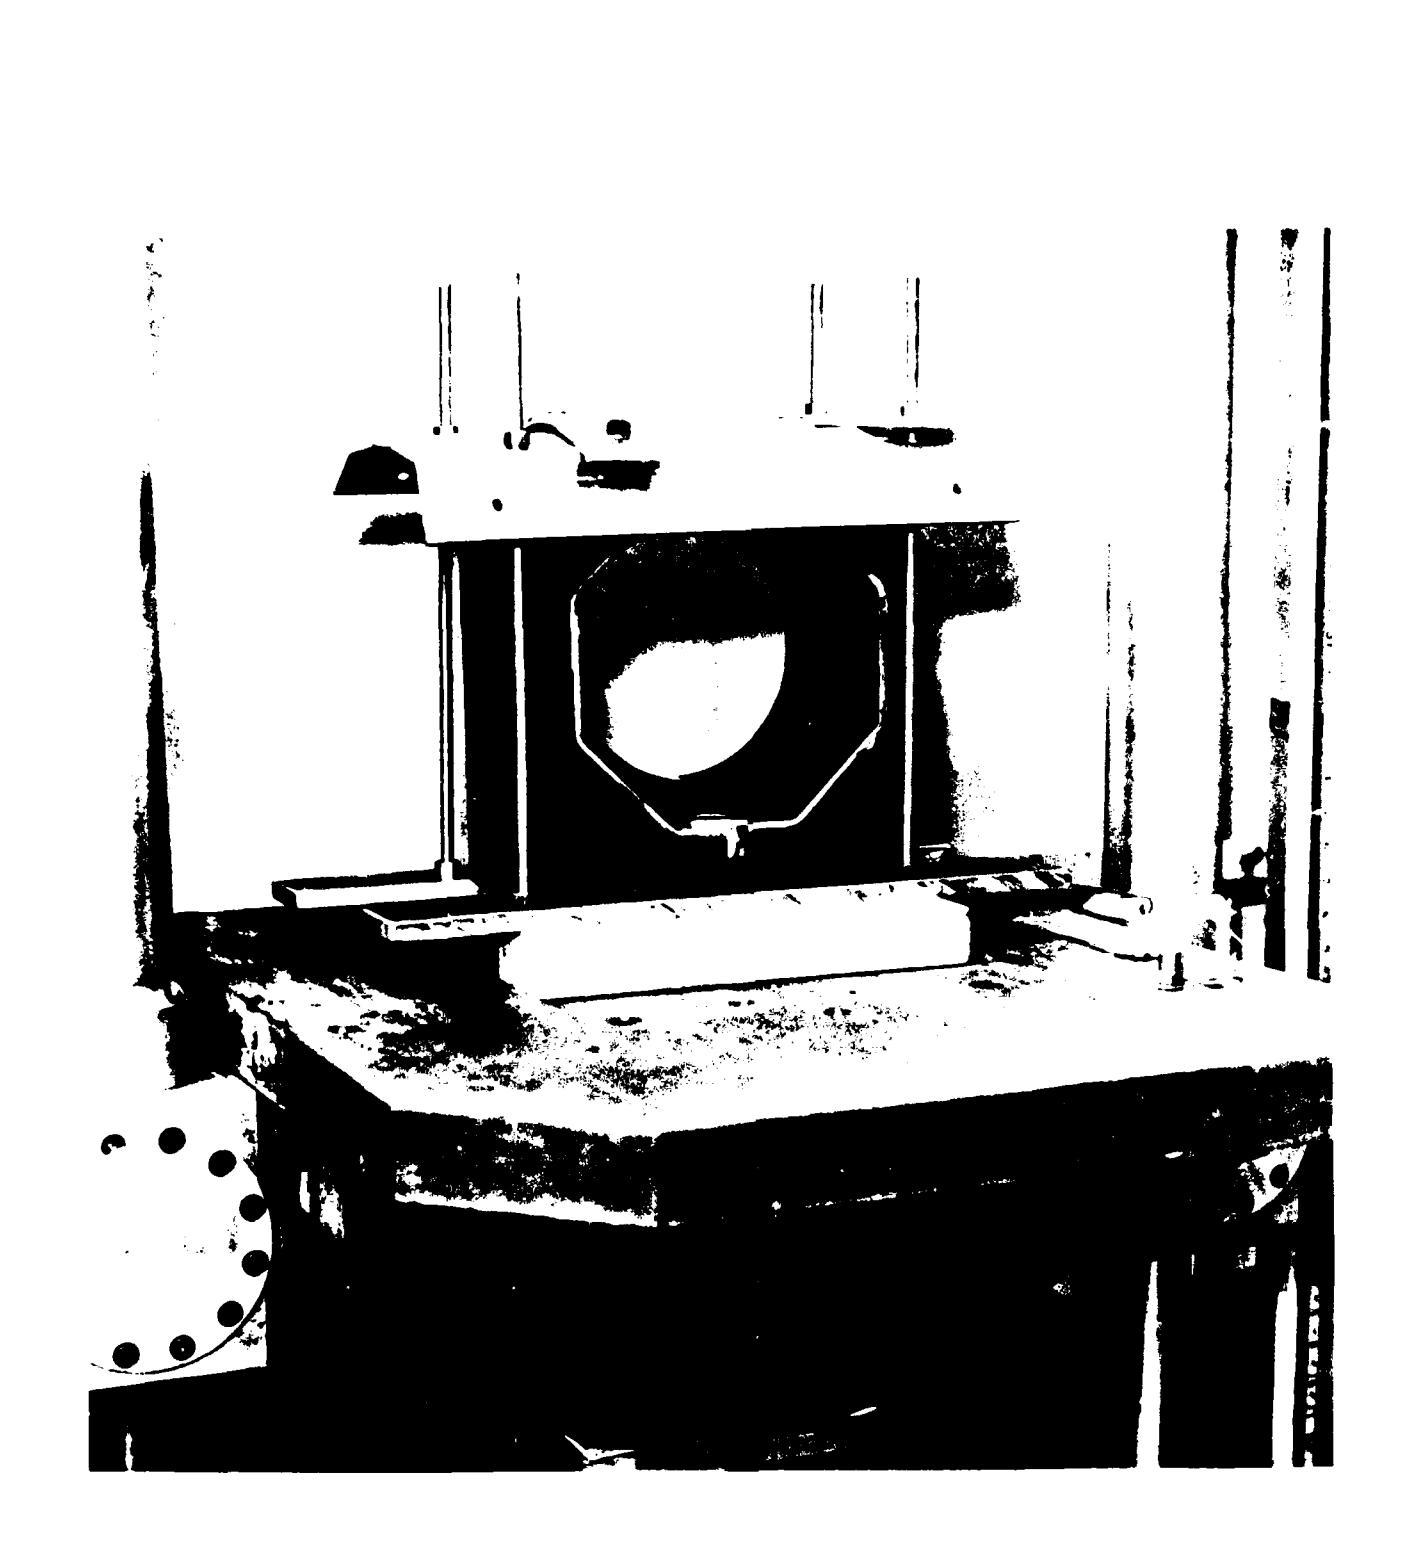
Figure 11. A bulkhead bolted to the platform of a snock suchage. (The bulkead was blocked up to allow access to the latch on the boltos.)

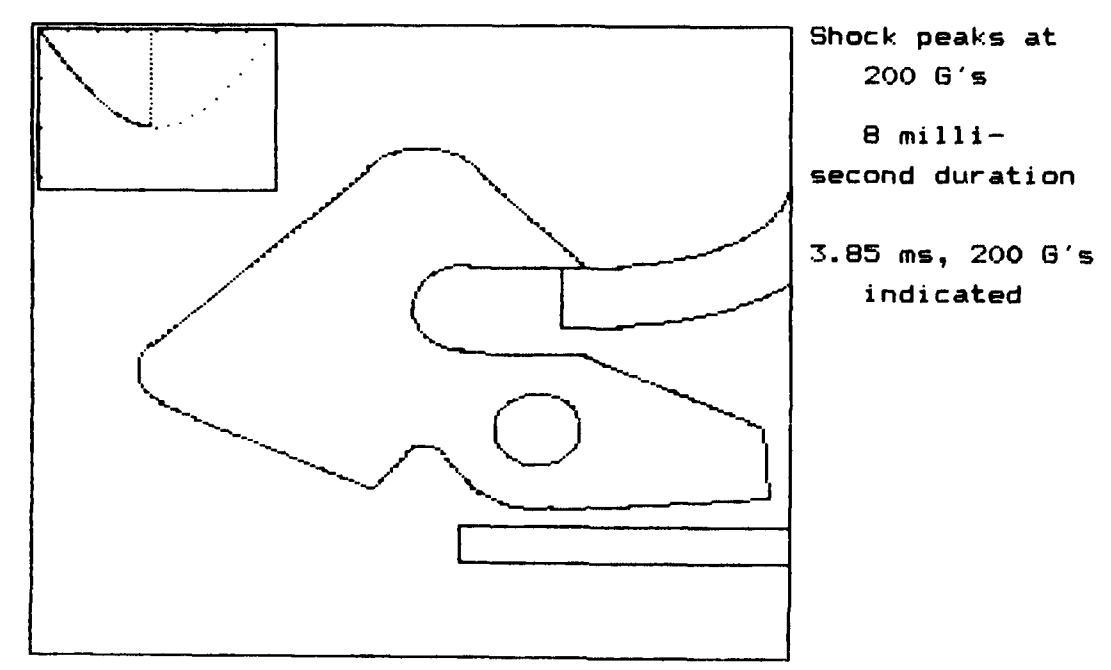
Baseline latch, handle initially INBOARD

Figure 13. The baseline latch halfway through a shock pulse (The lock has stopped rotating and is starting to close. Friction of the tooth against the cage plate was included in the simulation in order to get the calculated g threshold to agree with the test. The Rexnord lock has sharply pointed steel teeth which engrave the soft aluminum cage plate. This simulation can also show that the baseline latch will fly open under a much milder jolt if restraining friction is neglected.)

The graphic simulations of figures 13 through 15 illustrate locks under shock.

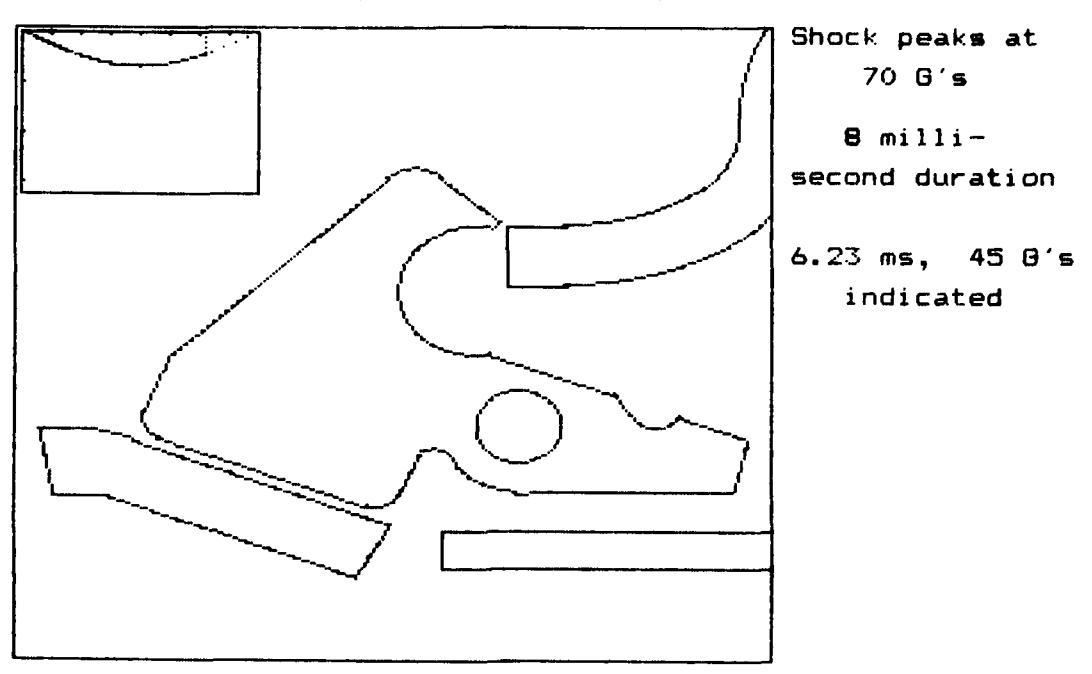
Heavy gripper plate, handle initially INBOARD

Figure 14. Heavy gripper plate during a mild shock (Following impact of the teeth on the cage plate the lock continues to move downward and causes the teeth to slide off. No friction is assumed. The springs have finally stopped the rotation of the lock and the lock begins to snap shut. However, the handle has already started to move downward again.
