Evaluation of Sikorsky S-76A 24 Missed Approach Profiles Following Precision MLS Approaches to a Helipad at 40 KIAS

October 1986

DOT/FAA/CT-TN86/31

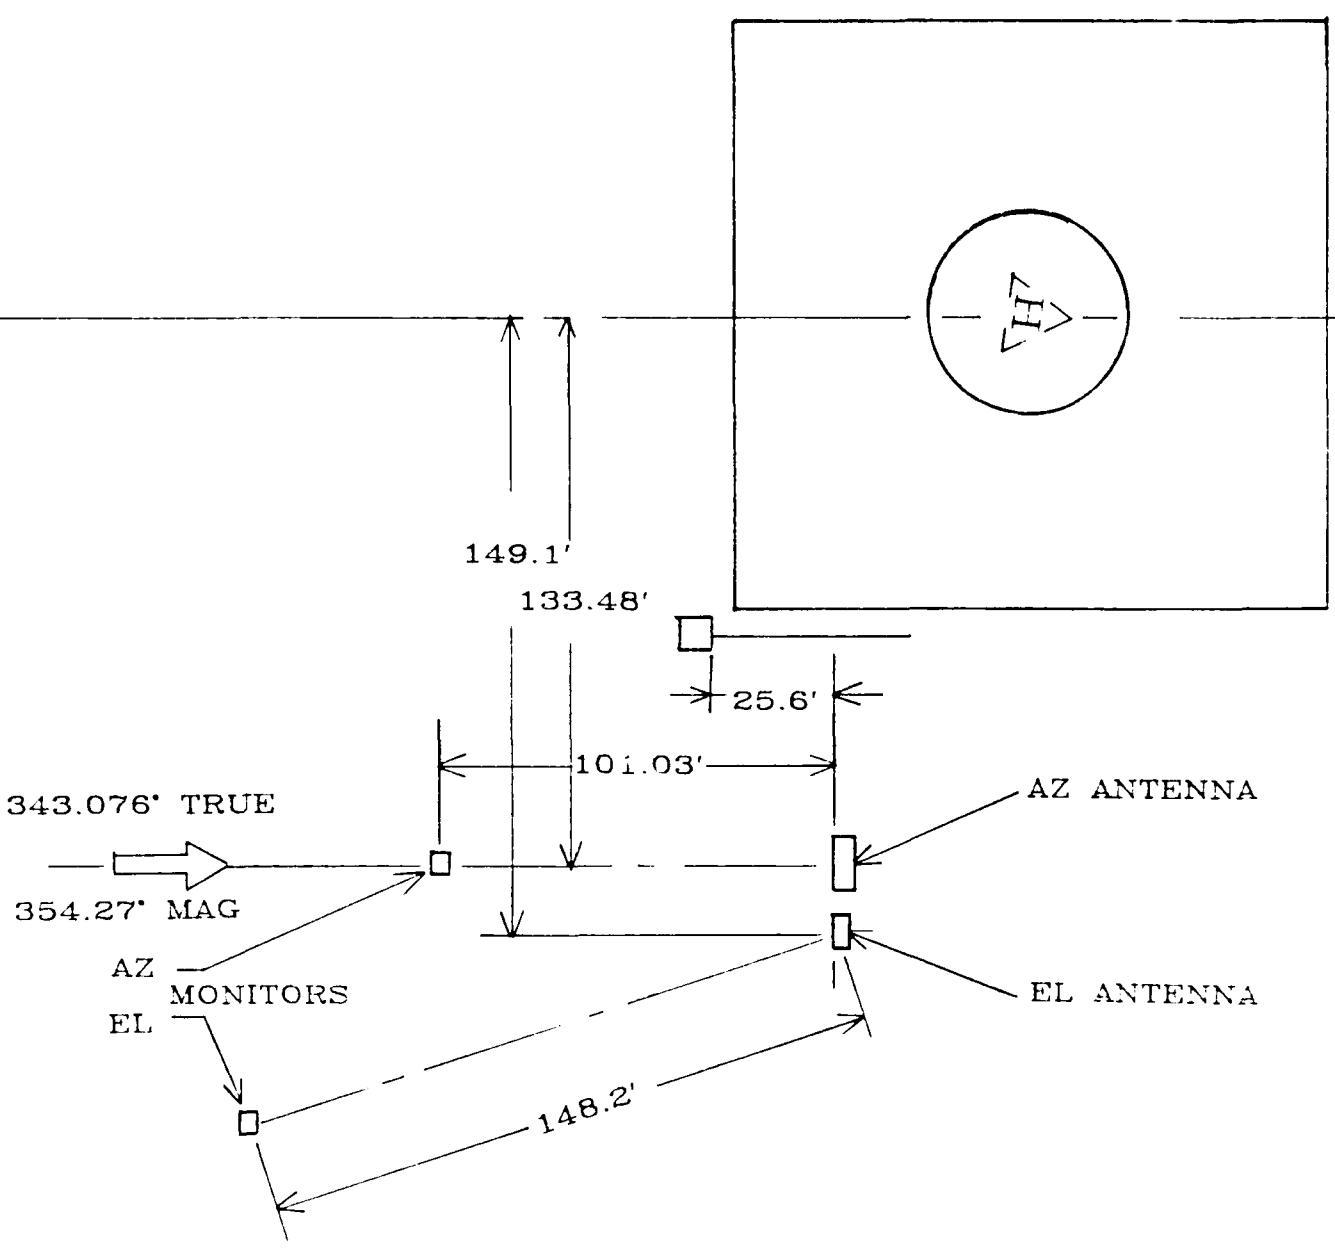
ACT--140 COLLOCATED MLS HELIPORT MLS CHANNEL 590 DME 'P 111.95

150' x 150' LIGHTED HELIPORT

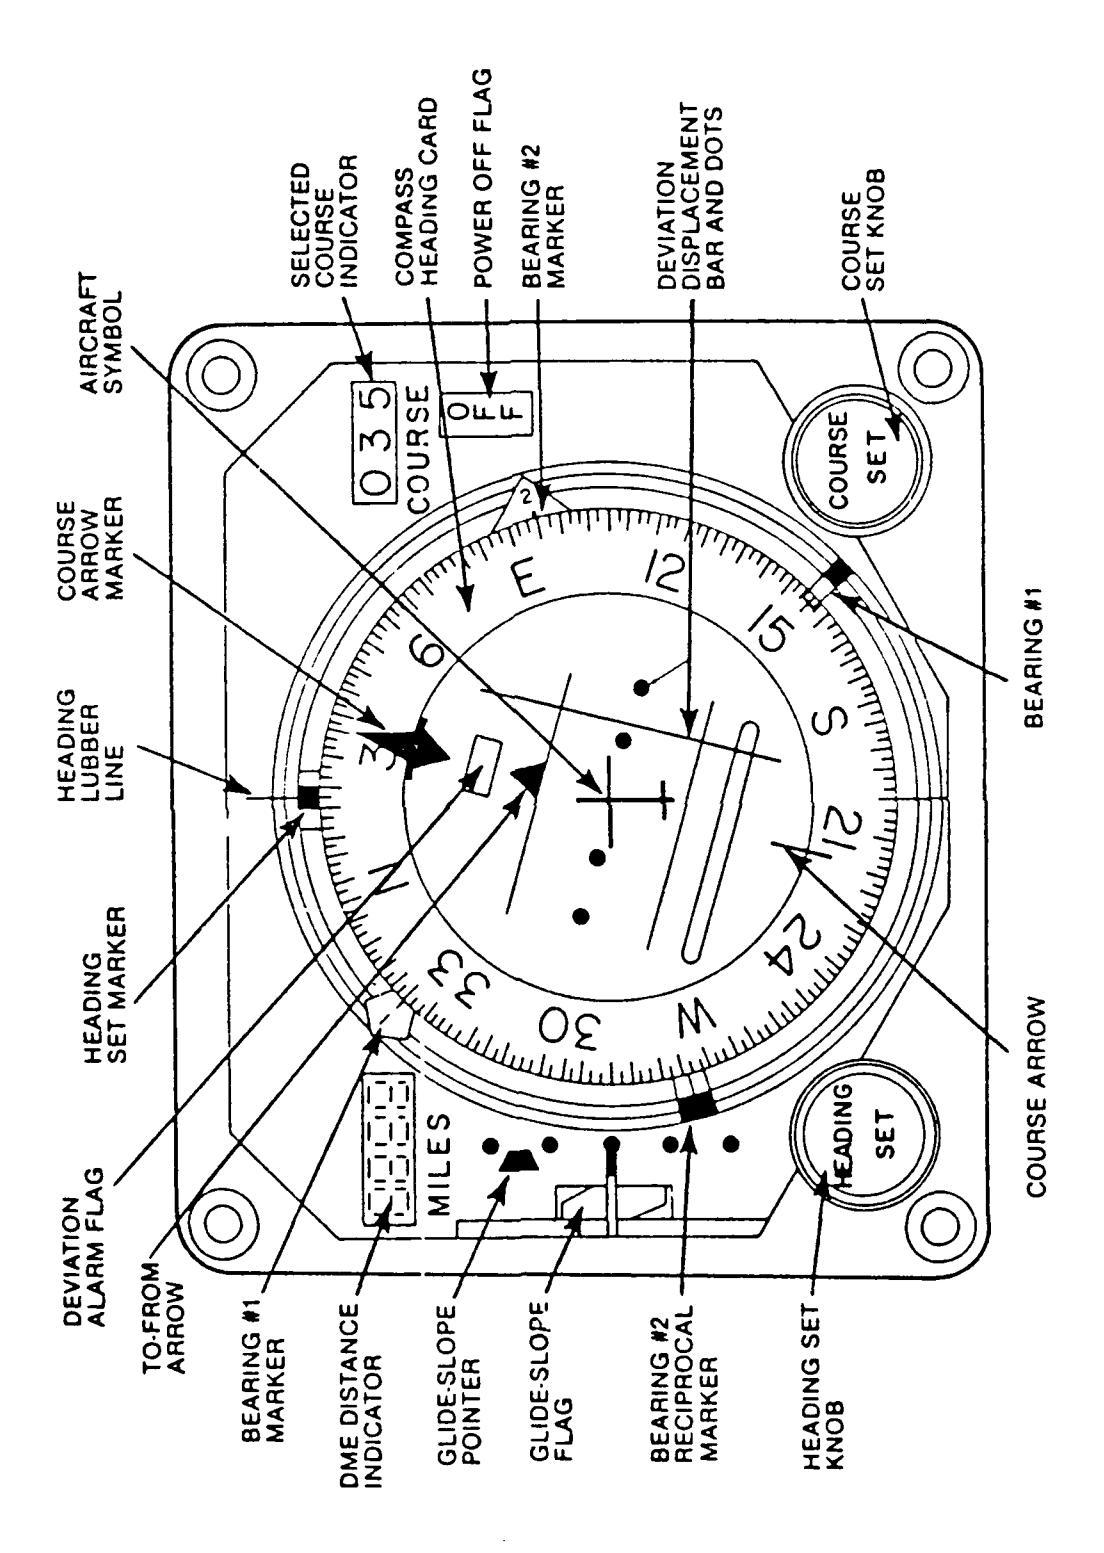
FIGURE 3. NEL INDICATOR

A modified Bendix MLS Service Test and Evaluation Program (STEP) receiver was utilized for this test. The receiver was modified utilizing the original 08A STEP format with the course widths set to $\pm 3.6^\circ$ AZ and an EL course width of \pm selected angle/3. The course deviation information was displayed on the pilot horizontal situation indicator (HSE). See figure 3.

System and a HELCIS Flight Director. However, for this test only raw data information was displayed on the pilot's HSI. The aircraft is certified for single pilot instrument flight rule (IFR) operations with a minimum instrument meterological conditions (IMC) airspeed (V_{mini}) of 60 knots and is representative of the IFR certified helicopters currently in use.

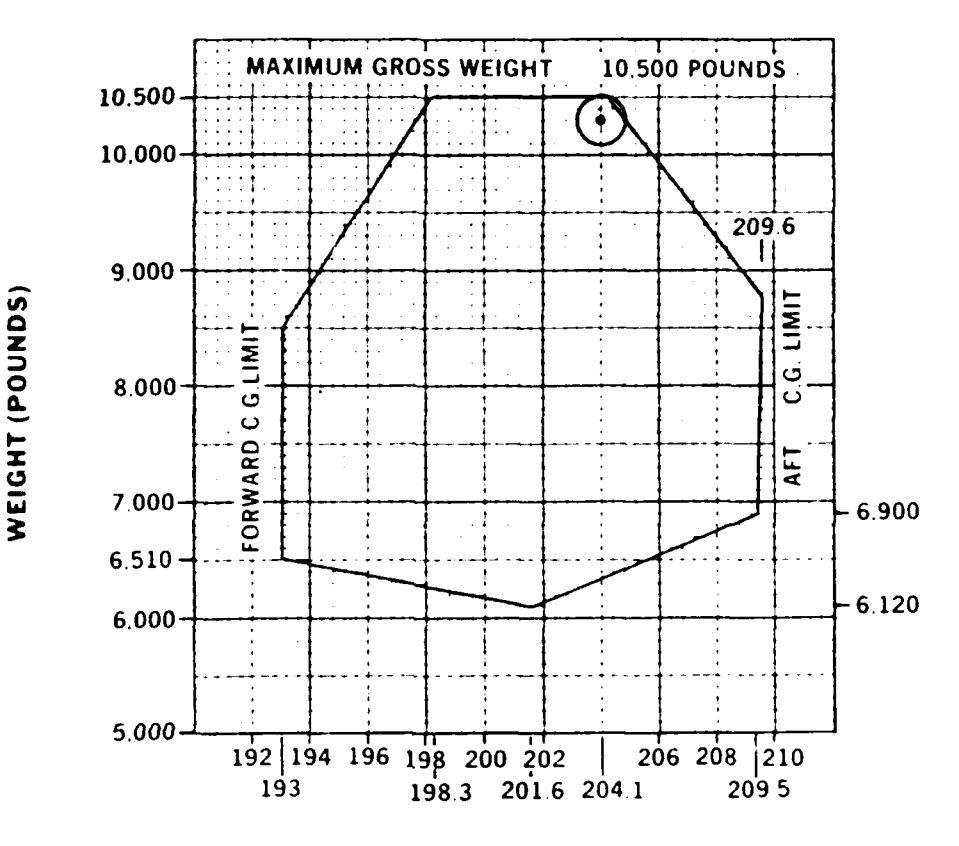
AIRCRAFT STA (INCHES)

THE AFT C.G. LIMIT HAS BEEN ADJUSTED TO ACCOUNT FOR THE LANDING GEAR RETRACTION HORIZONTAL MOMENT/100 OF PLUS (+) 33 THEREFORE LOADINGS BASED ON WHEELS DOWN CONDITIONS WHICH FALL WITHIN THE LIMITING C G OF THIS ENVELOPE WILL BE WITHIN C.G. LIMITS FOR FLIGHT WITH THE LANDING GEAR RETRACTED

The aircraft was operated between approximately 500 to 1500 pounds below the maximum gross weight of 10,300 pounds. However, this was not considered as a critical parameter in the test since no one engine inoperative (OEI) procedures were flown. The center of gravity (CG) for each flight was approximately 204 inches (see figure 4).

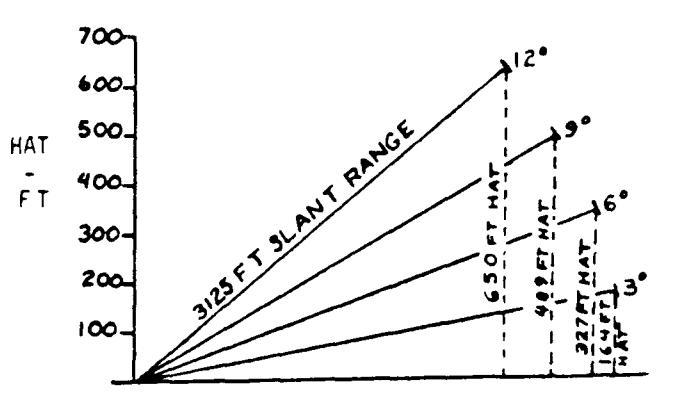
- NOTE 1: DISTANCE TO DECELERATE TO STOP AT .05G DECELERATION RATE = 3125 FEET FROM 6G KNOTS.
- NOTE 2: TIME TO DECELERATE TO STOP AT .05G DECELERATION RATE = 62.5 SECONDS FROM 60 KNOTS.

FIGURE 2. Glideslope angle versus height above touchdown required for initiation of decelerating approach to confined landing area.

The deceleration distance remains essentially constant regardless of the approach angle (i.e., glideslope) the pilot has selected; in other words, you still need 3000 feet to stop whether you're flying a 3^o approach or a 12^o approach if you initiate the deceleration from 60 knots. If this distance is translated into height above touchdown, as in Figure 2, we see immediately that, as the approach angle goes up, so too must the Height Above Touchdown (HAT) at which the pilot MUST HAVE VISUAL CONTACT WITH HIS LZ IF HE HAS NO CAPABILITY TO DECELERATE AND LAND UNDER IMC. We see from Figure 2, for example, if the ability to perform the IMC DSAL maneuver is lacking and a 9^o glideslope approach angle is required to get into a particular LZ, then the pilot must have visual contact with his intended LZ at roughly 490 feet HAT.

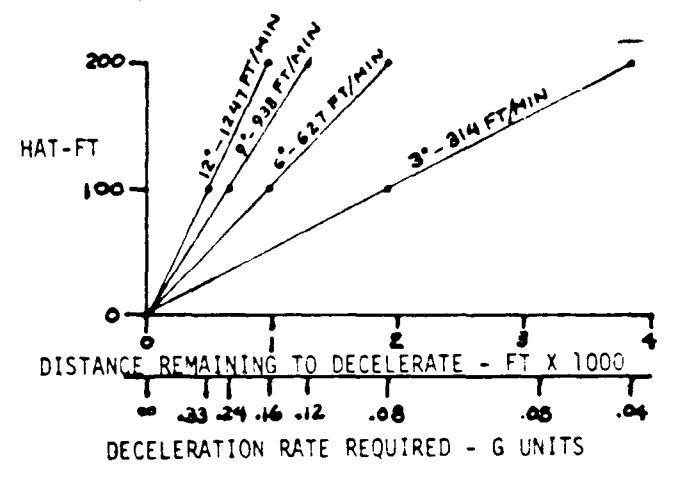
HAT VS DECELERATION DISTANCE AND RATE FOR VARYING GLIDESLOPE ANGLE WITH CONSTANT RATE OF DESCENT

Figure 3. Non-decelerating approach to fixed HAT (60 knot constant speed to HAT).

Lacking the capability to perform the DSAL maneuver under IMC, it is dangerous to think of performing helicopter IMC approaches into confined LZ's to a fixed Decision Height (DH) (e.g., Category II - 100 foot DH). If this is attempted, as the glideslope angle is increased, the distance available for the pilot to decelerate to his landing spot in a LZ is decreased (from the 3000 feet required) while at the same time his vertical velocity at DH and the magnitude of the visual deceleration after breakout is drastically increased Figure 3 is an illustration of these mutually hazardous effects. For example, from Figure 3, if

a pilot attempts to approach to a LZ under IMC at 60 knots along a 9° glideslope and does not expect to achieve visual contact with that LZ until reaching a DH of 100 feet HAT, then he would be left with

only 640 of the 3000 feet he needs to decelerate and land, and be required to perform that deceleration at .24G or 5 times the normal rate. The chances of performing such a maneuver without suffering serious consequences is doubtful. If, on the other hand, the pilot could begin his nominal .05G deceleration while still in IMC at roughly 3000 feet from the LZ, his vertical and forward velocity would be such that, from the point he achieved visual contact with his LZ at 100 feet HAT, he could continue a normal, steep, 9^o visual approach to his desired spot in that LZ (see Figure 4). In fact, if he could perform the deceleration

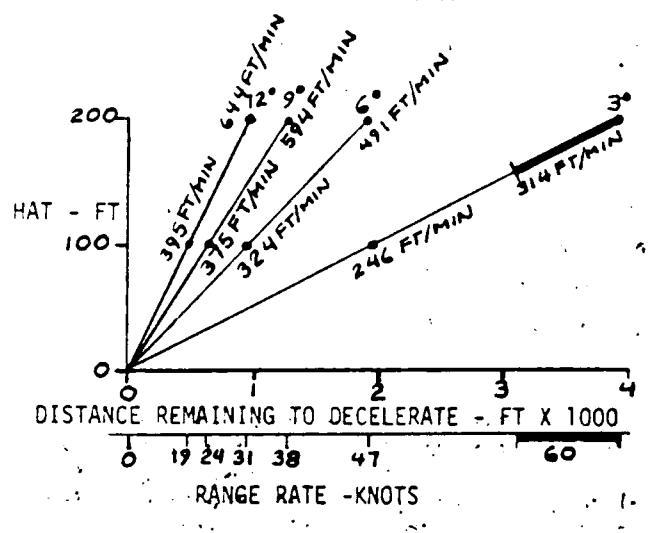
HAT VS DECELERATION DISTANCE AND RANGE RATE FOR VARYING GLIDESLOPE ANGLE WITH DECELERATING RATE OF DESCENT

Figure 4. Decelerating approach to fixed HAT (.05G`constant deceleration initiated from 60 knots at 3125 ft from touchdown).

maneuver under IMC, he could, with the proper guidance and display/instrumentation systems, continue the DSAL maneuver to his landing spot safely, without reference to any outside visual cues. The pilot will then have successfully accomplished under IMC what he routinely does in VFR. The implication of a capability such as this is clear: the utility of the helicopter will be enhanced significantly.

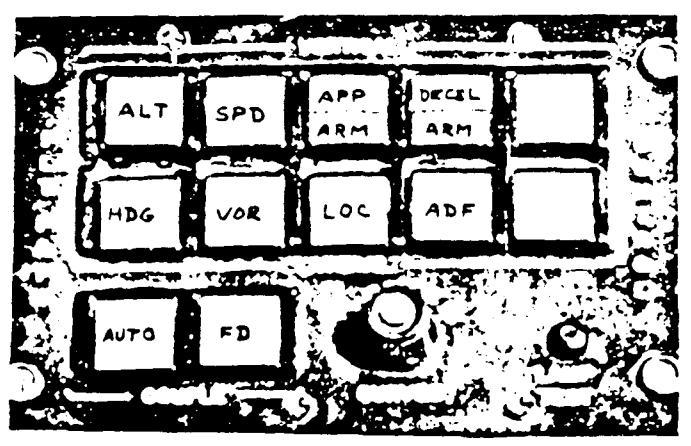
Figure 8. Flight Path Control (FPC) for Flight Director System.

Second clear ally addressing the performance of the IMC CSAL maneuver with the 4-que FD, it would be beneficial to review the functions of the FD components to which the pilot has access during flight. The pilot selects the vertical (altitude hold or approach), longitudinal (speed hold or deceleration) and lateral (heading, VDR, ADF or localizer) modes he wishes to fly on the "FLIGHT PATH CONTROL" (FPC) which is in the console located between the pilot's and co-pilot's seats (see Figure 3). The modes the pilot has selected are

annunclated by lights in the FPC buttons selected and on a 'flight director mode annunclator" panel located in the top center of the pilot's primary instrument cluster (see Figures 3 and 10). The pilot selects the course or heading he wisnes to fly with the appropriate course select or heading select knobs on the 'nonizontal situation indicator" (HSI) (see Figures 9, 10 and 11).

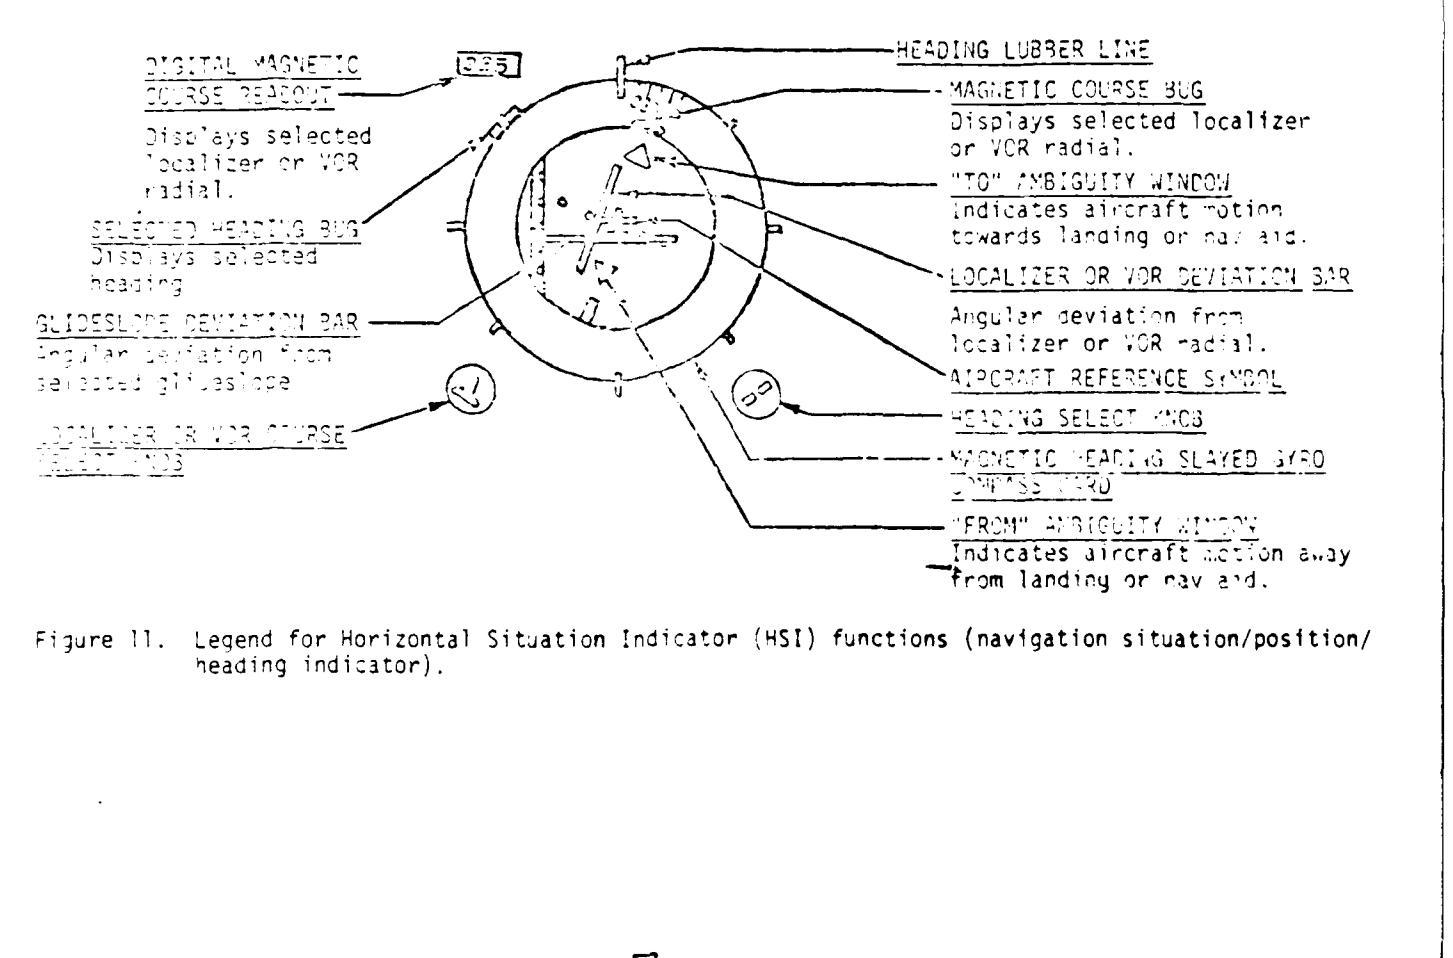
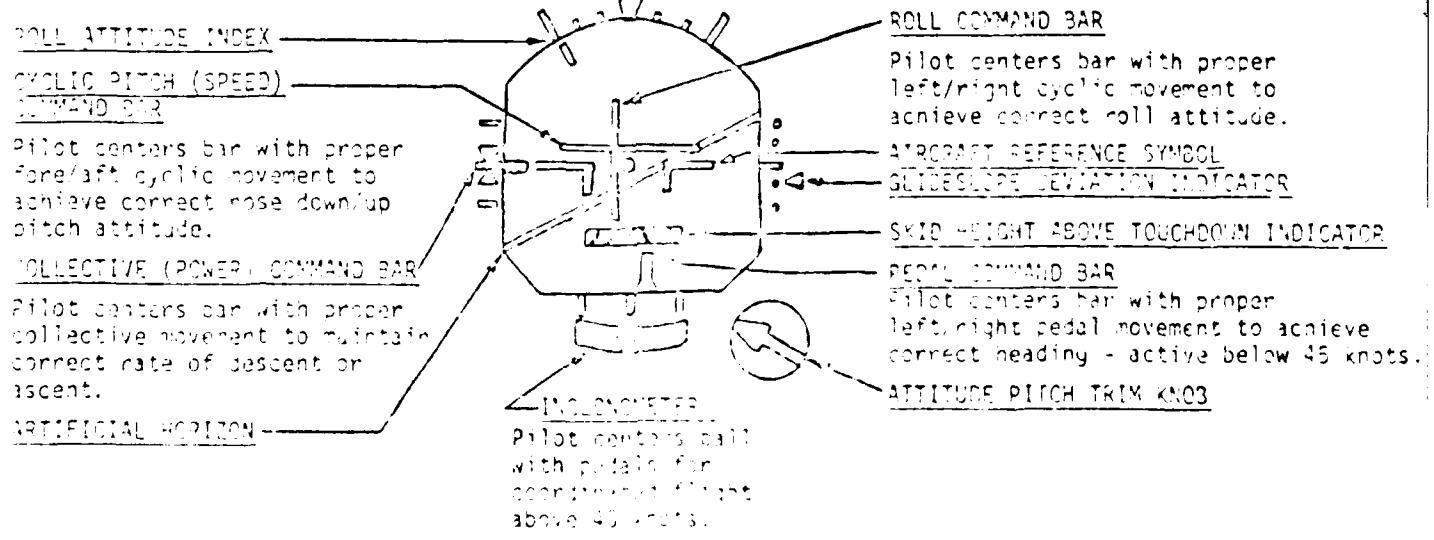
Figure 12. Expend for Attitude Director Indicator (ADI) functions (cyclic, collective, pedal control command/attitude indicator).

Four commands are presented to the pilot through the ADI (see Figure 12). The cyclic roll command bar is centered by causing the correct amount of (and rate of) bank through the correct use of his lateral cyclic control. The cyclic roll command bar thus directs the aircraft toward and subsequently causes it to maintain a selected heading or VOR, ADF, TACAN, go-around or localizer course. The cyclic pitch or speed command bar is centered by causing the correct amount of (and rate of) longitudinal pitch angle change through correct use of the fore-aft cyclic control. The cyclic pitch or speed command bar thus directs the aircraft to and causes it to maintain a selected airspeed or to follow the prescribed range rate deceleration profile. The collective (power) command bar is centered when the proper amount of collective (up or down, as required) has been applied by the pilot to control the rate of ascent or descent necessary to climb (or descend) to and maintain a preselected altitude, track a selected glideslope or establish the programmed rate of climb during the go-around or missed approach mode. The Pedal command bar is in view at airspeeds below 45 knots when one of the lateral FD modes is being flown. This har is centered by applying that amount of pedal required to align the aircraft with either a preselected course (e.g., inbound localizer course) or heading (e.g., go-around heading). When the pedal command bar is in view, priority is devoted to centering it rather than the turn coordination ball. The pedal command bar is especially important on aircraft lacking any sort of independent heading hold mode because, if properly flown, it prevents the aircraft from weathervaning into the

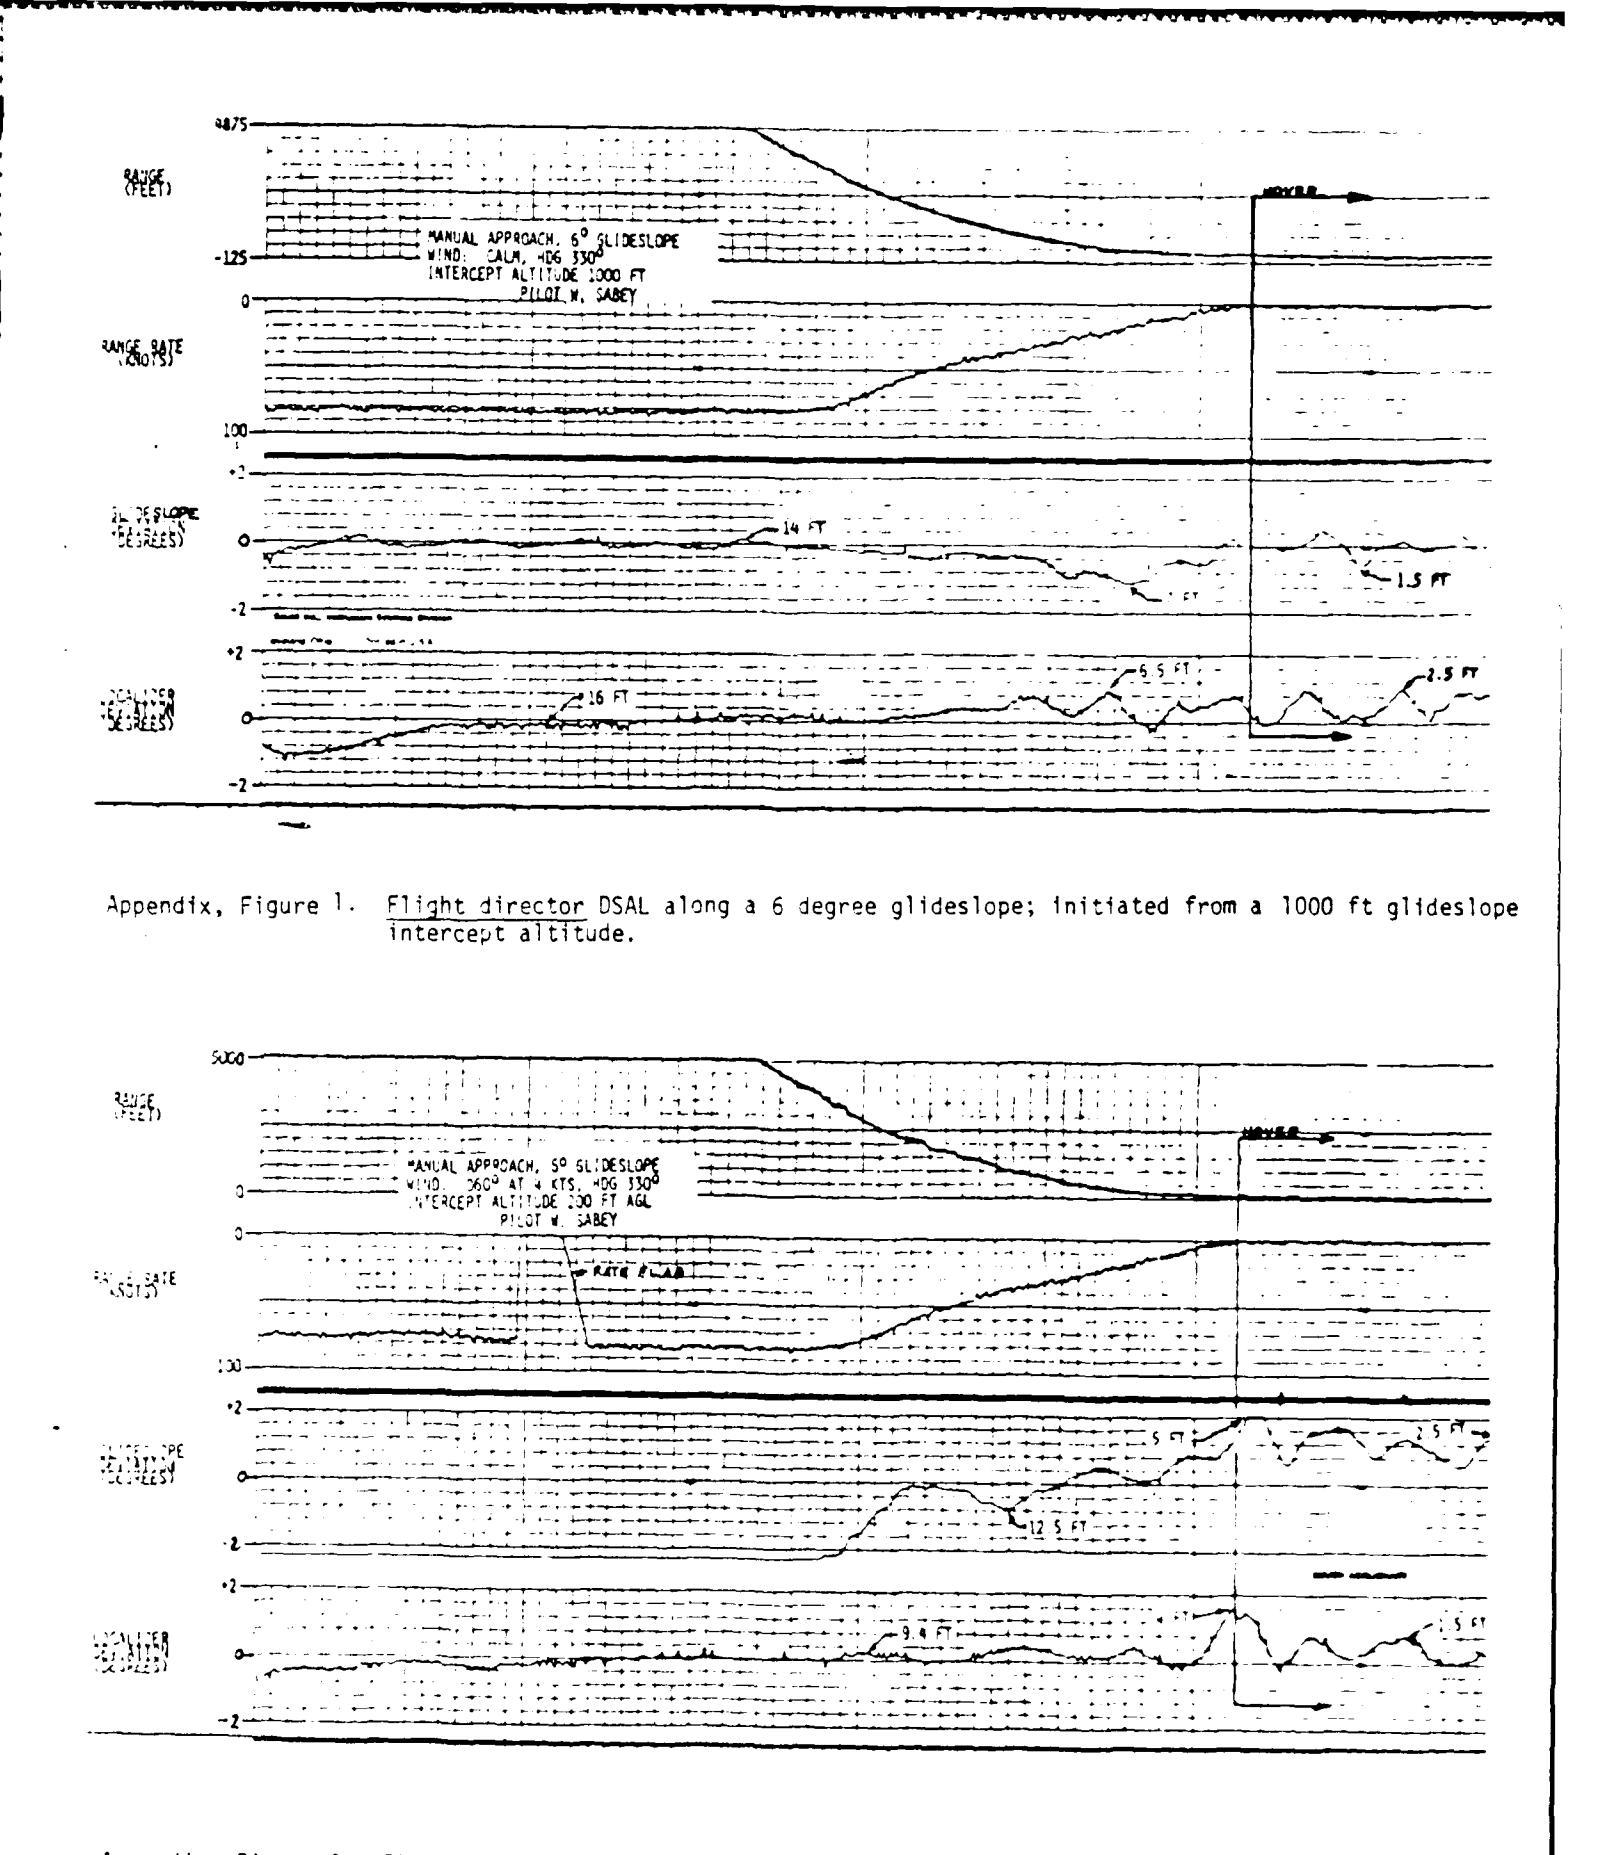
Appendix, Figure 2. Flight director OSAL along a 6 degree glideslope, initiated from a COO ft glideslope intercept altitude.

performance. Localizer and glideslope deviations in "feet" from centerline are superimposed on the angular data in spots representing the maximum displacements from course centerline. Note, that all approaches <u>converge</u> to a relatively stable hover over the spot of intended landing.

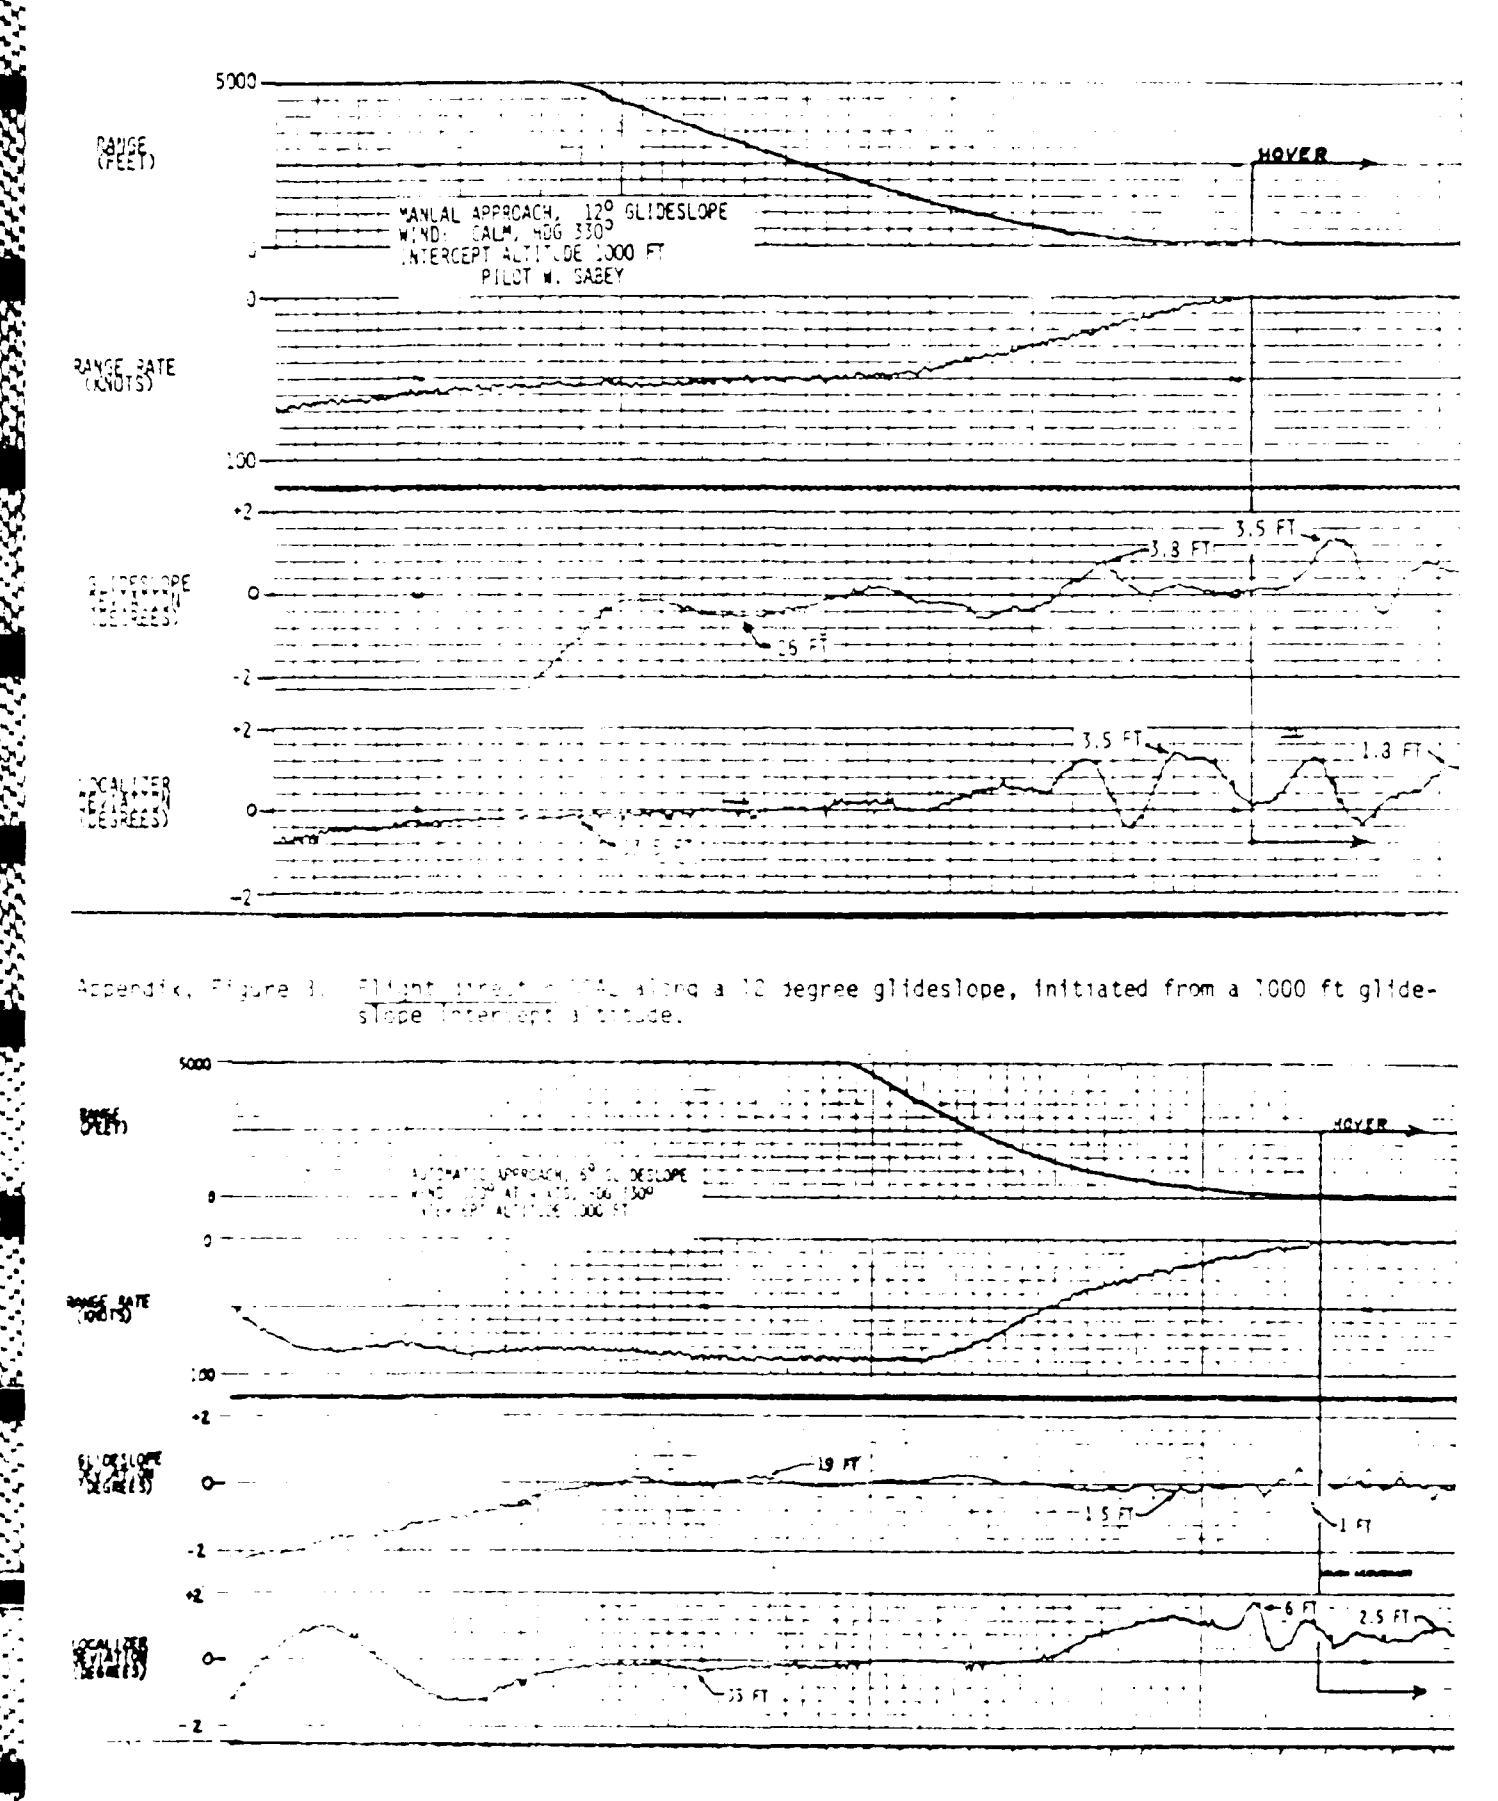
Appendix 4, Figure 4. Autopilot. MAL along a 6 degree glideslope; initiated from a 1000 ft glideslope intercept altitude.
