Office of the Chief of Naval Research Contract N00014-87-K-0326 Technical Report No. UWA/DME/TR-91/7

Dynamic Fracture Characterization of Al₂O₃ and SiC_w/Al₂O₃

L.R. Deobald and A.S. Kobayashi

September 1991

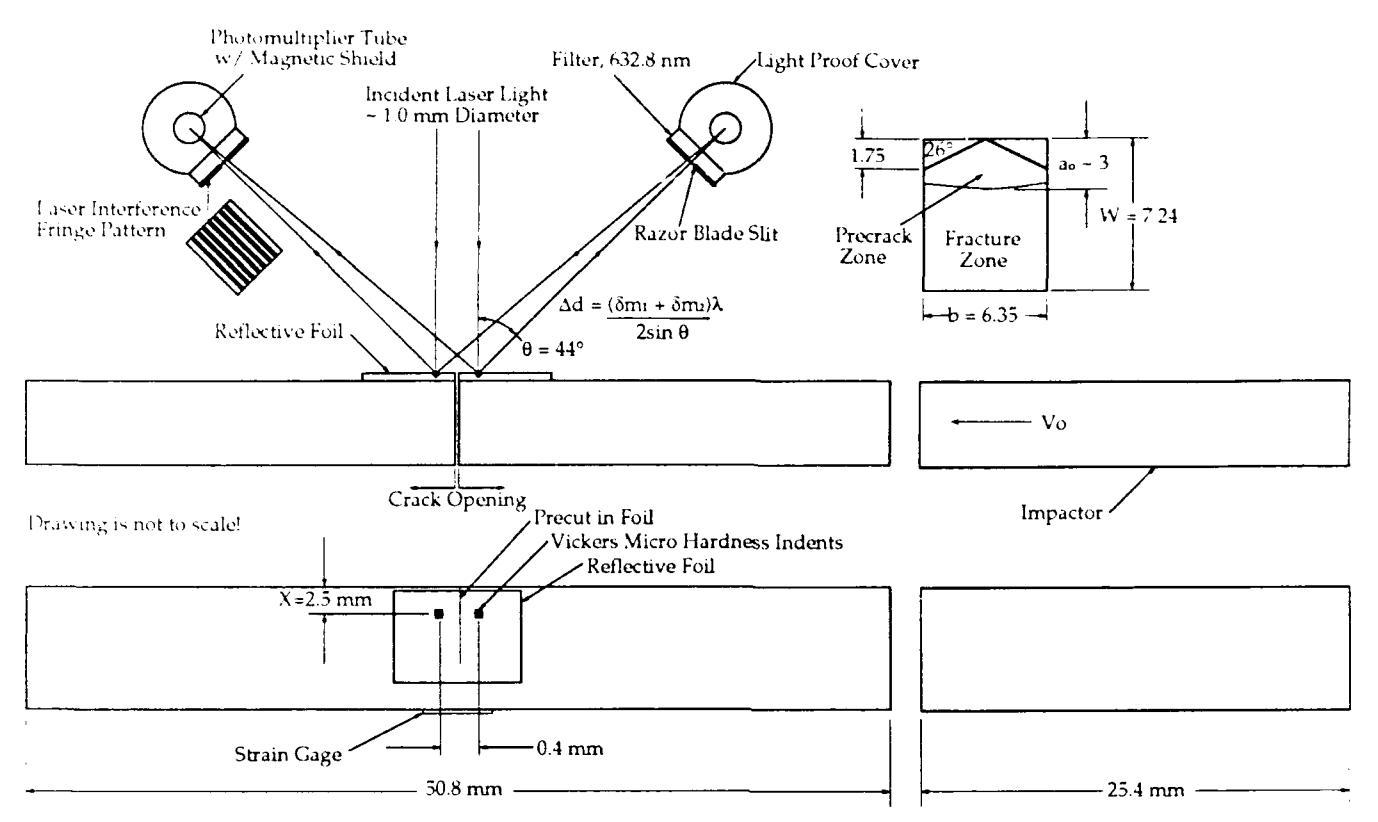
Figure 1, Specimen geometry and the LIDG technique.

A schematics of the LIDG used for this particular experiment is shown in Figure 1. The change in the crack opening displacement (COD) is registered as fringe motion at the two photomultiplier tubes (PMT) which were positioned at an angle of Θ on either side of the indentation pair. The change in displacement is then predicted by Equation (1), where δm_1 and δm_2 represent changes in fringe orders.

The specimen geometry is shown in Figure 1. A sharp precrack with an approximate initial length of 3 mm was introduced at the midplane of the bar using the single-edge-precracked-beam (SEPB)[4,5] method. A strain gage with short 1.6 mm gage length was mounted in front of the precrack, also at the bar's midplane. A metal foil for the LIDG method was mounted on the adjacent surfaces such that a cut in the center of the foil was aligned with the precrack. The foil was then polished and indented with the Vickers microhardness indentor which produced targets for the LIDG technique spaced 0.4 mm apart.

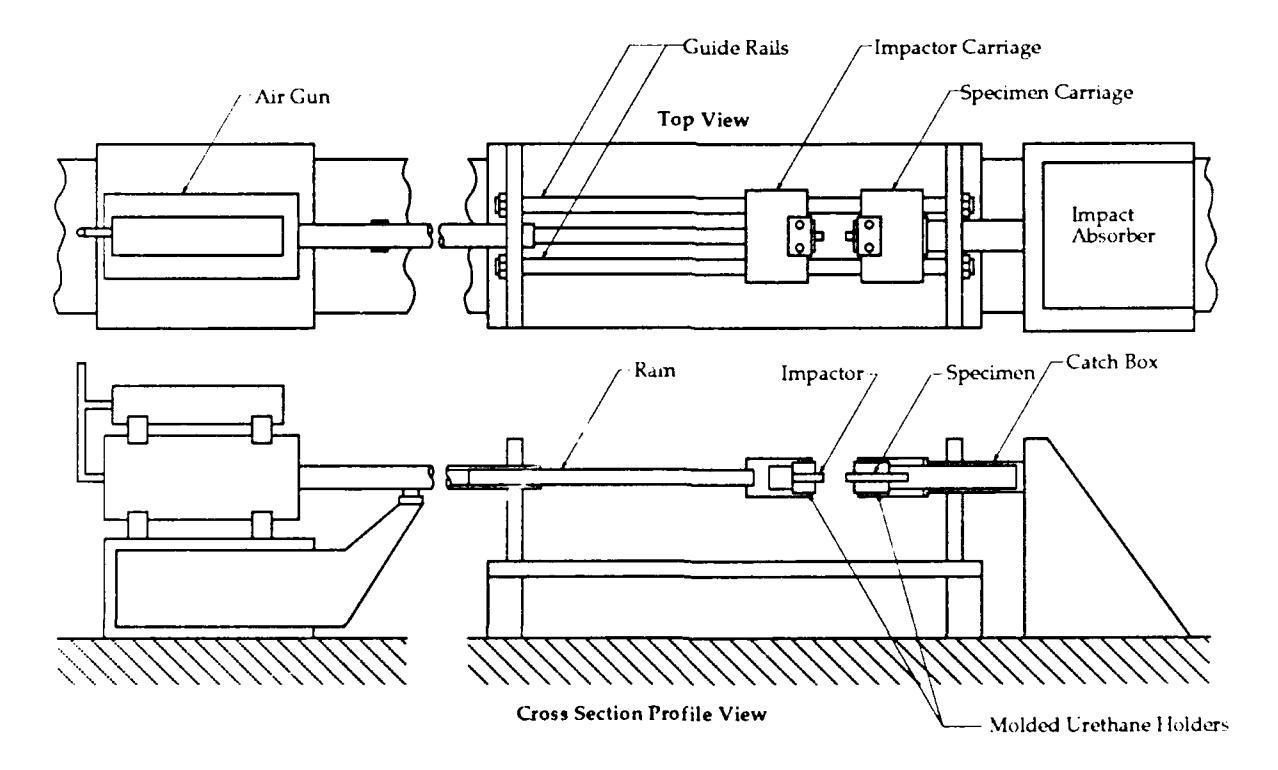
Figure 2, Impact apparatus and air gun.

Schematics of the impact apparatus and the air gun are shown in Figure 2. The specimen and impactor are held by molded urethane holders which are mounted in carriages. Both the specimen carriage and impactor carriage run on guide rails. An air gun propels the impactor carriage down the guide rails towards the stationary specimen carriage. The ceramic bars collide well before the collision of the urethane holders. This produces compressive stress waves emanating from the impact faces which propagate in either direction. The compressive wave reflects in tension from the free boundary ends. After a finite time, a net tension stress will suddenly appear at the sharp precrack and the ceramic bars will slide through the urethane holders after the impact.

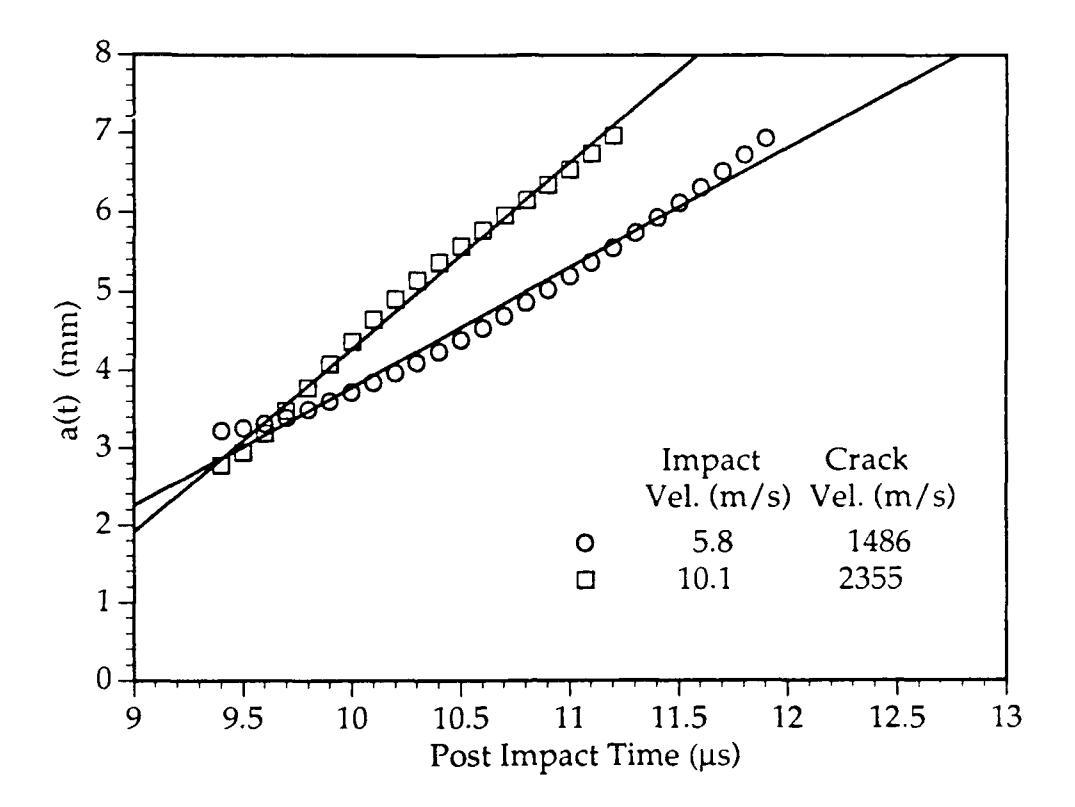
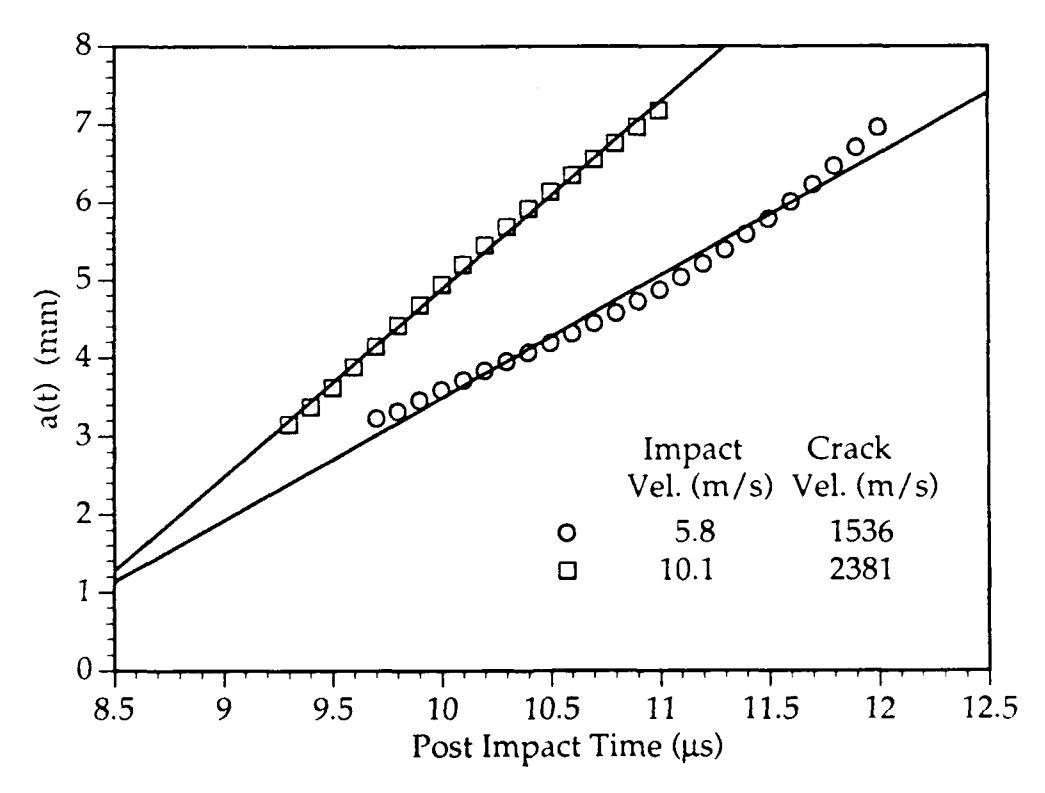
Figure 3, Crack length history for Al₂O₃.

Figure 4, Crack length history for SiC_w/Al_2O_3 composite.

The procedure presented in Reference [6,7] was used to obtain the crack length histories of the ceramic specimens impacted at velocities of approximately 5.8 and 10 m/s for each of the materials. The crack length histories are presented in Figures 3 and 4. The crack velocities increased with increasing impact velocity. The alumina and the composite material showed nearly the same crack velocities. The crack length varied almost linearly with time.

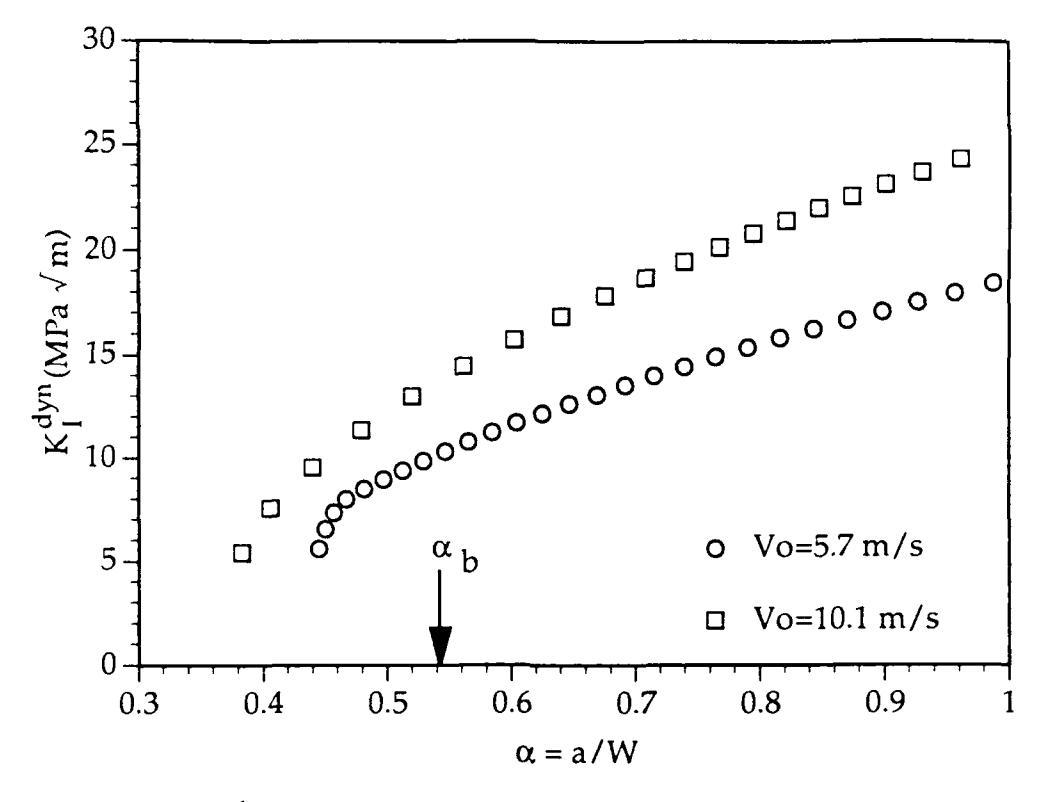
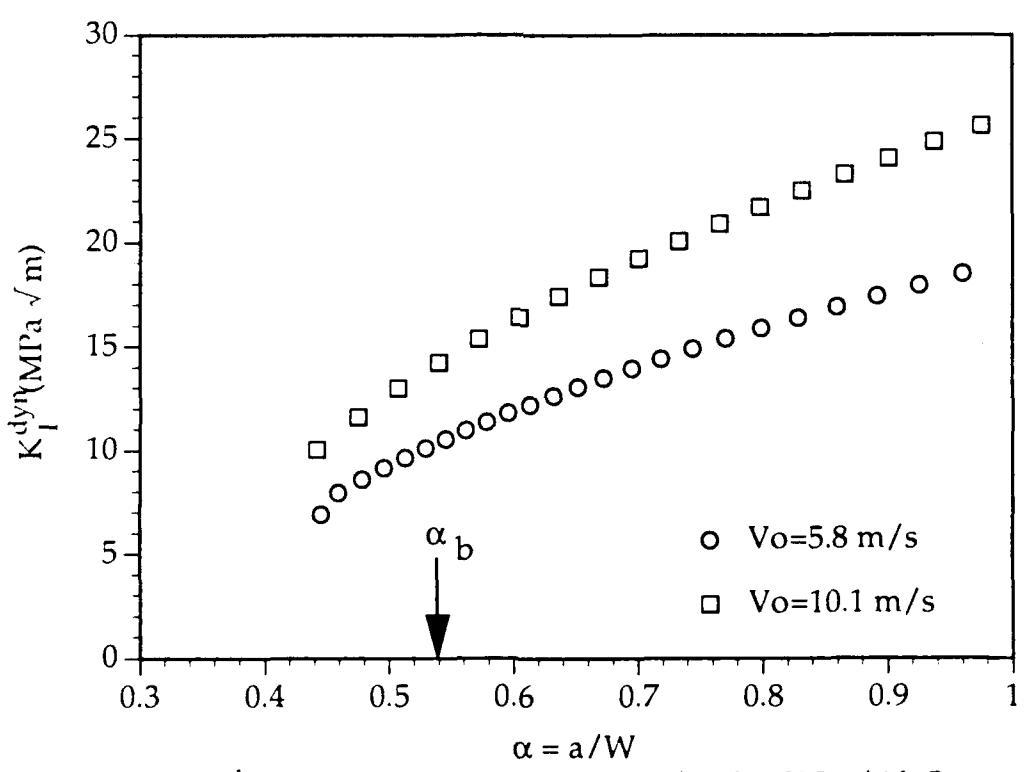
Figure 5, K_{1}^{dyn} versus crack position, $\alpha = a/W$ for Al₂O₃.

Figure 6, K_{l}^{dyn} versus crack position, $\alpha = a/W$ for SiC_w/Al₂O₃ composite.

The dynamic stress intensity factor, K_{I}^{dyn} , for the two materials are shown in Figure 5 and 6. The fracture toughness increased with increasing impact velocities within each material group. The K_{I}^{dyn} data was plotted as a function of the non-dimensional crack length, $\alpha = a/W$. Initially, K_{I}^{dyn} increased rapidly and then increased more slowly at a constant rate.

The dynamic initiation fracture toughness, K_{Id} , was calculated by the technique presented in Reference [7]. The results are summarized in Table 2. The specimens impacted at 10 m/s showed macroscopic crack branching at the crack lengths, a_b , marked in Figures 5 and 6. The crack branch toughness[8], K_{Ib} , is also listed in Table 2 which is defined by $K_{Ib}=K_1^{dyn}$ at $a=a_b$.

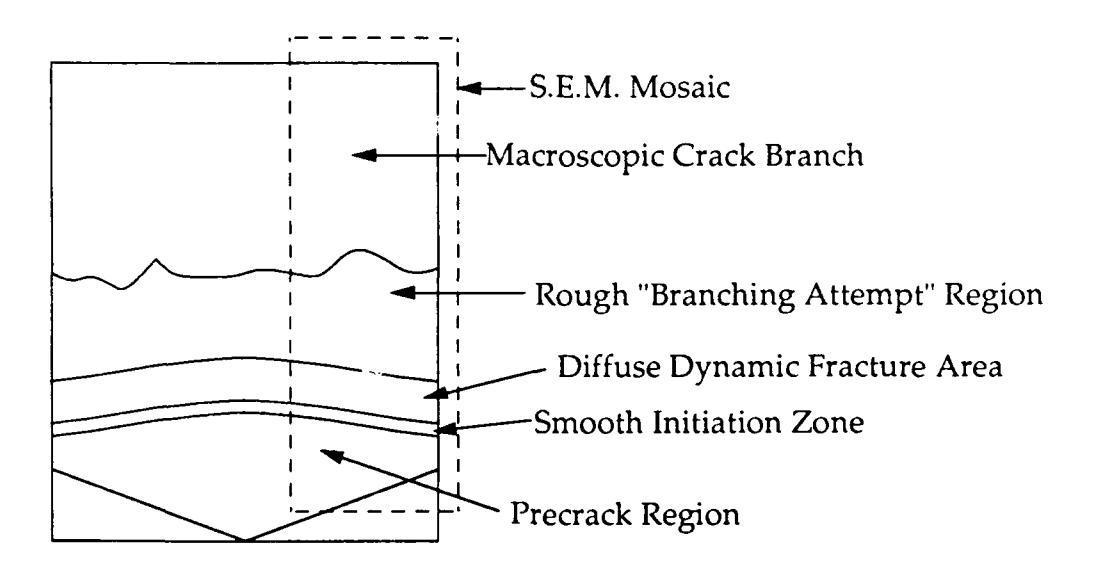
Figure 7, Schematic of fracture process regions on the ceramic bars.

The fracture surfaces exhibited as many as five different distinct regions (See Figure 7). The first zone was the precrack region which showed a relatively flat and uniformly diffuse surface. Immediately following the precrack region was a narrow band of smooth surface which was named the "crack initiation" zone. The third region was a rough, relatively flat dynamic fracture region. The next surface

consisted of small localized crack branches (branching attempts) on a surface which was rough and of non-uniform shading. All materials impacted at 10 m/s exhibited a macro-branched region (5th region). The specimens impacted at 5.8 m/s did not display the macroscopic crack branch region. The initial crack was longer in the center section where plane strain conditions were dominant. Figure 8 is a mosaic of Al_2O_3 showing this fracture morphology. These regions were difficult to observe with the SEM or the optical microscope, but were more apparent with the naked eye.
