Pipe Cleaning using 3M HFE Solvents and the RAAF Oxygen System Pipe Cleaning System

Lyn E. Fletcher, Robert Zugno and Jim Dimas DSTO-TR-1563

ABSTRACT

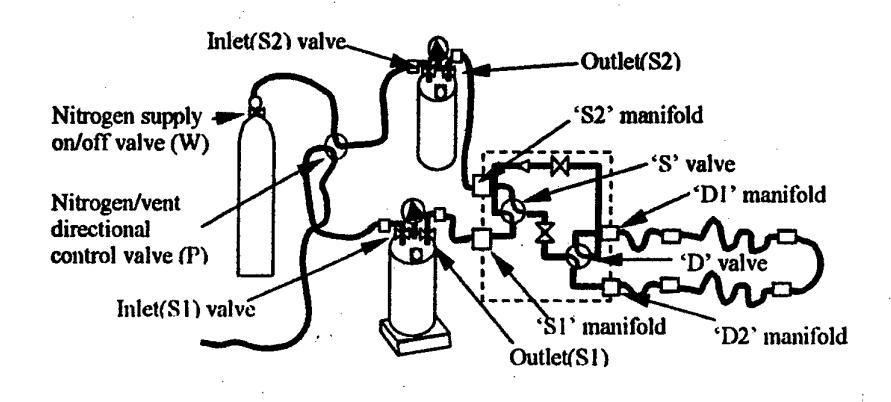
Figure 1 - Reverse Cycle Rig.

The pre-production rig (PPRig) consisted of two modules, manufactured by Rosebank Engineering to a RAAF/DSTO design. The first module, the reverse cycle rig, was designed to recirculate HFE-71DE and HFE-7100 from pressurized containers and be capable of reversing the flow direction through the pipes. Figure 1 shows a schematic of the reverse cycle rig.

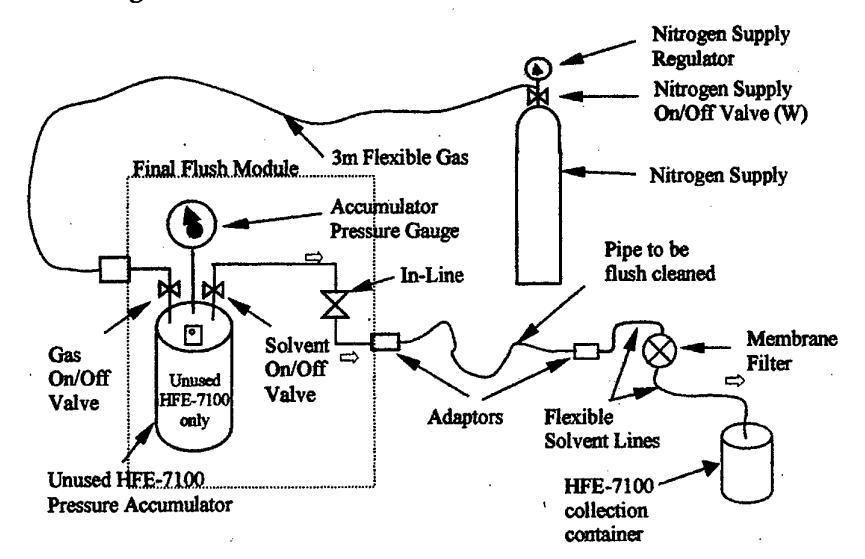
Figure 2 - Final Flush Rig.

The second module was designed to provide new HFE-7100 solvent through the pipes as a final flush and simplified verification step. Figure 2 shows the schematic of the final flush rig.

Between change over of solvents the pipes were purged for 2 minutes at 100 KPa with high purity nitrogen, delivered through the last pressure vessel connected. The final rinse was 600 ml of clean HFE-7100 flushed through at approximately 0.6 l/min. The pipes were then dried with high purity nitrogen until a refrigerant leak detector stopped alarming when waved over the end of a dried pipe.

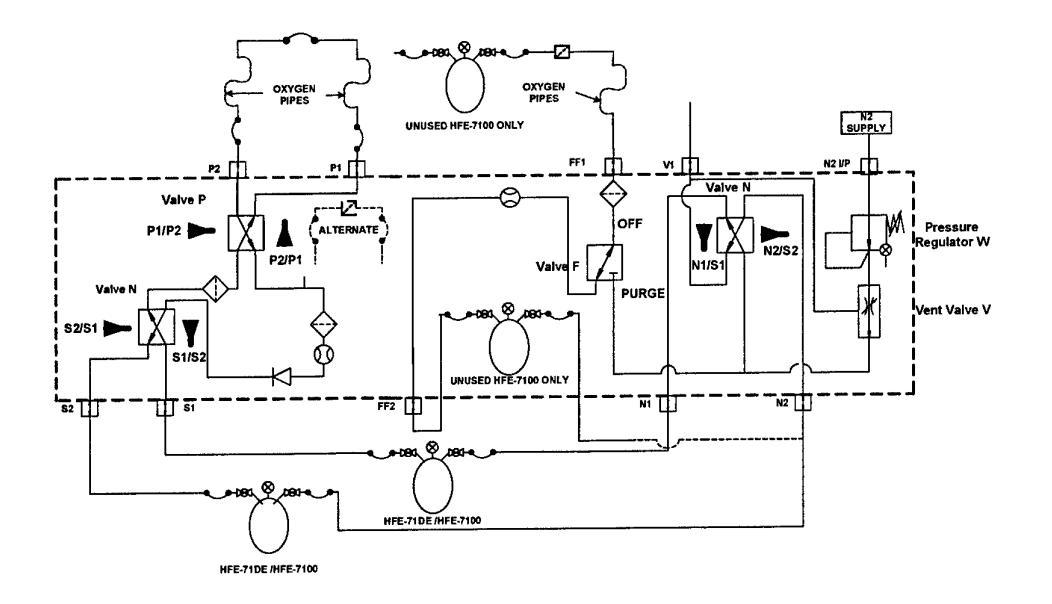
Figure 3 - Schematic of the Final Production Model of the Pipe Cleaning Rig.

The final design of the production rig involved merging the recirculating rig and the final rinse rigs. The Final Production Rig has a trolley with underneath storage for all of the pressure vessels and associated fittings. The production rig has two in-line flow meters that can measure flow rates directly, allowing for finer adjustment of the flowrates. Careful consideration was given to the venting requirements and a dedicated vest line was included. The full schematic of the rig is shown in Figure 3 and Figure 4 illustrates the rig in operation.

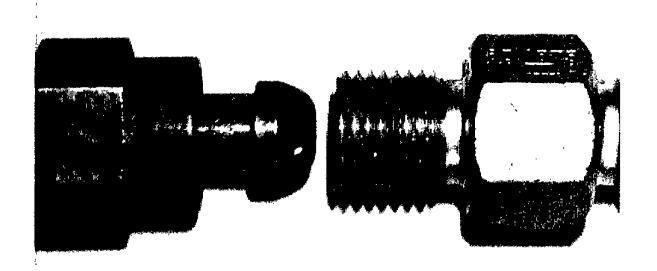
Figure 5 – HS748 pipe fittings and union.

The 1/8" copper pipes used on the HS748 aircraft are the smallest oxygen pipes in use by the RAAF. The pipes have a brass nipple which is silver soldered to the pipe and are connected using brass BSPP connections. Figure 5 illustrates the pipe end and fittings.

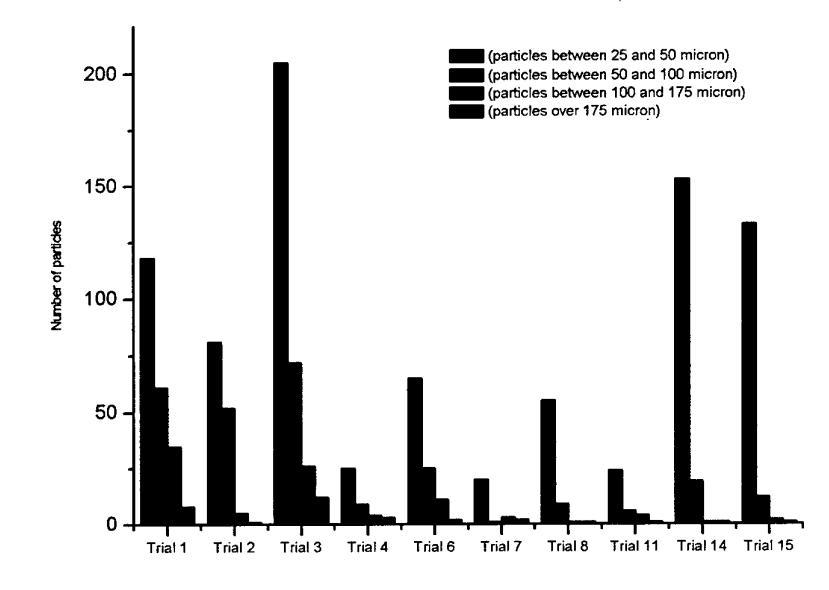
Figure 6 - Results HS 748 pipe cleaning for Aluminium particulate removal using the PPRig.

Trials one to three used the ISO conversion fittings supplied by Rosebank Engineering. These have a flat mating surface that was observed to dig into the dome brass end fittings on the HS 748 pipes. From Trial 4 onwards BSPP conversion fittings were used instead, which have an inverted cone shape. These fittings closely match the supplied connectors used for the HS 748 pipe system. The results using the ASTM F303 extraction method are shown in Figure 6. An improvement in particulate removal was immediately noticeable, although the improvement was not great enough to meet the G93 175 specification.

If voids were present in the end fittings and trapping particulates, reversing the flow direction more frequently and resuspending the trapped particles more often would increase the possibility of successful elimination from the pipes. During Trial 7, the flow direction was changed approximately every 5 minutes, 12 times overall. The results in Figure 6 show an improvement in particle removal.

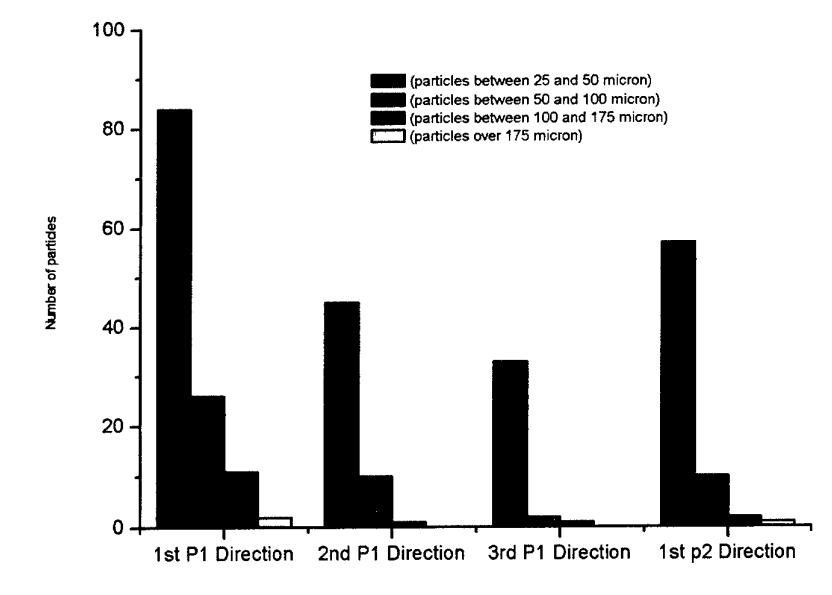
Figure 7- Consecutive Freon F303 Extractions Following Trial 6 (results not corrected for background blank).

Trial 6 was a repeat of Trial 4, but conducted at slightly higher flow rates, due to replacement of a partially blocked 2-micron filter element. The results of Trial 6 were not as good as the results from Trial 4. It is not clear with the limited data available whether this is associated with the flow rate change, or just an indication of level of normal variation in the results. To check whether the fittings are accumulating particles in the void in the connectors, a Freon extraction was done three times in the same direction, the direction reversed and another extraction performed. The results are shown in Figure 7 and show a significant increase occurring when the flow direction was reversed. This is consistent with trapped particles being released from voids or additional particles being produced during reconnection to the Freon extraction vessel.

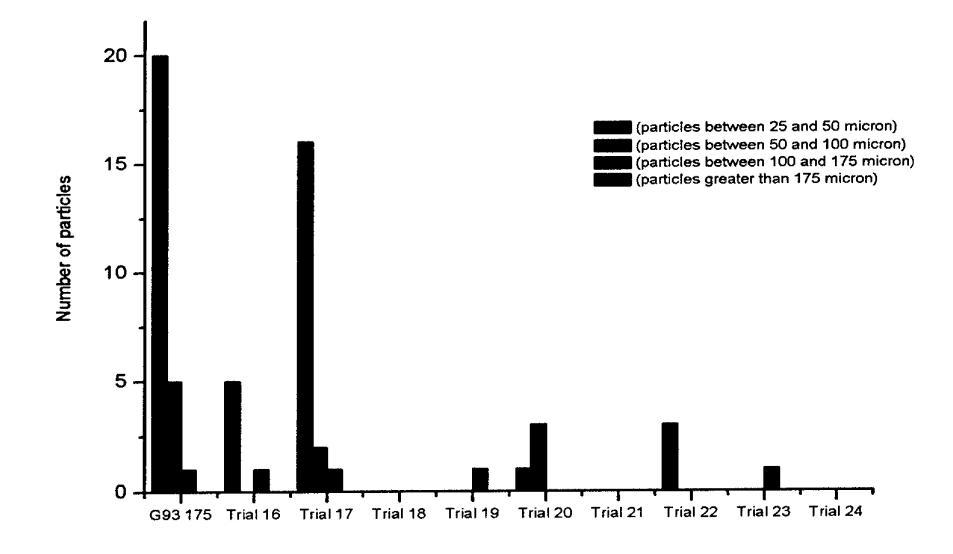
Figure 8 - Results for the G93 tests using four HS748 copper pipes permanently ganged and the modified Freon extraction method.

From Figure 8 all of the trials performed using the permanently ganged new HS 748 pipes and the modified extraction method met the G93 175 particle specification when tested using the G93 method. Trial 18 also met the specification when the more demanding F303 test was used (Figure 9). In all cases, we are subtracting a blank because the testing is not being performed in a proper Class 100 clean room and some environmental load can be expected to interfere with the results (which is an option in ASTM method F312).

The results of Trials 16-18 demonstrate that the pre-production rig can meet the G93 175 particle specification using draft instruction 2, with an initial nitrogen gas blowdown.

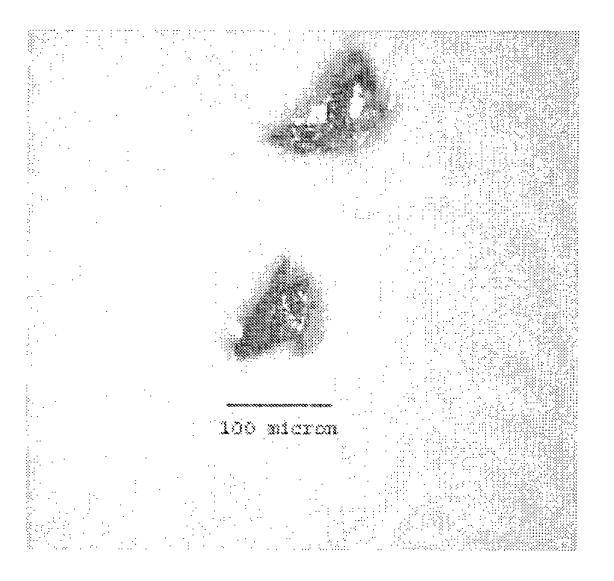
Figure 10 - Observed swarf particles in Trial 24 using F303 Freon extraction.

The swarf particles pictured in Figure 10, are grey metal particles, which are not copper or brass, and are therefore, not caused by particle generations from the copper or brass materials present in the HS748 pipes. The particles shown are consistent with the aluminium swarf particles introduced into the pipes as particle contamination prior to cleaning. Therefore, the presence of these particles is indicative of some of the original contamination not being fully removed. It is also worth noting that these particles do

Further trials were performed to determine if the process could be speeded up without compromising cleanliness. Trials 19 and 20 were conducted using a 5 minute recycle in each direction and the results for the G93 test also meet the particle specification. Trial 19 used the initial Nitrogen purge and Trial 20 had no nitrogen purge. It was noted that in the entire F303 tests of Trials 16-24, some aluminium swarf particles were evident in the 50-175 micron size ranges. Figure 10 is a photomicrograph of the swarf particles observed in the F303 test of Trial 24.

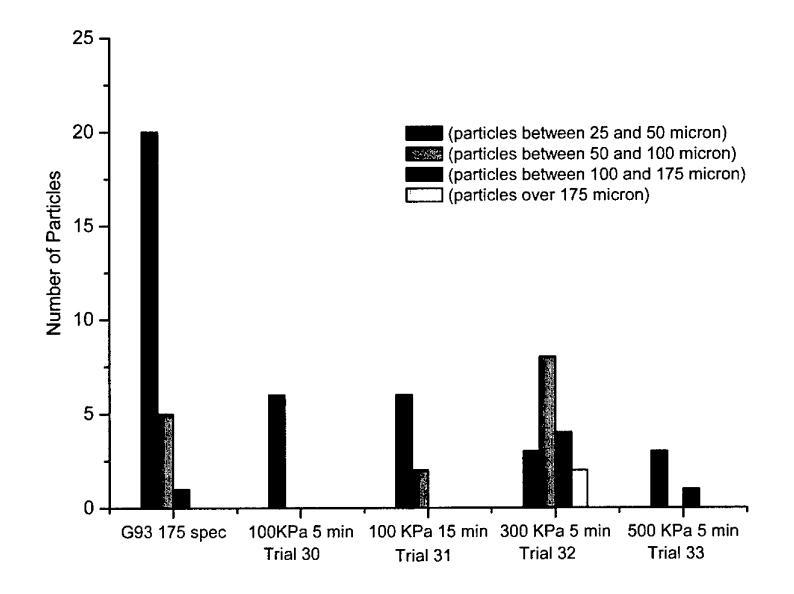
Figure 11 – G93 results for P3 pipes for a variety of different conditions.

From the data displayed in Figure 11 it is observed that the only time the G93 specification was not achieved was with the 300 KPa trial. Why this should be higher than either the 100 KPa or the 500 KPa experiment is unknown. However, it does demonstrate that there appears to be no advantage in increasing the pressure in the delivery vessel, and thereby increasing the solvent flow rates through the pipes beyond a flowrate sufficient to achieve full turbulent flow.

The results of the above trials are shown in Figure 11.

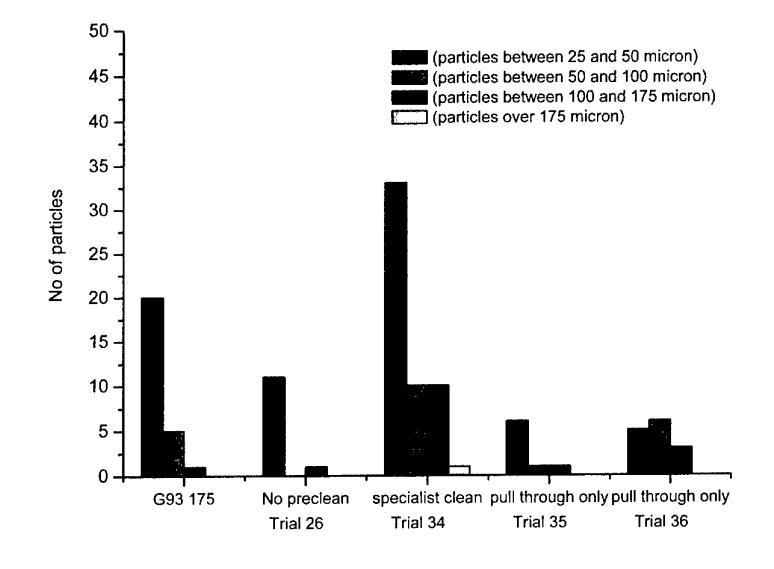
Figure 12 – Affect of different pre-treatments on results with P3 pipes.

Figure 12 list the affect of the different precleaning procedures has on P3 pipes as received from the squadron. These are more relevant to the actual conditions of the pipes before undergoing precision cleaning using the pipe cleaning equipment.

From Figure 12, the contamination is still present after cleaning in the specialistcleaned pipes. We have previously found, when cleaning up our cleaning rigs made from stainless steel, that stainless steel pipes after manufacture can be difficult to clean to the RAAF specifications. There are usually a lot of particles present in these pipes carrying over from the pipe manufacturing process. The use of a pull through prior to precision cleaning is therefore highly recommended with stainless steel pipes, especially newly manufactured pipes.
