HYDROGEN EFFECTS ON SILICON MICROSYSTEMS

Final Report

Lars Stenmark Uppsala University

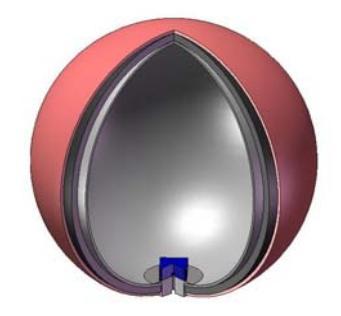
. Hydrogen is stored under high pressure in a large number of small autonomous sub-tanks, the MacroSpheres, in the concept. The difference between internal and external pressure controls the gas flow to or from the MacroSpheres. Advanced Micro System Technology (MST) is the key enabling element in the gas handling chip which is mounted inside each sub-tank. The system combines the best storage performance available with focus on a convenient and non-dramatic handling for the user. Some system highlights are presented in the following. In the concept, each small spherical tank contains its own gas handling system, integrated in form of a chip on the inside of the spherical tank, see figure 1.2-1 below.

Figure 1.2-1 Chip location inside a MacroSphere

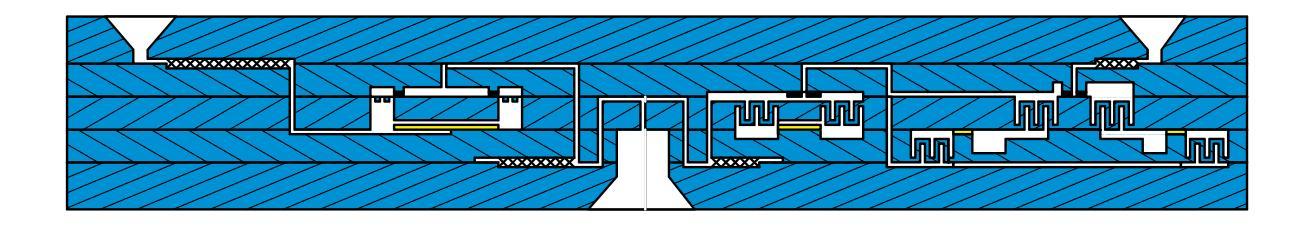
The fluid system which permits both filling and release of the hydrogen in a controlled way, is a silicon chip with several micro mechanical devices working together in a small stack of silicon wafers. The wafer stack consists of five micro machined wafers, two thicker protection wafers on both sides of three thin wafer with a number of very tiny mechanical structures etched out. In figure 1.2-2 is a cross-section through the stack depicted.

Figure 1.2-2 Wafer stack cross-section

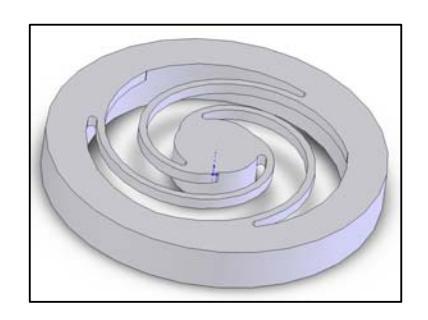
In some valve structures tiny suspension beams are used to support the valve cap, in others are thin membranes used. It is important that this tiny structures keep their mechanical properties also after a long exposure to Hydrogen under high pressure. A typical valve cap, with a diameter of 20-30 micrometers is depicted in figure 1.2-3 below.

Figure 1.2-3 A suspended valve cap.

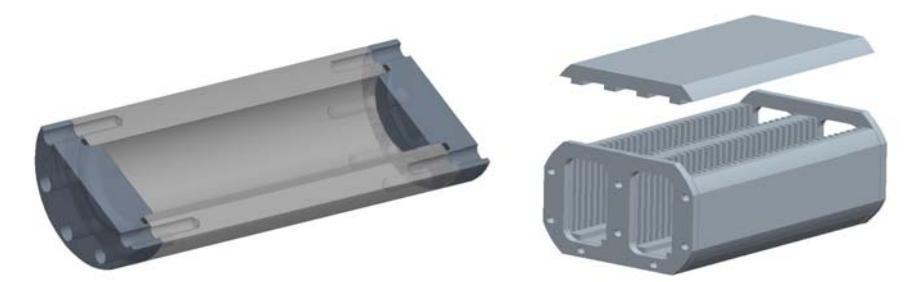
The chamber is design is a cylindrical form with a lid at each end as presented in the intrim report, see figure 2.1-1 left. The flanges at the end of the cylindrical body have connections to the gas line and pressure control system. Material is stainless steel.

The inner diameter is set to 45 mm in order to make the chamber usable even for pressurizing test of the macrospheres later on, as the macrospheres have their outer diameter of 40 mm.

Figure 2.1-1: Cut view of the H2-embrittlement test chamber (left) and an exploded view of a sample cassette (right).

The cassette supports two rows of samples very secure, each sample is supported on two sides. The main reason is to prevent that the samples are mixed by accident when removed from the chamber. The system has been working well.

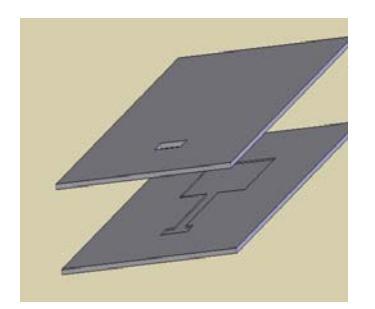
The bond strength test chip consists of two bonded silicon wafers where each has a thickness of $525\mu m$. The bottom wafer contains $50\mu m$ deep cavities where etch cavity consist of a smaller gas trench and a chamber which is pressurized during the burst tests. A picture of the wafer pair is depicted in figure 3.1-1 below. The top wafer sealing of the cavity has a trough etched visa, for feeding in the gas when the cavity is pressurized.

Figure 3.1-1 Design Bond strength test sample

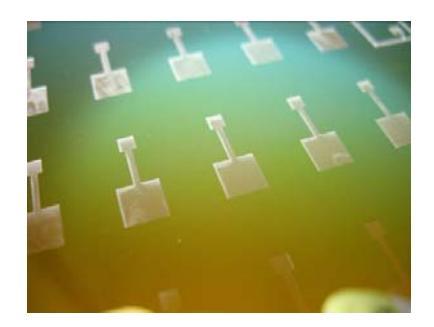
The total number of manufactured wafers where 6 bonded pair where three included direct fusion Si-Si bond and the other three direct fusion Si-SiO₂ bond. All wafers, independent of the type of bond interface, has been manufactured with exact same parameters in similar steps in order to make good comparative possible in later evaluation phase. All bonded pairs of wafers have been analyzed by IR-camera at wafer level before and after the high temperature bond annealing and oxidizing step (2000 nm at 1050 C) After annealing the chips was ID marked and diced to individual chips. The chips where voids have been detected are documented on chip level. The samples are manufactured in batches on four inch wafers; each bonded wafer pair contains 22 bond test chips. Both the cavities on the bottom wafer and the vias at the top wafer has been processed by a wet isotropic etch step using 40% wt KOH at 70°C.

Figure 3.2-1 Picture of one of the cavity wafers (W9) with KOH etched cavities. The cavity deep is measured to $52\mu m$.

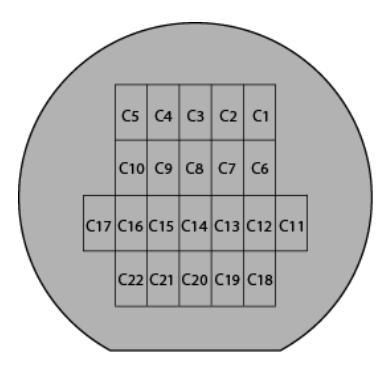
Figure 3.2-2 – Each bonded wafers pair contain 22 chip. This picture shows the identification numbers for each chip seen from the cavity wafer side. I.e. the via opening are on the backside in this figure.

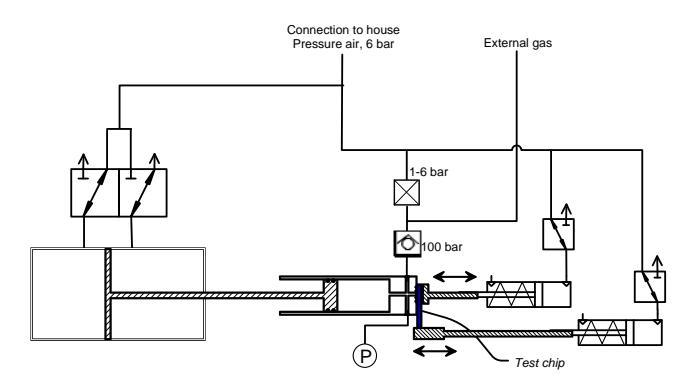
The basic design of the new equipment is briefly presented in this section. Instead for using high pressure direct from a standard gas bottle in the lab which always is a complication it was decided to use the "House gas" (Nitrogen,6 Bar pressure) and a pneumatic pressure amplifier to generate the burst pressure, see figure 3.6-1 below.

Figure 3.6-1, Bond Burst Equipment, Block diagram

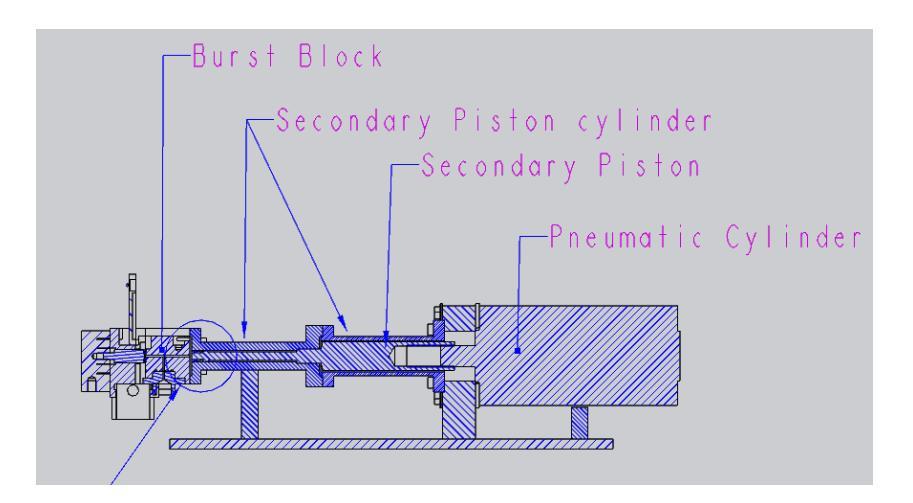
A separate feed line for the burst gas gives a possibility to use other gases in the sample interface, see future verification work. The large pneumatic cylinder is pushing a small piston forward until the remaining dead volume become very small and the gas pressure high. The generated pressure is continuously monitored and as soon as a sudden pressure drop is noted is the peak value recorded and the pneumatic cylinder reversed. Two short stroke cylinders also used in the system, one prevents the sample from falling down into a scrap box before bursting and the other is pressing the sample against the test block. The equipment is made user friendly as several safety switches are involved, so a sample can not be bursted if not in position and properly protected by safety lids.

Figure 3.6-2 Bond Burst Equipment, Cross-section

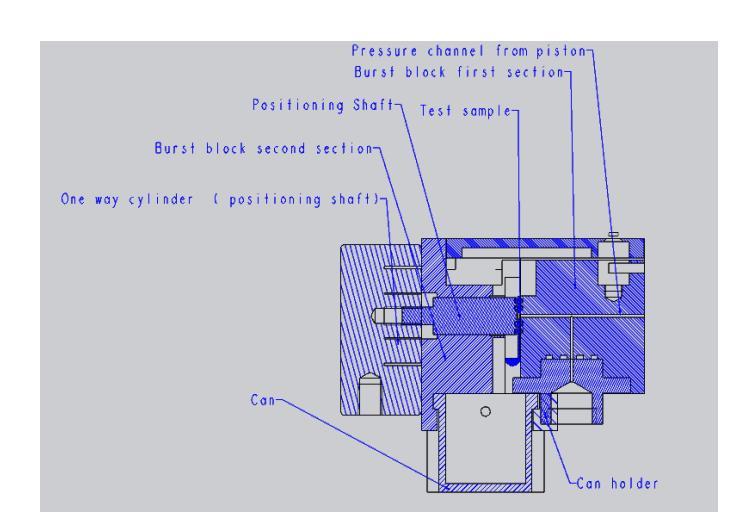
The test block is milled out from solid high strength aluminum with very narrow gas channels, the expected maximum pressure should be well above 100 Bar which is more than enough for most test structures. A more detailed cross-section though the test block is given below.

Figure 3.1-3 Test Block Cross-section

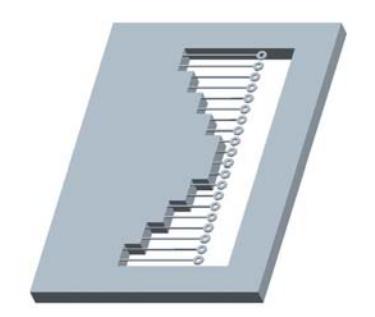
The static beam are small strait beams in the wafer plane. They have dimensions between 50-100 micrometer and a length of 1-5 mm. The dimensions resembles of the spring used in the micro mechanical hydrogen storage system under development, the MacroSpheres. They are etched out from a single silicon wafer by use of deep reactive Ion Etch. The area around the beams has been thinned down to approximately 100 micro meters with conventional wet etch. The rings at the end of each beam serves the purpose to give a well defined target for the micro manipulator tip when pushing down the beam. All rings are on a strait line in order to simplify the handling, the manipulator has only to move in one axis. The beams have five different lengths in order to give a possibility to eliminate unwanted side effects of the measurement set-up.

Figure 4.1-1 Test chip with 10 beams

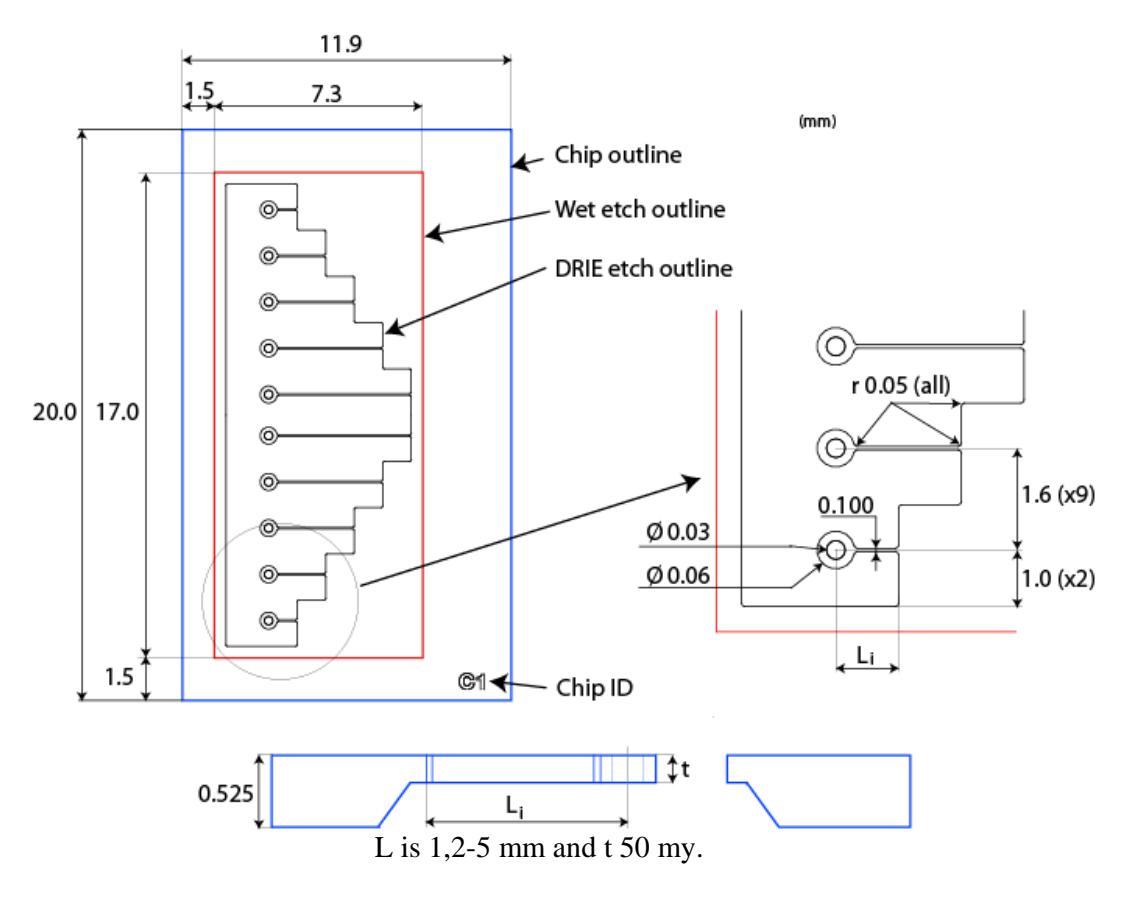
Figure 4.1-2 Detailed design test chip.

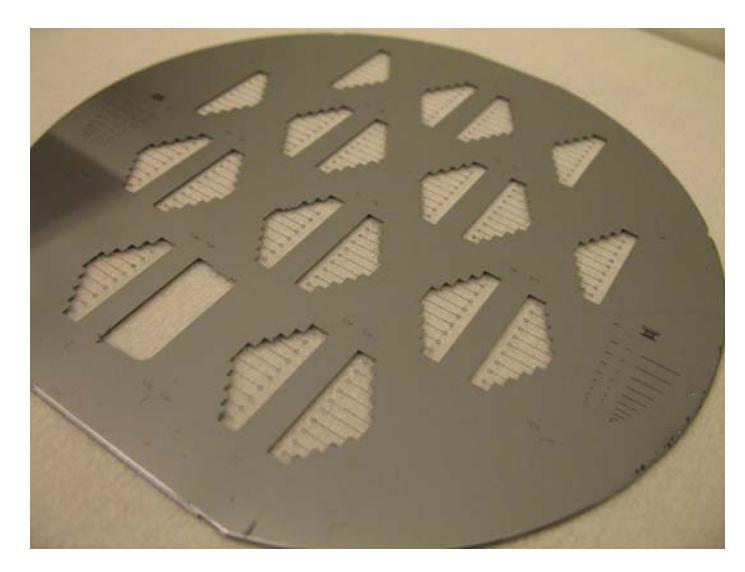
Figure 3.1 shows W7 with 19 intact chips and one destroyed, probably due to tension from the DRIE step. Some of the beams collapsed during the DRIE step as well. Figure 3.2 shows two intact chips more in detail.

Figure 4.1 A manufactured wafer (W7) with 19 intact chips.

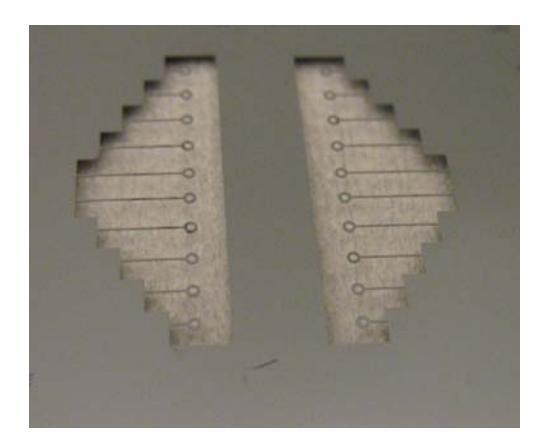
Figure 4.2 Close-up of two intact chips on W7.

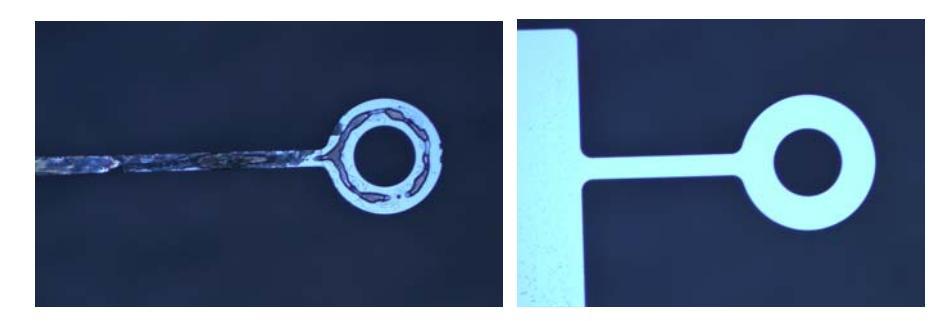
There was some residue left on the wafers after the DRIE etching; this could be seen as "burn marks" on many of the beams on both wafers. Figure 5.3 shows two beams from W8 photographed in optical microscope, one with residue and one without.

Figure 4.3 Left: beam (from W8) with residue ("burn marks") from DRIE, Right: beam in the same chip as the left picture with no residue.

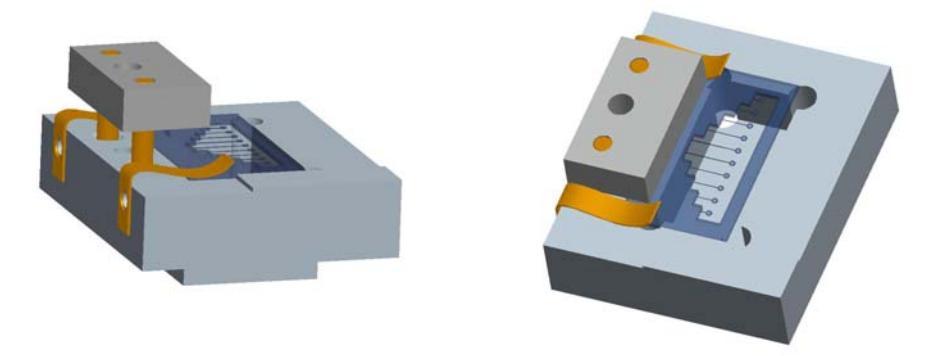
The equipment used when breaking the beams is MINIMAN II (further described in document **Test equipment and test plan for H2_Embrittning effect on mono crystalline silicon bulk Silicon**). The silicon samples are placed in a small holder (see figure 4.4-1), and the holder is mounted in MINIMAN II (figure 4.4-2)

Figure 4.4-1. Sample holder with mounted silicon sample.

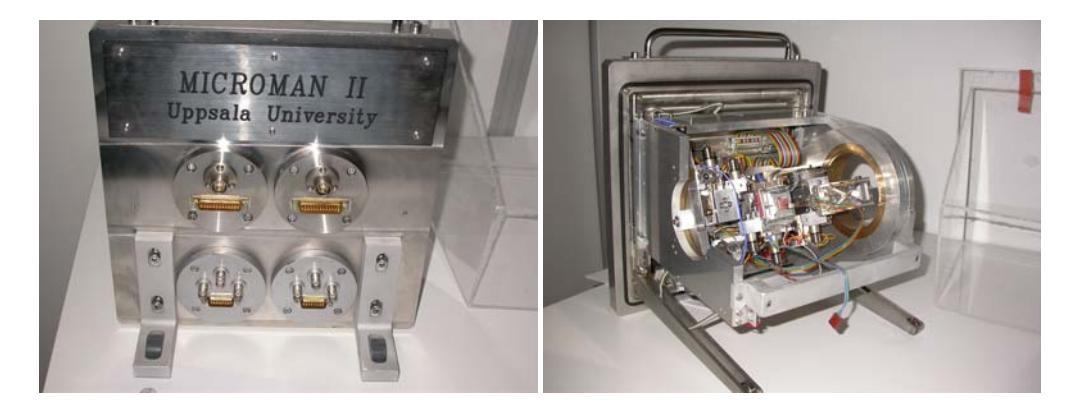
Figure 4.4-2. MINIMAN II

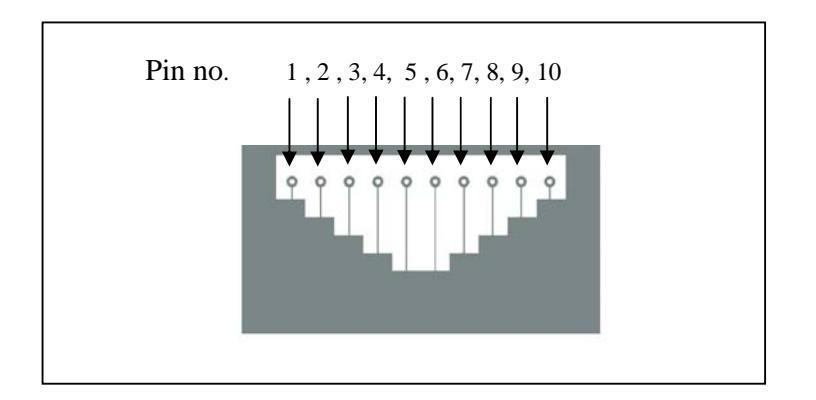
The manufacturing of the silicon structures used in this experiment is described in the document **P11_3-07-DRT-014**. The beams in the silicon structures are very fragile, and are easily break during handling. Due to this, some chips do not have complete amount of pins. Note that the definition below is made with the side of the chip that is marked with the chip id no facing upwards! However, pin 1 and 10 are identical, pin 2 and 9 are identical (and so on). Identical pins are handled as one test group for each chip

Figure 4.5-1. Definition of pin

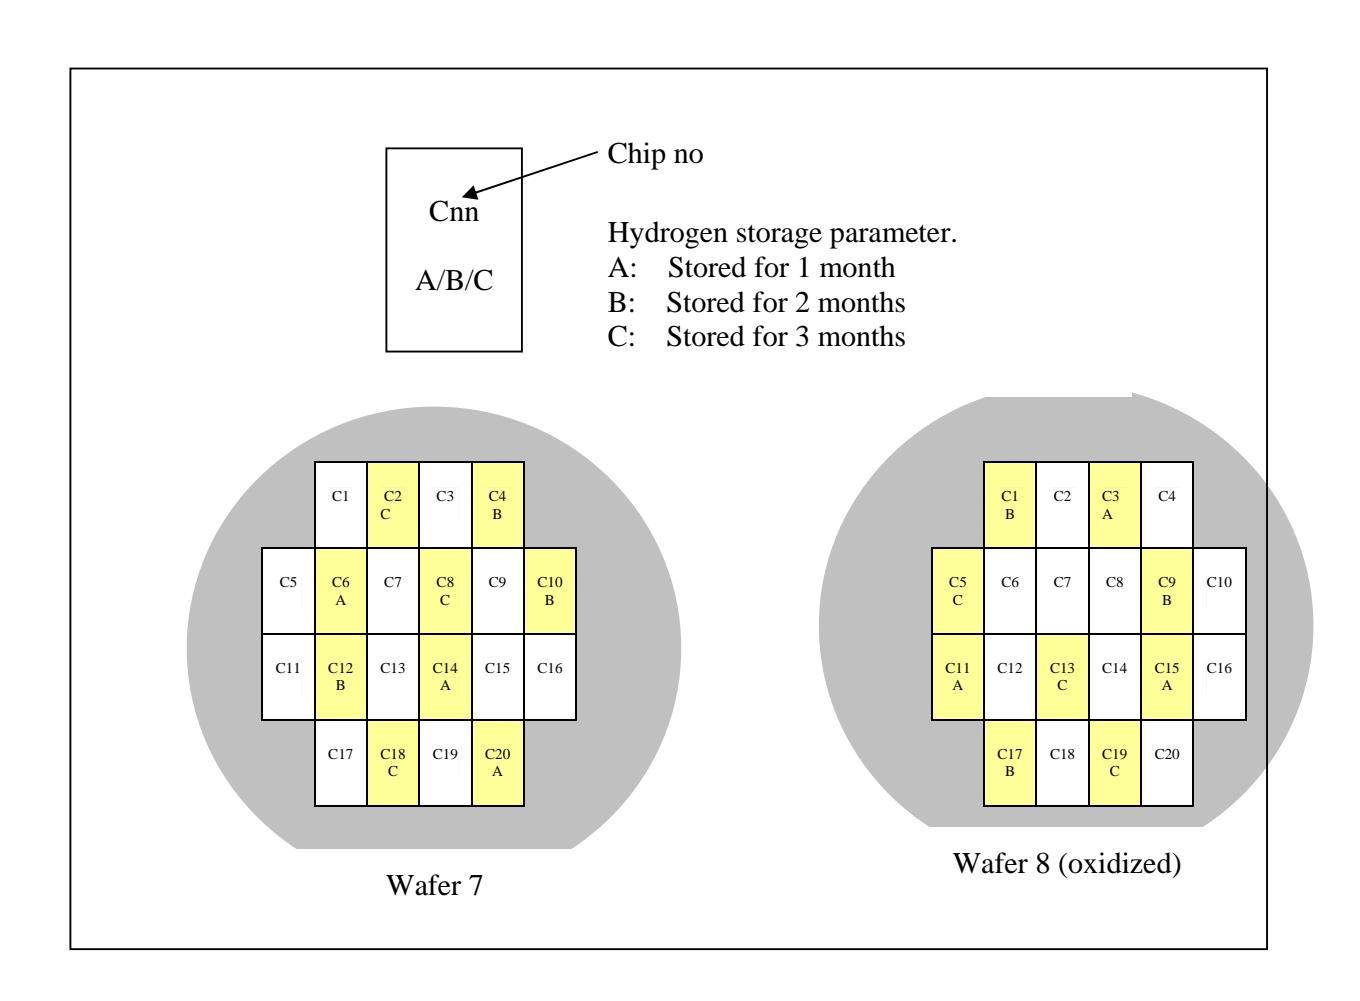
Totally, 18 chips are included in the study (marked yellow in Figure 2). Wafer 7 and wafer 8 have been manufactured mainly in the same way. The difference between them is that wafer 8 has been oxidized. Chips marked with yellow in Figure 2 indicates stored in hydrogen, white chip indicates no storage.

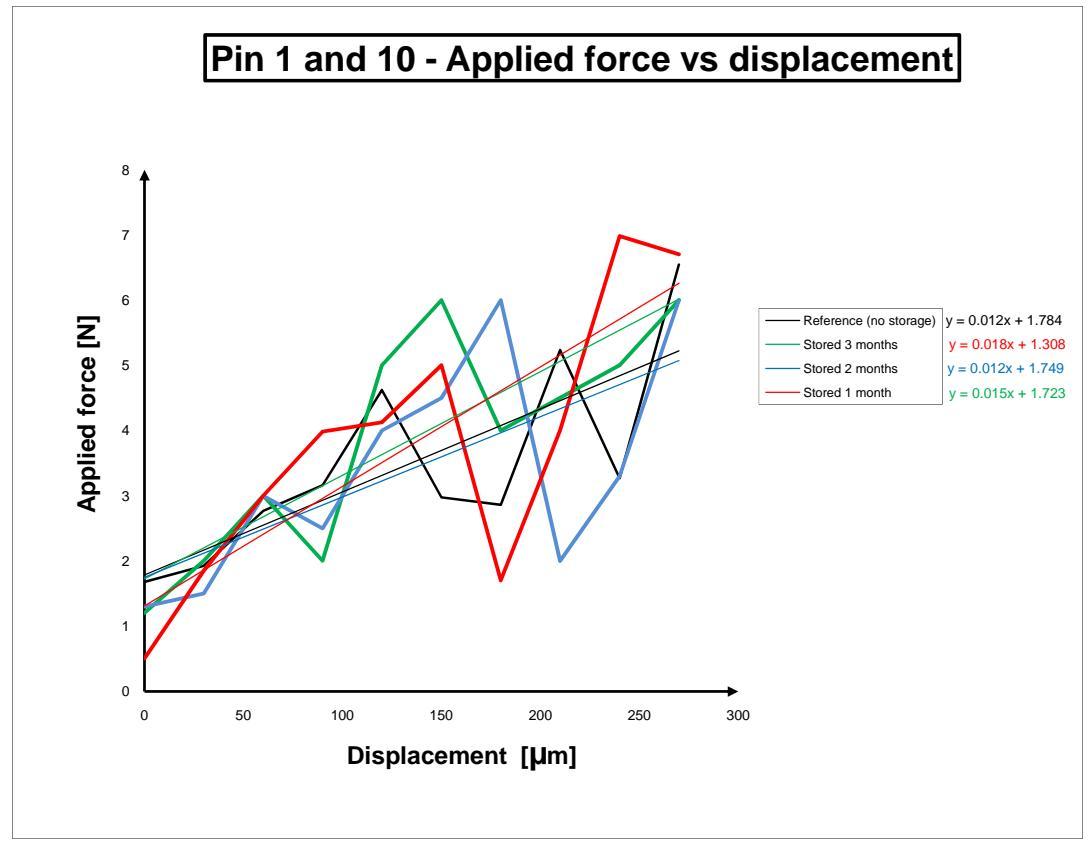
Figure 4.6-1. Overview of results.

The measurements show no signs of changes in brittleness between the four groups.

The equipment used for the measurements contained many sources of error and the measurements shows fluctuating curves. However, the overview of the different groups (different storage time) presented in figure 4 show no differences *between* the groups and this result should be regarded as reliable but handled as an indicating result. No numerical values should be regarded as reliable since there was no way of checking the accuracy of the logged normal force. Hence, the numerical accuracy of the measurements is questionable. However, the equipment was used in the same way for each measurement and the potential inaccuracy should be constant, causing no impact on the comparison between the different measurements.

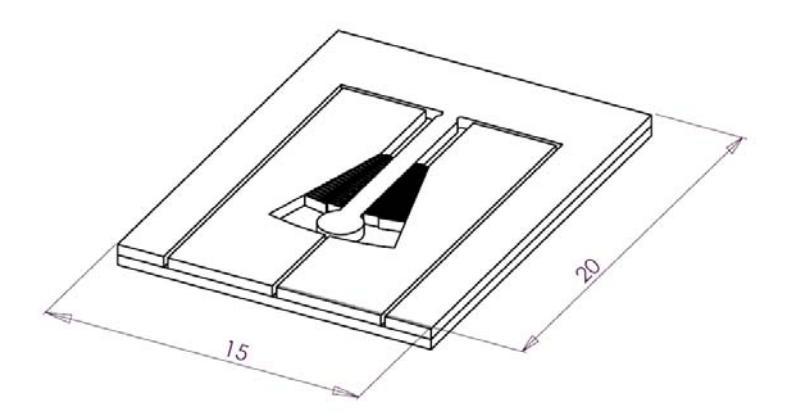
This is the most intriguing new test, the idea is to see if mono crystalline Silicon change it properties under high dynamic loads. The idea is to produce a number of samples, as depicted in figure 5.4-1 below. In a single silicon wafer a quite stiff beam is etched out with two comb actuator structures one on each side. Before the final etching the chip is mounted on a transparent carrier wafer. During the test is the free etched beam exitated in resonance by use of the two comb actuators and an optical feedback. After a burn-in time is the surrounding atmosphere changed to Hydrogen and the possible change in resonance frequency is monitored. The test chip is depicted in figure 5.4-1 below.

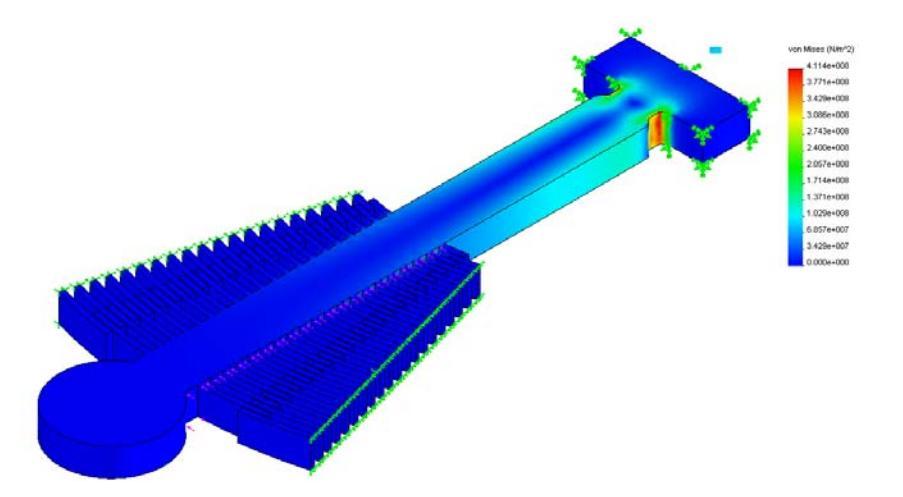
The basic idea is that if it is some cut-outs near the root of the beam it will be a point ot stress in which the silicon gitter is compressed or stretched out several thousand times per second, it would be a very sensitive indicator if something is going on i. e. if the material properties are changing in any way. In figure 5.4-2 is a simulation of a test beam depicted and it could be clearly seen where the stress concentration are located.

Figure 5.4-2 – Stress profile in the beam when the applied force is set to 0.1N. The maximum stress appears at the narrowing part of the beam and is simulated to $4.1E+8N/m^2$. This gives a safety factor (FOS) of 17. Due to that the maximum stress occurs at a processed surface the Yield strength should be lowered with approximated factor of 10. The estimated FOS is that case be around 1.7 which can be seen as the range where the beam could brake.
