Installation of Corrosion Control Solutions During System RESET

John Repp – Elzly Technology Corporation I. Carl Handsy – US Army TACOM Matthew Koch – USMC CPAC Program Office

13. SUPPLEMENTARY NOTES 2009 U.S. Army Corrosion Summit, 3-5 Feb, Clearwater Beach, FL					
14. ABSTRACT					
15. SUBJECT TERMS					
16. SECURITY CLASSIFICATION OF: 17. LIMITA				18. NUMBER	19a. NAME OF

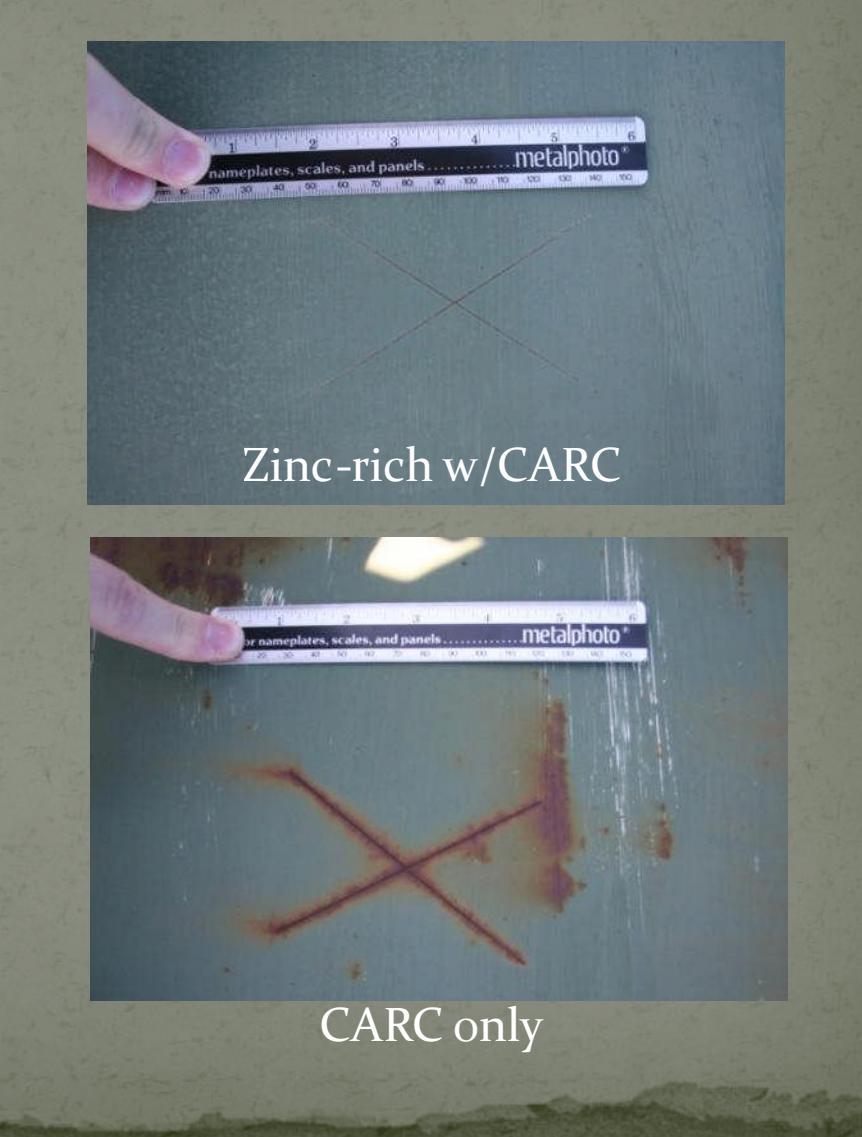
Demonstrated Benefits – Zinc-rich Coatings

- Widespread use on infrastructure elements (e.g., bridges and highways)
- Used on modern weapon systems (e.g., USMC MTVR)
- Past Army project demonstrated benefit
 - 7-years in marine environment
 - Compared to traditional CARC system over steel Negligible deterioration of zinc-rich material

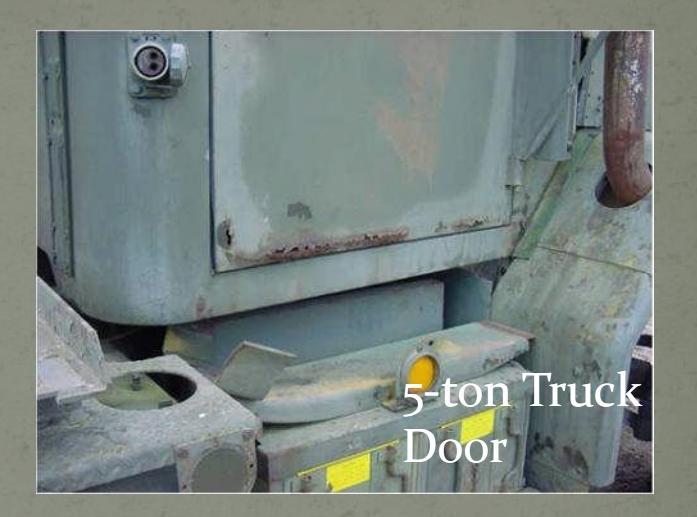
On body panels (like doors) corrosion often occurs along the bottom seam
Collection point for contaminants
No drainage / ability to clean out contaminants

- Galvanized sheet steel is commonly used in commercial automotive applications
- Manufacturing components out of galvanized steel is readily accomplished
- Modern Example
 - FMTV vehicles originally used carbon steel on cabs and experienced corrosion issues
 - Subsequent cabs were upgraded to galvanized steel with no reported issues
