SUBJECT: Report on Project Assessment of the follow-Up on the Nassriya Prison Facility, Nassriya, Iraq (Report Number SIGIR PA-08-131)

SIGIR PA-08-131

Follow-up on the Nassriya Prison Facility, Nassriya, Iraq

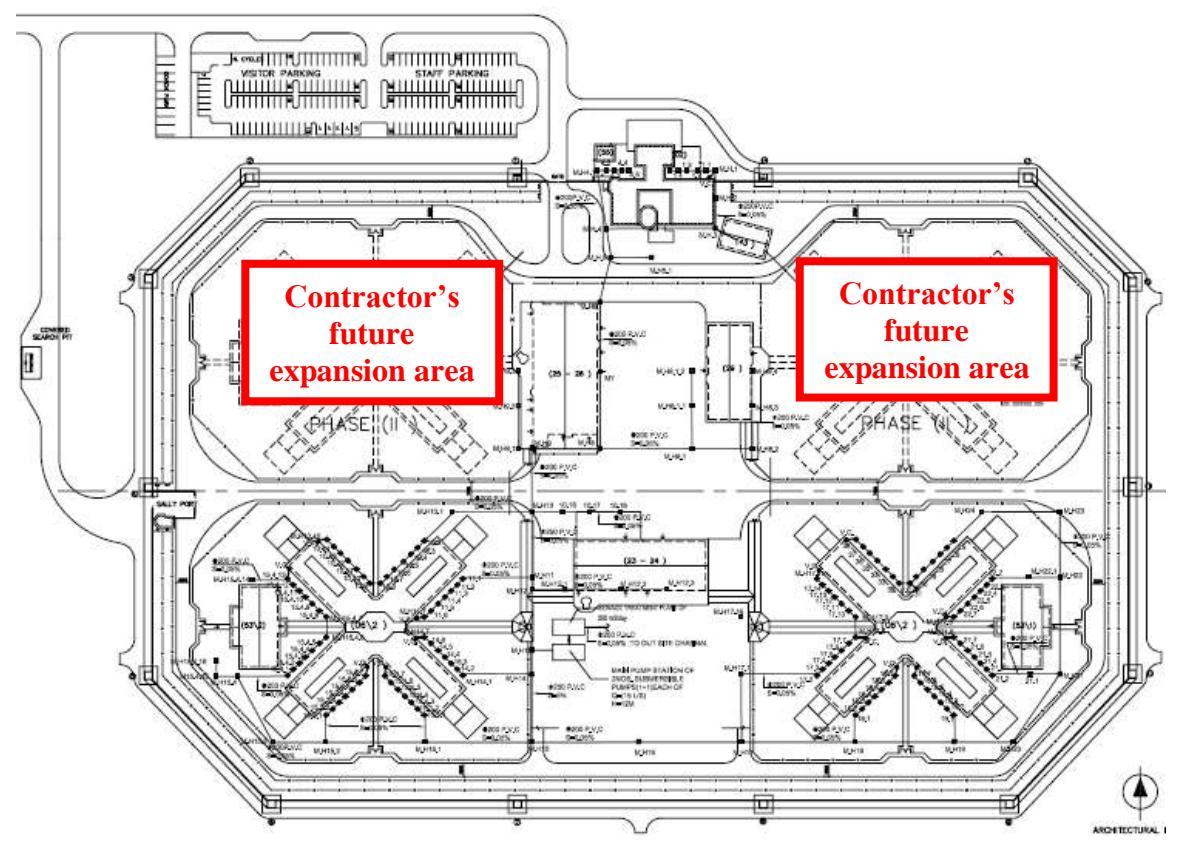
Figure 1. Parsons' revised prison layout with expansion capability (Figure courtesy of the USACE)

The Nassriya Prison Facility project was initiated to alleviate an already congested Iraqi prison system. Potentially, this facility may house inmates from Abu-Ghraib and Camp Bucca (currently at maximum capacity). The Nassriya Prison was designed under the United States standards for prisons, which include recreation and visitor buildings that should provide a modern, humane facility. In addition, the facility will provide approximately 1,000 jobs and an economic boost to the Nassriya region. The Nassriya Prison project¹, a facility located on 26 acres in the Thi Qar governorate, originally was conceived as a prison with the capacity to house 4,400 inmates. However, scope changes subsequently reduced the requirements for the prison to accommodate 800 inmates and provide the capability for later expansion (Figure 1).

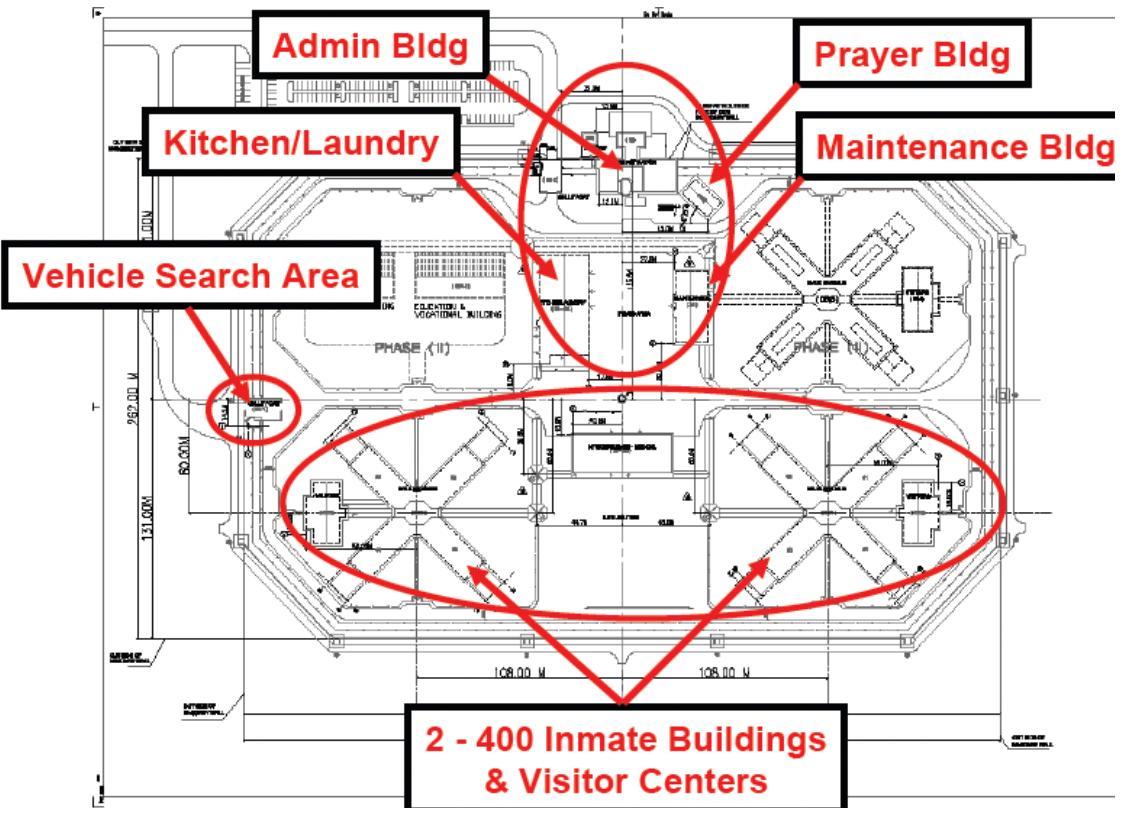
Figure 2. Current construction area (Figure courtesy of the USACE)

Contract W91GXZ-06-C-0040, also referred to as Phase I, was to complete the construction started by Parsons on two inmate housing units, administration building, maintenance building, laundry/kitchen, prayer room, roads, parking lot, and utilities (Figure 2 and Aerial Image 1).

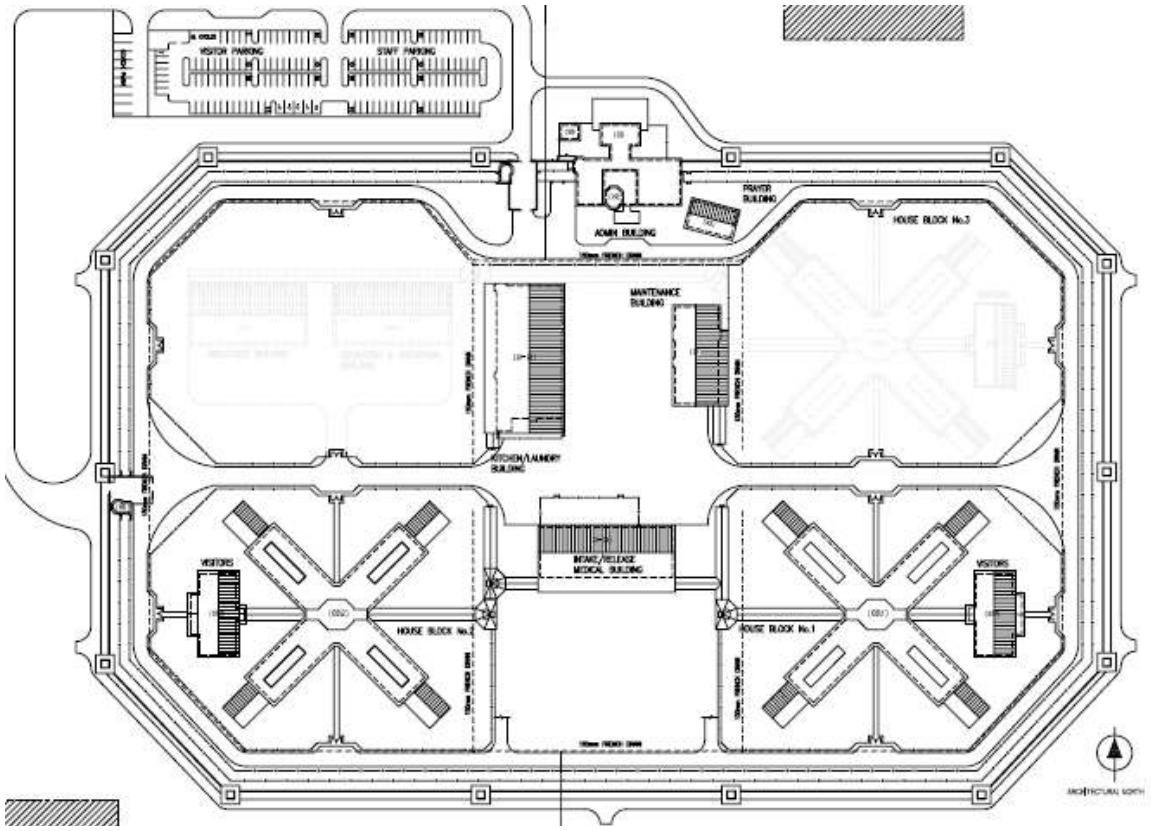
Figure 3. Completed Phase I (Figure courtesy of the USACE)

The Nassriya Prison project covered an area of approximately 104,000 square meters (m²). Phase I covered approximately 14,167 m² and includes completing construction on two inmate housing units, an administration building, maintenance building, laundry/kitchen, prayer room, roads, parking lot, and utilities (Figure 3). Utilities were unavailable to the prison site; therefore the scope of work included the design and construction of an on-site electrical power generation plant, a water treatment plant, and a package wastewater treatment facility. Phase II will cover approximately 910 square meters. Phase II construction will consist of one inmate housing unit and one visitation center.

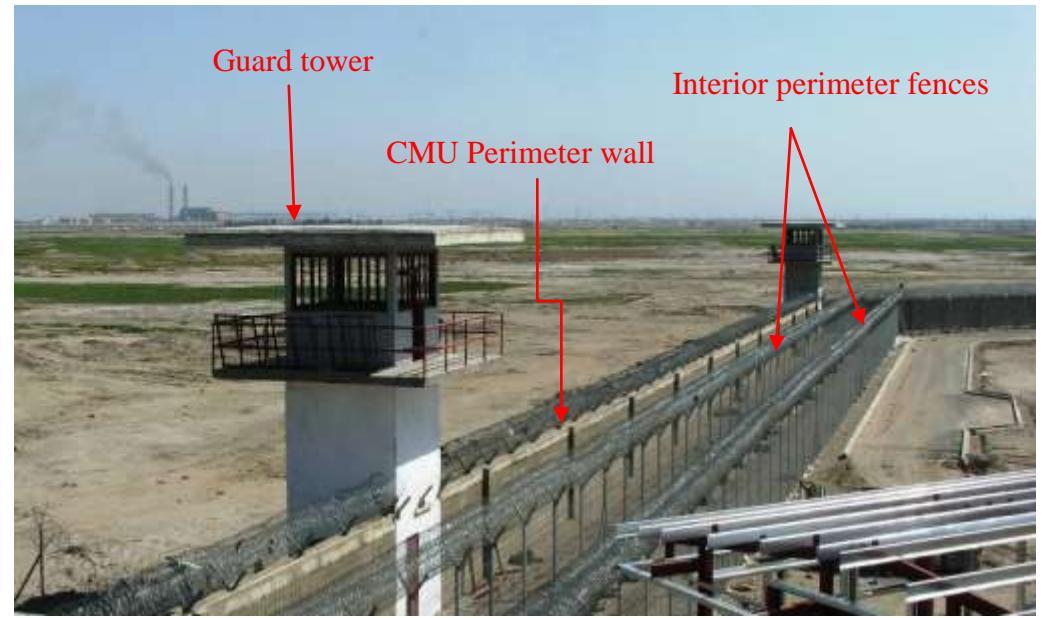
Site Photo 1. Guard tower, perimeter wall and interior chain link fences along prison perimeter.

The wall design required a three meter (m) high wall along the perimeter of the prison, using 400 millimeter (mm) thick reinforced concrete block supported by a 1-m wide and 1.2-m deep, continuous reinforced concrete footer. Additionally, a reinforced concrete (235-mm by 400-mm) capping beam was required along the top of the wall. For added stability and support, concrete block piers were required every 10-m along the wall. Along the top of the capping beam, three coils of galvanized steel razor wire were required. Inside the perimeter wall, the design required two internal chain link fences, 3-m high, and spaced 4-m apart, with three coils of galvanized steel razor wire running along the length of each fence.

The design required 14 guard towers along the perimeter wall. The 9-m high towers, included 200-mm thick reinforced concrete walls and floors. The design also included a reinforced concrete balcony that ringed the interior guard station on the observation level of the tower.

Site Photo 1 provides an example of the guard tower, the perimeter wall and the perimeter fence construction. During our site visit, we observed that the guard towers were in place, the perimeter walls were constructed, and the coils of wire were located on top of all perimeter walls. In addition, the interior perimeter fences were in place, as designed, with the three coils of razor wire on top of the fences, and the sully gate was installed (Site Photo 2).

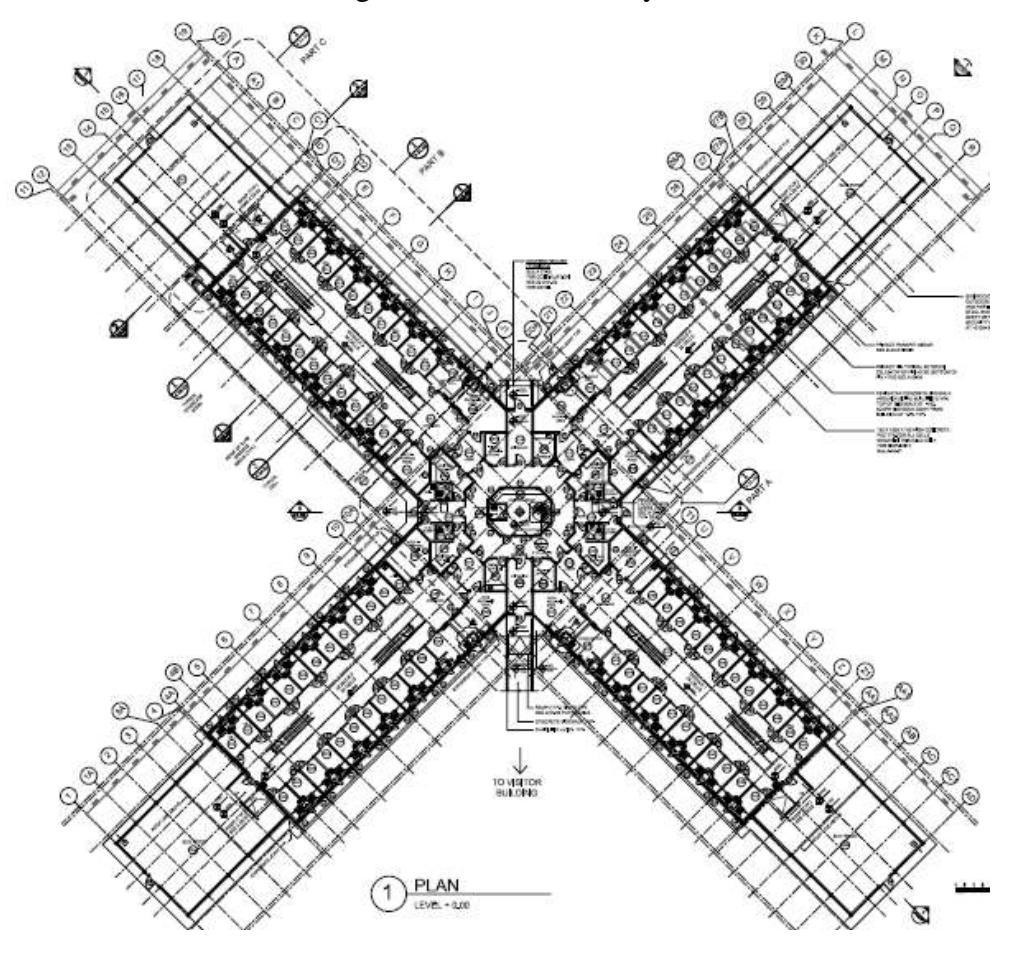
Figure 4. Inmate housing design (Figure courtesy of the USACE)

The two inmate housing units were completed at the time of the site assessment. The building design required a reinforced concrete "X" shaped structure in-filled with reinforced concrete block walls. The four wings of each housing unit were designed to contain two floors of inmate cells with 26 cells upstairs and 24 cells downstairs in

each of the four wings for a total of 200 cells per building (Figure 4). Site Photo 3 shows the exterior walkway leading into the entrance of one inmate housing unit.

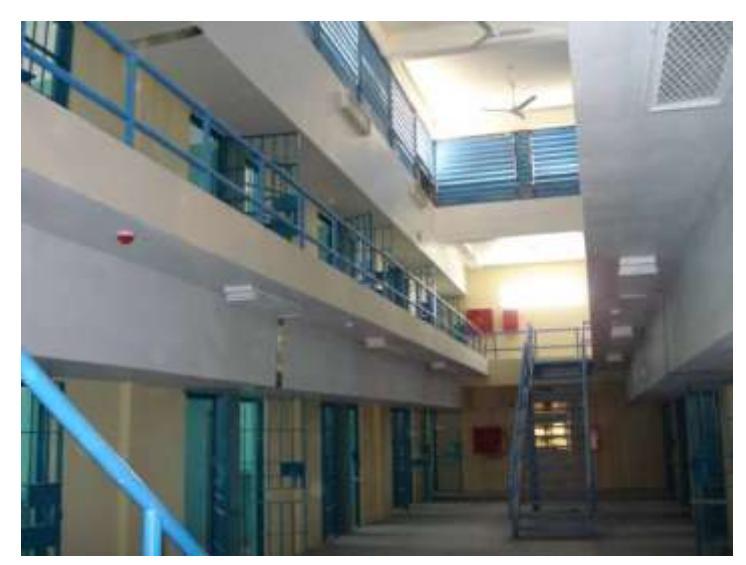
Site Photo 4. Inmate housing corridor one of four (Photo courtesy of the USACE)

The four wings of each inmate housing unit were connected to a central core area located on the ground level. The central core area contained a control room and control stations for each wing, a medical office, a pharmacy, as well as rooms for a barber shop, and a commissary for prisoners. Site Photo 4 shows the central core area leading to one wing of the inmate housing unit. The quality of workmanship exhibited in the inmate housing areas was satisfactory.
