# NASIRIYAH PRISON FACILITY NASIRIYAH, IRAQ

SIGIR PA-06-054 July 24, 2006

### SUBJECT: Report on Project Assessment of the Nasiriyah Prison, Nasiriyah, Iraq (Report Number SIGIR-PA-06-054)

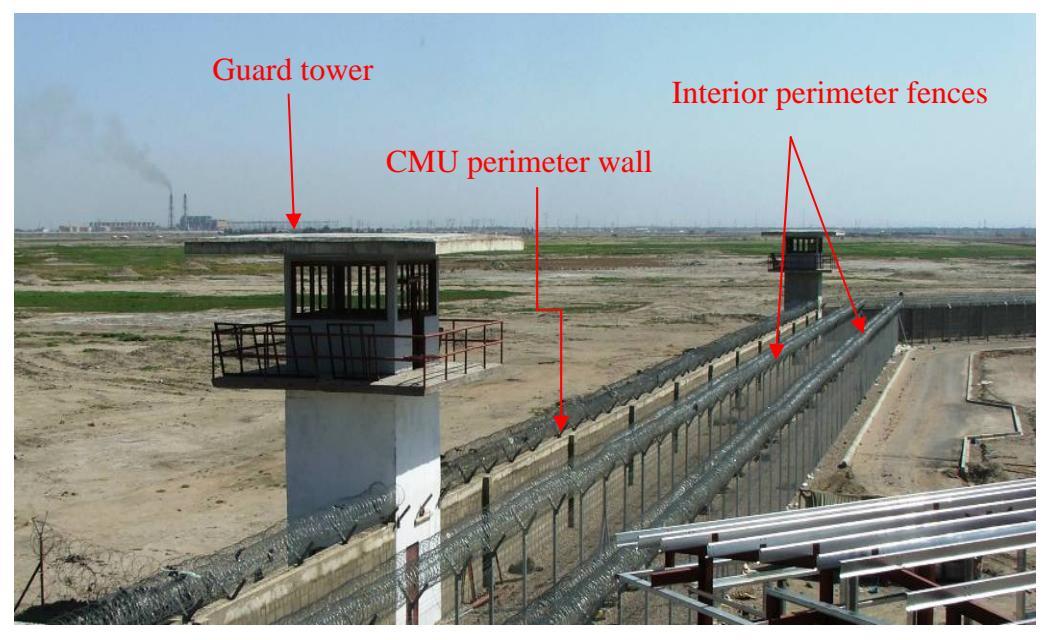
The design required 14 guard towers along the perimeter wall. The 9 m high towers, included 200 mm thick reinforced concrete walls and floors. The design also included a reinforced concrete balcony that ringed the interior guard station on the observation level of the tower.

Site Photo 1 shows the guard tower, the perimeter wall and perimeter fence construction. During our site visit, we observed the guard towers were in place and were painted. Due to time constraints, we were not able to closely inspect any of the towers. We also verified the perimeter walls were constructed and the coils of wire were located on top of all perimeter walls. In addition, the interior perimeter fences were in place as designed with the three coils of razor wire on top of the fences.

Site Photo 1. Guard tower, perimeter wall and interior chain link fences along prison perimeter.

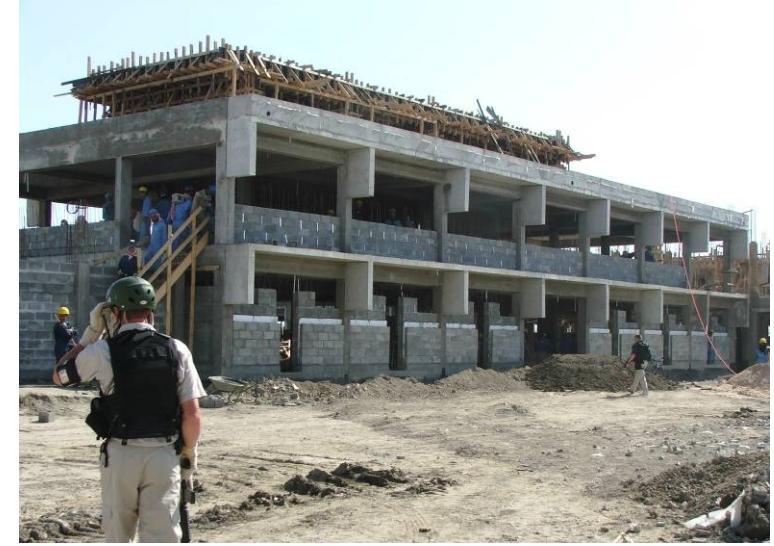
The two inmate housing units were under construction at the time of the site assessment. The building design required a reinforced concrete, "X" shaped structure infilled with reinforced concrete block walls. The four wings of each housing unit were designed to contain two floors of inmate cells, with 24 cells per floor in each of the four wings for a total of 192 cells per building. We observed considerable construction activities on both inmate housing units. Although, the structural frame (foundations, beams, columns, and floor slabs) was almost complete, we did not observe any concrete being poured, although forms were in place on the upper floors in preparation for additional pours. The contractor was also laying concrete block on each of the floors. Site Photo 2 shows one of the wings under construction, and also shows the partially constructed exterior block walls. The exterior block wall design required a cavity wall consisting of an inner 200 mm block (single block-width wall), horizontally and vertically reinforced, and anchored to an outer 100 mm block wall. Within the cavity between the walls, the design called for 50 mm of insulation board, and a finish coating of cement plaster and paint on the interior and exterior side of the wall. Site Photo 3 provides a picture of the cavity wall construction.

Site Photo 2. Exterior view of one of the four wings of an inmate housing unit

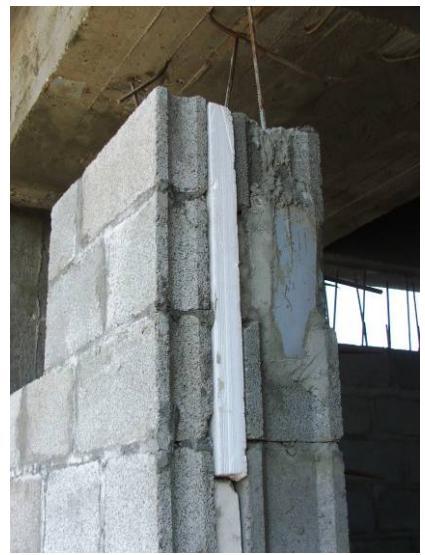
Site Photo 3 – Exterior cavity wall

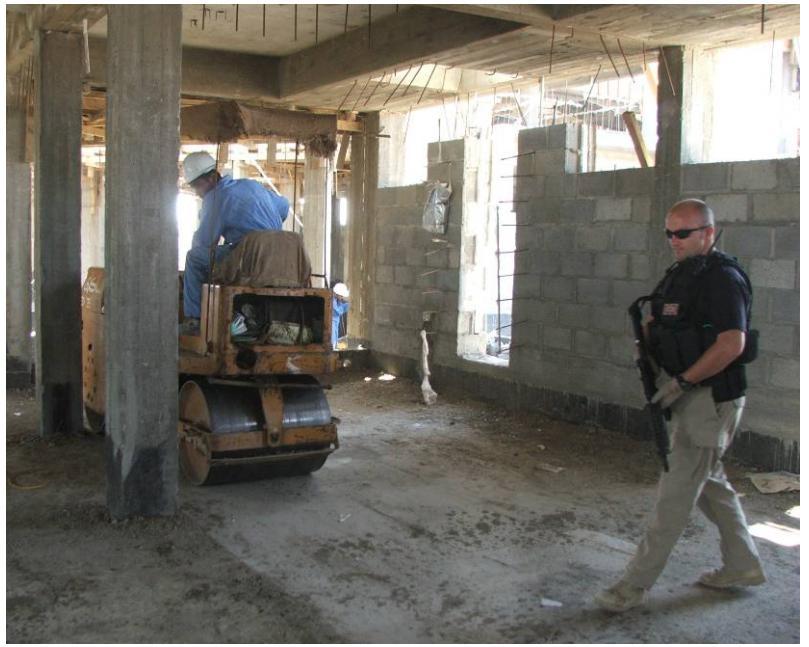
Each inmate cell is designed for two persons, with a sink, an eastern style toilet, a shower, and two beds consisting of a 750 mm by 1800 mm concrete pad on the cell floor as one bed and the other being a wall mounted 750 mm x 1800 mm steel bed frame. The design also required an exercise area at the end of each wing, partially covered with a pre-engineered metal roof structure. Plumbing work had not started yet, so we did not observe any interior finishes within the cells. Additionally, on the ground floor in each of the two inmate housing units, the contractor was still preparing the site prior to pouring a 150 mm reinforced concrete floor slab. Site Photo 4 shows one of the workers compacting the ground floor soil base prior to the construction of the concrete floor slab.

Site Photo 4. Ground floor soil base being compacted

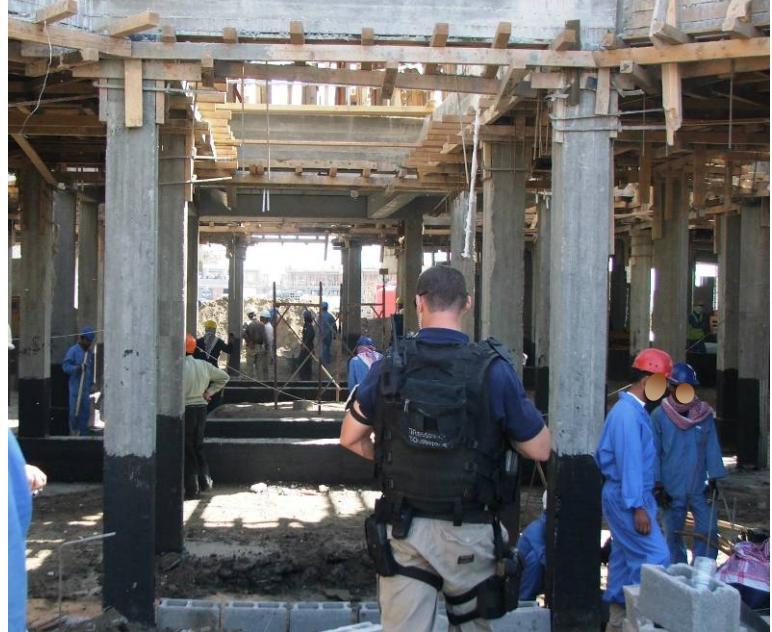
The four wings of each inmate housing unit connect to a central core area located on the ground level. The central core area contained a control room and control stations for each wing, a medical office, a pharmacy, rooms for a barber shop, and a commissary for prisoners. At the time of our site visit, the work in this area involved preparing the soil base for the floor slab and interior block wall construction. Site Photo 5 shows the central core area construction in one of the inmate housing units.

Site Photo 5. Central core area under construction in inmate housing building

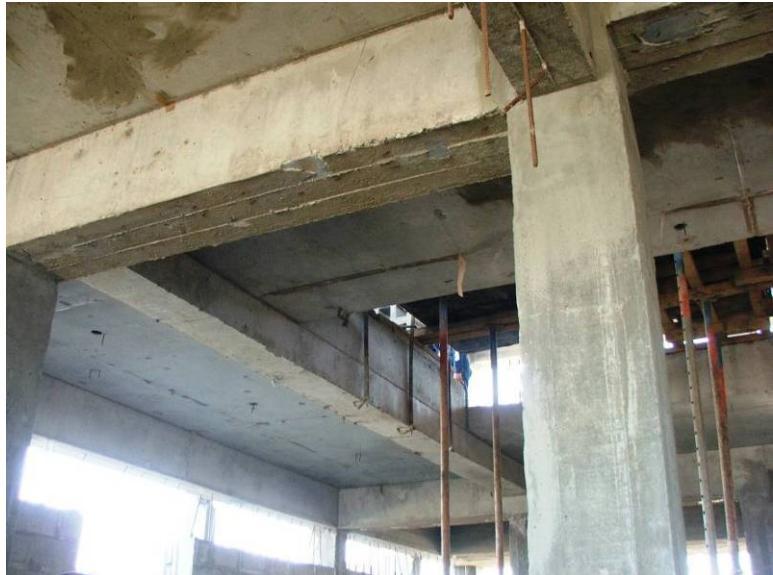
The quality of workmanship exhibited in both inmate housing areas was good. The structural concrete we observed did not have any noticeable cracking, segregation or honeycomb areas. Site Photo 6 shows the reinforced concrete workmanship in one of the inmate housing units. In addition to the structural concrete, the block wall construction also appeared to meet the requirements of the design drawings and specifications.

Site Photo 6. Structural concrete frame for inmate housing building, second level

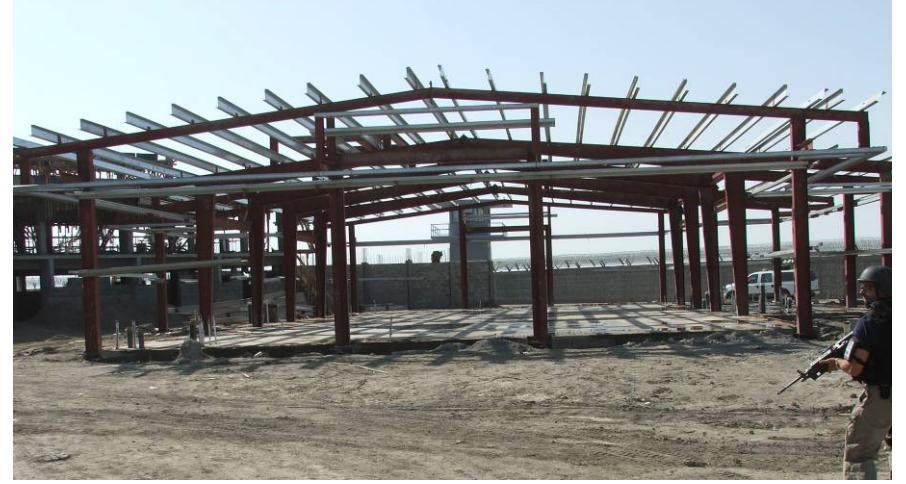
A visitation center was co-located with each inmate housing unit. Visitation centers were separate structures adjacent to an inmate housing unit. They were designed as one story, pre-engineered metal buildings, approximately 20.7 m by 32 m in size. The design required a foundation consisting of isolated reinforced concrete pad footings (2 m x 2 m) supporting reinforced concrete column pedestals (400 mm x 400 mm) and the reinforced concrete grade beams around the building perimeter. The concrete pedestals were designed to support the pre-engineered building's structural steel columns, and the grade beams supported the building 's exterior walls. At the time of our site visit, both visitation centers had complete foundations and concrete floor slabs, and most of the structural steel frame (steel columns, roof joists, etc.) on each center had been erected. Utility (sanitary and electrical) pipe and conduit were also installed under the concrete slab and stubbed up through the slab. During the site visit, we did not observe any defects with the quality of the visitation centers.

Site Photo 7. Structural frame for visitation center building

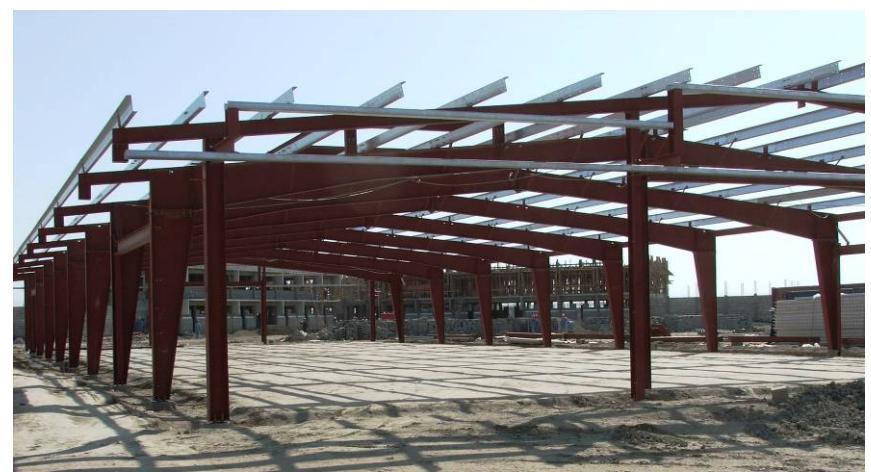
The structural design required a foundation consisting of isolated reinforced concrete pad footings (2 m x 2 m) supporting reinforced concrete column pedestals (400 mm x 400 mm) and reinforced concrete grade beams. The structural frame of the building included columns, roof joists, and purlins. When we toured the site, the foundation work and the structural steel frame were substantially complete, as shown in Site Photo 8. Inside the building, the sub-base was being prepared prior to pouring the concrete floor slab. Based on our observations, the construction progress appeared to meet the requirements of the design.

Site Photo 8. Intake/release/medical building structural frame

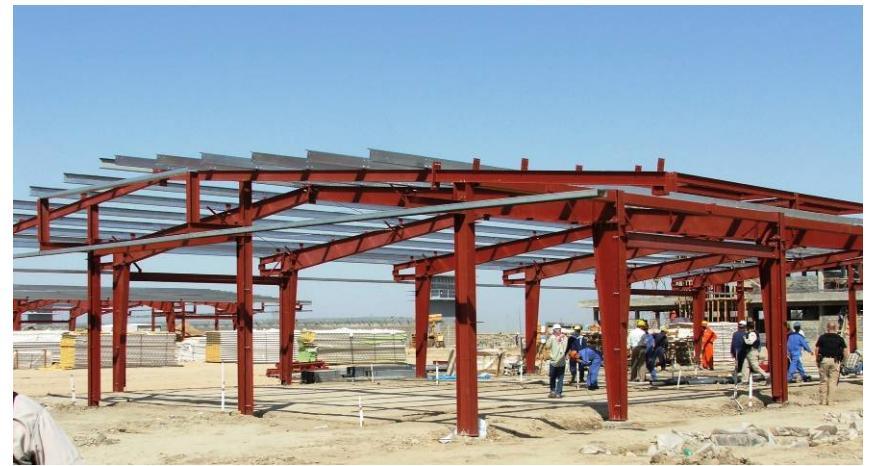
The maintenance building is another pre-engineered building with a similar foundation and structural design as the visitation centers and the intake/release/medical building. The 38 m x 17.1 m maintenance building included a vehicle maintenance area, workshops, as well as equipment and material storage rooms. When we inspected the maintenance building, workers were preparing the floor slab sub-base and installing PVC electrical conduit and PVC sewer pipe prior to the floor slab being poured. Site Photo 9 shows the work activity taking place at the maintenance building. The work we observed appeared to be consistent with the requirements of the design.

Site Photo 9. Maintenance building structural frame; workers installing under-slab conduit

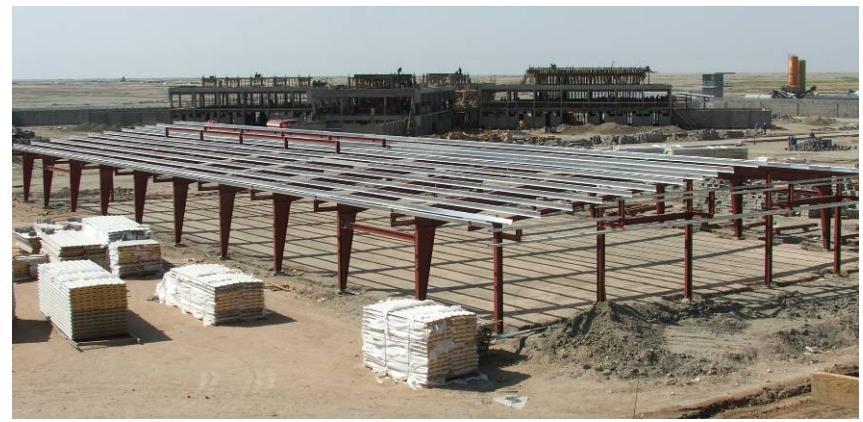
The 58 m x 26 m kitchen and laundry building structural design was similar to the other pre-engineered buildings. The architectural floor plan showed that approximately 20% of the building will be used for laundry services. The kitchen area floor plan included refrigerated and dry food storage rooms, food preparation and cooking areas, and a dishwashing room. In addition, the floor plan included a dining area for the prison staff. At the time of the assessment, the kitchen and laundry building's reinforced concrete footers and column pedestals had been

constructed and most of the structural steel frame erected as shown in Site Photo 10. Due to time constraints, we did not inspect the kitchen and laundry building other than to verify its location and current construction status.

Site Photo 10. Kitchen and laundry building structural frame

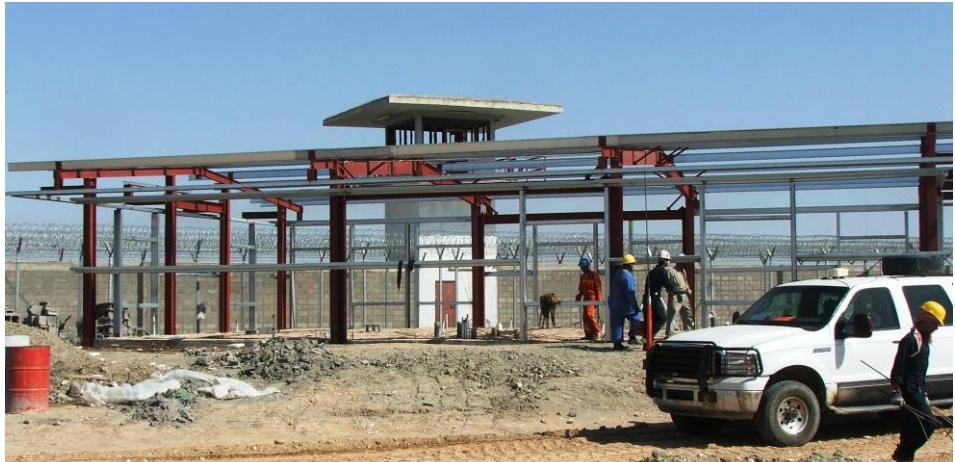
The 18 m x 10.2 m prayer building architectural design included prayer rooms and ablation facilities. The building is the smallest pre-engineered building at the prison. At the time of the assessment, the prayer building's reinforced concrete footers and column pedestals had been constructed and most of the structural steel frame erected. Utility stub ups were also in place in the floor slab base. Site Photo 11 shows the construction status of the prayer building. We did not closely inspect the building other than to verify its location and current construction status.

Site Photo 11. Prayer room building structural frame

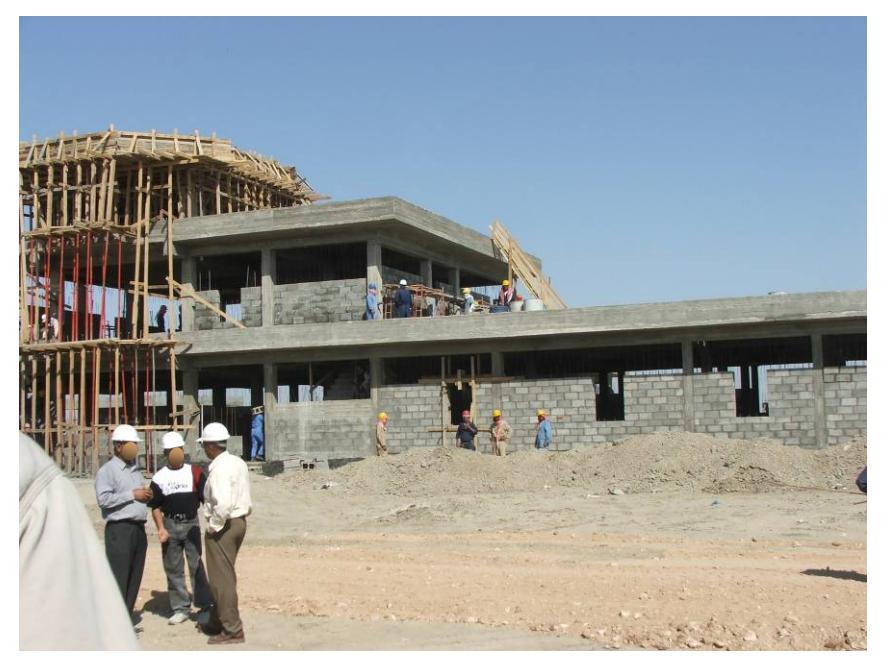
The administration building structural design required a reinforced concrete frame supported by a reinforced concrete foundation consisting of a combination of isolated pad footers and continuous spread footers. The exterior walls, similar to the inmate housing units were designed as cavity walls consisting of an inner 200 mm block wythe, horizontally and vertically reinforced, anchored to an outer 100 mm block wythe. Within the cavity between the walls, the design called for 50 mm of insulation board, and a finish coating of cement plaster and paint on the interior and exterior side of the wall. At the time of our assessment, workers were installing conduits and PVC pipe on the ground floor as well as constructing exterior block walls, and installing forms for window and door lintels. Site Photos 12 and 13 show construction work taking place on the exterior and interior of the building during our inspection.

Site Photo 12. Exterior wall construction on the 2nd story of the administration building

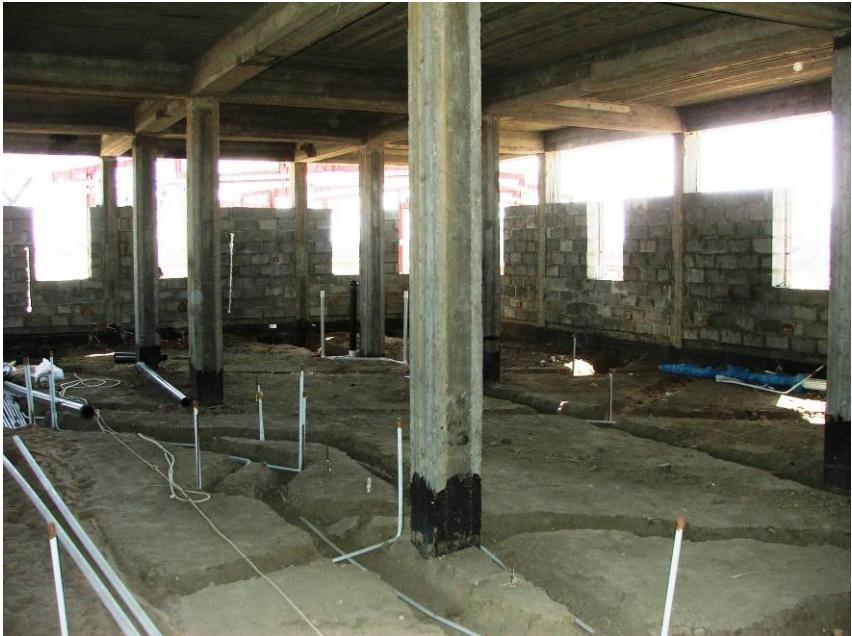
Site Photo 13. Under-slab PVC conduit and pipe being installed in administration building

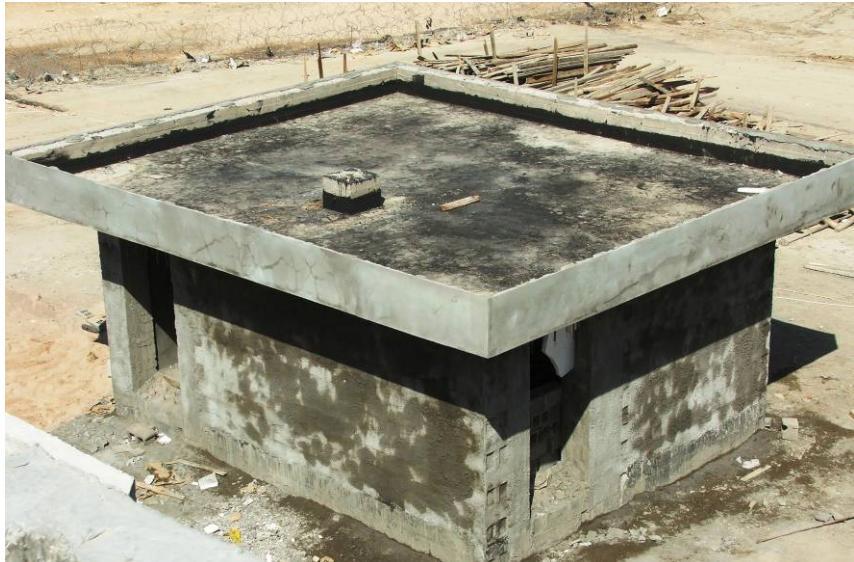
We did not inspect the prison armory, which was designed as a two-room, 6.5 m x 5 m reinforced concrete block structure, located adjacent to the administration building. However, we did view the exterior of the building and verified its location. The exterior block walls were constructed and plastering was in progress. The reinforced concrete roof slab and parapet were also constructed, but the built up roof was not complete. Site Photo 14 shows the exterior of the armory.

Site Photo 14. The prison armory

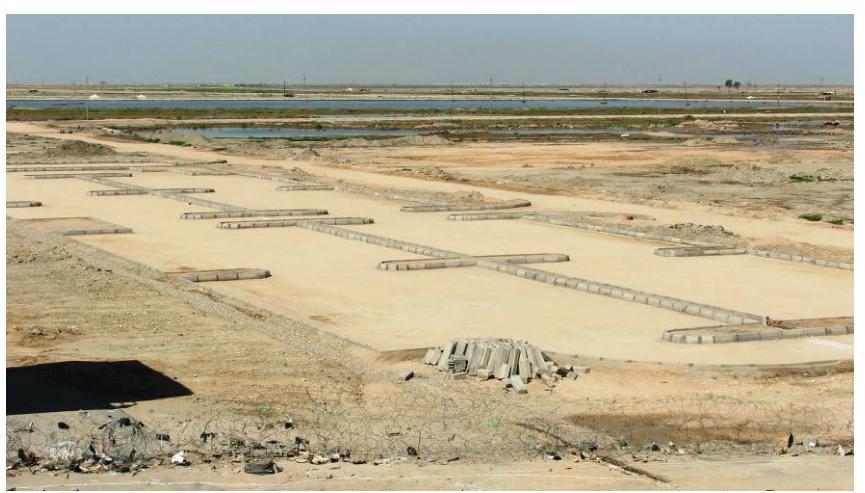
The other prison facilities under construction we did not inspect were the access road and the visitor/employee parking lot. The 160-space parking lot was not complete, although the traffic islands, curbing, and pavement base were constructed. As a result of delays caused by the shortage of asphalt, paving operations had not started. For a picture of the parking lot islands, curbing and base preparation, refer to Site Photo 15.

Site Photo 15. Prison parking lot ready for paving

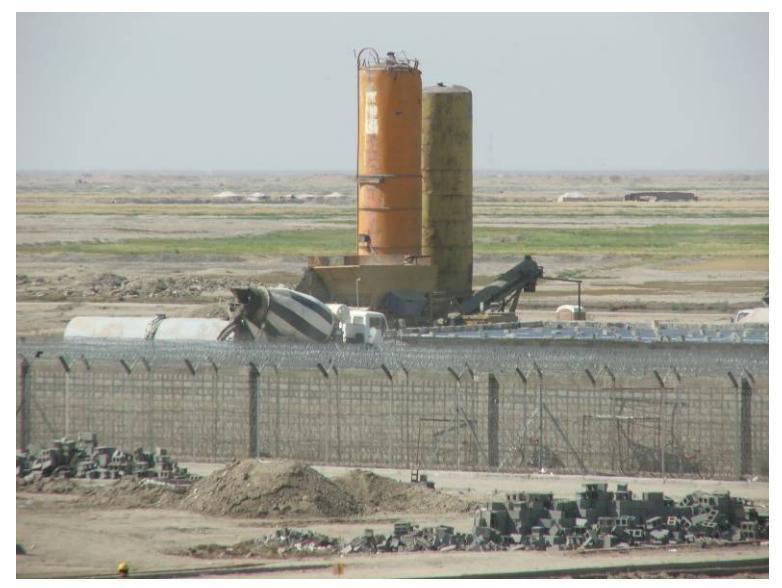
During construction, the contractor stated they utilized a primary and a secondary batch plant for on-site batching of concrete. Site Photo 16 shows the primary plant, located just outside the prison perimeter wall. The use of the concrete batch plants appear to have contributed to more consistent concrete quality.

Site Photo 16 Primary and secondary batch plants
