# The Effect of Weld Penetration on Blast Performance of Welded Panels

DSTO-TR-3017

A modified explosion bulge test method was used demonstrate the difference in performance of full-penetration (nominally 100%) welds and partial-penetration (nominally 70%) welds under blast loading. The welded coupons consisted of armour steel plate, Bisalloy BisPlate High Hardness Armour steel, welded to Bisalloy BisPlate80 steel with an austenitic filler material, TETRA S 20 9 3-G. If was found that full-penetration welds will withstand, without cracking, closer blasts, and correspondingly greater blast loading, than partial penetration welds. However, there may be some critical length and size dimensions of the incomplete penetration for which the blast performance of the welded panel is not adversely affected.

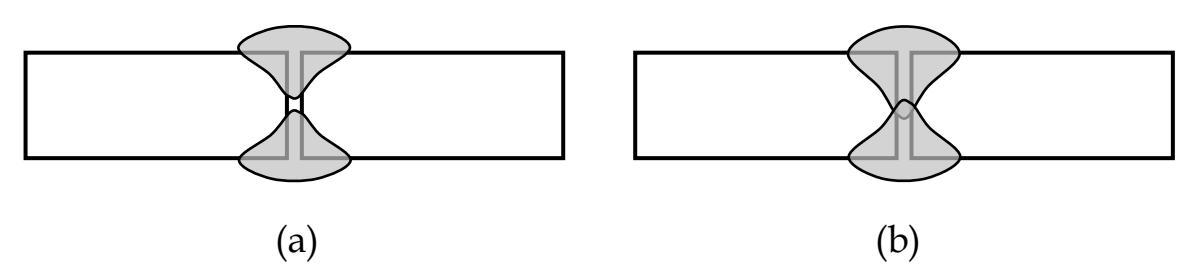
Figure 1: (a) A partial-penetration and (b) a full-penetration butt weld

Thus far there has been no testing to assess the risk posed by the presence of welding discontinuities, such as partial-penetration, in an armoured vehicle. The presence of incomplete or partial penetration along lengths of a welded vehicle has the potential to significantly reduce the blast resistance of the structure. Incomplete or partial-penetration, shown in Figure 1 (a), is where two opposing weld beads do not interpenetrate. In contrast, a full-penetration weld, shown in Figure 1 (b), will have interpenetration of the two opposing weld beads. Partial-penetration discontinuities can be detected using radiographic or ultrasonic inspection methods.

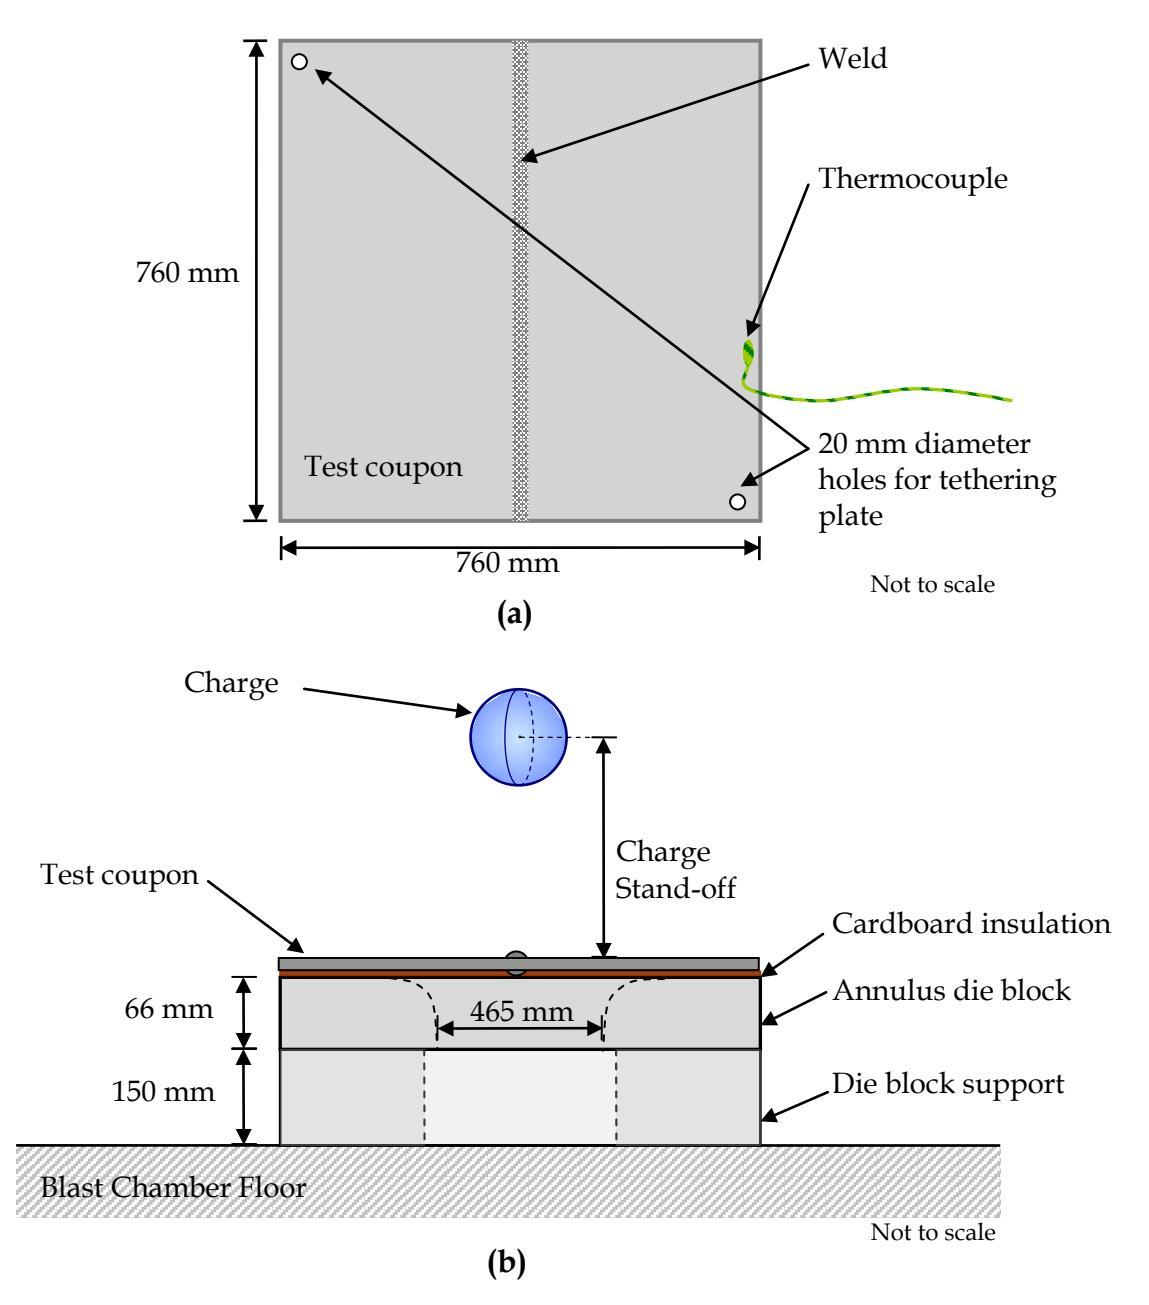
*Figure 2: Schematic diagram of (a) a test plate showing plate dimensions, thermocouple location, weld and location of holes and (b) the test set-up immediately before each test.*

In an EBT a test coupon measuring 760 mm by 760 mm is placed on an annulus-shaped die to allow the test coupon to bulge as a result of loading generated by an explosive charge suspended above the coupon. A schematic of the EBT test configuration is shown in Figure 2. The bulged coupon is described as having a 'compression' side, the side facing the charge, and 'tension' side, the side facing the die, which follows the convention defined within the standard for explosion bulge testing [5]. However, as the applied loading often produces deflections that are greater than half the plate thickness it is more likely that the full thickness of the plate experiences tension. Nevertheless, the tension/compression nomenclature has been maintained in this report for consistency with the standard.

In this series of tests the stand-off distance, defined as the distance between the compression surface of the test coupon and the centre of the charge, was the parameter varied – decreasing the stand-off resulted in more severe blast loading.

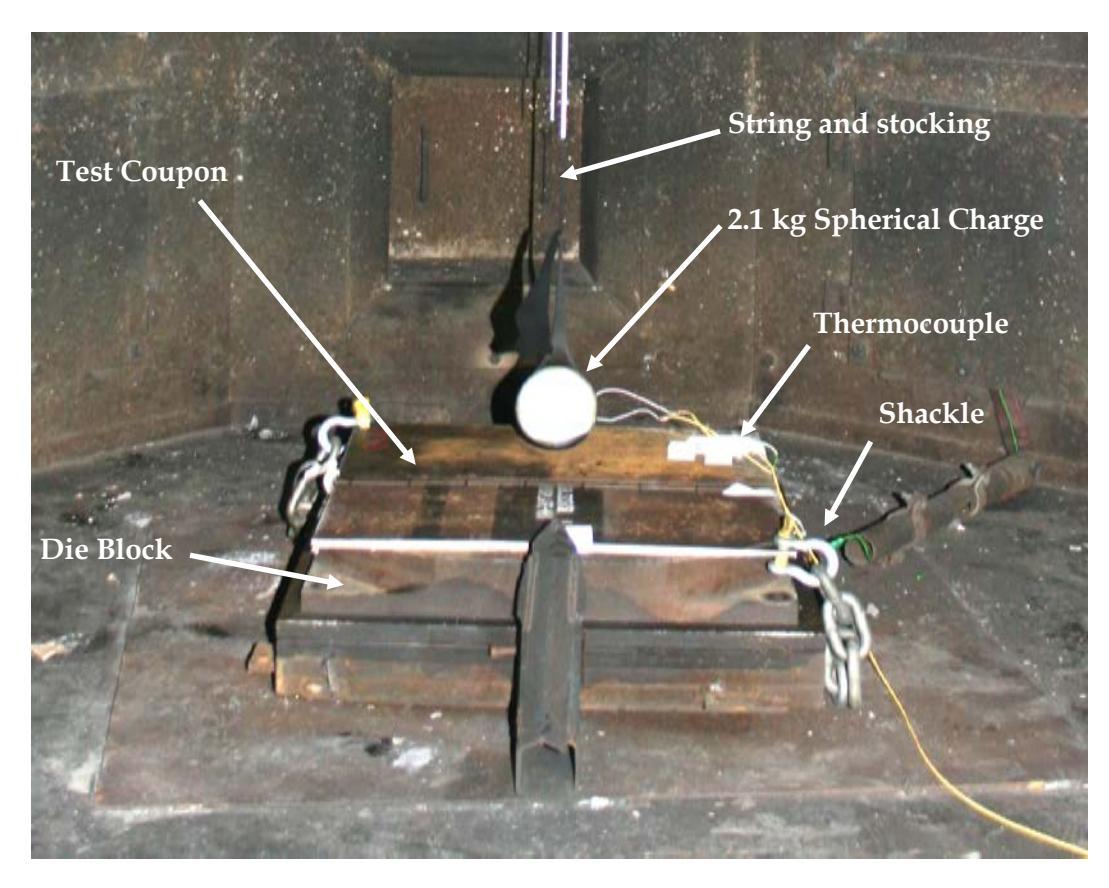
Figure 3: Experimental set-up in Blast Chamber

Tests were conducted in the 3 kg Explosion Chamber at the High Explosives Firing Complex (HEFC) at DSTO's Edinburgh site. A photograph of the test setup is shown in Figure 3.

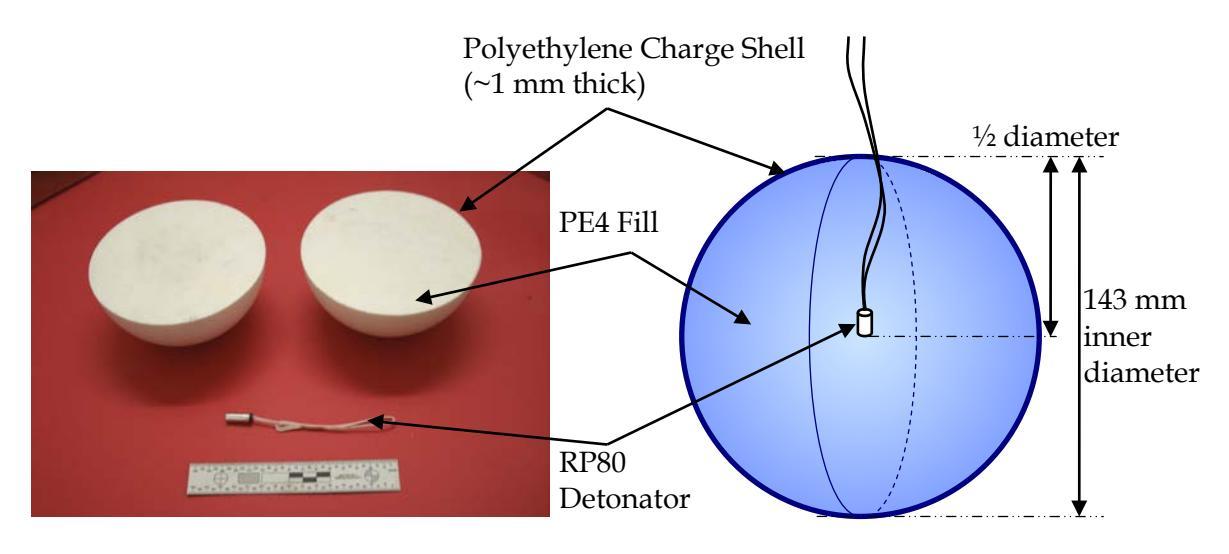
Figure 4: Charge configuration for all tests

A spherical charge was selected to achieve greater consistency in the shape of the explosive loading and to increase the potential for scalability and comparisons with future experimentation. The charge consisted of two high density polyethylene hemispheres packed with a combined mass of  $2.100 \pm 0.025$  kg PE4 plastic explosive. The charge was initiated with an RP80 detonator positioned as shown in Figure 4.

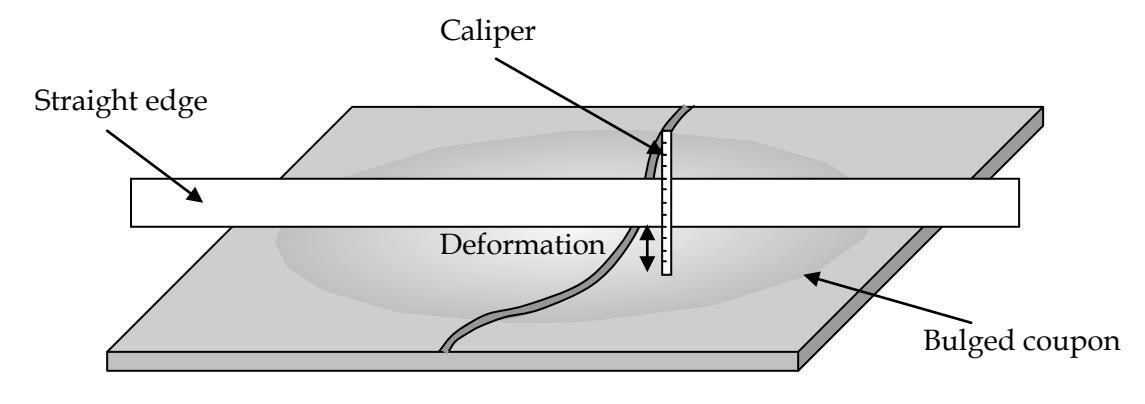
Figure 5: Method for measuring coupon deformation

Post blast deformation was measured by placing a straight edge across a tested coupon, perpendicular to the weld bisecting the bulge, and using a caliper to measure the distance from the straight edge to the plate at intervals from the centreline of the weld, as shown in Figure 5.

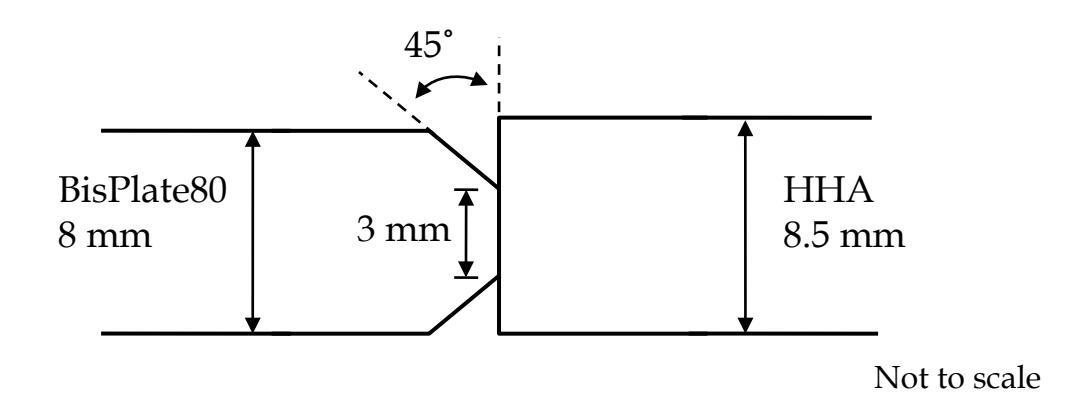
Figure 7: Edge preparation for GMA welding process

Consumable:	1.2 mm diameter TETRA S 20 9 3-G
Shielding gas:	Argon
Preheat:	None
Run off/ run on plates:	Yes
Edge Preparation:	double bevel-groove and tee edge
<u> </u>	(bevel on the BisPlate80)

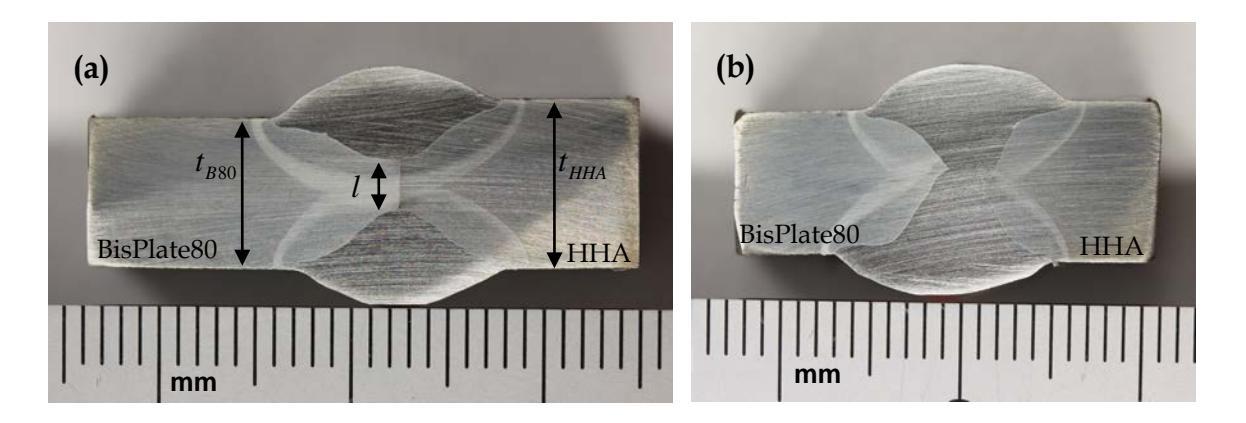
Figure 8: Micrographs showing (a) the partial (~70%) penetration weld and (b) the full (100%) penetration weld, where  $t_{B80}$ ,  $t_{HHA}$  and l are the thickness of the BisPlate80, BisPlate HHA and the un-fused portion of the edge, respectively.

A total of 25 coupons were welded, 15 with parameters to achieve partial (approximately 70%) penetration and 10 with welding parameters to achieve full (100%) penetration. The welding parameters are listed in Table 4 and micrographs of the two weld conditions are shown in Figure 8. The estimated heat input is approximately 800 J/mm for the full-penetration condition and 780 J/mm for the partial-penetration condition.

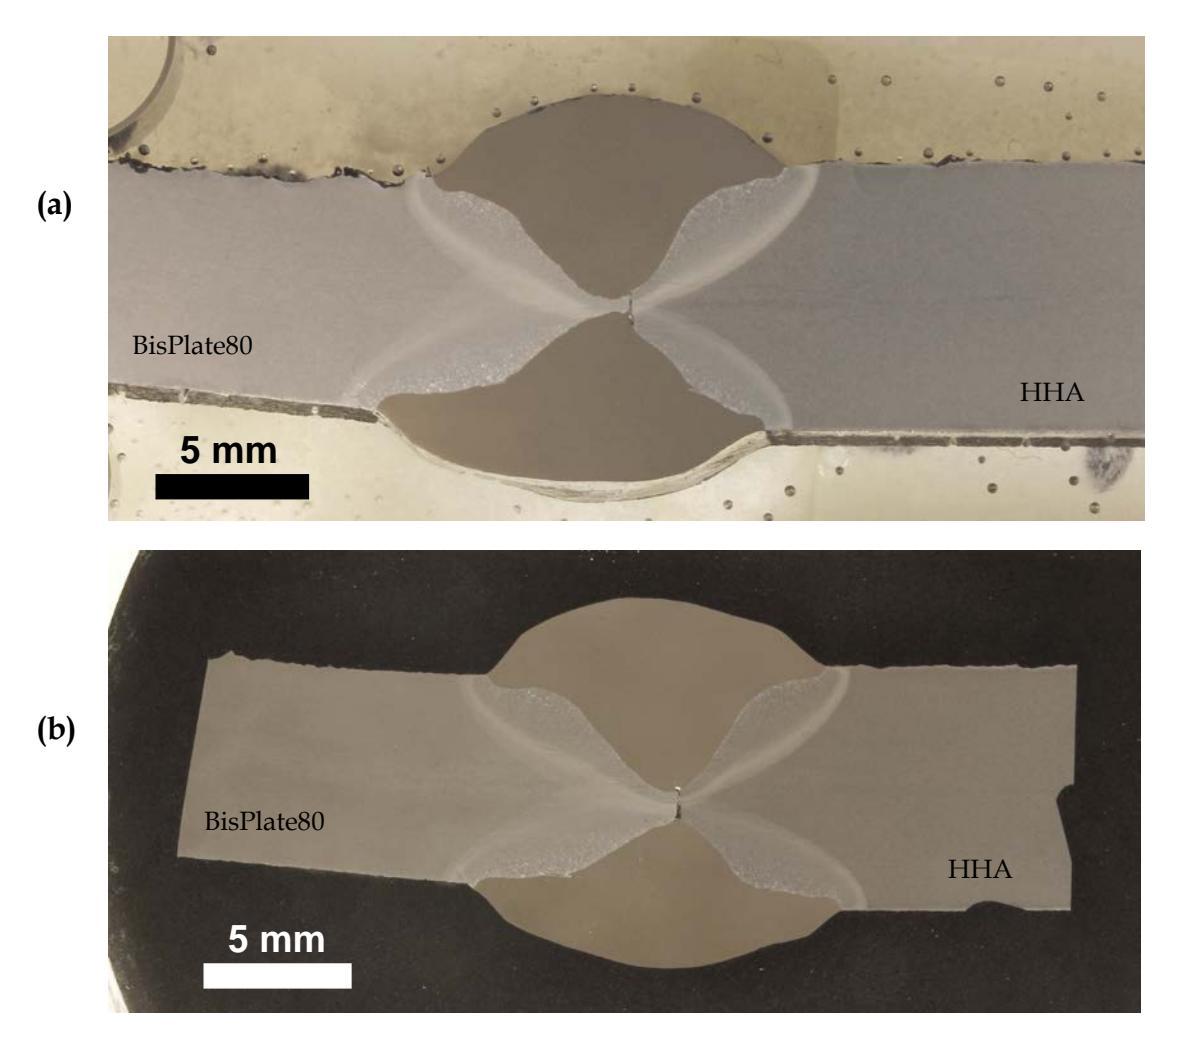
*Figure 9: Polished and etched section of coupon labelled (a) 100-02 and (b) 100-04 showing less pronounced partial-penetration (~90% penetration).*

Coupons 100-02 and 100-04 represent a less severe incomplete penetration condition than the specified partial-penetration coupons. The metallographic sections in Figure 9, taken after testing, show that the size of the incomplete penetration in the through thickness direction is approximately 1 mm, or a 90% penetration condition, for both coupons. These two plates were set aside until testing had established the threshold stand-off distance below which the full-penetration coupons exhibited cracking. Coupons 100-02 and 100-04 were then tested at that threshold stand-off distance in order to investigate the effect of threshold loading on a less severe incomplete penetration condition.

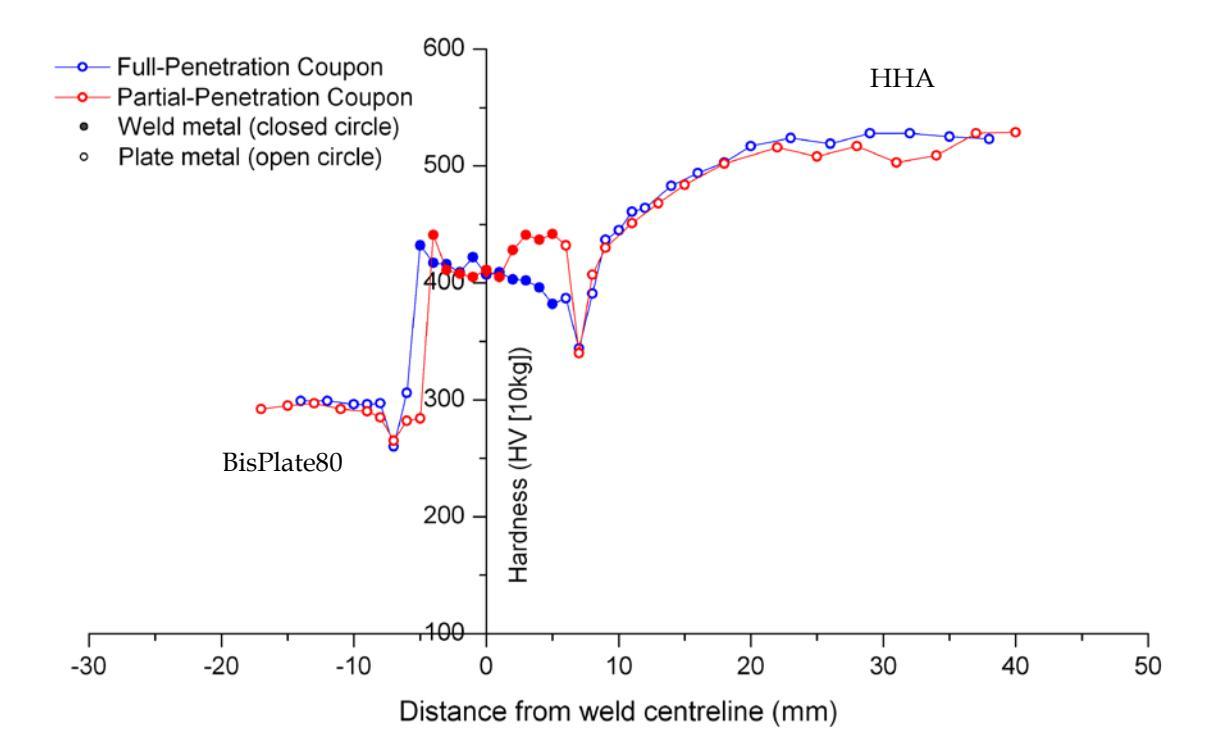
*Figure 11: Hardness traverse across a partial-penetration (70%) and a full-penetration (100%) coupon.*

A hardness traverse was performed across a mounted and polished section of both a partial-penetration and a full-penetration coupon. A Vickers hardness indenter with a 10 kg load was used for the hardness tests. The traverse was taken approximately 500  $\mu$ m from the plate surface through the first pass, as shown in Figure 10 for the full-penetration coupon. These results have been plotted in Figure 11.

The hardness traverses plotted in Figure 11 show that the weld hardness profile of the test coupons is reasonably consistent between the two welding conditions. The measured hardness of the weld material ranged between 382HV and 442HV.

The BisPlate80 HAZ extends approximately 4 to 6 mm from the fusion boundary, beyond which the BisPlate80 hardness values plateau at approximately 300HV. The hardness traverse values progressing from the fusion boundary into the BisPlate HHA plateau at approximately 520HV approximately 20 mm from the fusion boundary.

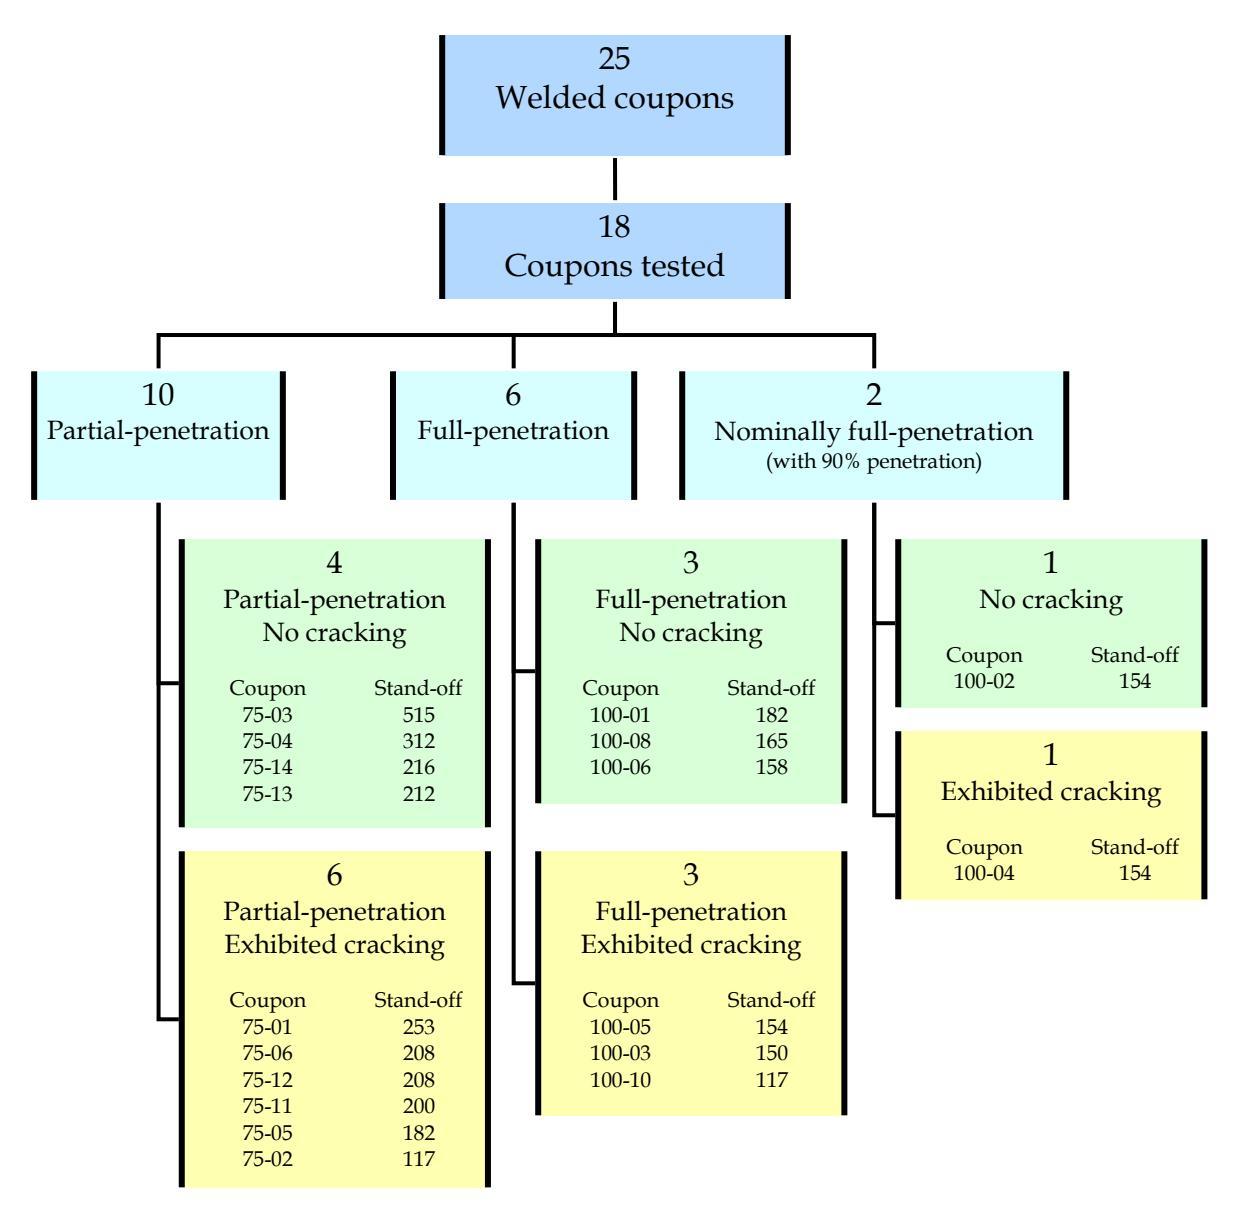
*Figure 12: Categorical breakdown of observed coupon behaviour. Stand-off distances are expressed in millimetres*

Eighteen blast tests were conducted during the trial. The tests were conducted on ten partial-penetration coupons, six full-penetration coupons and two nominally full-penetration coupons that contained limited lengths of approximately 90% penetration weld. The response of the welded coupons to blast ranged from minimal detectable change, observed at a stand-off of 515 mm, to extreme deformation and extensive cracking in both the weld zone and the plate material at stand-off distances below 150 mm. The full spectrum of these responses is shown photographically in Appendix D and a categorical breakdown of observed coupon behaviour is shown diagrammatically in Figure 12.

As stated previously the response of the coupons to the blast loading ranged from little discernable deformation to extensive cracking. Figure 12 contains a list of the coupons which exhibited cracking.

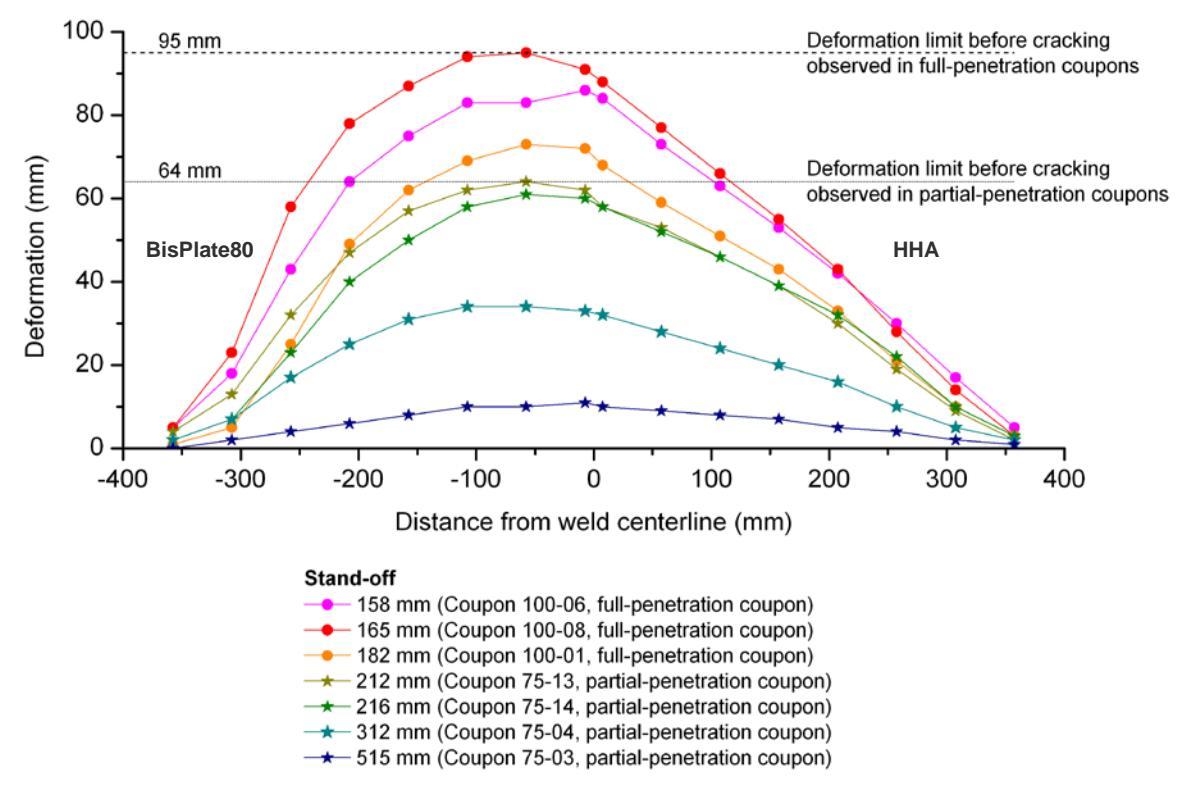
*Figure 13: Centreline deformation of plates that did not exhibit cracking. The stand-off distance that corresponds to each test is specified in the legend. The negative distances denote BisPlate80 material whereas positive distances are BisPlateHHA; the weld centreline is the zero reference.*

Deformation measurements were made of the uncracked coupons across the weld centreline as described in Section 3.2. Figure 13 shows the deformation across the plate revealing the shape of the bulge. The deformation limit before coupon cracking for full-penetration coupons was approximately 31 mm greater than for partial-penetration coupons. This suggests that the full-penetration coupons were able to accommodate 50% more deformation before cracking. It can also be observed that the shape of the deformation is asymmetric with the BisPlate80 material exhibiting a more rounded bulge compared to the BisPlate HHA.

<sup>&</sup>lt;sup>3</sup> The asymmetric nature of the bulge observed in Figure 13 results from the large difference in the strength of the BisPlate80 and the BisPlate HHA.

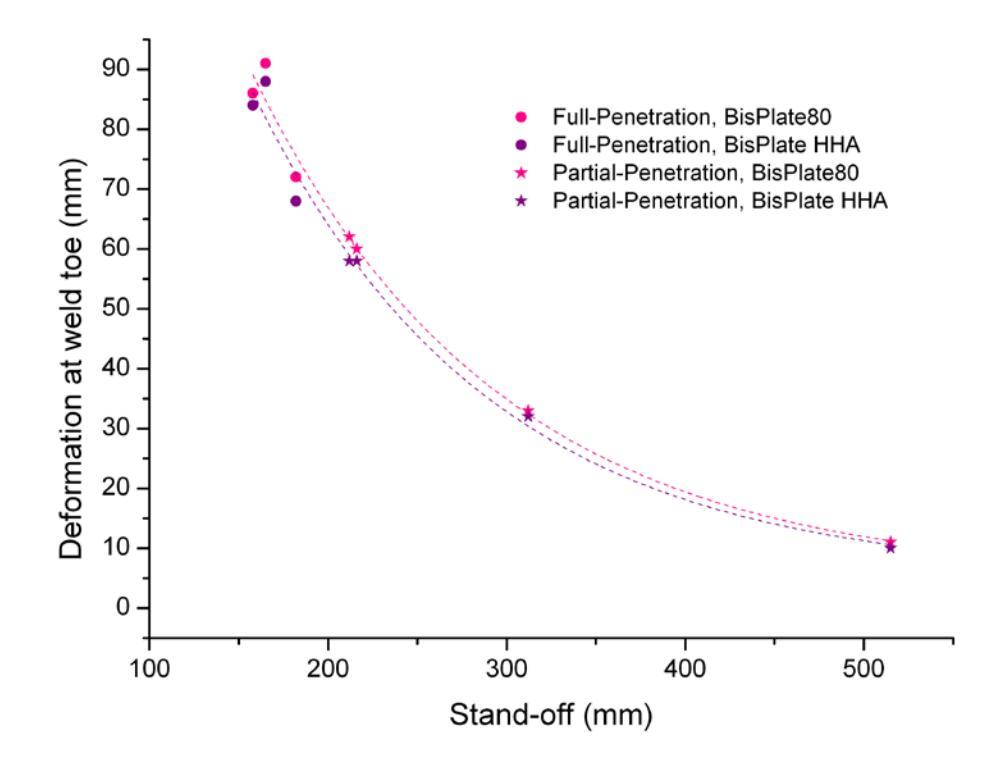
*Figure 14: Bisplate80 (pink) and BisPlate HHA (purple) deformation measured at the centre of the un-cracked coupons at the weld toe. Lines have been drawn to guide the eye to the trend in the data.*

Figure 14 shows the measured deformation at the weld toe at the centre of the coupon as function of the stand-off, for both the BisPlate80 and the BisPlate HHA material. The plate deformation showed a trend of increasing deformation with decreasing stand-off distance. The results for the full-penetration coupons contain an apparent outlier to this trend (at 165 mm standoff). This is most likely to be an artefact of the deformation measurement technique and will be discussed in Section 6.

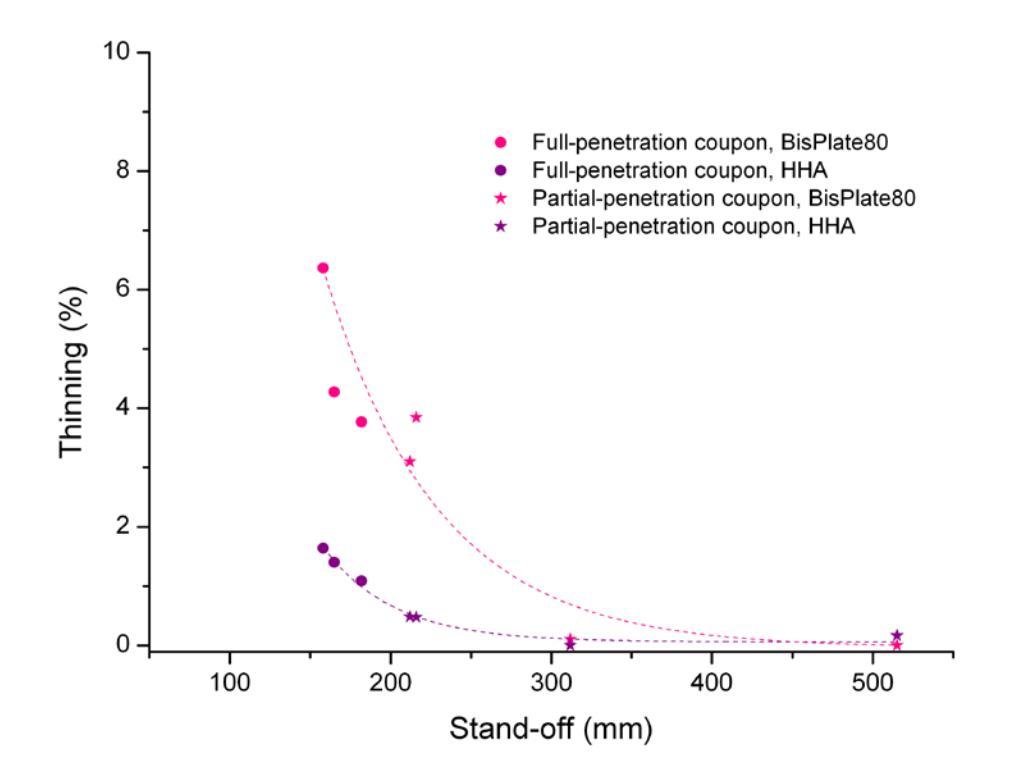
*Figure 15: Thinning results from the coupons that did not exhibit cracking. Lines have been drawn to guide the eye to the trend in the data.*

Figure 15 shows the thinning that was measured on the full-penetration and partialpenetration coupons which did not exhibit cracking. The BisPlate80 material experienced greater thinning, in all but one test, in comparison to the BisPlate HHA material. The exception occurs when there is almost zero discernable thinning. This exception is most likely a result of the error in the thinning measurements and the variability of the plate thickness. A dashed line has been drawn to guide the eye to the trend where more thinning will occur at smaller charge stand-off distance.

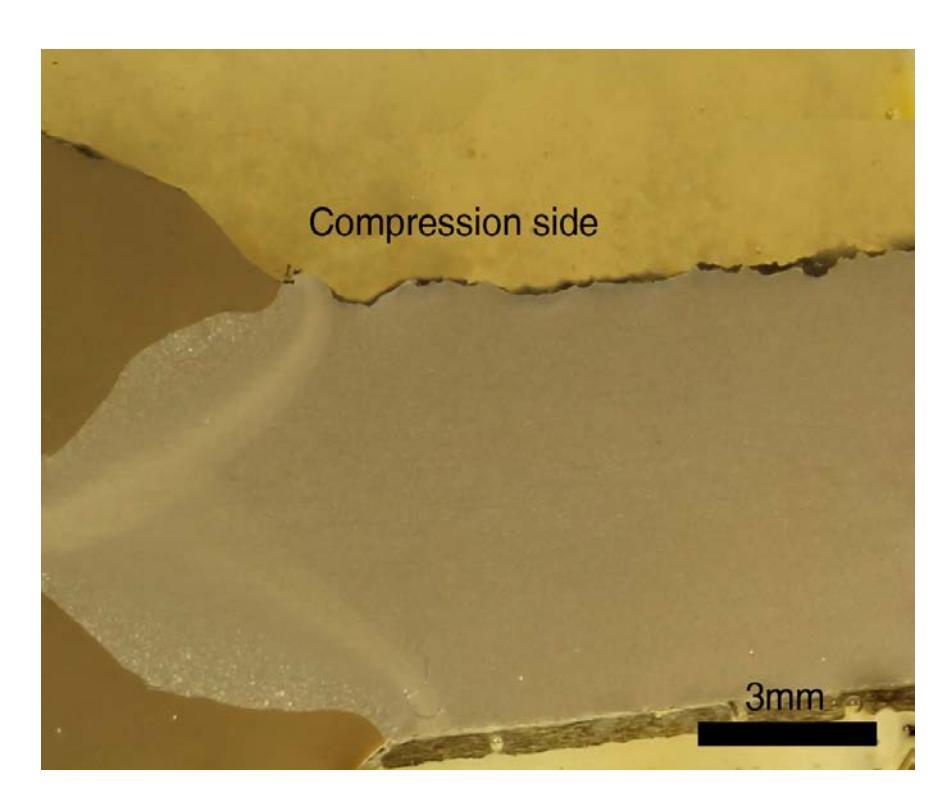
*Figure 16: The uneven surface topography on the compression side of plate 100-02*

Error in the thinning measurements is always present as a result of the uneven surface topography created by the blast on the compression face of the plate. This is why an average of multiple thinning measurements was generated. The cross-section image of the compression side in Figure 16 shows the surface finish produced by close exposure to the blast. The compression surface is uneven and cratered with thickness variations that can be 0.25 mm or more.

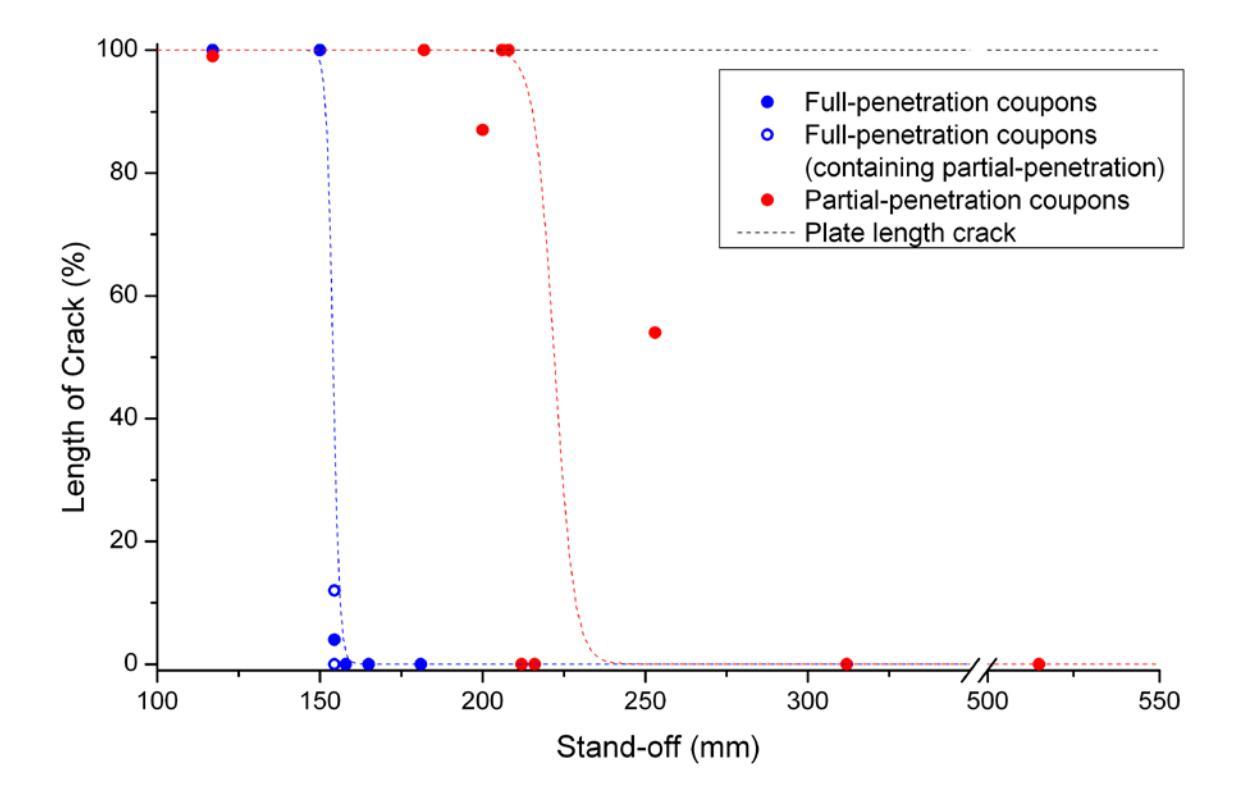
Figure 17: Longitudinal crack length results (expressed as a percentage of the coupon length) for coupons tested at different stand-off distances for the eighteen blast tests. The dashed lines have been drawn to guide the eye to the trends in the coupon behaviour and are not mathematical fits to the data.

Figure 17 shows the length of cracking in the coupon, expressed as a percentage of coupon length, observed as a result of varying the stand-off distance between the charge and the coupon. Coupons 100-02 and 100-04, containing the unintended incomplete penetration defects, have been grouped by colour with the full-penetration data, albeit with an open symbol.

The full-penetration data in Figure 17 shows that there is a distinct threshold stand-off, below which the coupon will exhibit cracking. The partial-penetration data shows a similar threshold, however there is more scatter in the results. Lines have been drawn in Figure 17 to guide the eye to the location of these thresholds but are not mathematical fits to the data. It is evident from these results that the stand-off distance at which failure occurs is greater for the partial-penetration weld condition.

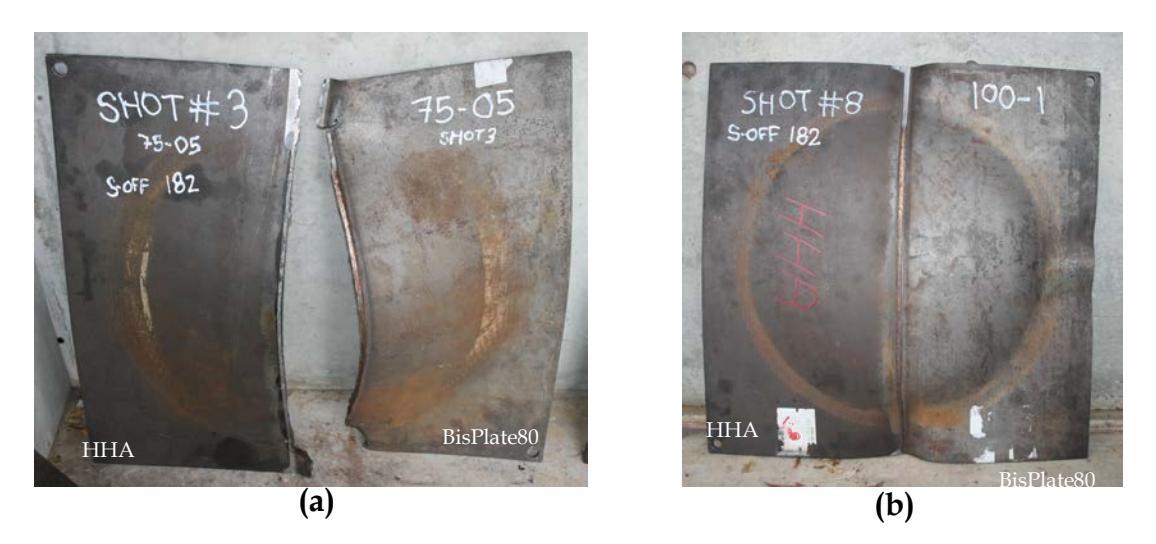
*Figure 18: A direct comparison of the blast resistance of; (a) a partial-penetration coupon and (b) a full-penetration coupon, where both were tested at a stand-off distance of 182 mm. The partial-penetration coupon failed completely whereas the full-penetration coupon did not exhibit cracking.*

Further illustrating the difference between the two welding conditions is the direct comparison between a partial-penetration coupon (75-05) and a full-penetration coupon (100-01), which were tested at the same stand-off distance of 182 mm (Figure 18). At this stand-off distance the partial-penetration coupon has completely failed through the weld zone, while the full-penetration coupon has deformed without cracking. The full-penetration coupons remained intact until the test stand-off distance was reduced to 154 mm.

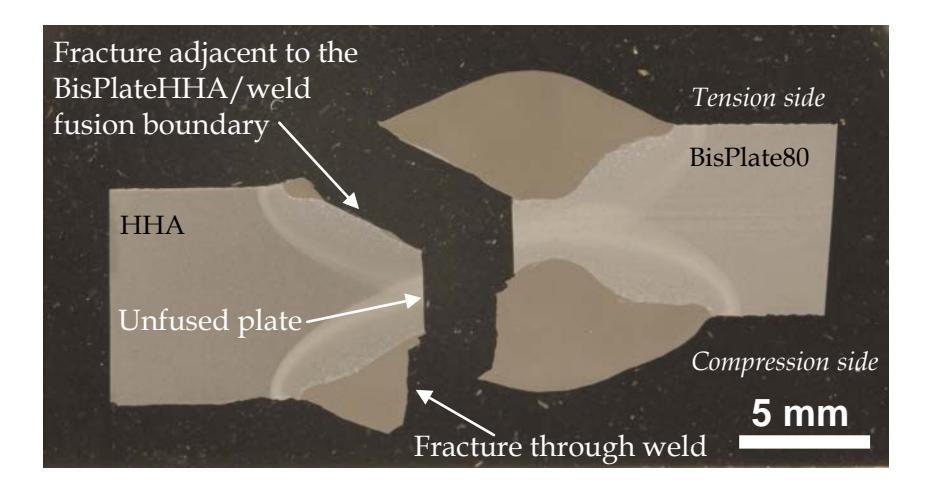
*Figure 19: A polished and etched section of a failed partial-penetration coupon (75-12) illustrating the most common crack location configuration.*

In the five partial-penetration coupons with cracking solely in the weld zone, the crack location configuration varied from coupon to coupon and along the length of the cracks in individual coupons. The most common crack location configuration, however, was adjacent to the fusion boundary between the BisPlate HHA and the weld on the tension side and through the weld metal on the compression side. Figure 19 is a polished and etched section taken through the fracture surface of coupon 75-12 showing this predominant crack location configuration.

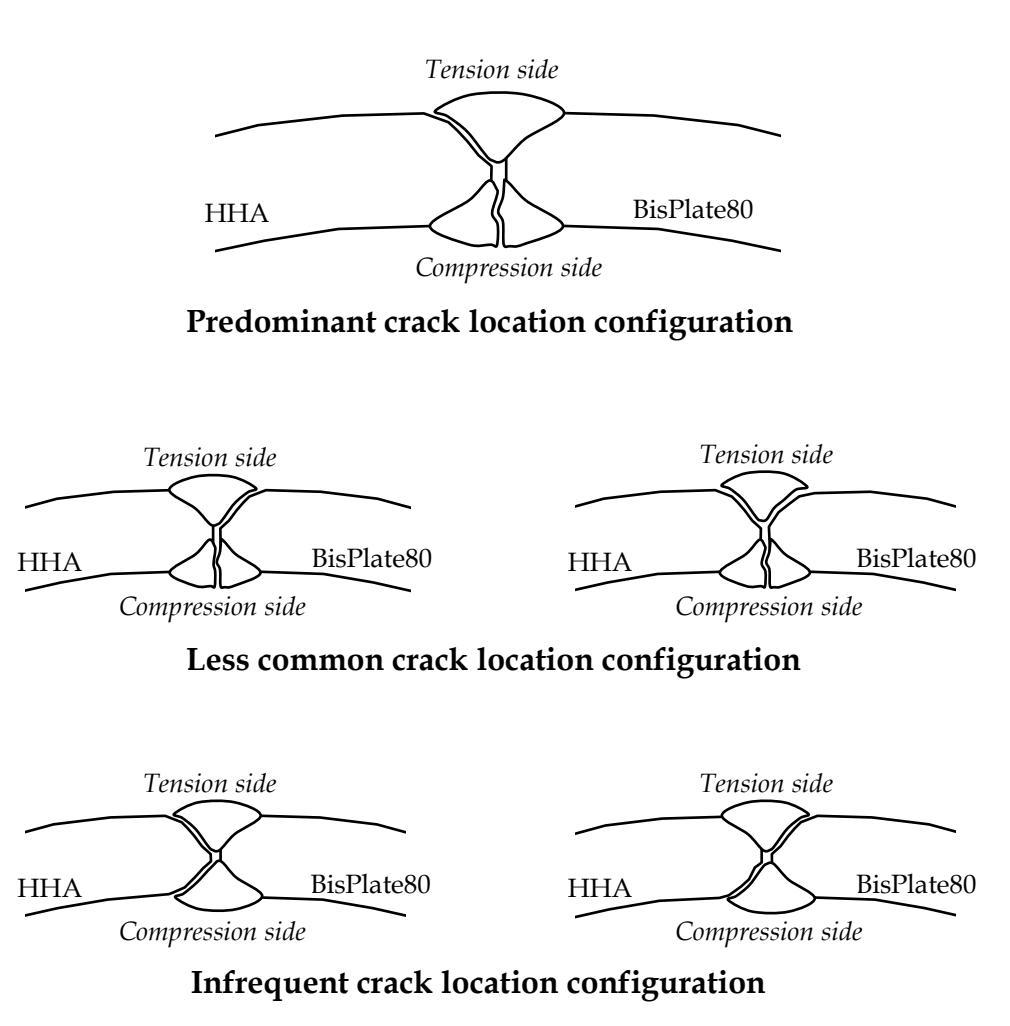
*Figure 20: Crack location configurations observed in cracked partial-penetration coupons. Crack configurations often varied along the length of the crack.*

Figure 20 shows the range of crack location configurations that were observed in the cracked partial penetration coupons. Crack configurations often varied along the length of the crack.

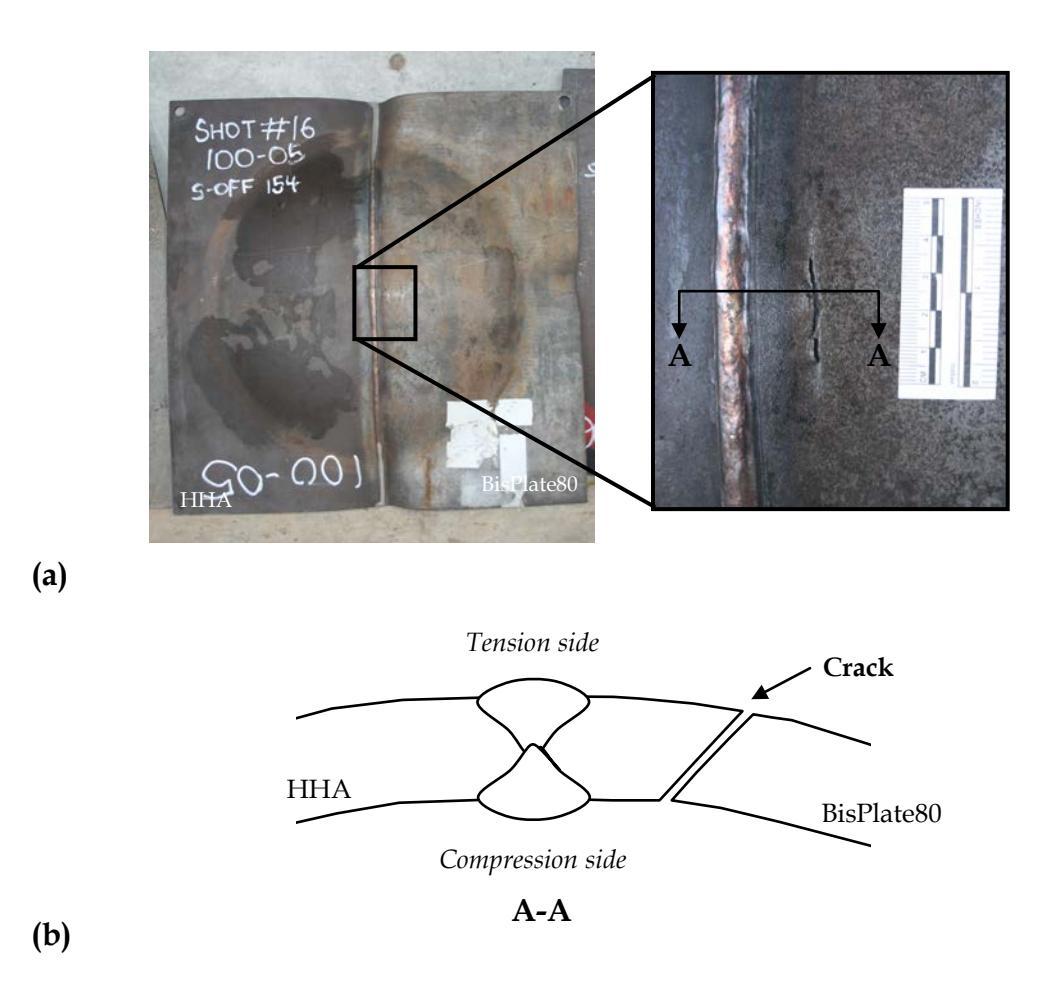
*Figure 21: Full-penetration coupon (coupon 100-05) tested at a stand-off distance of 154 mm, (a) photograph and close-up and (b) schematic of cross-section 'A-A'.*

Three full-penetration coupons exhibited cracking. These are shown in Figure 21, Figure 22 and Figure 23, corresponding to coupons 100-05, 100-03 and 100-10, respectively. Of these coupons, the test with the largest stand-off distance, 154 mm (Figure 21, coupon 100-05), exhibited cracking only in the BisPlate80 parent metal, 20 mm from the weld toe on the tension side through to 8 mm from the weld toe on the compression side. The crack was located outside the HAZ, and only grew to approximately 30 mm in length. The fracture path was at a 45° angle to the plate surface which is characteristic of a slant fracture resulting from tensile tearing. A sketch of the cross-section 'A-A' through this crack is shown in Figure 21 (b).
