ASD TECHNICAL REPORT 61-507

FLIGHT VIBRATION SURVEY OF **JRB-52B AIRCRAFT**

JULY 1961

AERONAUTICAL SYSTEMS DIVISION AIR FORCE SYSTEMS COMMAND UNITED STATES AIR FORCE WRIGHT-PATTERSON AIR FORCE BASE, OHIO

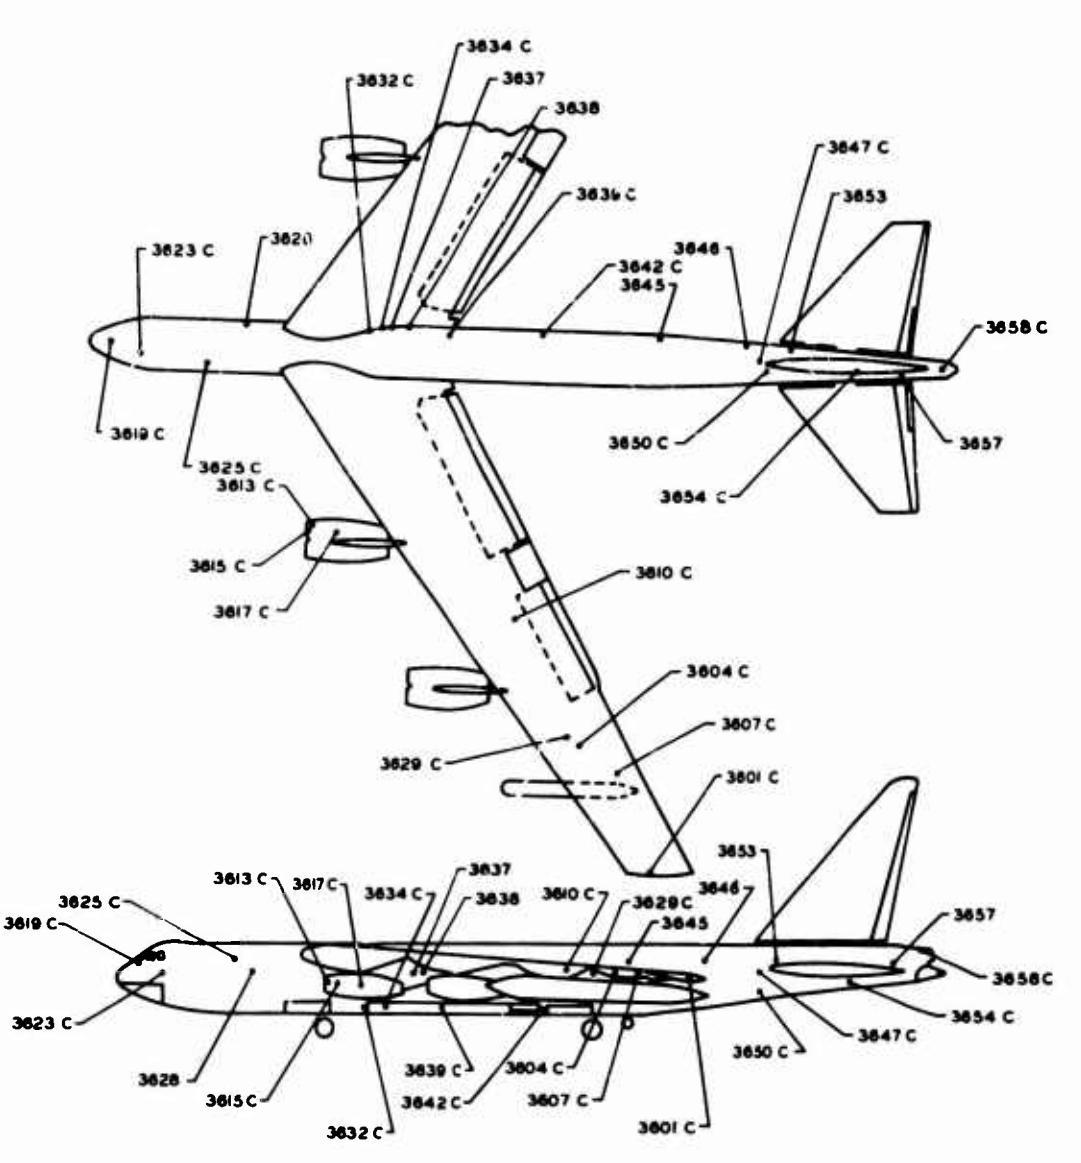
Figure 1. Schematic Presentation of Pickup Locations

MB Manufacturing Co. Type 124 velocity pickups were mounted in clusters at 26 separate test points to sense vibration along each major axis of the aircraft engines and structure. The locations are summarized in Table I and depicted in Figure 1. The Type 124 velocity pickup has the following characteristics:

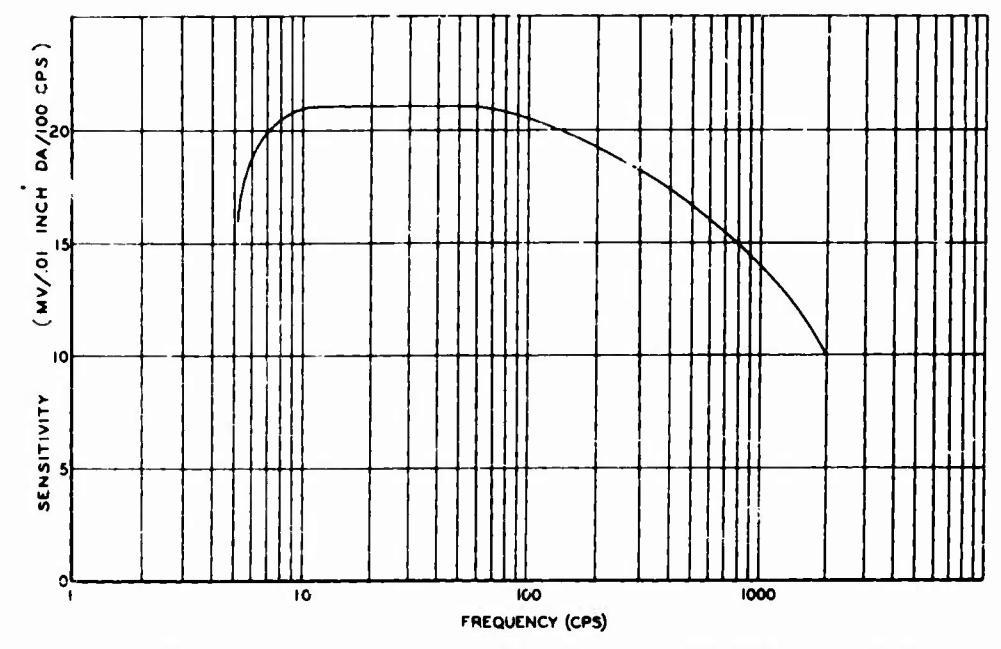
Figure 2. Frequency Response of M. B. Type 124 Vibration Pickup

A typical response curve is shown in Figure 2. The three-position mounting blocks used to attach the pickups to the vehicle structure have no resonances below 500 cps.

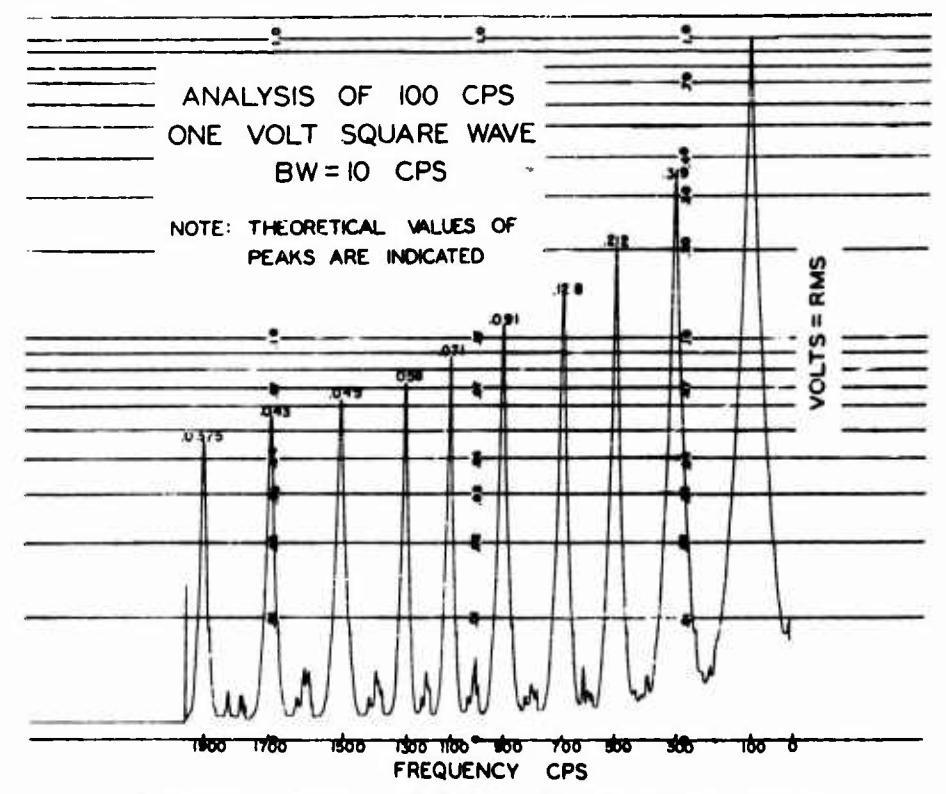
Figure 4. Analysis of 100 cps One Volt Square Wave

The Model 510 Davies automatic analyzer is a constant-bandwidth, heterodyne analyzer complete with motor-driven, variable-frequency oscillator. The system has fix separate analyzers and can analyze six data-channels simultaneously. Both the oscillator scanning rate and analyzer bandwidth are adjustable within the following limits: (1) scan rate range of 0.3 to 3.0 cps/sec, and (2) bandwidth range of 1 to 40 cps. The output of the six wave-analyzer-channels is fed into six modified Brown strip-chart-recorders. Continuous spectrum plots of frequency (cps) vs. voltage (rms) are produced by the strip-chart-recorders. The chart speed is serve controlled and can be varied from 0.08 inches per minute to 13.5 inches per minute. The voltage is plotted on a logarithmic scale and the time required for full-scale deflection, i.e., zero to one volt, is approximately two seconds. A sample analysis of a 100cps square wave is shown in Figure 4. In selecting the bandwidth to be used in an analysis of this type, one must consider the following: (1) the frequency resolution desired, (2) the rate of scan, (3) the length of the data sample, (4) the time available for data analysis, (5) the quantity of data to be analyzed, (6) the type of data being analyzed, and (7) the type of presentation of the completed data. Based on a consideration of these variables, a bandwidth of ten cycles per second was selected for these analyses.

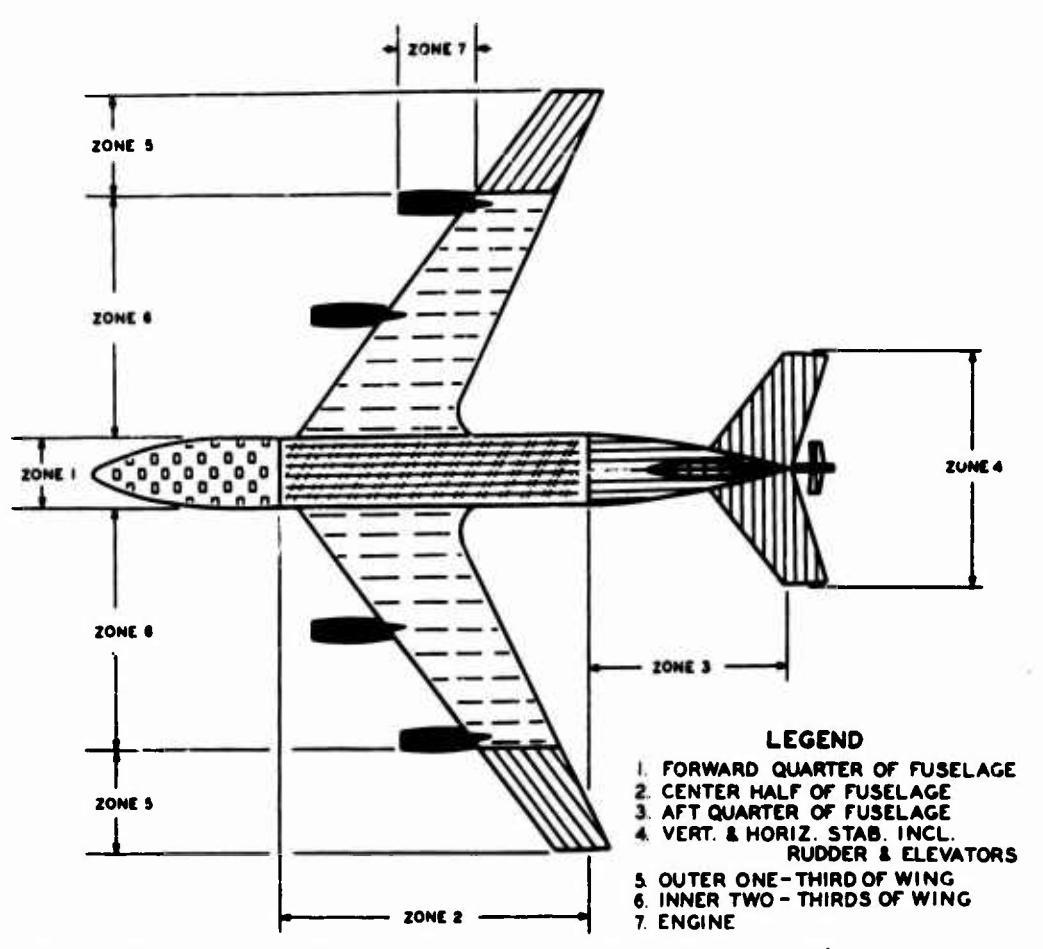
Figure 5. Schematic Presentation of Seven Basic Aircraft Structural Zones

Where the overall vibration-environment for a generalized structural zone, e.g. forward quarter of the fuselage, is desired, the Type 3 graphs are the most useful. The structure of the test vehicle has been arbitrarily divided into 9 major areas. Each of these major areas has been further subdivided into the following three categories: (1) vehicle structure, (2) rigidly mounted equipment, and (3) shockmounted equipment. A complete listing of these "structural zones" is contained in Table V. Figure 5 presents a typical basic distribution of seven aircraft structural zones.

As indicated in the section of this report which describes the method of data presentation, the structure of the aircraft has been divided into 9 zones. These in turn have been subdivided into three categories: (1) structure, (2) rigidly mounted equipment, (3) shockmounted equipment. With three exceptions all structural zone plots in this report are for data obtained on the aircraft structure.

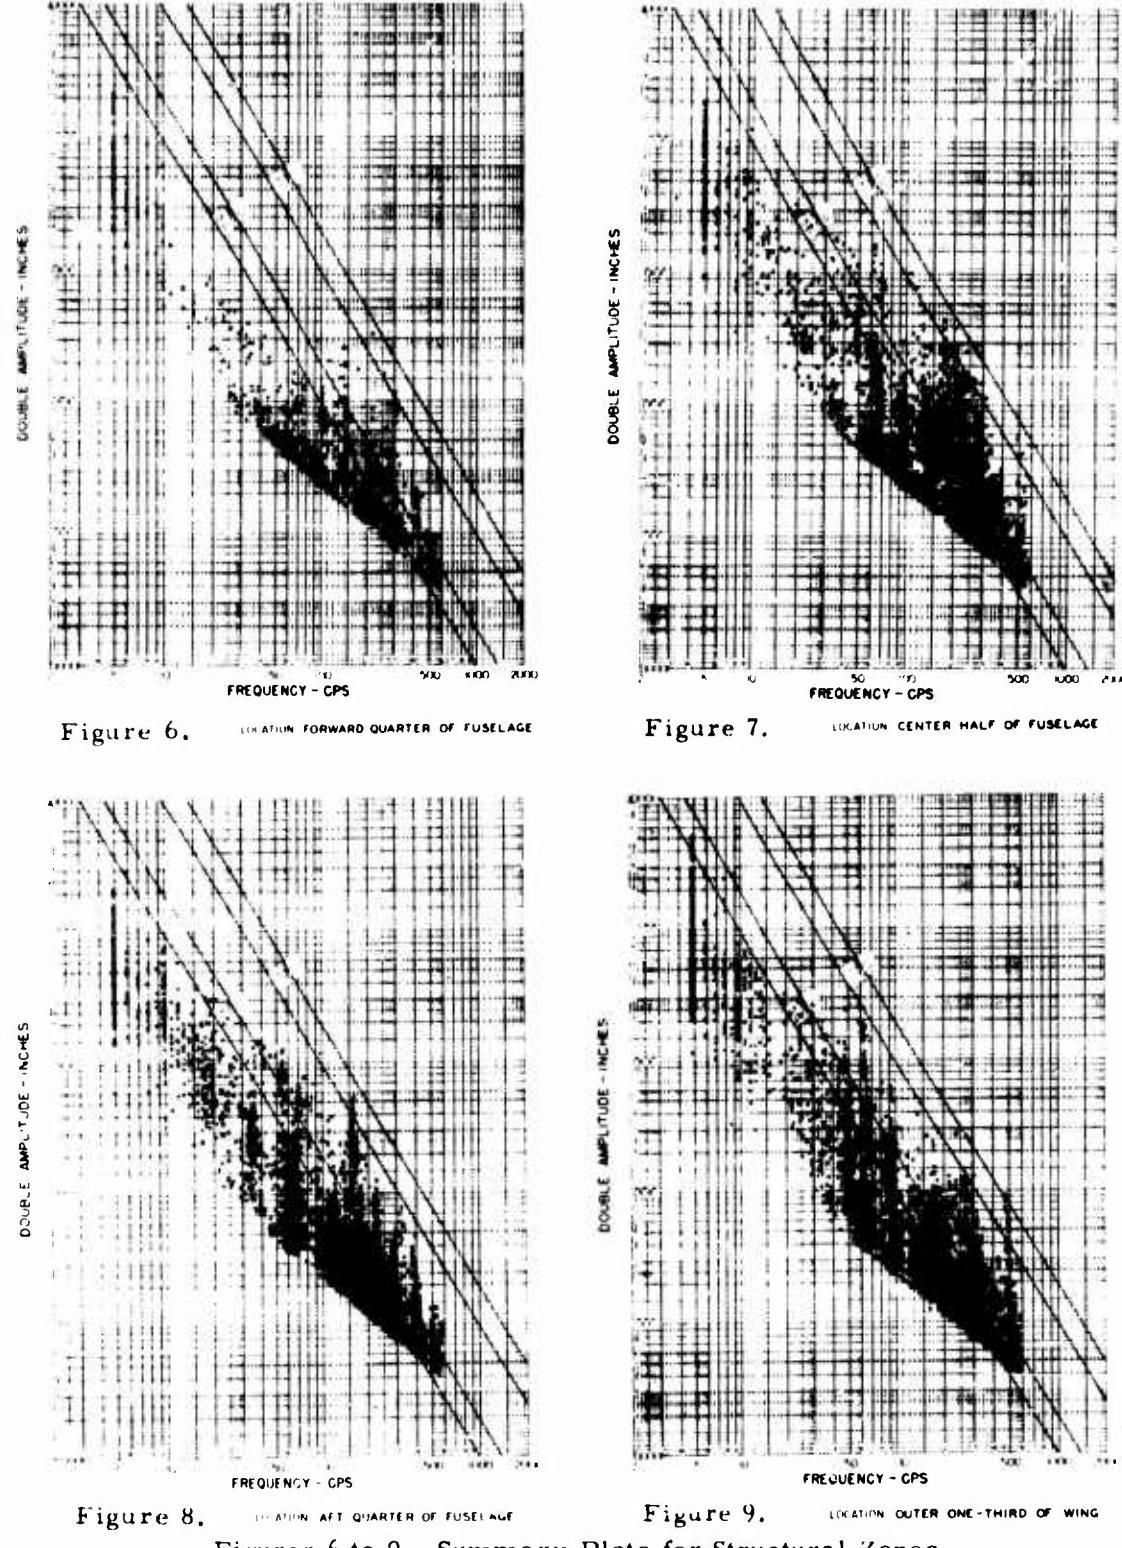
Figure 6 shows the data obtained on the structure of the forward quarter of the fuselage (from Sta 0 to 469). The data covers the 5-to 600-cps range rather thoroughly. The peaks which occur in the low frequency range (from 5 to 10 cps) are primarily a result of turbulent air and aerodynamic buffeting. The scattered data points between 10 and 100 cps are very low in vibratory double amplitude (with all values below 0.5 g). At the 100-to 110-cps frequency range, there is a peak condition showing the frequency range (6, 100 rpm) of the low-speed rotor of the twin spool J-57 engine. The data occurring in the 140-to 150-cps frequency range is due to the highspeed rotor. The 300-to 310-cps frequency range shows the second harmonic and 450 is the third harmonic of the high-speed rotor frequency. The concentration of data in the vicinity of 300 cps could be attributed to harmonics of both the high- and low-speed rotors. However, past experience has indicated that the most probable source is the high-speed rotor. The limited scatter of points throughout the 100-to 600-cps frequency range is due to the different power settings, most of which occur between 90 and 95% rpm. The gunfire produced no appreciable double amplitudes in this area. There were 1,650 data points obtained in the forward quarter of the fuselage.

Figure 7 shows the vibratory pecture of the data obtained on the structure of the center half of the fuselage (Sta 469 to 1408). The lower frequency data are a result of takeoff, turbulent air, and touchdown. The scattered points up to 100 cps are caused by the flight conditions shown in Table II. The higher double amplitudes in this region are caused by takeoff, turbulent air, and touchdown. The peaks occurring at approximately 100, 150, 200, 300, 400, 450, 500, and 600 cps are the fundamental rotor frequencies and their respective harmonics. Gunfire produced a slight increase in amplitude in this area. The center half of the fuselage yielded approximately 4,800 data points.

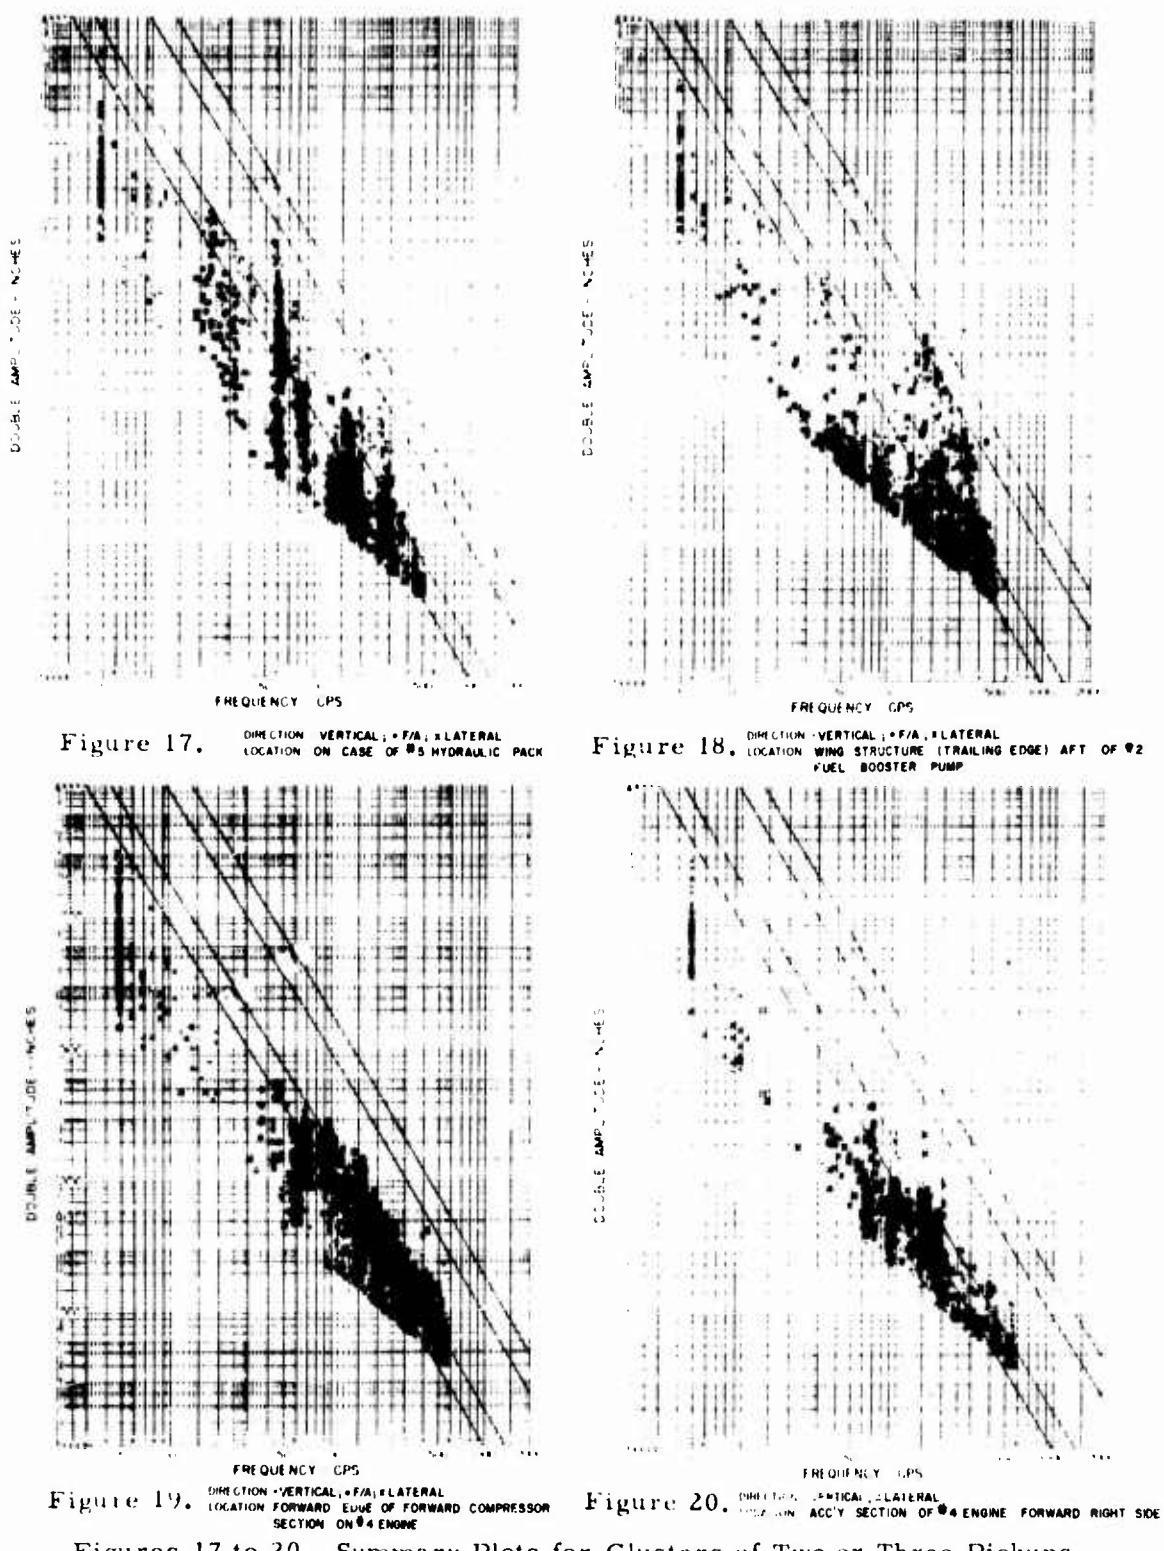
Figures 17 to 20. Summary Plots for Clusters of Two or Three Pickups

The Type 1 graphs permit a detail study of the vibration characteristics along a single axis at a particular location in the test vehicle. The Type 2 graphs present the overall vibration-environment measured under all test conditions at each of the 26 test points; generally, these include all data obtained from the 2 to 3 pickups in each cluster.
