MISCELLANEOUS PAPER S-69-10

EVALUATION OF SURFACING MATERIALS FOR FIRM BASE TACTICAL AIRFIELDS BARE BASE SUPPORT

EVALUATION OF SURFACING MATERIALS FOR FIRM BASE TACTICAL AIRFIELDS

Bare Base Support

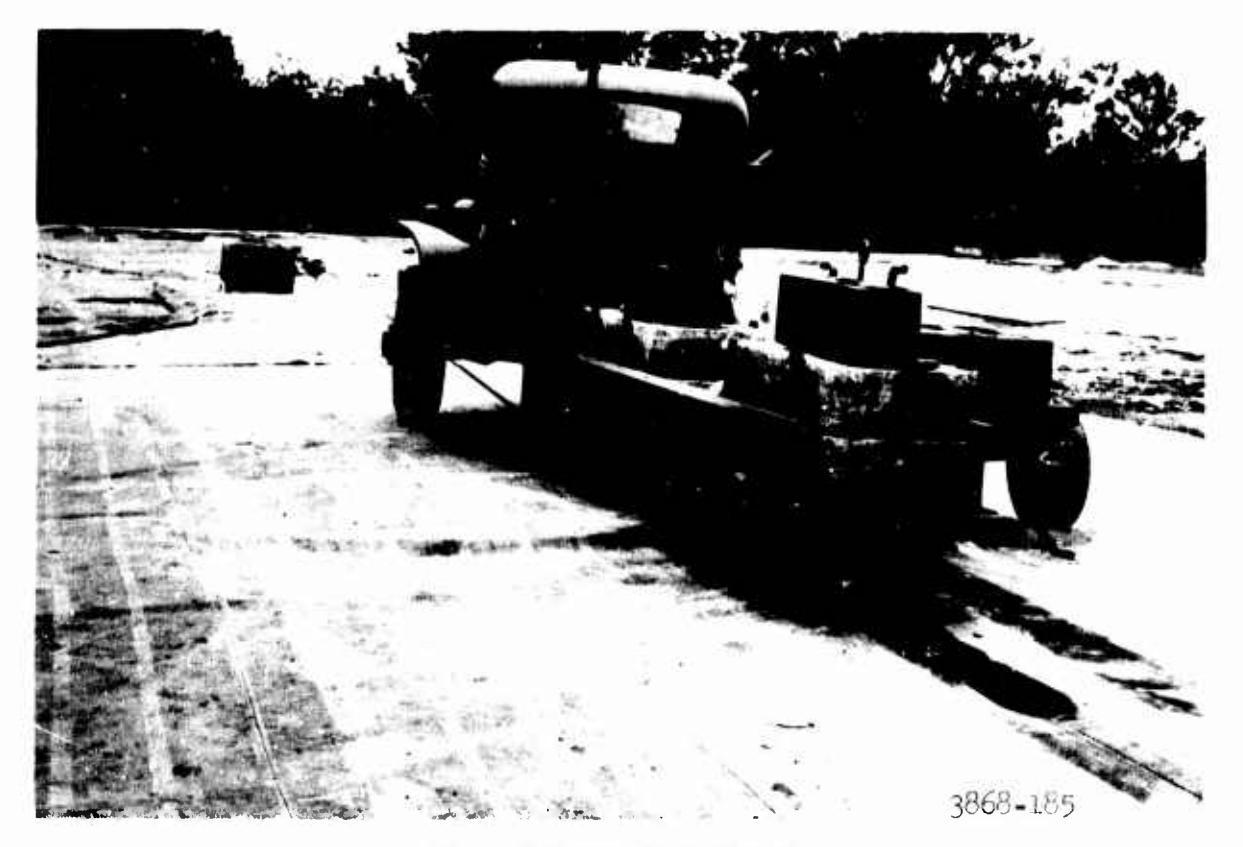
Fig. 1. Skid cart with F-4C loading

16. The vehicle used for skid and short-radius turn tests is shown in fig. 1. The vehicle had a load wheel centered in the rear of the frame, an outrigger wheel to prevent overturning, and two front wheels by which the vehicle is normally powered. For the skid tests, the vehicle was pulled by a powered mover, and for the short-radius turn tests, the vehicle was rotated by a forklift. For the C-130 loading, the vehicle had a 30,000-lb SWL on a 20x20, 22-PR tire inflated to 100 psi. For the F-4C loading, the vehicle had a 25,000-lb SWL on a 30x11.5, 24-PR tire inflated to 250 psi.

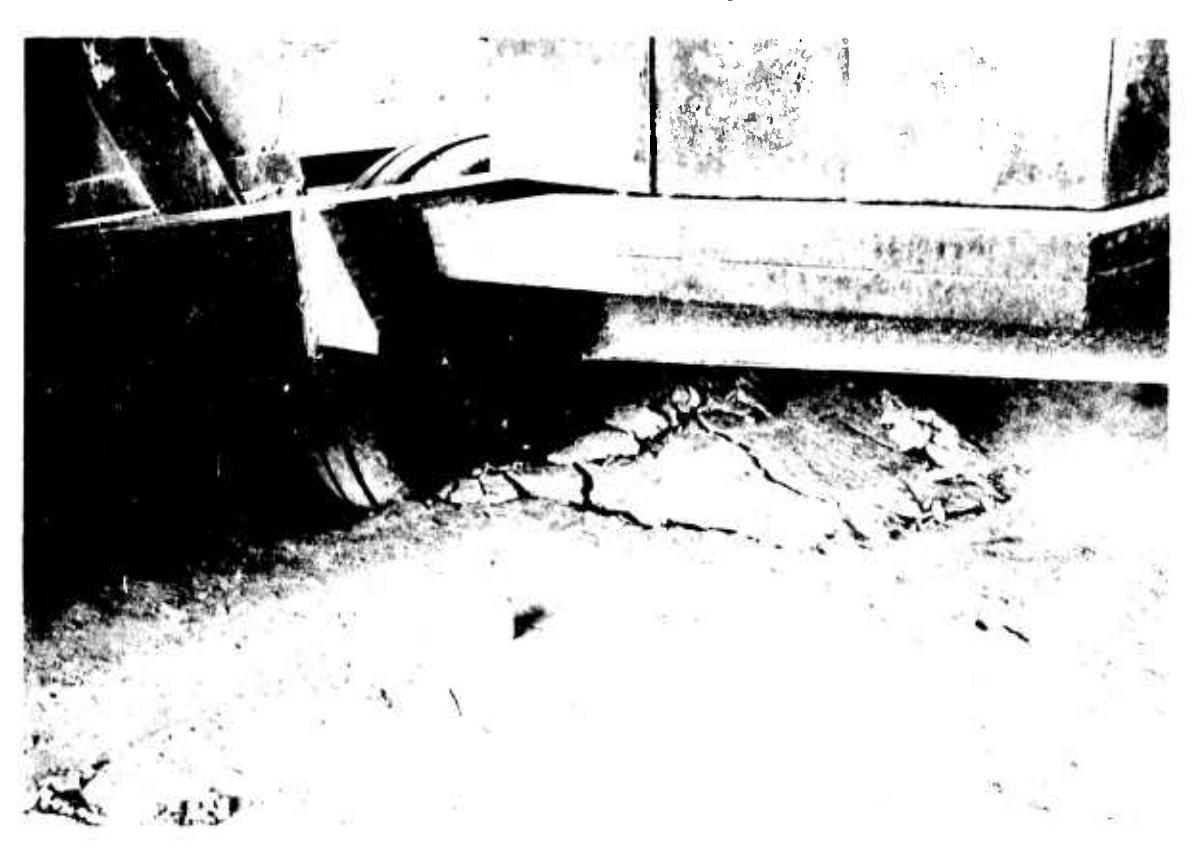
Photograph 4. Test 1; vehicle immobilized during skid pull with F-4C loading on unsurfaced 26-CBR subgrade

26. At this time it was decided to conduct further skid tests on the bare soil surrounding the test section in areas that indicated higher soil strength. The area adjacent to the test section was lean clay soil. The first skid test was conducted in an area in which a cursory check had indicated a surface soil strength of 43 CBR. However, subsequent tests indicated that at 6 in. below the surface, the soil strength was 9 CBR, and the average soil strength was approximately 26 CBR. As the skid pull was begun, the load wheel sank into the soil and became immobilized (photograph 4). A second pull was performed in an area

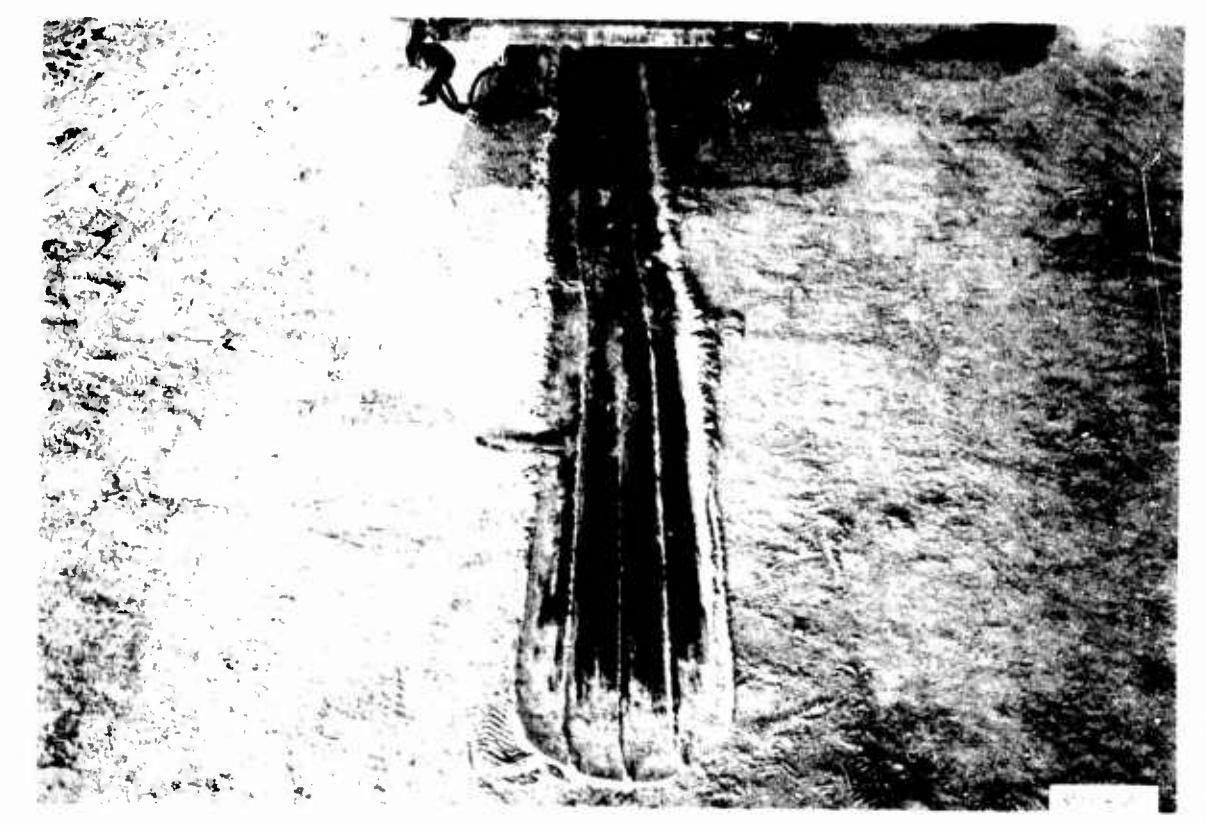
Photograph 5. Test 1: unsurfaced 80-CBR area after pull with F-4C loading

in which a surface strength of 93 CBR was indicated. However, subsequent soil tests indicated the soil strength at 6 in. below the surface to be 66 CBR, and the average strength was 80 CBR. The test vehicle was pulled approximately 15 ft, and no sinkage or rutting was observed (photograph 5).

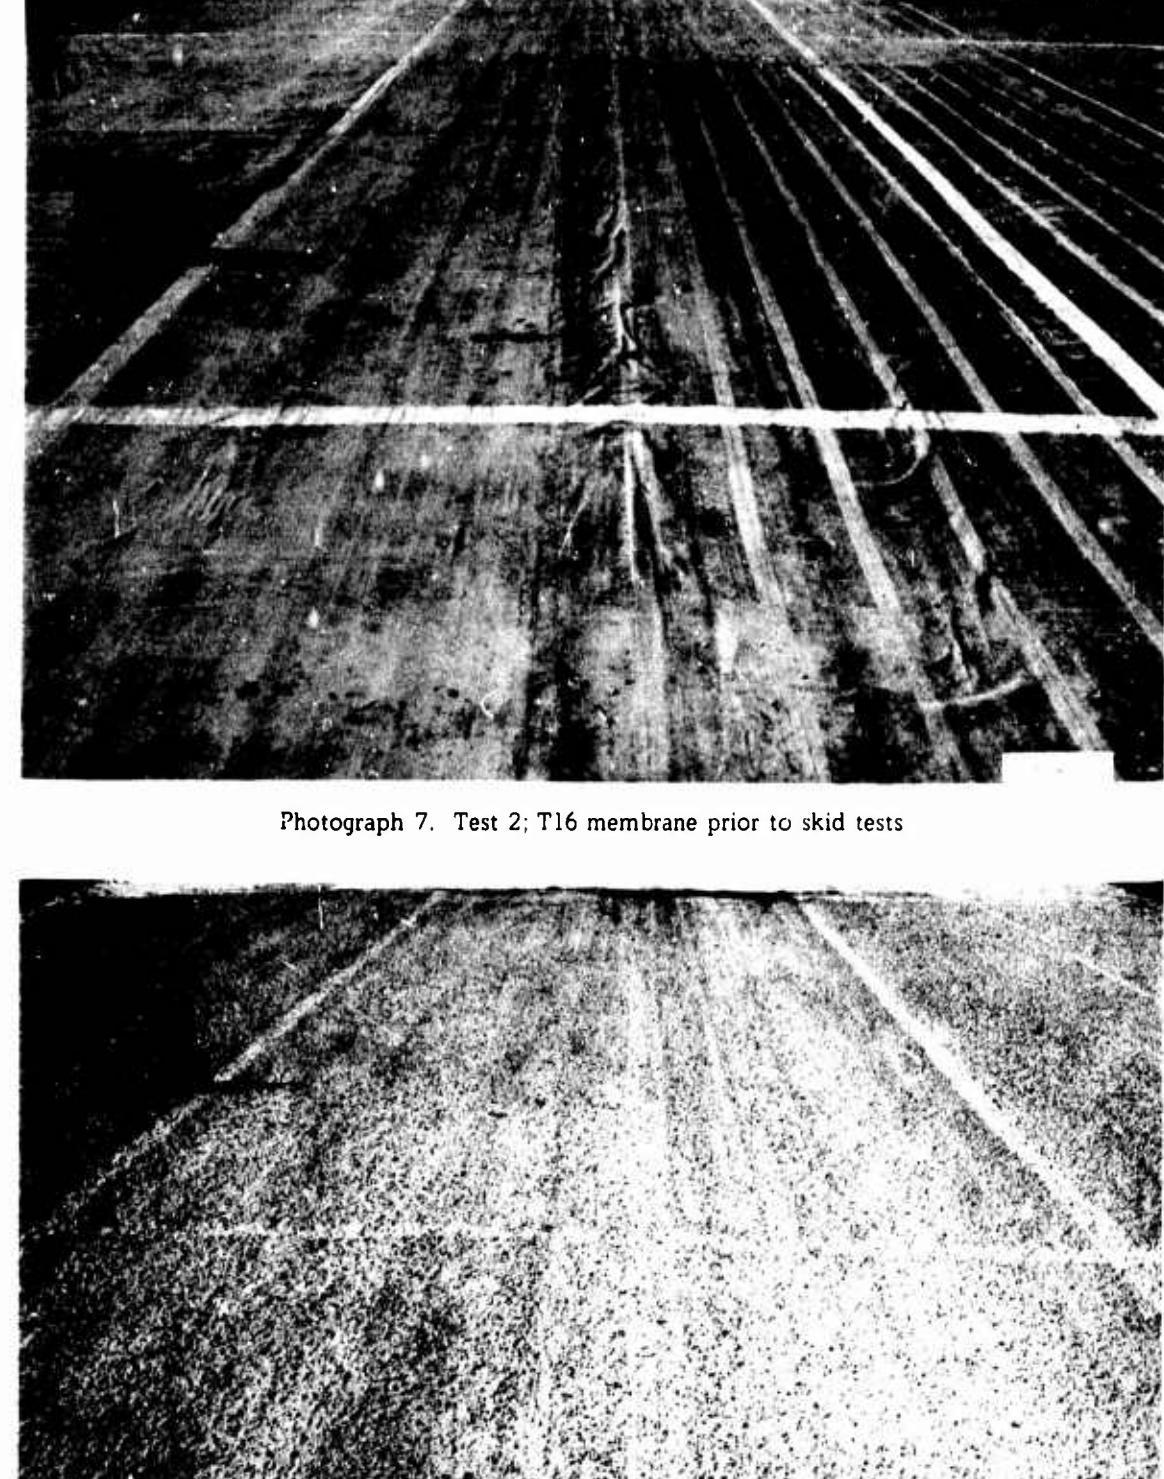
Photograph 8. Test 2; DBST over T1 membrane prior to skid tests

31. Items 1 and 2 were covered with a double bituminous surface treatment (DBST) over T1 mem brane. The T1 membrane was joined to T16 membrane, which covered items 3 and 4. Items 5 and 6 were surfaced with WX18, which was joined to the T16 membrane. The bottom surfaces of the base soil in items 1 and 2 were protected with T16 and 6-mil polyethylene membrane, respectively. The bottom surfaces of items 3 and 4 were protected with Griffolyn membrane, a nylon-reinforced plastic material. The bottom surfaces of items 5 and 6 were protected with 6-mil polyethylene and T16 membrane, respectively. All subsurface membranes were bonded together to form one integral sheet, and all membranes continued up the sides, and in items 1 and 6, up the ends of the base course to the surface of the test section where they were bonded to the surface membranes to form a complete watertight envelope. A 10-ft-wide traffic lane and traffic guidelines were painted on the test section for the traffic tests of the related Bare Base project. General views of each test surface just prior to skid tests are shown in photographs 6-8.

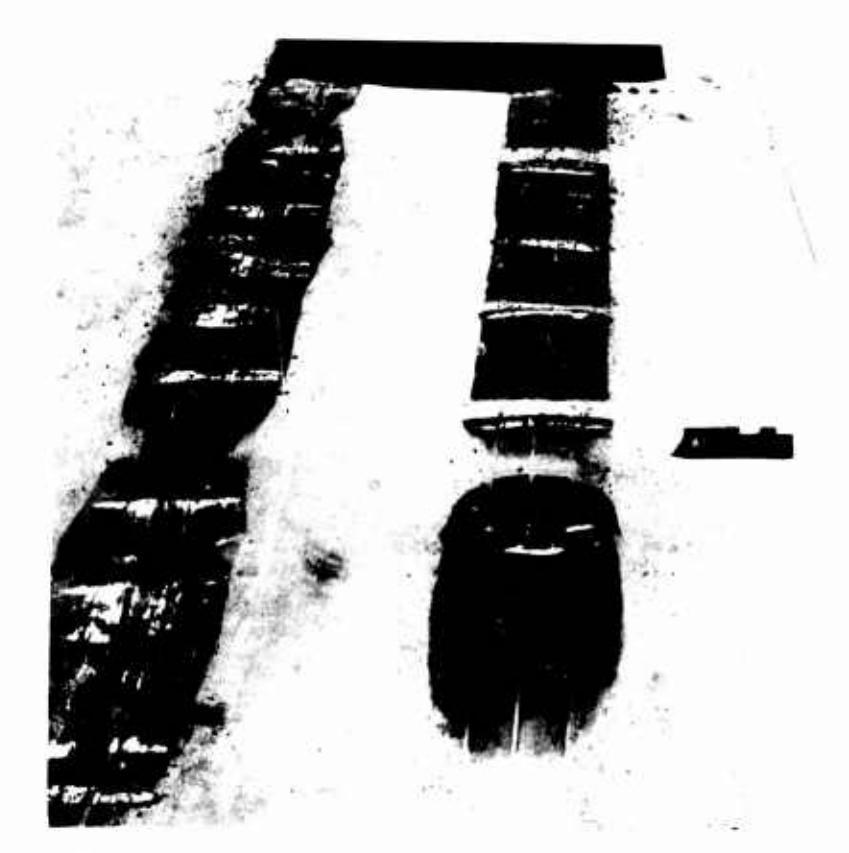
Photograph 9. Test 2; WX18 after second pull with F-4C loading

33. Skid tests on WX18. Two locked wheel skid pulls were made initially on the WX18 membrane. The skid tests caused only slight abrasion of the WX18, although there was noticeable wear of the load tire (photograph 9).

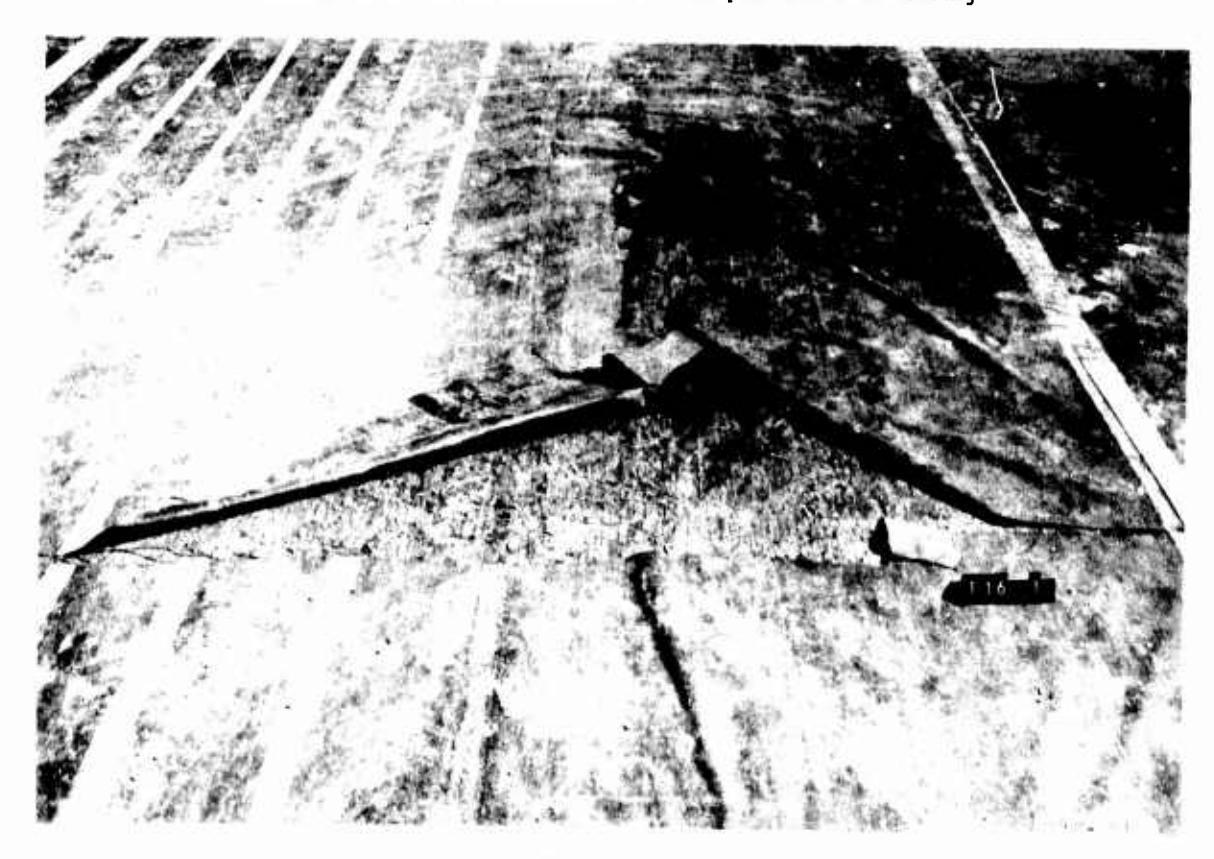
Photograph 10. Test 2; T16 after one pull with F-4C loading

34. Skid test on T16. One skid pull tore the T16 membrane severely, exposing the underlying base soil (photograph 10).

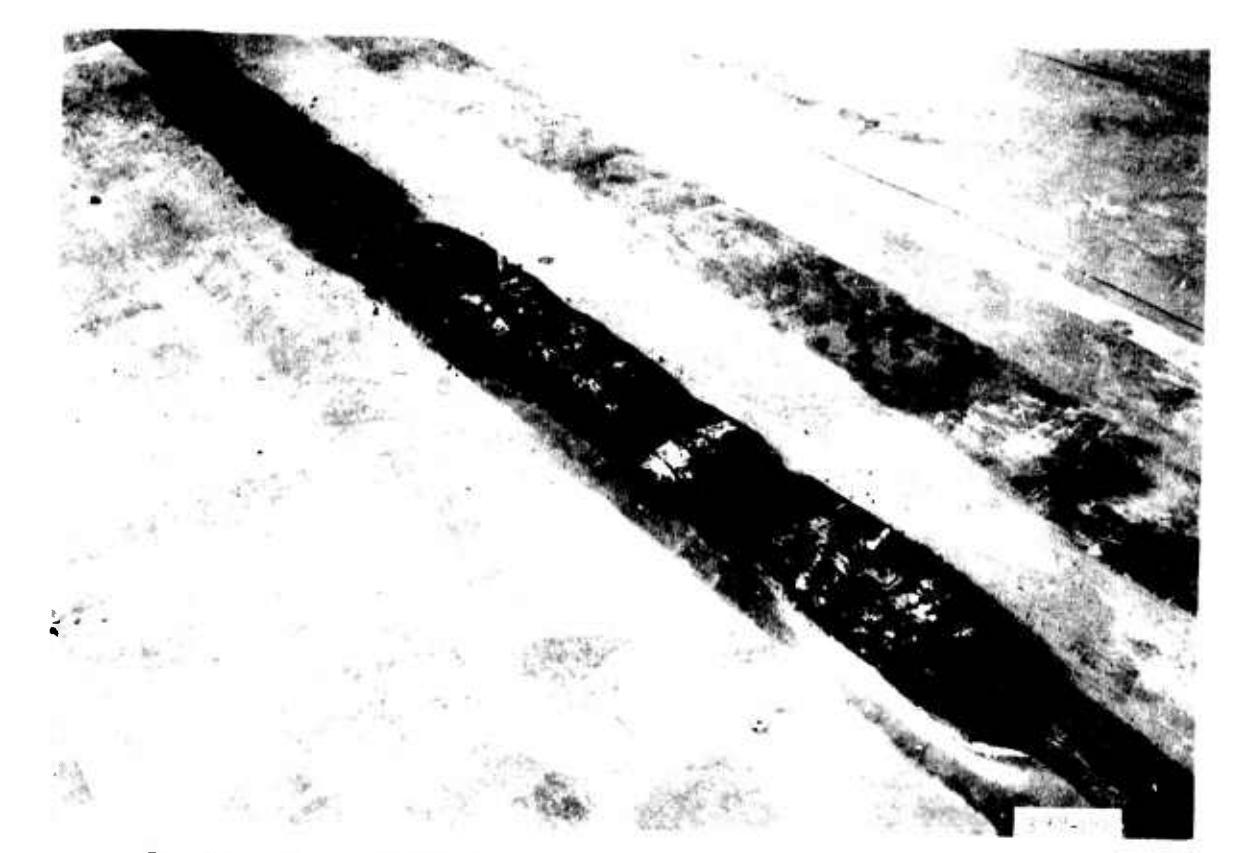
Photograph 13. Test 2; WX18 with black enamel paint after third skid (F-4C loading)

37. Skid tests on painted WA18. During the initial skid tests on the WX18 membrane, it had been observed that, although membrane damage was slight and generally superficial, there were a few small areas in which the neoprene had been abraded off the membrane, exposing the internal nylon cord. To protect the nylon cord from possible damage due to prolonged exposure to sunlight, it is necessary to maintain an opaque coating over the cord in these areas. Therefore, a coat of common black enamel paint was applied over one of the initial skid areas, and after the paint had dried, three additional skid tests were conducted on the painted area. Each skid caused abrasion of the painted surface, and after the third skid, it was observed that a considerable amount of the paint had been removed (photograph 13).

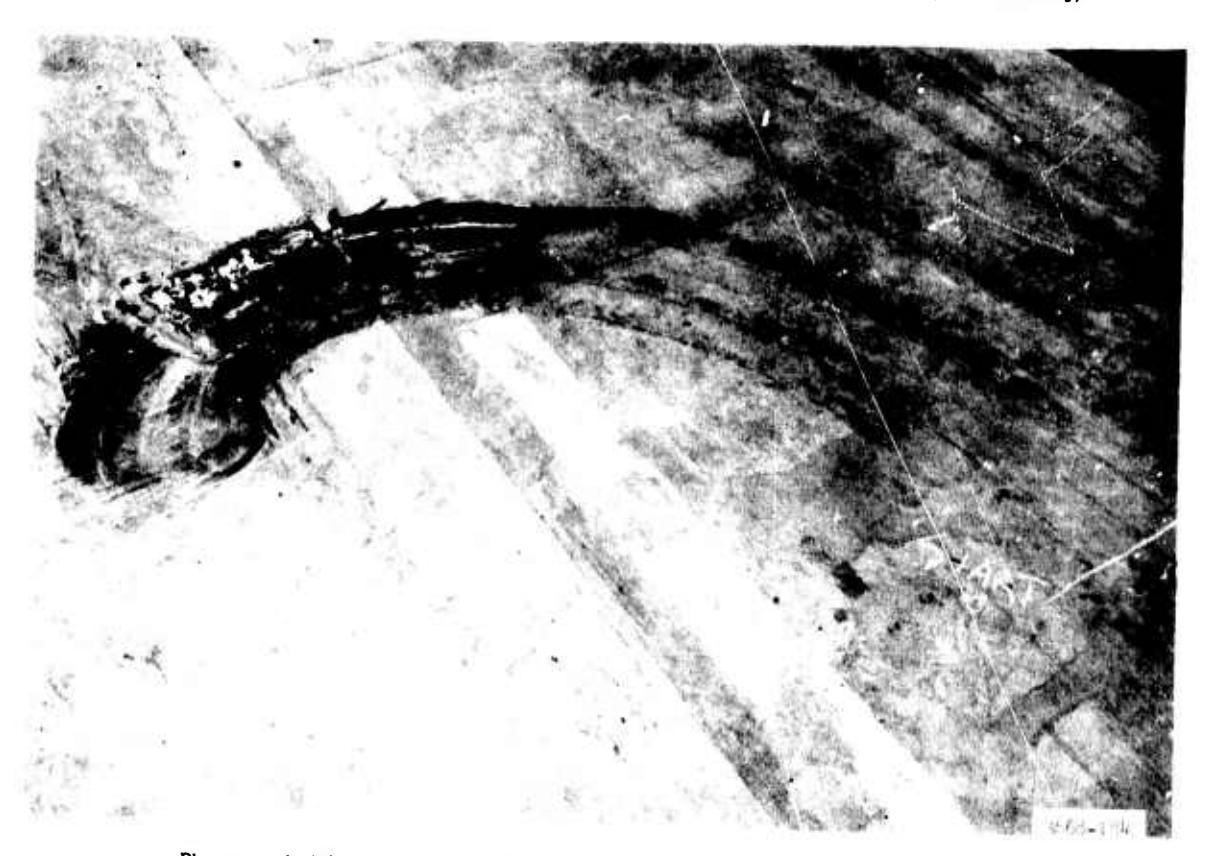
Photograph 14. Test 2; WX18 after short-radius turn test with F-4C loading

38. Short radius turn test on WX18. One short-radius turn test was conducted on dry WX18 membrane using the procedure described in paragraph 18. The result was slight abrasion of the membrane and a noticeable amount of tire abrasion, as can be seen in photograph 14.

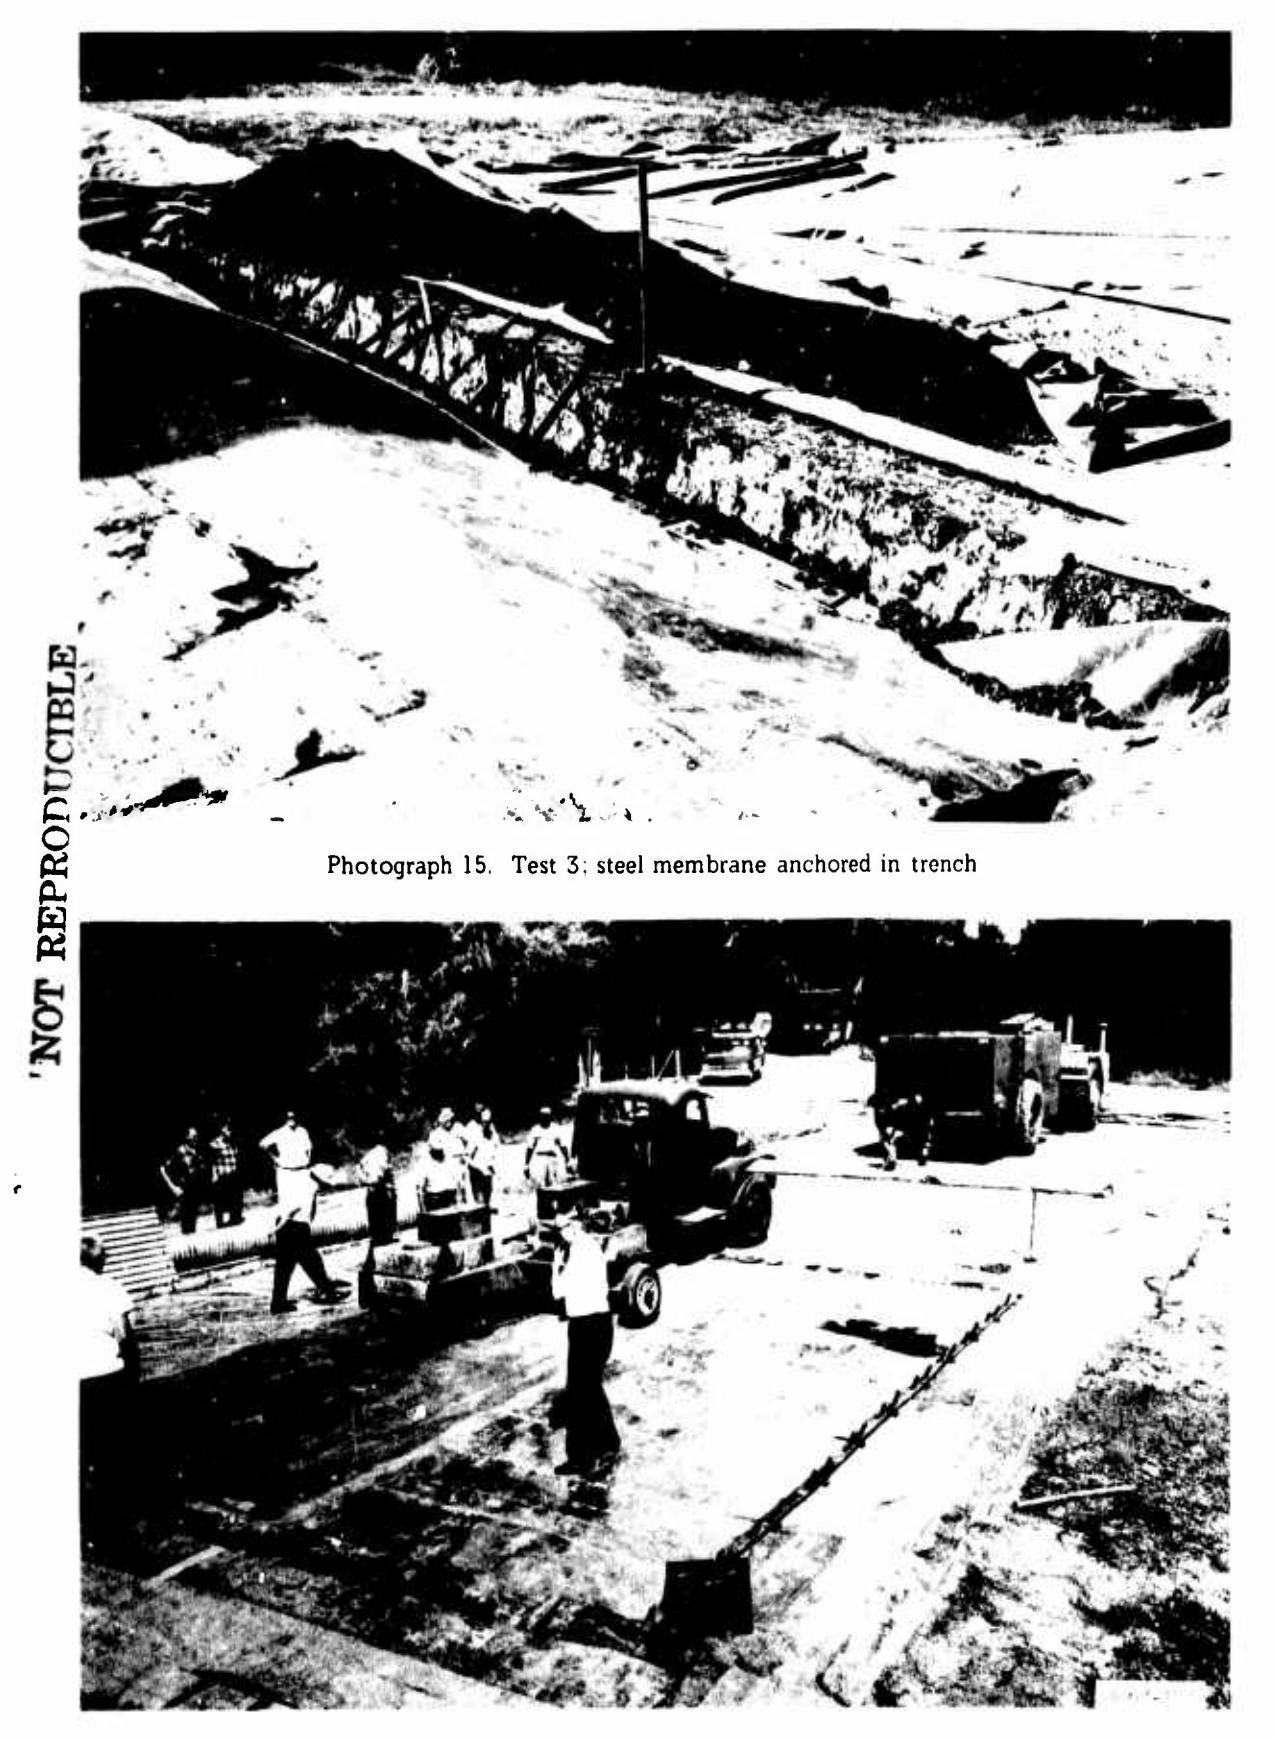
Photograph 16. Test 3; skid test in progress on steel membrane

was treated with an antiskid compound in a strip approximately 10 ft wide down the center $c\hat{c}$ the membrane. All skid tests were run in this area. The membrane was placed so that the lapped joints lay transversely on the section, with the overlapping edge in the direction of the skid pulls. A general view of the membrane during the conduct of a skid test is shown in photograph 16.

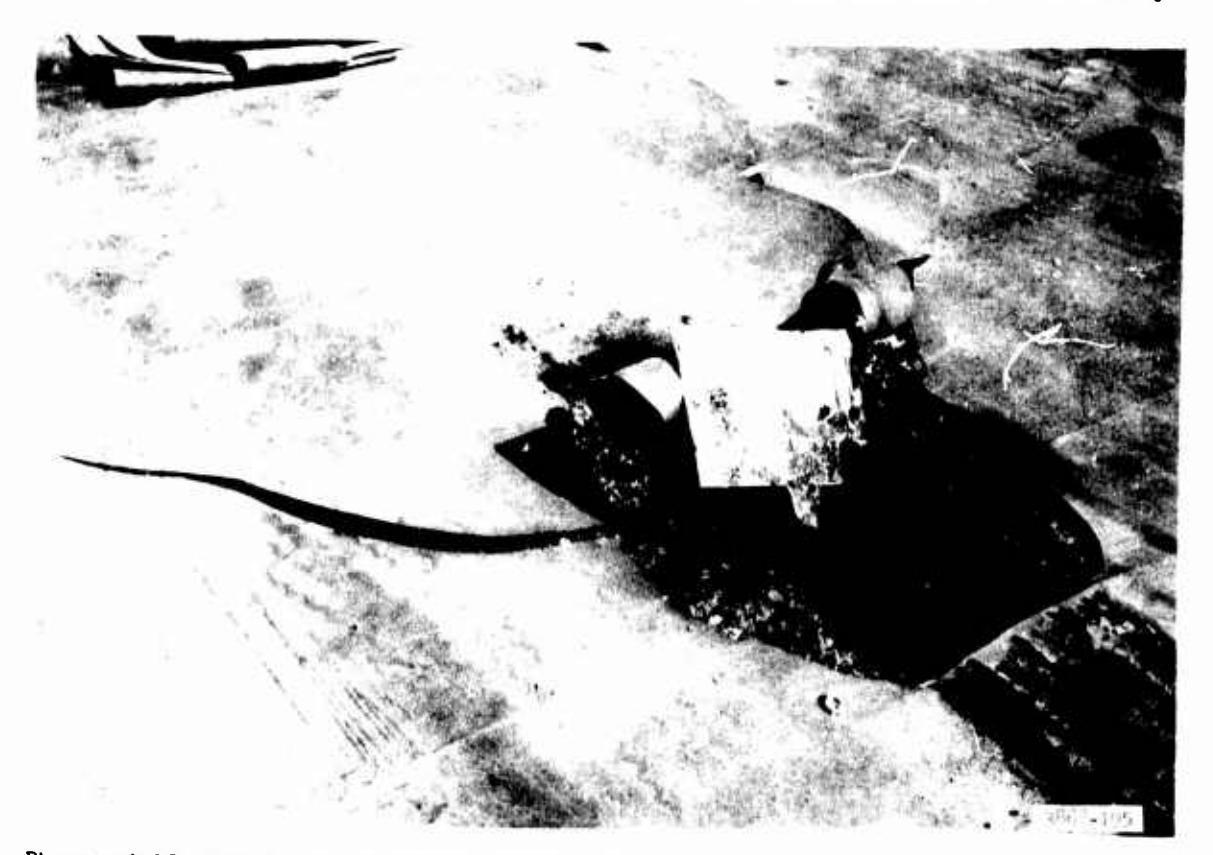
Photograph 18. Test 3; close-up of steel membrane after second dry-surface skid test with F-4C loading

42. Dry membrane. Two skid tests were made on the membrane in a dry condition. During each pull, a bow wave developed in front of the locked load wheel, causing a buildup of membrane that eventually led to tensile rupture under and slightly ahead of the load wheel. Photograph 17 shows a close up of the load wheel and the ruptured membrane after the first skid. Photograph 18 shows a close-up of the failure area in the membrane after the second skid, and photograph 19 shows a general view of the membrane after both skids.

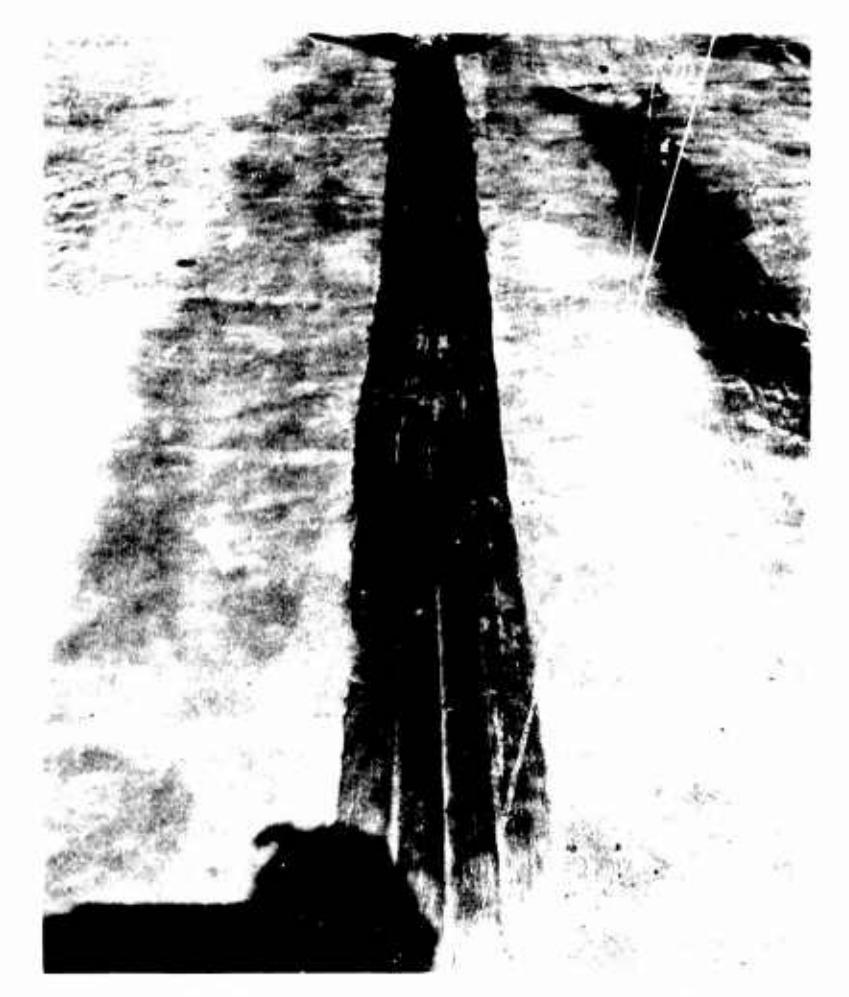
Photograph 19. Test 3; general view of steel membrane after second dry-surface skid test with F-4C loading
