## **USAAMRDL TECHNICAL REPORT 72-30**

EVALUATION OF THE EFFECTIVENESS OF USING SONIC DATA TO DIAGNOSE THE MECHANICAL CONDITION OF ARMY HELICOPTER POWER TRAIN COMPONENTS By G. William Nogg Way 1972

EUSTIS DIRECTORATE U. S. ARMY AIR MOBILITY RESEARCH AND DEVELOPMENT LABORATORY FORT EUSTIS, VIRGINIA

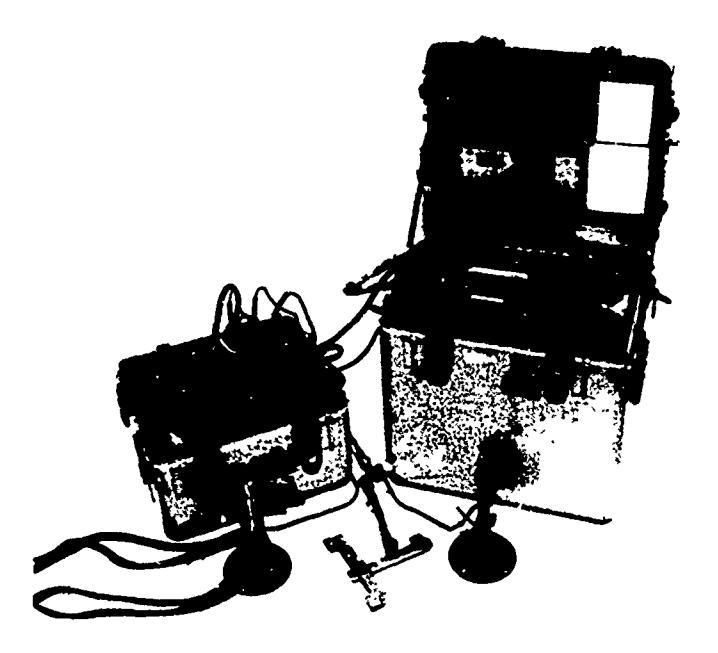
Figure 1. CWEA-4 Sonic Analyzer.

The CWEA-4 sonic analyzer (Figure 1) consists of a power supply, the basic CWEA sonic analyzer with UH-1 helicopter plug-in module capability, three microphones, a tape programmer, and associated cabling.

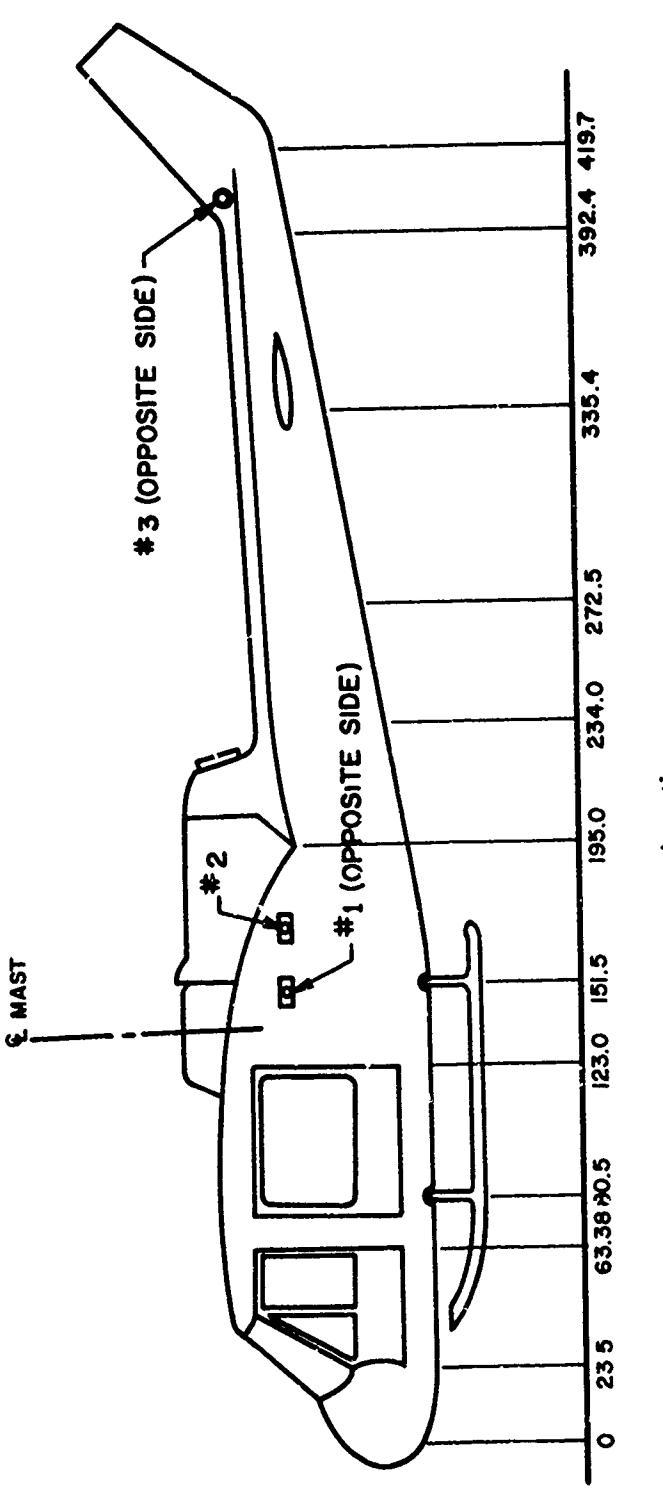
Figure 2. Microphone Locations for Main Rotor Transmission and Tail Rotor Gearboxes – Models UH-1A, UH-1B, and UH-1C Helicopters.

The microphone system consists of three condenser microphones (Figures 2 through 6) located as follows:

Fastened on right side of tail section with suction cup - 3 inches away from skin - aimed at 42-degree gearbox. 3

A three-prong bracket was used to mount microphones 1 and 2 at the respective transmission and engine inspection doors on the UH-1A, UH-1B, and UH-1C model helicopters (Figure 4). On model UH-1D, a suction cup was used for the microphone 1 installation and a three-prong bracket for microphone 2 (Figure 5). A suction cup was used to mount microphone 3 on all model helicopters (Figure 6).

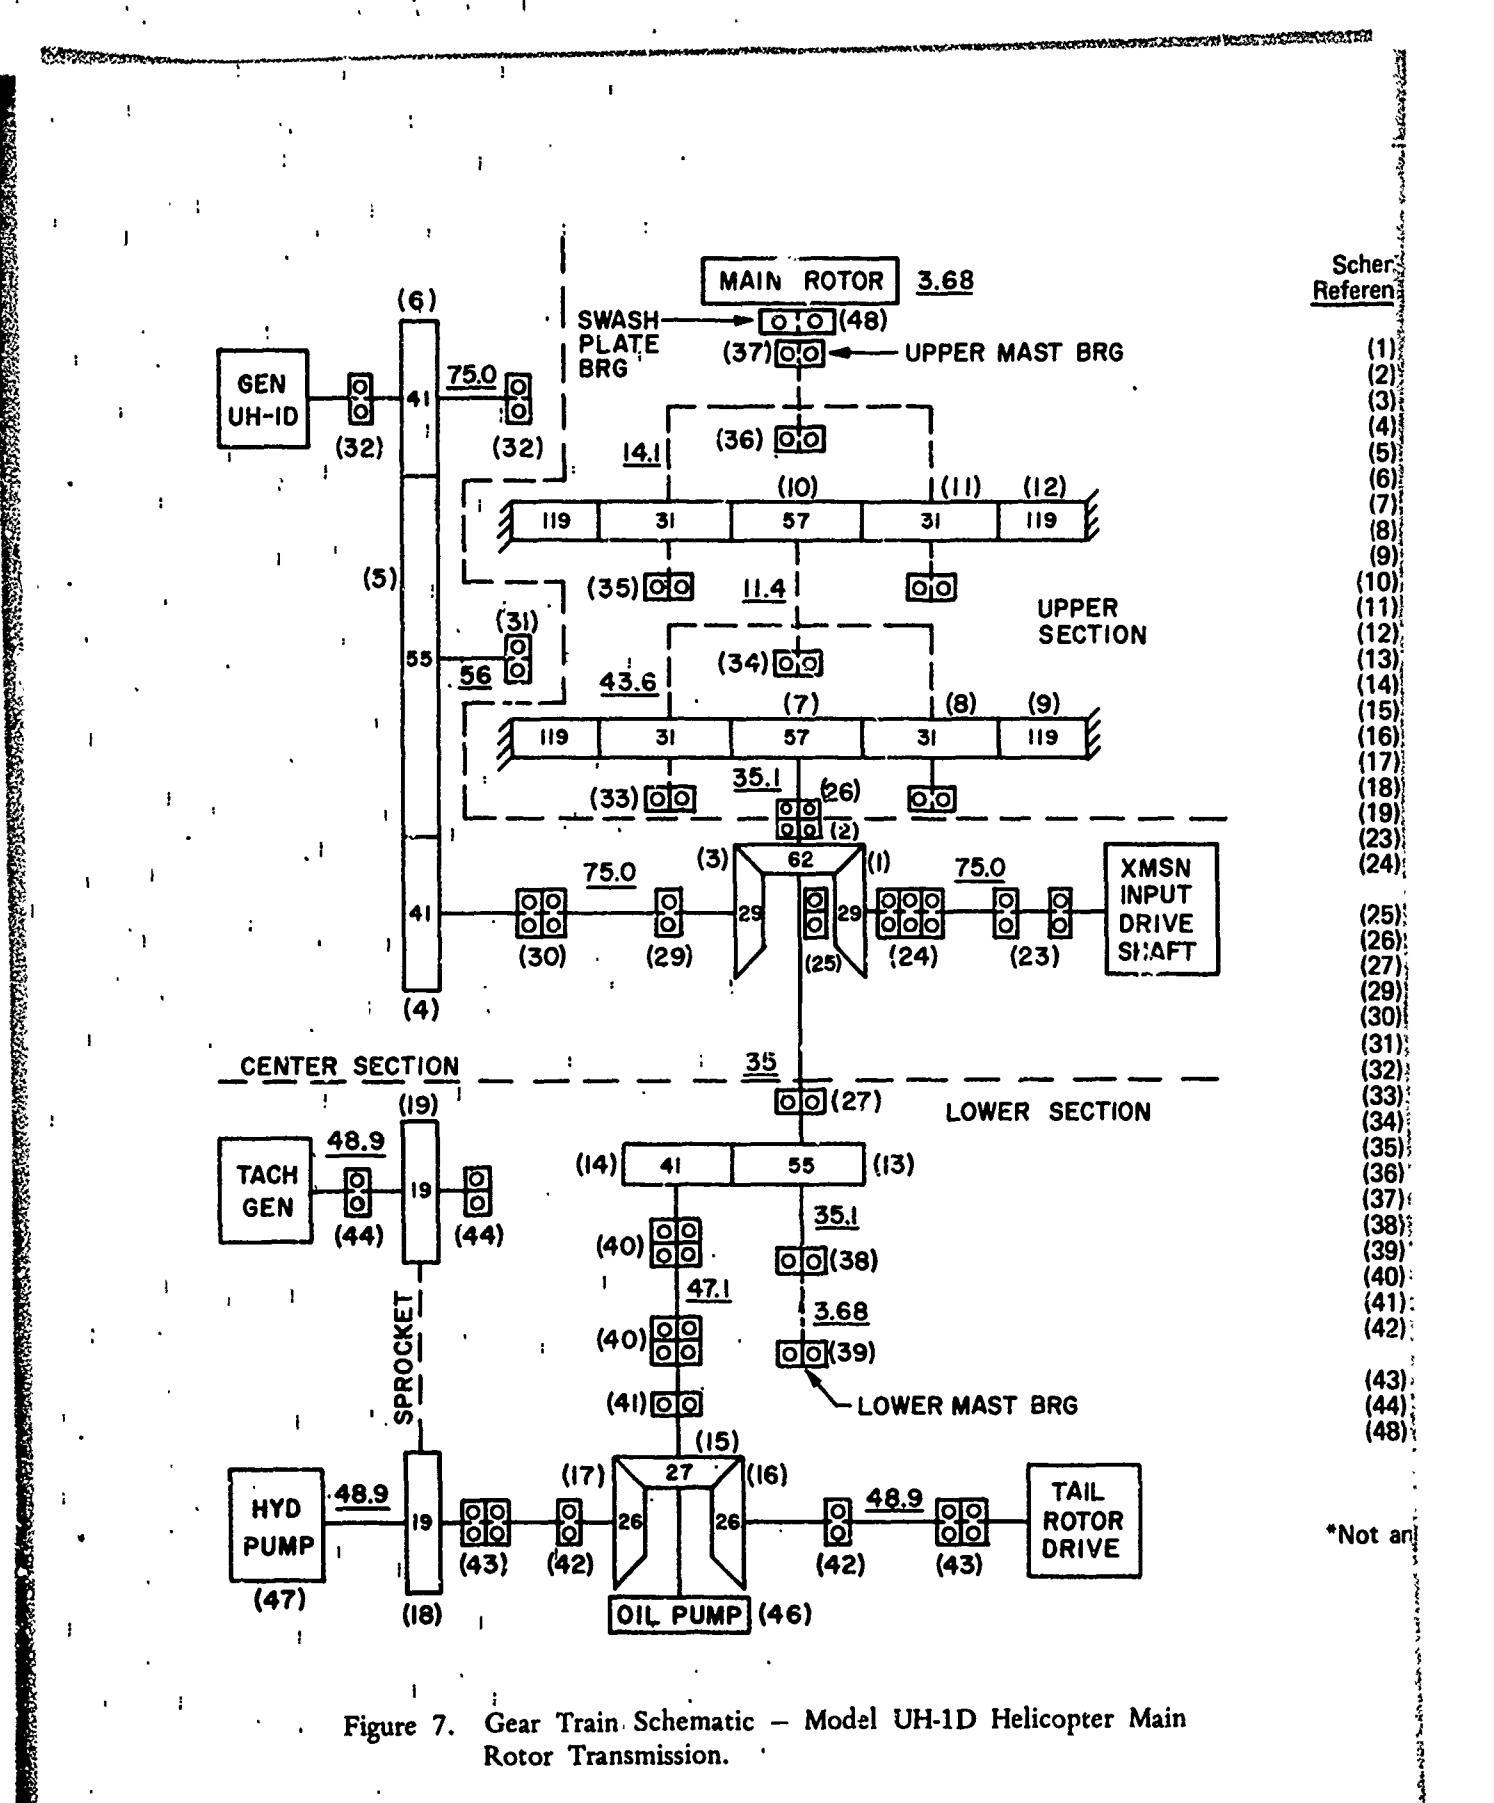
Gear train schematics for the power train components of the UH-1 helicopter are shown in Figures 7 and 8. The identification code used in these figures is as follows:

- 1. The number written in parentheses is used to identify and locate the individual component. This number corresponds to the number in the applicable table and on the program tape.
- 2. The number printed on the gear indicates the number of gear teeth.
- 3. The number underlined indicates the component shaft speed in revolutions per second (rps).

ROTOR ùΝ. 3.68 Part Number Part Name Reference No. 0:0(48) 7)[0:0]-- UPPER MAST BRG 204-040-700 **Drive Bevel Gear** (1)(2) (3) 204-040-701 **Drive Bevel Gear** 204-040-100 Generator Bevel Gear Generator Spur Gear Generator Spur Gear (4)\* 205-040-101 20 205-040-102 (5) (6)\* 205-040-103 Generator Spur Gear (10)1(1) (12)204-040-329-1 Lower Sun Gear (7) 57 119 31 Lower Planetary Pinions (8) 204-040-108-7 Lower Ring Gear 204-040-331-5 (9) 204-040-330-1,-3 Upper Sun Gear .4 00 (10)UPPER 204-040-108-7 Upper Planetary Pinions (11) SECTION (12)204-040-331-5 Upper Ring Gear 4)00 204-040-763 Drive Spur Gear (13) (14) 204-040-762 Driven Spur Gear (7) (8) <u>(9)</u> 204-040-103-7 Drive Bevel Gear (15) 57 31 119 204-040-104-13 Driven Bevel Gear, Tail Rotor (16) 204-040-105 Priven Bevel Gear, Accessories (17) Sprocket Wheel Assembly Sprocket Wheel, Hydraulic Pump Input Quill Shaft Bearing .**2**6) 204-040-112 (18)\* 00 00  $(19)^{*}$ 204-040-113 00 (2 204-040-142-1 (23)62 (24) 204-040-346-3 Input Quill Shaft Bearing, 75.0 XMSN Triplex Ball (Input Pinion) INPUT Roller, Input Quill Shaft Bearing Input Gear Shaft Bearing, Duplex Ball (25) (26) 204-040-269 0 б DRIVE O 204-040-345-3 SHAFT (24)(23)(27) 204-040-271 Main Reduction Gear Bearing 204-040-105 (29)\*Generator Drive Shaft Bearing (30)\* 204 040-106 Generator Drive Shaft Bearing (31)\* 204-040-107 Generator Drive Shaft Bearing Generator Drive Shaft Bearing (32)\* 205-040-108 00(27) 204 0-725 Roller Set. Lower (33) LOWER SECTION 204-040-135 (34) Main Rotor Reduction Bearing, Lower (35) 204-040-725 Roller Set, Upper (13) 55 (36) 204-040-135 Main Rotor Reduction Bearing, Upper Upper Mast Bearing Lower Transmission Bearing (37) 204-040-136 35,1 204-040-135 (38) 204-040-270 Lower Mast Bearing 00(38) (39)(40) 204-040-143 Lower Transmission Input Duplex Bearing (41) 204-040-310 Lower Transmission Input Bearing 3.68 (42) 204-040-310-1 Tail Rotor Drive Bearing and Accessory 00(39) **Drive Bearing** (43)204-040-143-1 Tail Rotor Drive Duplex Bearing LOWER MAST BRG (44)\* 204-040-145 Tachometer Drive Shaft Bearing Swash Plate Bearing (48)\* 204-101-425

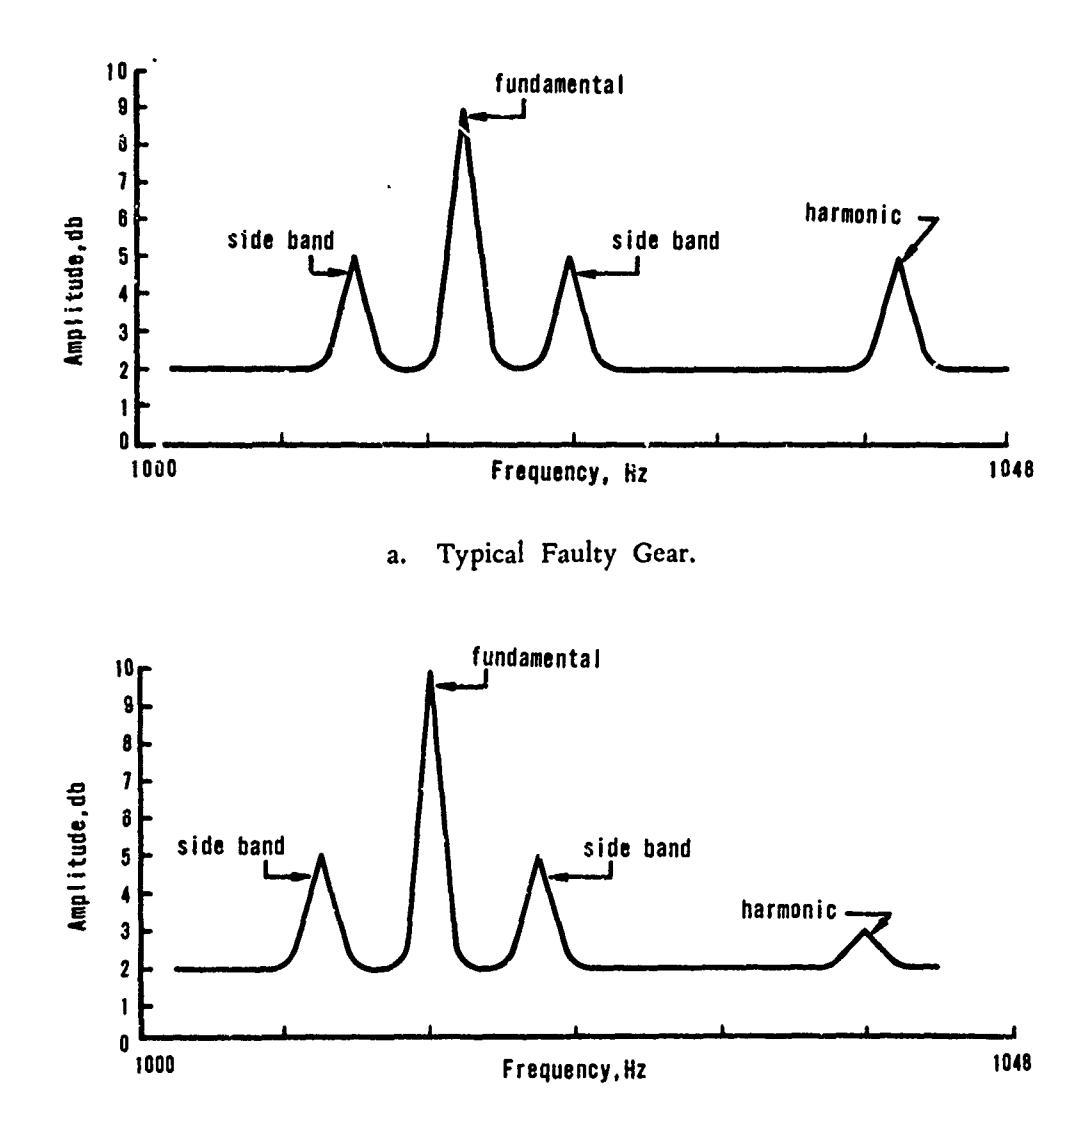
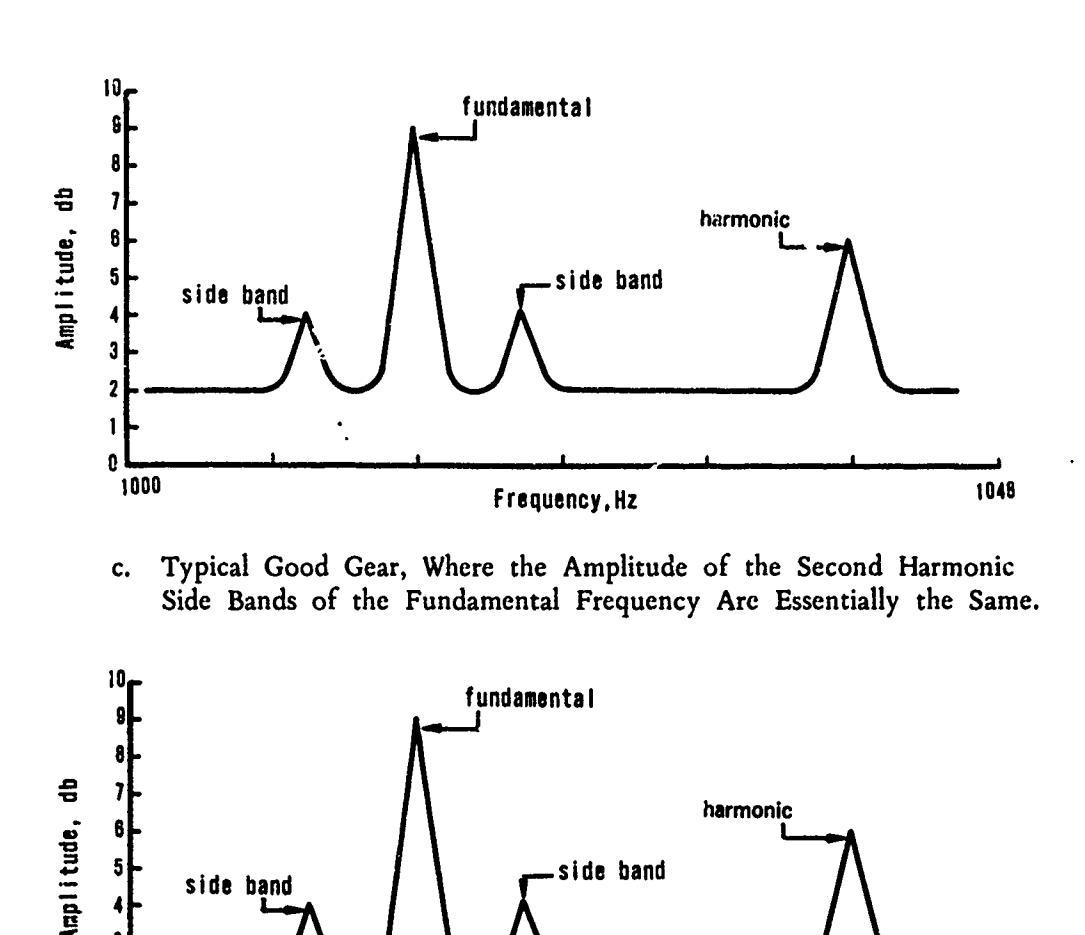
Figure 12. Simple Frequency/Amplitude Spectrums.

frequencies of interest in the various spectrums, it can be seen that the faulty gear could not be identified by noting the exceedance of any particular frequency amplitude. For example, it is seen that the amplitude of the fundamental frequency of one of the good gears exceeds that of the faulty gear. On the other hand, it can be observed that the summation of all of the frequency amplitudes of each gear results in values where the faulty gear value is higher than those of the good gears. The summation approach is used as the procedure for identifying faulty gears.

b. Good Gear, Where the Amplitude of the Second Harmonic Is Low.

On the example spectrums of Figure 12, it was assumed that the noise levels of all the gears were the same. In real life, this is not the case, inasmuch as the noise level in the neighboring frequency range associated with any component is different from run to run. Therefore, in order to compare spectrums of various runs, the spectrums had to be normalized. There appeared to be a relationship between the noise level of a good gcar and the amplitude of the characteristic frequency, inasmuch as those spectrums that displayed a high noise level also displayed a high frequency amplitude. In other words, the signal-to-noise ratio appeared to remain mathematically relatable, even constant, for good gears of the same type. This is depicted graphically in Figure 13.

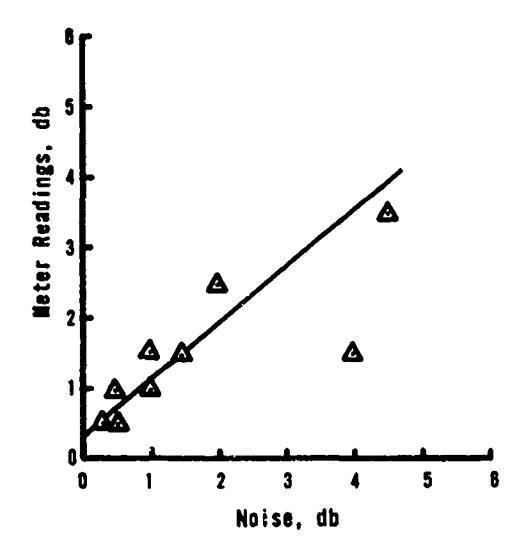
Figure 15. 90-Degree Gearbox Bevel Gears – Second Harmonic Meter Readings (2ft) Versus Noise Readings

Plots of the second-harmonic frequency and the upper and lower side-band frequency meter readings versus noise readings are presented in Figures 15, 16, and 17. The values used are from Table IV. Since the slope of the average value for the meter readings versus noise readings for all three figures was found to be essentially the same (.72), one general equation can be written to correct all three frequency readings for a normalized noise level of 1.5. The resulting

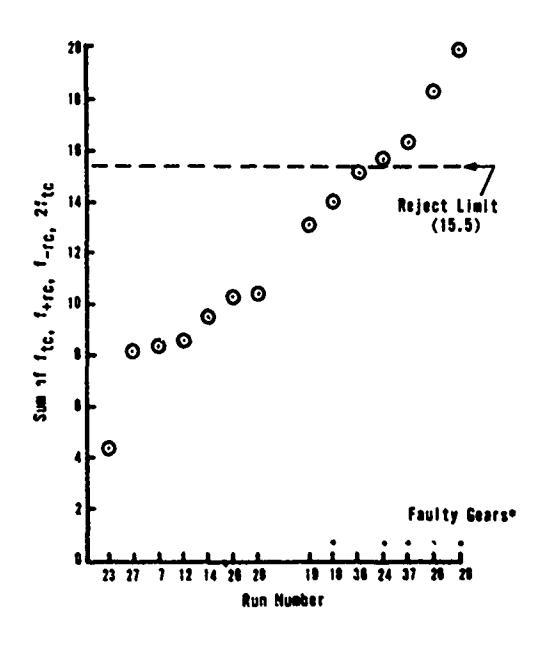
Figure 18. Summation of Corrected Meter Readings for the 90-Degree Gearbox Bevel Gears.

By plotting (Figure 18) the values of the sum of the four corrected frequency readings versus the test runs identified as being on good or faulty gears, it can be observed that a reject limit of 15.5 can be established.

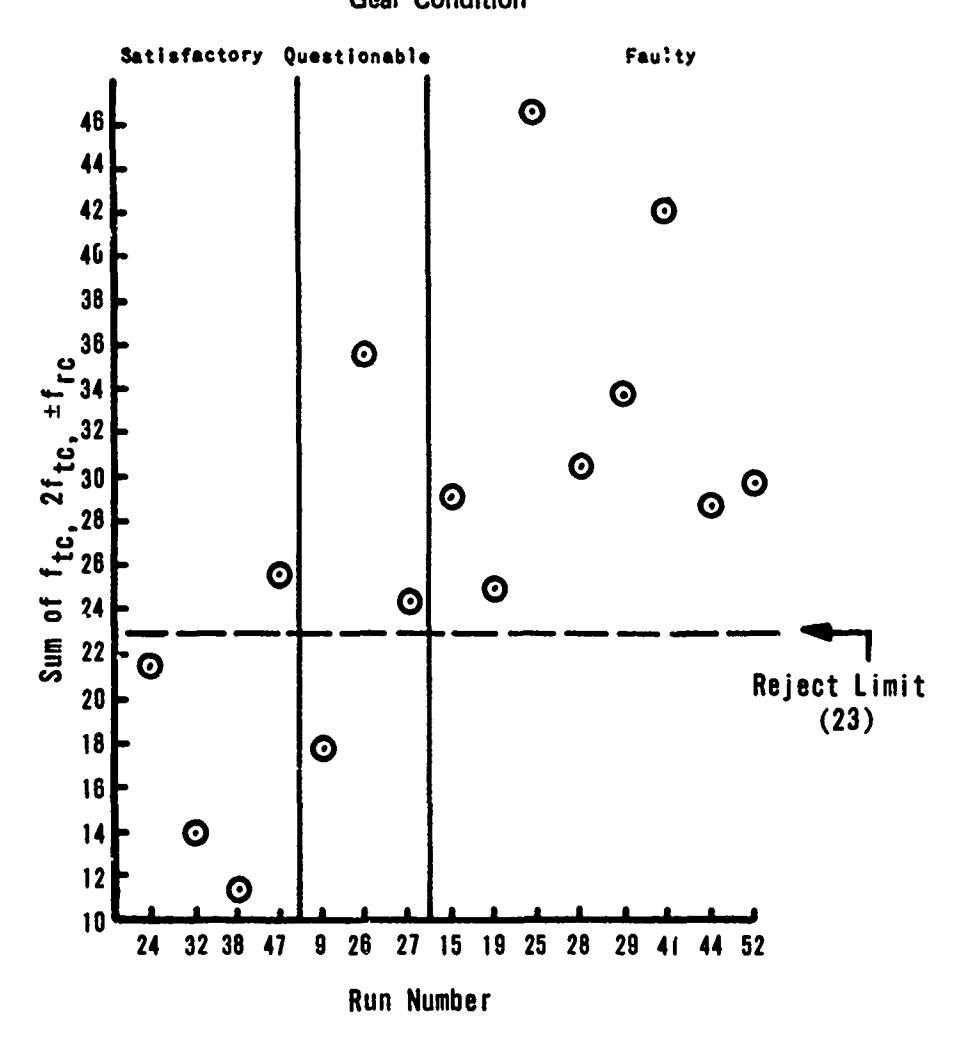
As shown in Figure 19, a reject limit of 23 has been established for gears (7), (8), and (9). It can be easily seen that this limit will accept three of the four satisfactory gears and will reject all of the faulty gears.

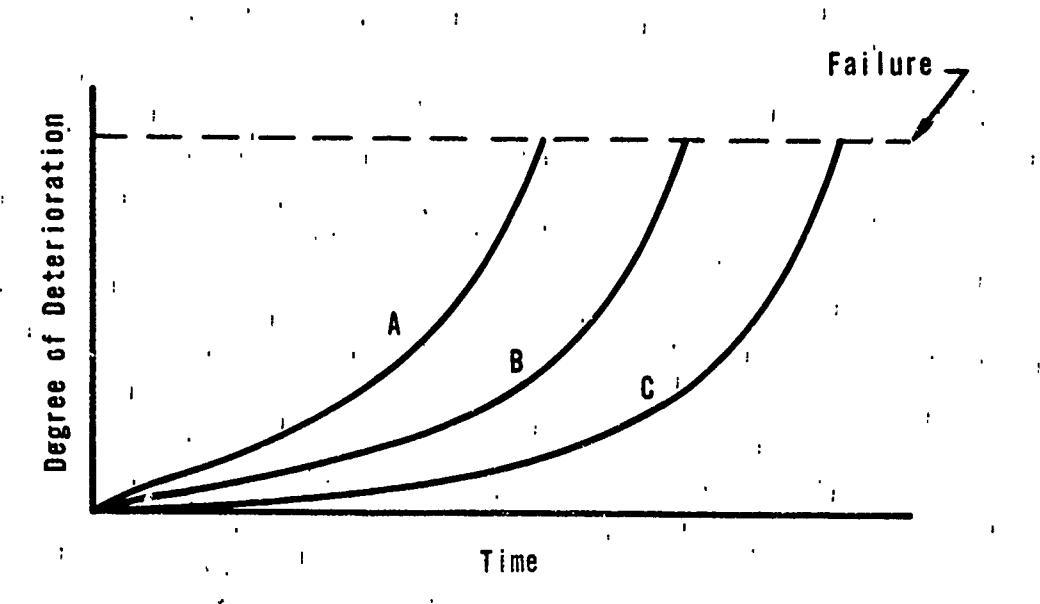
Figure 21. Wearout Rates of Three Components of the Same Type.

Figure 21 represents the hypothetical, but plausible, deterioration rates of three components of the same type. The point to be made here is that even though they are all three the same type, their rates of deterioration are different.

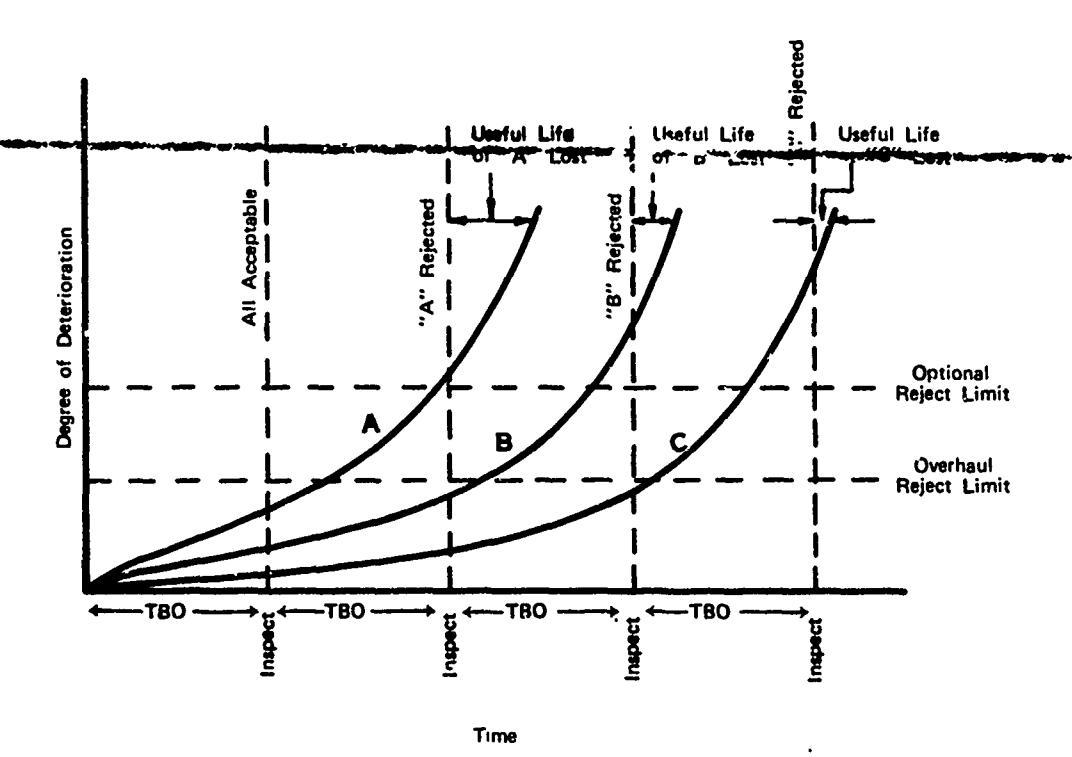
Figure 22. Reject Limit Established by the Inspection and Overhaul Procedure (First Example).

Figure 22 shows a desirable schedule of the inspection and overhaul procedure. Here, it is shown that the combination of the interval between inspections and the reject limit used during the inspections is providing assurance that a component of this type will not fail during the interval between inspections.

The number of hours that a component could have been operated if it had not been rejected during inspection comprises the useful life lost. It can be seen that if the reject limit were raised to some higher value representing a higher degree of deterioration, it would have the propitious effect of reducing the useful life lost, up to the point where the reject level becomes so high that a part is not rejected during the inspection process and then fails before the next inspection cycle. This can be seen to occur in case "A", if the reject limiwere higher than the optional reject limit shown in Figure 22.

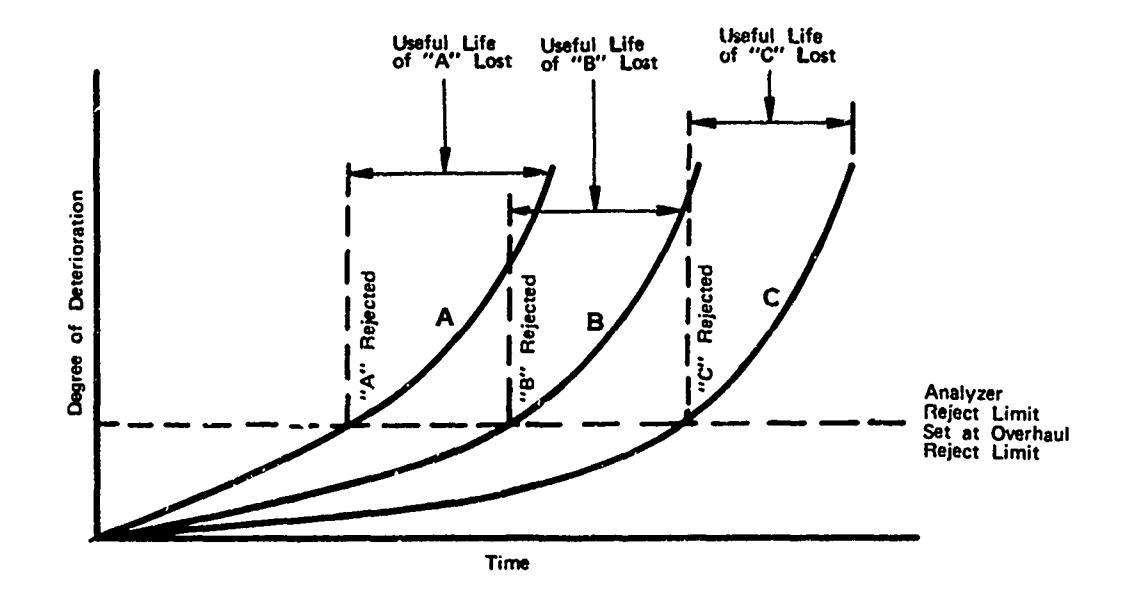
Figure 24. Reject Limit Established by an Analyzer Using Limit Criteria Set by Overhaul Procedure.

Now, one might ask what would be the effect of eliminating the inspection/TBO procedure altogether and, instead, using an analyzer which continuously monitors the mechanical condition of the component. Figure 24 shows the effect of such a procedure. It can be seen that this procedure would be less desirable than the inspection/TBO procedure, if the same reject criteria are used, because it increases the useful life lost. This curious result is one for contemplation of the fallacy of using such an analyzer approach.

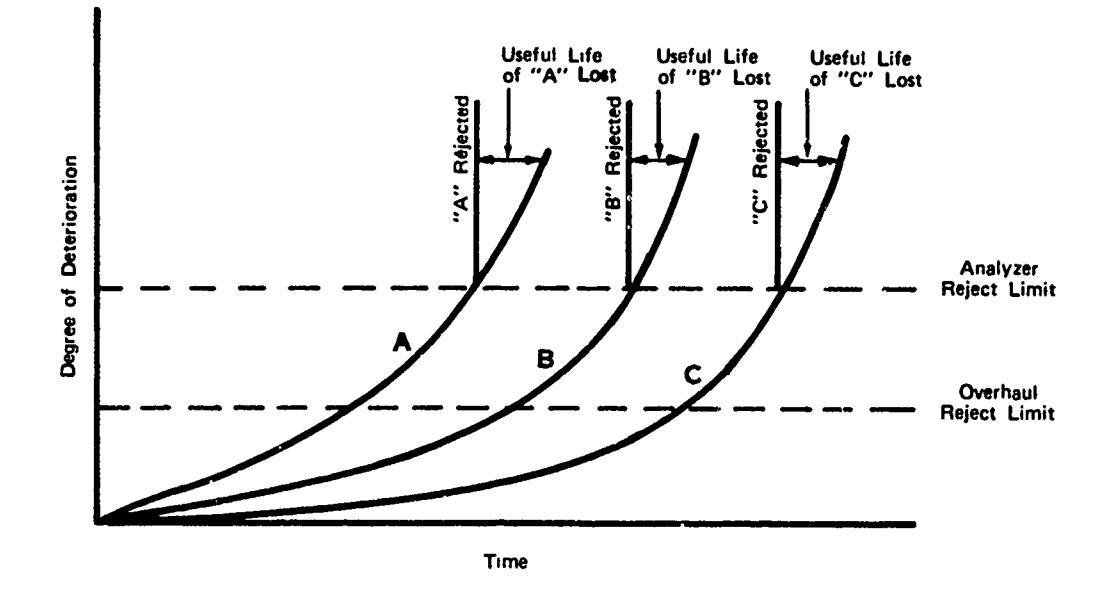
Figure 25. Reject Limit Established by an Analyzer Using Limit Criteria Set by the Analyzer's Capabilities.

The fallacy of the approach and the obvious correction that should be made can be seen in Figure 25. Because the analysis process can be continuous, the need to allow for any deterioration that may occur after the inspection can be eliminated. This means that the analyzer reject limit could be evaluated to a level that is just short of the tailure point by an amount which would permit sufficient time to order a replacement component and so replace the component prior to complete failure.
