# Cultural Landscape Inventory for Picatinny Arsenal, New Jersey

Megan W. Tooker and Adam D. Smith

August 2016

Final report

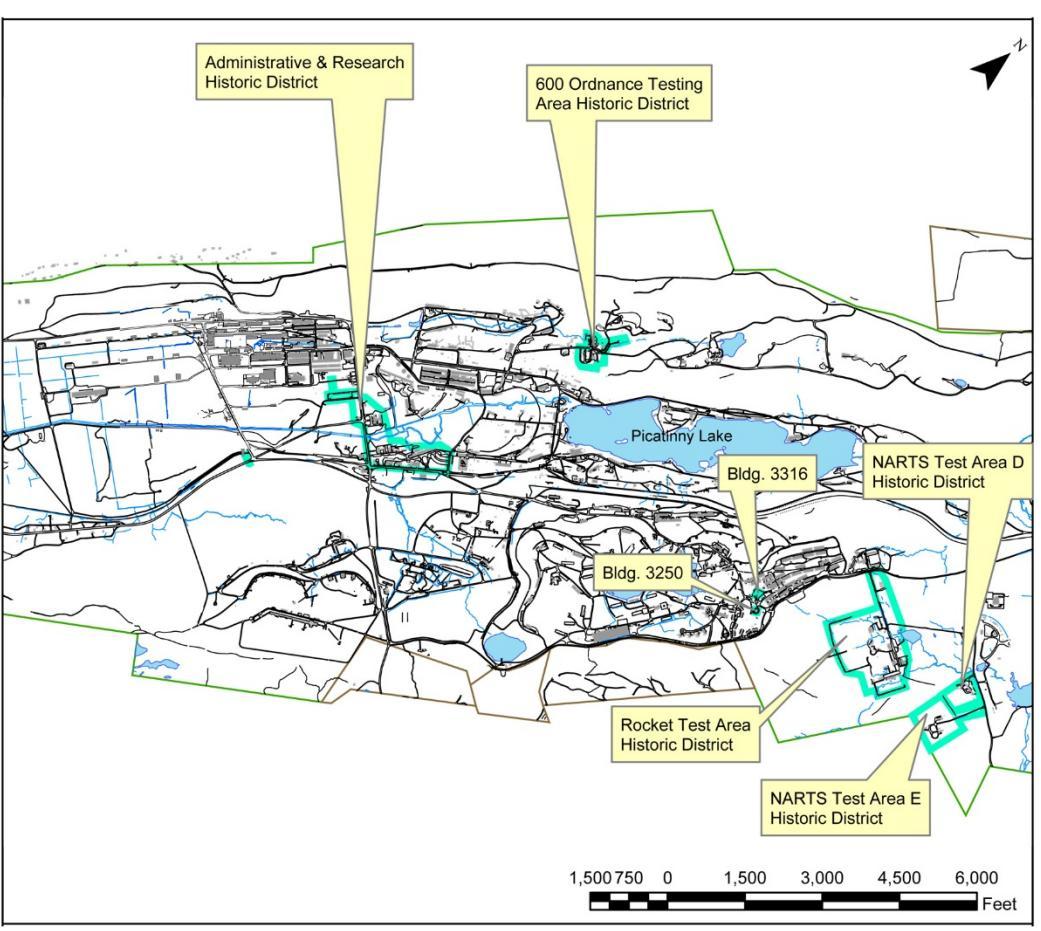
Figure 1. Map showing locations of current historic districts and buildings at Picatinny Arsenal, as noted in 2008 ICRMP (Chugach Industries 2008).

PICA has evaluated approximately 1,159 buildings, structures, and objects and found that 99 are eligible for inclusion on the NRHP.<sup>1</sup> Of these 99 resources, 97 are located within five historic districts—the Administration and Research Historic District, the 600 Area Ordnance Testing Historic District, the Army Rocket Testing Historic District, NARTS<sup>2</sup> D Historic District, and NARTS E Historic District (Figure 1). Two of the 99, Building 3250 and Building 3316, are

located outside the historic districts (Figure 1). Within the five districts, there are 22 noncontributing properties.

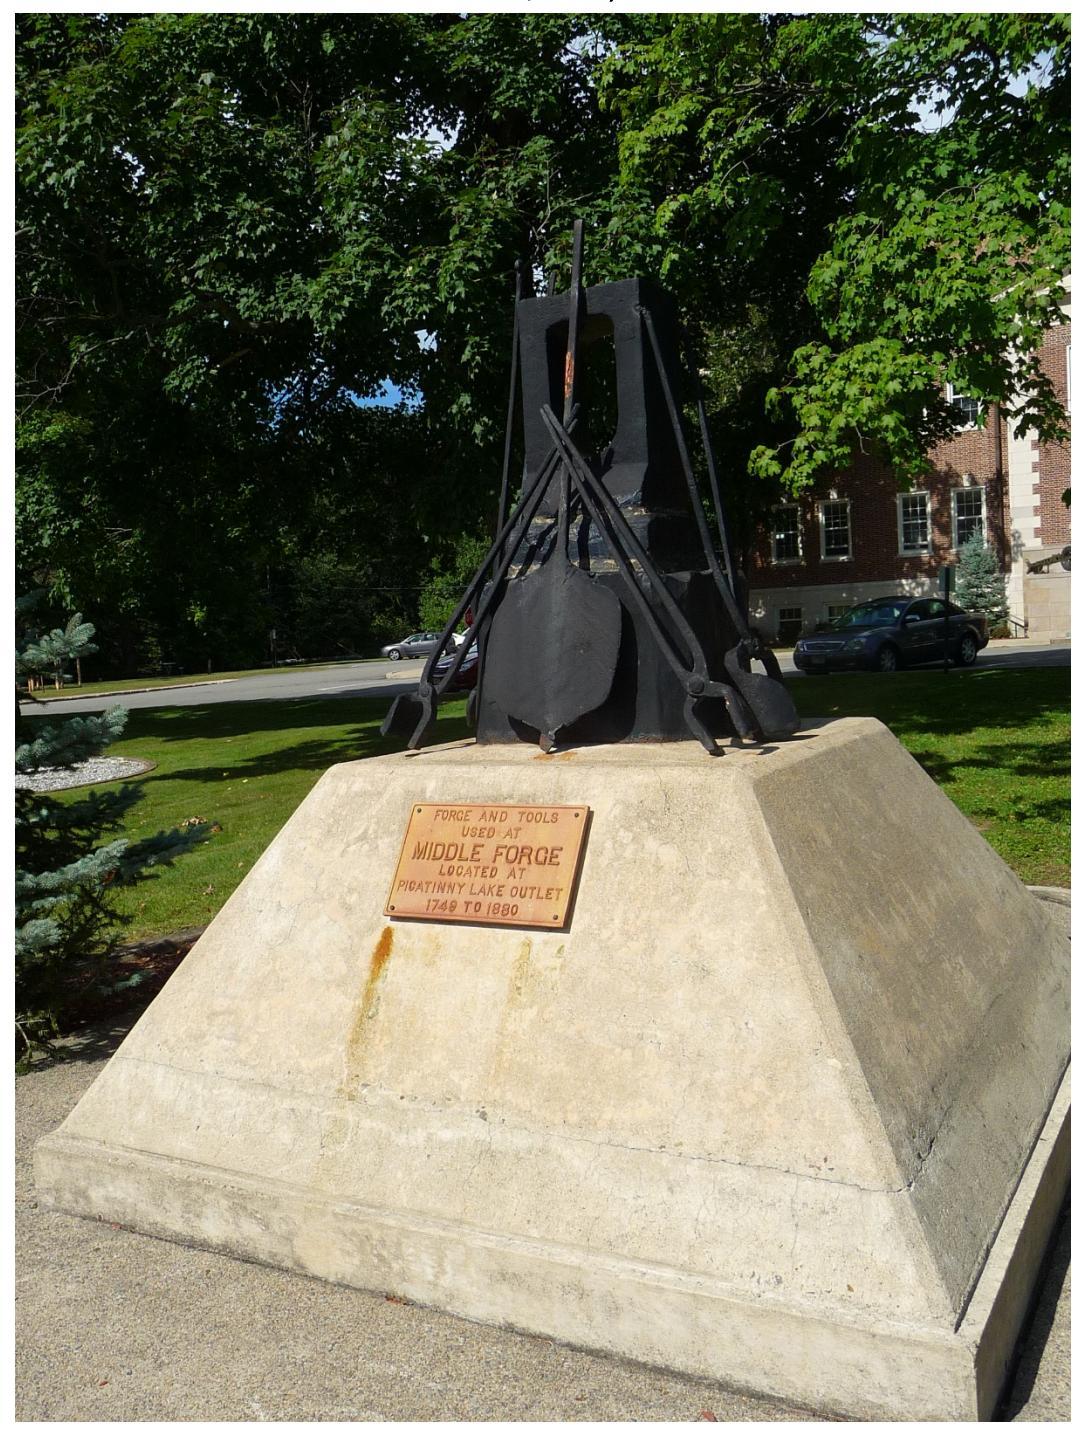
Figure 3. Middle Forge Monument (Monument 151M), located in front of Building 151 (ERDC-CERL, 2013).

The iron industry in New Jersey was a profitable one from 1804 to 1816, but the depression in 1820 caused a downturn. The decade from 1830 to 1840 was again profitable for iron makers. A technological change in the process in 1837 introduced a hot blast process, which reduced the charcoal needed by one-half. A stone coal manufacturing process led, however, to the ultimate cessation of iron forge works in general. At the height of its operation, the Middle Forge reportedly employed 60 men and produced 10–20 tons of iron per week (Figure 2). The forge trip hammer (with a 14-inch square face and weighing 600 pounds) and the anvil (two feet square and weighing an estimated 4,000 pounds), along with other forge tools are on exhibit at Picatinny Arsenal (Figure 3, Monument 151M).

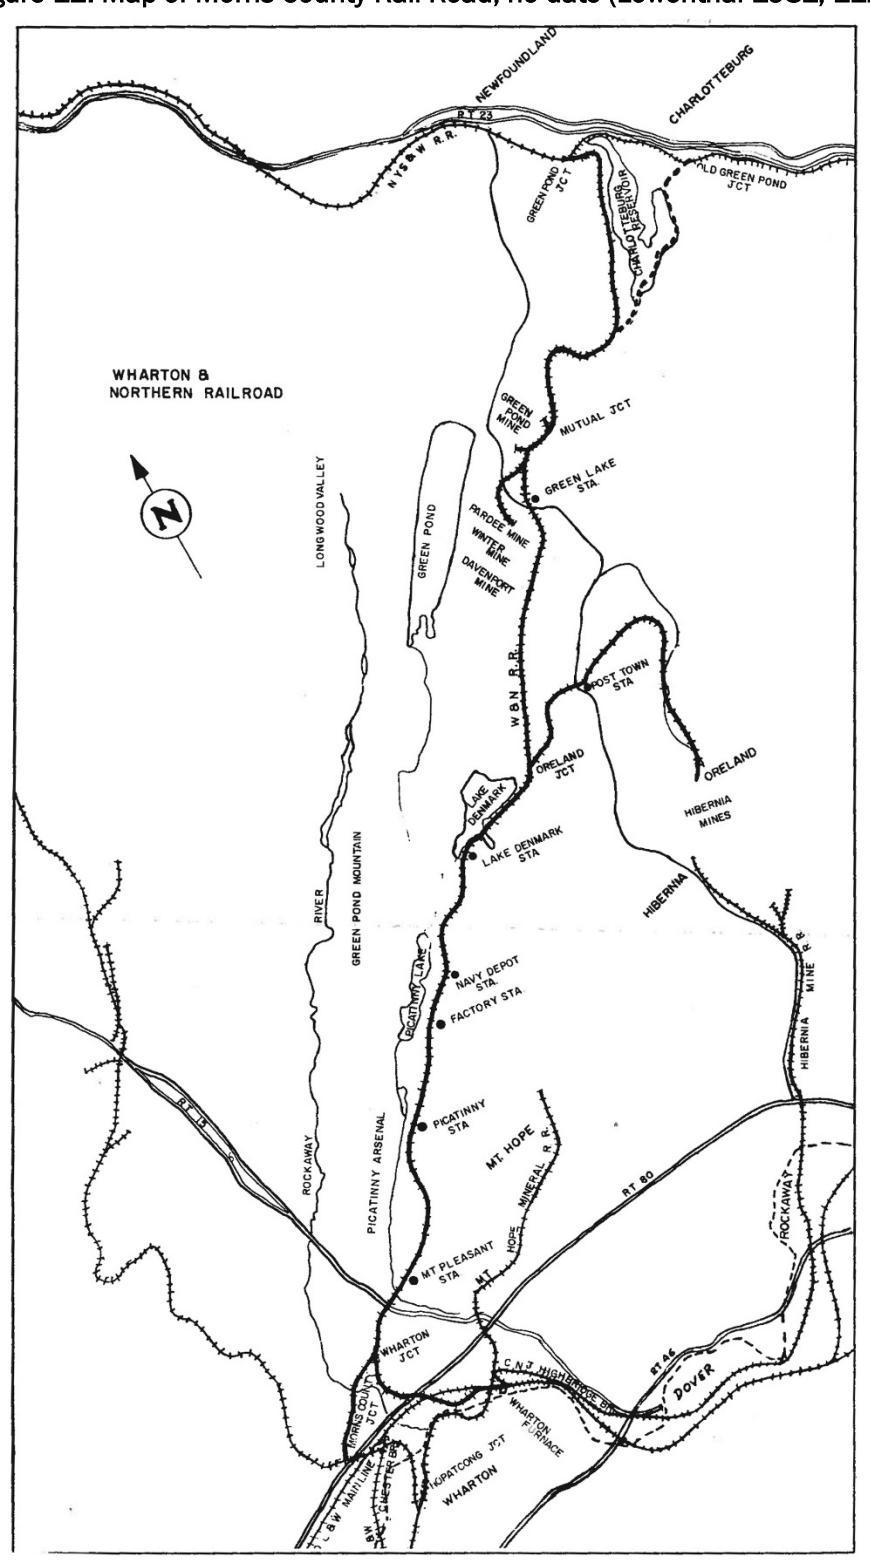
Figure 12. Map of Morris County Rail Road, no date (Lowenthal 1981, 112).

Accessibility to a railway was a criterion for site selection for powder depots on the East Coast in the 1860s and 1870s. Land for the Picatinny Powder Depot was purchased in 1880. By 1887, 23.5 miles of track—called the Wharton & Northern Railroad—connected the Army depot with the Delaware Lackawanna and Western Railroad, and the Dover and Central Railroad of New Jersey at Wharton. The track was laid out by the Morris County Railroad Company of New Jersey, under the terms of a nine-acre right-of-way granted by a 99-year lease which ended in 1986 (Harrell 1996, E-464). The tracks are now owned by PICA. Rail links, both within and outside Picatinny Arsenal, were an essential part of its operability (Figure 12).

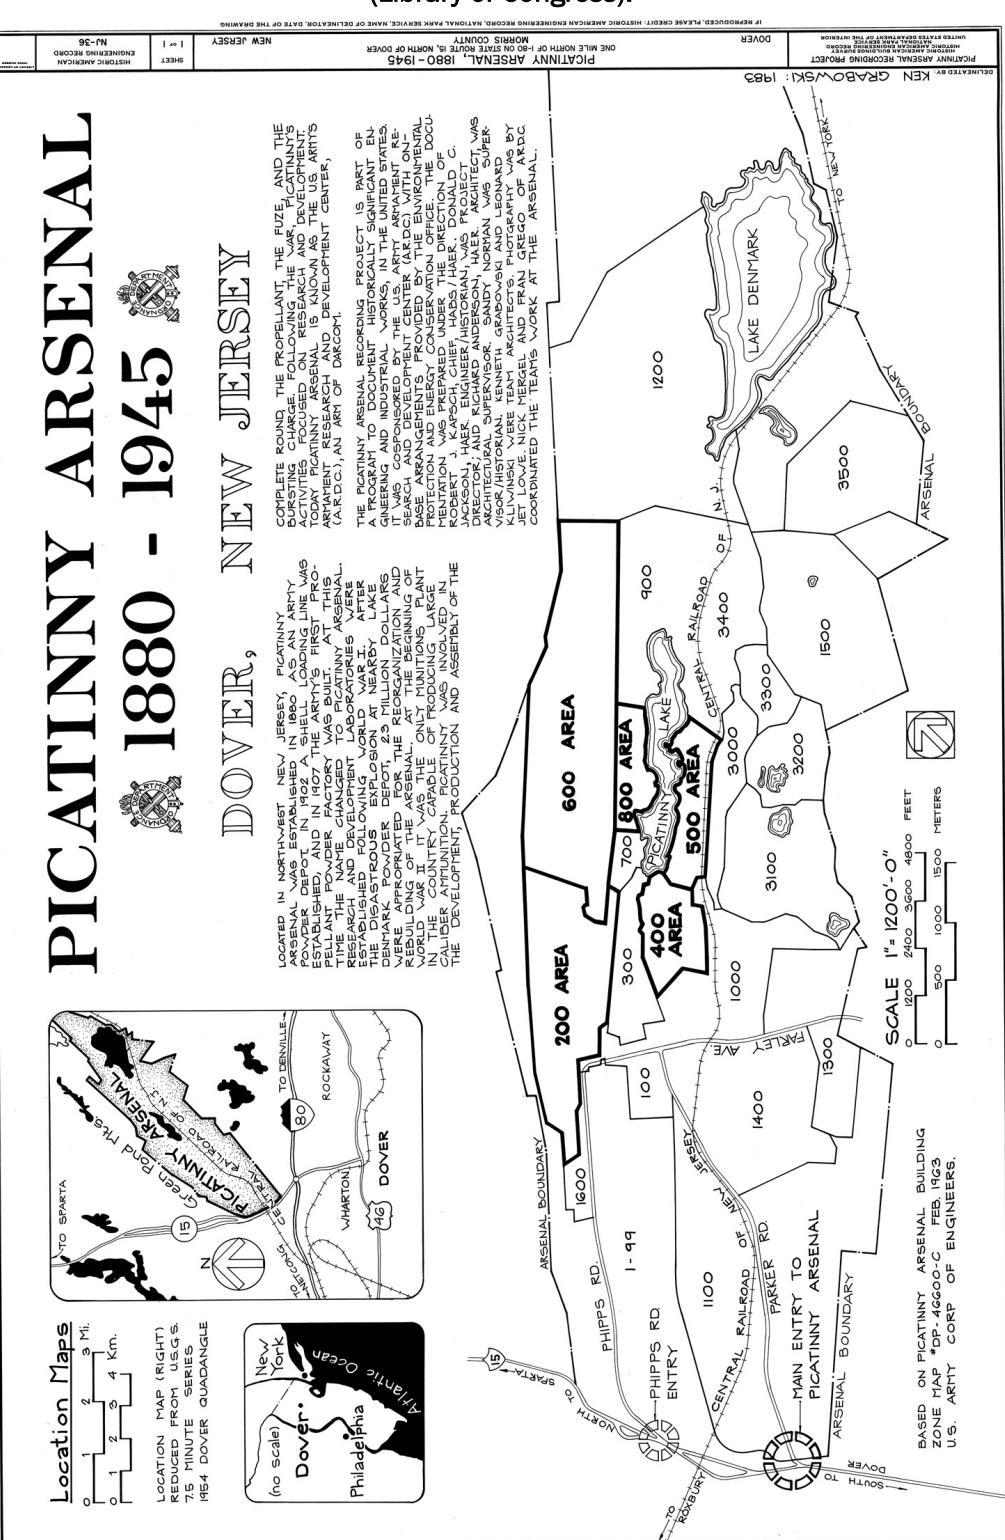
Figure 20. Overall map of PICA showing manufacturing and testing areas, 1983 (Library of Congress).

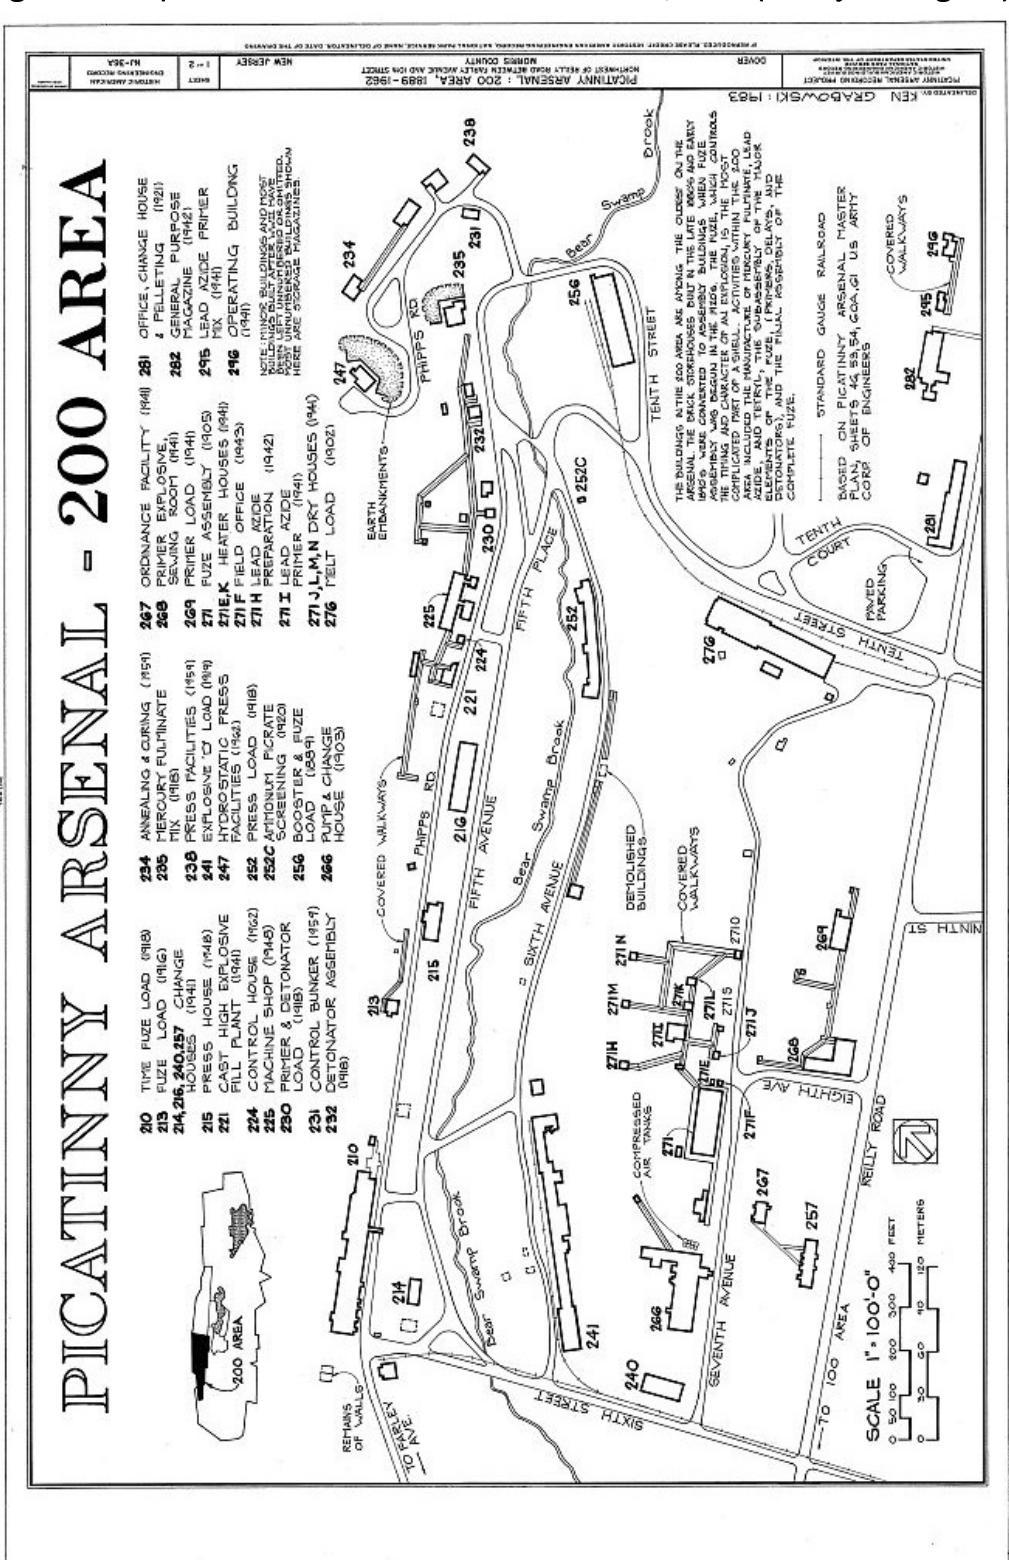
Figure 21. Map of 200 Area from HABS documentation, 1983 (Library of Congress).

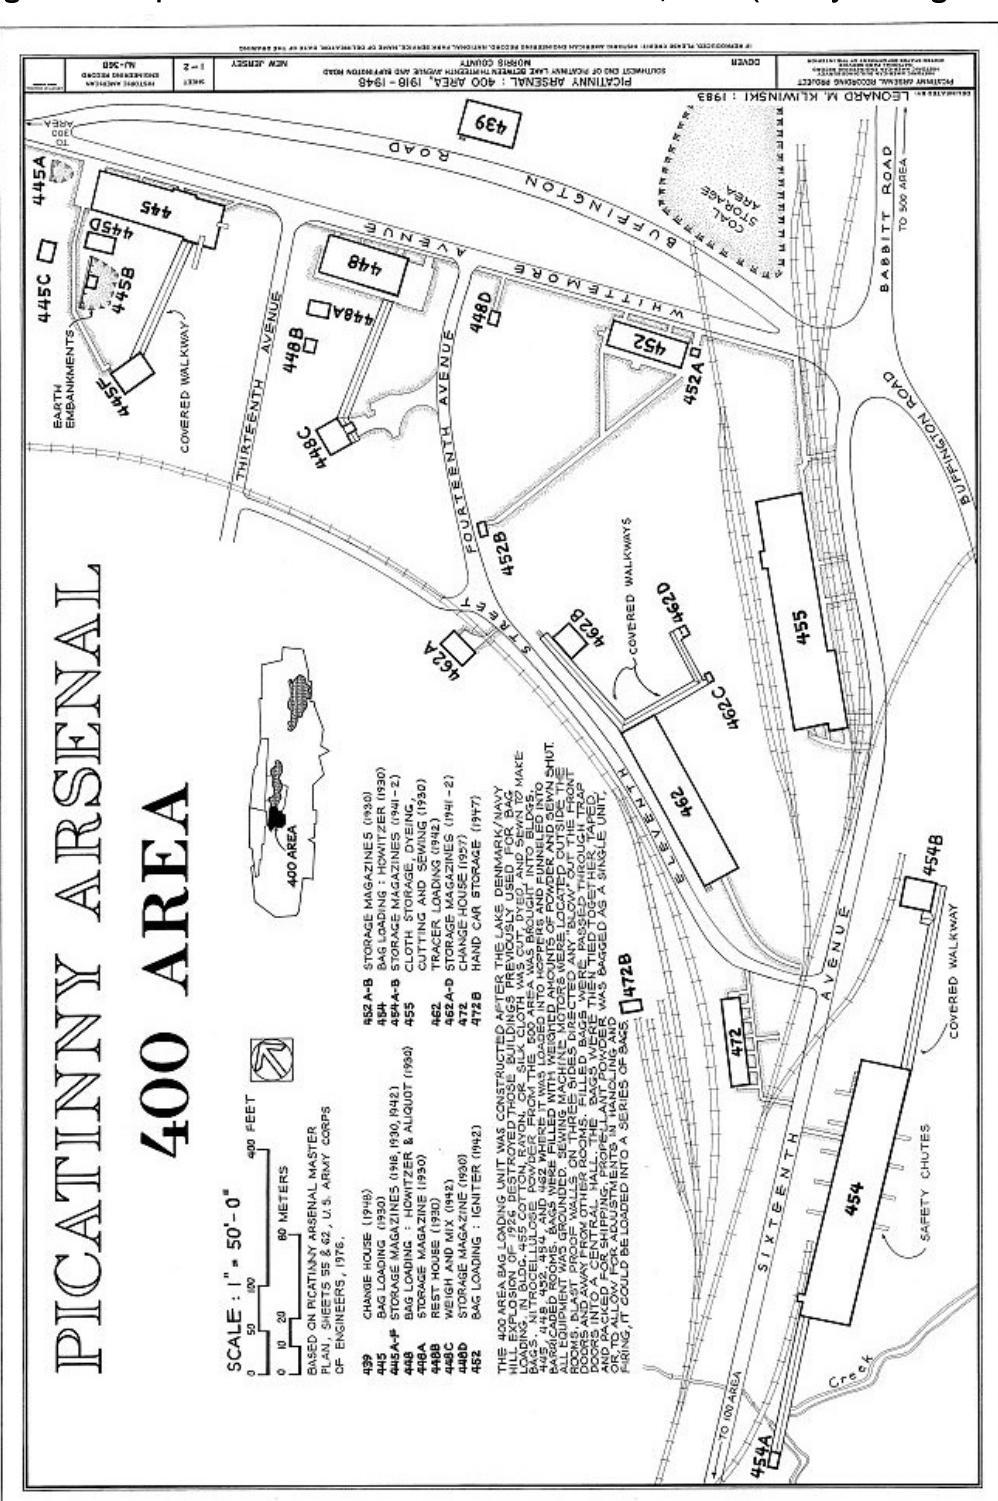
Figure 22. Map of 400 Area from HABS documentation, 1983 (Library of Congress).

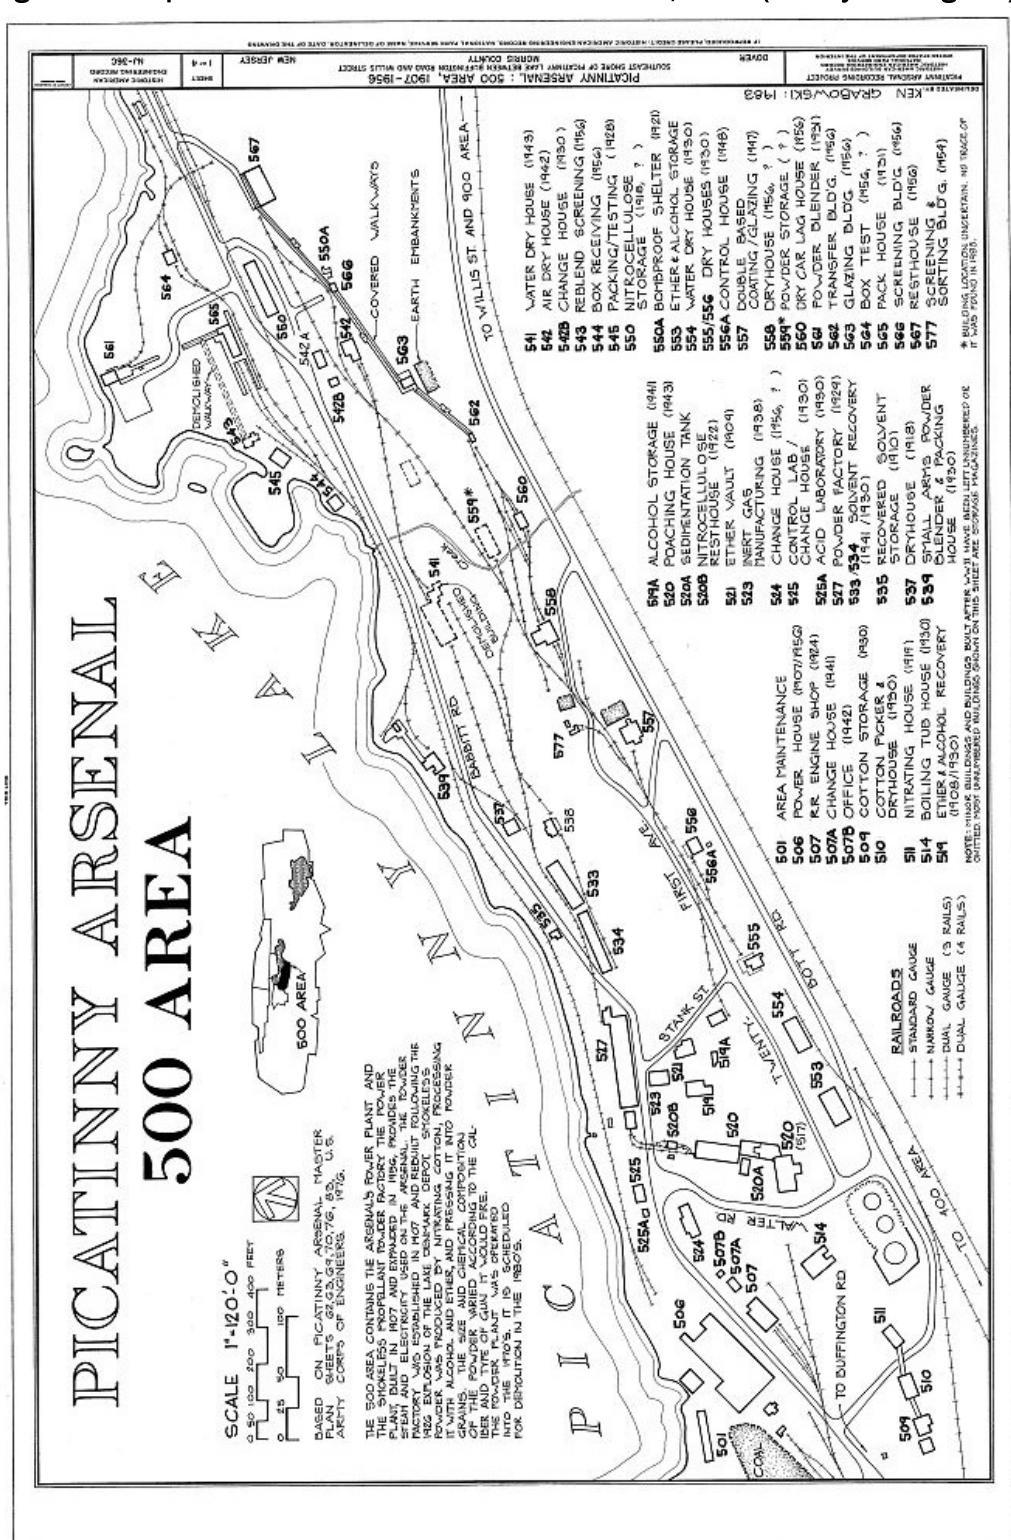
Figure 23. Map of 500 Area from HABS documentation, 1983 (Library of Congress).

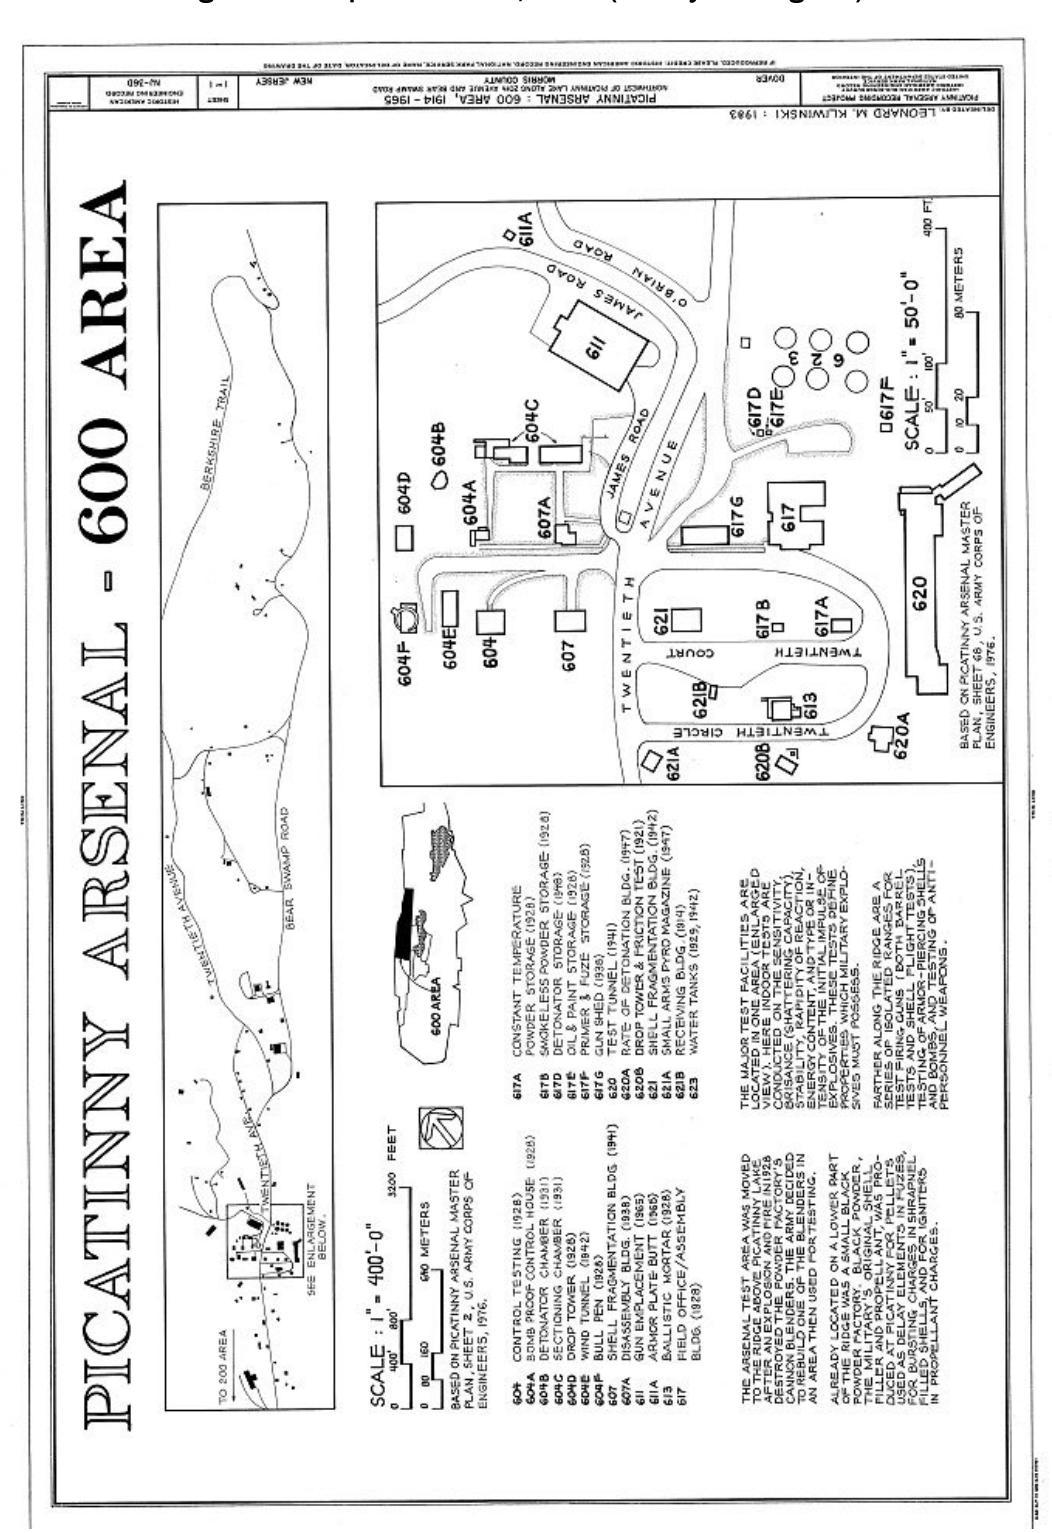
Figure 24. Map of 600 Area, 1983 (Library of Congress).

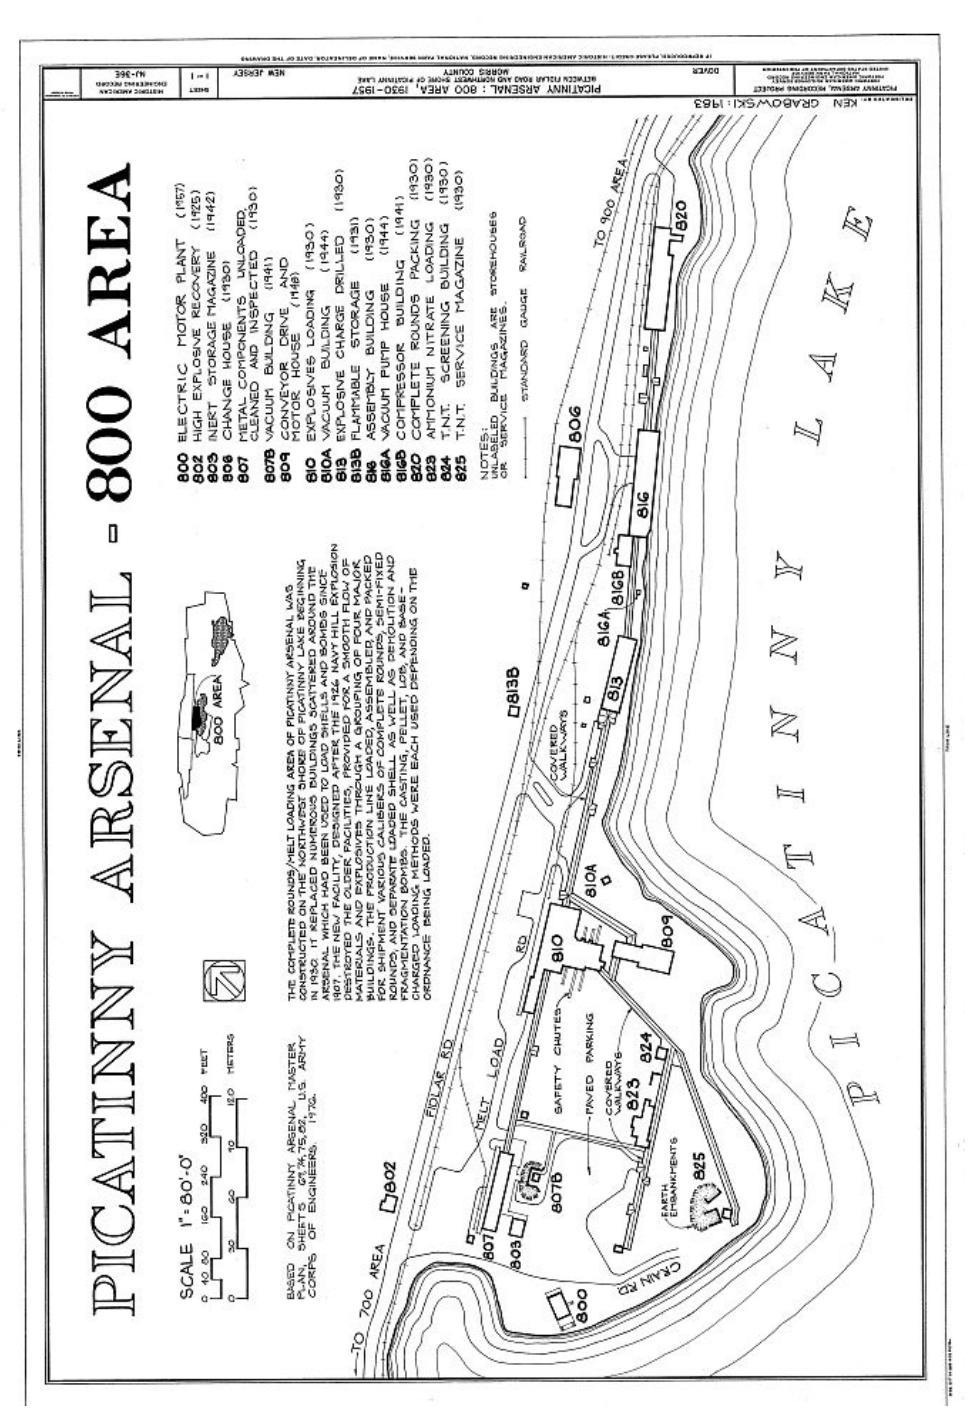
Figure 25. Map of 800 Area, 1983 (Library of Congress).

Located along the north side of Picatinny Lake, the 800 Area (Figure 25) was constructed in 1930. The buildings form a straight line to provide for a smooth flow of materials and explosives from building to building under covered walkways. This area was established to load, assemble, and pack for shipment various calibers of complete rounds, shells, and fragmentation and demolition bombs. Many of the original buildings are derelict, and others have been heavily modified. Loading is still the main use for a few of the buildings in the area such as Buildings 810 and 816. It was determined in 1999 that the plant no longer has integrity (Nolte et al. 1999a, 4–48).

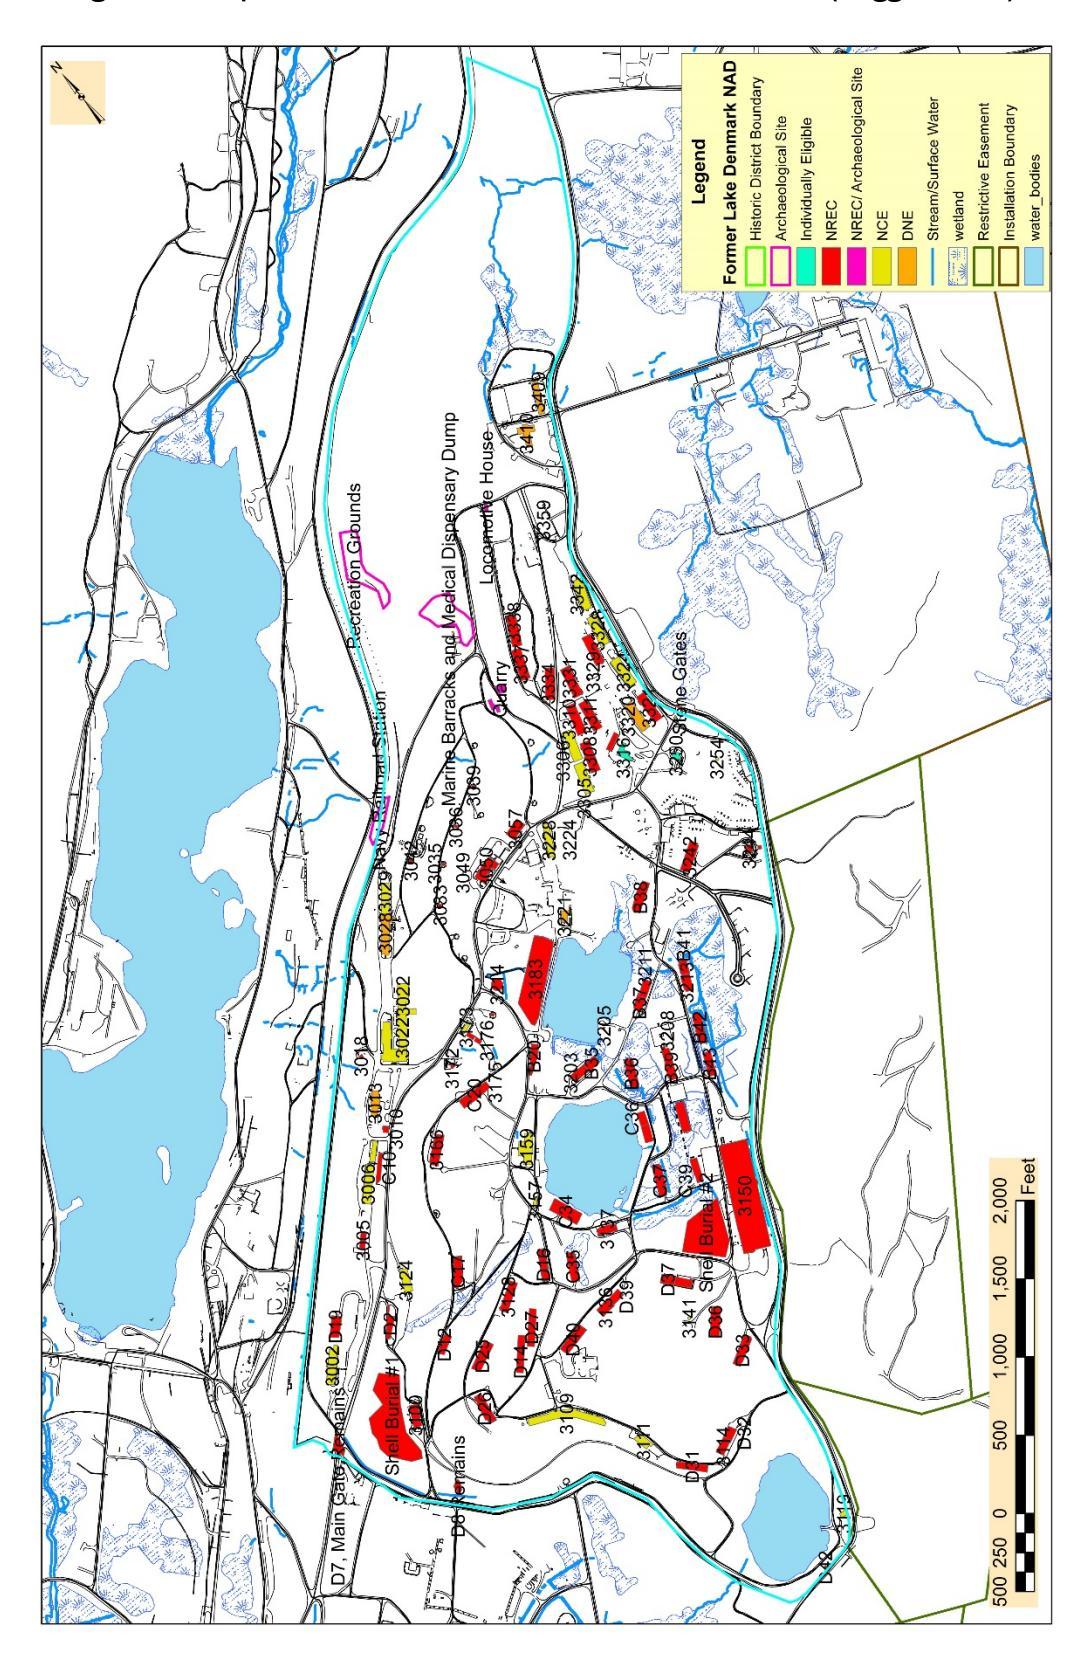
Figure 31. Map of former Lake Denmark NAD Historic District (Huggan 2015).

This area has been covered in another report, *Cultural Landscape Analysis of the Former Lake Denmark Naval Ammunition Depot at Picatinny Arsenal* (Huggan 2015), which identifies the newly established Former Lake Denmark NAD Historic District (Figure 31). Additionally, Building 3250 (built in 1890 for the Naval Commanding Officer; Figure 32) and Building 3316 (built in 1903 as a stable; Figure 33) were determined eligible to the NRHP in an earlier HABS survey (Thurber et al. 1985).

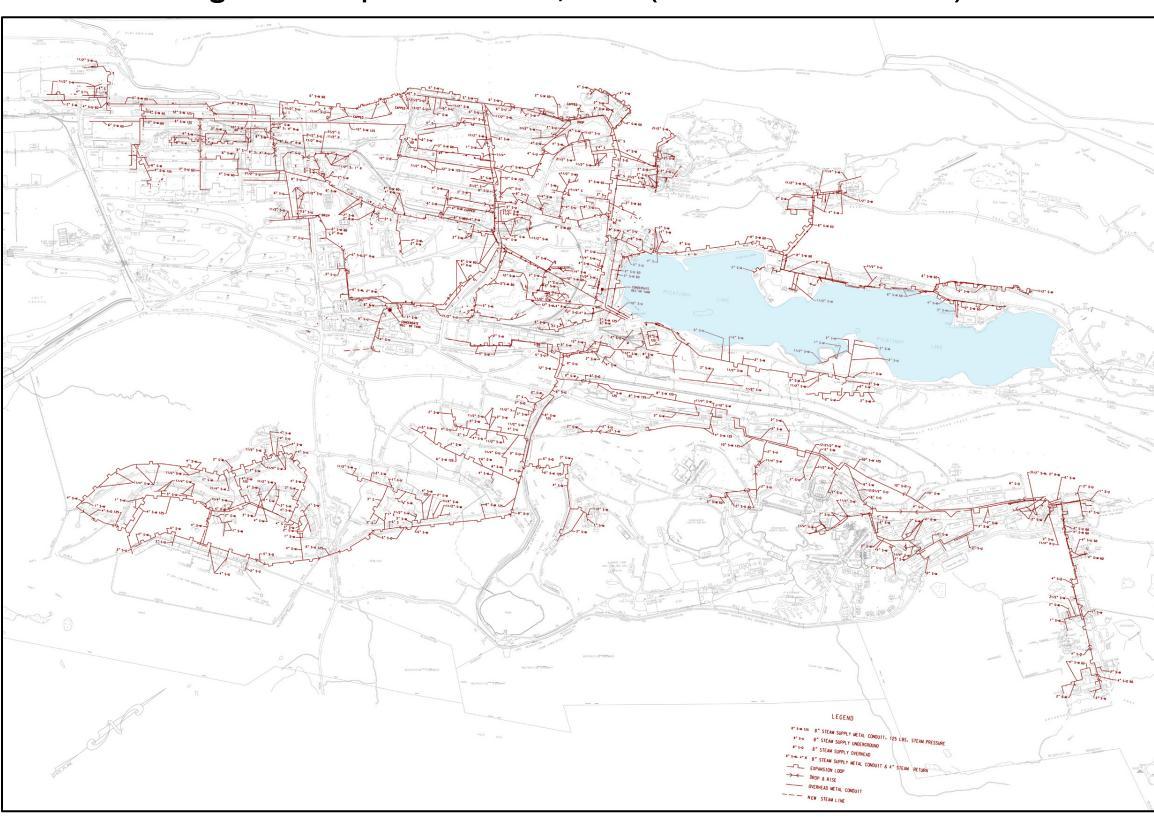
Figure 36. Map of steam lines, 2009 (PICA Cultural Resources).

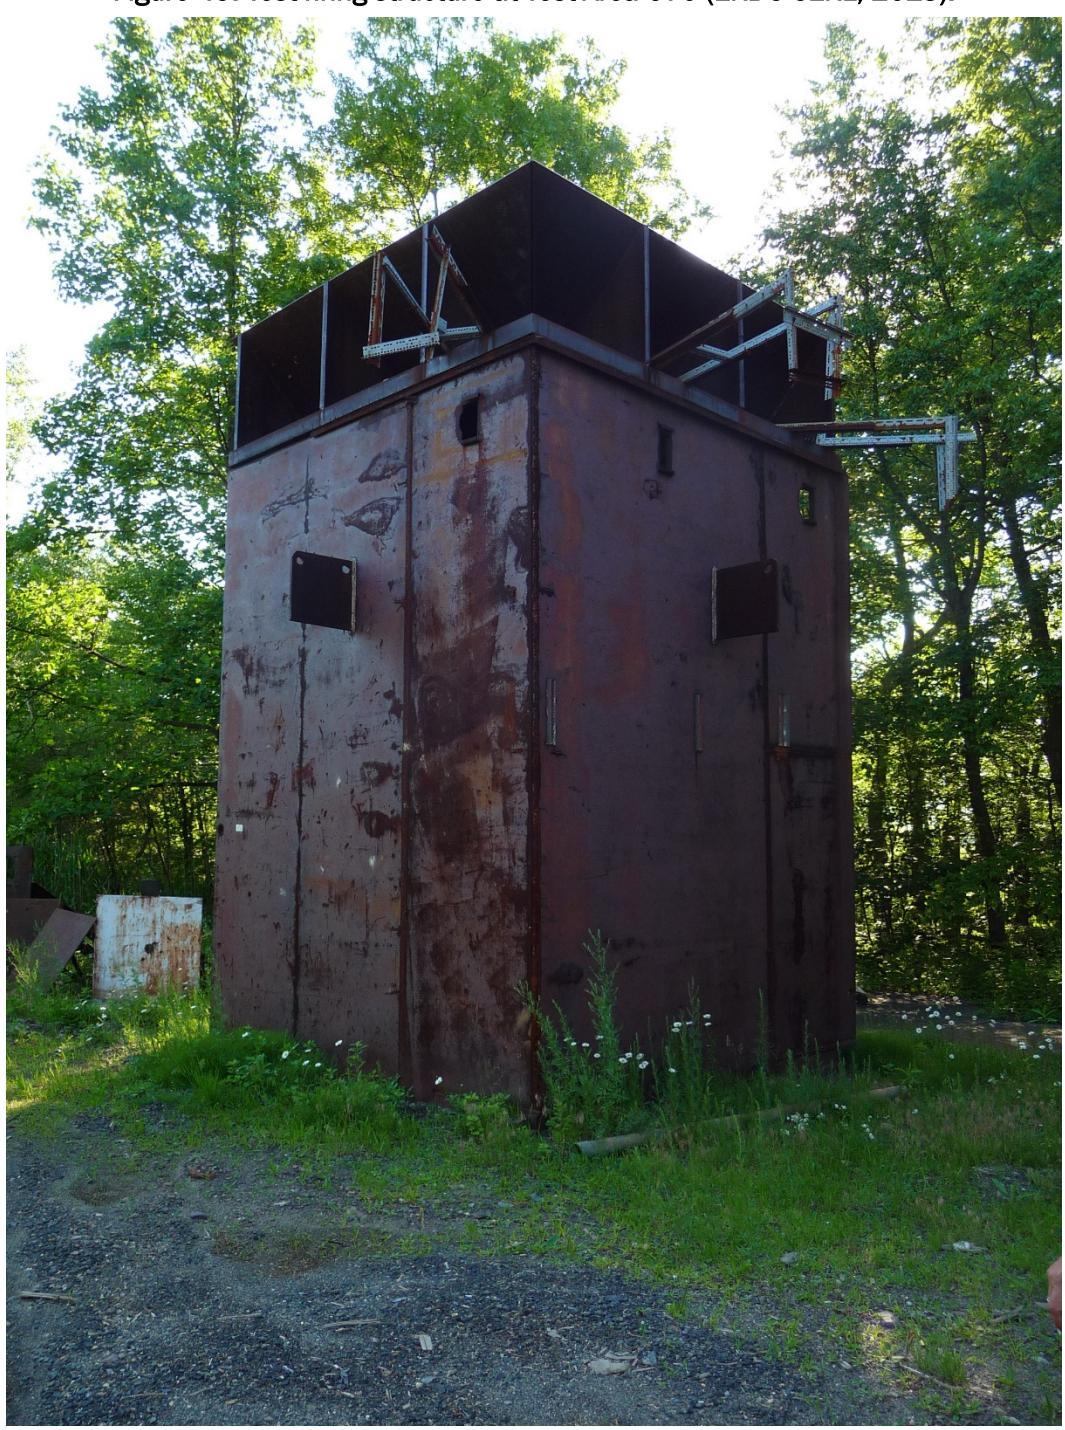
Figure 49. Test firing structure at Test Area 670 (ERDC-CERL, 2013).

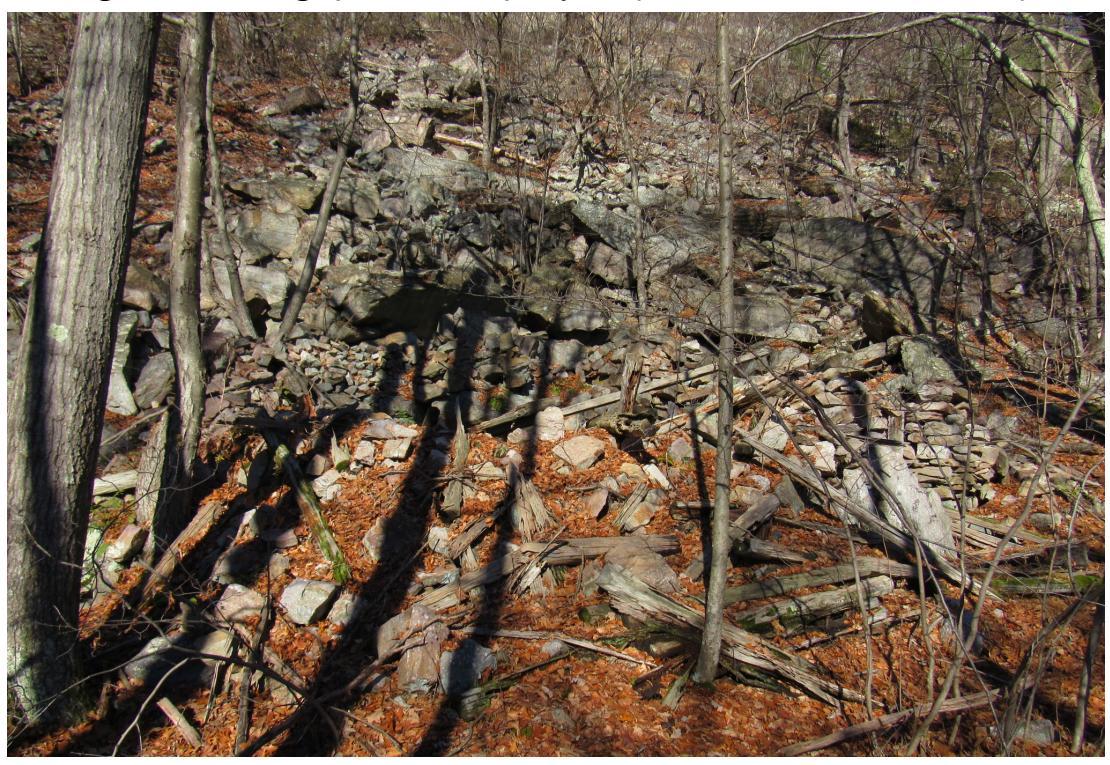
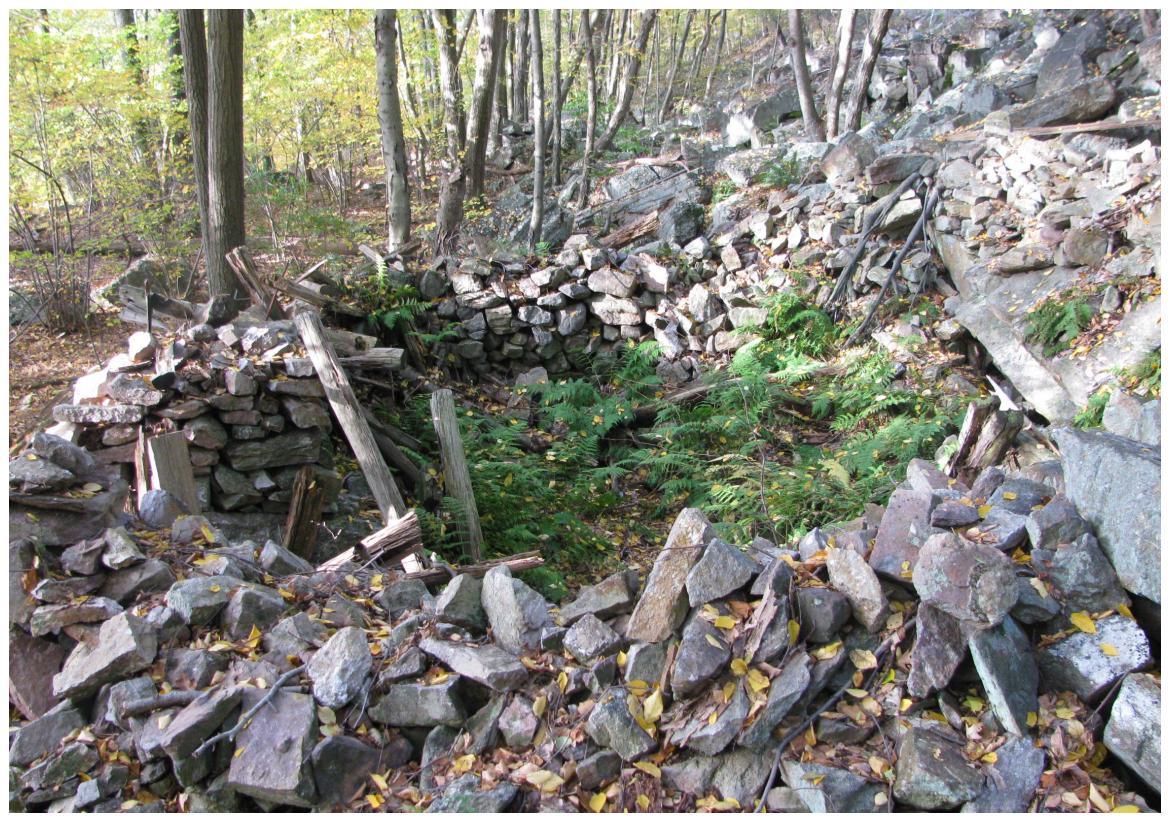
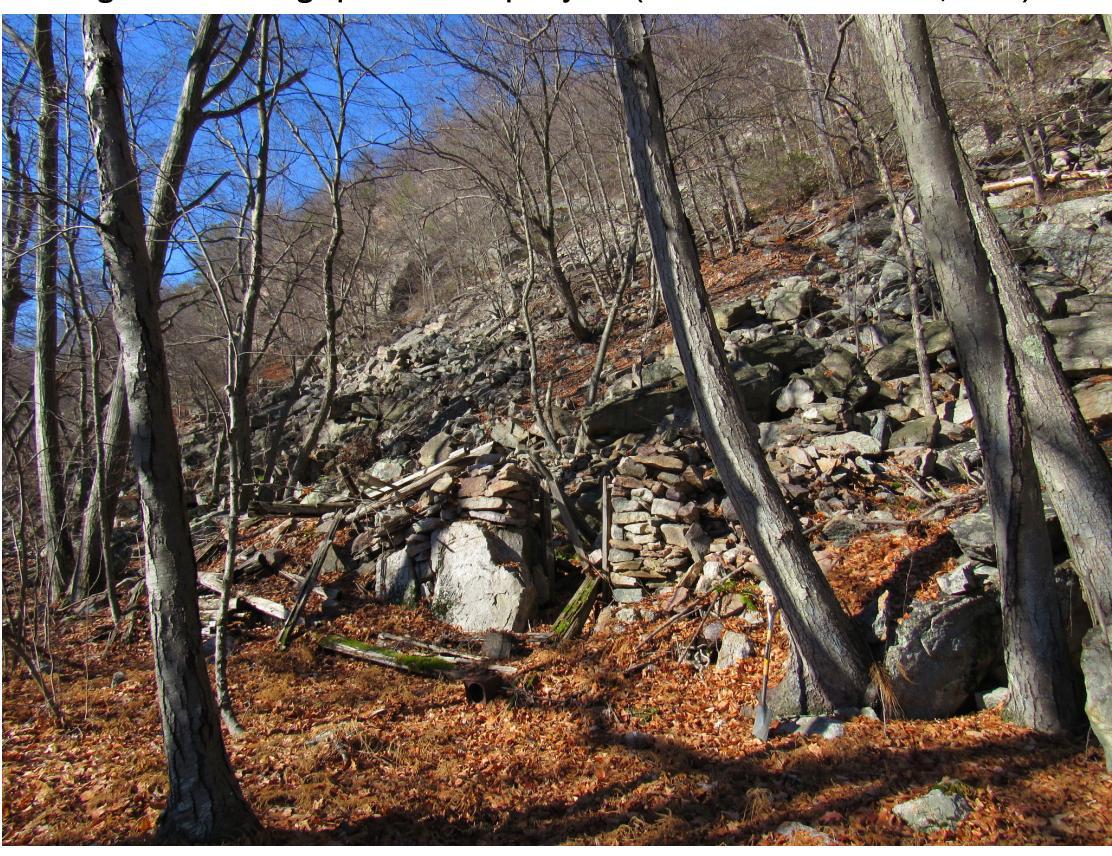
Figure 107. Photograph of former quarry site (PICA Cultural Resources, 2015).

Figure 108. Photograph of former quarry site (PICA Cultural Resources, 2015).

Figure 109. Photograph of former quarry site (PICA Cultural Resources, 2015).

A former quarry, located behind Building 806 along Fidlar Road, has been identified as Site 28Mr361 (Figure 107-Figure 109). The quarry provided the stone that was used for the foundations, windows sills, and lintels of most of the earliest buildings. A 1931 history of Picatinny Arsenal noted that "Two quarries were opened about a mile from the magazine, and roads built to them. The conglomerate was abandoned and considerable stone was taken out of these quarries, and hauled and built in the foundation...corners, sills, and door jambs. The stone was laid in pure cement mortar." (Rogers 1931, 58). The second quarry mentioned in Rogers (1931) has not been located to date.
