# Cultural Landscape Inventory for Picatinny Arsenal, New Jersey

Megan W. Tooker and Adam D. Smith

August 2016

Final report

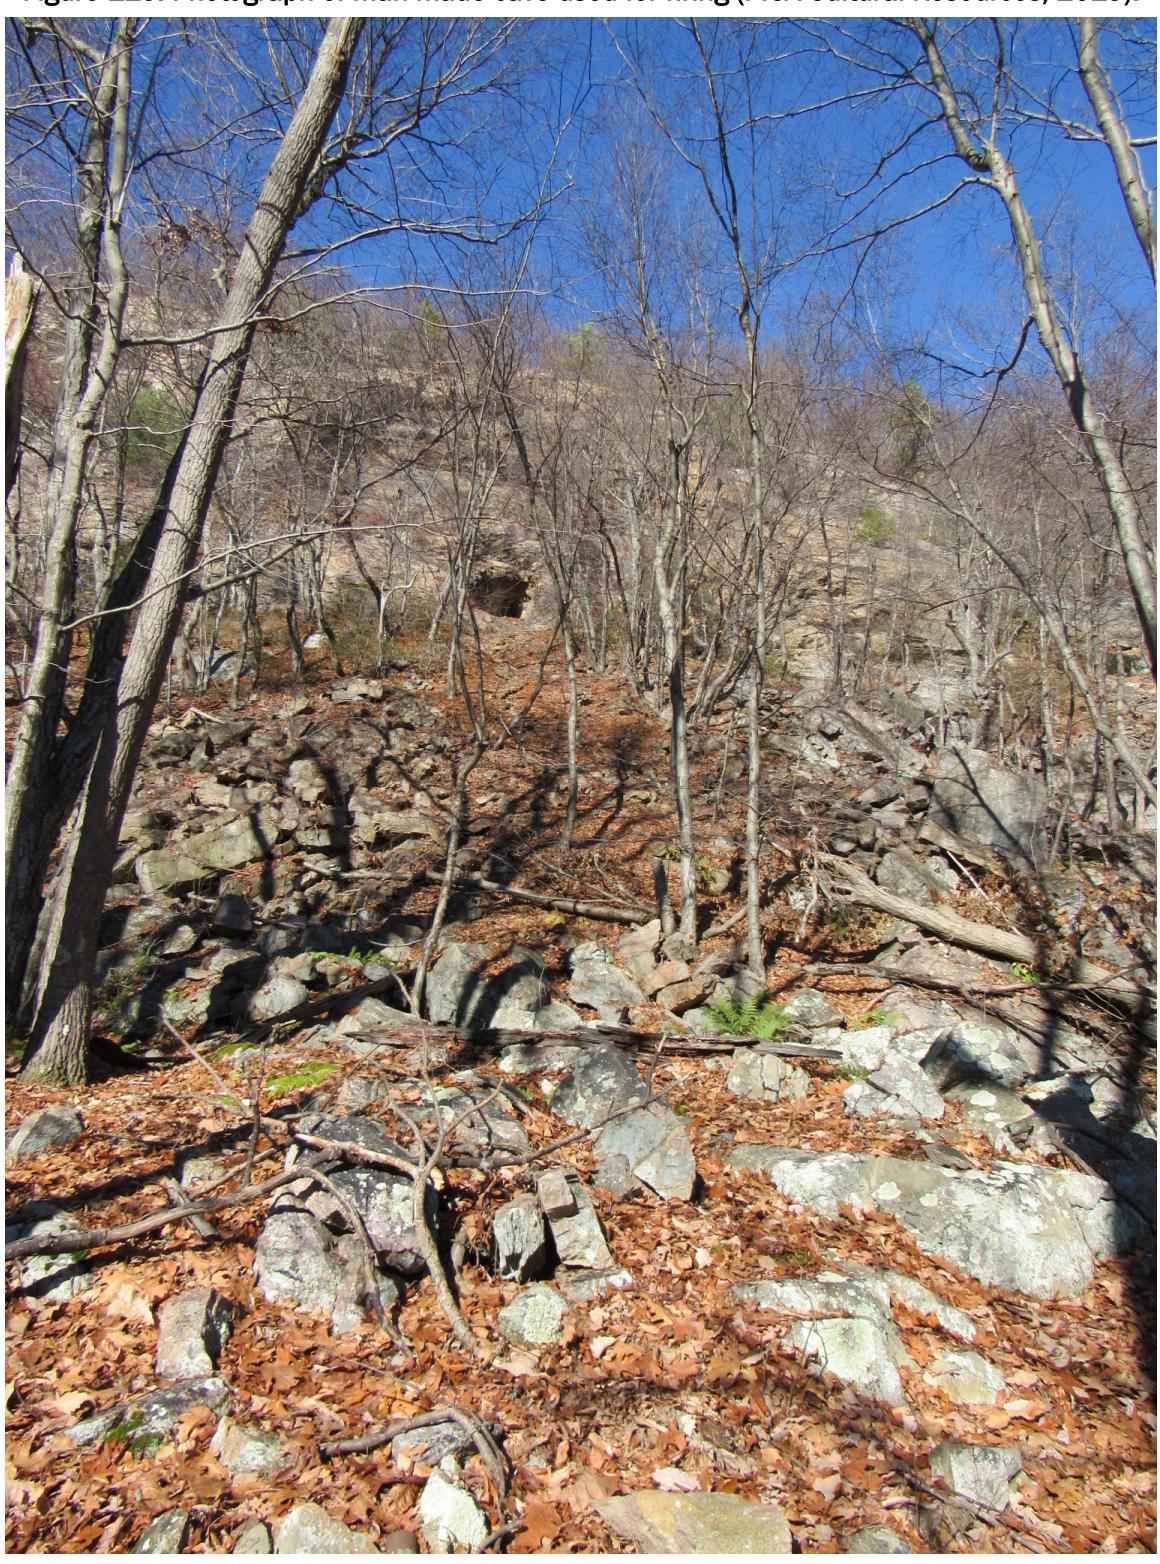
Figure 110. Photograph of man-made cave used for firing (PICA Cultural Resources, 2015).

Also located just west of this area, is a man-made cave that Picatinny created in the 1920s when they used to fire ammunition rounds into the mountainside from the old Proving Grounds that was located in the 500 Area (Figure 110). This practice was discontinued after the 1926 explosion when all test areas were contained on the 600 Hill and the Gorge. Noted on a 1920/1922 map, the cave can be seen from Building 3013 along Navy Hill during the winter season when the leaves are off the trees.

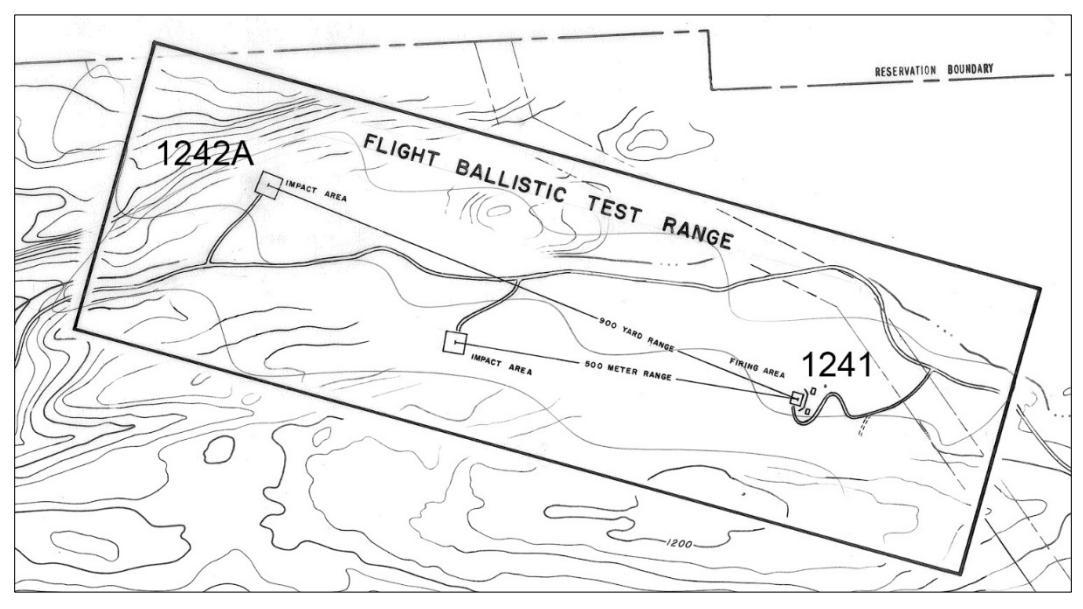
Figure 117. Flight Ballistic Test Range from 1962 map (PICA Drawing Vault).

The Flight Ballistic Test Range is located in the northern tip of Picatinny Arsenal. The range spans Gorge Road with the firing area and 500 m impact area to the east of Gorge Road, and the 900 m impact area and slug butt to the west. It appears not in use today, but several key features remain of the landscape (Figure 117–Figure 123). Most notable of these features are Building 1241 (a magazine) and Building 1242A (a slug butt). Another structure and a switch box are in disrepair. Building 1242A was listed as not found and not eligible during the 2007 architectural survey (Nolte et al. 2007, B-12), and Building 1241 was not surveyed. While sections of the firing line by Building 1241 appear to be recently mowed (not in successional growth), the view is now obstructed to the slug butt and the landscape lacks integrity.
