DEPARTMENT OF THE ARMY US ARMY RESEARCH, DEVELOPMENT AND ENGINEERING COMMAND TANK AUTOMOTIVE RESEARCH, DEVELOPMENT AND ENGINEERING CENTER 6501 E. 11 MILE ROAD WARREN, MI 48397-5000

Date: 1 May 2017

### TARDEC Direct Energy Deposition Technical Analysis

### Design of Experiments, Part 1, Phase 1

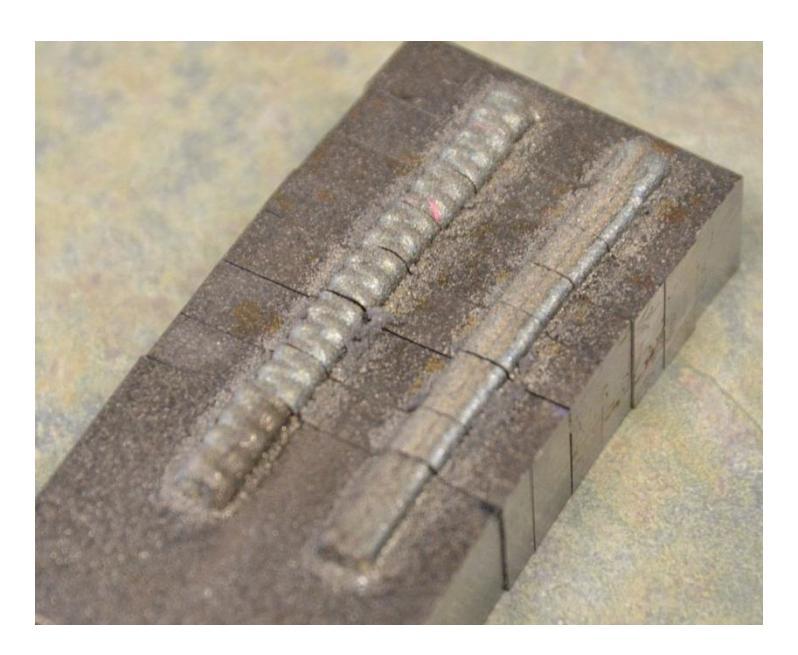
Figure 1: Sectioned deposition lines. On the left can be seen the Longitudinal/Transverse deposition pattern, and on the right Longitudinal deposition pattern.

Visual inspection of the deposition can be seen in Figure 1. These depositions were cross sectioned every half inch, from one end to the other, to evaluate the cross sectional layer quality. See Figure 2. The surfaces were polished to a one micron finish, and then etched to evaluate the micro structure and to distinguish between the A514 and Steel interface. It was determined that the Stellite 21 requires a specialty etchant to reveal the microstructure of future depositions. However, this etchant was not available at the time of this report and not required at this point of the evaluations, as only identifying the interface was required.

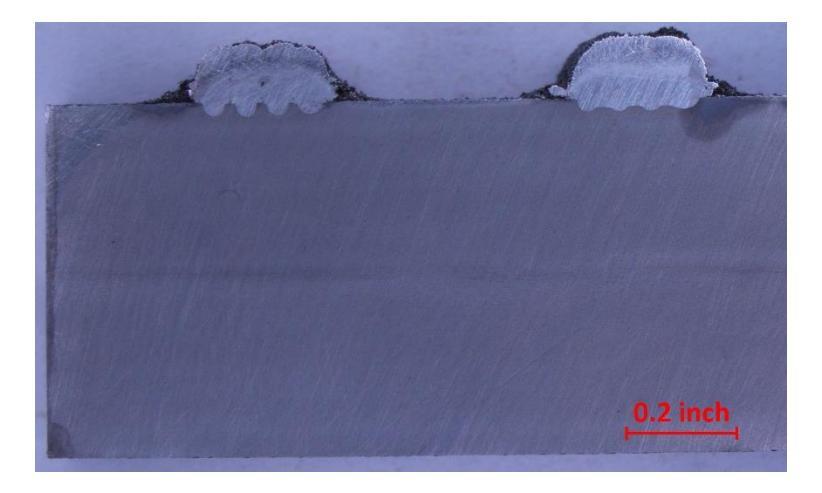
Figure 2: Cross sectioned deposition lines. On the right can be seen the Longitudinal/Transverse deposition pattern, and on the left Longitudinal deposition pattern.

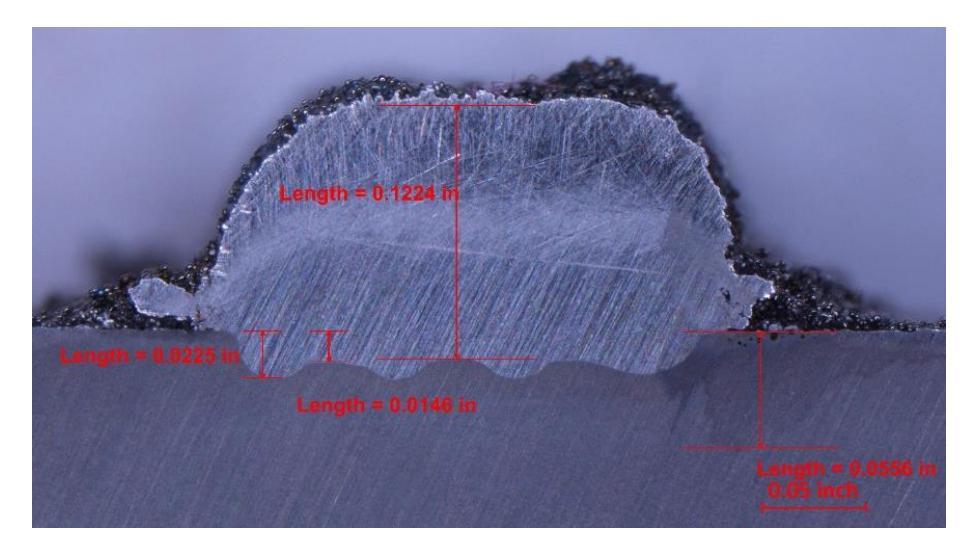
Figure 3: Cross sectioned deposition lines. On the right can be seen the Longitudinal/Transverse deposition pattern, and measurements of the deposition penetration depth and height.

As seen in Figure 3, the deposition had a penetration depth of 0.5715 mm (0.0225 inches) from the surface of the A514 substrate. Total height of the deposition was roughly 3.1090 mm (0.1224 inches), including the overall depth of

penetration. The height of the deposition from the surface of the substrate to the top of the deposition was 2.7635 mm (0.1088 inches). A close inspection of the surfaces indicated one or two pores near the interface on one of the cross sections, as could be seen via microscopic inspection.

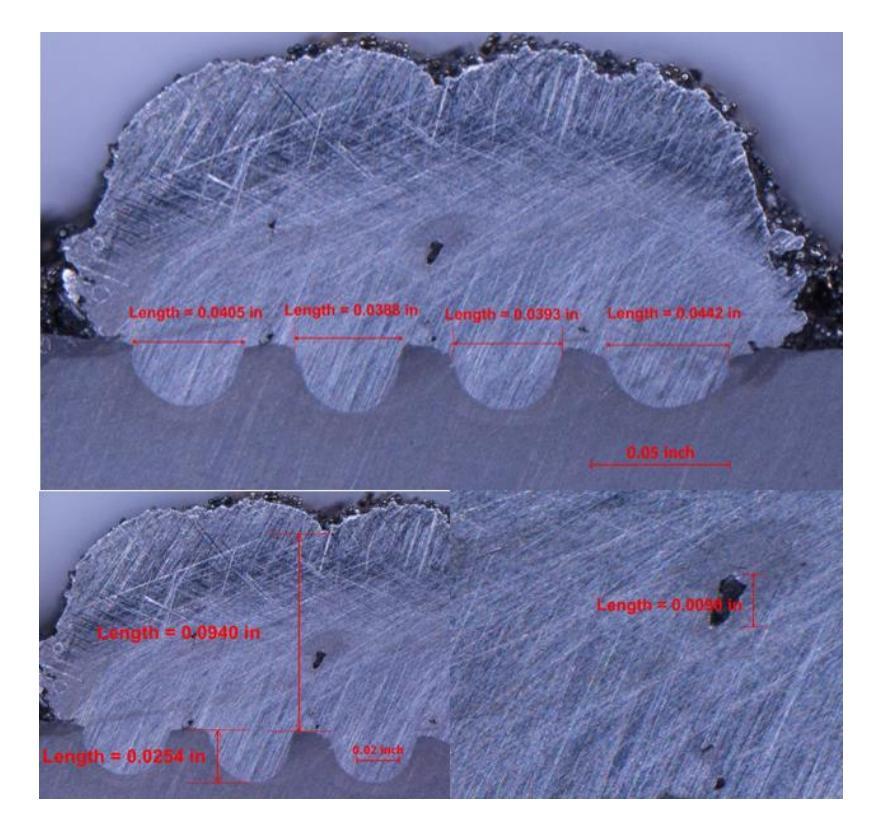
Figure 4: Cross sectioned deposition lines. On the right can be seen the Longitudinal deposition pattern, and measurements of the deposition penetration depth and height.

As seen in Figure 4, the deposition had a penetration depth of 0.6452 mm (0.0254 inches) from the surface of the A514 substrate. Total height of the deposition was about 2.3876 mm (0.0940 inches). The surface was further noted to contain porosity between the corners of the deposition passes, as well as within the material between layers. Large pores were documented between the deposition passes.

The micro-pores in the Longitudinal deposition appeared to be in less numbers than the Longitudinal/Transverse deposition, but contained more pores and what appeared to be some inclusions within the bulk of the deposited powder. See Figure 10. This was in addition to the visual pores (Figure 4) already identified by microscopic analysis.

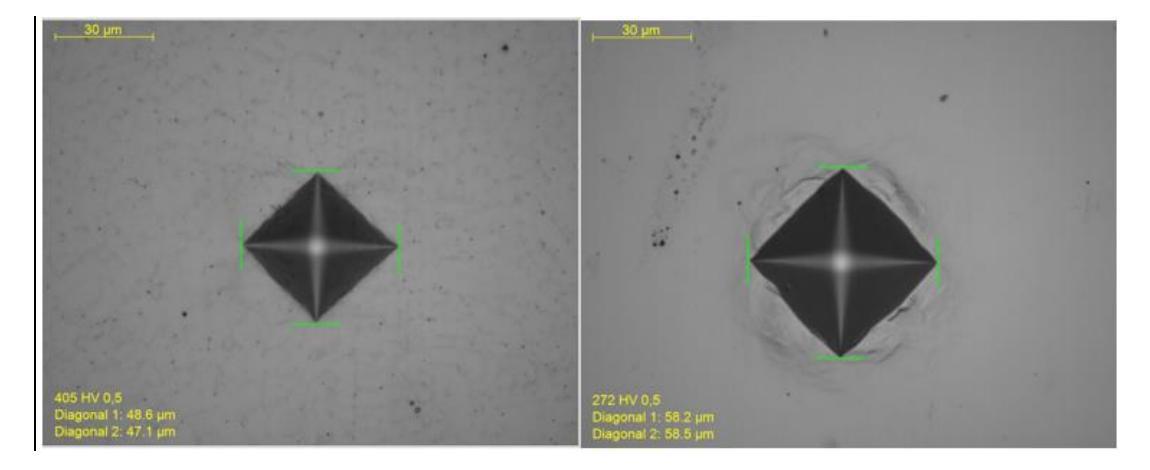
Figure 5: Longitudinal/Transverse deposition indents. On the left is a Vickers indent into the Stellite 21 deposition and on the right is an indent into the A514 steel. Note the difference in hardness of each material.

In Figure 5 and 6, Vickers hardness data was collected and analyzed to determine the quality of the deposition. The hardness measurements for the deposition were compiled and the average hardness was determined to be 376 HV. The average hardness of the substrate was determined to be 274 HV.

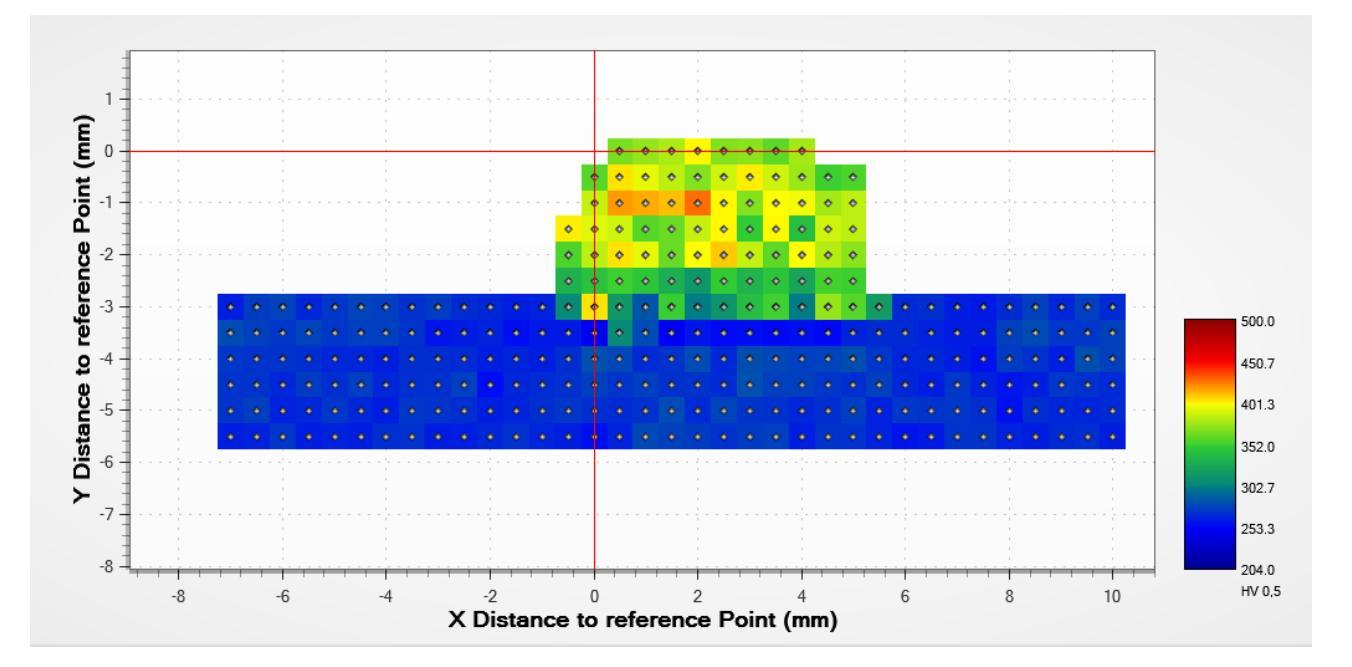
Figure 6: Longitudinal/Transverse deposition hardness mapping of the deposition, interface, and substrate.

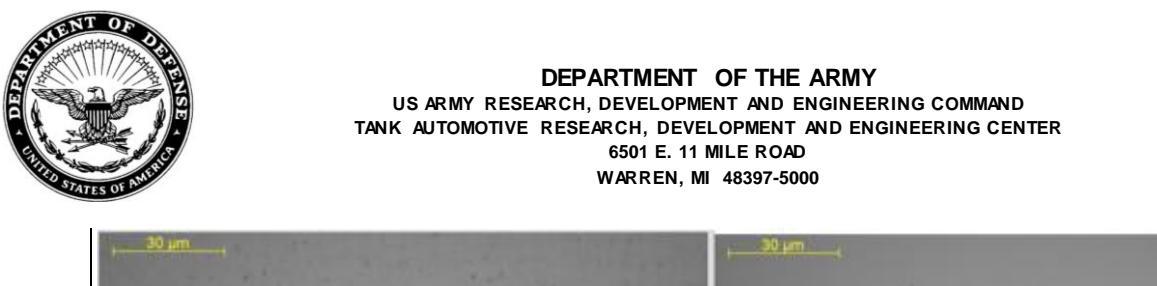
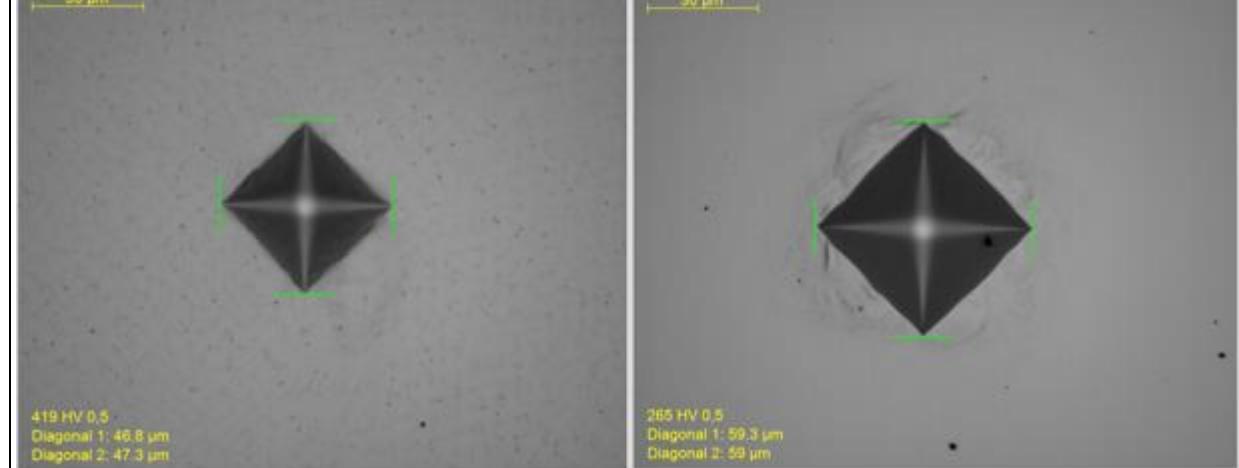
Figure 7: Longitudinal deposition indents. On the left is a Vickers indent into the Stellite 21 deposition and on the right is an indent into the A514 steel. Note the difference in hardness of each material.

In Figure 7 and 8, Vickers hardness data was collected for the Longitudinal deposition, and the average hardness was determined to be 400 HV. The average hardness of the substrate was determined to be 276 HV.

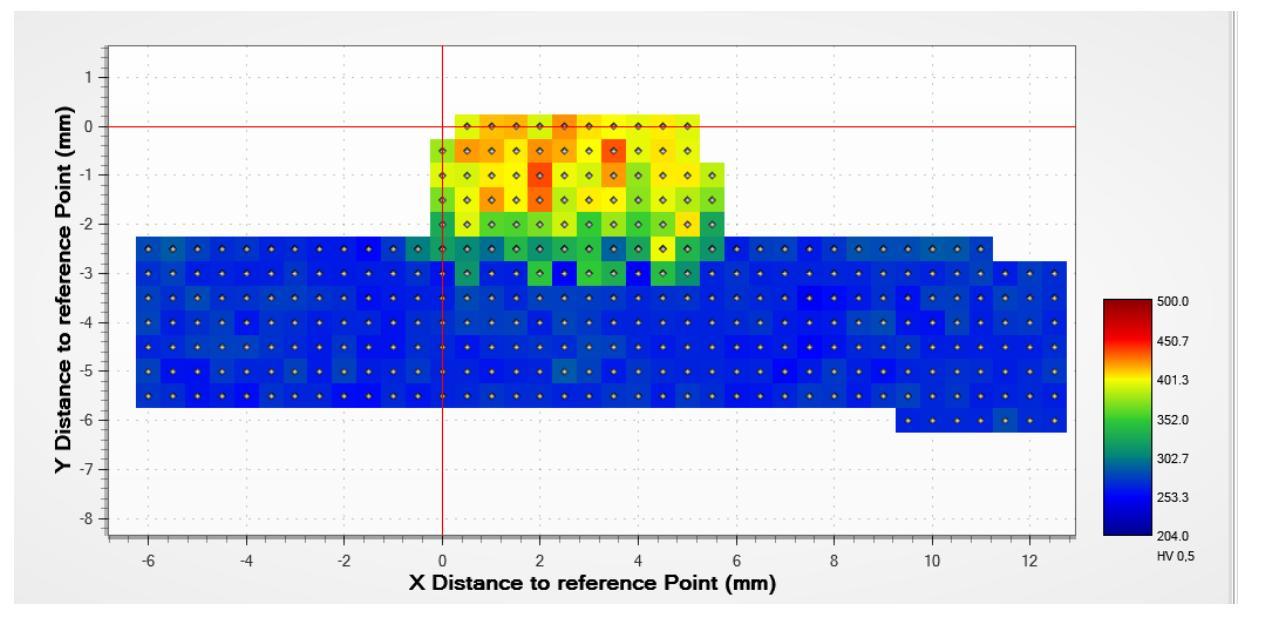
Figure 8: Longitudinal deposition hardness mapping of the deposition, interface, and substrate.

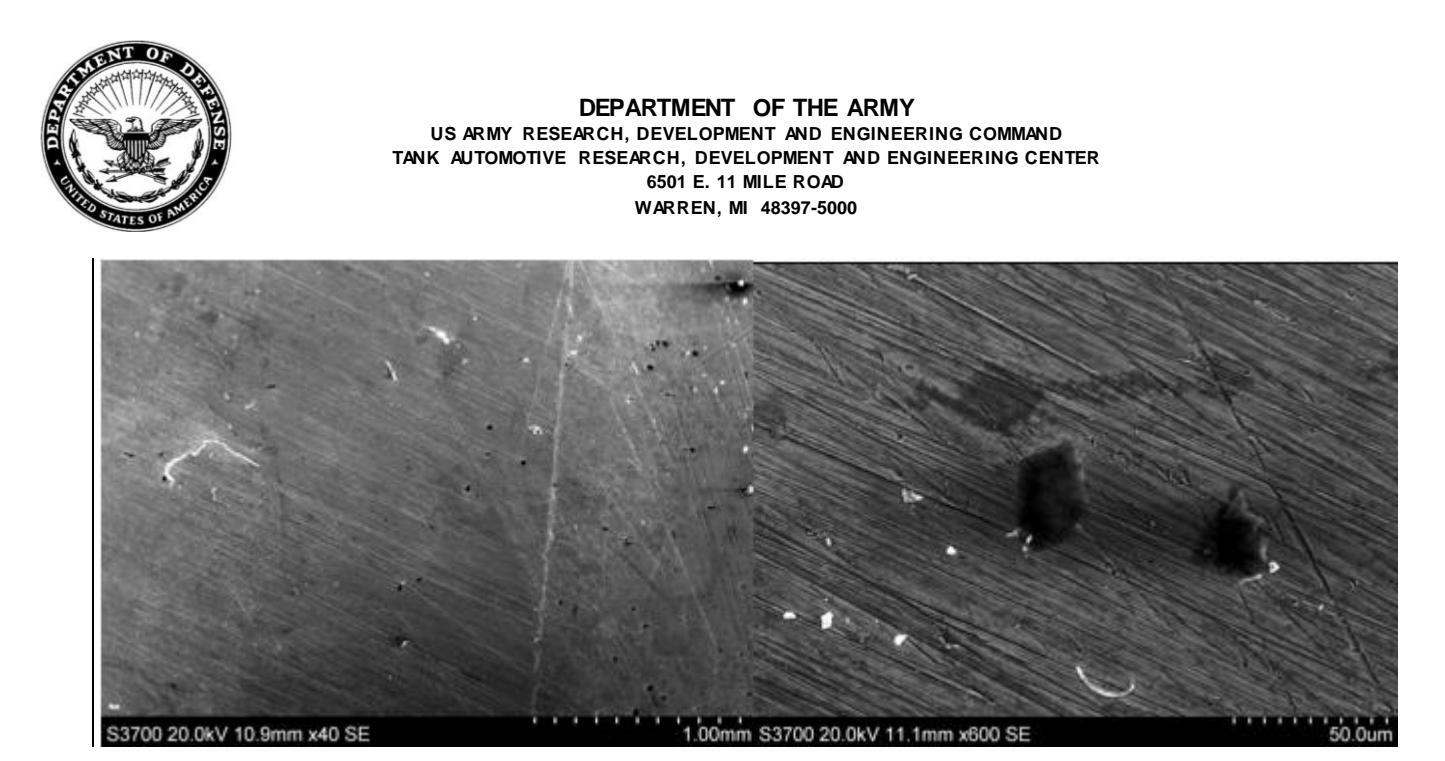
Figure 9: Longitudinal/Transverse deposition SEM imaging of pores and cross sectional surface. The image on the left shows right side of the deposition. The pores located on the right side of the left image are near the surface of the deposition. The image on the right is a close up of two of the pores.

SEM analysis was conducted and found micro pores in both the Longitudinal/Transverse and Longitudinal depositions. These pores were found to be roughly 25 micrometers in diameter. However, the Longitudinal/Transverse deposition had very few pores in the bulk material of the deposition. See Figure 9. The vast majority of pores were located around the deposition surface (away from the bulk material), which would otherwise be removed during CNC finishing operations.

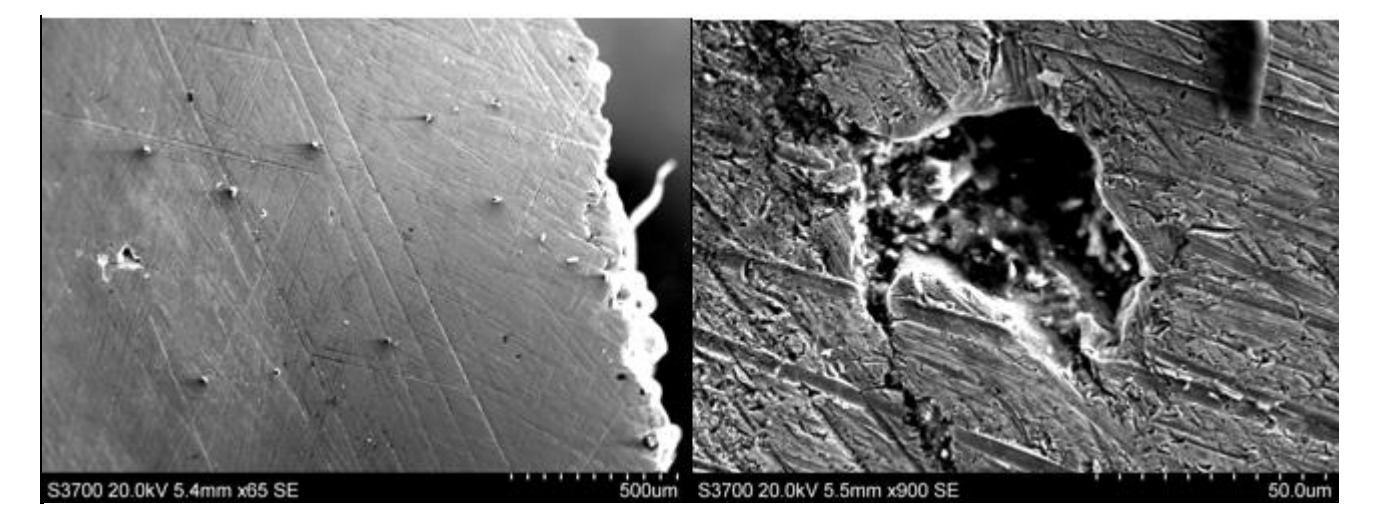
Figure 10: Image on the left is of the Stellite 21 Longitudinal deposition upper right edge SEM imaging of pores and cross sectional surface. The image on the right is of a pore in the core material of the Stellite 21 deposition.

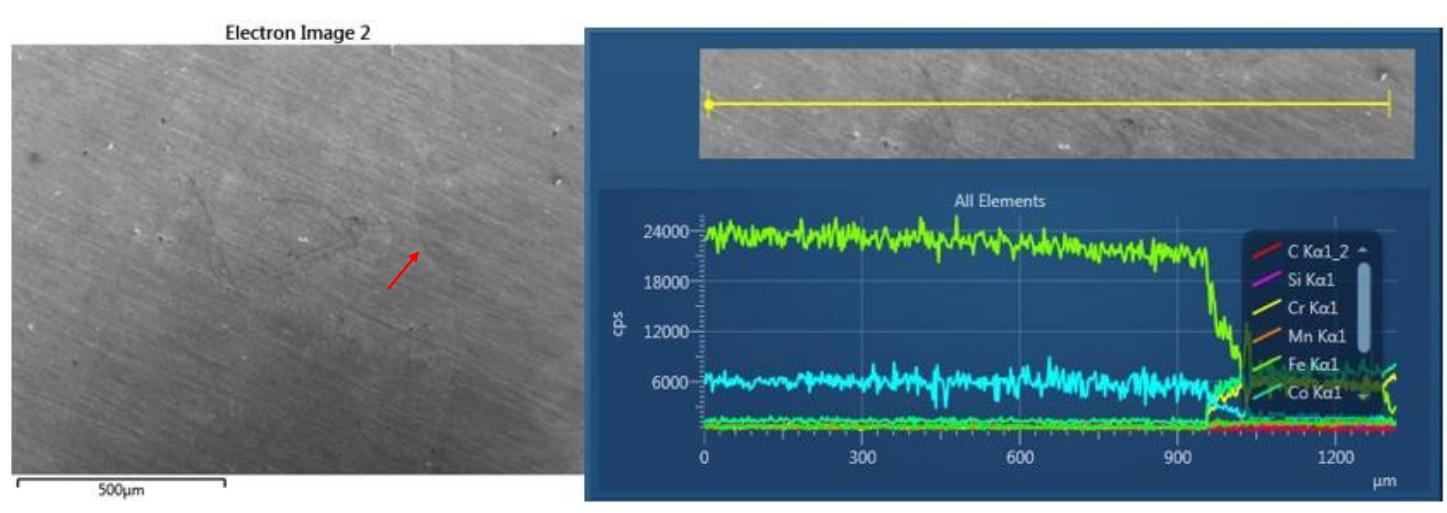
Figure 11: EDS line scans of the Longitudinal/Transverse deposition A514 (on the left)/Stellite 21 (right) chemical analysis.

Line scans were conducted across the surface interfaces of each deposition line, as well as some of the defects. The transition from the A514 steel and the Stellite 21 can be identified by the drop in the Fe content and increase in the Cobalt and Chromium, as seen in Figures 11 through 16. A close look at the images on the left of these figures will allow the observer to identify the steel/stellite interface by the slight change in shading.

Figures 11 and 12 demonstrated a change in chemical composition as the scanning line crossed the A514/Stellite 21 interface. As can be seen from these images, the surface had little to no defects, and the interface was clearly bonded. Figure 13 shows a line scan of the defects near the deposition surface. Large spikes in carbon are observed, which may be a residual surface coating from polishing medium that was trapped in the pore.

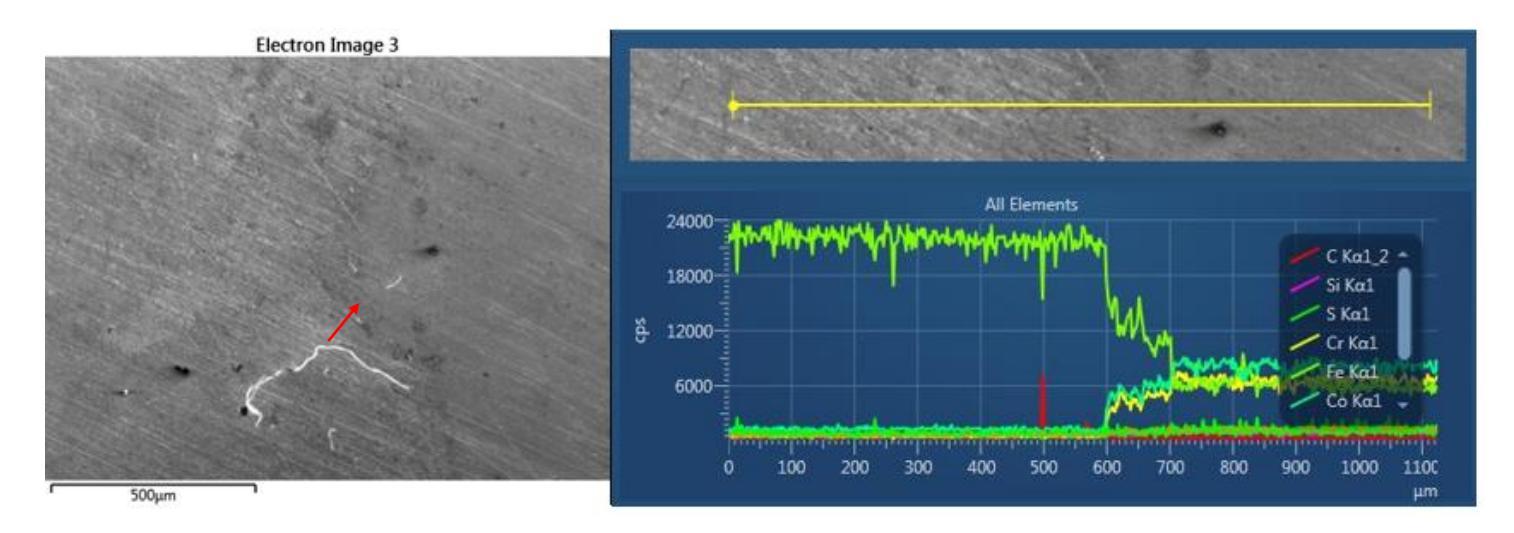
Figure 12: EDS line scans of the Longitudinal/Transverse deposition A514 (on the left)/Stellite 21 (right) chemical analysis.

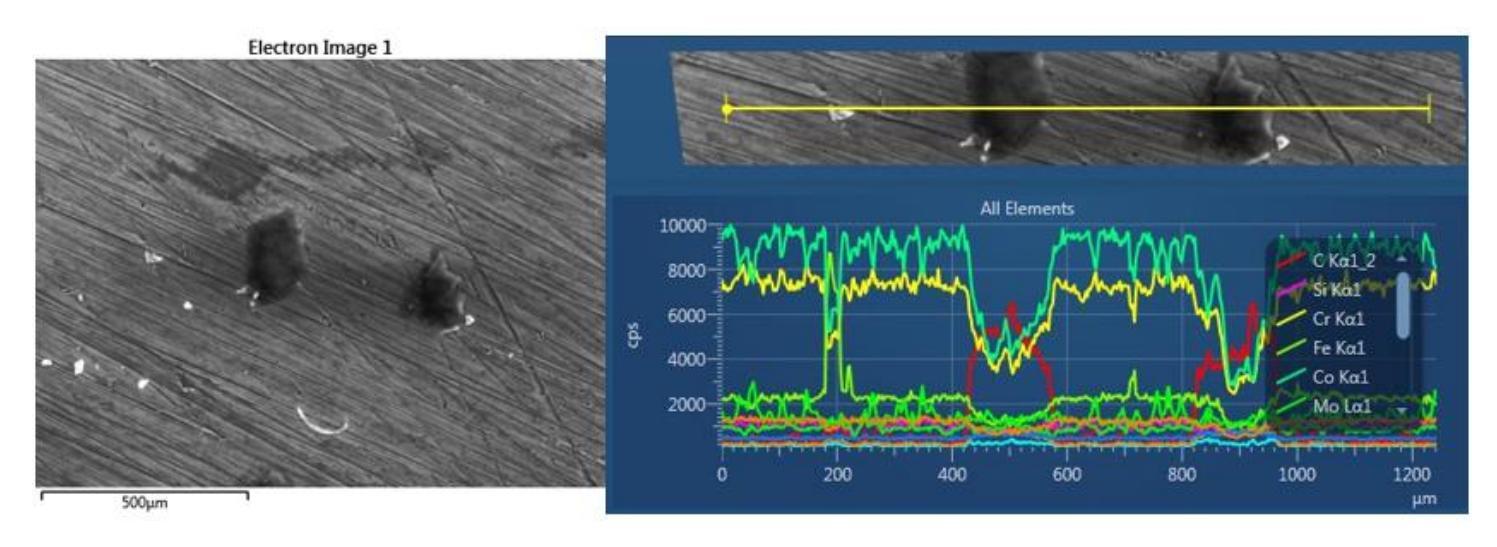
Figure 13: EDS line scans of the Longitudinal/Transverse deposition Stellite 21 (right) chemical analysis near surface pores.

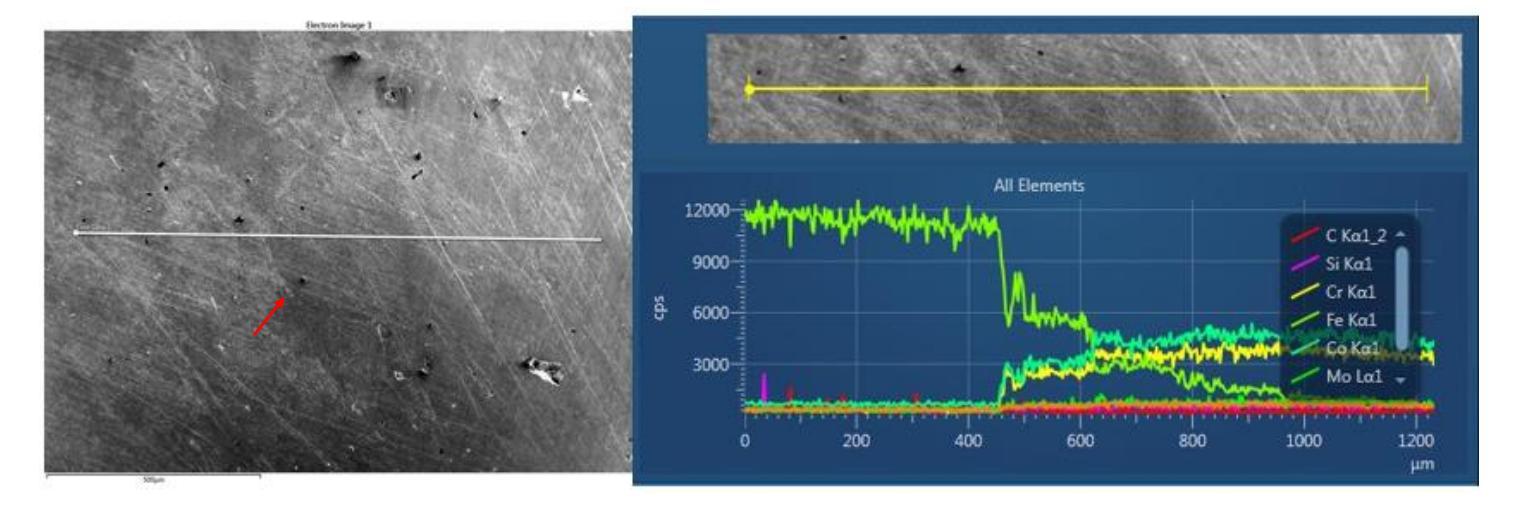
Figure 14: EDS line scans of the Longitudinal deposition A514 (on the left)/Stellite 21 (right) chemical analysis.

Figures 14, 15, and 16 demonstrate the change in chemical composition as the scanning line crosses the A514/Stellite 21 interface for the Longitudinal deposition. As can be seen from these images, the surface has a large number of defects in the deposition and near the fusion zone of the two materials.

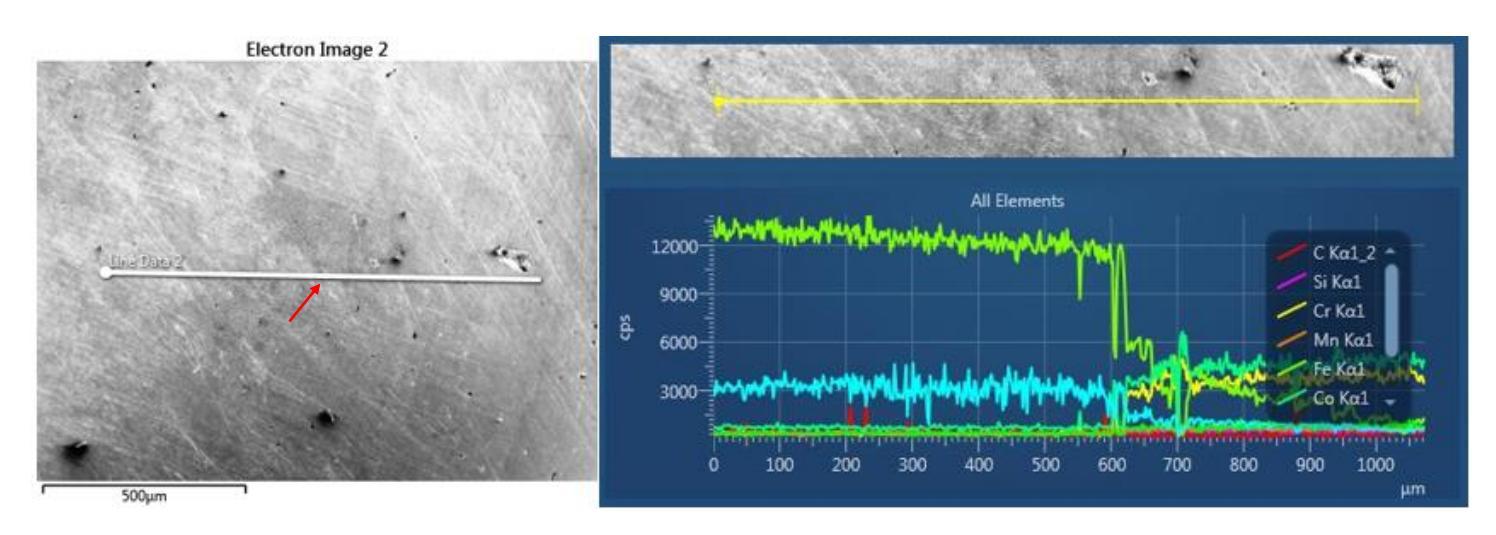
Figure 15: EDS line scans of the Longitudinal deposition A514 (on the left)/Stellite 21 (right) chemical analysis.

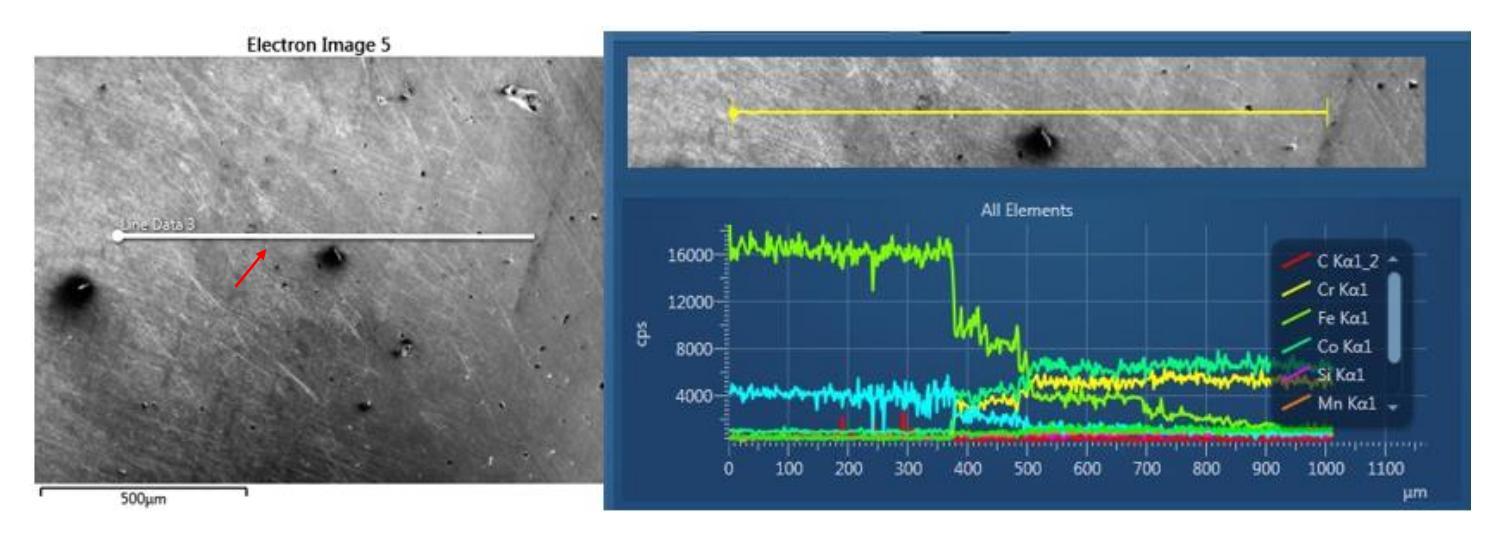
Figure 16: EDS line scans of the Longitudinal deposition A514 (on the left)/Stellite 21 (right) chemical analysis.
