00 USARTL-TR-79-3 6 65 ORIVESHAFT ALIGNMENT INDICATOR AB Frank A. Bill, Robert B. Bossler, Jr. KAMAN AEROSPACE CORPORATION Old Windsor Road FILE COPY Bloomfield, Conn. 06002 January 1979 200 Final Report for Period November 1975 - May 1978 Approved for public release; distribution unlimited. DC 70770 20 1979 55UU **Prepared** for D APPLIED TECHNOLOGY LABORATORY U. S. ARMY RESEARCH AND TECHNOLOGY LABORATORIES (AVRADCOM) Fort Eustis, Va. 23604 79 03 19

DRIVESHAFT ALIGNMENT INDICATOR DESIGN DESCRIPTION

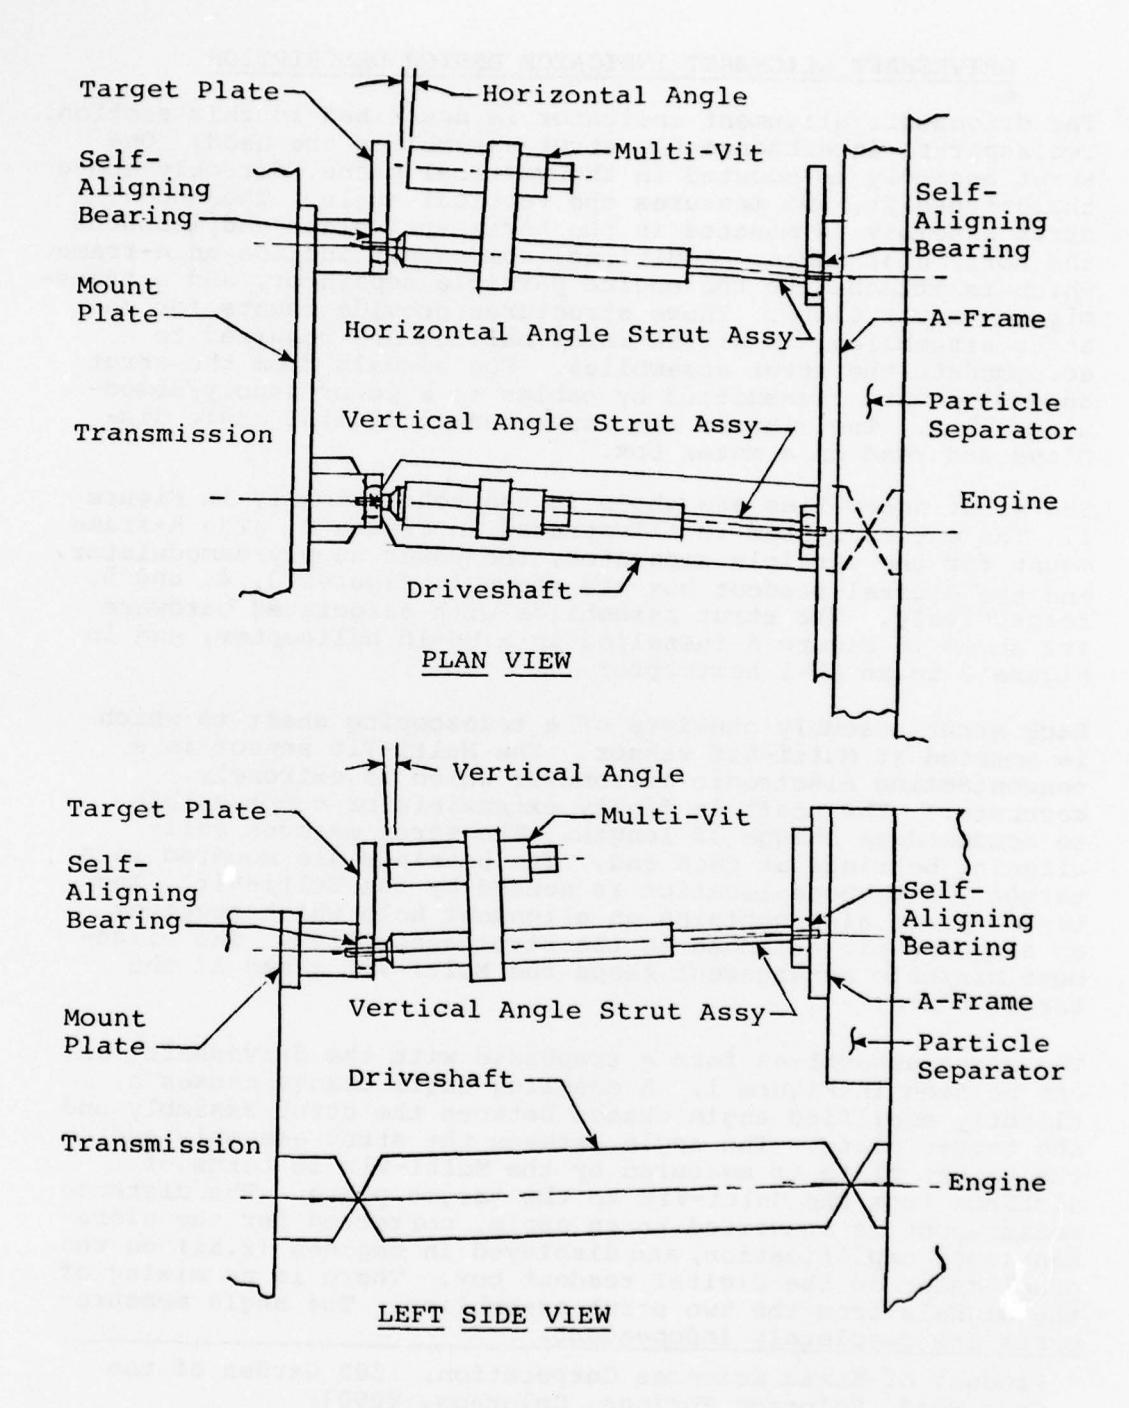
Figure 1. Strut Installation - Schematic.

The strut assemblies form a trapezoid with the driveshaft, as can be seen in Figure 1. A coupling angle change causes a slightly amplified angle change between the strut assembly and the target plate. The angle between the strut assembly and the target plate is measured by the Multi-Vit in terms of distance from the Multi-Vit to the target plate. The distance measurement is converted to an angle, corrected for the aforementioned amplification, and displayed in degrees (x.xx) on the panel meter on the digital readout box. There is no mixing of the signals from the two strut assemblies. The angle measurements are completely independent.

The strut assemblies are shown in use schematically in Figure 1. The entire system is illustrated in Figure 2. The A-frame mount for the particle separator, the power supply/demodulator, and the digital readout box are shown in Figures 3, 4, and 5, respectively. The strut assemblies with associated hardware are shown in Figure 6 installed in a UH-1H helicopter, and in Figure 7 in an AH-1 helicopter.

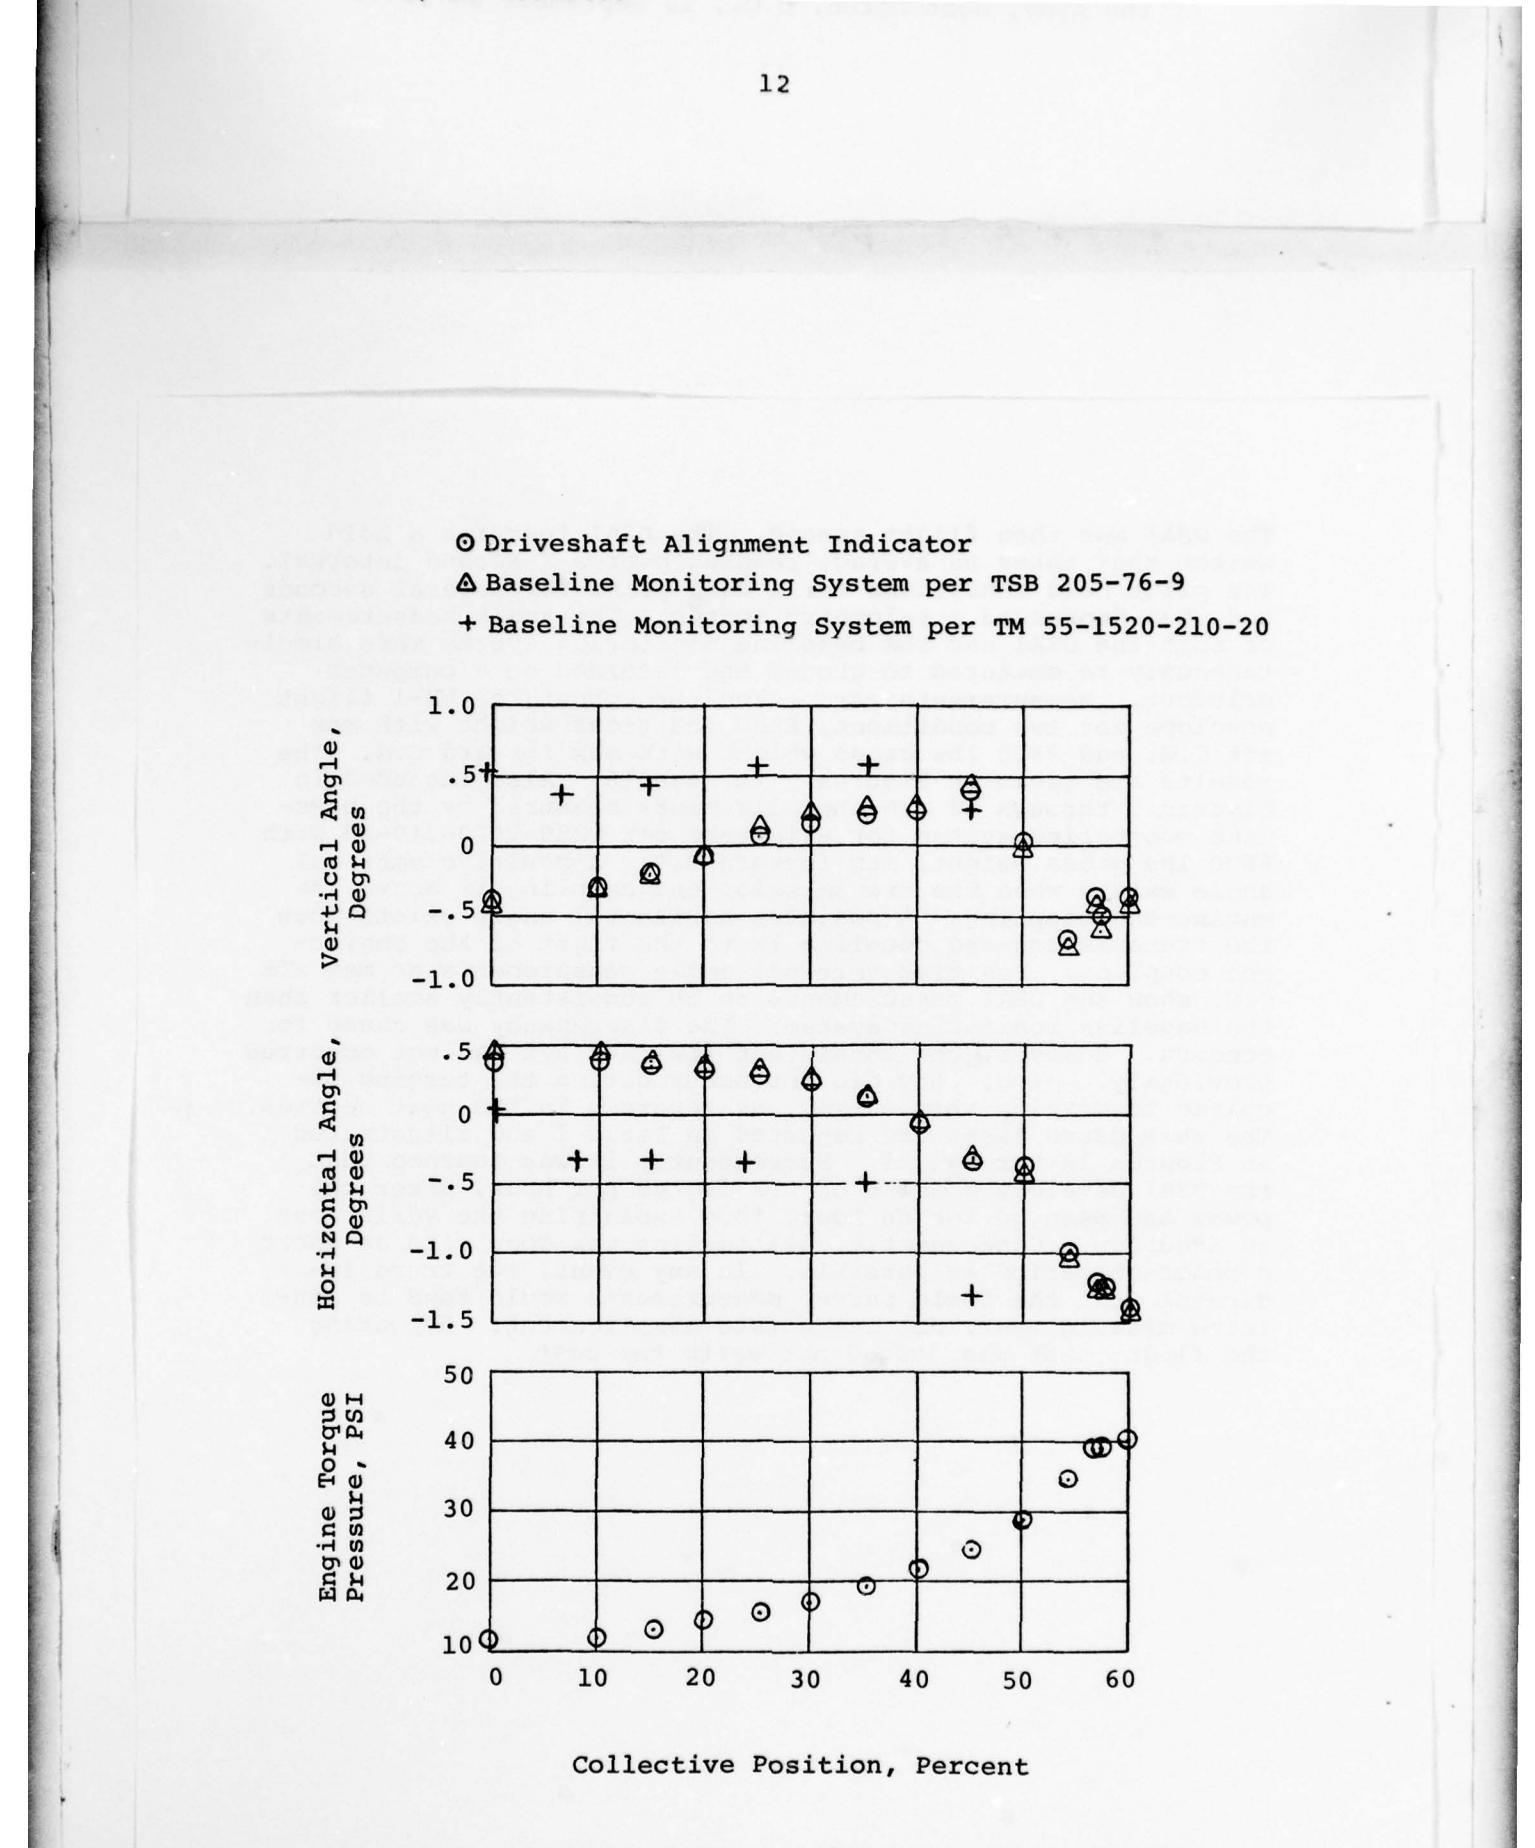
Figure 9. Ground and Hover Alignments, Forward C.G. (Station 133), 8600 Lbs G.W.

The DSAI was then flight tested. The DSAI features a hold switch that takes an average reading over a 2-second interval. The pilot held conditions for a data point for several seconds and then depressed a telemetry switch. The angle measurements of both the DSAI and the baseline monitoring system were simultaneously telemetered to ground and recorded on a computer printout. Measurements were taken throughout the UH-1 flight envelope for two conditions, 8600 lbs gross weight with max aft C.G. and 8600 lbs gross weight with max forward C.G. The results are given in Figures 9 through 16. Also included in Figures 9 through 12 are the alignments measured by the baseline monitoring system for alignment per TM55-1520-210-20 with 8600 lbs gross weight, max forward C.G. A positive vertical angle exists when the transmission-end coupling is above the engine-end coupling. A positive horizontal angle exists when the transmission-end coupling is to the right of the engineend coupling. Positive vertical angle measurements at max aft C.G. show the DSAI measurements to be consistently smaller than the baseline monitoring system. The discrepancy was cause for concern. However, the consistent low readings had not occurred previously. Also, they did not occur during the testing required to develop shim curves, as reported in the next section. The shim curve tests are reported in Table 1 and illustrated in Figures 18 through 23. Subsequently it was learned that the DSAI develops a drift of 0.2 degree per hour, after the power has been on for an hour, thus explaining the variations in accuracy. Consequently, all testing was done with as short a power-on period as possible. In any event, the trend indicates that the field survey measurements would tend to minimize misalignment, not exaggerate misalignment. Repeating the flight test was judged not worth the cost.

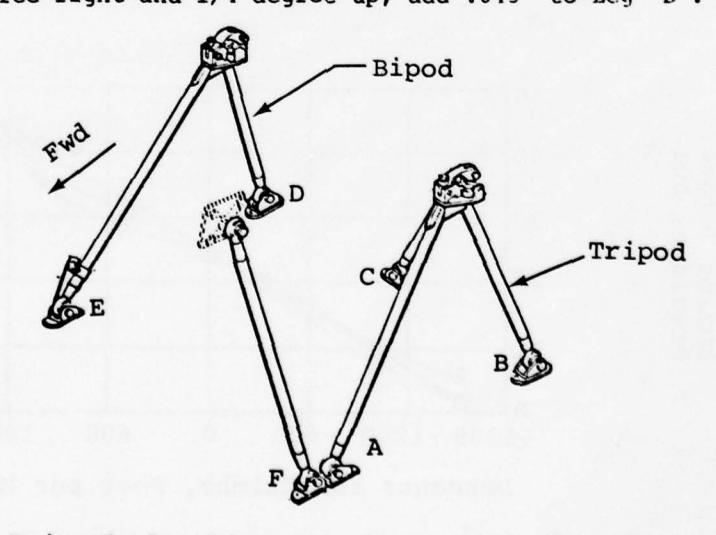
Figure 24. Driveshaft Alignment Chart with Shimming Instructions.

то	move	1/2	degree	to the left, remove .075" from Leg "A".
То	move	1/2	degree	to the right, add .075" to Leg "A".
То	move	1/2	degree	to the left, add .063" to Leg "E".
То	move	1/2	degree	to the right, remove .063" from Leg "E".
То	move	1/2	degree	up, remove .029" from Leg "F".
То	move	1/2	degree	down, add .029" to Leg "F".
То	move	1/2	degree	up and 1/2 degree right, add .038" to Leg "B".
то	move	1/2	degree	down and 1/2 degree left, remove .038" from Leg "B".
То	move	1/2	degree	left and 1/4 degree up, add .058" to Leg "C".
То	move	1/2	degree	right and 1/4 degree down, remove .058" from Leg "C".
То	move	1/2	degree	left and 1/4 degree down, remove .045" from Leg "D".
TO	move	1/2	degree	right and 1/4 degree up, add .045" to Leg "D".

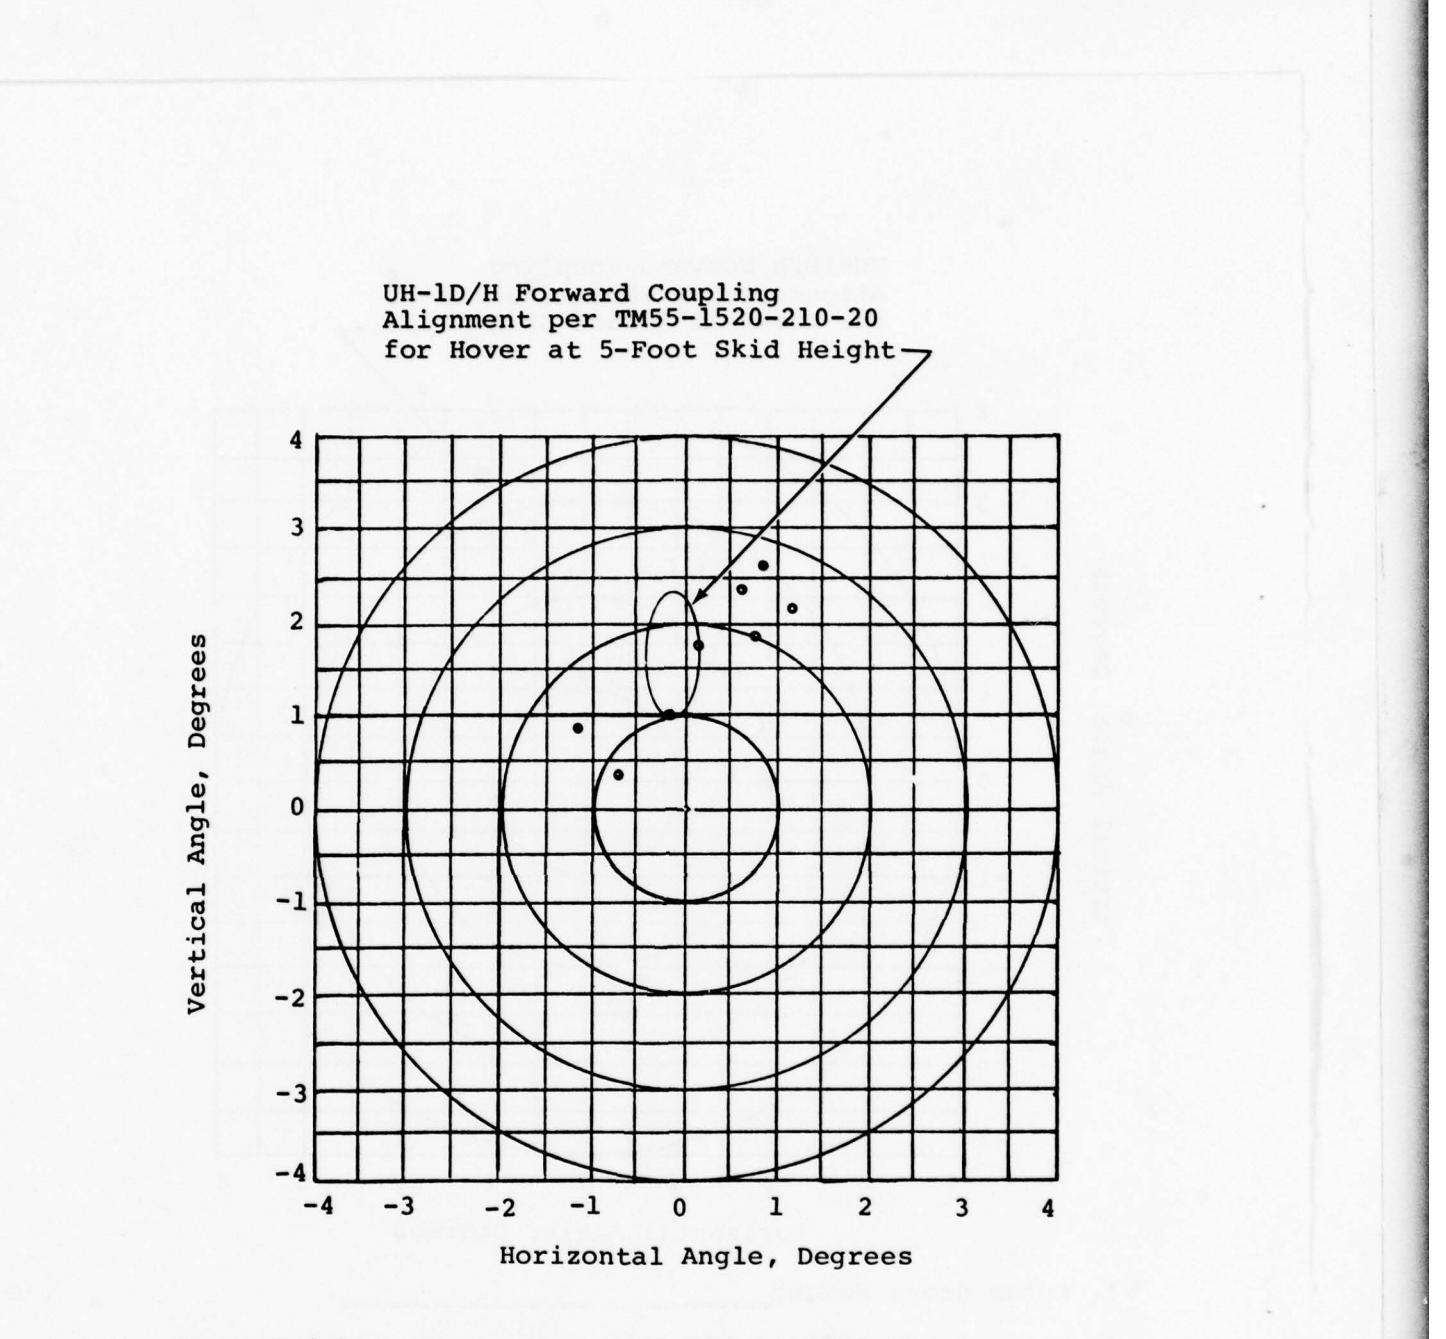
Figure 28. Eight UH-1 Helicopters Flown at Bradley Field.

Gross Weight: <u>Range from 7231 lbs to 7726 lbs</u>. Center of Gravity: <u>Range from 137.0 inches to 141.7 inches</u>. Plotted data from 5-foot hover.

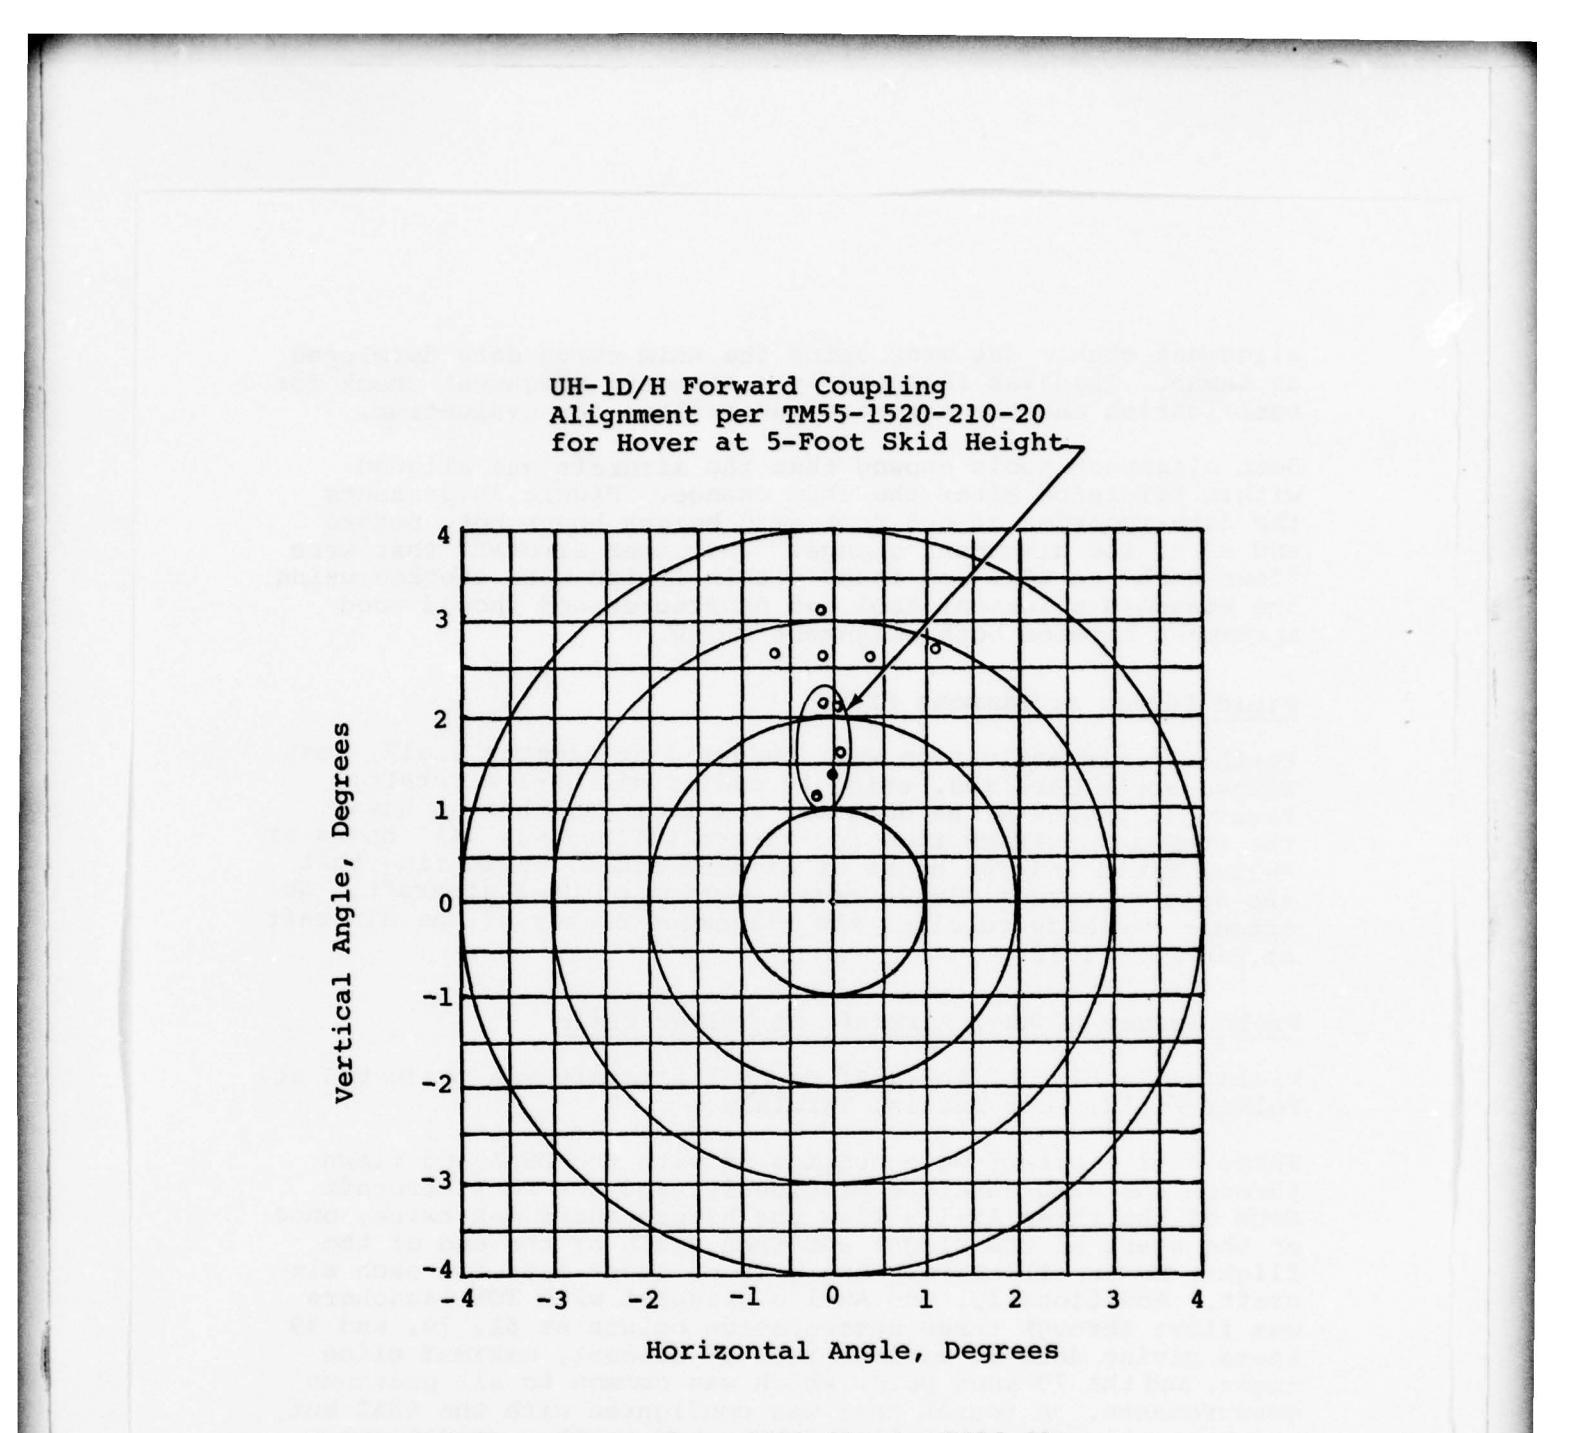
Figure 29. Ten UH-1 Helicopters Flown at Felker Field.

Gross Weight: Range from 6989 lbs to 7413 lbs. Center of Gravity: Range from 139.8 inches to 144.6 inches. Plotted data from 5-foot hover.

Ten UH-1 helicopters equipped with the DSAI were flown at Felker Field, Fort Eustis, Virginia. The recorded results for 5-foot skid height hover are presented in Figure 29. One of the aircraft flown that showed a high vertical reading on the DSAI was checked for alignment using the standard alignment tool and found to be outside of limits. This aircraft had approximately 964 hours since the last known alignment. An

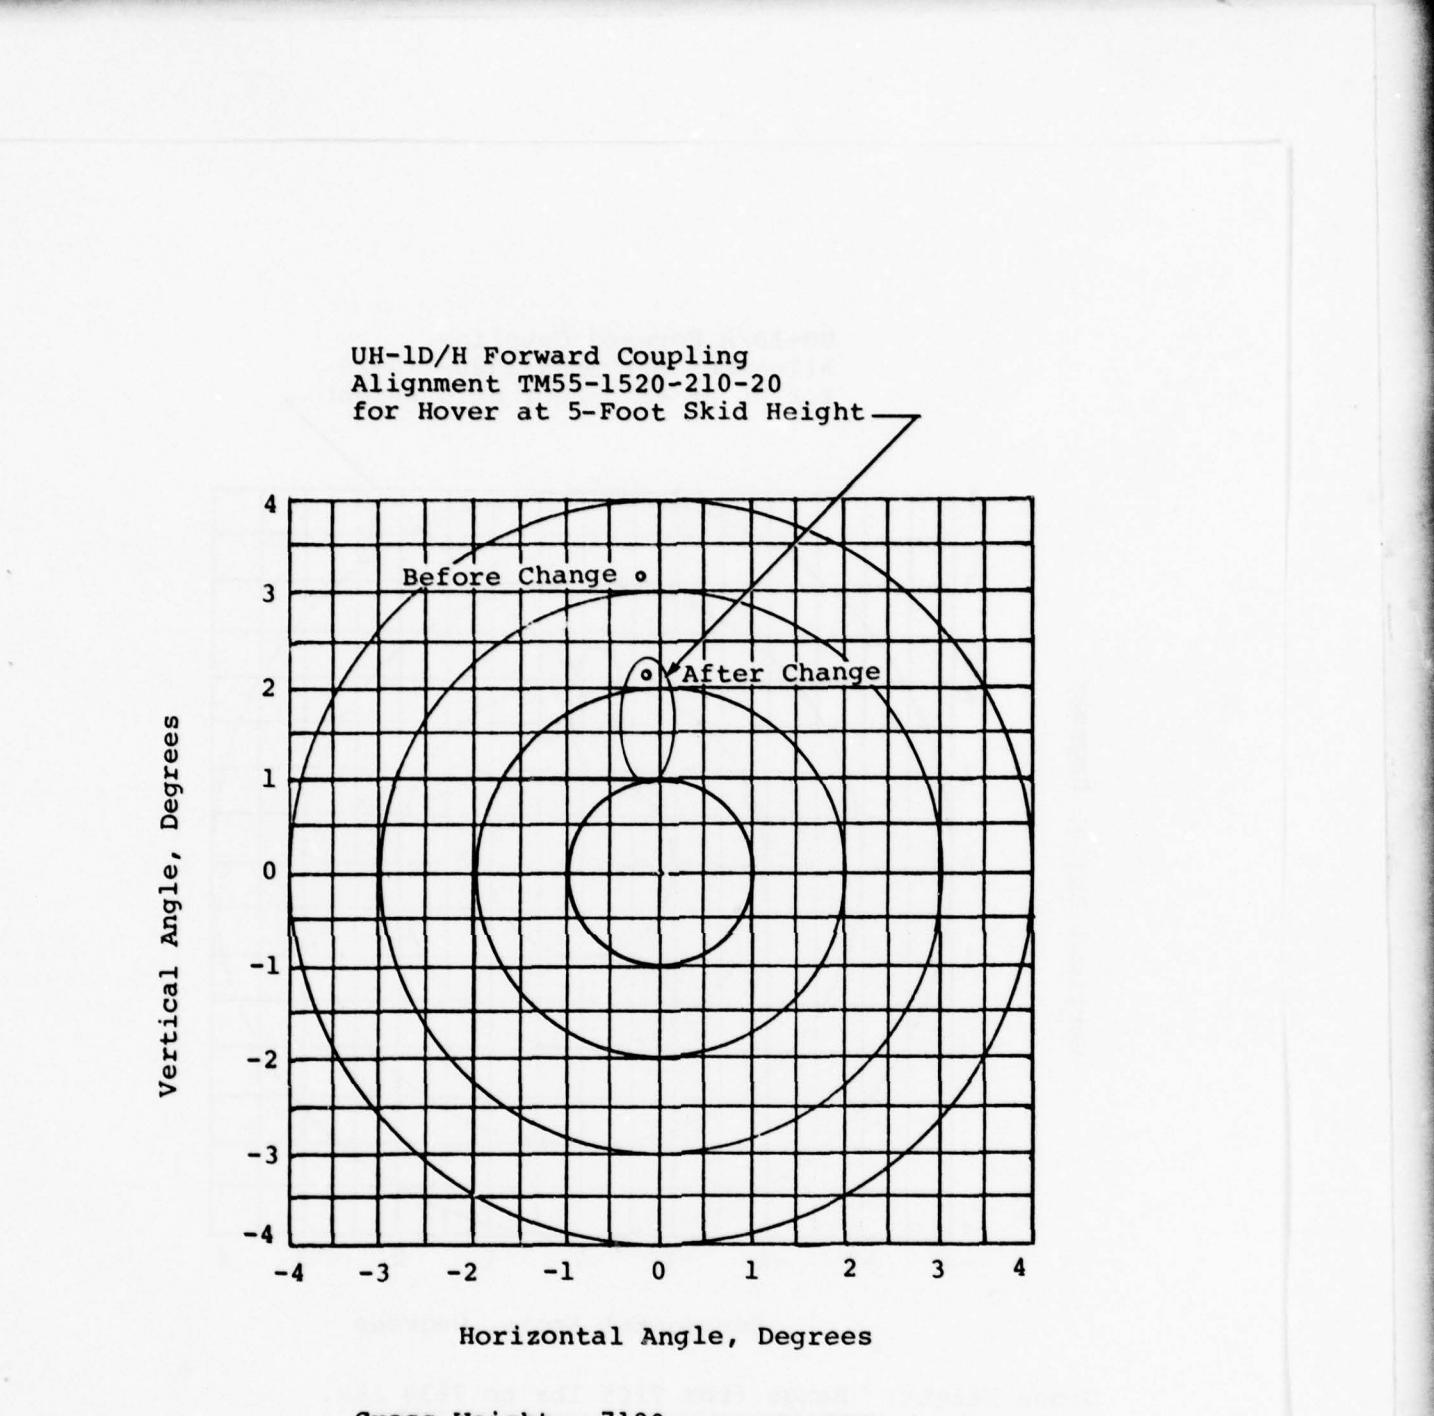
Figure 30. UH-1 Flown Before and After Alignment Change -Felker Field.

Both alignment tools showed that the aircraft was aligned within tolerance after the shim change. Figure 30 presents the data recorded at a 5-foot skid height hover both before and after the alignment change. Two other aircraft that were flown with the DSAI and found within limits were checked using the standard alignment tool and procedures and showed good agreement between both alignment tools.

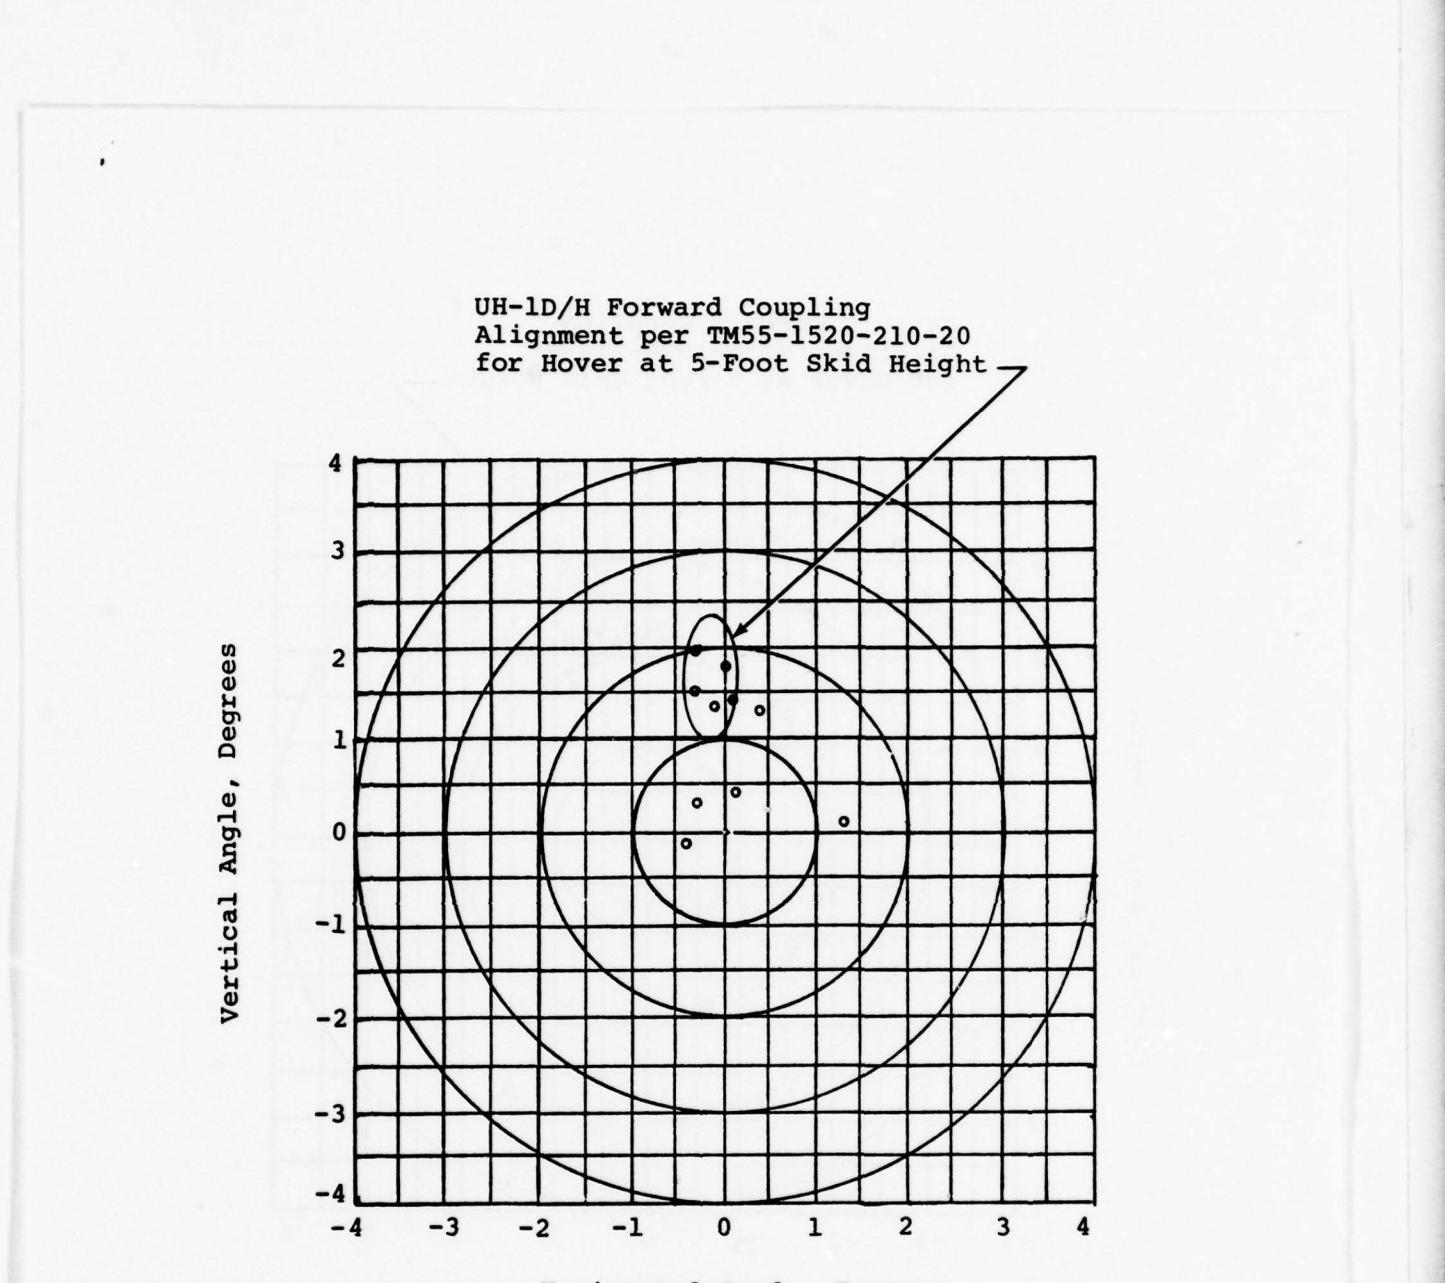
Figure 31. Ten UH-1 Helicopters Flown at Simmons Field.

Gross Weight: Range from 7265 lbs to 7638 lbs. Center of Gravity: Range from 137.01 inches to 139.5 inches. Plotted data from 5-foot hover.

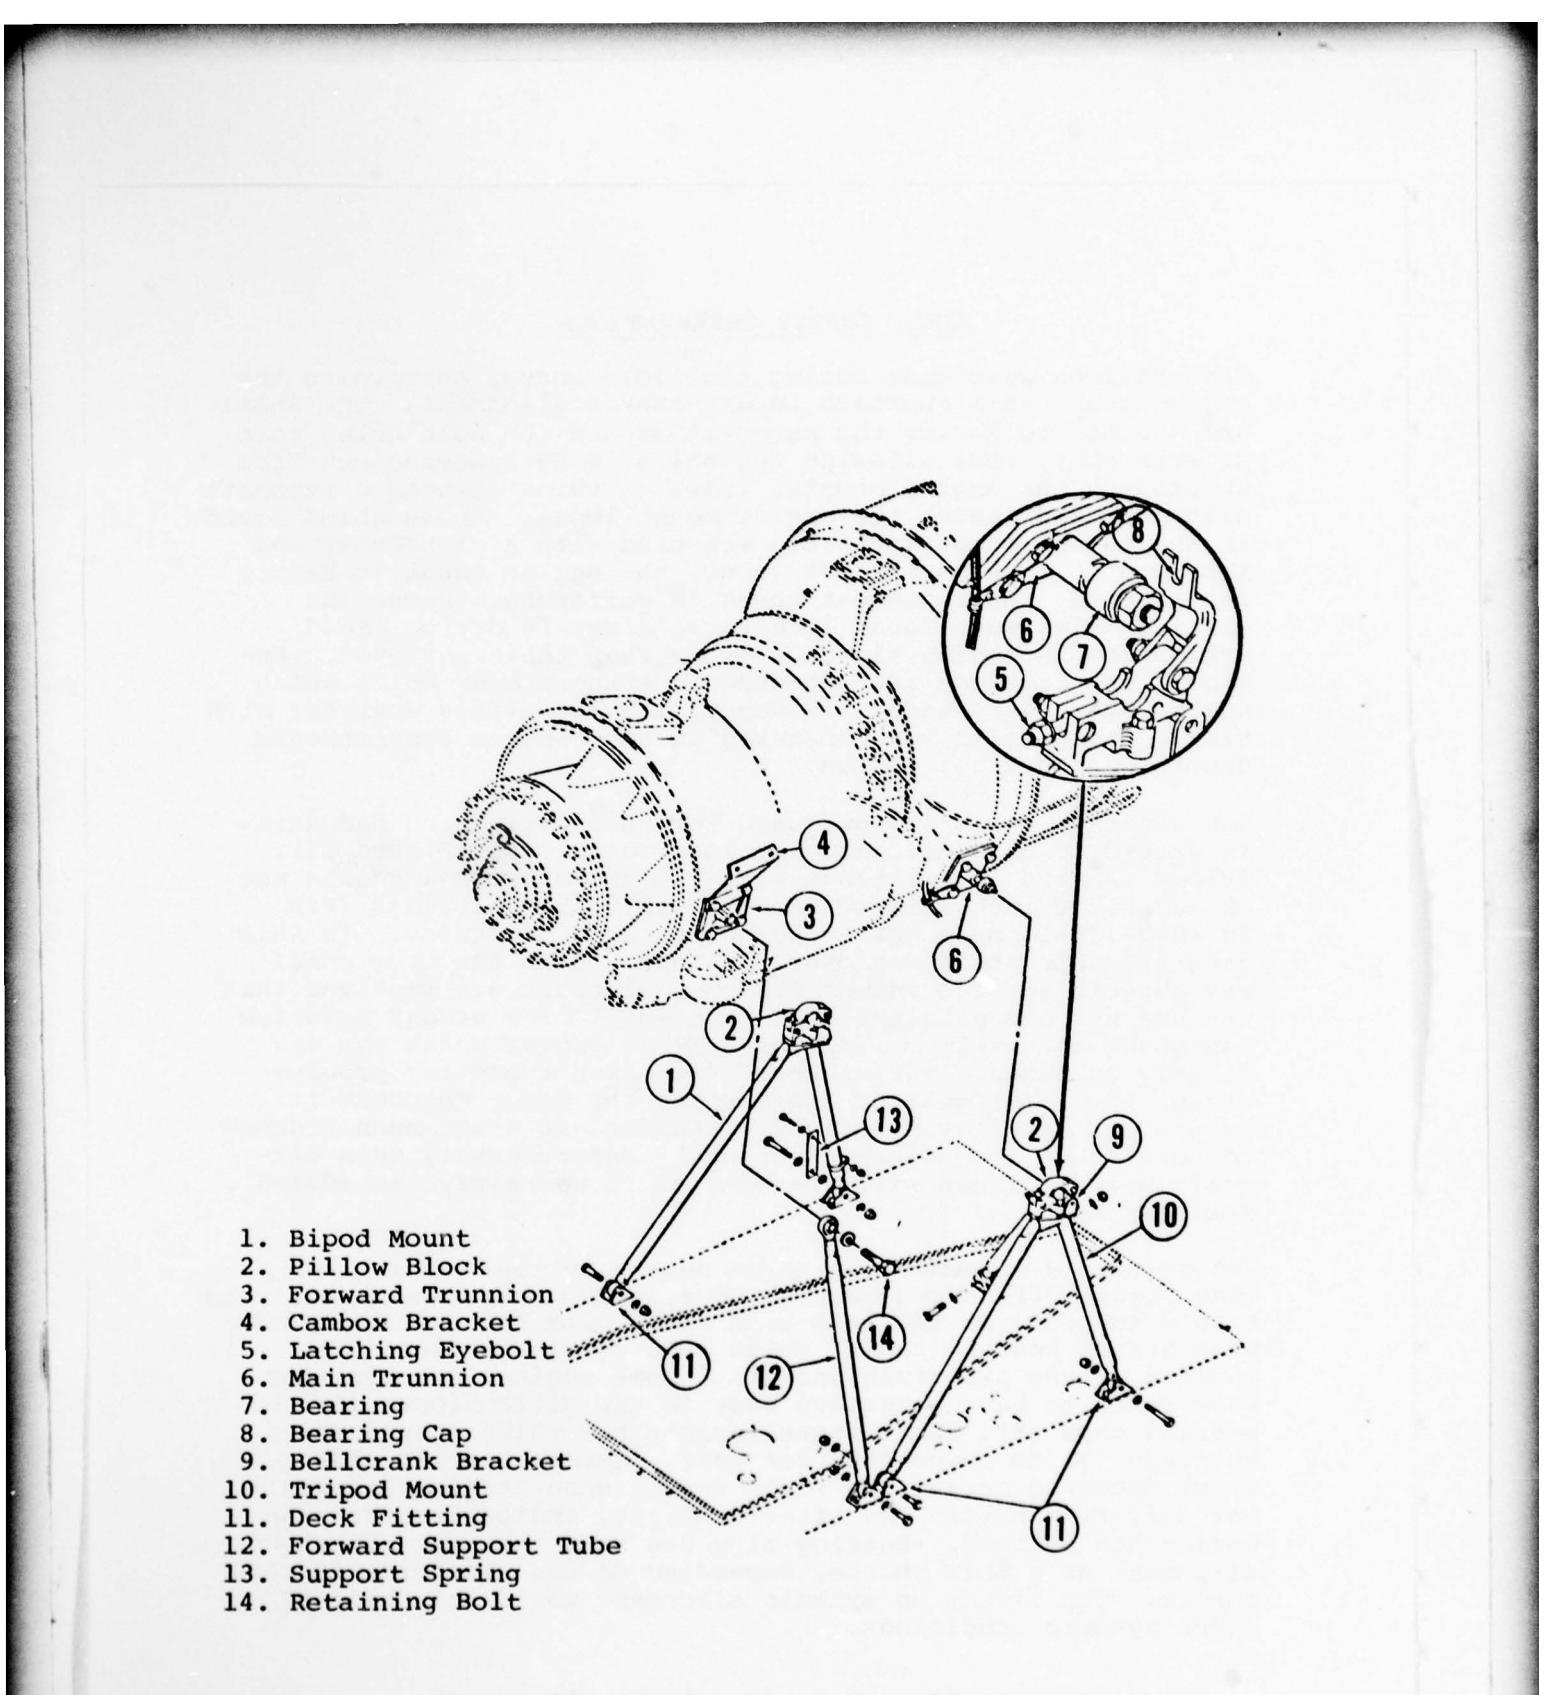
The engine is suspended at three points by the engine mount, (See Figure 34). The bipod support, on the right-hand side, and tripod support, on the left-hand side, both have pillow blocks with hinged bearing caps. These caps retain bearings (7) mounted on the two trunnions (6). Some engine installations were found to have excessive wear in the pillowblocks (2) and bearing caps (8). Some installations had shims around the bearings (7) to compensate for wear. Excess bearing slop was first detected during the field survey when static alignment was different before and after a flight, indicating that the engine had shifted. Bearing slop can have the same effect on alignment as a shim change, depending on the direction of mount forces. The effect on dynamic alignment would only be seen under dynamic conditions.

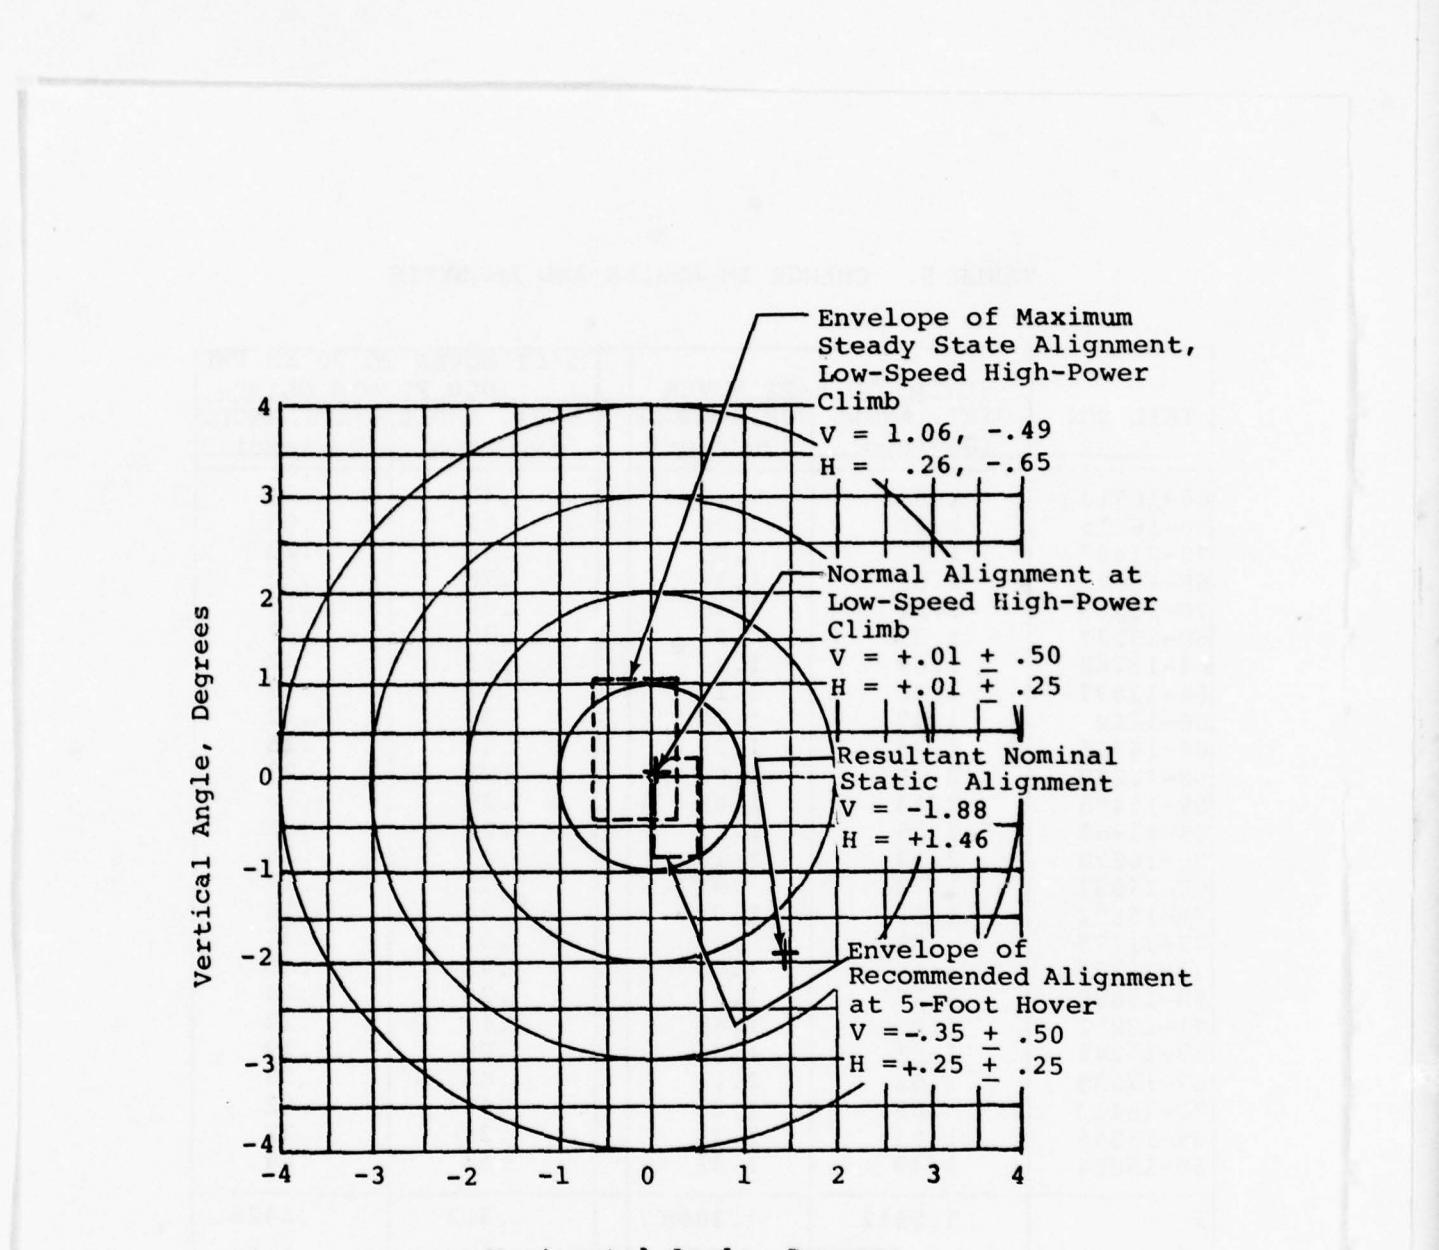
Improved Alignment Possible for Three Conditions and Maximum Expected Misalignment.

These data were used to predict the improved alignment that would result with driveshaft alignment specified at the 5-foot hover condition, shown in Figure 36. Suggested alignments are: vertical angle -.35 degree \pm .50 degree and horizontal angle +.25 degree \pm .25 degree. At low-speed high-power climb, the resulting nominal alignment would be: vertical angle + .01 degree \pm .5 degree, horizontal angle +.01 degree + .25 degree.

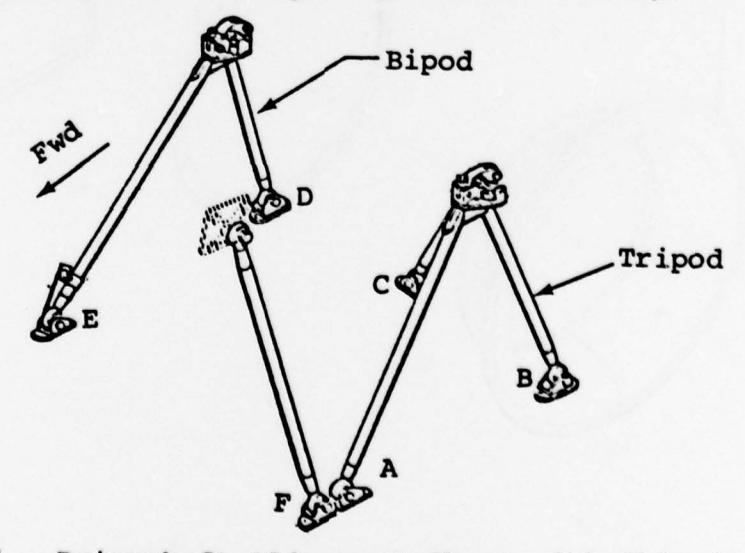
Figure C6. Driveshaft Alignment Chart with Shimming Instructions.

UH-1 Forward Coupling Alignment for Hover at 5-Foot Skid Height per TM55-1520-210-20

То	move	1/2	degree	to the left, remove .075" from Leg "A".
То	move	1/2	degree	to the right, add .075" to Leg "A".
То	move	1/2	degree	to the left, add .063" to Leg "E".
То	move	1/2	degree	to the right, remove .063" from Leg "E".
То	move	1/2	degree	up, remove .029" from Leg "F".
то	move	1/2	degree	down, add .029" to Leg "F".
то	move	1/2	degree	up and 1/2 degree right, add .038" to Leg "B".
то	move	1/2	degree	down and 1/2 degree left, remove .038" from Leg "B".
То	move	1/2	degree	left and 1/4 degree up, add .058" to Leg "C".
То	move	1/2	degree	right and 1/4 degree down, remove .058" from Leg "C".
То	move	1/2	degree	left and 1/4 degree down, remove .045" from Leg "D".
To	move	1/2	degree	right and 1/4 degree up, add .045" to Leg "D".

- 25- Loosen screws around intake bellmouth in forward firewall and around attachment ring in aft firewall, Figures C7 and C8.
- 26- Consult Figure C6 to determine amount and location of shim change required. Make shim change. After shim change tighten screws around intake bellmouth and in aft firewall.
- 27- Close engine cowling and transmission fairing.
