CORROSION/EROSION BEHAVIOR OF SILICON NITRIDE AND SILICON CARBIDE CERAMICS -GAS TURBINE EXPERIENCE

R. NATHAN KATZ CERAMICS RESEARCH DIVISION

April 1979

ARMY MATERIALS AND MECHANICS RESEARCH CENTER Watertown, Massachusetts 02172

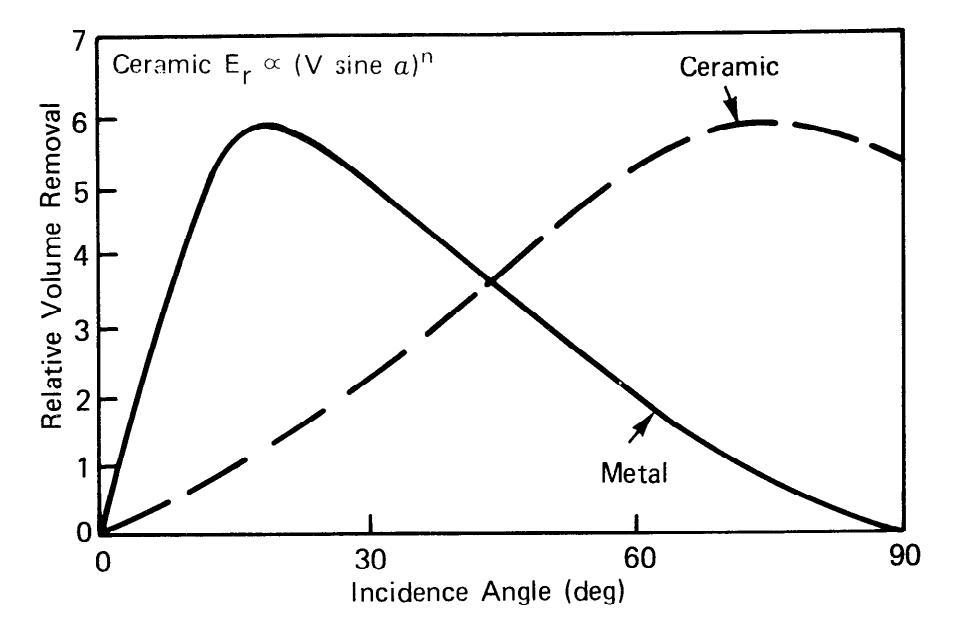
Figure 1. Comparison of ceramic versus metallic particulate erosion resistance behavior.

Only solid particle erosion will be considered. An extensive literature on liquid droplet erosion exists, and interested readers are referred to References 4 and 5. The phenomenology of the solid particle erosion behavior of metals and ceramics are significantly different as illustrated schematically in Figure 1.

A particle impingement angle of 15 to 20° results in a maximum erosion rate for metals, whereas this is a relatively benign situation for a typical ceramic. The maximum erosion rate for ceramics occurs at 90° impingement.⁶ In general, erosive wear of ceramics follows an empirical equation of the form:

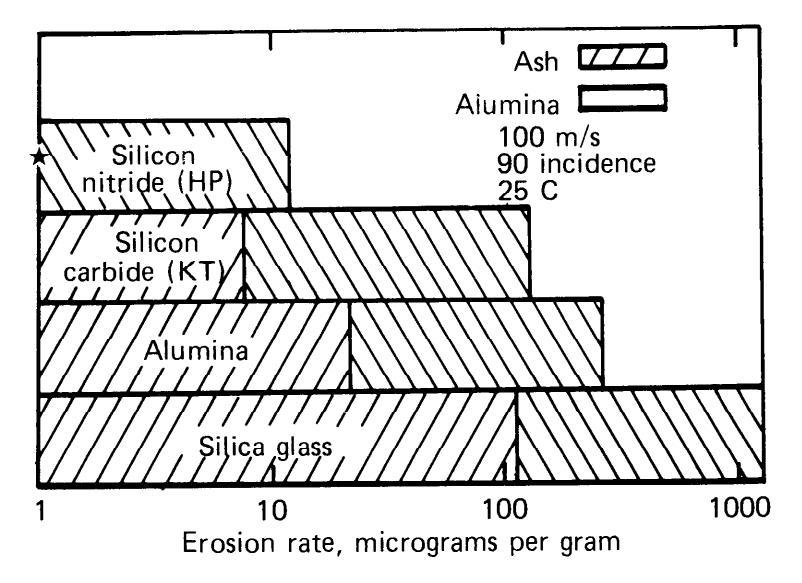
Figure 2. Erosion rate of ceramics by ash one-tenth the rate using alumina (after Meyers et al., Reference 7).

As part of a program to utilize ceramics in helical expander Brayton cycle turbomachines for coal-fired topping cycles, Myers el al.⁷ have acquired data on the relative resistances of various ceramics to both fly ash and alumina particulates. The results of these room temperature tests are shown in Figure 2. Subsequently, erosion tests of HPSN, HPSiC, and Crystar-sintered SiC were conducted in a 1360 C combustion gas steam containing 6 g/min of coal fly ash impinging at 100 M/S. Erosion was not a problem; ash build-up was!

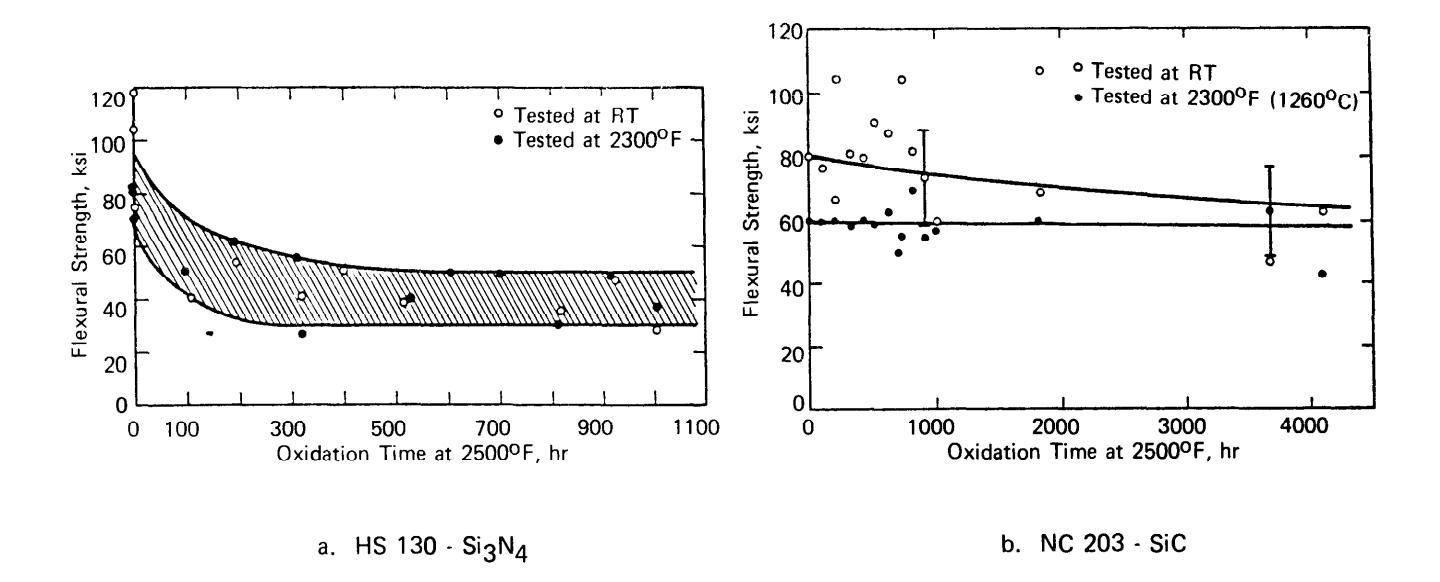
Figure 3. Retained strength after 2500 F oxidation of hot-pressed Si_3N_4 and SiC at RT and 2300 F (Reference 9).

Miller et al. have obtained data on the effect of long-term oxidation on the retained strength of HS 130 (the predecessor of NC 132), hot-pressed silicon nitride, and NC 203 silicon carbide. The results for HS 130 (Figure 3a) show that retained strength is significantly degraded after long-term oxidation at 2500 F, even at temperatures as high as 2300 F. This strength reduction is attributed to surface pitting at the Si $_{3}N_{\mu}/SiO_{2}$ interface. The results for NC 203 (Figure 3b)

show slight degradation of RT strength and no degradation of 2300 F strength, even with exposure to 4000 hours. The strength reduction in the RT tests is attributed to cracking of the SiO_2 surface layer on cooling.

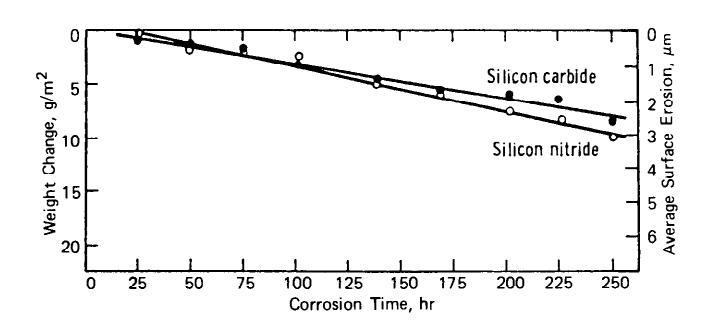
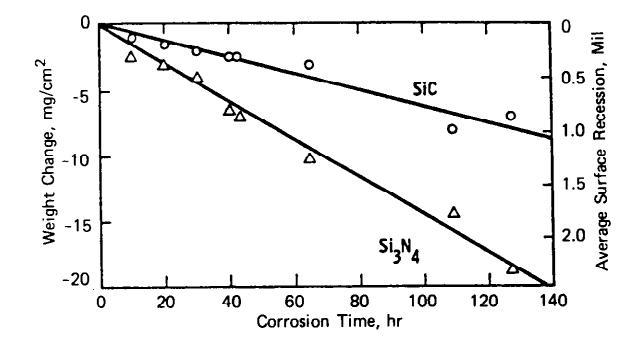
a. Corrosion/erosion behavior of hot-pressed silicon carbide and silicon nitride in turbine passage at 2000 F, 3 atm. pressure and 152 m/s gas velocity using Exxon No. 2 diesel oil.

b. Corrosion/erosion behavior of hot-pressed silicon nitride in turbine passage at 2500 F, 3 atm. pressure and 500 ft/sec gas velocity using Exxon GT-2 oil.

Figure 4. Corrosion/erosion behavior of hot-pressed SiC and Si_3N_4 (Reference 9).

Work by investigators at Westinghouse documented in the ARPA "Brittle Materials Design" program final report⁹ provides data on corrosion/erosion behavior of HS 130 and NC 203 materials in a 3 atm. combustor rig burning Exxon #2 diesel fuel. This fuel was barium free and had: 0.35 w/o (max) S; 0.01 w/o (max) ash; and 0.2 w/o (max) carbon residue. Results of 250-hour test programs for 2000 F and 2500 F exposures are shown in Figures 4a and b. The effect of these exposures on retained strength at 2000 F (1100 C) are presented in Figure 5 and Table 4. No room temperatures retained strength data are available. It is evident from Figure 5 that exposures at 2000 F had no effect on strength at 2000 F. (Miller et al. note some effect on longer duration testing.) Strengths of both materials at 2000 F are severely degraded by the 2500 F exposures.

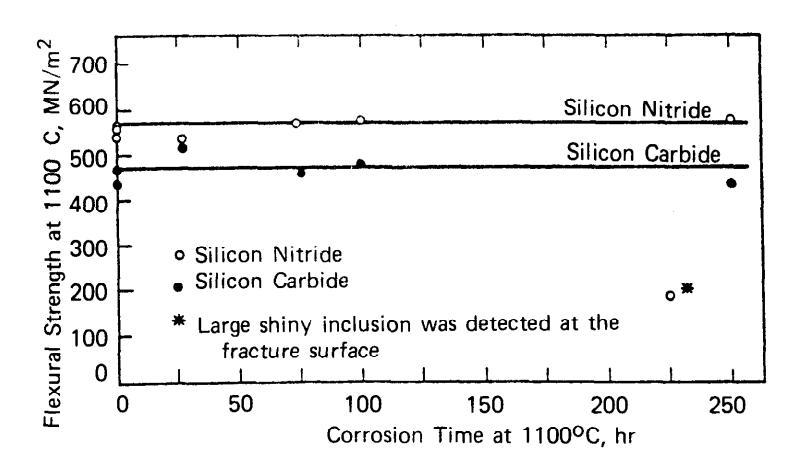
Figure 5. Effect of gas turbine environment on the flexural strength of hot-pressed Si_3N_4 and SiC (Reference 9).

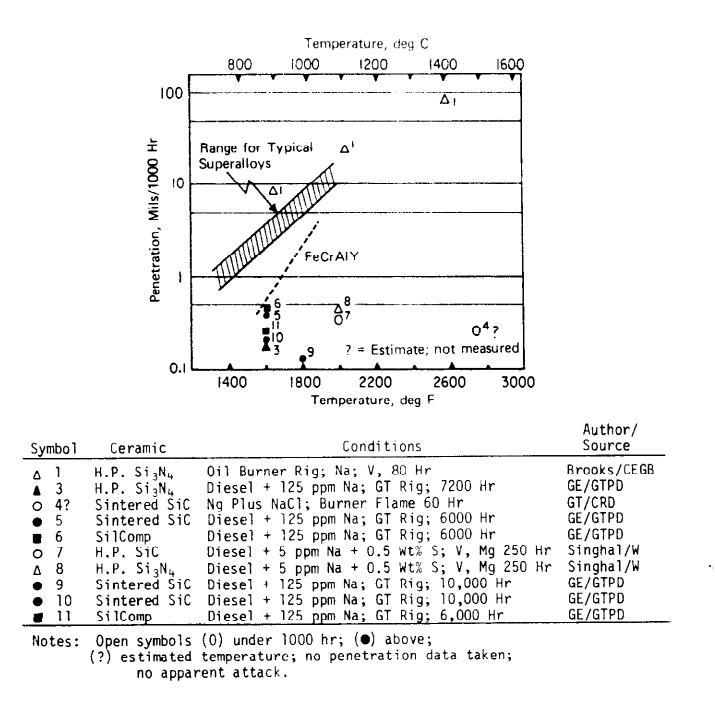
Figure 6. Corrosion behavior of ceramics (after Sims & Palko, Reference 10).

Gas turbine engineers refer to the corrosion caused by the joint attack of Na and S as hot corrosion. Sims and Palko¹⁰ have recently reported on hot corrosion studies on several Si_3N_4 and SiC carried out by themselves, and others. Their results, shown in Figure 6, indicate that except for the oil-fired boiler data (a heavy slagging environment) the ceramics seem to perform much better than the super alloys. It is important to note that some of the G.E. tests go to 10,000 hr at 1600 F.

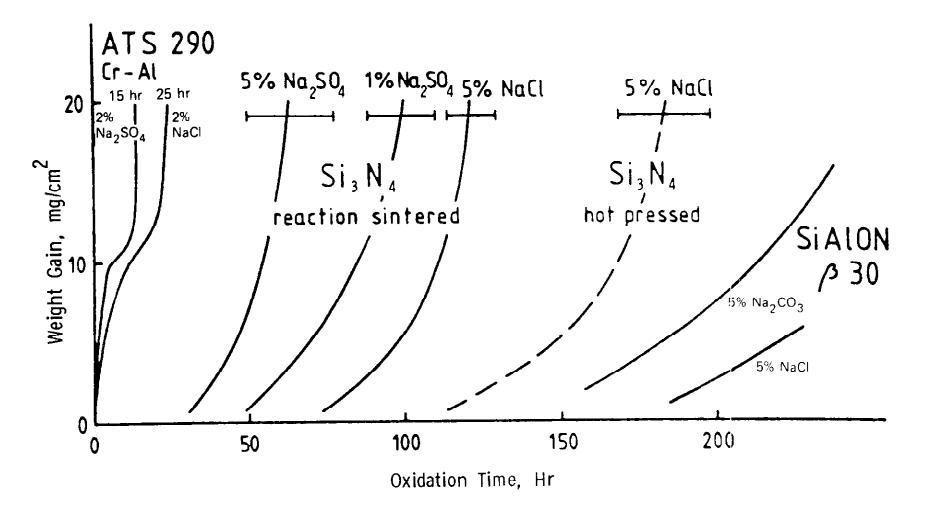
Figure 7. Corrosion of Si₃N₄, SiALON and a Cr-aluminized superalloy in burner gas under cycling conditions (after Schlichting, Reference 14).

second phases). The tests were performed in a burner rig (fuel unspecified) cycling between 1000 and 1200 C. Sodium chloride and H_2S added into the burner gas were found not to corrode the ceramics. The presence of compounds which form alkali melts in which a surface sodium silicate glass may dissolve the Si_3N_4 , such as Na_2SO_4 or Na_2CO_3 , do cause hot corrosion. However, as is shown in Figure 7, RBSN is several times more resistant to hot corrosion than is the superalloy tested; and the SiALON is more than an order of magnitude more resistant. Schlichting points out that controlling the Na_2O content of the contaminant will significantly increase the ceramic lifetime.

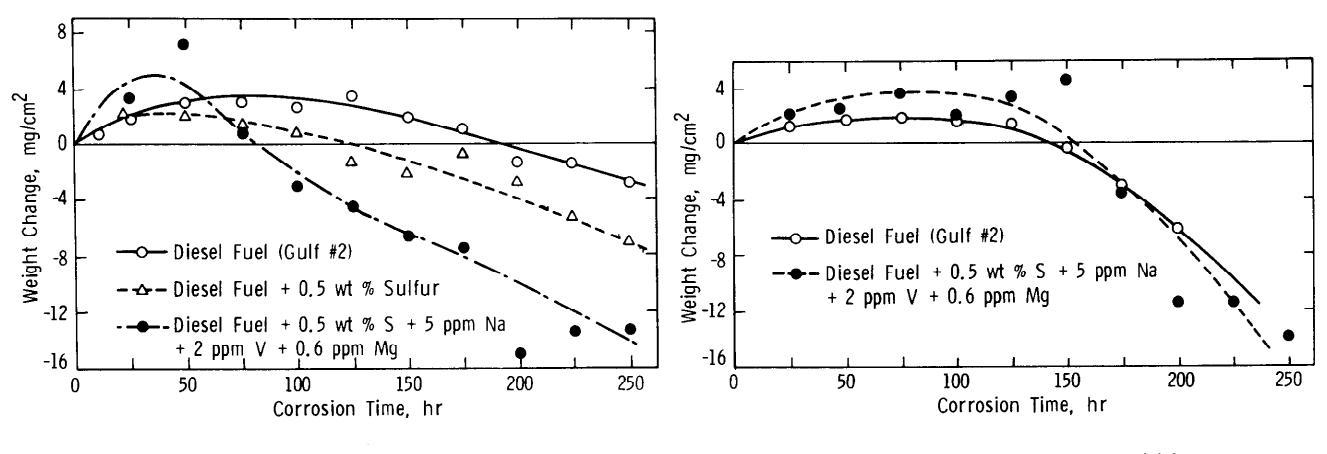
a. Hot-pressed silicon nitride

b. Hot-pressed silicon carbide

Figure 8. Effect of fuel contaminants on the corrosion of hot-pressed silicon nitride and hot-pressed silicon carbide in a turbine test passage at 2000 C and 3 atm. pressure (Reference 15).

Schlichting¹⁴ studied the addition of V_2O_5 to the burner gas stress described above. He observed little dissolution (corrosion) of Si₃N₄ or SiALON's in this environment. Investigators at Westinghouse¹⁵ have examined the combined effects of S, Na, V, and Mg on the behavior of HS 130 and NC 203 at 2000 F as shown in Figures 8a and b. Impurities seem to affect the corrosion/erosion behavior of HS 130 but not NC 203. However, the maximum weight gains after 250 hours are similar for both materials.

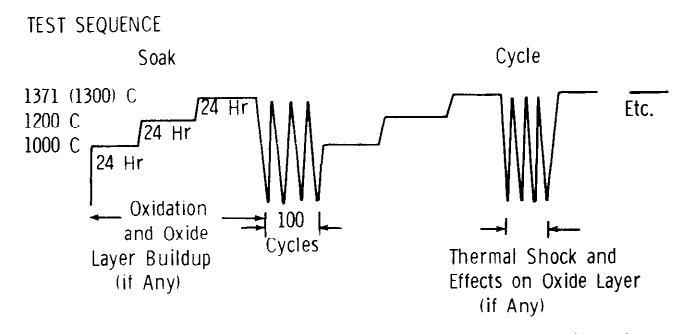
Note: Maximum temperature of 1300 C is used for SiC materials with free silicon as a constituant.

Quinn has been investigating combined high temperature exposure in air with thermal cycling, under a joint DOE/AMMRC program.¹⁷ Three hundred and sixty hours of exposure in air at temperatures ranging between 1000 and 1371 C plus 500 thermal cycles are accumulated on each material studied according to the schedule shown in Figure 9. The thermal cycles are carried out in an oxygen-MAPP gas

flame (clean flame) with air quenching as described in Reference 18. Silicon nitrides and silicon-free SiC's are given a maximum exposure/cycle temperature of 1371 C (2500 F); for SiC materials with free silicon such as G.E.'s SilComp the maximum temperature is 1300 C (2372 F). "Virgin" materials properties (4-point modulus of rupture and Weibull "m," both at RT) were obtained on a population of 16 samples per material. Environmentally exposed materials properties (retained strength and Weibull "m," at RT) were obtained on a population of 11 to 12 samples per material. Materials tested to date are NC 132 (HPSN), NC 203 (HPSiC), NC 350 (RBSN), KBI - RBSN, and G.E. SilComp. Quinn's results are shown in Table 9. His results on NC 132 and NC 203 are in good agreement with the Westinghouse results on oxidation exposure in air shown in Figure 3. This would indicate that the effect of thermal cycling in the manner shown in Figure 9 is less important than is the effect of oxidation exposure. Both grades of RBSN evaluated suffered ~20% strength reduction after exposure. This is less than one might have anticipated from the work of Mangels and Godfrey cited earlier. Quinn's data covers higher temperatures and longer times than the AiResearch work discussed above, therefore it is not appropriate to draw comparisons. The SilComp data is the first on the retained strength of this class of materials. Therefore, no comparisons can be made.

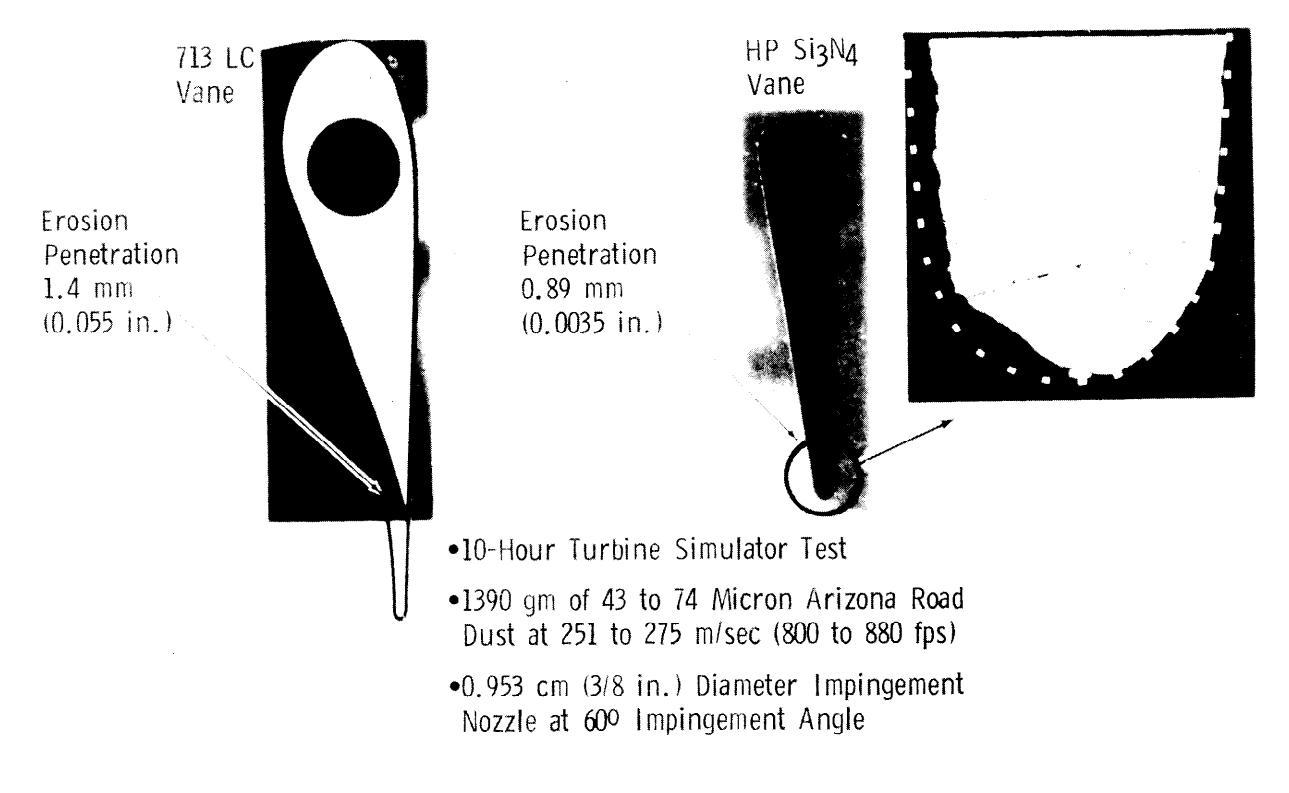
Figure 10. Erosion at 1700 F.

The 10-hour accelerated erosion test used 43 to 74 μ m Arizona road dust, which was impinged on selected vanes at a 1700 F vane temperature and 1750 ft/sec gas velocity. The results were dramatic (Figure 10) and showed the clear superiority of HPSN over the 713 LC superalloy. The 70-hour corrosion test was carried out at 1700 F, with 3 ppm of artificial sea salt injected into the gas stream. The results showed that HPSN was 27 times more corrosion resistant than 713 LC alloy, or a 0.0004-inch recession for HPSN versus 0.0011 for 713 LC.

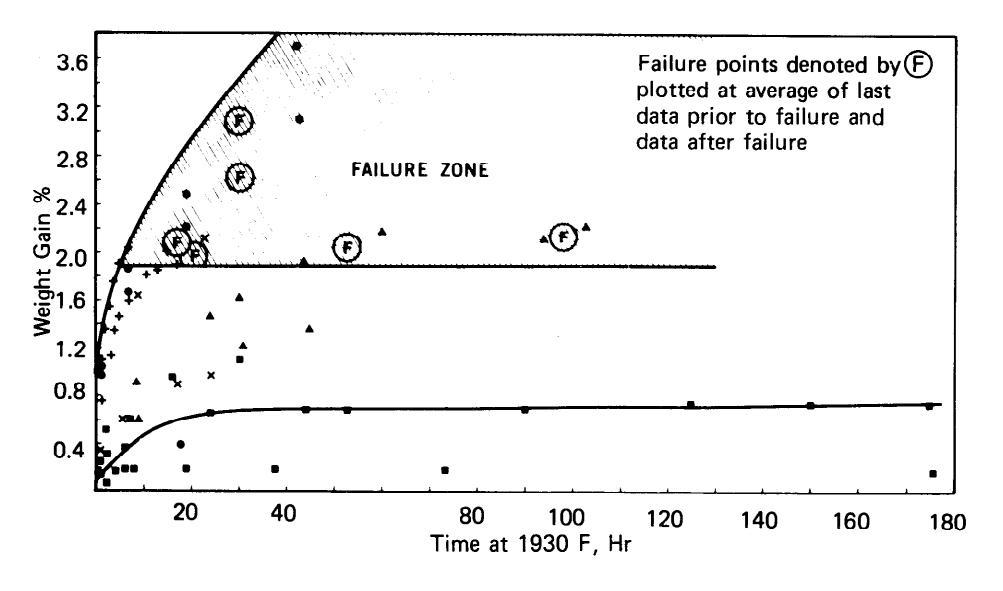
Figure 11. Weight gain versus engine rig test time at 1930 F for Ford 2.55 g/cc density RBSN stators showing failure zone (Reference 21).

Figure 11 shows early data on Ford 2.55 g/cc RBSN relating weight gain and stator lifetime in an engine rig.²¹ Figure 12 shows more recent results for newer 2.7 g/cc RBSN components (both stators and nose cones).²⁰

While the investigators at Ford do not offer a mechanism for the weight gain, the porosity and previously observed oxidation weight gain behavior of RBSN would lead one to speculate that the gain is due to oxidation. The observation that the weight gain of the reaction-sintered SiC in the same test was negligible²⁰ lends support to this speculation. This correlation between oxidative weight gain and component performance has obvious implications as a component qualification and NDE technique for RBSN.

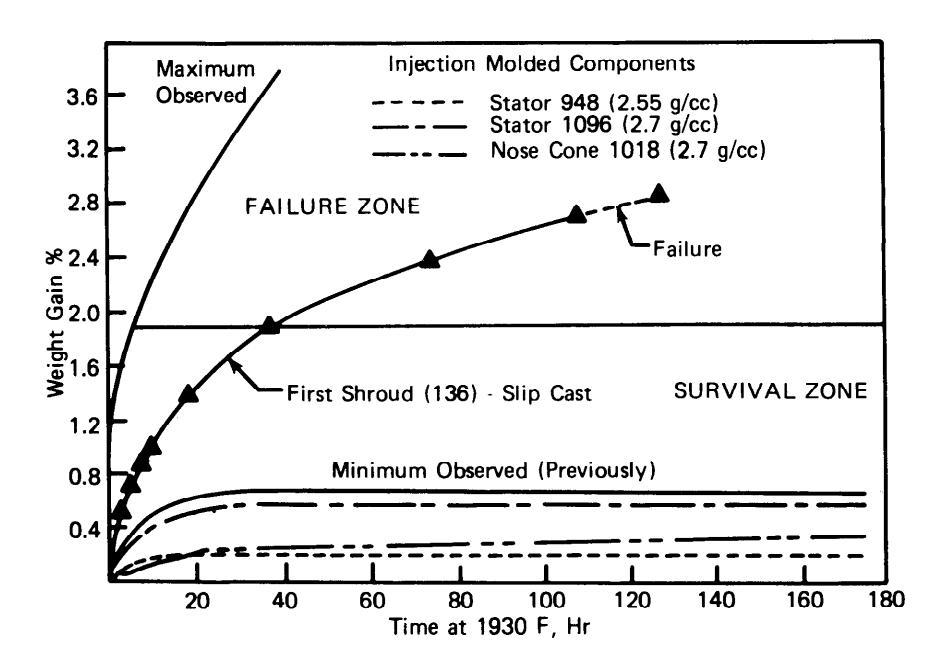
Figure 12. Weight gain versus engine rig test time at 1930 F for Ford 2.55 and 2.7 g/cc RBSN stators showing failure and survival regimes.
