AEROSPACE REPORT NO. TR-2000(1494)-1

# Burst Tests of Filament-Wound Graphite-Epoxy Tubes

# Pathfinder Test Series for Delta II GEM Motor Cases

20 December 2000

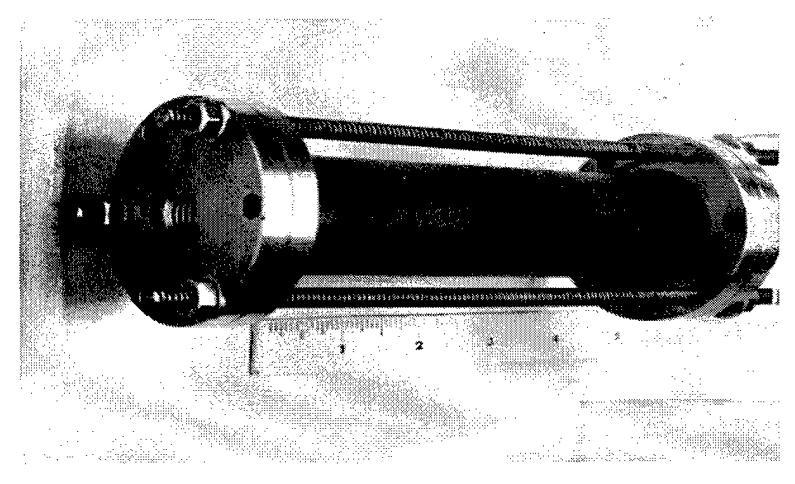
Figure 1. Mini-test series specimen assembly.

A thick-wall annular cylinder was machined from a piece of inert solid propellant. The cylinder had an ID of 0.6 in. and an outer diameter (OD) of 1.5 in. The inert propellant cylinder fit snugly inside the composite tube. The length of the cylinder was slightly shorter than that of the tube. Both ends of the tube were sealed with epoxy into groves on stainless steel flanges used as end-fittings, and the ends of inert propellant cylinder were sealed against the end flanges with O-rings. The two flanges were joined using three brass rods at 120-deg intervals. The rods carried the axial load when the cylinders were pressurized. Under this condition, the tubes experienced only circumferential stress. Figure 1 shows the assembly, including test specimen, end-fitting, and the tie-rods.

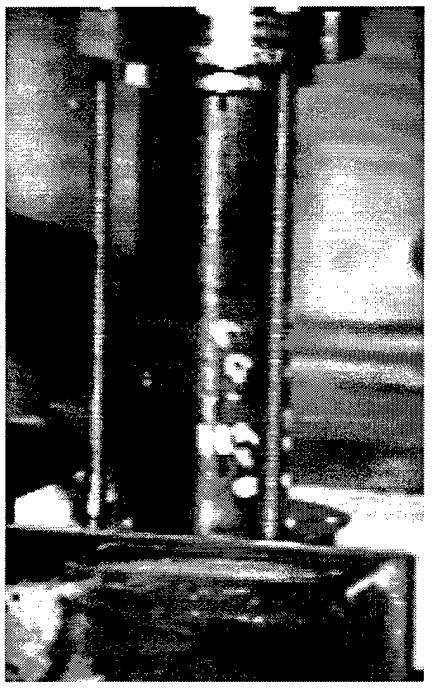
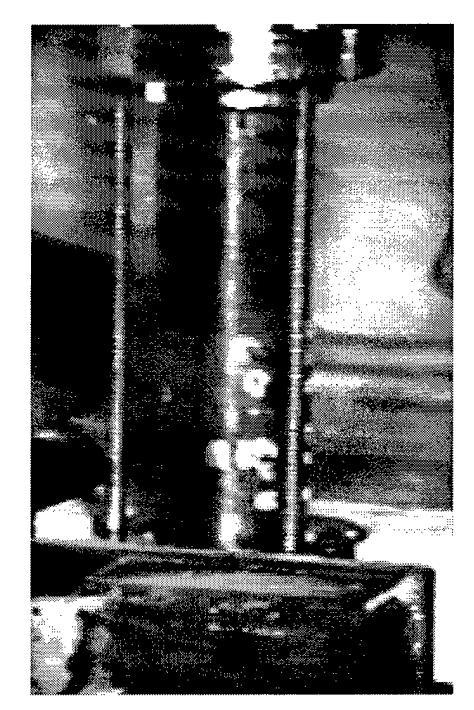
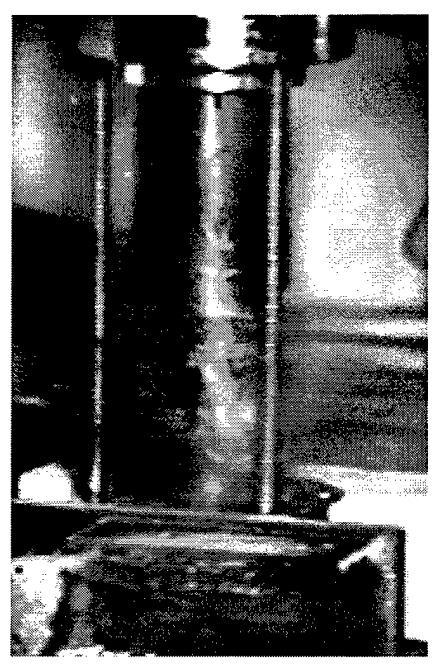
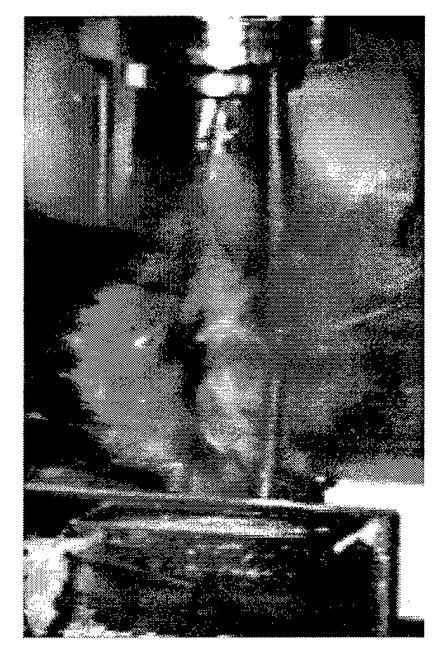
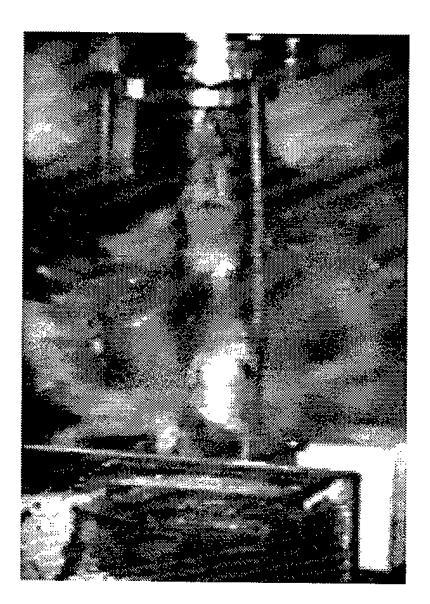
Figure 2. Failure image of mini specimen no. 4 frame #1 (initial state).

Figure 3. Failure image of mini specimen no. 4 frame #2 (0.44 ms).

Figure 4. Failure image of mini specimen no. 4 frame #3 (0.88 ms).

Figure 5. Failure image of mini specimen no. 4 frame #4 (1.32 ms).

Figure 6. Failure image of mini specimen no. 4 frame #5 (1.78 ms).

- The failure mode of specimens tested with an inert propellant insert, whether local initial damage existed or not, was always a line crack in the axial direction caused by the hoop stress. This is demonstrated by the high-speed camera images. Figures 2 through 6 depict sequential high-speed camera images starting from the beginning of the failure for tube no. 4. The images were taken at 2250 frames per sec. A longitudinal line cut, 0.25-in. long by one-ply deep, is visible between two white dots made using "liquid paper." In Figure 3, the crack widened after 0.44 ms. In Figure 4, the composite layers were blown out and a hole formed in the inert propellant. Figures 5 and 6 show that the hole in the inert propellant resulting from the tube rupture moved upward.

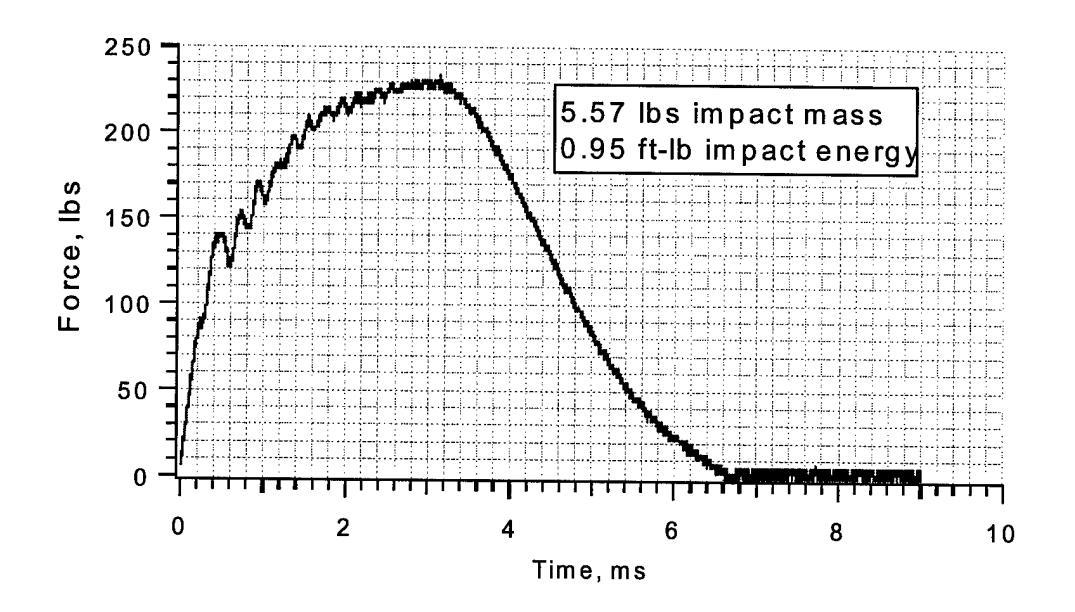
Figure 7. Impact load time history for 5.57-lb impactor.

From the impact load-time history, it is seen that the pulse widths increase with the mass of the impactor at the impact energy. For example, the pulse-widths were approximately 6.3 ms and 9 ms for the 5.57- and 9.75-lb impactors. This impact pulse-width versus impact mass observation is shown in Figures 7 and 8 for these two cases, at an impact energy of approximately 0.92 ft-lb (11.0 in-lb). The pulse-width ratio (1.43) is approximately equal to the square root of the mass ratio (1.38).

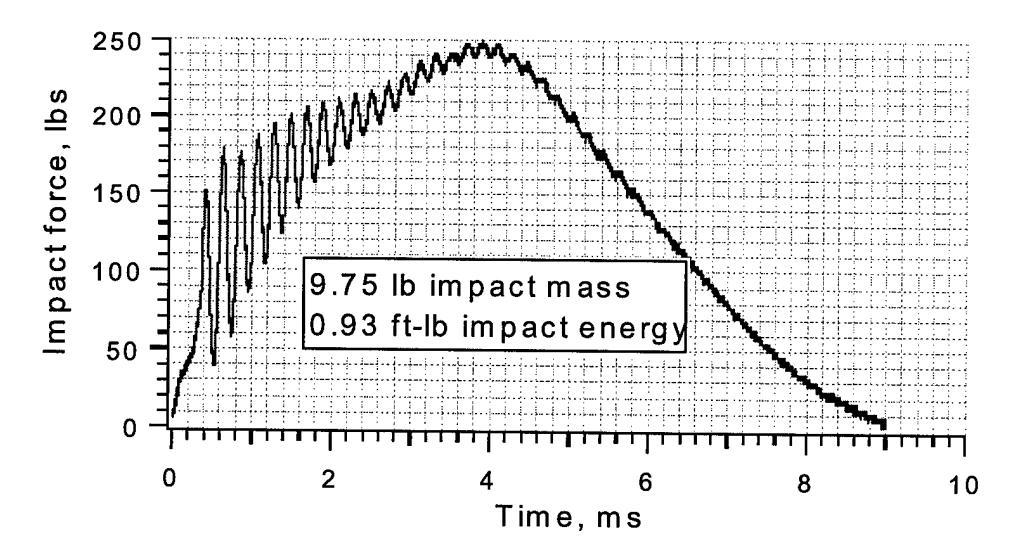
Figure 8. Impact load time history for 9.75-lb impactor (the high frequency component of the signal is an artifact of the load cell).

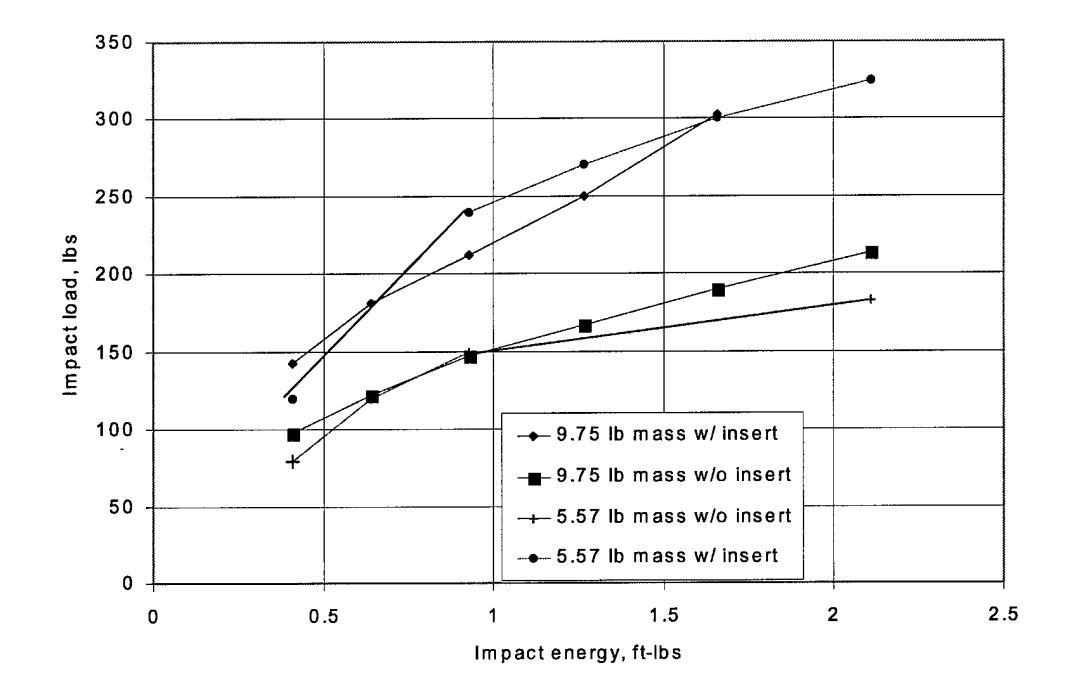
Figure 9. Impact load versus impact energy with and without inert propellant insert (5.57-lb. and 9.75-lb. mass).

Figure 9 depicts the impact load versus impact energy for the 5.57- and 9.75-lb impactor masses for both cases (with and without inert propellant). Figures 10 depicts the energy absorbed from impact versus impact energy for the same impacts. It is seen from these figures that (1) the impact loads were higher for the case with inserts than without inserts; (2) the absorbed energy for the case with inserts was typically above 50% when inserts were used; and (3) the absorbed energy fraction dropped to below 25% when there was no insert present.

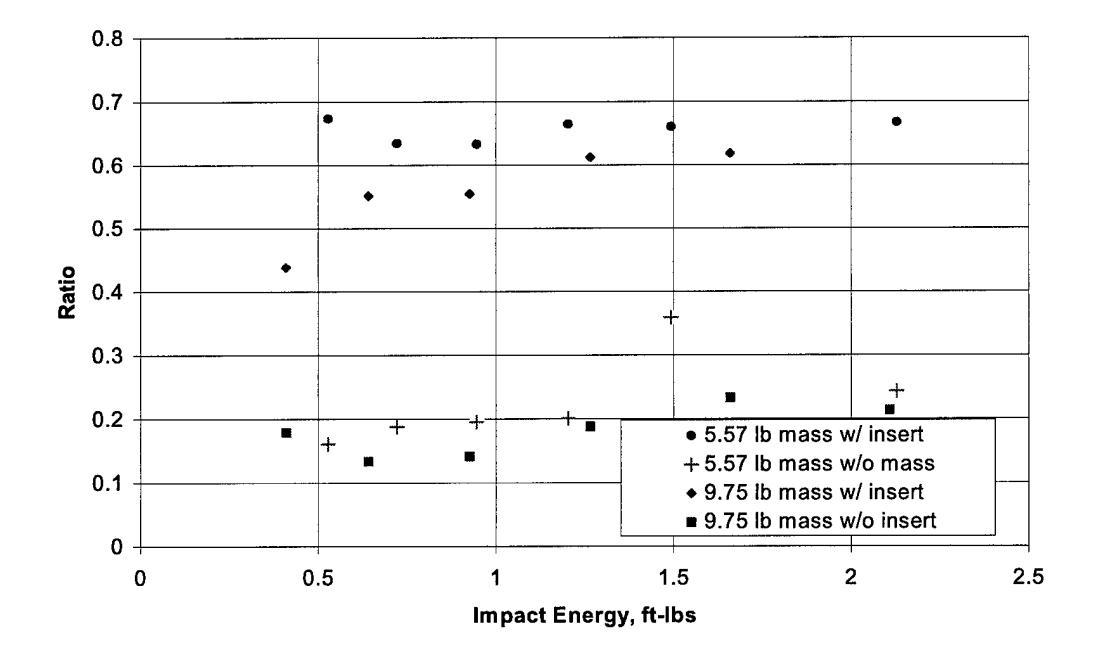
Figure 10. Ratio of absorbed energy to impact energy with and without inert propellant insert (5.57-lb and 9.75 -lb mass).

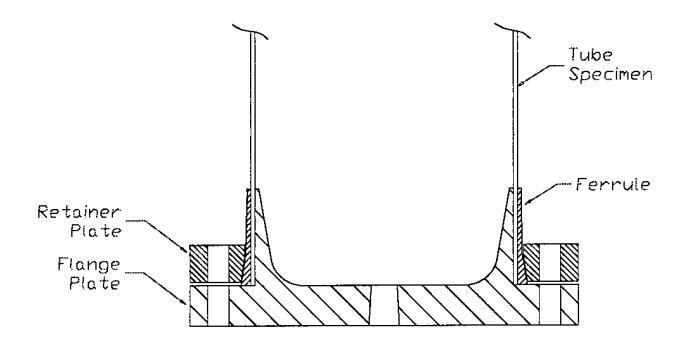
Figure 12. Cross-section sketch of end fitting.

An improved end-fitting design was produced for this program.<sup>3</sup> The basic concept is to apply a radial compression to the end-fitting insert/tube interface. This compression will generate a mechanical friction force (or shear force) when the tube and the end fitting are being pulled apart longitudinally. This increases the shear strength capability of the end fitting by an amount equal to the product of the compressive stress, the friction coefficient, and the contact area between the tube and the insert. Figure 12 shows the design of the end fitting used to generate the radial compression. The fixture includes a circular flange plate with an inner insert, a ferrule, and a retainer plate with an outer diameter equal to that of the flange. The ferrule has tapered thickness such that it is thicker toward the base and thinner at the tip. The thin section at the tip gives high radial compliance to limit stress concentrations between the ferrule and the tube that may induce early failure. The retainer plate has an inner diameter slightly smaller than the outside diameter of the ferrule so that they can interfere. Both the flange and the retainer plates have 16 holes aligned at the same radial and angular locations. In assembling the fitting, the inner surface of the tube is first bonded to the outer surface of the inner insert. The outer surface of the tube is then bonded to the inner surface of the ferrule. The interference between the retainer plate and the ferrule introduces a gap between the retainer plate and the flange. These two components are then forced to contact by tightening the 16 bolts through the holes. This procedure brings the ferrule, the tube, and the inner insert in radial compression. The radial compression increases the shear strength between the tube and the end fitting by an amount equal to  $\mu NA$  where  $\mu$  is the frictional coefficient, N is the normal compressive stress, and A the total contact area between the tube and the ferrule, and between the tube and the inner insert. The estimated values of  $\mu$ , N, and A are:  $\mu$ , 0.25 to 0.4; N, 8000 psi; and A, 25.0 in<sup>2</sup>. These values give allowable internal pressure between 4000 and 6300 psi. The adhesive between the epoxy and the stainless steel has a shear strength of 4000 psi, which provides a higher margin. Figure 13 depicts a specimen with the end fitting assembled.

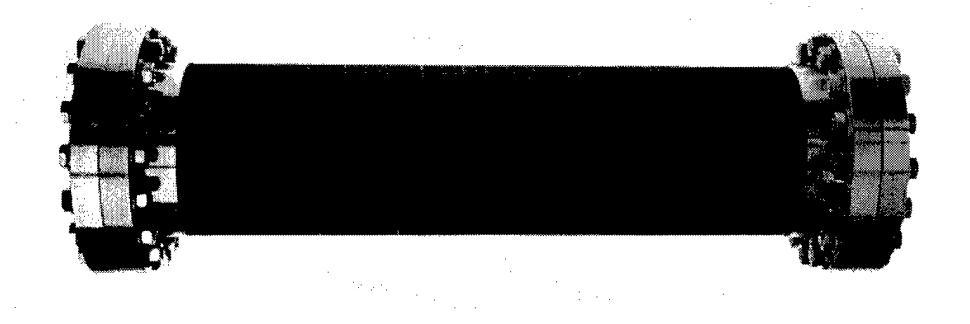
Figure 13. Graphite-epoxy tube specimen with end fitting.

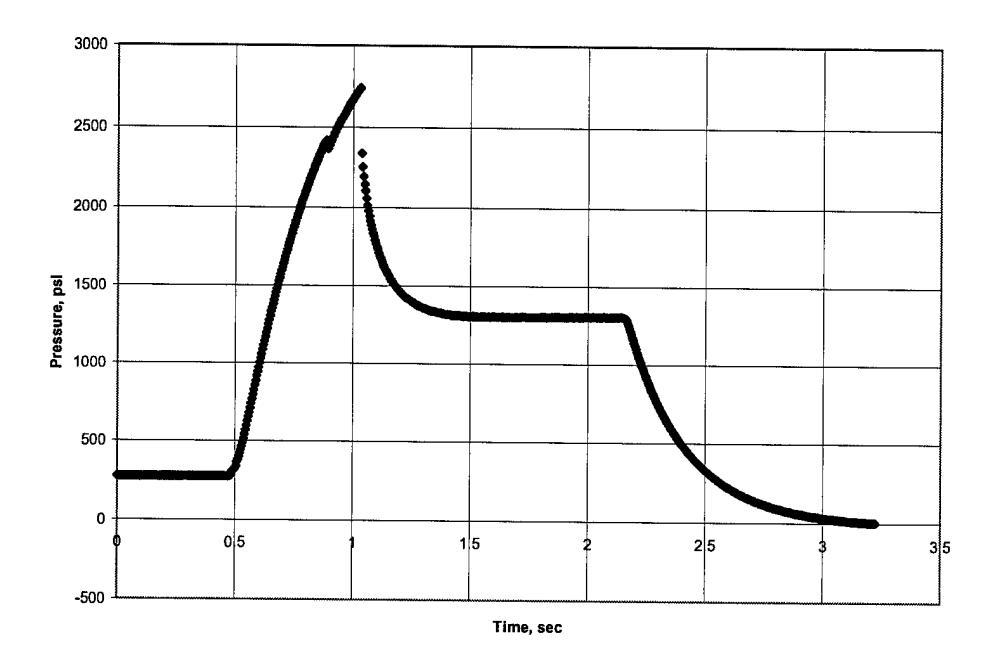
Figure 14. Pressure/time history of hydraulic-test for tube G2 (no insert included).

Two specimens were tested and burst in this category (G2, G3). The burst pressures were 2750 and 2744 psi. These values, when compared with the 3233 psi burst pressure of an undamaged tube under a hydraulic pressurization, show a 15% strength reduction. The pressurization rate was about 6 psi/ms. The pressure-time history of a typical failure represented by tube G2 is depicted in Figure 14. The failure occurred in approximately 0.5 to 0.6 sec.

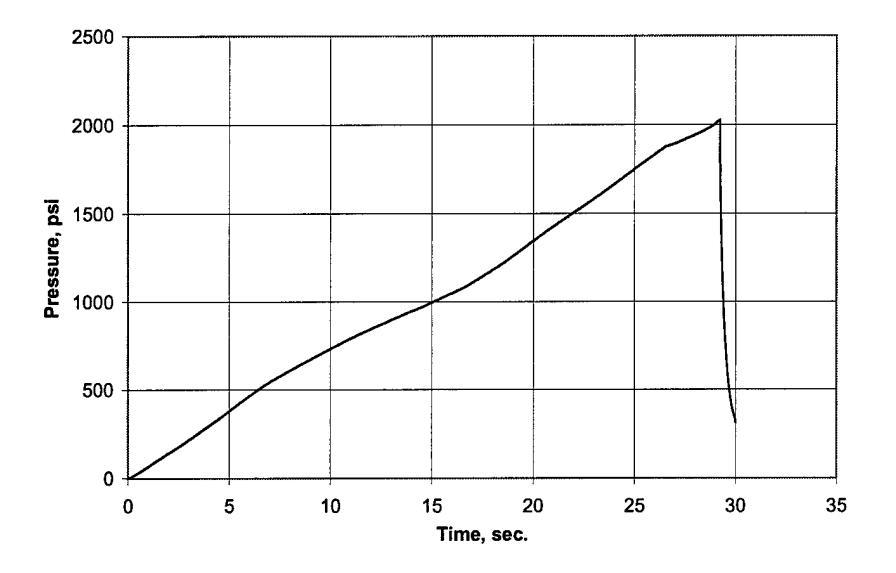
Figure 15. Pressure/time history of pneumatic test for tube E3 (with plastic insert).

Of a total eight tests, two burst successfully (E2, E3). The burst pressures were 2030 and 2096 psi. It appears that these two specimens were from a weaker tube (tube E), from which all the burst pressures were low. There were various reasons for the large number of unsuccessful tests in this category. One tube failed at 2926 psi when the end fitting slipped. Another tube, G1, had a wood insert instead of plastic. Because of the high porosity of wood, the pressurizing gas permeated the wood insert, allowing a much higher total volume of gas in the test specimen. When it burst, the high energy content of the gas led to a complete disintegration of the specimen (and the wood insert), and no recoverable piece was found. The pressure/time history for tube E3 is depicted in Figure 15.

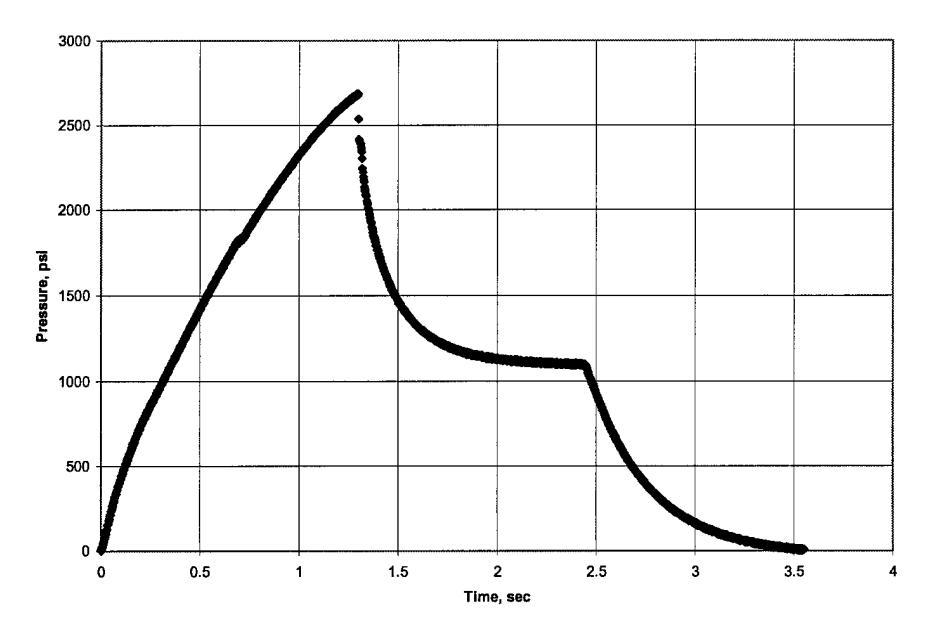
Figure 16. Pressure/time history of pneumatic burst test for tube G6 (tube had an inert propellant insert).

Seven out of nine tubes burst successfully in this category (E4, E5, G6, A3, F3, F6, D6). Tube C3 was not included in the statistics because leakage occurred during the two previous tests before it burst in the third test cycle. The average burst pressure was 2440 psi. The pressurization rate was about half that of the typical hydraulic pressurization. Figure 16 depicts the pressure/time history of tube G6, a typical successful test.

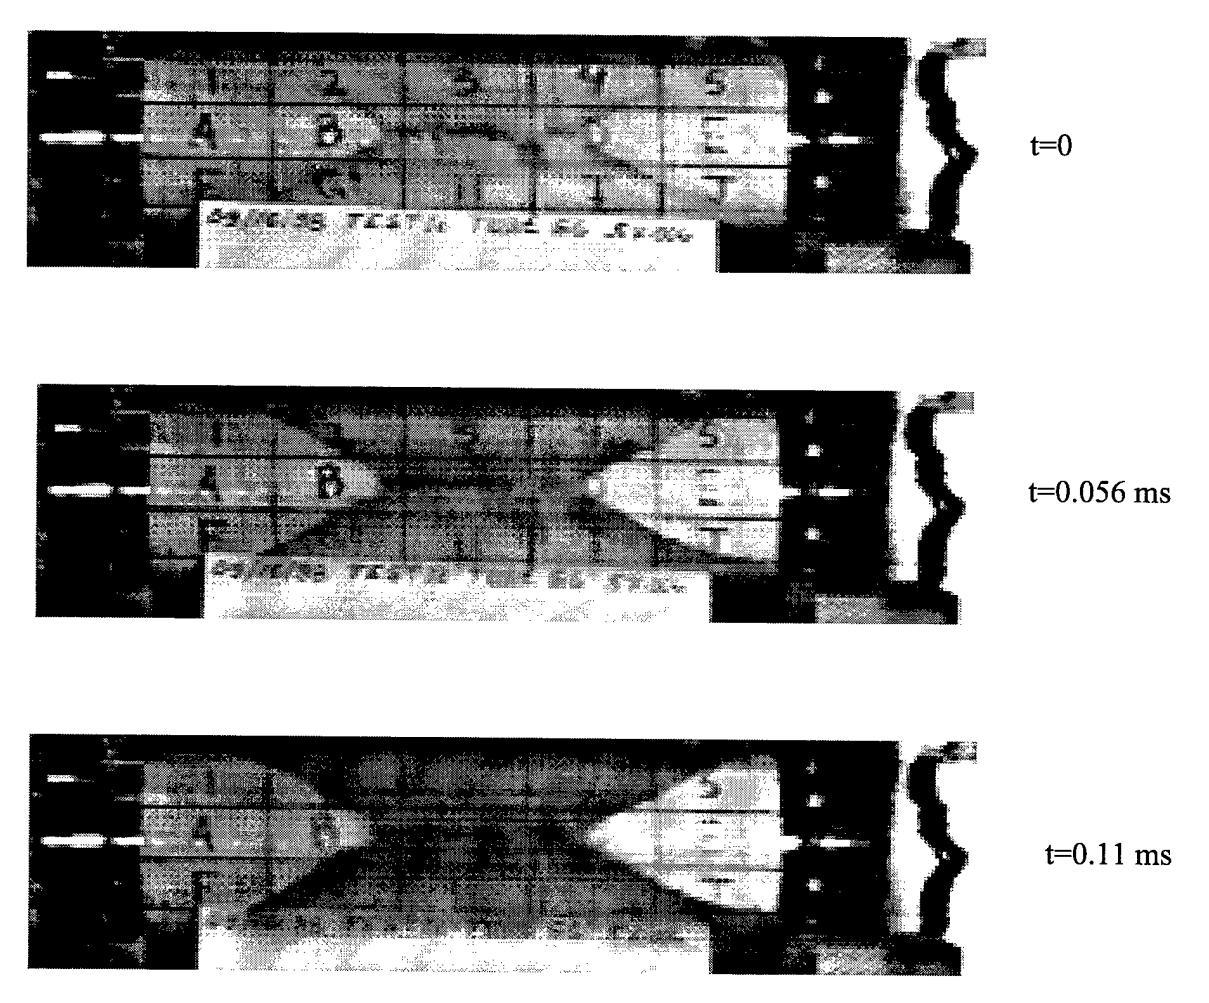
Figure 17. Pneumatic test with inert propellant insert.

Three different failure modes were observed in this test series: a local leakage, a bursting mode with the tube split initiated from the line crack, and a bursting mode with complete tube disintegration. The bursting mode with a linear tube split was the most common mode, and simulates the mode observed during Flight 241. Under the line cut damage mode, failures always initiated at the tip of the cut. The propagation direction could go either longitudinally (parallel to the tube axis), or along the direction of the helical wraps. In this failure mode, whether the crack propagated longitudinally or helically, the crack typically propagated along about one-third of the length of the tube and then split into two cracks propagating at about ±30-deg relative to the axis. This is apparently the result of end effects due to the presence of the end fitting. However, the specimen is long enough that the end effect had no impact on the initial propagation of the burst. Figure 17 depicts the first three images of typical longitudinal crack propagation and failure paths at 0.056-ms intervals. The two triangular zones in these figures stayed intact with the end fittings. Figure 18 depicts the first two images of helical crack propagation and failure paths at 0.056-ms intervals. For this hydraulic pressurization case, water is seen seeping out of the cut location. The burst mode with complete tube disintegration only occurred when there was a large volume of compressed gas present to provide the energy for disintegration, as described above. In this case, the debris from around the cut was thoroughly fragmented, and no pieces could be recovered which were large enough to verify the failure initiation location.

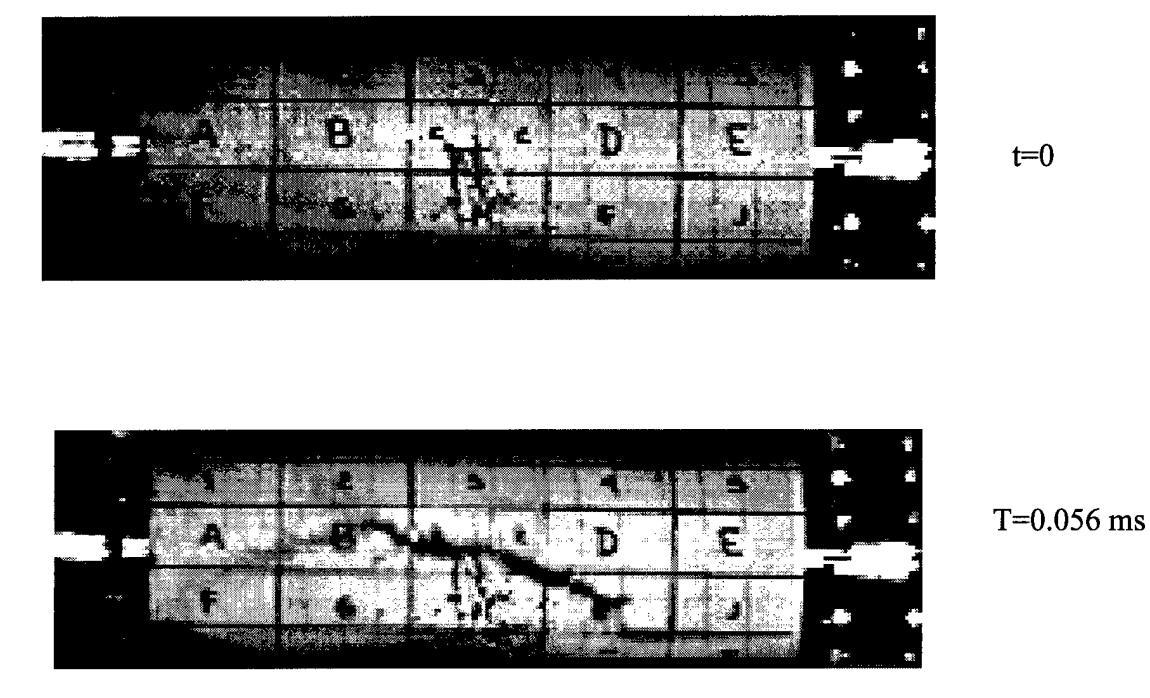
Figure 18. Hydraulic test of tube G2.

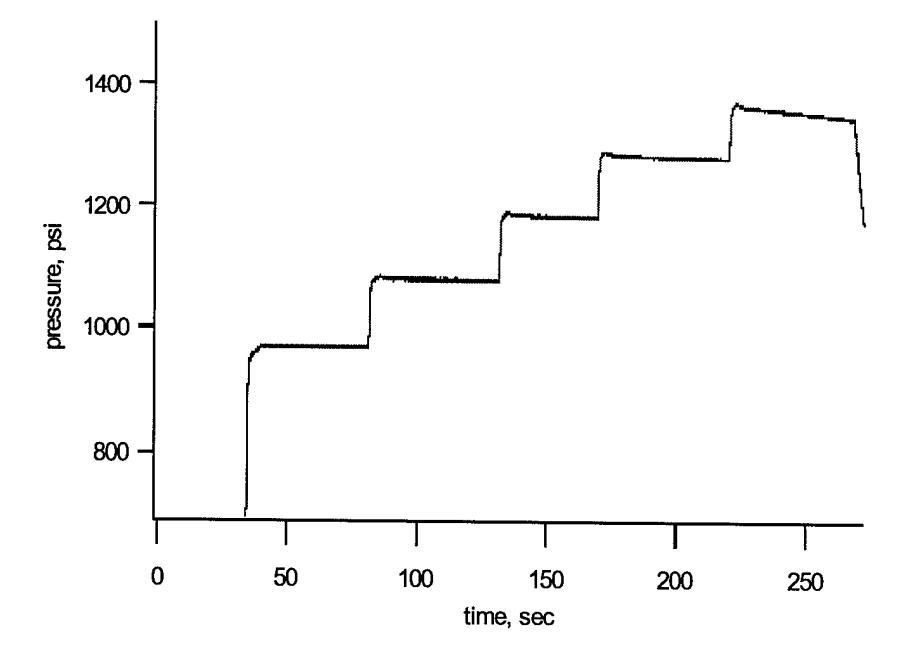
Figure 19. Pressure/time history of five incremental pressurization tests for test no. 20 (tube F5).

Many tubes failed in a leakage mode instead of bursting. In order to examine the problem of leakage in this test series, two tests were conducted using a slow, incremental, pressurization process starting at a low pressure, increasing in 100 or 200 psi steps, and holding for about 40 to 50 seconds at each pressure. One of these two test specimens F2, was given a 0.5 by 0.006-in. cut and the other tube, F5, was undamaged. In both cases, it was observed that tube started to leak at a pressure between 1200 and 1400 psi. This is less than 50% of the typical burst pressure. When the pressure was vented and reapplied, the leakage occurred at a lower pressure of 900 to 1000 psi. Further pressurization of the tube, although resulting in no fiber breakage, caused the tube to leak at an even lower pressure. Figures 19 and 20 illustrate the pressurization history of tube F5. The leakage was evenly distributed over the tube surface indicating a matrix cracking under pressure-induced tensile stress. This observation suggests that cracks initiated in a graphite-epoxy tube at a high-pressure level may propagate sufficiently to cause leakage at a subsequently applied lower pressure.

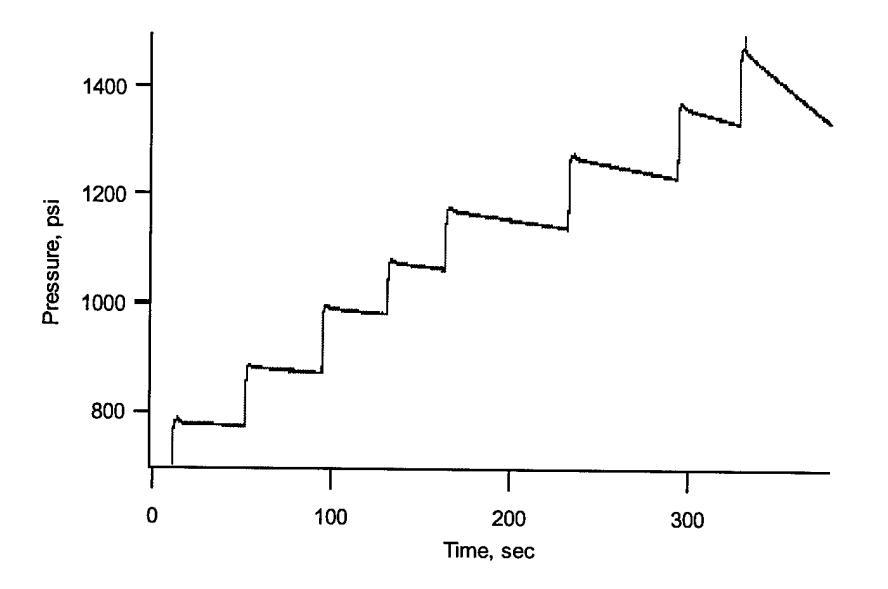
Figure 20. Pressure/time history of eight incremental pressurization tests for test no. 20 (this test series was conducted after the test series in Figure 19).

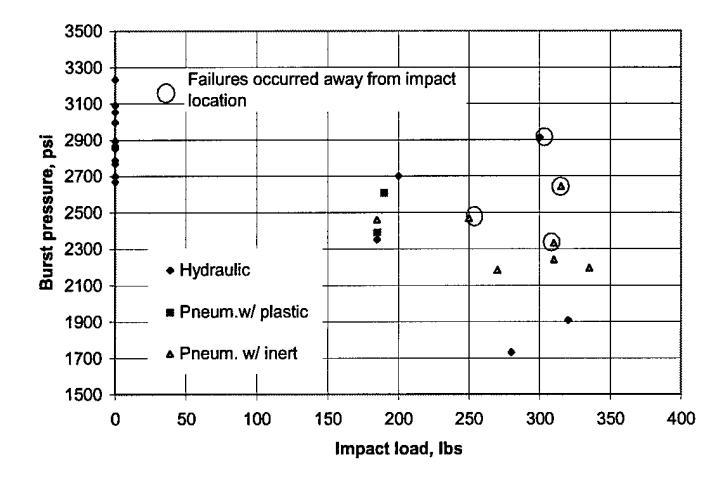
Figure 21. Burst pressure versus impact load.

An additional 11 burst pressure data points are included in Figure 21. These data were obtained from a different program using an identical specimen configuration. The tests were conducted under hydraulic pressurization with very slow pressurization rate typically 200 to 400 seconds to burst. The average burst pressure was 2887 psi with a standard deviation of 307 psi.

The failure modes of impacted specimens are very different from those with a line cut. From the highspeed camera images, it was apparent that the failure origins of the impact-damaged tubes were not necessarily at the impact location. In Figure 22, tube C2, which was pneumatically tested with an inert propellant insert, had the fracture origin at the upper left corner of the tube, although some hoop fibers close to the impact location had broken at 4.5 ms before the catastrophic failure occurred. Another two tubes, C7 and F7 also had fracture origins away from impact locations. On the other hand, tube B1, which had an impact load of 335 lb, had its fracture initiated from the impact location, as illustrated by Figure 23. Figure 24 shows that the failure of tube C6, which had an impact load of 310 lb, started toward the bottom of the specimen despite the fact that all these tubes were impacted and tested using the same set-up. This may suggest that different types of damage might have occurred in tubes that received essentially identical impacts. However, four tubes were inspected after impact using both ultrasound and thermography techniques and no damage other than that at the impact location was observed. Figure 25 shows the two photographs of tube F7, one a thermography image and the other an ultrasound image. Unfortunately, there was no NDE such as acoustic emission data recorded that allowed the determination the fracture initiation location. Such data will help analyze the failure data more accurately. This type of instrumentation is definitely needed in future bursting with impacted tubes. No leakage was observed in the damage test series. All specimens that fractured away from the impact locations were also identified with individual circles in Figure 21.

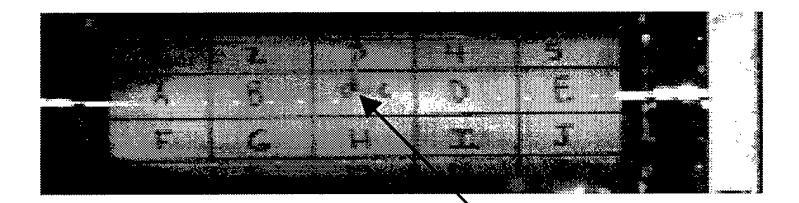
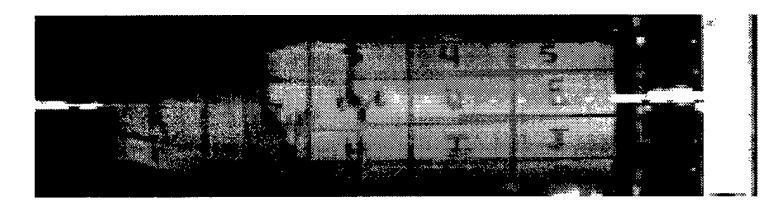
Impact location

Figure 22. Failure mode of tube C2 under pneumatic gas with inert propellant insert (specimen impacted with 315-lb load).

It is speculated that the failure initiation away from the impact location may be the result of impact induced bending stress. An impact to the tube will create a stress wave propagating in both longitudinal and circumferential directions. The wave-induced deformation will subsequently generate bending moment throughout the entire tube at various times. The bending stress can be high because of the thin wall thickness of the tube and the compressive stress may cause fiber buckling if a local defect exists. When fibers buckle, they lose their load carrying ability and the buckled region becomes the weakest link. Failure will then initiate from this region from the subsequent pressure loading.

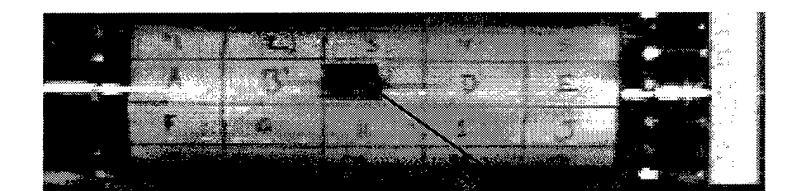
Impact location

Figure 23. Failure mode of tube B1 under pneumatic gas with inert propellant insert (specimen impacted with 335-lb load).

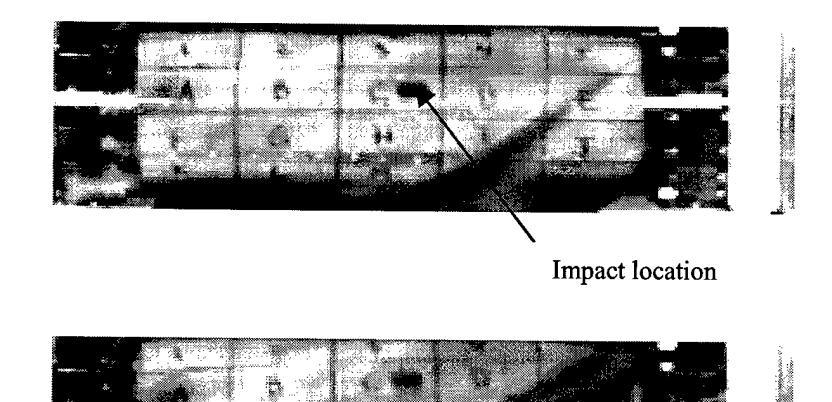
Figure 24. Failure mode of tube C6 under pneumatic gas with inert propellant insert (specimen impacted with 310-lb load).
