# **General Atomics Pulsed Power Capacitor Comparison Test Report**

## ARL-TR-7350 • JULY 2015

by Richard L Thomas Sensors and Electron Devices Directorate, ARL

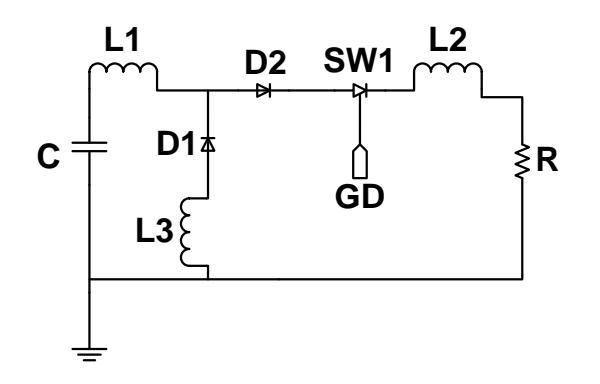
Fig. 1 Test circuit

To properly evaluate how the capacitor will respond to load variations outside of the system, the testbed described in the circuit shown in Fig. 1 was used. This circuit comprises the device under test C, buss inductance L1, adjustable inductances L2 and L3, anti-parallel diode D1, series diode D2, high current switch SW1, and adjustable resistance R. There are 2 extreme waveform characteristics that are used to vet the capacitors. The first of these 2 waveforms is a low inductive load path, which will produce a waveform with a rate of rise greater than 20 kA/µs and no voltage reversal on the capacitor. This requires the circuit to have approximately 70 nH of inductance for L2 and 10 nH for L3 with R at 33 mohm. The other waveform requires a much lower rate of rise but produces a 20% voltage reversal on the capacitor and a much longer current pulse. This requires the circuit load to have approximately 700 nH of inductance for L2 and no change with L3 with R equal to 25 mohms. The test circuit has a buss that can adjust the distance between the buss, thus varying the inductance to the desired level. The reconfigurable load bank consists of 9 different paralleled stacks of 0.1 ohm resistors that can hold up to 0.4 ohms.

discharge life. Furthermore, we varied the inductance in the reverse-current path between the anti-parallel diode and capacitor to produce an increase in capacitor voltage reversal attempting to achieve a 3-kV voltage reversal. The objective buss was replaced by the provided evaluation buss, which increased the voltage reversal to 1.5 kV, as shown in Fig. 10. Eleven discharges were fired with the evaluation buss at 10 kV with a 1.5-kV reversal and a 148-kA forward and 64-kA reversal current. This resulted in capacitance change of 0.1  $\mu$ f and no change in the dissipation factor, which remained at 0.0073. An additional 450 nH of inductance was inserted between the capacitor and the anti-parallel diode on the return side of the evaluation buss. This yielded 3 kV of voltage reversal at a charge voltage of 8.6 kV. This was achieved by increasing the inductance of L3 in the testbed Fig. 1.

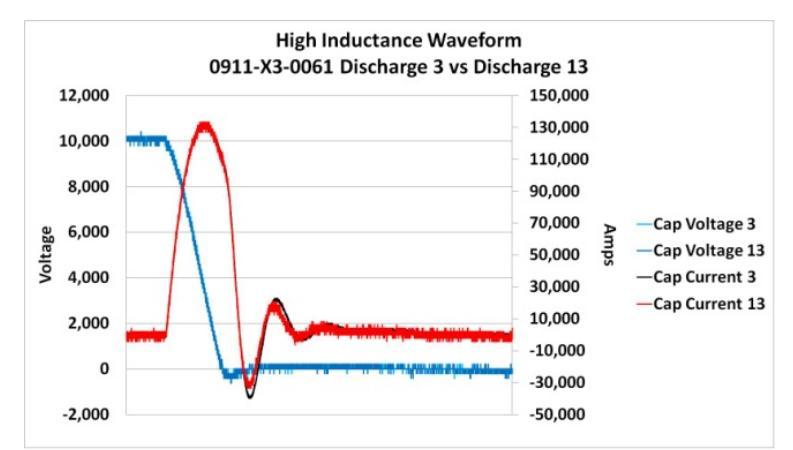
Fig. 2 Cap 0061 discharge 1 vs. discharge 13

This capacitor is designed to have a capacitance of  $315 \,\mu$ f with a rated voltage of 10 kV. Serial numbers 0911-X3-0061 and 0911-X3-0064 were subjected to the high inductance circuit, and capacitor number 0911-X3-0057 was subjected to the low inductance circuit. These capacitors were charged, pulsed, and measured for capacitance, dissipation factor (DF), and equivalent series resistance (ESR) to document the change from discharge to discharge. Figure 2 shows the waveform from discharge 3 to discharge 13 on Cap 0061, Fig. 3 shows the waveform from discharge 1 to discharge 8 on Cap 0057. There is what appears to be a slight change in the waveforms over the discharge life; however, Fig. 5 shows that the capacitance loss for each of the capacitors is significant from discharge to discharge and a 10% capacitance loss is reached rather quickly with Cap 0057 only able to supply 8 discharges before the capacitance loss threshold is reached.

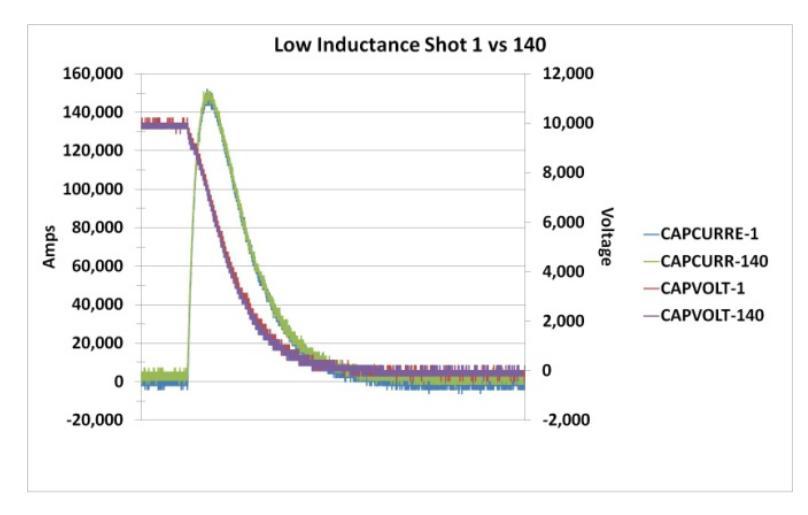
Fig. 6 Cap 8 low inductance discharge 1vs. discharge 140

This model capacitor is designed to have a capacitance of 400  $\mu$ f at a rated voltage of 10 kV. Two of these capacitors, Cap 8 and Cap 9, were tested, of which Cap 8 was exposed to a total of 458 20 kJ discharges over its life with a total capacitance loss of only 0.007%. Cap 8 was initially subjected to the low inductance circuit, which produces a di/dt of 22 kA/ $\mu$ s. Figure 6 shows the discharge comparison between discharge 1 and discharge 140 under these conditions.

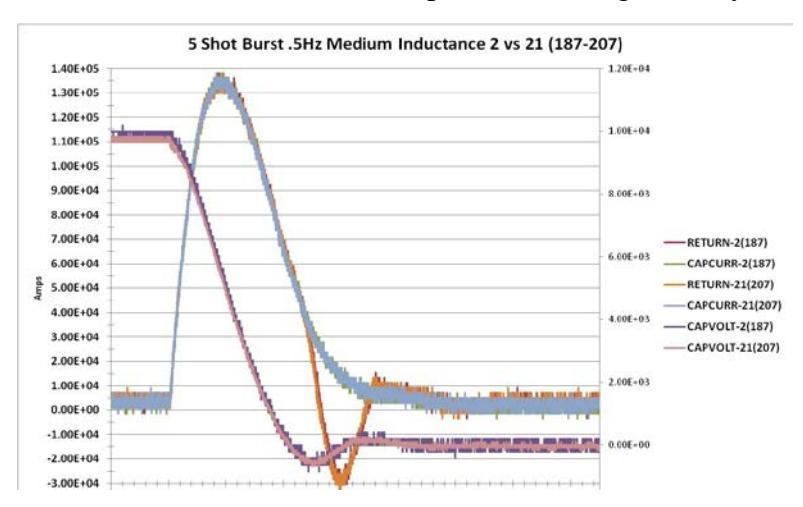
Fig. 7 Medium inductance discharge 2 vs. discharge 21

Cap 8 was then exposed to what was called a medium inductance circuit to see if the introduction of a 30-kA current reversal would degrade the capacitor. This test was done with discharges fired in a burst of 5 at a rate of 0.5 Hz. Figure 7 shows that the capacitor saw no significant degradation after a total of 20 discharges under these conditions with a capacitance change of only 0.005%.

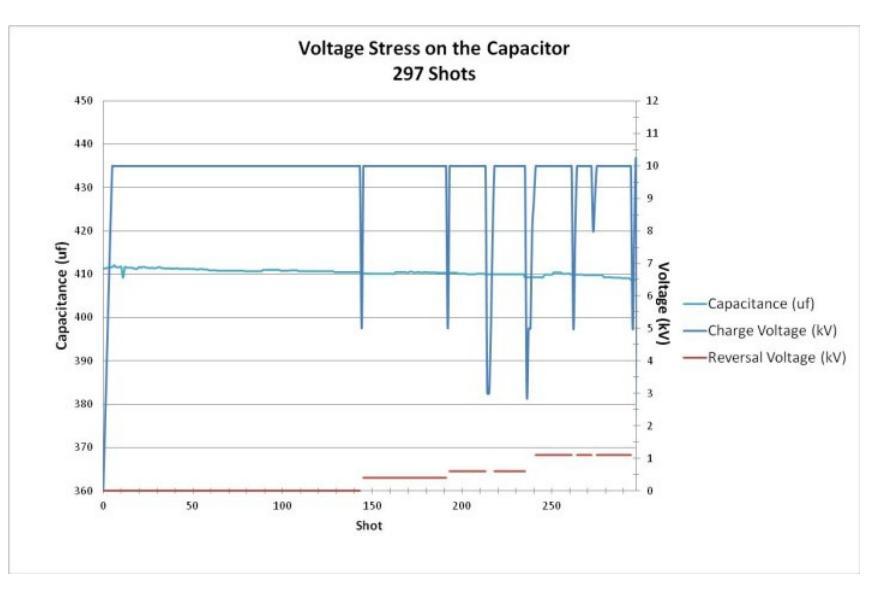
Fig. 8 Voltage stress on the capacitor

After more than 280 discharges at 10 kV with reversals up to 1.1 kV and peak forward currents up to 150 kA and peak current reversals of up to 72 kA, as shown in Figs. 8 and 9, respectively, the lifetime of this capacitor was an order of magnitude higher than the expected 20 to 30 discharge limitation (10% capacitance loss). These evaluations resulted in a capacitance loss of less than 0.01%.

Figure 8 illustrates that the voltage reversal across the capacitor was only 1.1 kV with a 72-kA current reversal. This observation (Fig. 8) led us to perform an evaluation that would apply higher voltage reversals on the capacitor to stress the dielectric, which would induce degradation and identify the cause of low

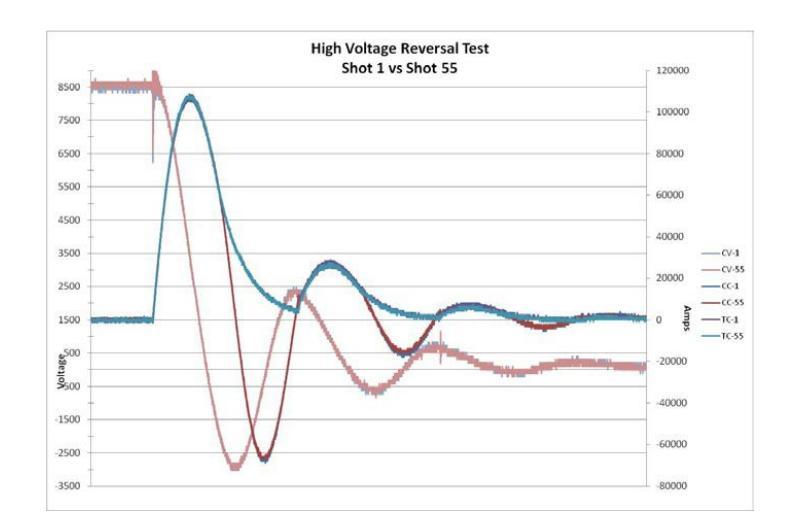
Fig. 11 High voltage reversal test

The capacitor was stressed under this condition with a discharge rate of 1 discharge every 10 s after which the capacitance measurements were taken after 10 discharges. The benefit and purpose of this test is to solely stress the dielectric in the capacitor without stressing the end connections due to fact the peak currents are reduced to no more than 110 kA. Table 1 shows a negligible decline in the capacitor changing 0.1 to 0.2  $\mu$ F after 10 discharges. Figure 11 shows the voltage and current waveforms of an 8.6 kV discharge overlaying discharge 1 to discharge 55, which confirms the stability of the capacitor.

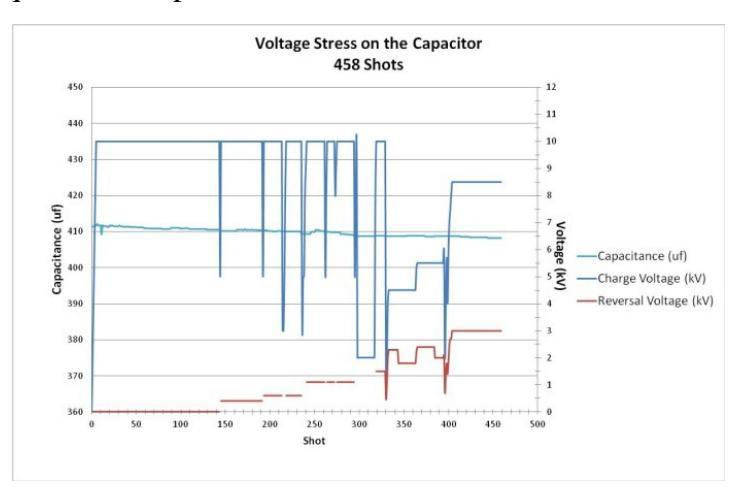
Fig. 12 Voltage stress on Cap 8

Figures 12 and 13 show the capacitance over 458 discharges stressed by voltage and current, respectively. Based on Figs. 12 and 13, the voltage and current stress on the capacitor did not induce a large variance in capacitance throughout the evaluation sequence of Cap 8.

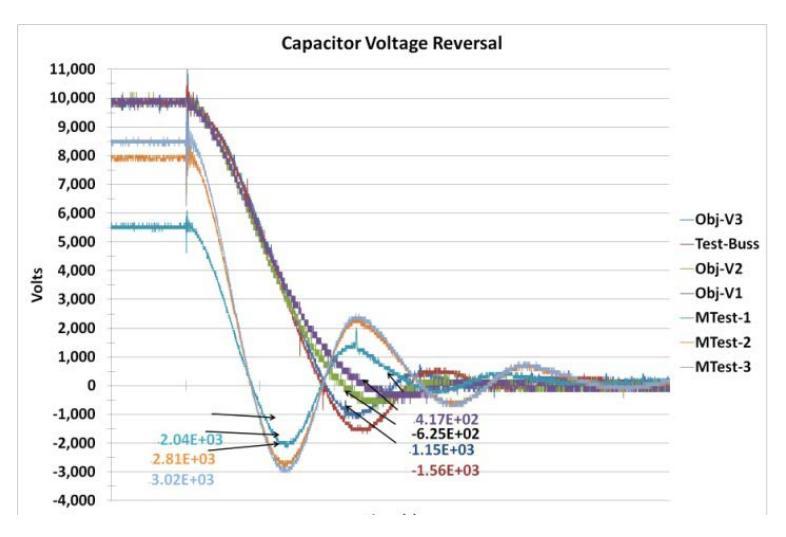
Fig. 14 Cap 8 voltage reversal

Figure 14 illustrates the different voltage waveforms that the capacitor endured during high load inductance evaluation. In Fig. 14, Obj-Vx represents different inductances used with the objective buss, Test-Buss represents waveforms generated by the evaluation buss, and MTest-x represents waveforms generated by the additional inductance added to the evaluation buss.

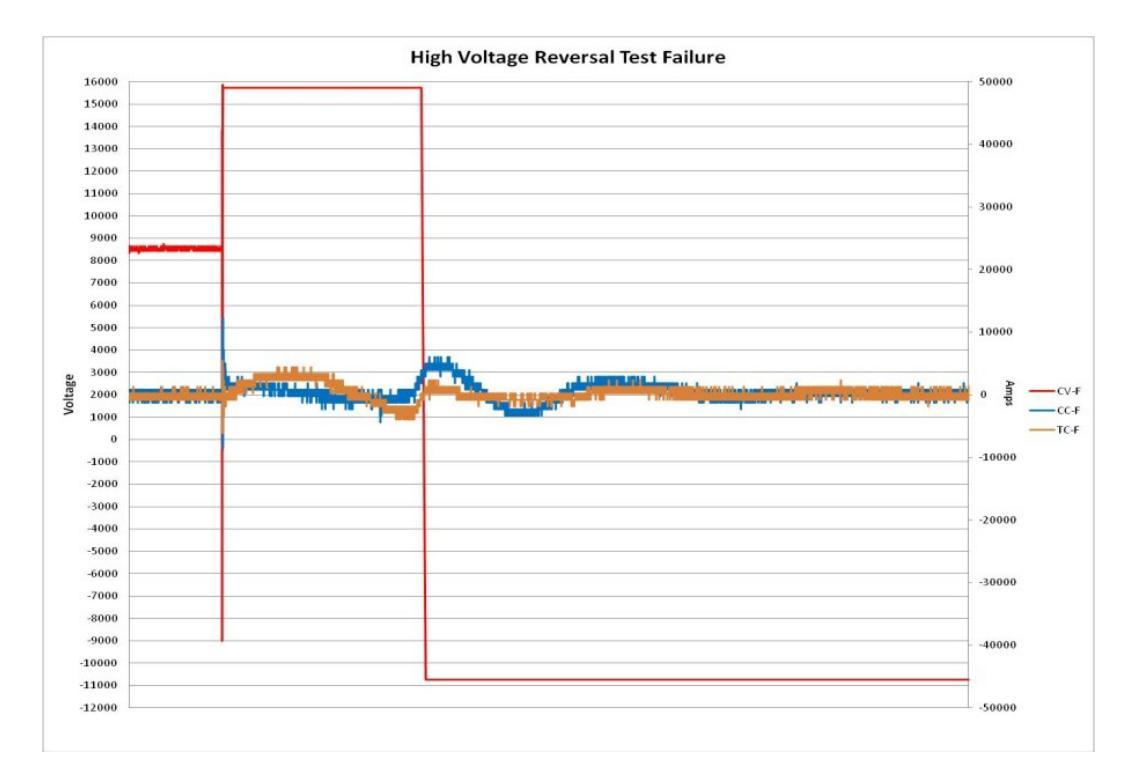
Fig. 15 High voltage reversal test failure

On discharge 56 of the 3-kV reversal evaluation, the capacitor shorted out internally during the discharge, as illustrated in Fig. 15. Figure 15 depicts that when the capacitor fault condition happened, a small percentage of current with much lower energy was discharged through the switch (pulse current info attained from Rogowski coil). Figure 15 also shows the saturation of the voltage probe due to the capacitor failure.

Just before failure, Cap 8 had a capacitance of 408.7  $\mu$ F and a dissipation factor of 0.0078. From these results, we believe that the current density in the end connections internal to the capacitor where not the point of failure. These results point to the inductance in the anti-parallel diode path across the capacitor, which leads to higher voltage reversal on the capacitor thereby damaging the dielectric. Because the objective buss has very low inductance in the anti-parallel diode path, it is expected that discharge life should be well over 30. The pictures in Figs. 16 and 17 show the result of the failure.

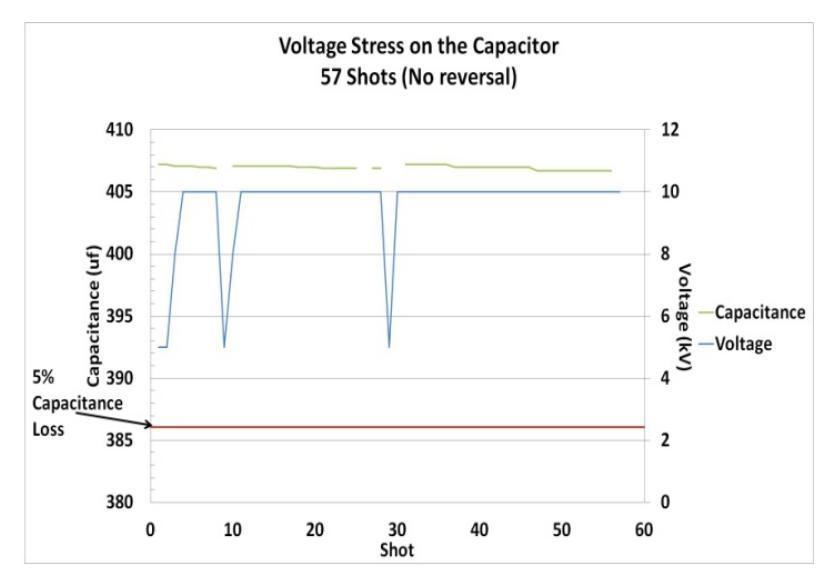
Fig. 18 Voltage stress on the Cap 9

Cap 9 was tested in the low inductance circuit with 25 discharges single discharge and then 25 discharges in a burst of 5 at a rate of 0.4 Hz. Figures 18 and 19 show the capacitance loss with respect to the voltage and current stresses respectively. It is clear that Cap 9 is following the trend of Cap 8. Further testing on Cap 9 will take place with other system component integration.

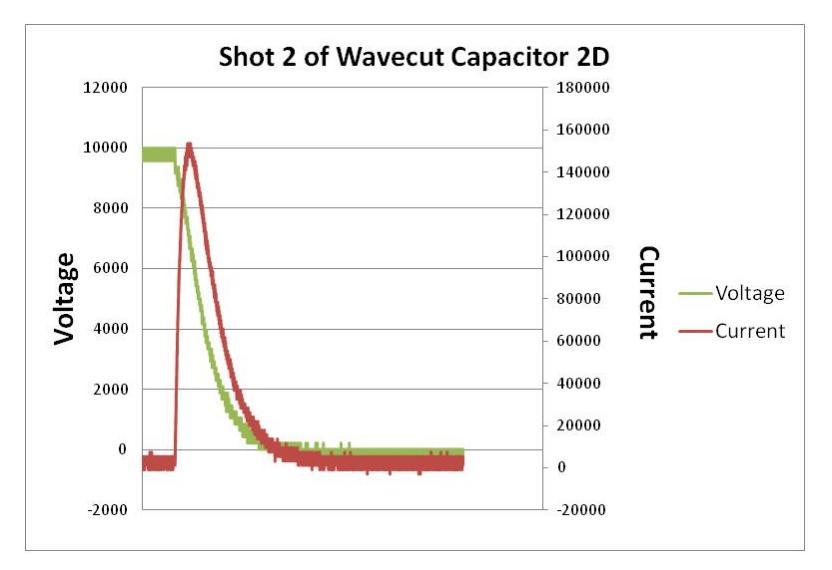
Fig. 20 Discharge waveform

The capacitor was then inserted into the discharge circuit where the case of the capacitor was floating respect to the terminals. The discharge circuit produced a high di/dt waveform with no voltage reversal. The capacitor was discharged in 2-kV increments until a 10-kV charge was achieved. Figure 20 shows the full 10-kV discharge waveforms. On the third discharge, the header popped off of the capacitor. The following pictures show the state of the capacitor after this event. After ensuring that the capacitor was fully discharged it was found that the capacitor was in good condition with a capacitance of 405.3 µf, DF of 0.0056, and an ESR of 0.0023. The pictures in Figs. 21 and 22 show the result of the failure.
